Final Five-Year Review Report

**Site 12 - Town Gut Landfill and
Site 42 - Olsen Road Landfill**

**Naval Support Facility – Indian Head
Indian Head, Maryland**

August 2007

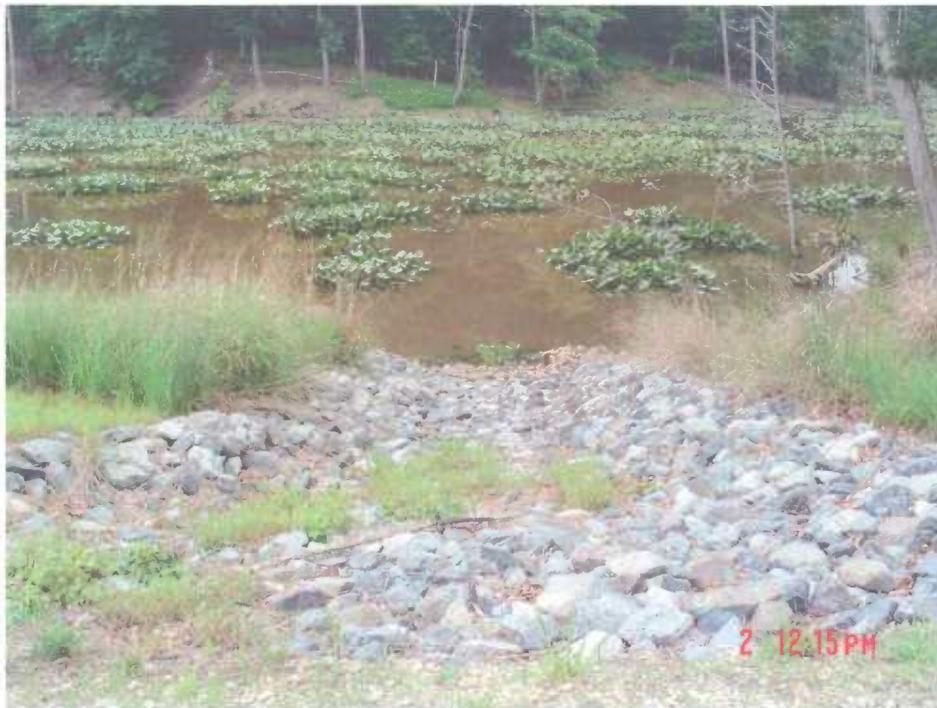
The drainage structures consist of two rip-rap drainage channels, three culverts, and several smaller rip-rap areas. All drainage structures appeared to be in good condition and functioning as intended. The longest rip-rap channel (to the east of the central landfill portion and extending from Atkins Road northward to the pond) had significant vegetation growing between the rip rap. As a preventive maintenance measure, it is recommended that any excessive vegetation and debris be removed from the rip rap area so that surface water runoff is not restricted through the channel and so that saplings and brush do not become established. One of the rip-rap lined outfall channels (downgradient of Atkins Road and east of the southern landfill portion) also had significant vegetation and leaves present in the rip rap. The exit end of the culvert was partially blocked by sediment, vegetation, and leaves. Although this channel still functions as intended, it is recommended that the sediment, excess vegetation and leaves be removed so that surface water may run off freely through the channel.

Drainage Channel on Southern Portion, Looking Southwest

- The landfill vegetation should be cut once per year to prevent the establishment of trees and brush. The cut height should be appropriate for the time of year (not too short in mid summer to avoid killing the vegetation).
- As a preventive maintenance measure, it is recommended that excess vegetation and debris be removed from the rip rap area so that surface water can flow freely through the channel and so that brush and saplings do not become established.
- New brass locks, all with the same key, should be placed on all the monitoring well covers.

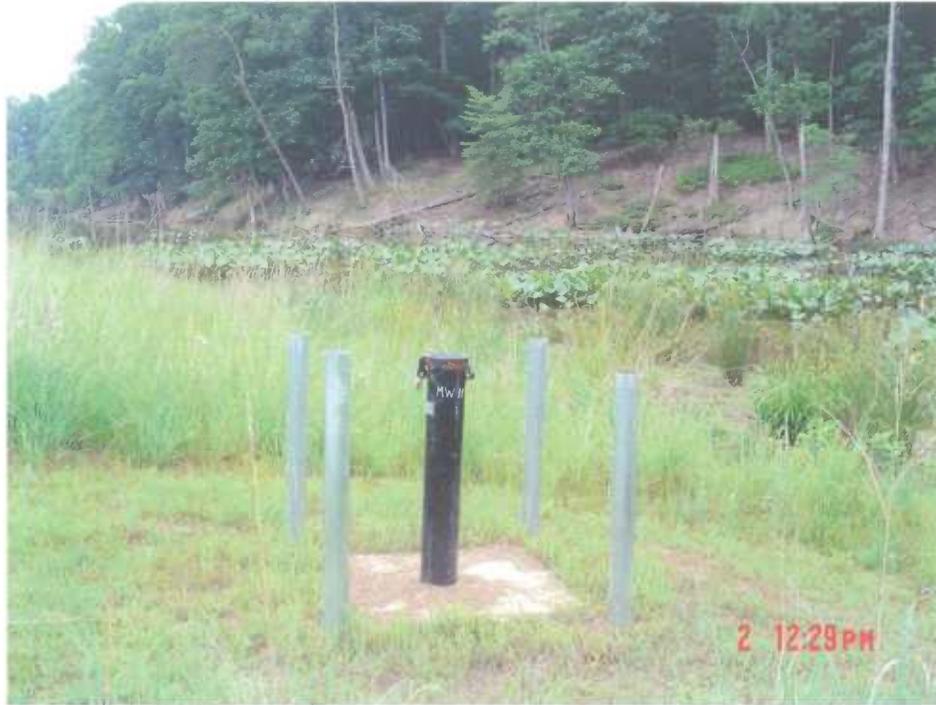
The monitoring wells appeared to be in good condition at the time of inspection; however the locks were either missing or rusted rendering all the wells unlockable. All wells will be furnished with new locks that can be opened with the same key.

MW – 11 on Southern Portion, Looking South

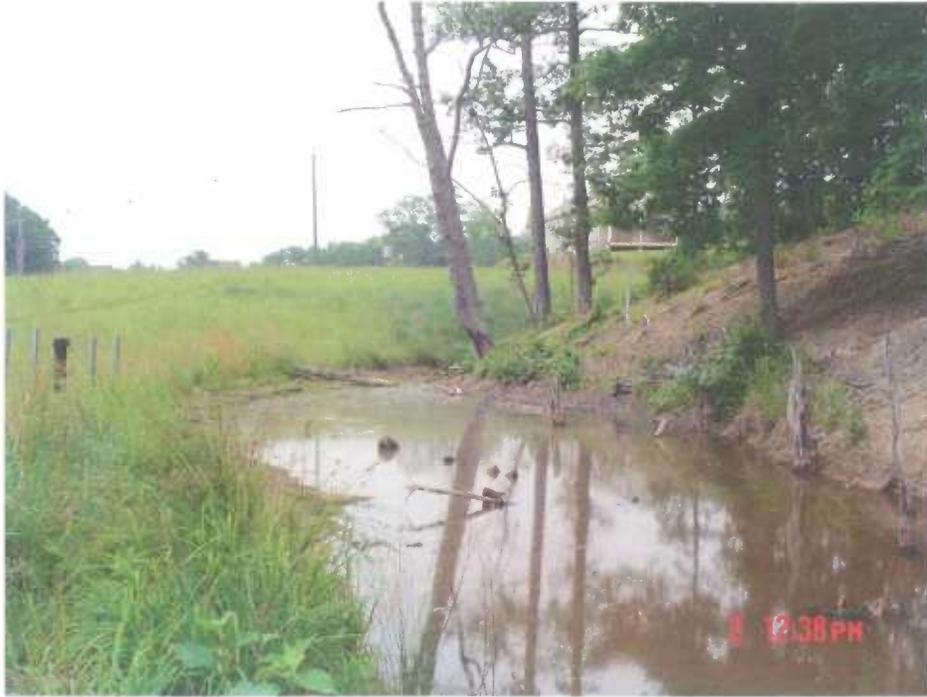
Southeast Side of Southern Portion and MW - 13

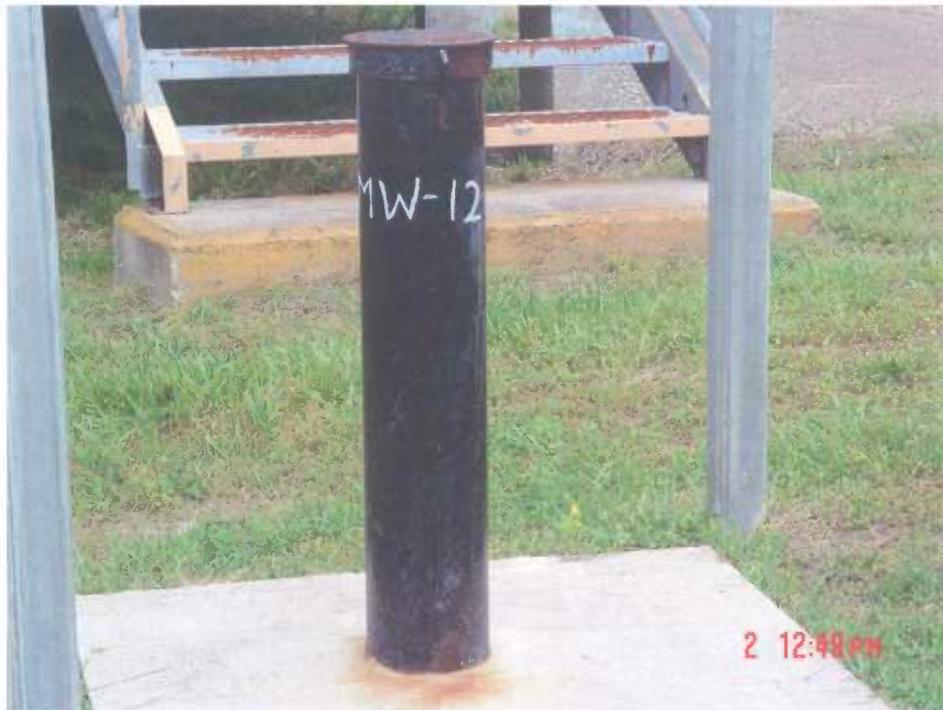
MW – 12, East of Intersection of Atkins Road and Atkins Road Extension

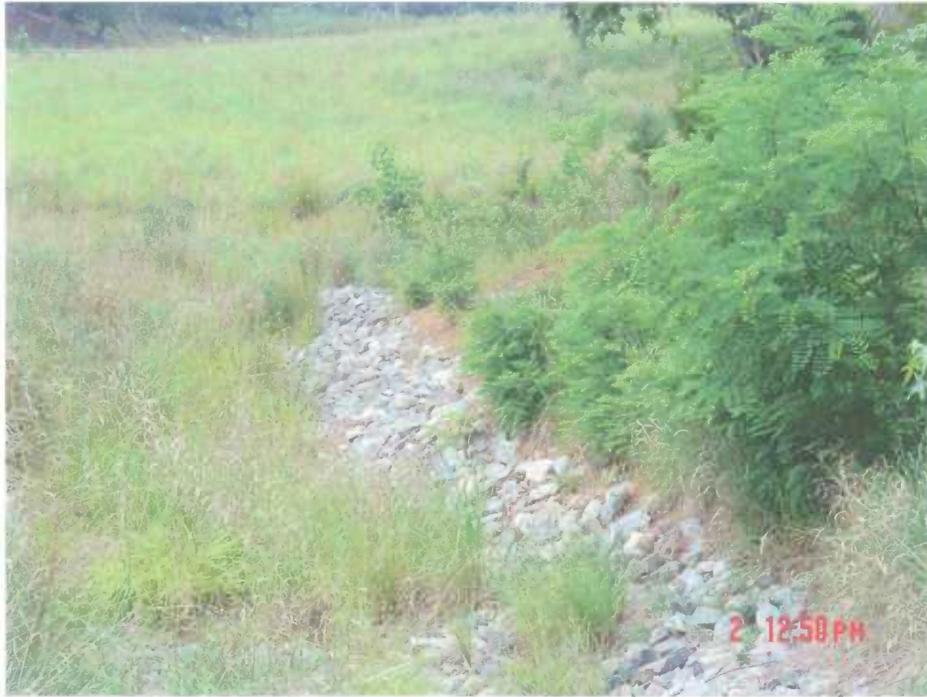
Drainage Channel East of Central Portion

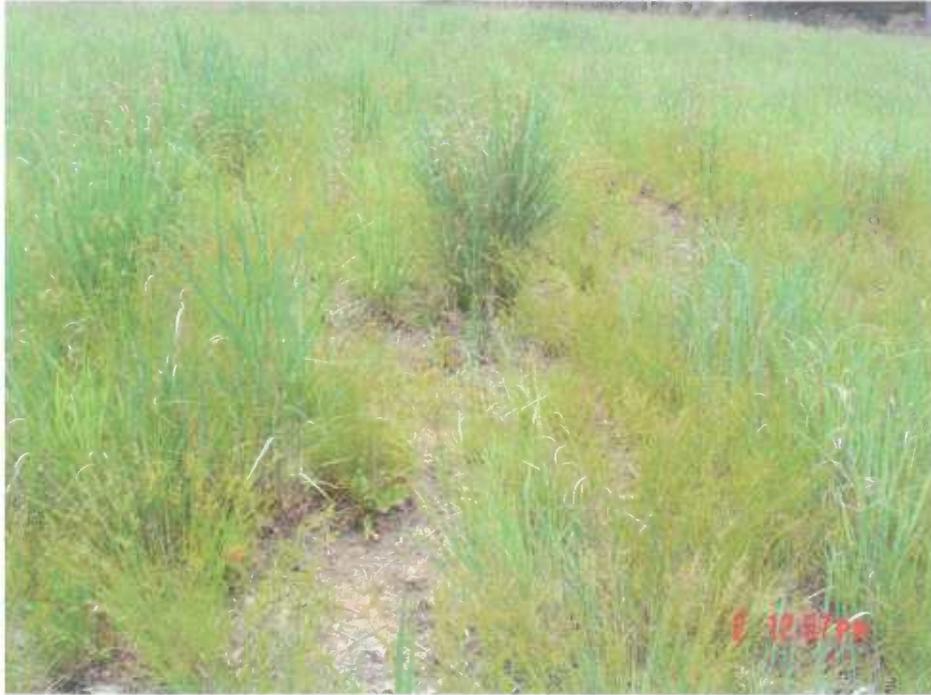
The landfill cover appears to be in very good condition and there were no signs of erosion, cracks, settlement, ponding or seeps. Vegetation on the landfill surface appeared to be full and in good condition. In fact, the vegetation is more than waist high in places and should be mowed. There was no physical sign of slope failure on any of the sides of the landfill. A hole, presumably dug by a burrowing animal, was present on the east side of the northern portion of the landfill. This hole was located to the west of S12MW009 but without a drawing and a tape, it was difficult to determine if the hole was on or adjacent to the landfill.

Area of Sparse Vegetation on Northern Portion

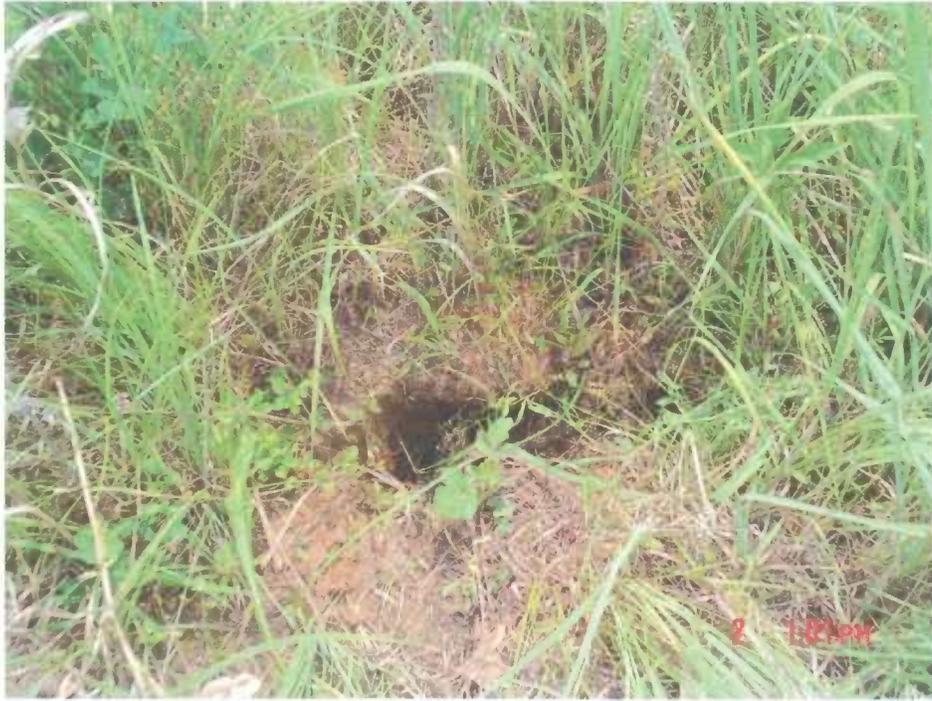
Possible Animal Hole or Erosion on Northern Portion

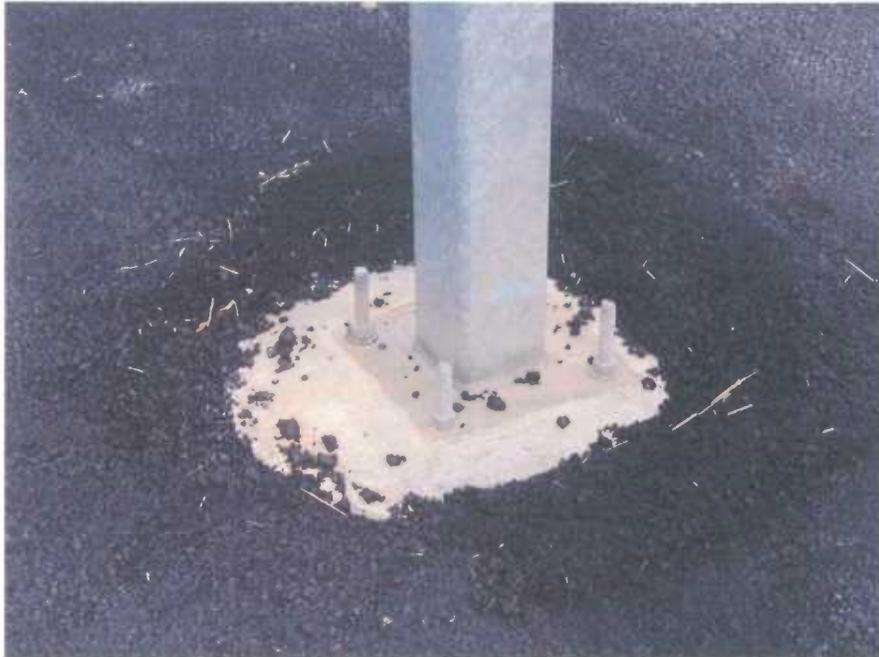
Photo Ref. 123

**Typical Depression In Asphalt Cover Portion Of The
Engineered Cap System At Steam line Support.**

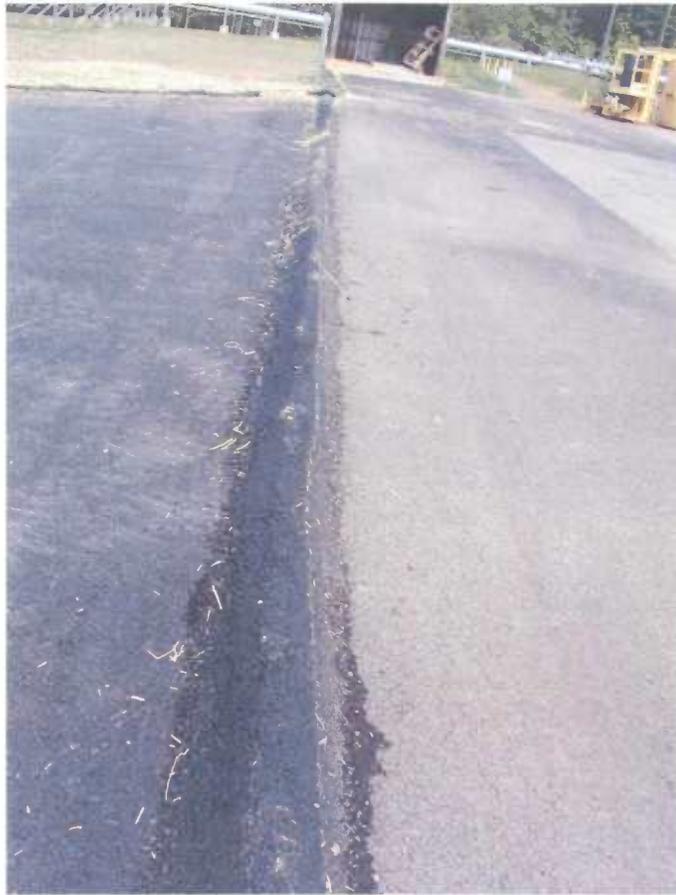
Photo Ref. 120

The only devices used to prevent access to the engineered cap system are signage and a guide rail. Signs are in place, legible, and in good condition. During the site inspection, it was decided to add a guide rail along the southern extent of the Building 1866 parking lot outside the limits of the newly installed geomembrane cover to prevent vehicular traffic from traversing the asphalt portion of the engineered cap system. This guide rail has been installed.

Rolled Asphalt Curb Where The Asphalt Portion Of The Engineered Cap System Meets The Building 1866 Parking Area (Looking Northwest). Location Of Proposed Guide Rail.

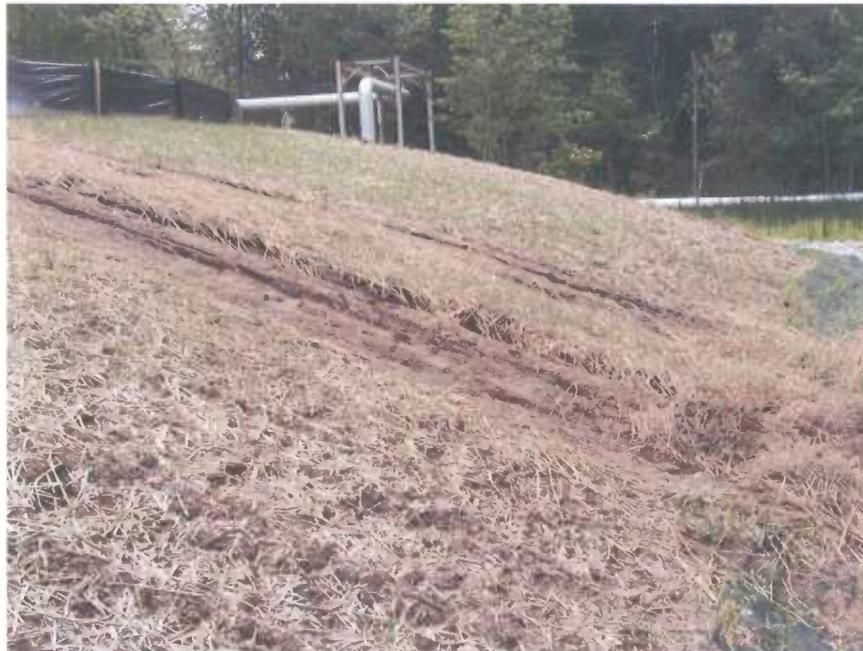
Photo Ref. 102

The final construction walkthrough for the Olsen Road Landfill remediation occurred on the morning of the site inspection. Due to the recent completion of the engineered cap system, the landfill and associated structures (gabion walls, monitoring wells, and asphalt cover) appear to be in very good condition. Additionally there was no sign of slope failure on any side slopes and no sign of settlement across the surface of the landfill. Based on the walkthrough, the following item remains to be performed: vegetation on the soil cover portions of the engineered cap system is still in the process of being established and evidence of erosion was noted. Discussions with the remedial action contractor resulted in the decision to add temporary erosion and sediment controls until vegetation is established on the engineered cap system.

**Evidence Of Erosion On Slope Of Landfill Prior To Establishment Of Final Vegetation.
Looking Southeast From Discharge End Of Western Drainage Ditch.**

Site 42: It is recommended that temporary erosion and sediment controls be added until vegetation is established on the engineered cap system.

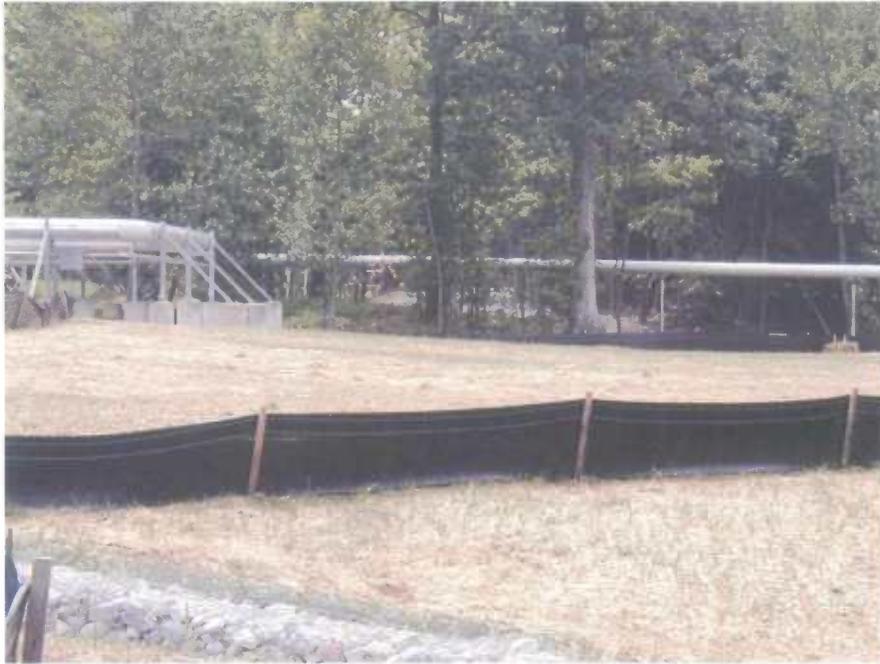
Photo Ref. 095

**Southeastern Plateau Portion Of The Landfill.
Temporary Silt Fence To Be Removed Following Establishment Of Final Vegetation.**

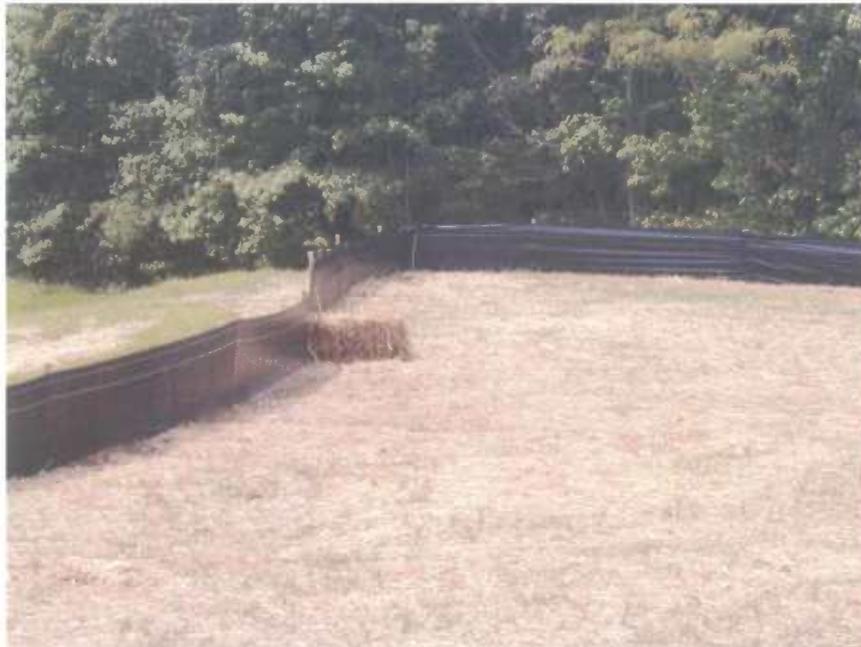
Photo Ref. 092

Vegetation Process And Temporary E&S Controls On The Ridge Of The Southeastern Portion Of The Landfill. Looking From The Steam Line To The South.
