**COMMENTS ON GROUP A POINTS OF INTEREST
NAVAL TRAINING CENTER, SAN DIEGO
CTO-0082**

**Group A POIs
Naval Training Center, San Diego**

Claire Trombadore
United States Environmental Protection Agency

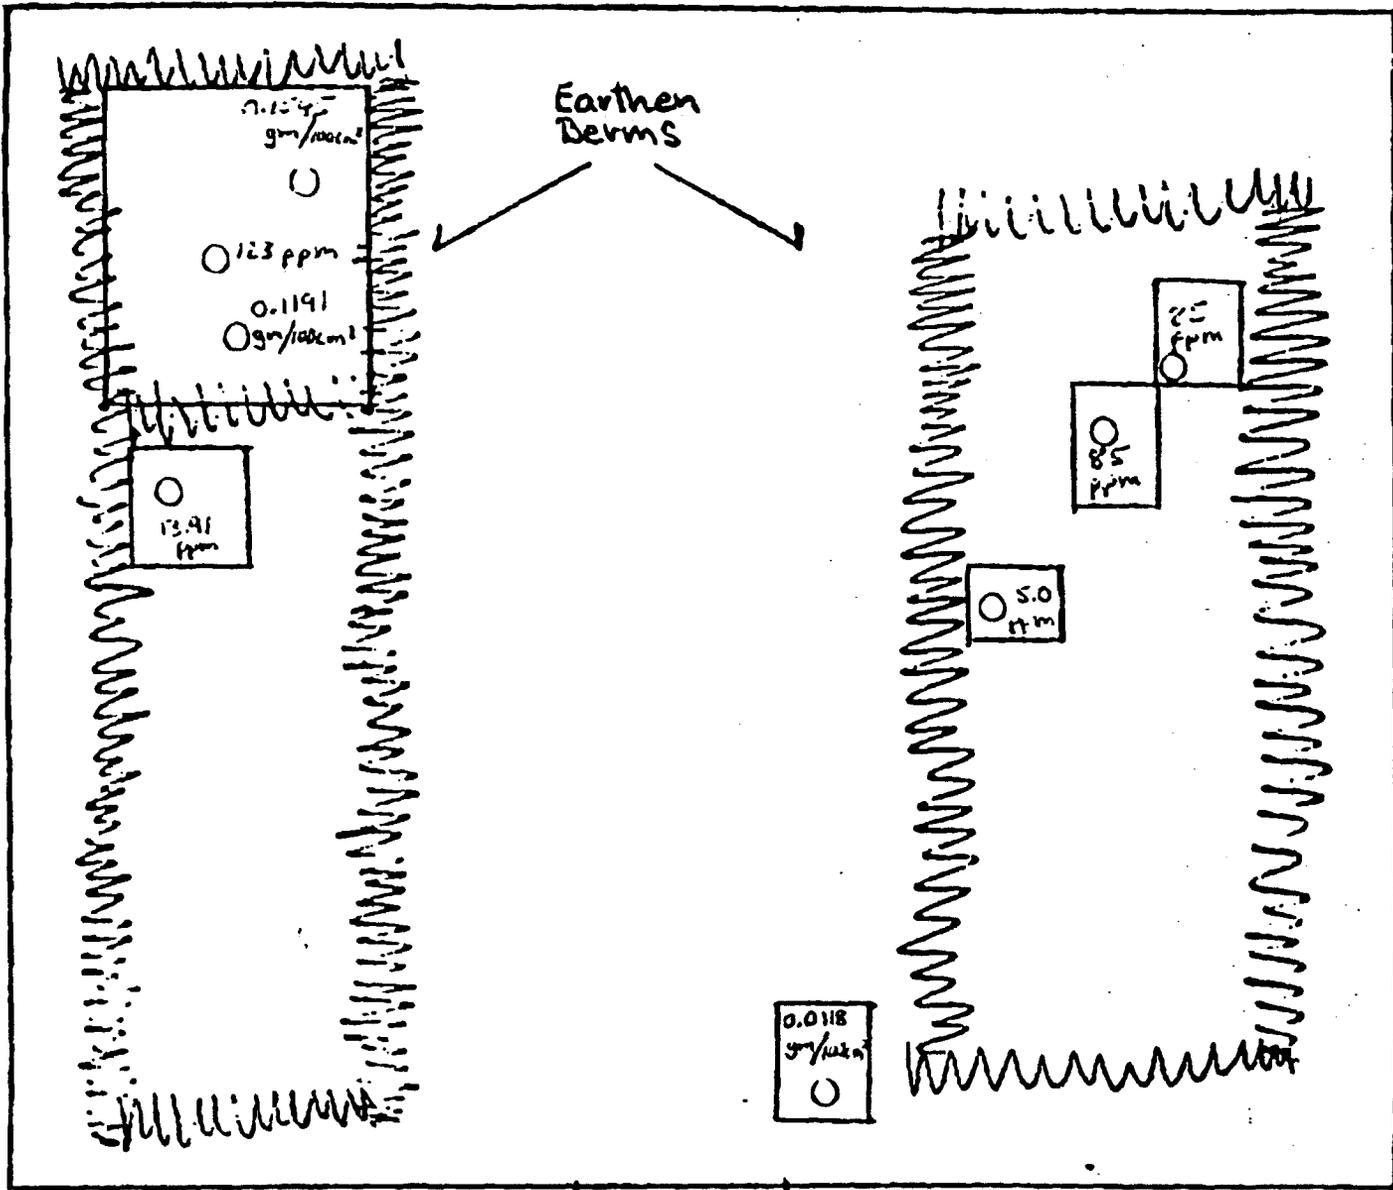
Stockton Rd.

10. CONTAMINATION LIMITED TO 70 SQUARE FEET OF ASPHALT SURFACED TEMPORARY STORAGE AREA AND SURROUNDING DIRT BERMS.
11. INITIAL RESPONSE BY PERSONNEL. ALL LEAKAGE WAS INITIALLY

Earthen Berms

6. PWC personnel working under the supervision of a PWC Environmental Protection Specialist excavated the contaminated asphalt and soil and loaded the waste into certified containers prior to hauling waste to an EPA permitted disposal facility. Uniform Hazardous Waste Manifests are included as enclosure (3).
