United States Department of the Interior

FISH AND WILDLIFE SERVICE
Washington, D.C. 20240

Re: Draft Expanded Range Assessment and Phase II Site Inspection Work Plan, Former Vieques Naval Training Range (VNTR) Vieques

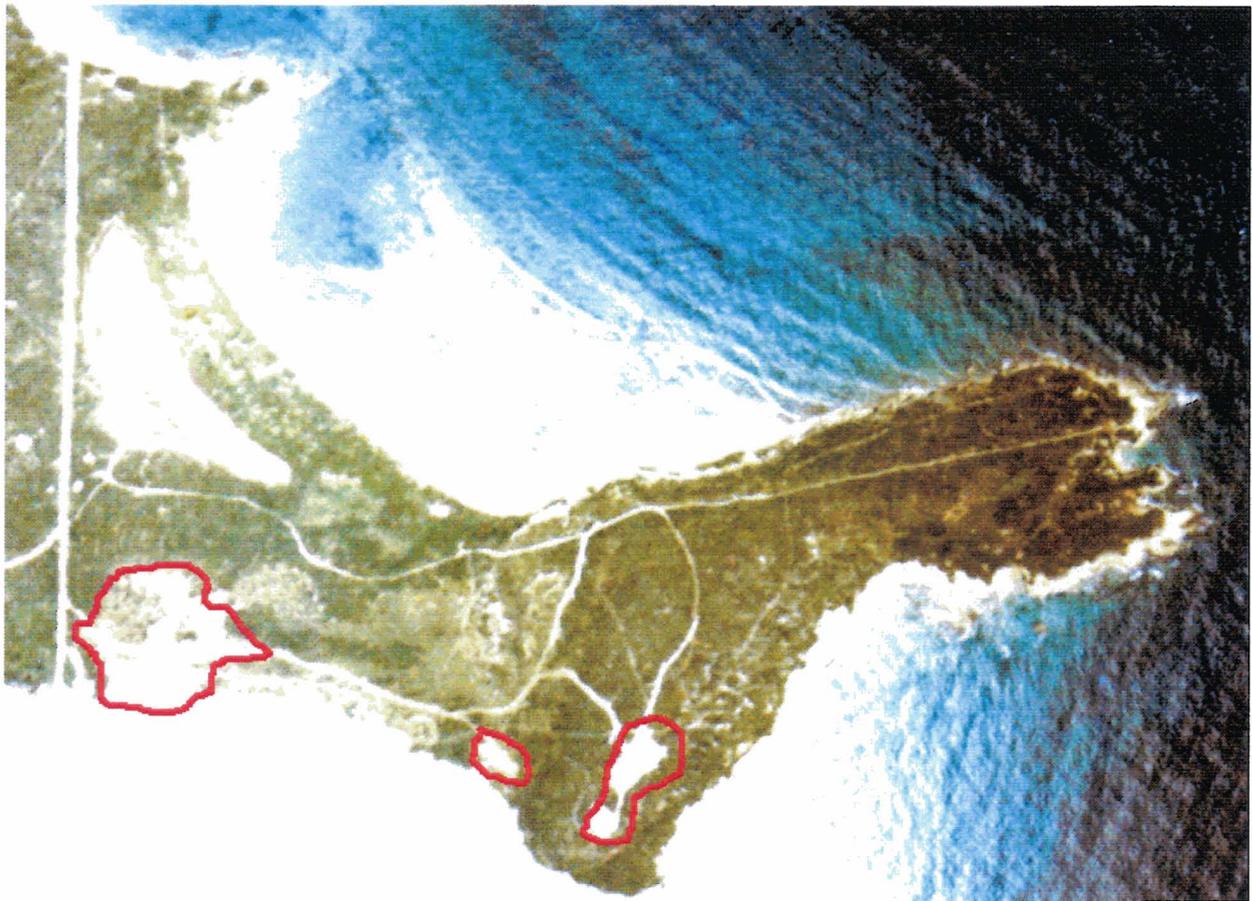
The Eastern Conservation Area (ECA) has been added to the existing TCRA as a MRA. It was established in the early 1980's as a conservation zone because of its unique ecology. However, aerial photos show extensive ground scarring and trails along the southern portion (Photos 1 and 2) that should be targeted for investigation. This area is botanically unique and vegetation removal should be minimized. Site selection and Work Plans for this area should be closely coordinated with the FWS. The existing trail system in this area should be included since it will be used by FWS personnel to access the different sites. We would also like to request that Dr. Gary Breckon be allowed to accompany the flora/fauna survey team into the ECA. Dr. Breckon has been contracted by the FWS to update the flora checklist for Vieques and he has already added several new species to the island botanical inventory. Given the uniqueness of this area, we believe that his participation in the survey would be a benefit to both the Navy and the FWS.

Photo 1. Eastern Conservation Area circa 1970. Note ground scarring and road cuts throughout the area.

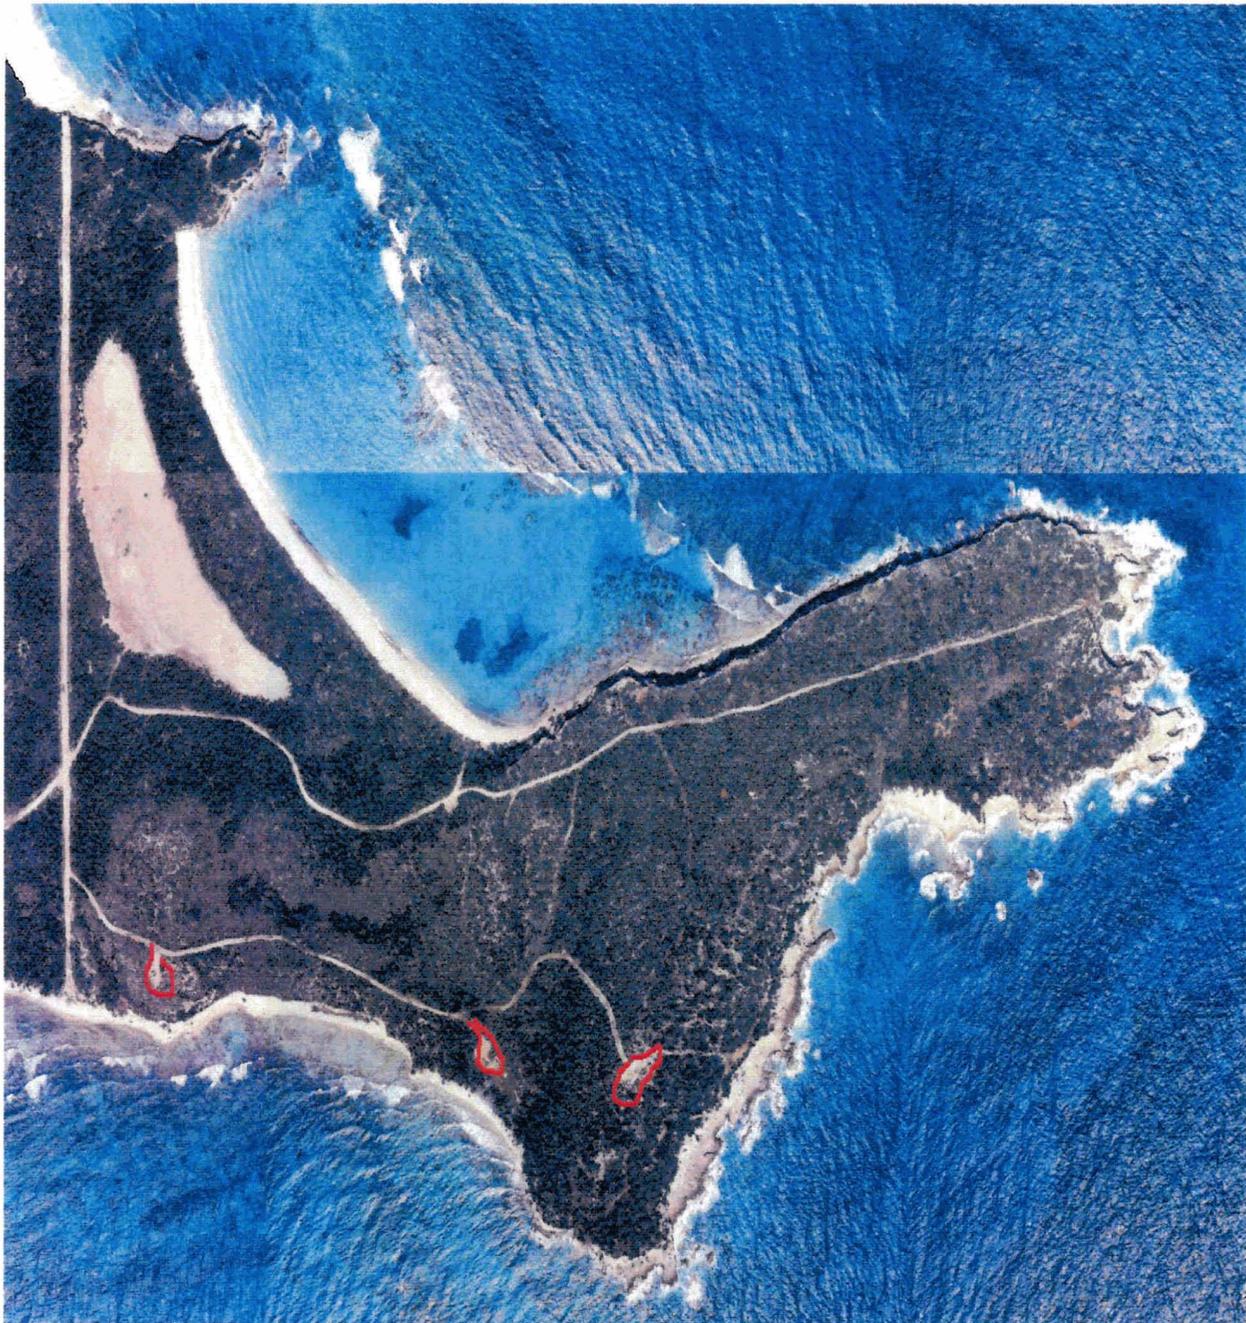
Photo 2. Eastern Conservation Area circa 2000. Note there are still some ground scars, but the majority of the area has some vegetative cover.

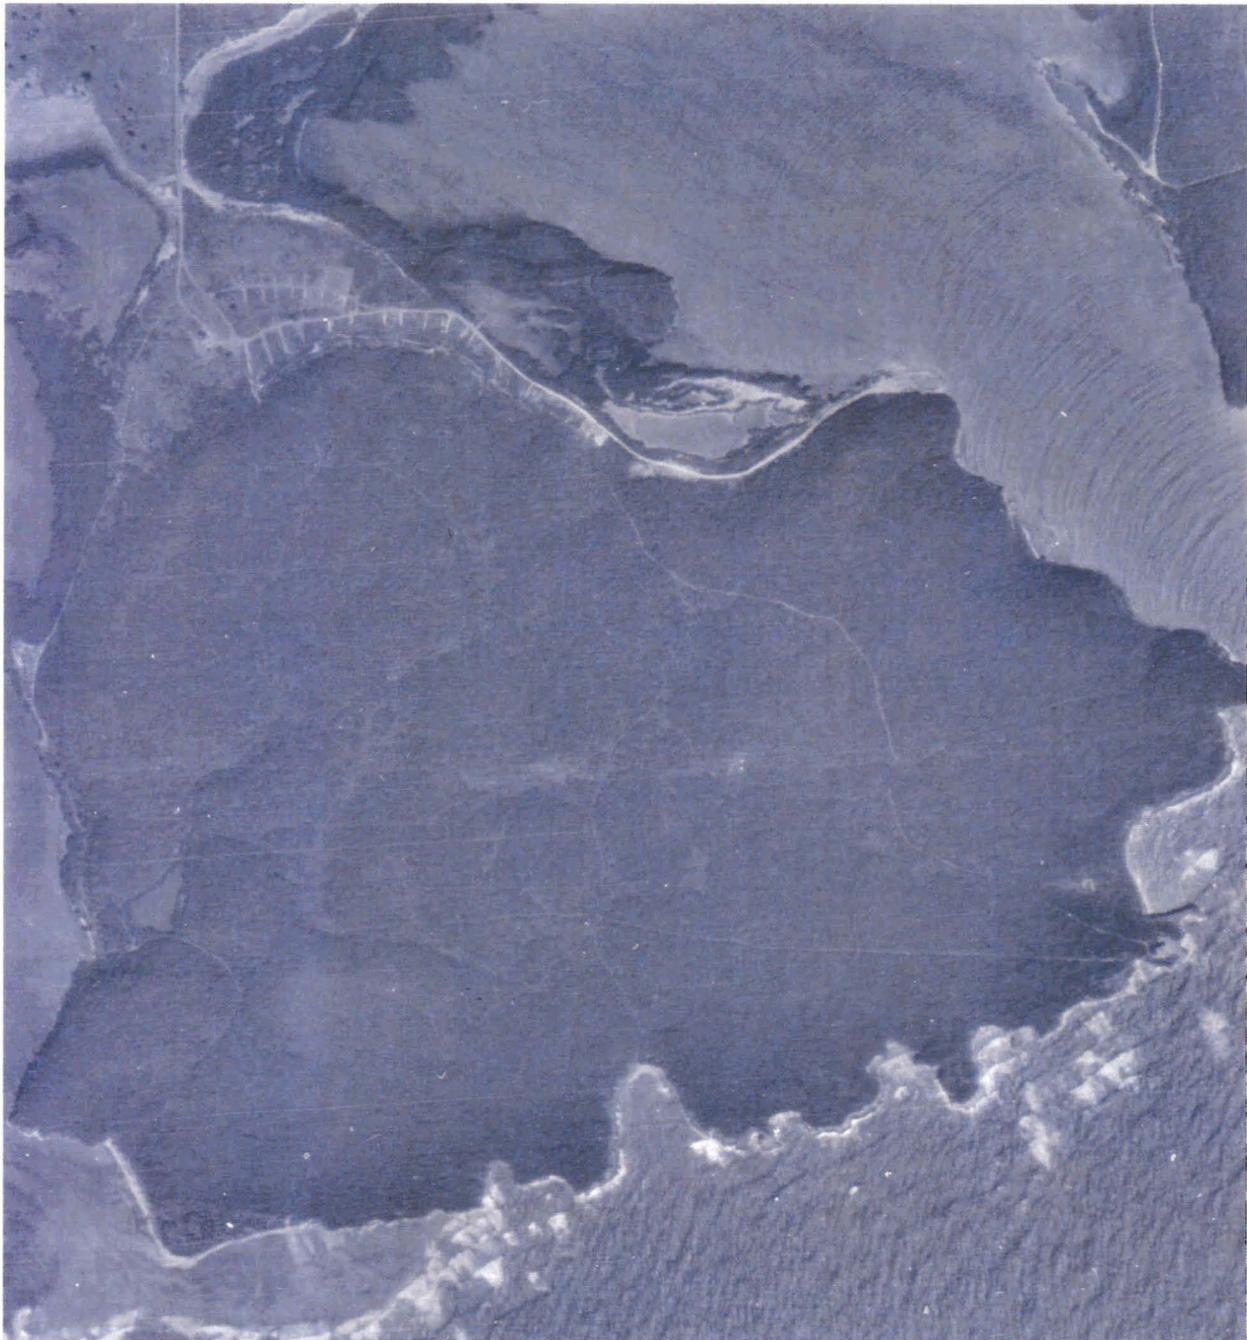
Photo 3. Puerto Ferro circa 1959. Note the location and extent of PI-9 (MRS 12). The fill area east of PI-9 in the bay was first noted at this time. Also note road heading southwest from this site.

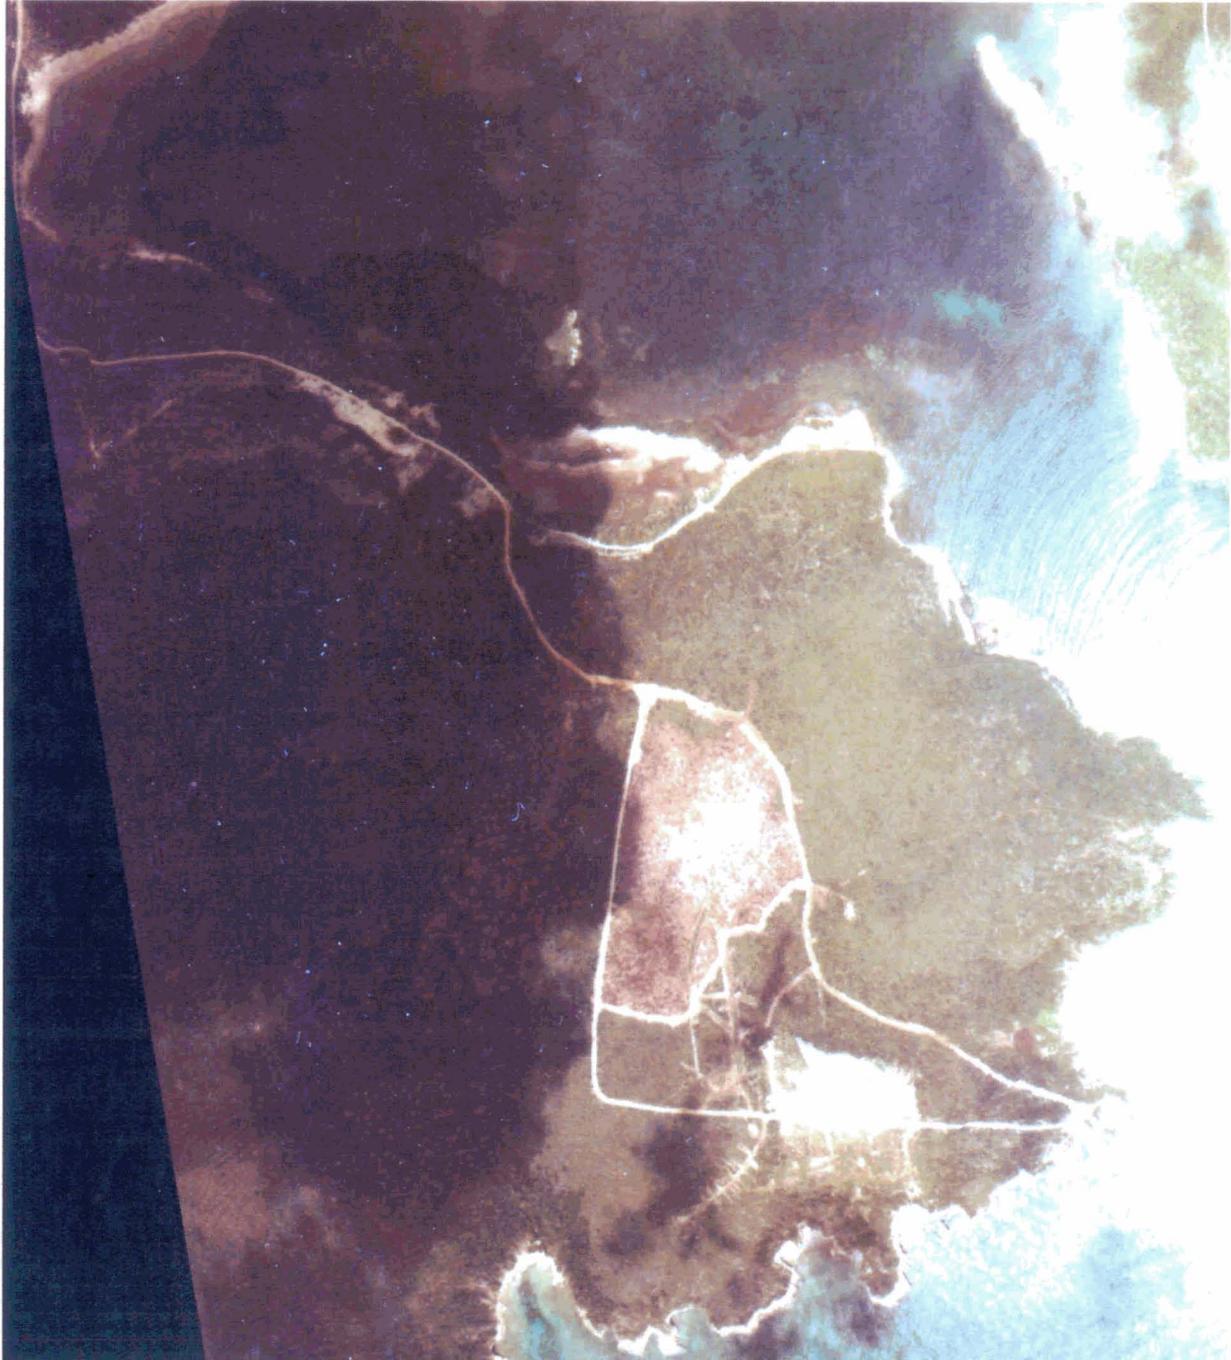
Photo 4. Puerto Ferro circa 1970. Note the decrease in size of PI-9, however this photo marks the appearance of PI-13 (MRS14 or 46), scarred areas near the lighthouse, the creation of the existing lighthouse road, the burn area in the central portion of the photo, and additional roads. With the exception of the lighthouse road, many of these sites are now covered with sparse vegetation.

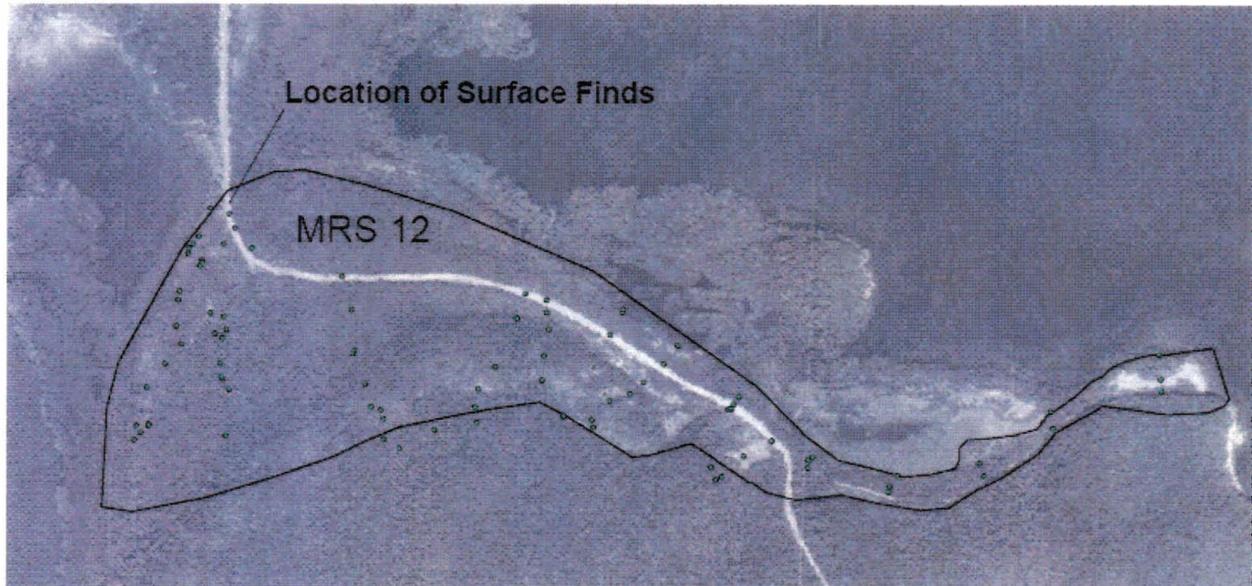
Photo 5. Expanded Range Assessment Site Investigation Phase I subsurface anomalies. Note that many of the hits were in the location of the old ammunition or explosive storage areas. Two expended 155 mm and 120 mm projectiles were found near the access road where several buildings once stood. While no anomalies were found north of the road, aerial photos indicate that structures were present north of the road where it curves to the east.

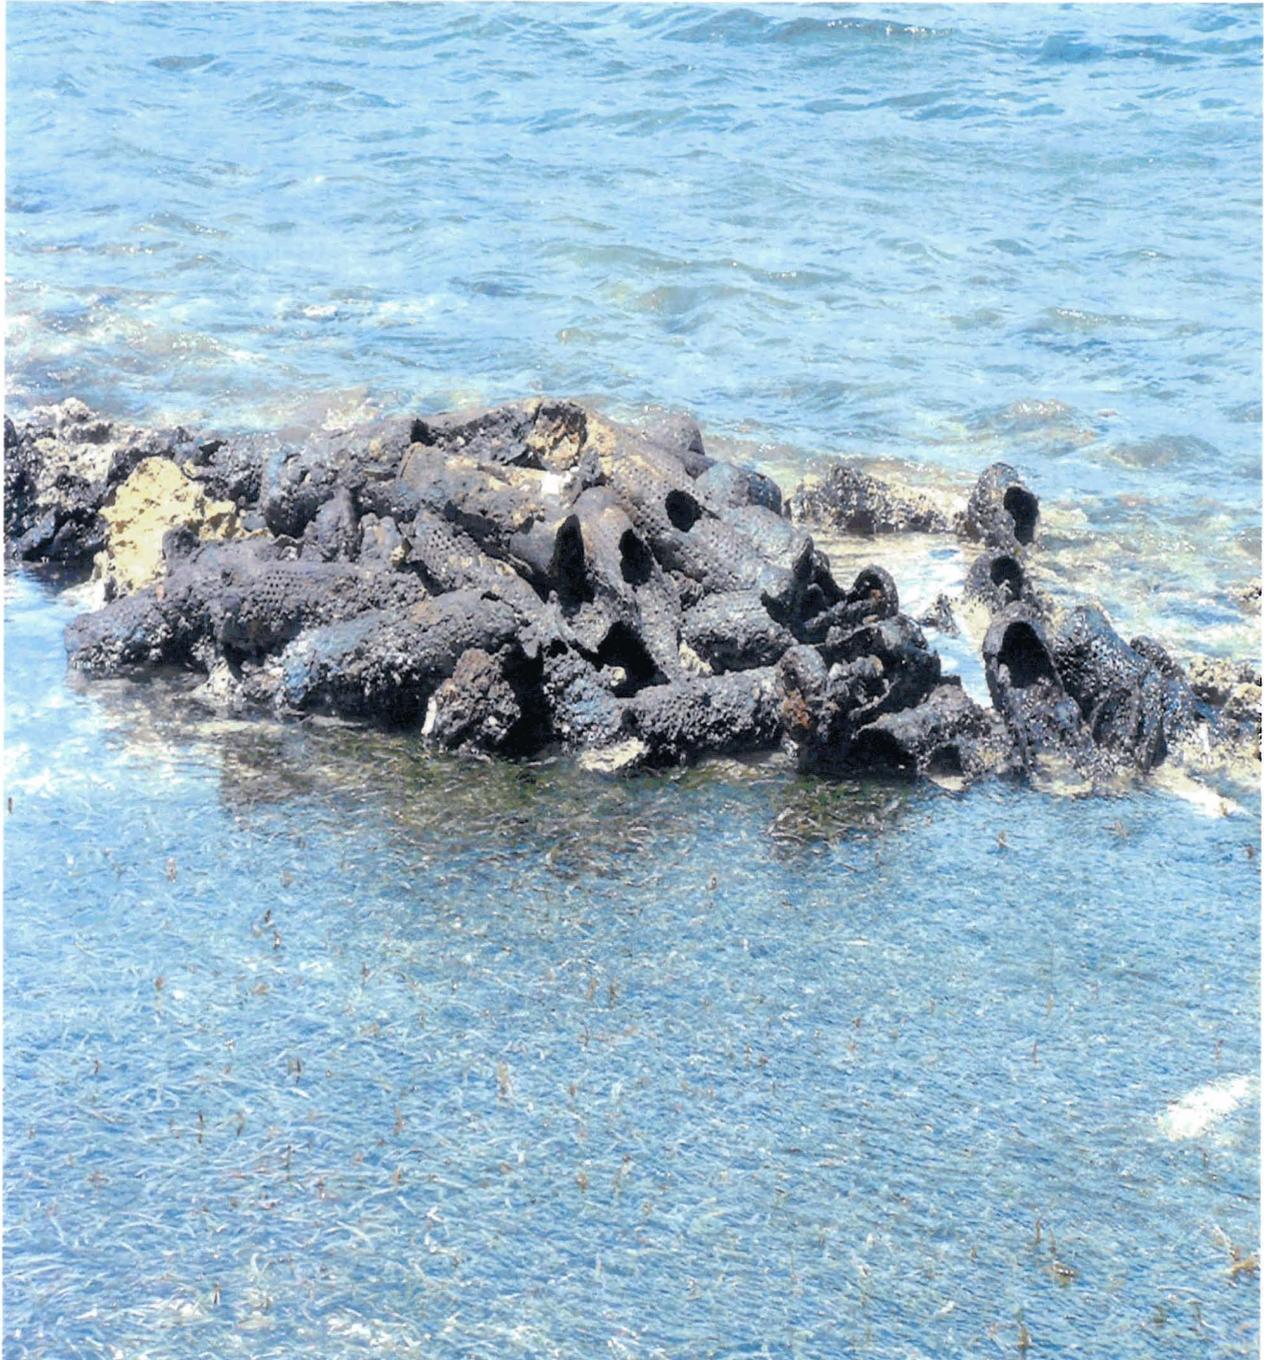
Photo 6. Shell casings found in very shallow water several yards from the current shoreline of the fill area along the eastern shore of PI-9. The fill area may have extended beyond this point and the fill may have eroded and exposed the casings. This particular area is usually shown to demonstrate “contamination” that has been caused by historic Department of Defense activity at Vieques.

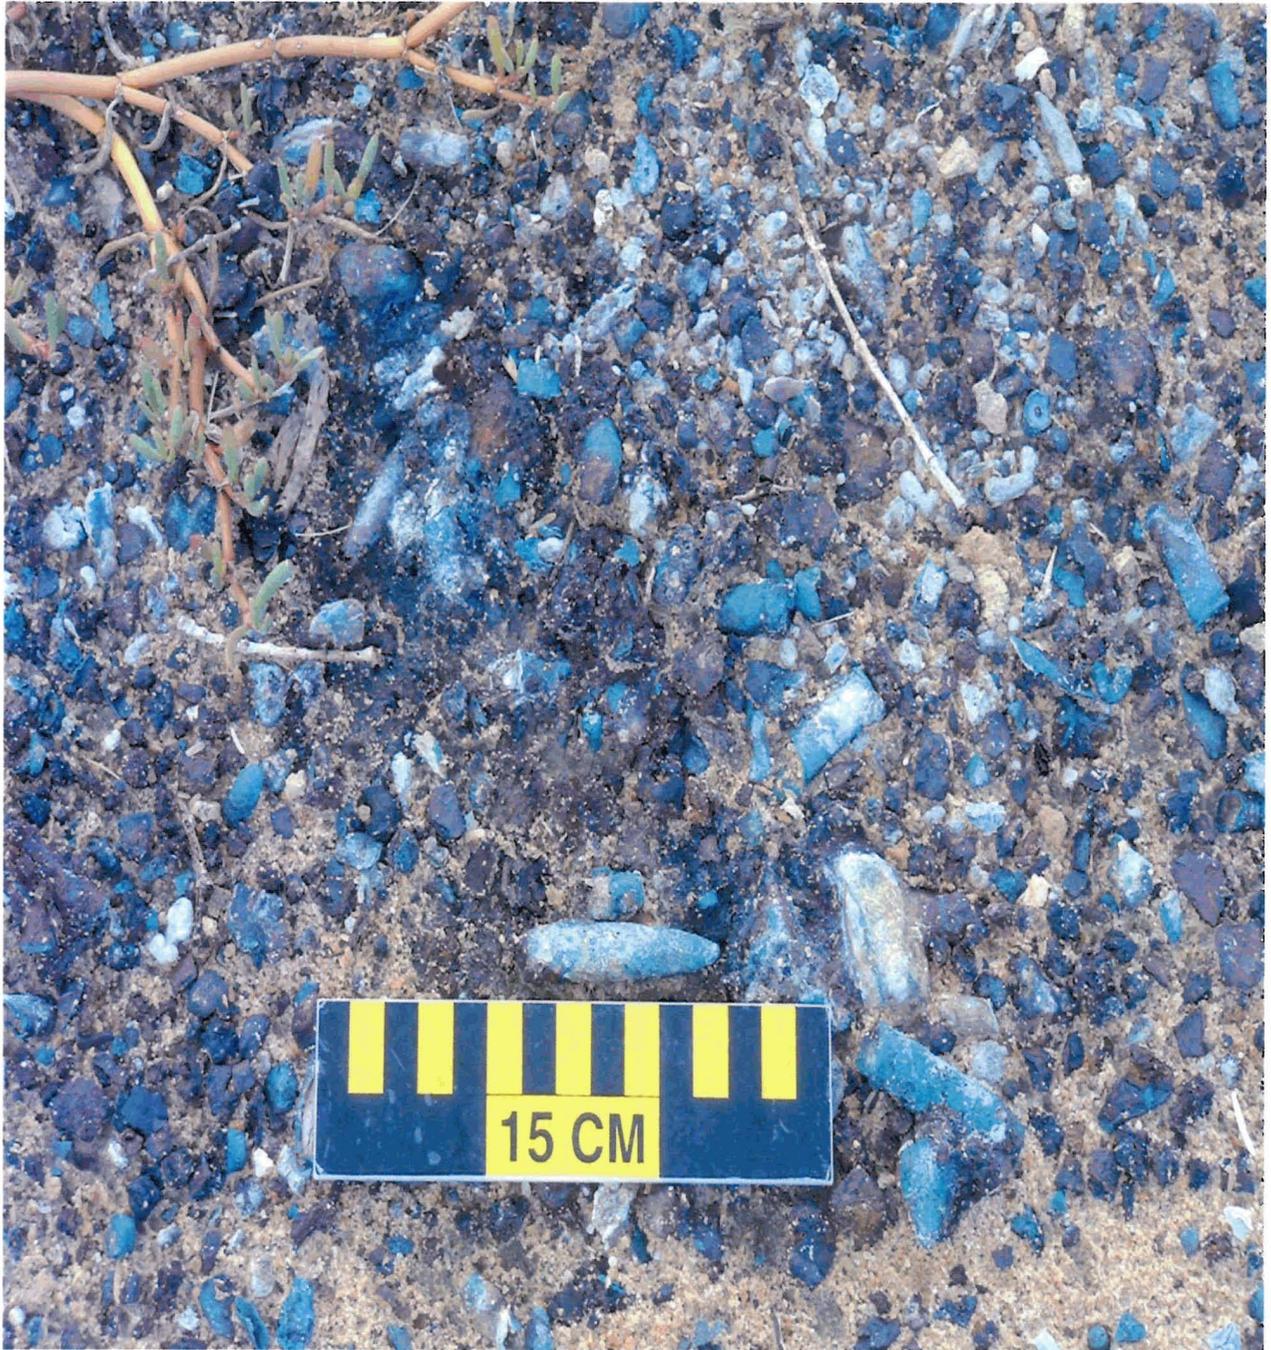
Photo 7. Deposit of small arms ammunition in salt flat north of PI-9. The extent of this dump is not known.

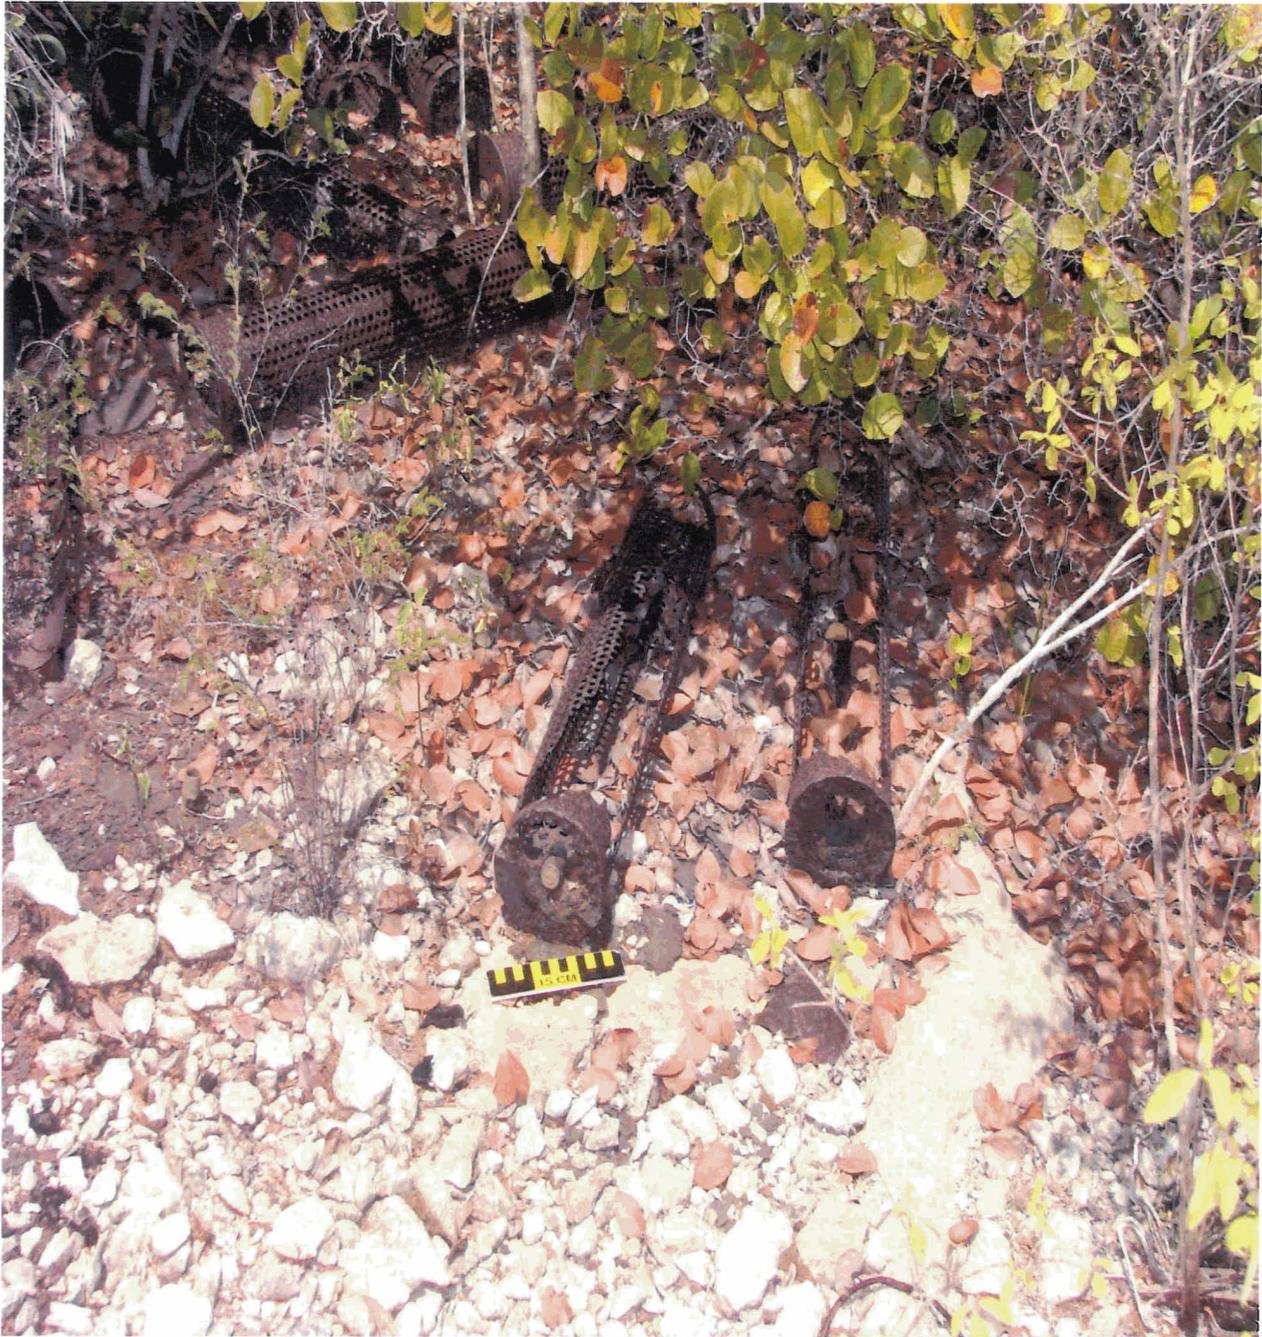
Photo 8. One of several trash dumps located along the old lighthouse road in Puerto Ferro containing munitions debris. The extent of these dumps is not known.

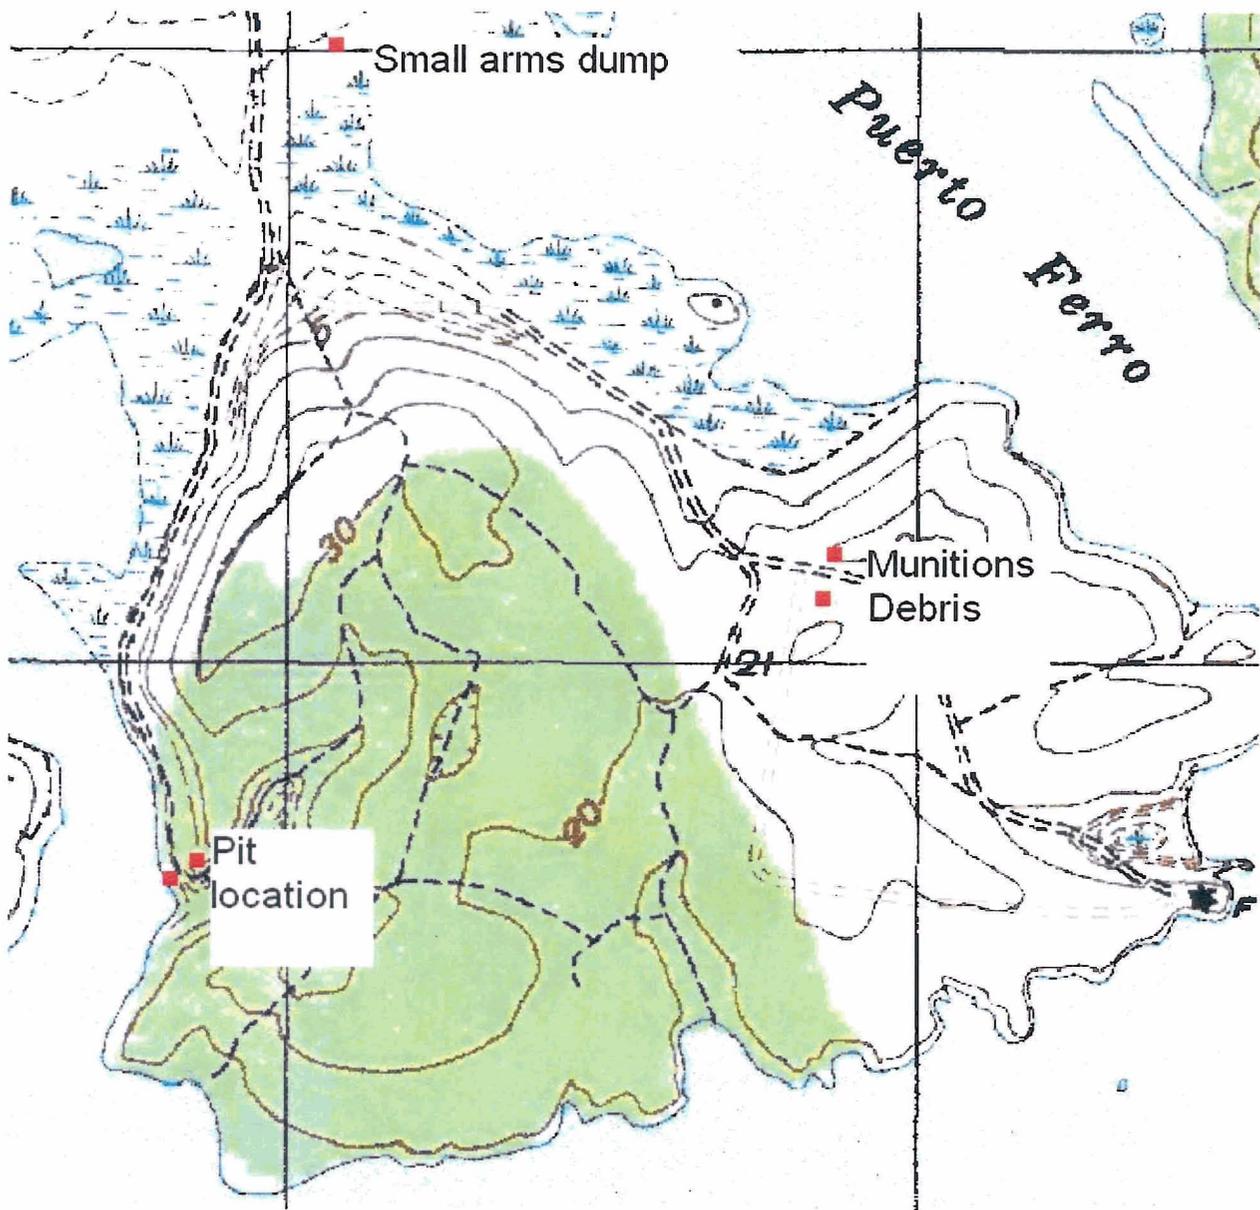
Figure 1. Location of additional sites on the Puerto Ferro Peninsula that should be included in the current round of investigations.

The Puerto Ferro Peninsula area has several MRSs and possibly some additional areas that warrant investigation. This is also the only area within the open section of Camp Garcia that is closed to the public. With its close proximity to open areas and the location of the historic Berdiales Lighthouse, opening this peninsula to public use is a priority for the FWS and the Municipality of Vieques. This area is currently composed of PI (Photo Identified area)-9 (MRS 12), PI-13 (MRS 14 or 46; in Table 3-1 it is cited as MRS 14, but in Figure 3-1 it is shown as MRS 46), the near shore munitions reef, several small trash piles containing shell casings, a small arms dump site and two large pits along a trail (Photos 3 through 8 and Figure 1). Photo Identified area 9 was clearly visible in historic aerial photos of the area (Photos 3 through 5) and is identified as a munitions or explosive storage area. At that time, a dirt road ran south along the west side of the peninsula, and two pits about 6-feet across and 3-feet deep are found on either side of this road, near a small inland lagoon (Figure 1). The origin of these pits is unknown, but there are sizable trees growing near them indicating that the area has not been disturbed in recent years. Another site associated with PI-9 is a fill area first identified in 1959 at the edge of Puerto Ferro and likely associated with an explosive storage area to the west. The deposit of shell casings associated with this site (Photos 6 and 7) are noted as increasing in size in 1962. In the 1970 aerial photos, the current access road to the lighthouse appears along with a large degree of ground disturbance. This is when PI-13 first appears along with the areas that now contain several trash piles (Photo 8). The FWS requests that during the Phase II Site Investigation (SI), all of the sites in the Puerto Ferro Peninsula be investigated.
