N62578.AR.002241
NCBC DAVISVILLE
5090.3a

October 22, 2007

Re: Interim Groundwater Sampling Event 05-April 2007 Results Report for Site 03: Construction Equipment Department, at the former Davisville Naval Construction Battalion Center, North Kingstown, RI dated September 2007

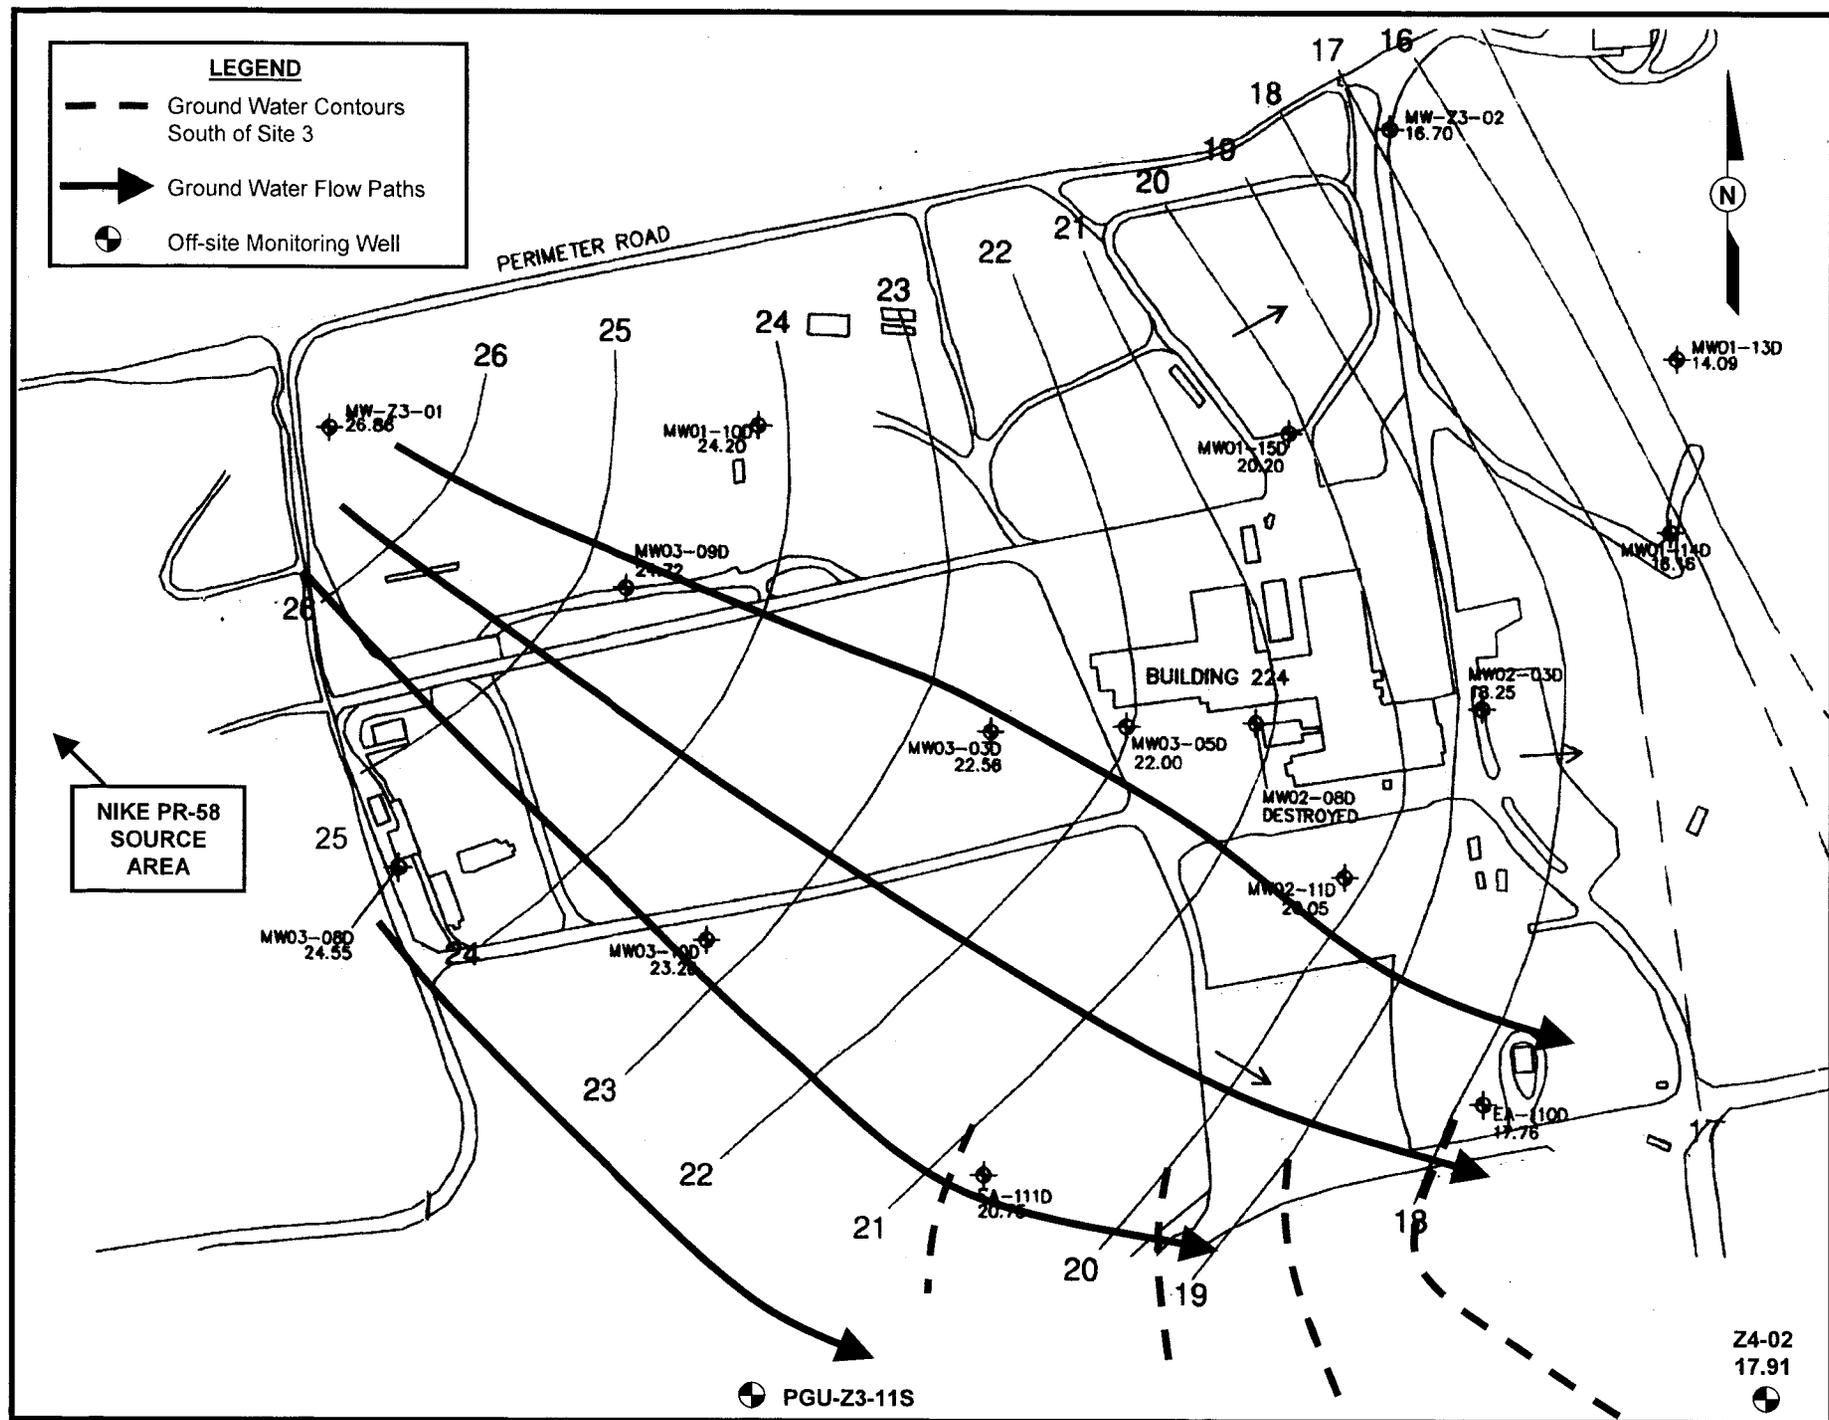
Figure 1. Deep overburden ground water flow direction.

Further, while the Navy Figure 3A for the deep overburden did not include the ground water elevation from MW Z4-02, the ground water elevation for that deep overburden well measured during the same synoptic ground water elevation measurement round clearly shows that the deep ground water flow direction follows an inflection in the ground water flow patterns. This axis of ground water flow is oriented into the Site 16 area. Therefore, CVOC released at the former Nike PR-58 site, the western boundary of Site 03, or the northwest corner of Site 03 (possibly the vicinity of EA-104 just west of the Site 03 boundary) is likely to migrate to the location of Site 16 following the ground water flow lines from those locations. The ground water flow path from these locations extends over a wide segment of the southeast boundary of Site 03 as shown on the attached Figure 1.

Comment 1: *Page 1-3, Section 1.3, 2nd Paragraph:* The statements in this paragraph are incorrect and misleading. Specifically, the Navy judges the CVOC source to be on the former Nike PR-58 site. While a source does exist at that location, it is clearly not the only source at Site 03 or just off of the Site 03 boundaries. In particular, it is not clear that a source does not exist at the northwest corner of Site 03 or just across the boundary at the location of EA-104D/R. Also, the statement that studies on the Nike PR-58 site shows “the main plume moving east toward the adjacent Navy property (designated as Parcel 7). A branch of the plume has been determined to extend to the north, beyond the Navy property line, towards private residences identified as having private wells” is not correct. The Navy has only to look at its own ground water contours for the Site 03 deep overburden and bedrock ground water to see that the primary direction of ground water flow is to the southeast from the former Nike PR-58 site and the western and northwestern areas of Site 03. The Navy Figures 3A and 3B with ground water flow paths superimposed are attached as Figures 1 and 2 of this technical document review.

Site 03 area. As shown on Figures 1 and 2 attached, groundwater flow from the former Nike PR-58 site source area and the western boundary of Site 03 migrates in a southeastern direction. Monitoring well distribution at Site 03 is weighted to the north and northeast in the Site 03 area.

Comment 5: *Page 2-1, Section 2.1, Last Sentence:* The statement “Groundwater in both the deep overburden and bedrock aquifers is interpreted to generally flow to the east, towards Allen Harbor and Narragansett Bay” is not supported. Inspection of Figures 3A and 3B of this IGWSE report clearly show the primary direction of groundwater flow to the southeast as shown on the attached Figures 1 and 2.
