SAMPLING AND ANALYSIS OUTLINE FOR BUILDING 927 BASE REALIGNMENT AND
CLOSURE ZONE C DEVELOPED NON-INDUSTRIAL AREA GROUP 6 NAS CECIL FIELD FL
10/1/1995
ABB ENVIRONMENTAL SERVICES INC

SAMPLING AND ANALYSIS OUTLINE
BUILDING 927
BASE REALIGNMENT AND CLOSURE
ZONE C, DEVELOPED NONINDUSTRIAL AREA
GROUP VI
NAVAL AIR STATION CECIL FIELD
JACKSONVILLE, FLORIDA

October 1995

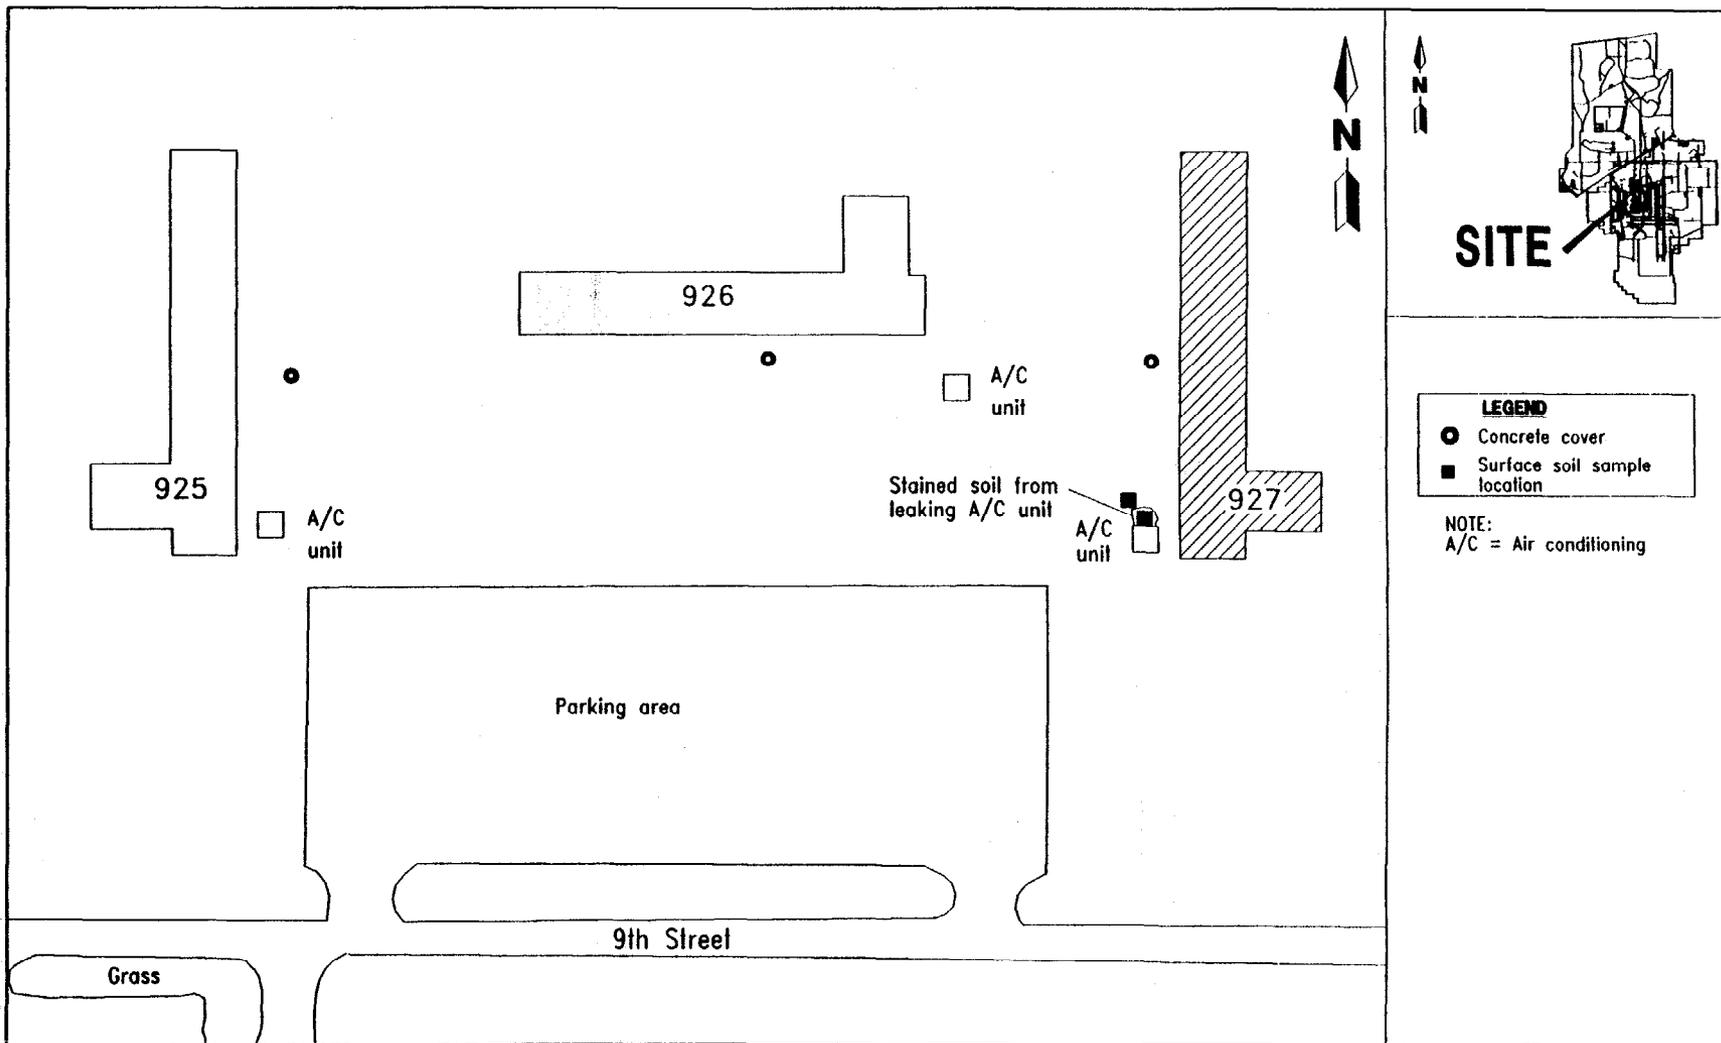
**FIGURE 1
BUILDING 927 -
BARRACKS FOR ENLISTED PERSONNEL
PROPOSED SAMPLE LOCATIONS**

This Base Realignment and Closure (BRAC) Program Phase II Sampling and Analysis Outline briefly describes and proposes a recommendation for Building 927 located on 9th Street between A and B Avenues (Figure 1) at Naval Air Station (NAS) Cecil Field. Building 927 is a barracks for enlisted personnel.

The outdoor condensing unit for the air conditioner (presumably the compressor) was observed to be leaking oil onto the concrete pad and the ground adjacent to the unit.

organics and target analyte list (TAL) inorganics is recommended. Sample collection techniques, quality assurance objectives, quality control requirements, and sample handling and shipping procedures are outlined in the BRAC Project Operations Plan (ABB-ES, 1994b). The proposed sampling locations are shown in Figure 1.

To evaluate the presence or absence of contaminants that may have contaminated surface soil, two samples will be collected 0 to 1 foot below land surface (bls) near the air conditioning compressor. The surface soil samples will be analyzed for TCL organics and TAL inorganics.
