**PROJECT COMPLETION REPORT
PHASE 1 GROUNDWATER TREATMENT
AND RECOVERY SYSTEM
AT
OPERABLE UNIT 1**

**NAVAL AIR STATION
PENSACOLA, FLORIDA**

Prepared by
**BECHTEL ENVIRONMENTAL, INC.
OAK RIDGE, TENNESSEE**

March 2000

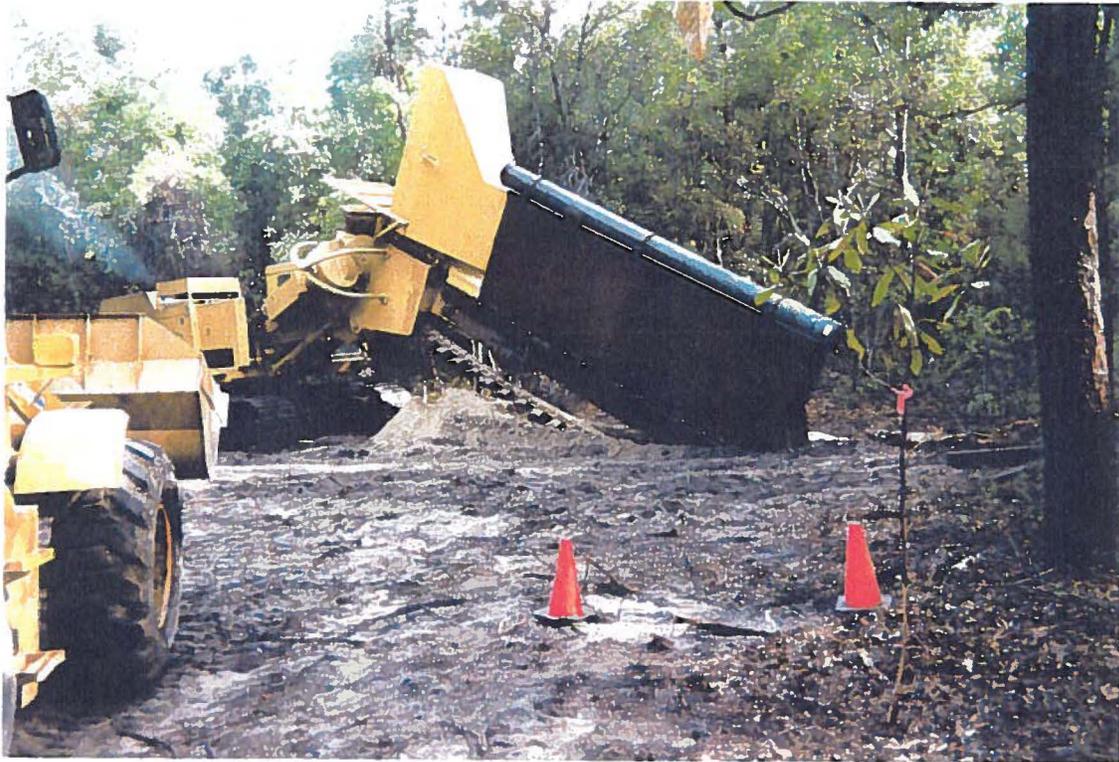
Photograph No. 1: Continuous trenching machine setting 12-in. riser pipe.

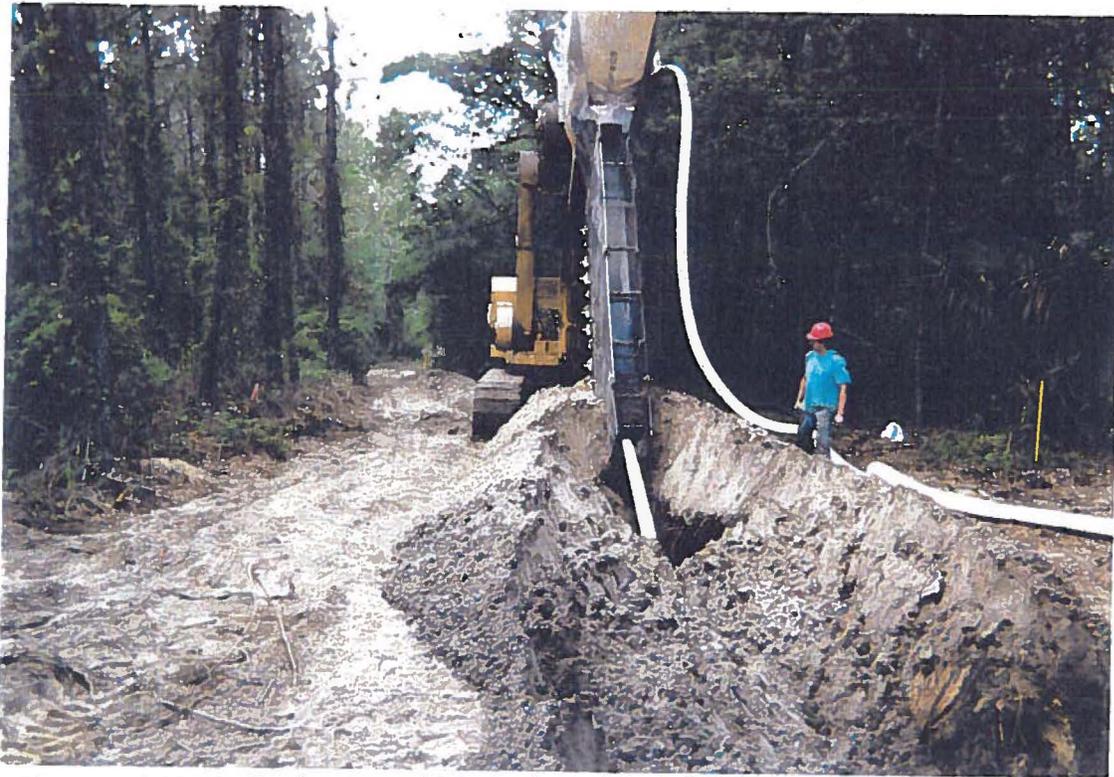
Photograph No. 2: Deployment of 5-in. horizontal drain in interceptor trench.

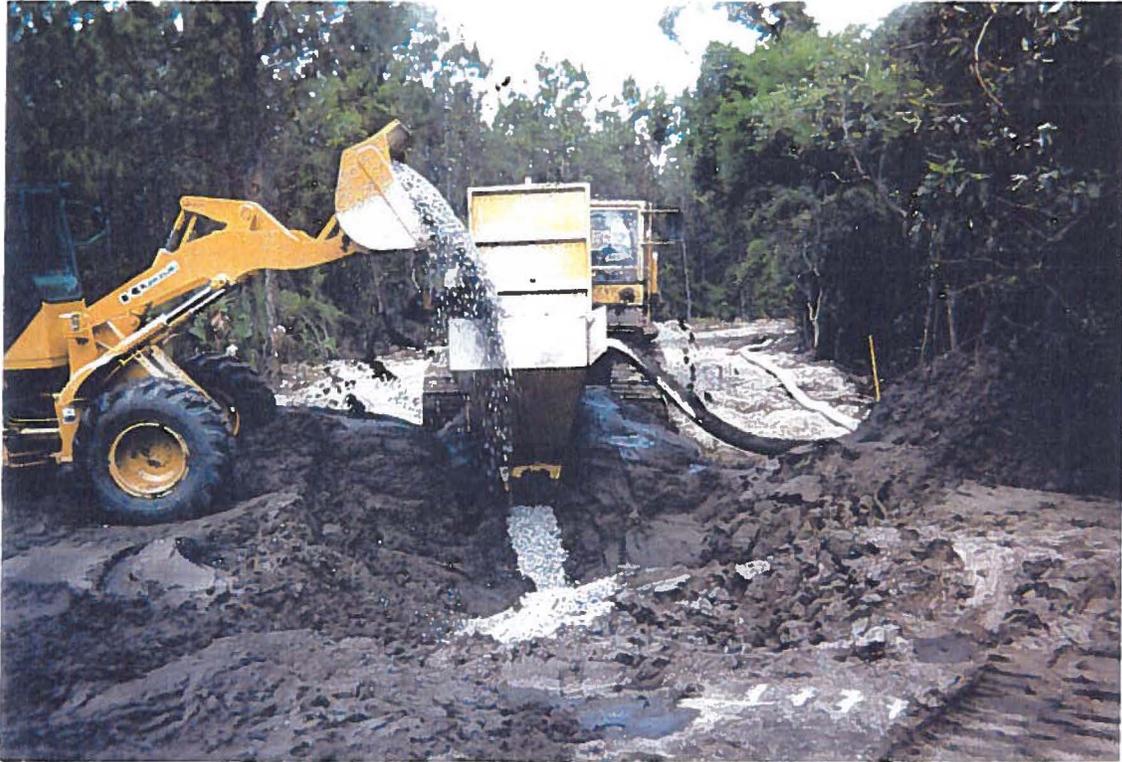
Photograph No. 3: Placement of limestone rock into interceptor trench.

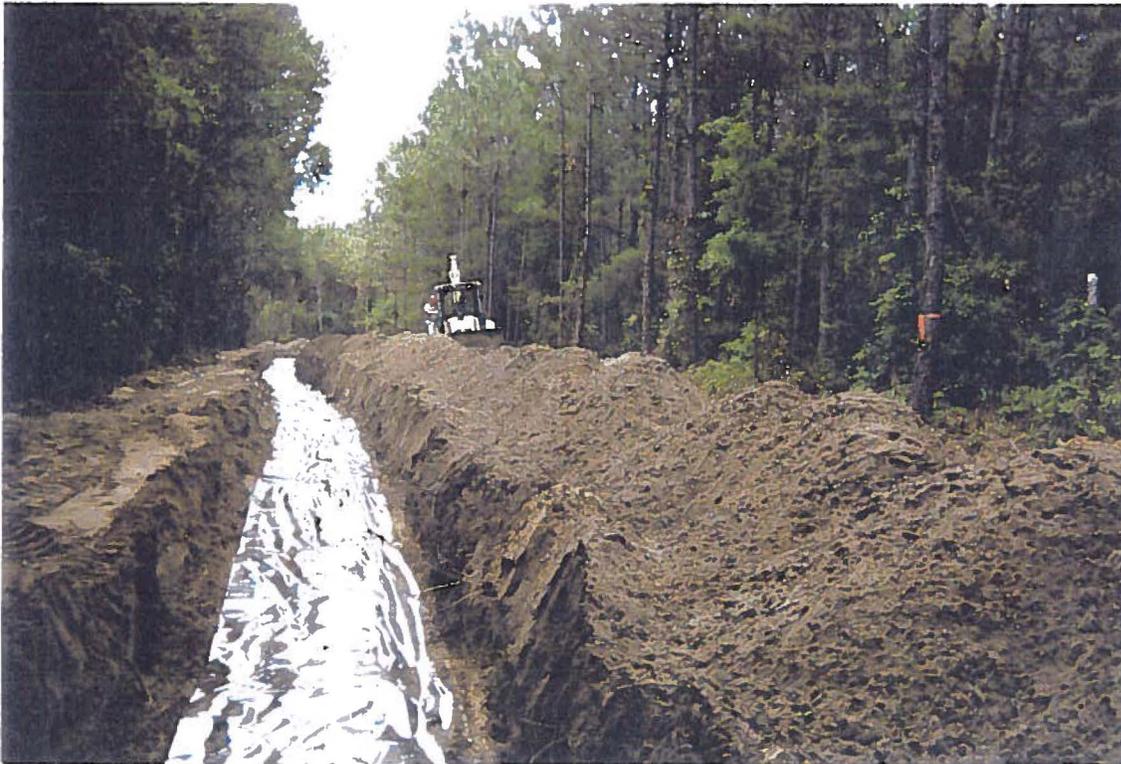
Photograph No. 4: Installation of 20-mil PVC liner on top of limestone rock.

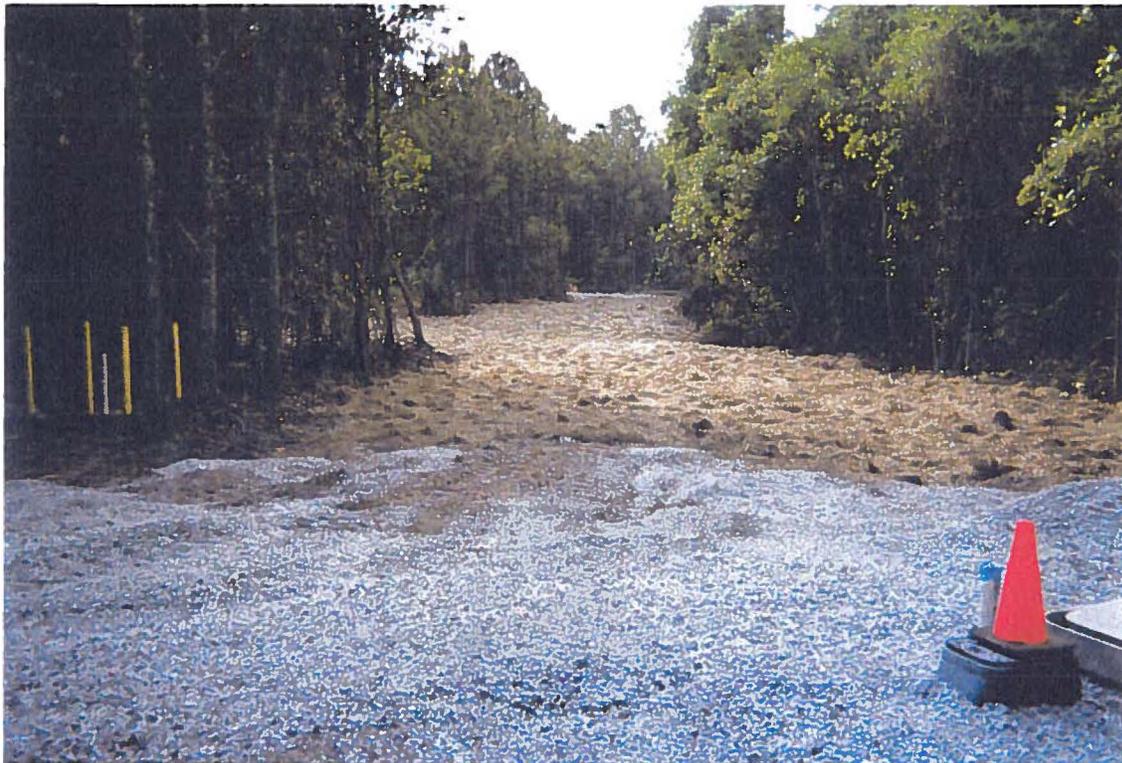
Photograph No. 5: Completed interceptor trench installation.

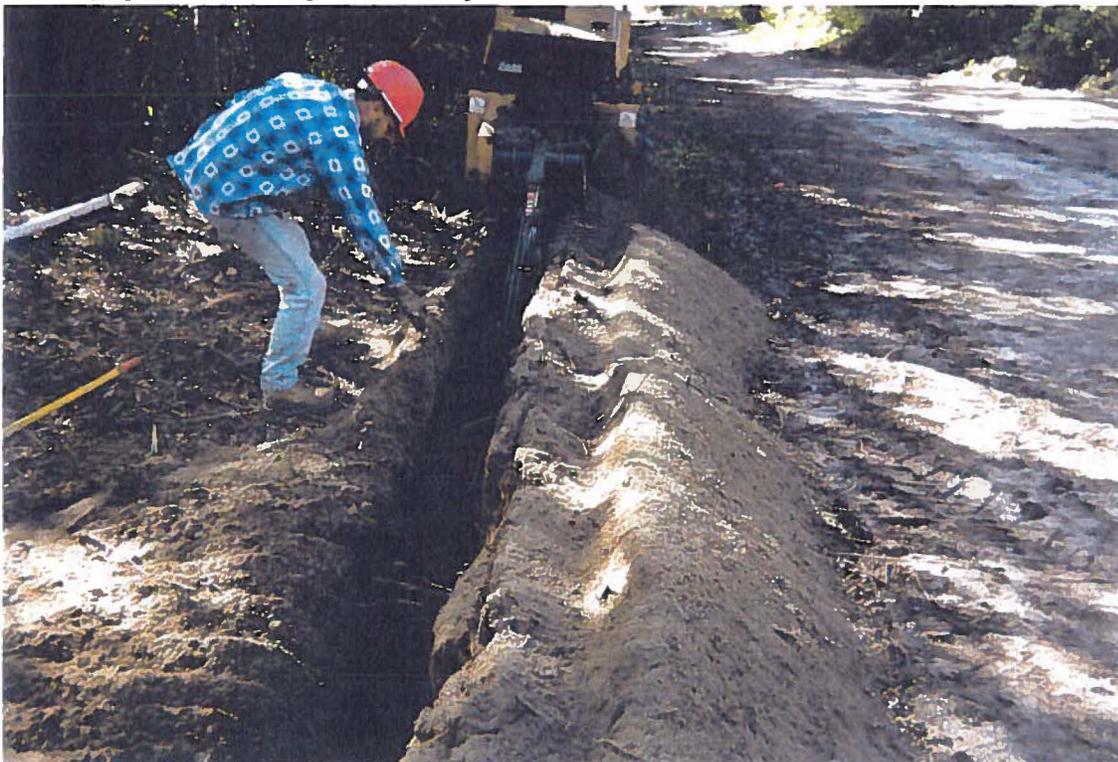
Photograph No. 6: Trenching for 2½-in. force main installation.

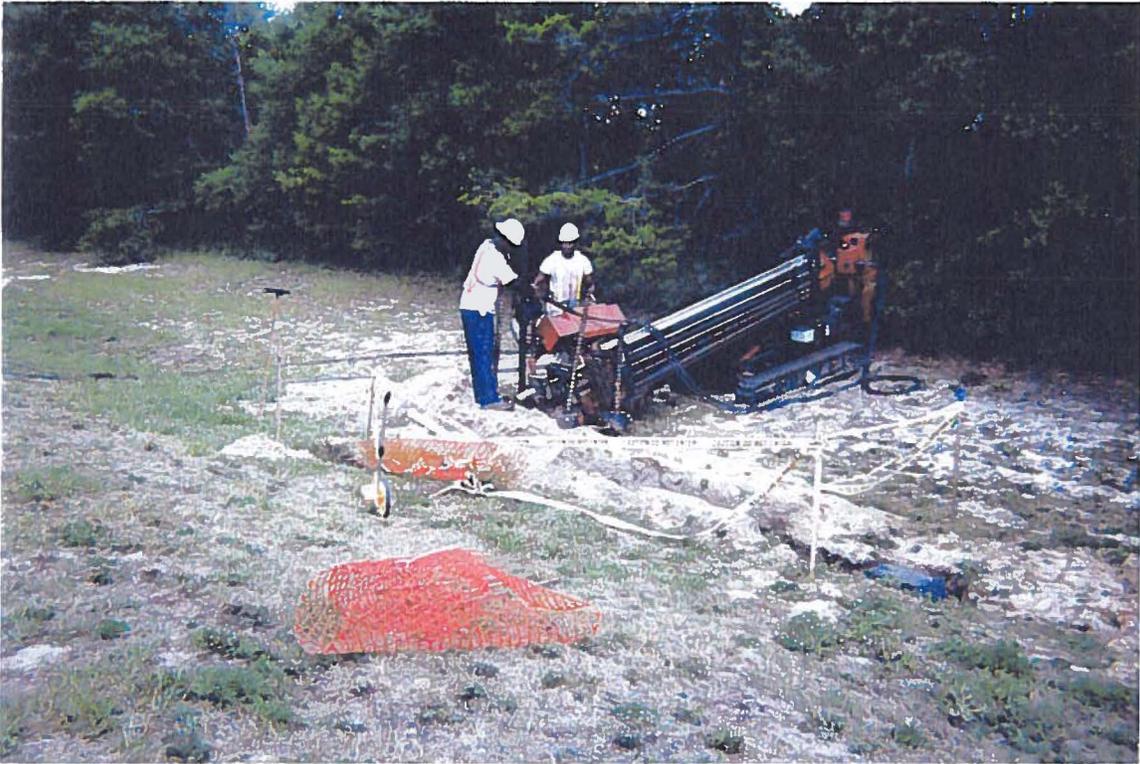
Photograph No. 7: Directional drilling under Taylor Road.

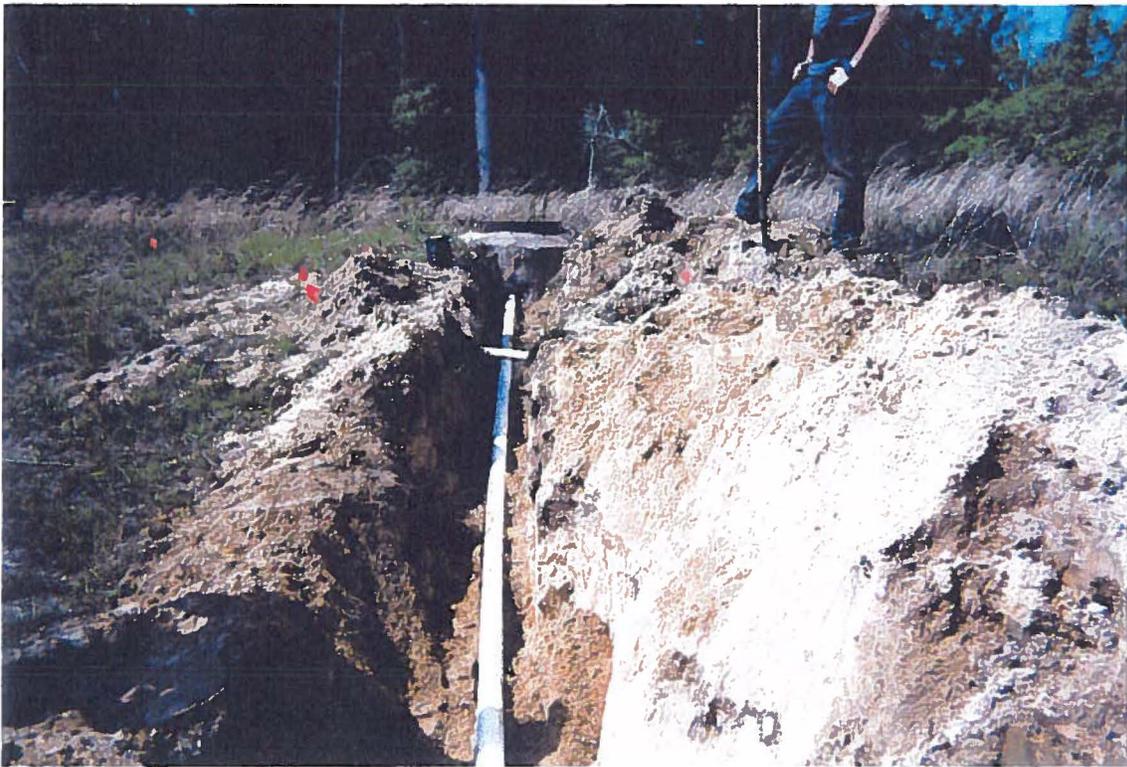
Photograph No. 8: Force main termination at sanitary sewer manhole.

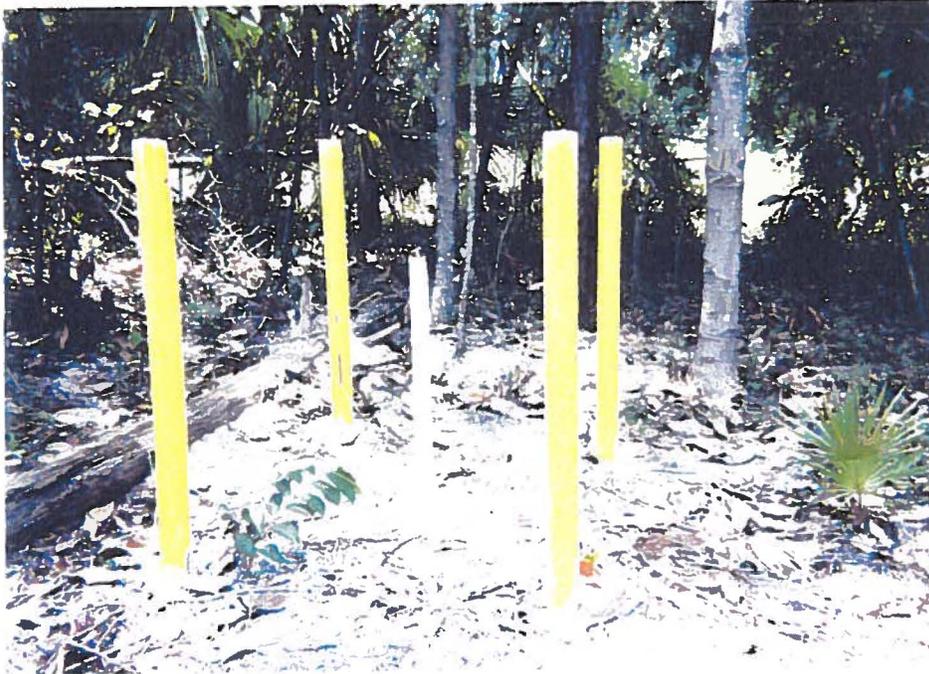
Photograph No. 9: New piezometer installation.

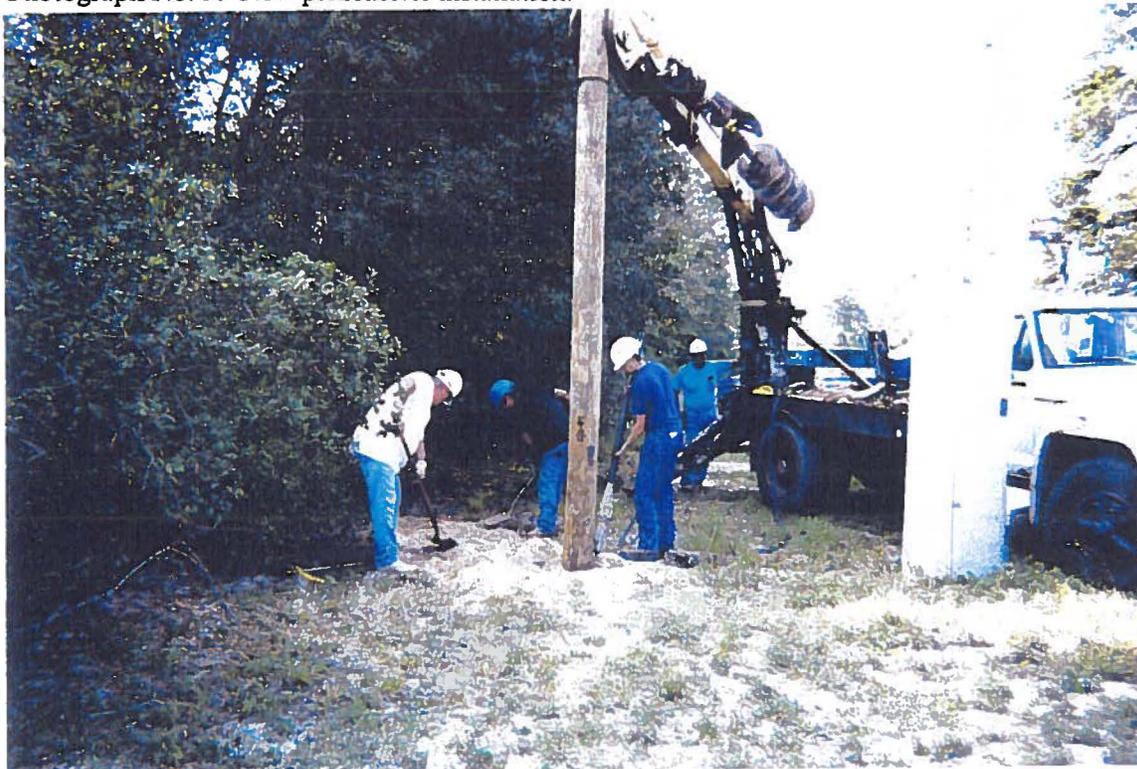
Photograph No. 10: Installation of new pole line for overhead electrical service.

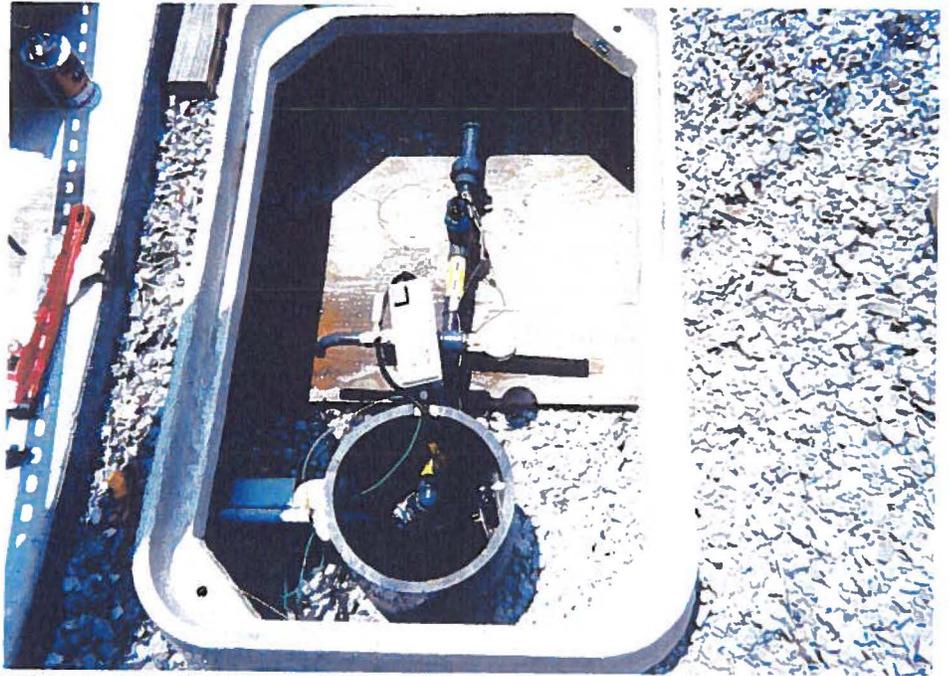
Photograph No. 11:
Well head construction
at 12-in. riser.

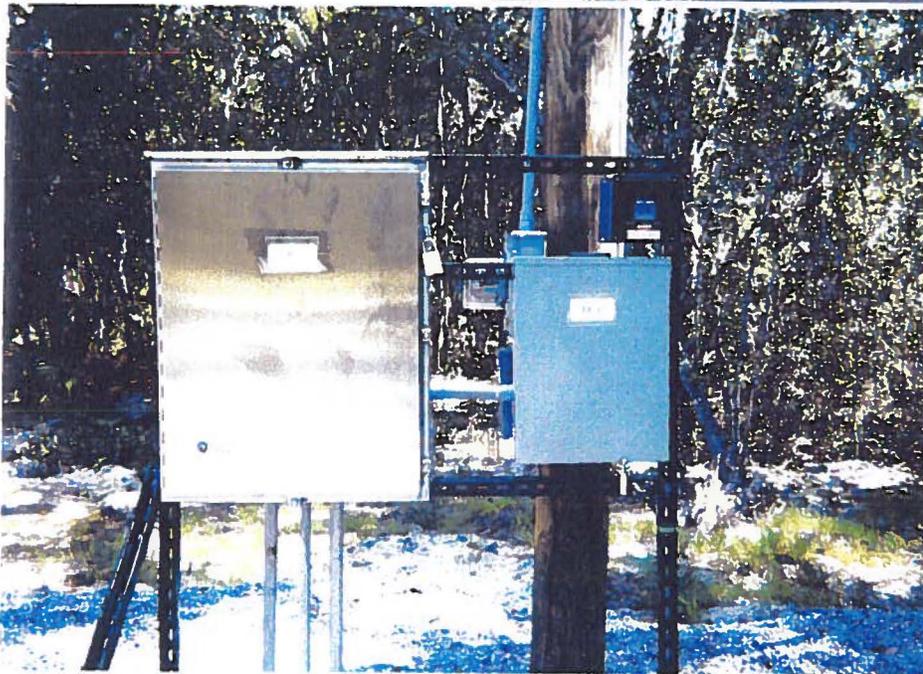
Photograph No. 12:
Control and lighting panels

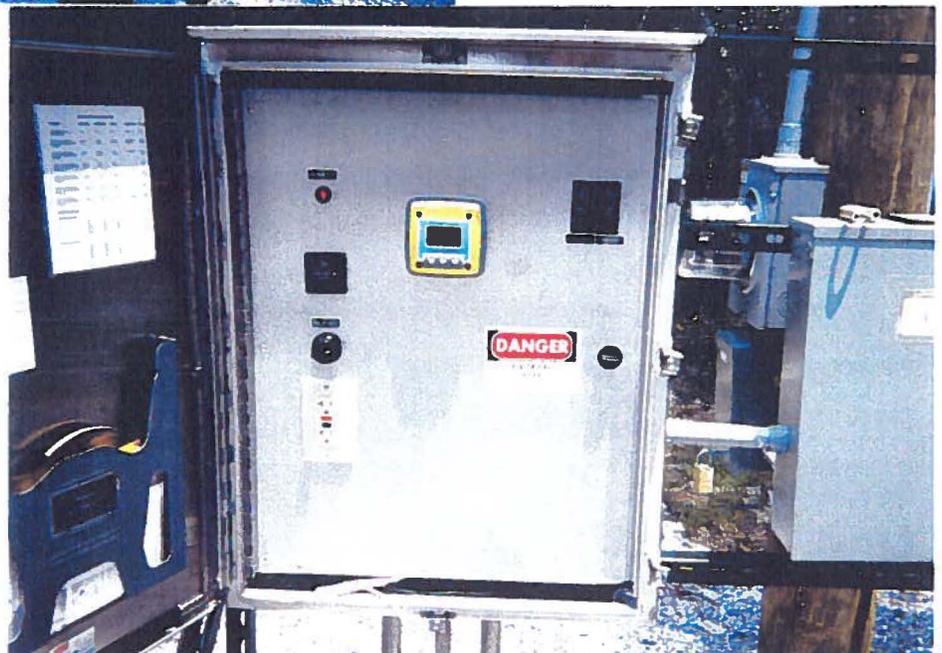
Photograph No. 13:
Instrumentation layout
at control panel (CP-1)
