AR_N00217_000699
HUNTERS POINT
SSIC NO. 5090.3.A

Enclosure (1) Responses to Agency Comments on the Draft Storm Water Discharge Management Plan, Installation Restoration Site 01/21, Industrial Landfill, Parcel E, Hunters Point Shipyard, April 22, 2003

**RESPONSES TO REGULATORY AGENCY COMMENTS ON THE
DRAFT STORM WATER DISCHARGE MANAGEMENT PLAN, IR-01/21,
INDUSTRIAL LANDFILL, PARCEL E
HUNTERS POINT SHIPYARD, SAN FRANCISCO, CALIFORNIA**

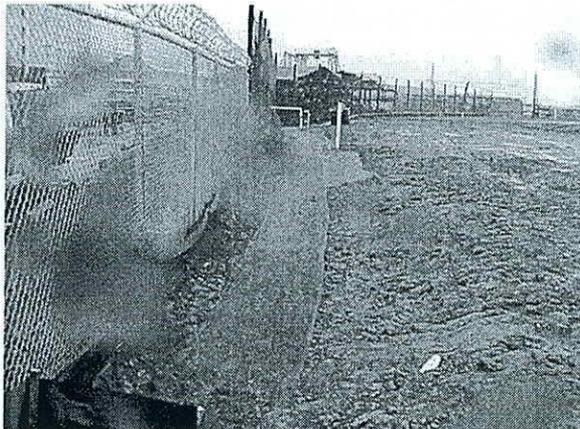
- 1. Comment:** During Board staff's February 12, 2003 inspection of the landfill, it was observed that although a vegetative cap covers much of the landfill, there are large areas, including roads, portions of the landfill cap, and drainage ditches that are within areas that are completely unprotected (see Photos 1 and 2). The existing Best Management Practice (BMP) implementation was not in compliance with the State Water Resources Control Board General Permit for Storm Water Discharges Associated with Industrial Activities (NPDES Permit No. CAS000001 – Industrial General Permit), which requires identification and implementation of BMPs that will effectively prevent discharges of pollutants to waters of the State.

Photo 1. Jute mat within a portion of the drainage ditch along the north side of the facility surrounded by large area of unprotected dirt.

Appropriate BMPs should be implemented immediately in these areas to prevent further erosion, which could result in a discharge of sediment or other contaminants into drainage ditches, catch basins, and the San Francisco Bay. The post-construction BMPs described in the General Permit for Storm Water Discharges Associated with Construction Activity (SWRCB Order No. 99-08-DWQ – Construction General Permit) are considered by Board staff to be appropriate BMPs to utilize under the Industrial General Permit, because the subject facility is primarily unpaved and includes areas that have been recently disturbed by construction activities.

Response: Construction was completed on the landfill gas control system in October 2002. The storm water discharge management plan (SWDMP) was issued after construction and was intended for IR-01/21, an industrial landfill site with only maintenance activities associated with the landfill cap. The SWDMP, therefore, follows the substantive requirements of the State Water Resources Control Board General Permit for Storm Water Discharges Associated with Industrial Activities rather than construction activities. The best management practices (BMP) implemented are identified in Section 4.3.8 of the SWDMP. These included fiber rolls, vegetation, erosion control matting (jute matting), and silt fences. These erosion and sediment controls are in compliance with the Industrial General Permit because they prevent discharges of pollutants from the site and into San Francisco Bay (Bay). These BMPs are consistent with the maintenance BMPs discussed in California Department of Transportation Statewide Storm Water Quality Practice Guidelines (California Department of Transportation 2002). These BMPs are also listed as erosion and sediment controls in the General Permit for Storm Water Discharges Associated with Construction Activity. The Construction General Permit, however, does not apply to this site for the reasons explained below.

After the SWDMP was released, additional maintenance work was required at the University of California, San Francisco (UCSF). Specifically, work was necessary to (1) alleviate problems at the UCSF’s research facility drainage ditch, and (2) complete the irrigation system for the landfill cap in the area of the “v” ditch.

This work had been completed the day before the RWQCB visited the site and was the cause of sparse vegetation. The installation of an underground storm water drain line and catch basins for UCSF and the associated maintenance BMPs, which included silt fences and vegetation, were noted in the SWDMP in Section 4.3.8. Following seeding of the drainage channel above the drain line, jute mats were installed to protect young roots from being washed out during storm events and to allow vegetation to establish. Jute matting was also installed in the ditch northwest of the cap, near the location of the main pipe feeding the cap irrigation system. Reinforced channel liners, soil cement, stabilizers, or binders, fiber matrices, and geotextiles are not appropriate BMPs following seeding because these covers prevent the growth of vegetation by blocking sunlight and/or the infiltration of water.

Sheet flow in the area northwest of the cap is directed from the ditch to a heavily vegetated channel that leads into a seasonal freshwater wetland area. Any sediment in the runoff before sedimentation was established would be filtered out before reaching the Bay. The seasonal wetland area has a large water containment capacity and would act as a sedimentation basin. Flow in the UCSF ditch enters the basewide storm water drain system, which has an outfall at the southern end of Parcel E. This outfall will be shown on the final version of the SWDMP. Erosion and sediment controls in the ditch include vegetation with jute matting in the ditch, gravel bags, and silt fences around the catch basins. The gravel bags and silt fences provide some filtering of the runoff, but primarily slow the flow so that sediments can naturally drop out before reaching the catch basins.

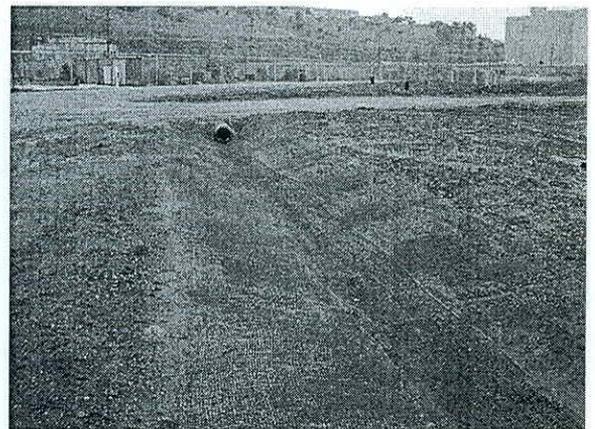
Photo 2. Jute mat with new vegetation growing in surrounded by dirt area and adjacent to dirt roads with no additional protection to prevent erosion. The extent of vegetation in the photograph is significantly less than 70 percent.

The Construction General Permit states that all disturbed areas must be stabilized and goes on to explain that “stabilization” means that a uniform vegetative cover with 70 percent coverage has been established, or equivalent stabilization measures have been employed. Therefore, until permanent vegetation is established, appropriate soil cover measures must be implemented to protect soil particles from detachment and transport by rainfall. Measures such as: covering with blankets, reinforced channel liners, soil cement, stabilizers, or binders, fiber matrices, geotextiles, mulch, temporary/permanent seeding/vegetation, or fiber rolls, and a variety of other alternatives are recommended as alternative stabilization measures. Dirt roads on the landfill are subject to erosion and should be stabilized using appropriate BMPs, for example, allowing vehicles in only limited areas and using barriers or fencing and maintaining a gravel cover on roadways.

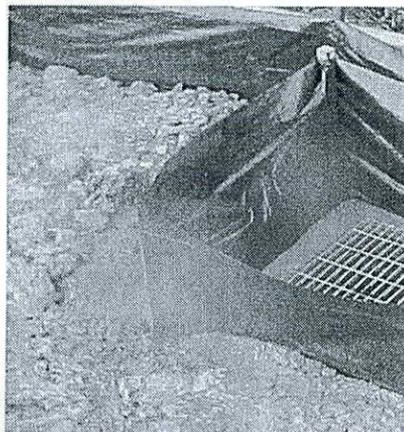
The text states that an underground drainage pipe and catch basin would be installed with a 4-by-4-foot square silt fence around the catch basin grate as a temporary sediment control measure while vegetation in the area is being established. Photo 3 shows that this catch basin and silt fence are surrounded by unprotected soil. As stated above, some type of soil cover must be implemented while waiting for the vegetation to be established. Secondly, Board staff believes that a silt fence is not an adequate sediment control measure for the area around the catch basin as sediment-laden stormwater migration could occur through the silt fence. A BMP that will effectively filter sediment, such as sand or gravel bags or fiber rolls should be placed around the catch basins. In addition, Section 4.2.2 and Figure 4 should be revised to include a description of the route and ultimate destination of the storm drain flow in this area.

Photo 3. Catch basin and silt fence surrounded by unprotected soil, allowing sediment laden storm water to pass through the silt fence into the catch basin and storm drain.

Response: Gravel bags along with silt fences and vegetation have been installed in these areas. This was noted by the RWQCB in a subsequent inspection.

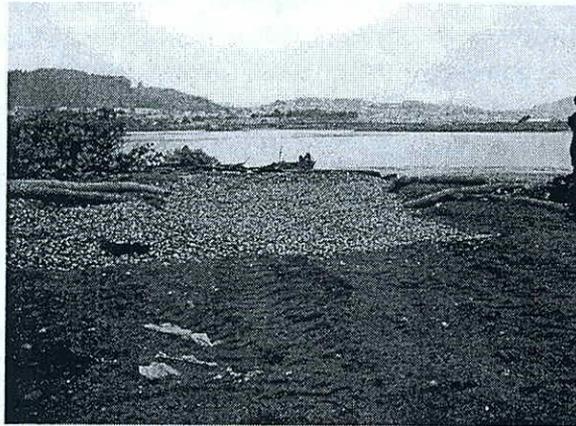
The text states that a sedimentation basin is planned to collect storm water flow from south and southeast of the cap upstream of a location where it channelizes just before entering the Bay. This area is alternatively called the “black sand beach” or “gully” area. Prior to installing the sedimentation basin, the Navy states that two rows of 120-foot length fiber rolls would be installed as a temporary control measure. As shown on Photo 4, Board staff observed that the fiber rolls were for the most part improperly installed on top of the ground surface rather than within a trench, thereby allowing sediment to bypass the barrier. The present installation technique will not prevent sediment-laden stormwater from entering the Bay at this location which Board staff understands the sediments may contain elevated concentrations of pollutants.

Photo 4. Fiber rolls that appear to be improperly installed in “black sand beach” or “gully” area, possibly allowing contaminated sediments to enter San Francisco Bay.

During the inspection, Board staff were informed that after the original proposed temporary control measures were installed, they were washed away during a heavy rainfall and pollutants from this location may have been released in to the Bay. Board staff is concerned that the regulatory agencies were not informed about this release of potentially toxic compounds into San Francisco Bay. The revised document should include a plan for submitting to the Board a report within five days of any discharge of contaminated sediment to San Francisco Bay. The report should include an estimate of the volume of sediment discharged to the Bay, the concentration of this sediment, an evaluation of the environmental effect of this discharge,

The revised report should state that the Navy is committing to maintain this area into the future. The engineering analysis of alternative sediment control measures for this area should be provided, as well as rationale for selecting a sedimentation basin. This analysis should include a discussion of the extent of contamination in this area and the effect of the sedimentation basin on impacted sediments and soils in the area. As with the other unvegetated areas across the landfill, interim soil stabilization measures should be put into place immediately.

Response: During a heavy rain event, noticeable erosion channels were discovered in the gully area. In response, the Navy installed Geotextile secured with gravel rocks at a low point to divert flow and prevent further erosion in the area. This low point was, in effect, a lined channel that provided an outlet for the runoff. The fiber rolls were also installed across the entire outflow path to control the flow and filter any sediment. The partially buried fiber rolls act as a barrier to slow the runoff and allow sediments to settle out. The fiber rolls visible in the photo were, in fact, buried about 3 inches (one third the diameter of the rolls) and sit atop dirt berms approximately 2 to 3 feet above the low point. Runoff in this area will not be sufficient to flow over the berms.

The Navy implemented additional controls after the site tour to address RWQCB's concerns. Gravel bags (one to two bags high) were placed bayside of the fiber rolls.
