**FINAL SITE MANAGEMENT PLAN FOR FISCAL YEAR 2019-2020  
ENVIRONMENTAL RESTORATION PROGRAM NSWC INDIAN HEAD MD**

# **Site Management Plan**

Fiscal Year 2019-2020

### **Naval Support Facility Indian Head**

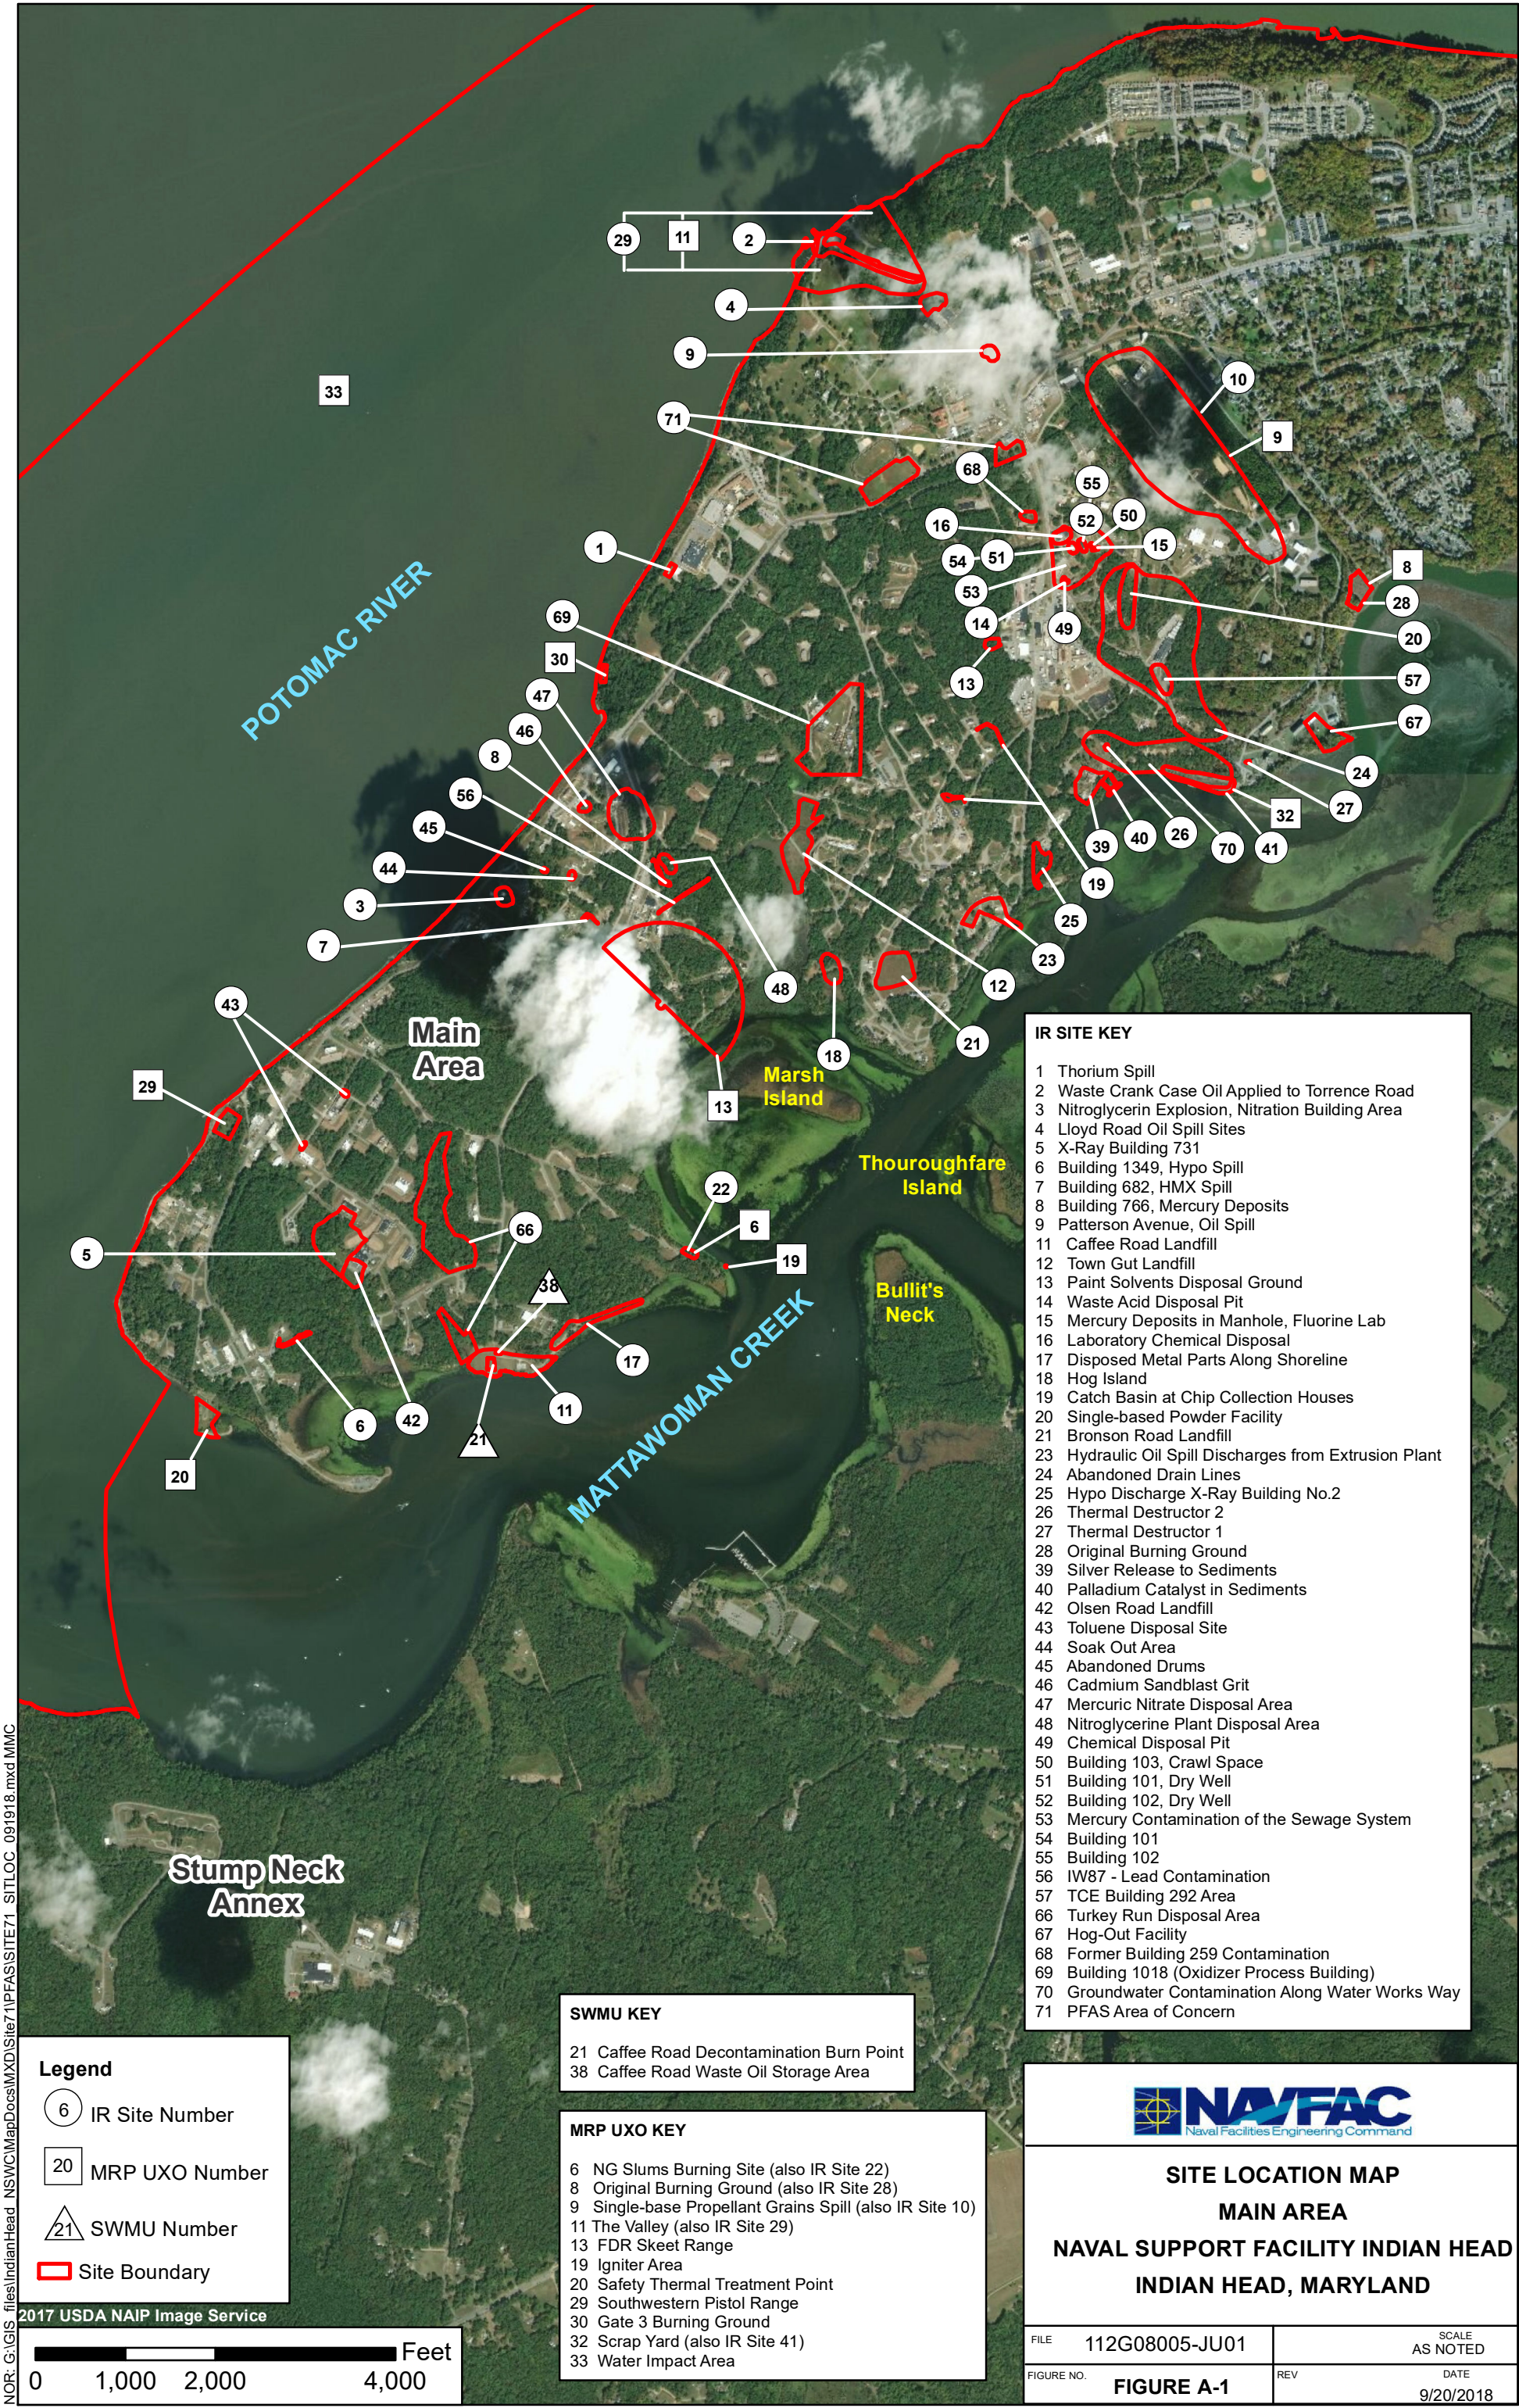
FILE	112G08005-JU01	SCALE	AS NOTED
FIGURE NO.	FIGURE A-1	REV	DATE
			9/20/2018

SITE LOCATION MAP  
MAIN AREA  
NAVAL SUPPORT FACILITY INDIAN HEAD  
INDIAN HEAD, MARYLAND

\* New "Site 71" is an Area of Concern (AOC) consisting of five potential PFAS sites: two on the Main Area (Figure A-1) and three on the Stump Neck Annex (Figure B-1).

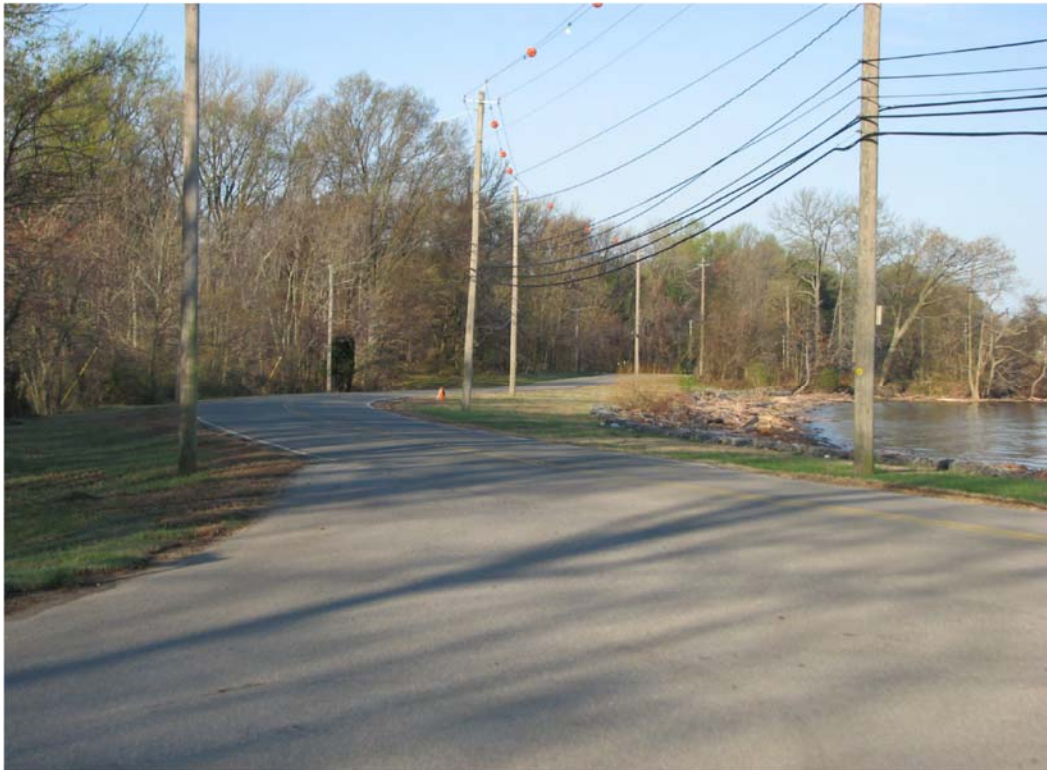
Site 37 – Looking south along Causeway. (2010)

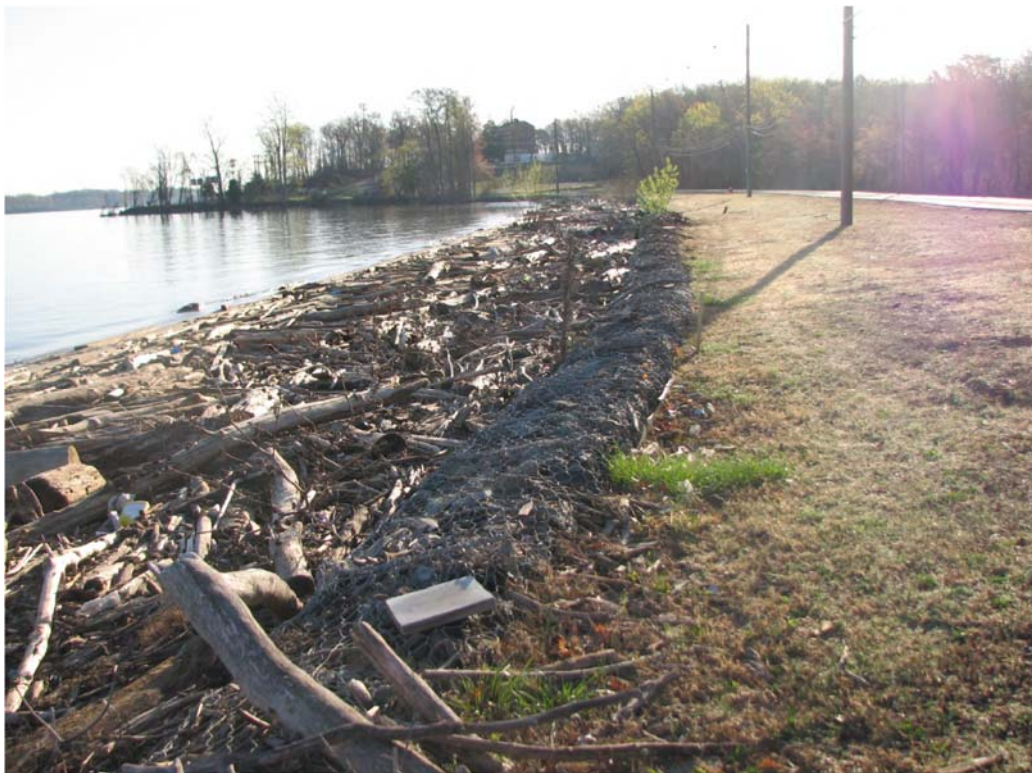
Site 37 – Looking north on shoreline along Causeway. (2010)

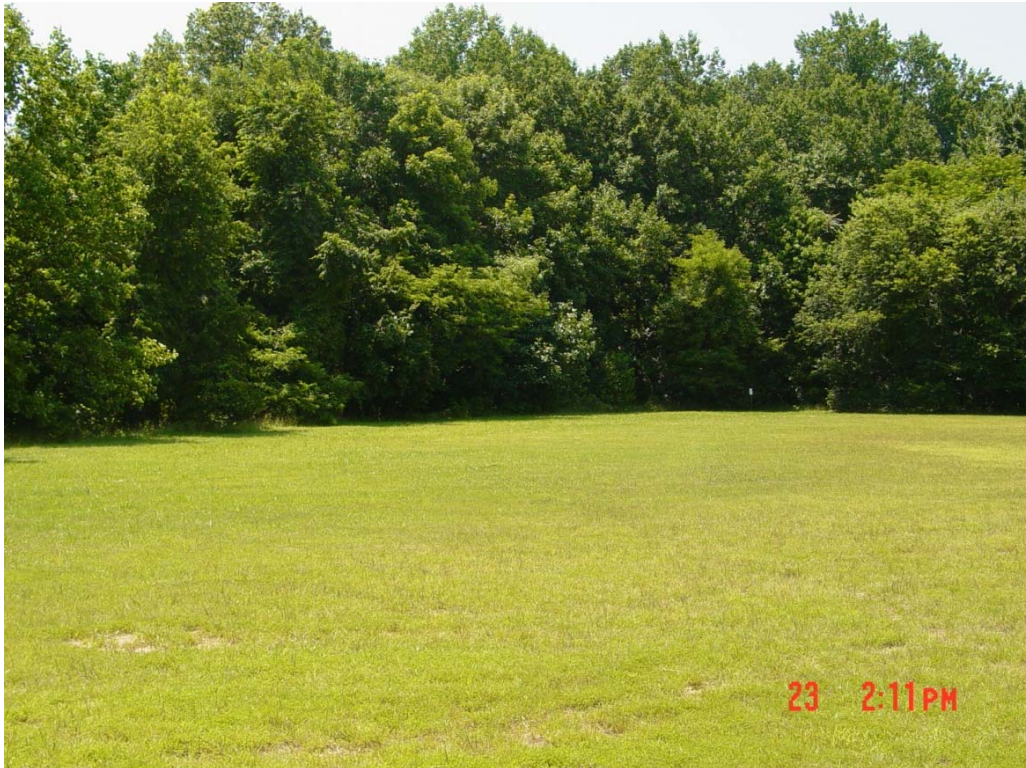
UXO 7 – Current conditions at the Old Demolition Range. (2003)

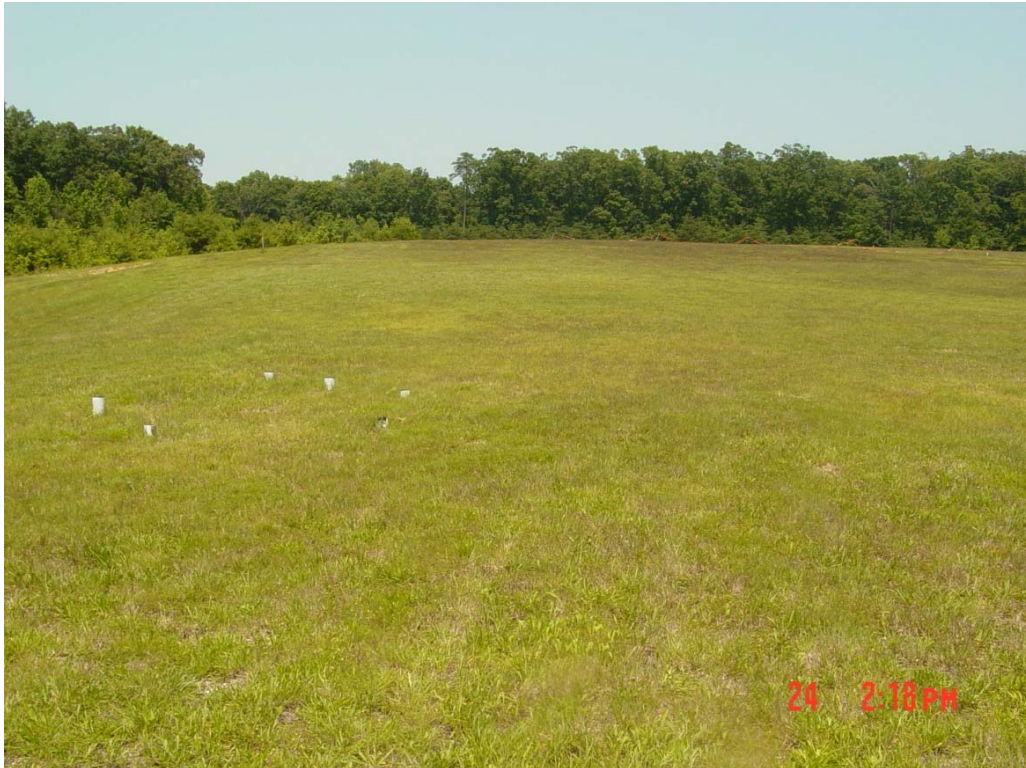
UXO 22 – Current conditions at Test Area 2 – off-set PVC test ports. (2003)
