## Environmental Restoration Program Naval Air Station Patuxent River

# Restoration Advisory Board Meeting

15 March 2016

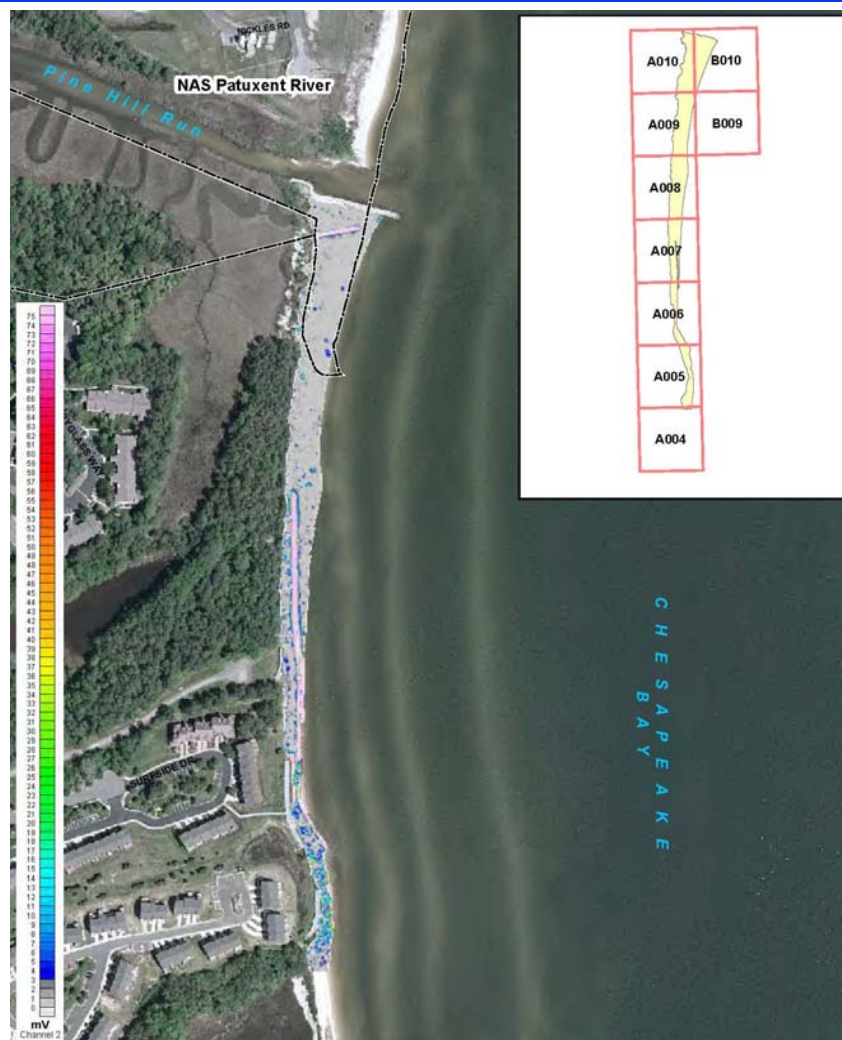
# UXO-1 Magnetic Anomalies

- Preliminary Assessment and Site Inspection (PA/SI) were completed in 2013
  - First two steps of the CERCLA Process
  - The SI included digital geophysical mapping
  - Identified 721 metallic anomalies
  - 145 known “cultural debris” (rebar or pipe sticking out of the sand)
  - Likely much more debris in (cans, rebar, pipes, etc) subsurface

- Conduct high resolution geophysics
  - Distinguish between likely munitions items and cultural debris
- Excavate and remove items suspected to be munitions
- 2016
  - Generate Explosive Safety Submission
  - Generate and sign Action Memorandum
  - Outreach to Cedar Cove Home Owner's Association
- 2017
  - Conduct geophysics and removal

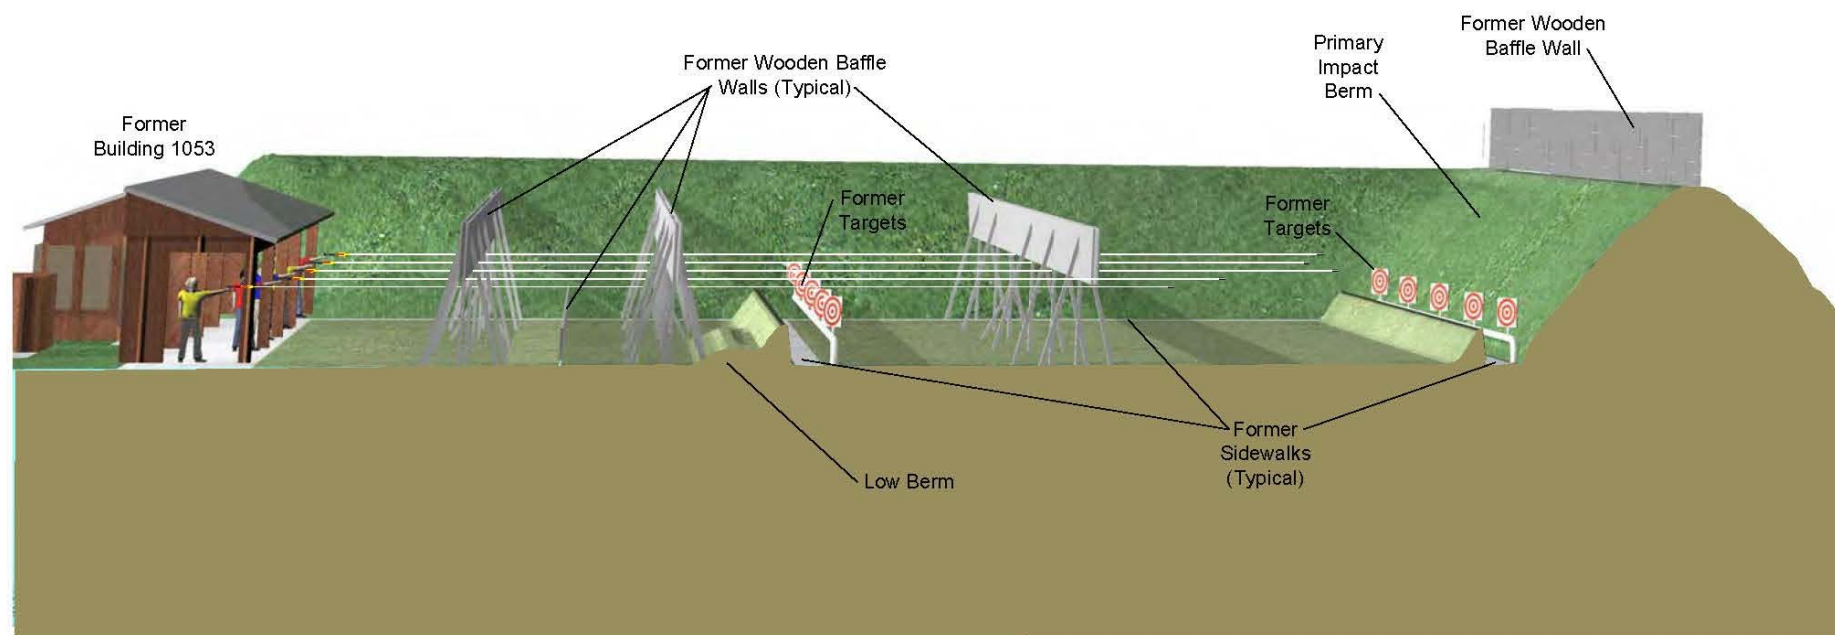
# UXO-2 OU-1 Layout

- Two Operable units (OUs)
  - Former Pistol Range (OU-1)
  - Former Skeet Range (OU-2)
- Former Pistol Range
  - Shoot pistols from fixed positions at targets of varying distances and sizes
  - Surrounded on three sides by impact berm
  - Reportedly used from 1943 to 1993
  - Primary contaminant is lead from the bullets
  - Possibly other trace metals from jackets and casings

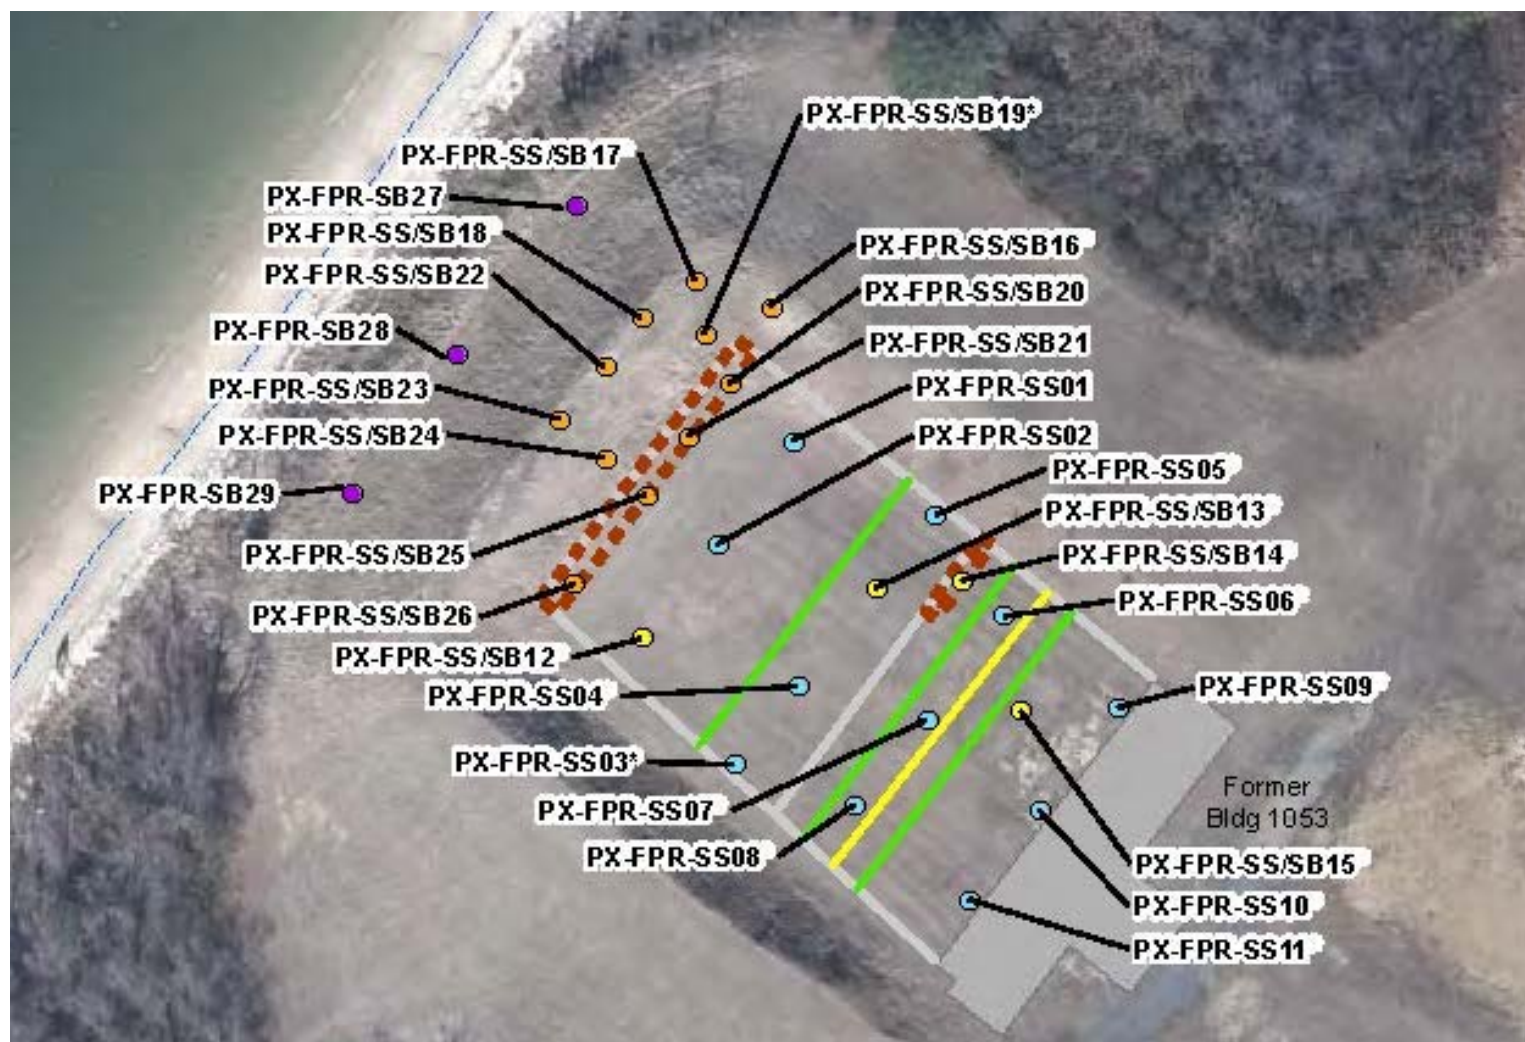
# UXO-2 OU-1 Sampling Locations

- Completed PA/SI in 2012
  - Included limited lead sampling in surface and subsurface soil
  - Concentrations of lead ranged from 6.3 milligrams per kilogram (mg/kg) to 7,020 mg/kg
  - Lead was compared against human health and ecological screening values
    - Lead was identified as a potential concern

- Proceed through the rest of the CERCLA process
  - Remedial investigation (RI) → Feasibility Study (FS) → Proposed Remedial Action Plan (PRAP) → Record of Decision (ROD)
  - Proceed to Remedial Action (RA)
    - Very likely (removal of berms and shallow soil)
- RI, FS, PRAP, ROD were awarded this year
- Preliminary discussions regarding the scope of the RI are ongoing
  - Primarily soil and groundwater sampling
