## Environmental Restoration Program Naval Air Station Patuxent River

# Restoration Advisory Board Meeting

17 October 2017

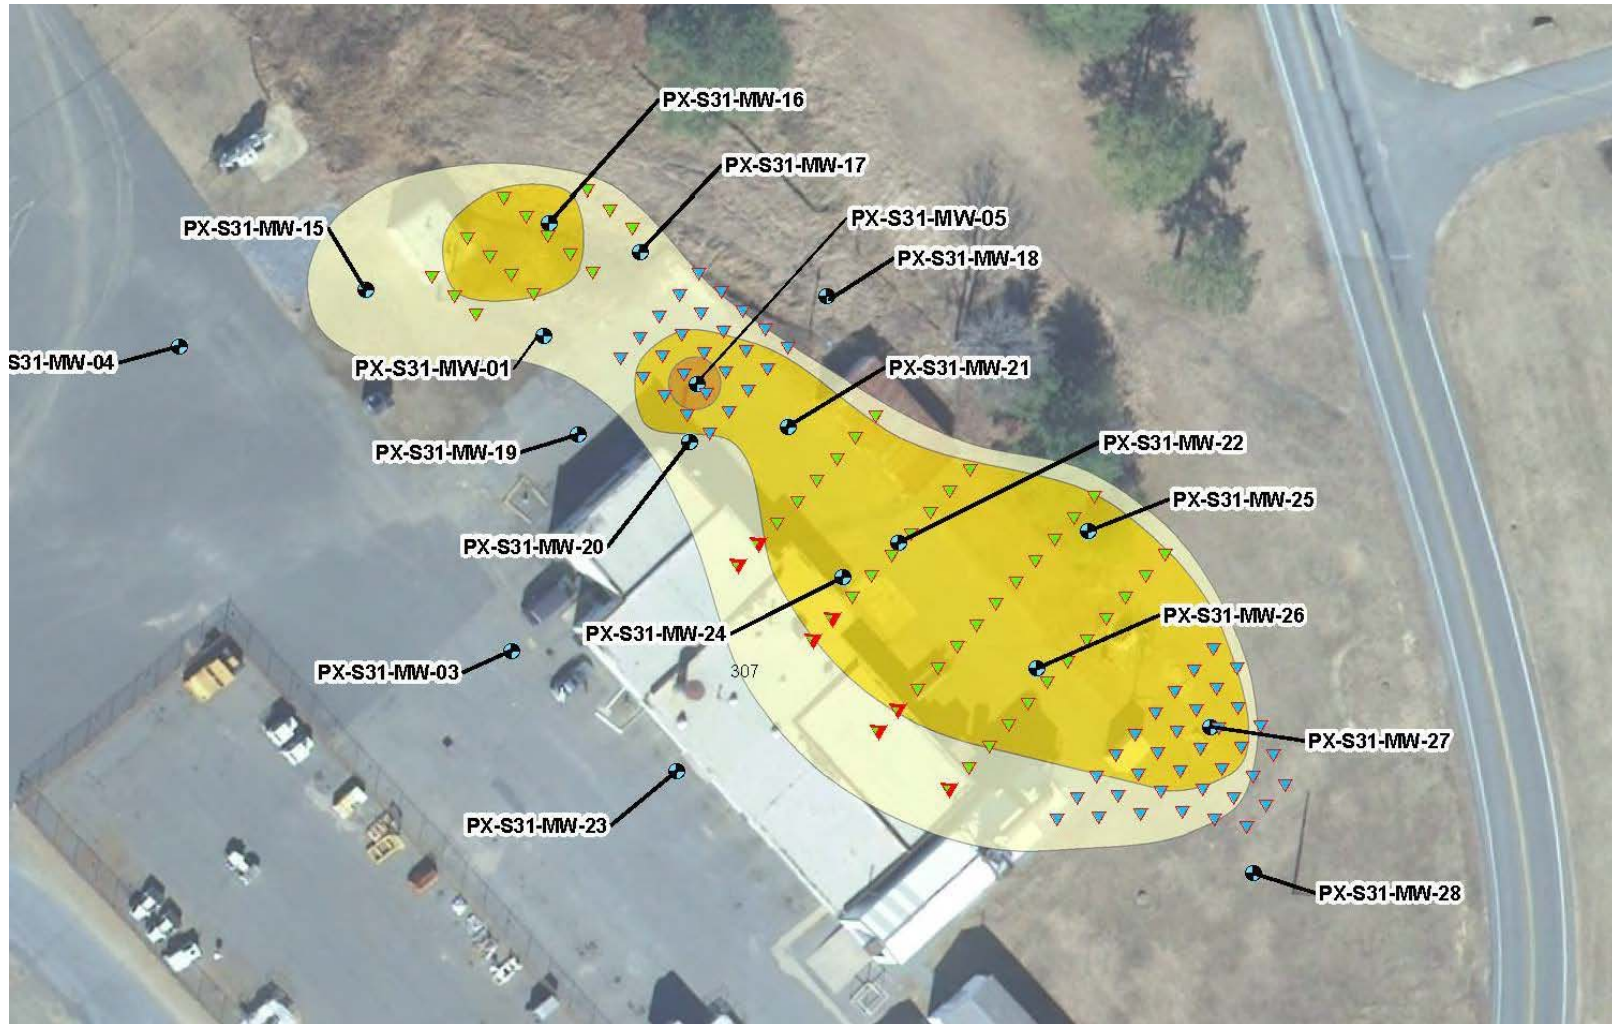
# Insitu Bioremediation

- Soil excavation and insitu bioremediation
  - Remove metals-impacted soils and dispose in approved landfill
  - Inject vegetable oil into the ground to induce natural bacteria to degrade VOCs
    - Monitor results
    - Reinject if necessary
  - Employ land use controls to ensure that consumption of groundwater is prevented

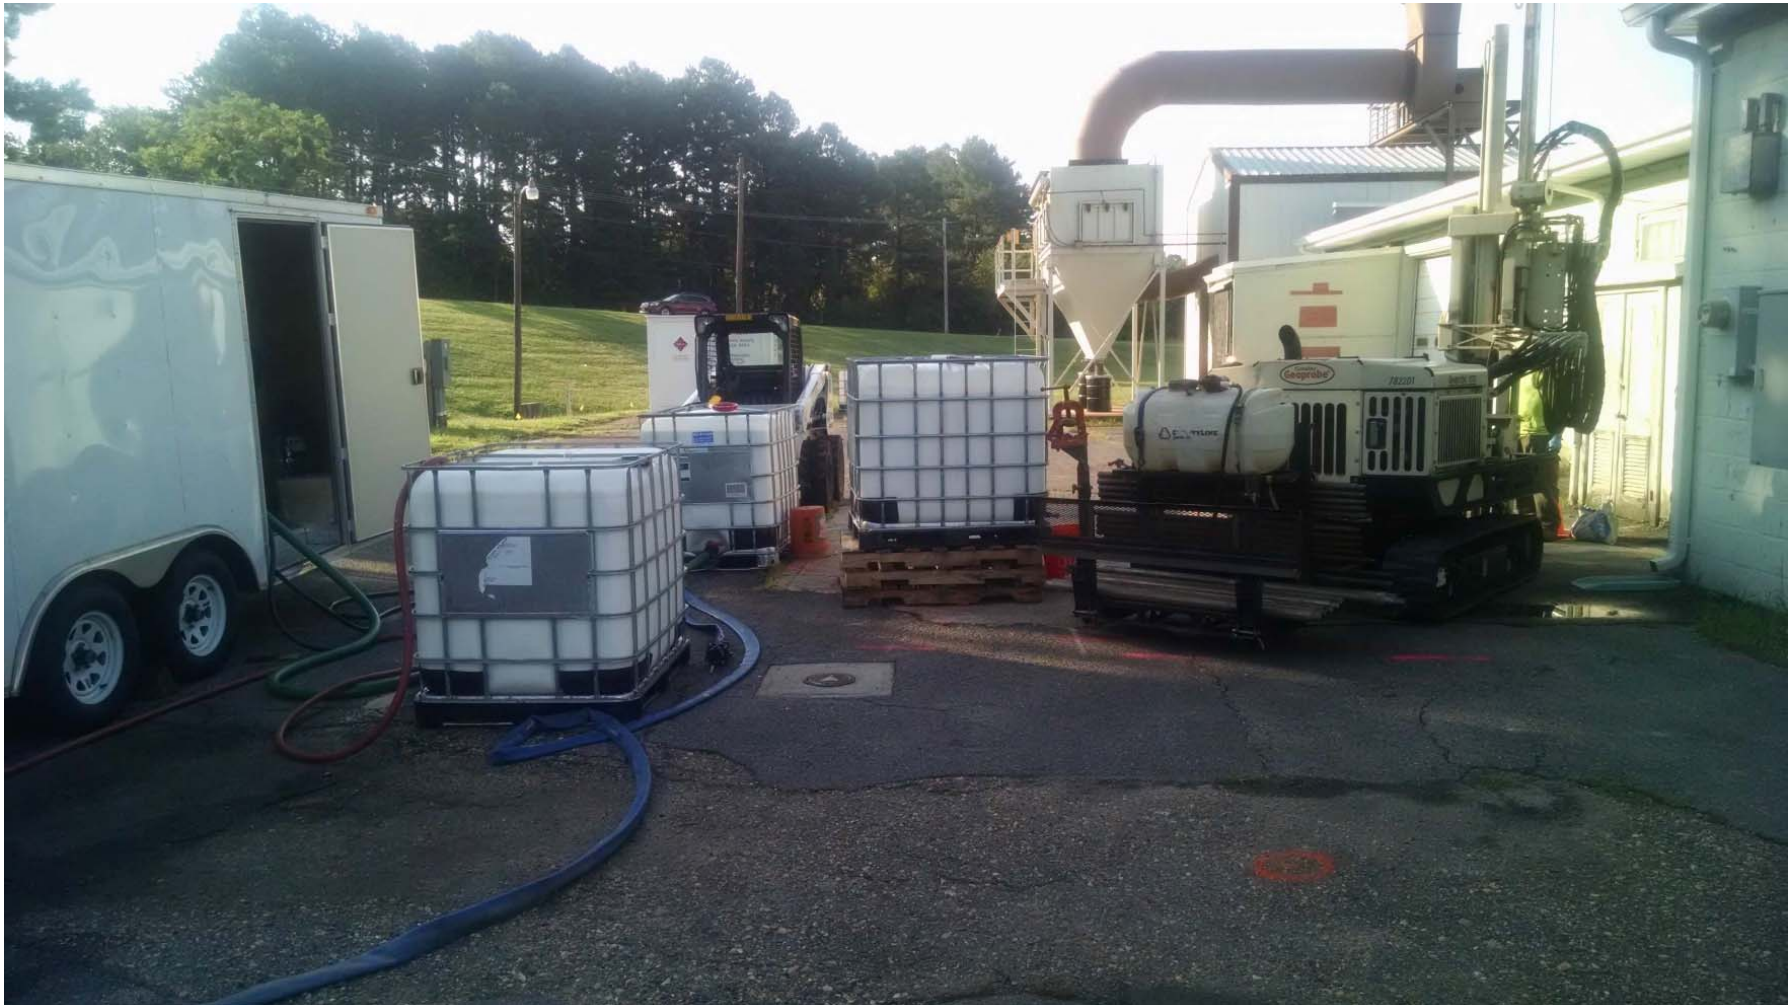
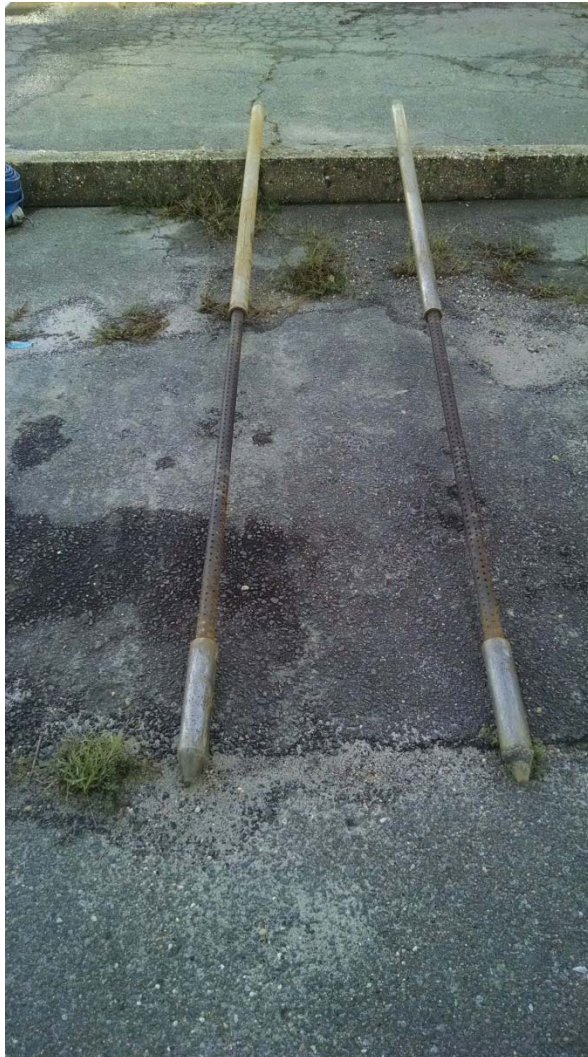
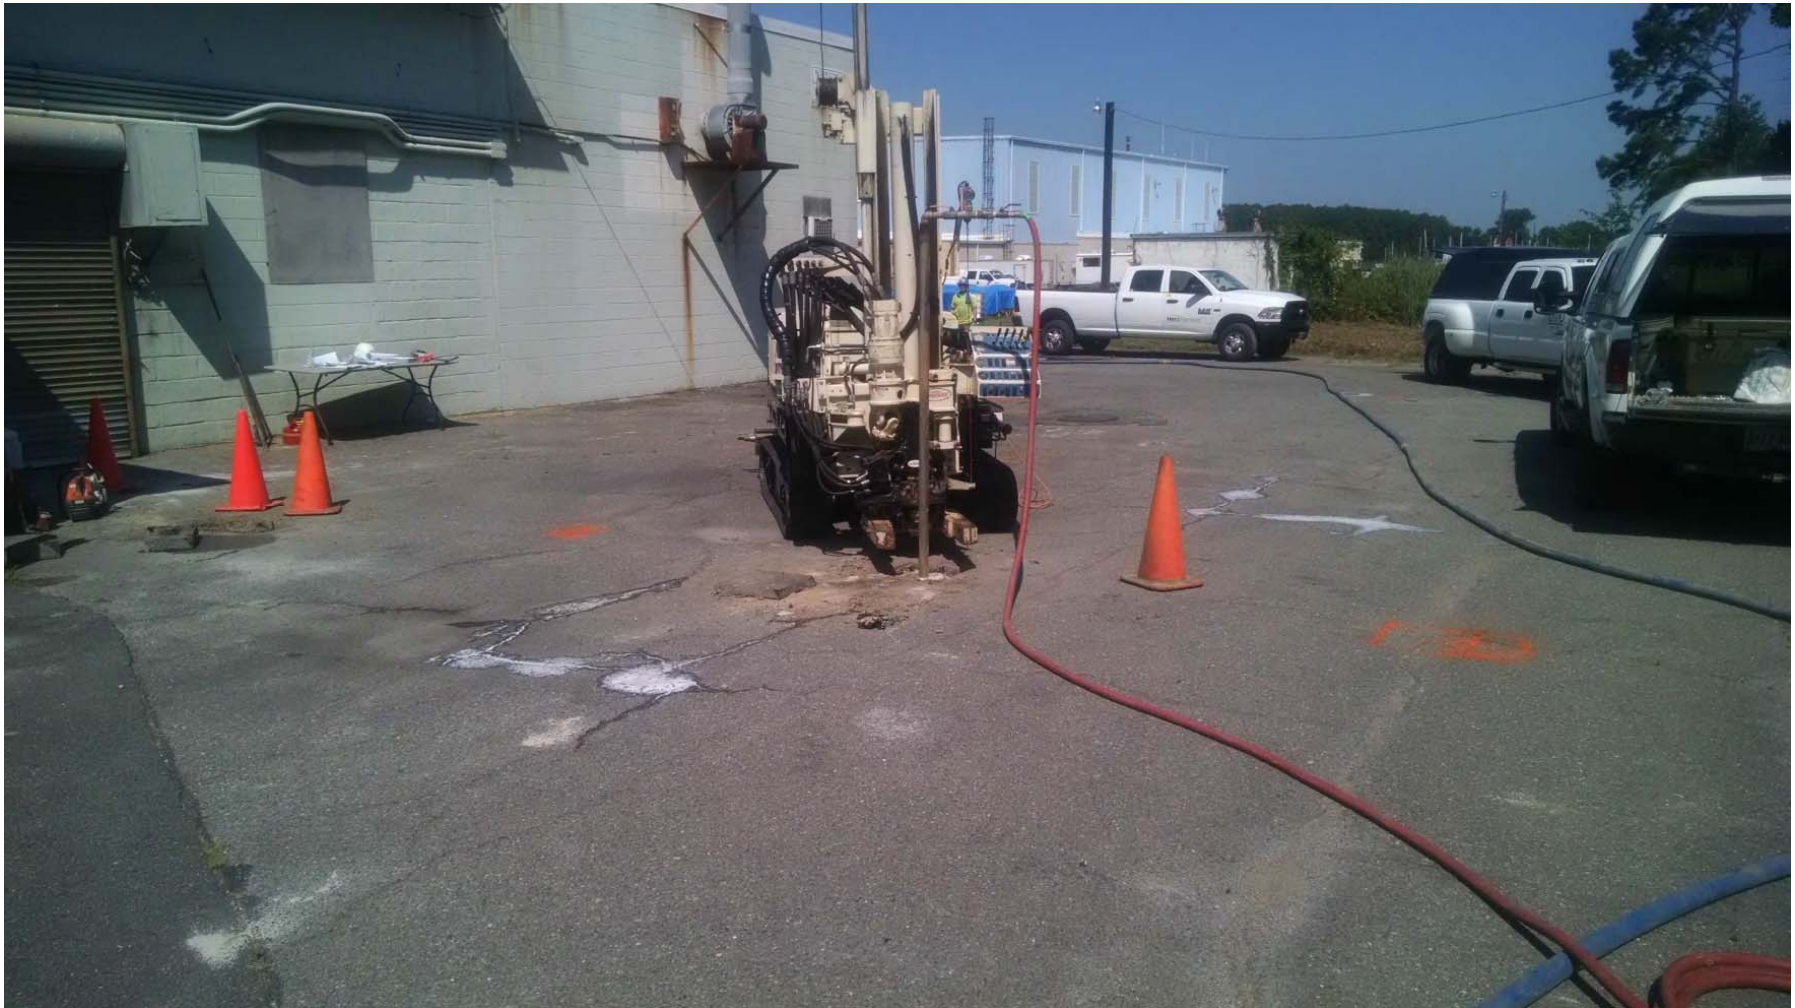
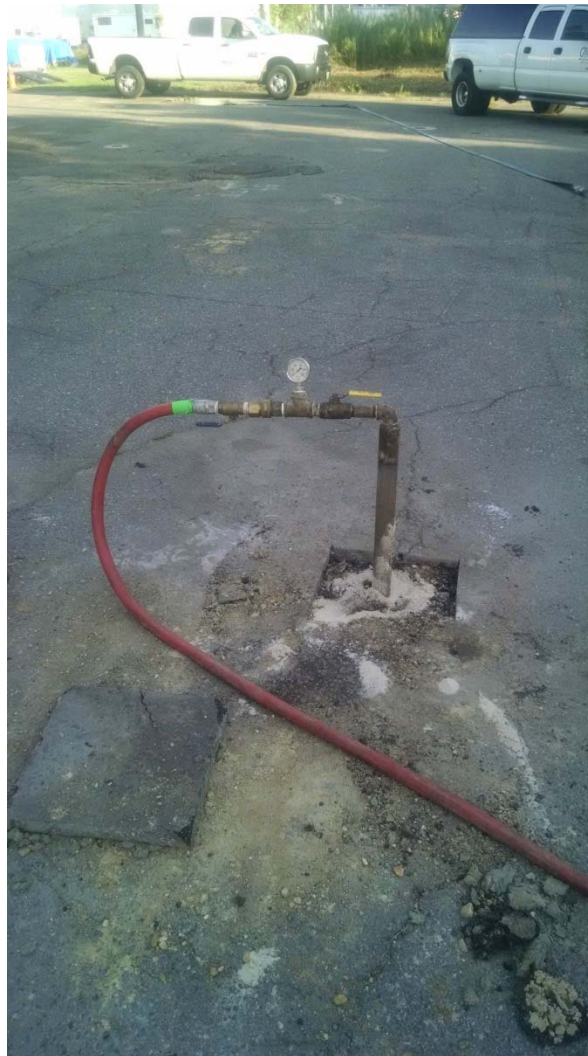
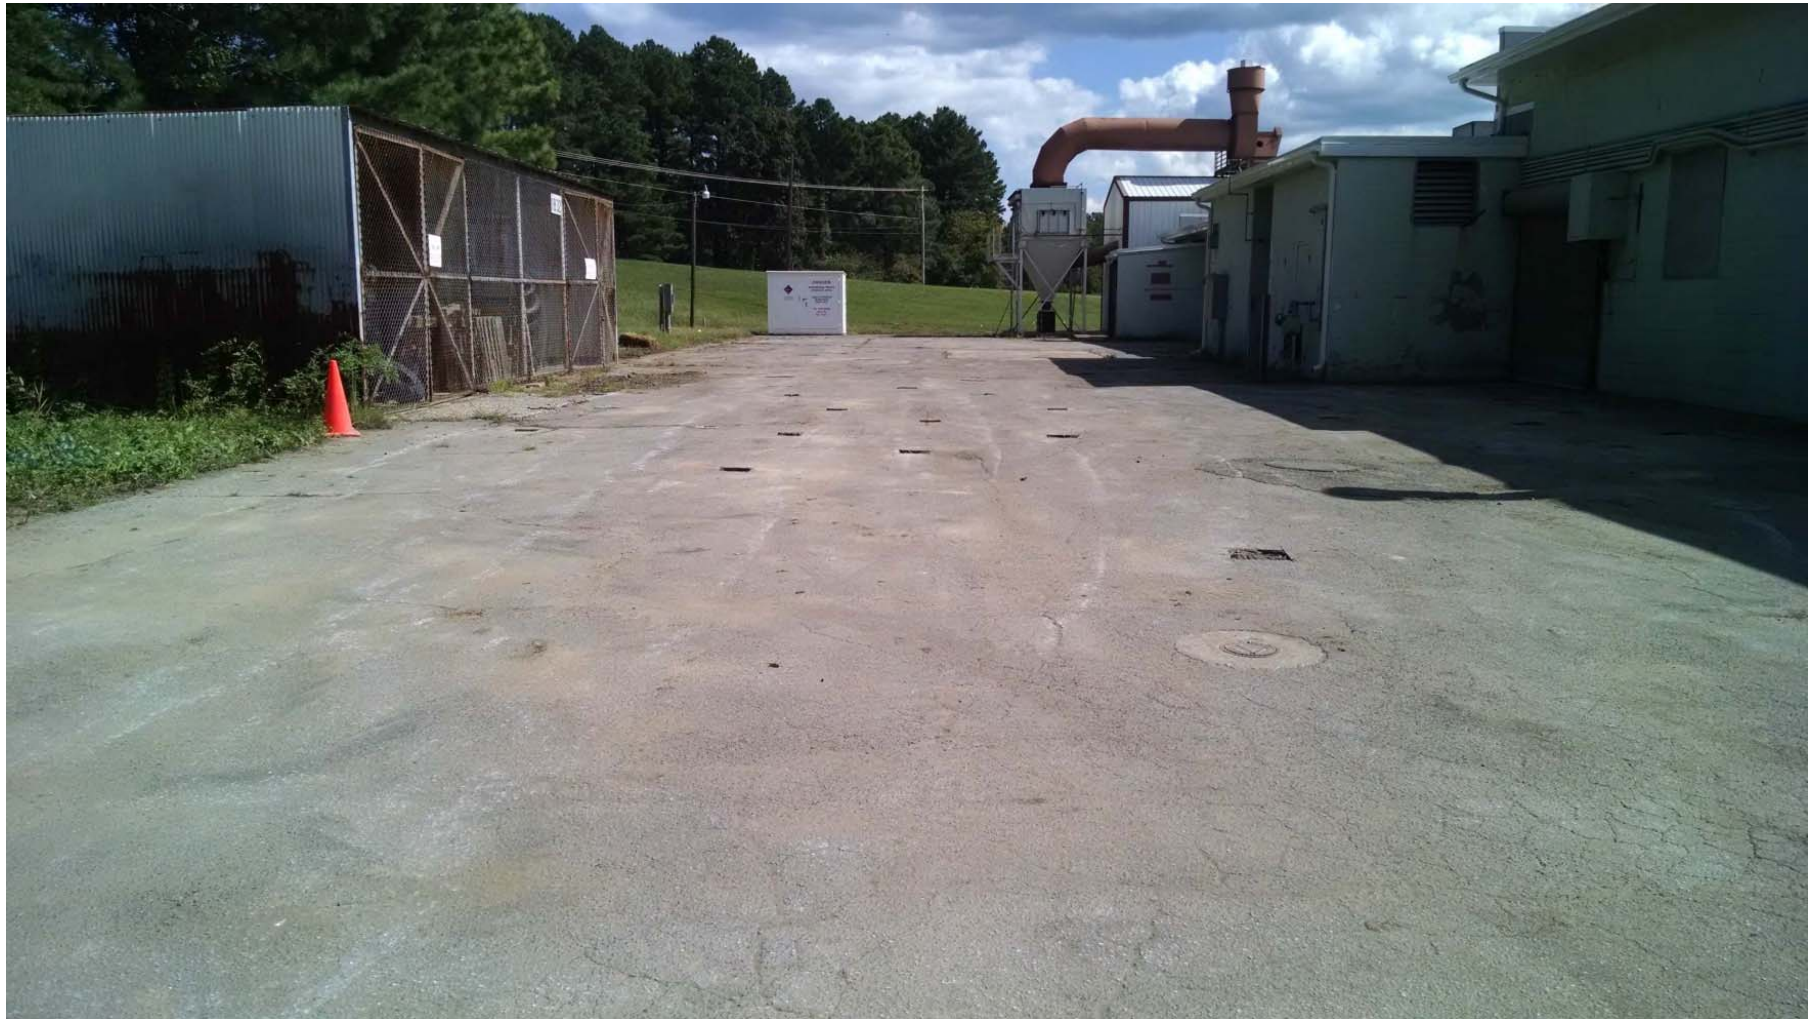
# Site 31 Remedial Action

- Completed groundwater injections and soil excavation in August
- Generate Land Use Control document
- Monitor VOC concentrations in groundwater quarterly, until cleanup goal is achieved
- Additional injections if warranted in the future

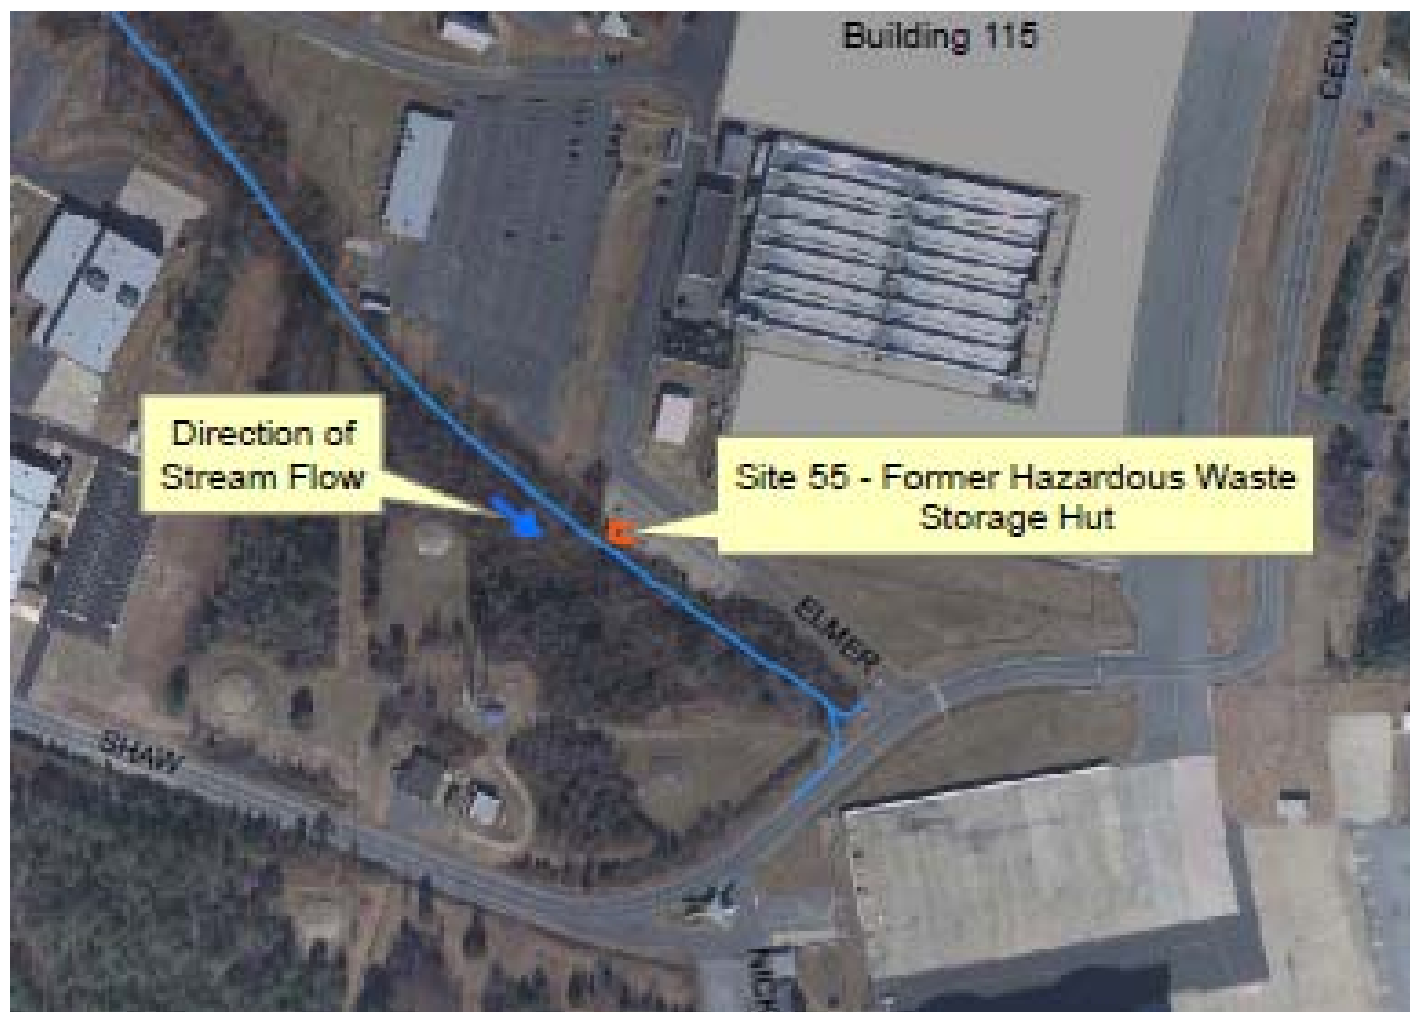
## Site Layout

- PCBs stored in a hazardous waste storage hut adjacent to the site
- Performed a remedial investigation
  - PCBs identified in stream sediment
  - Low concentrations of VOCs identified in groundwater

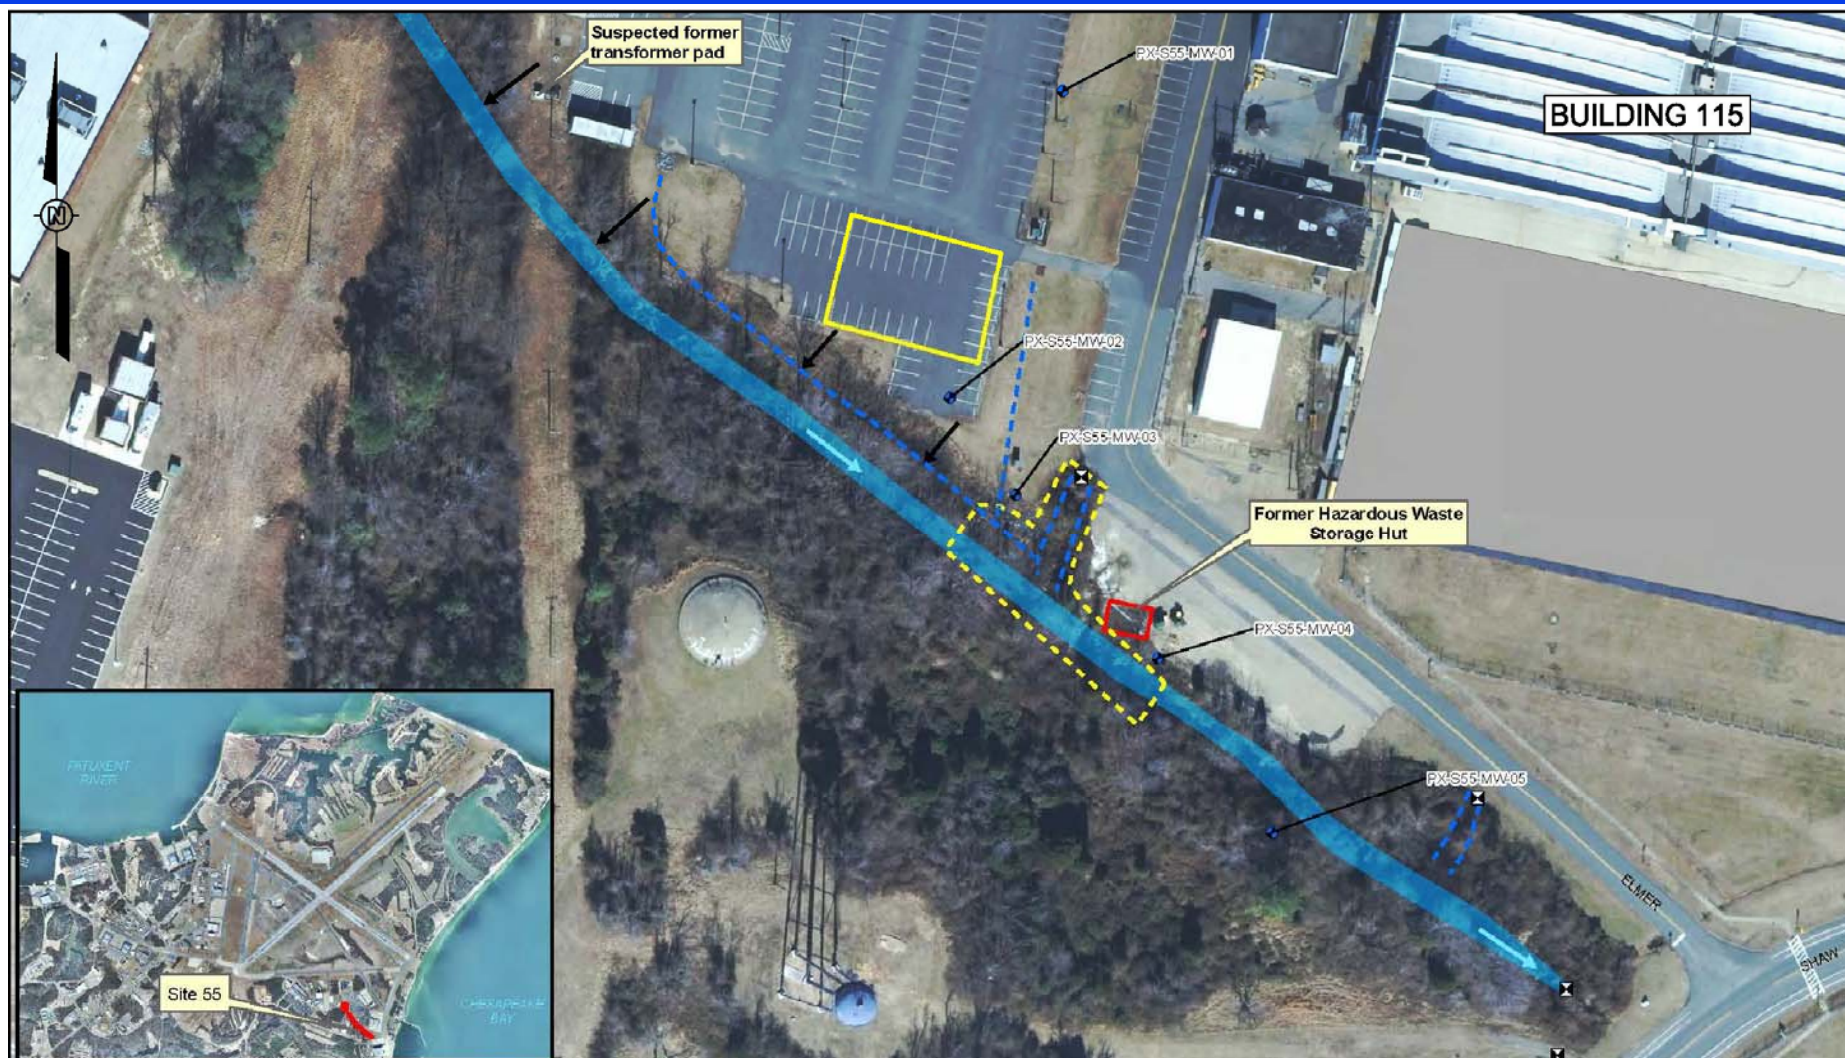
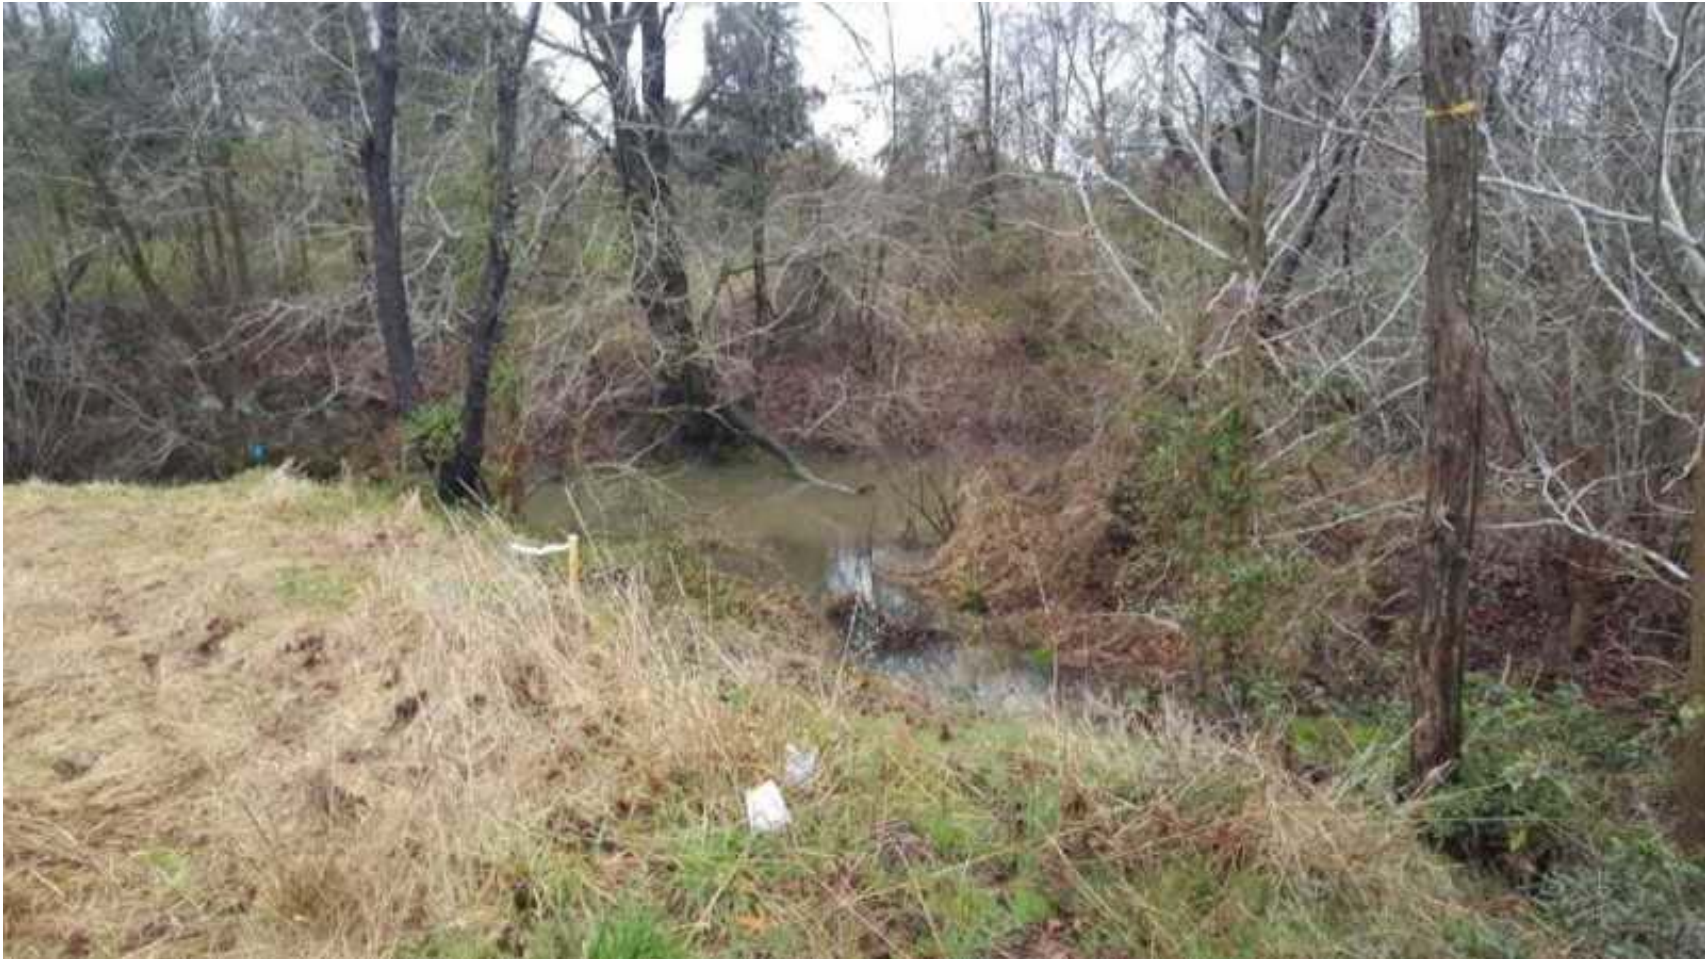
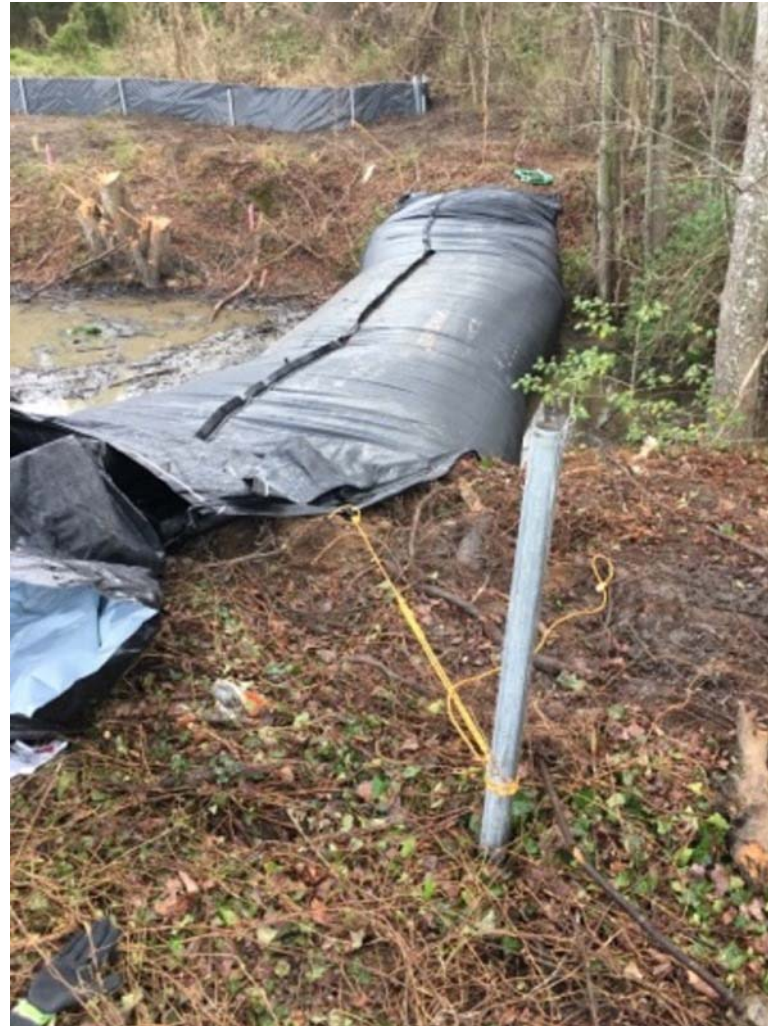
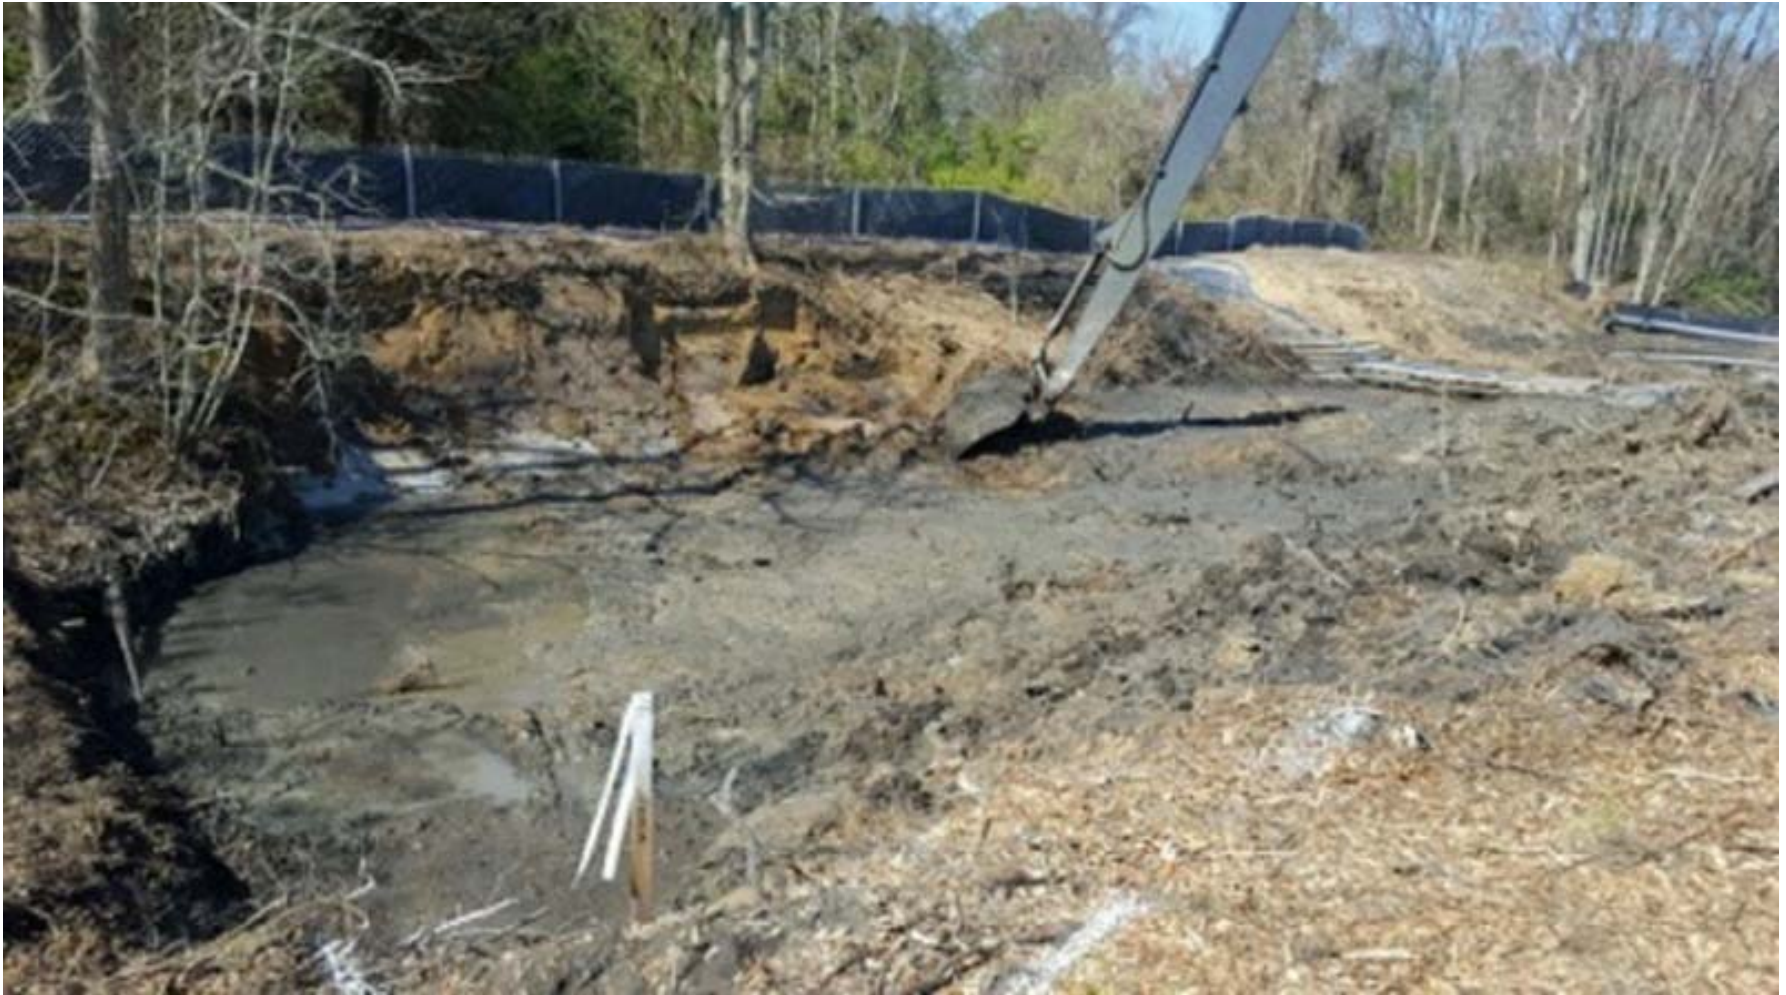
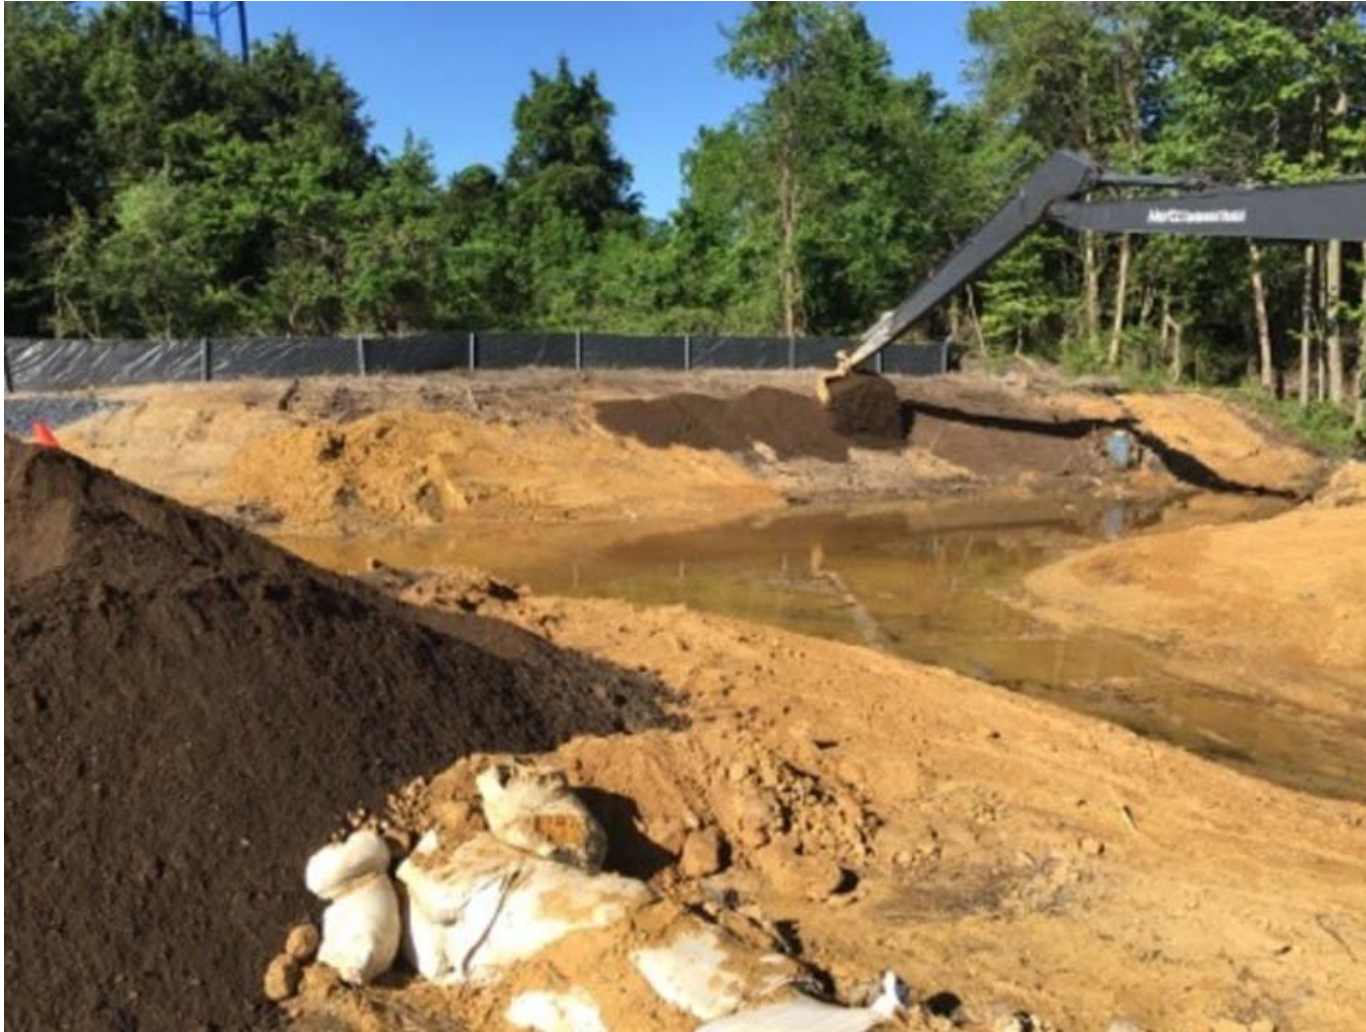
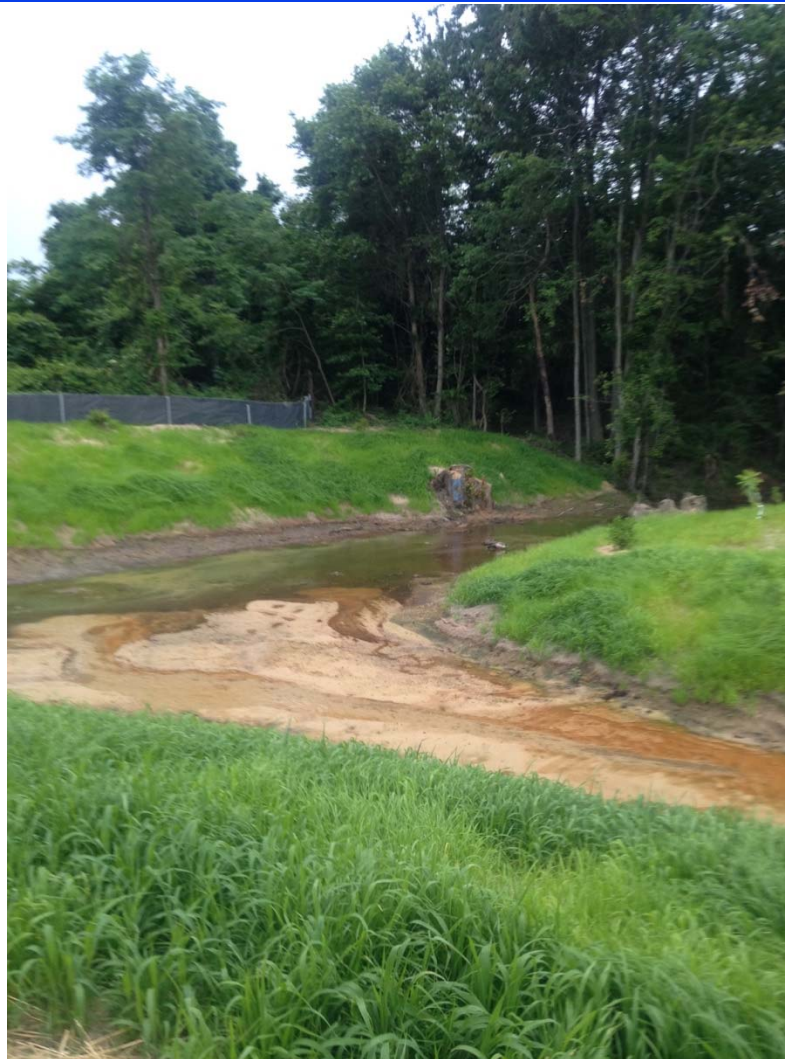
# Removal Action

- PCBs identified in sediment present ecological risk to stream biota
- Simplest, most cost-effective solution: excavate and dispose of sediment, backfill with clean fill
