Concrete Pile Handling – Crushed/Leg Amputation

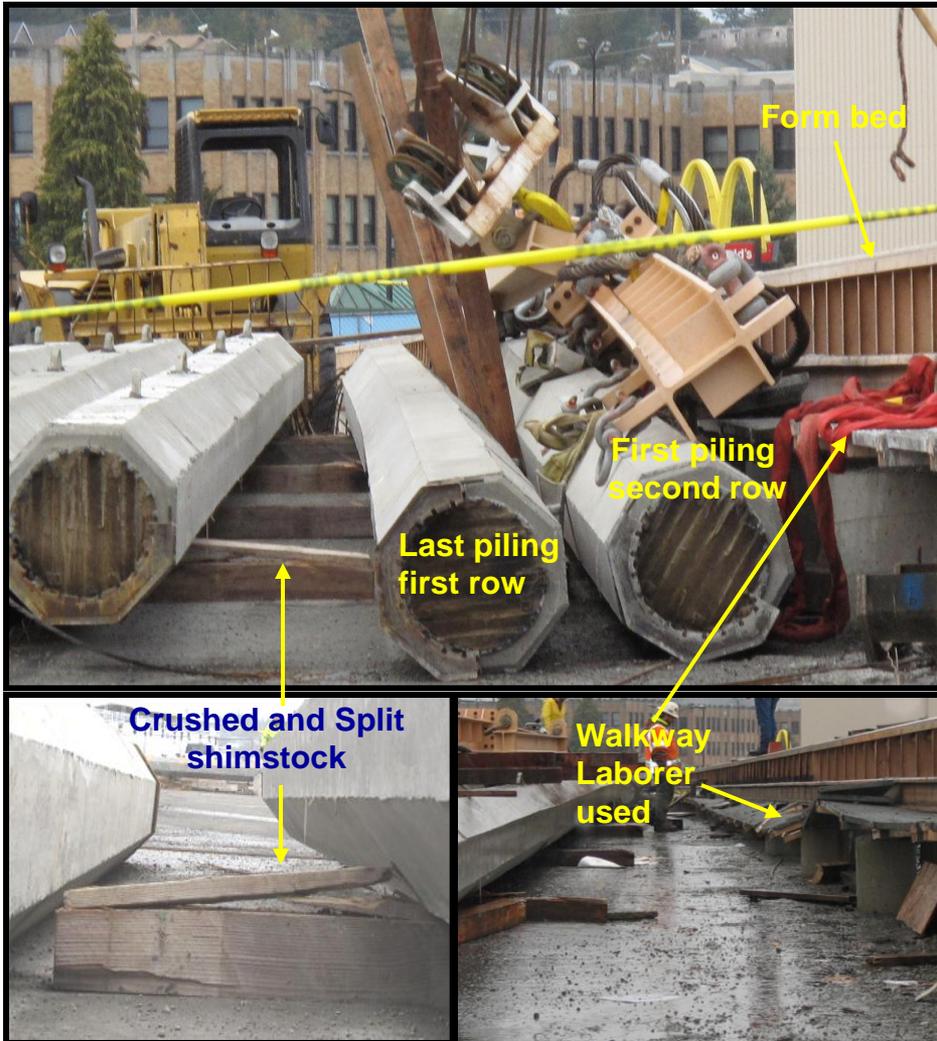
A 23 yr. old contract laborer lost a right leg below the knee and suffered fractures in her left leg and hip from a crushing injury at the pile manufacturing site.

Activity: Stowing newly casted pilings. First row of pilings were placed on dunnage and shimstock. Second tier begun with outside piling located on last piling set. Rigging was removed by rigger and laborer and both moved away from site on form bed walkway. Moments after stowage of second tier piling, it rolled on the legs of the laborer who stood on the form bed walkway.

- > workers knowingly worked in a crushing hazard area;
- > failure of of shimstock and dunnage no inspection criteria used;
- > storage area surface slopes;
- > personnel assisting in handling pilings – training and knowledge of hazards and hazard controls unknown.

- > AHAs must be updated when additional site hazards are discovered;
- > inspection criteria must be developed and followed when using wood dunnage for storing heavy materials;
- > personnel must be properly trained, briefed, and supervised when engaging in workplace activities they are not familiar with.
