Atlantic Division, Naval Facilities Engineering Command

ACCIDENT ABSTRACT

ACCIDENT TYPE: Dropped crane supported load
INJURY: Fatality/Crushed
TYPE OF WORK: Pier reconstruction
EQUIPMENT INVOLVED: Floating Crane
SAFETY EQUIPMENT: Long pants, shirt, safety glasses, and hardhat

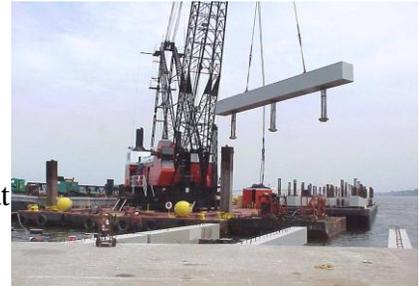
A contractor crane was supporting a concrete beam while an employee attached additional rigging under the load. The precast concrete embeds failed causing the concrete beam to fall crushing the employee.

- ◆ Contractor procedures not as designed: Original shop drawings showed a Spreader Bar for lifting concrete beams which was not used allowing for additional horizontal forces due to sling angle.

- ◆ Embed bolts overloaded: Embed bolts and nuts were not in accordance with manufacturers instructions and were not installed or designed with the correct safety factor.

- ◆ Nuts for bolted connection to cap embeds not used properly: According to the manufacturer instructions two nuts per bolt were to be used. The contractor installed only one. Additionally, the nuts were designed to be used only one time then discarded. The nuts were used repeatedly.

- ◆ Pad Eye (lifting attachment device) manufactured by contractor: Not in accordance with standards or contract requirements – not proof tested (125%) – not labeled with weight capacity and were damaged/bent.

At no time should any employee be positioned under any crane-supported load. Critical lifts promulgating a crane critical lift plan and associated planning steps in accordance with EM 385-1-1 include any rigging that may be considered technically difficult or unusual.
