**Final  
Site Management Plan  
Fiscal Year 2013**

Atlantic Fleet Weapons Training Area - Vieques  
Vieques, Puerto Rico

Contract No.  
N62470-08-D-1000  
CTO-023 and 037

**September 2012**

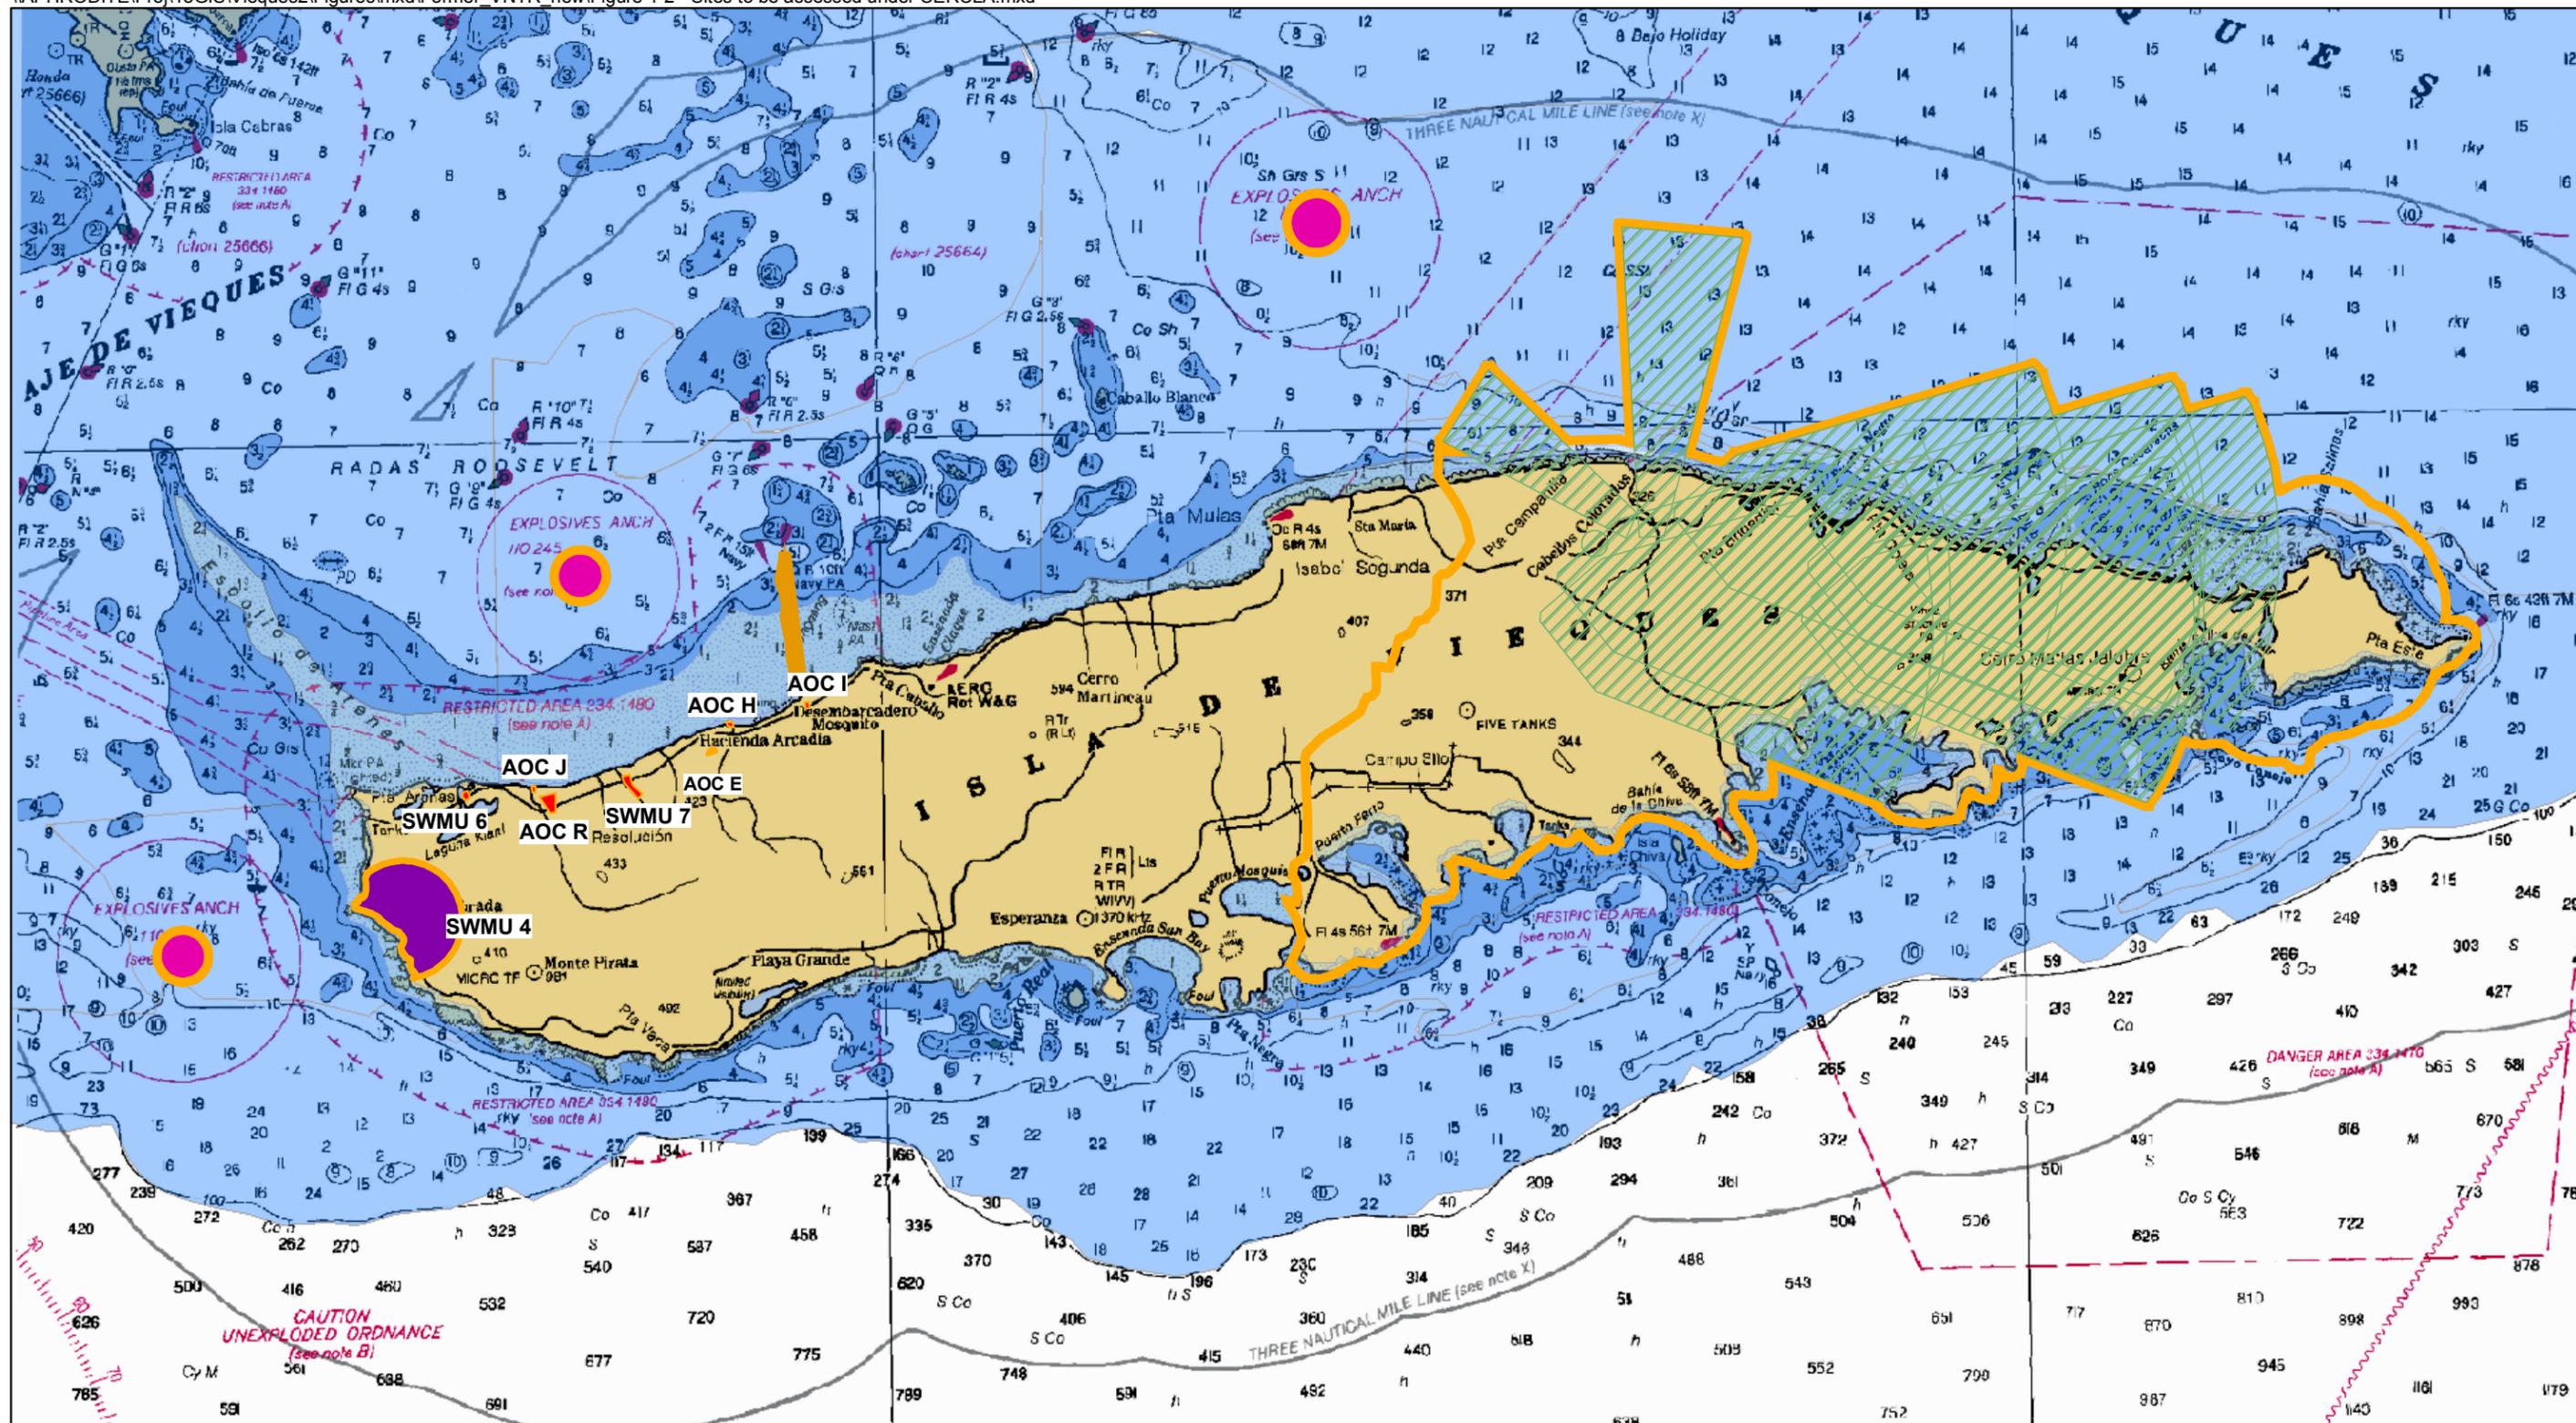
**Figure 1-2**  
**Vieques Sites to be Assessed Under CERCLA**  
*Site Management Plan, FY 2013*  
*Vieques, Puerto Rico*

- Agreed Areas of Proposed NPL Site
- Anchorage Location Boundary
- Western Vieques Environmental Sites
- SWMU 4 (Former OB/OD Site)
- Artillery Safety Fan
- Water Depth**
- 0-10 Feet
- 10 - 150 Feet
- Greater Than 150 Feet

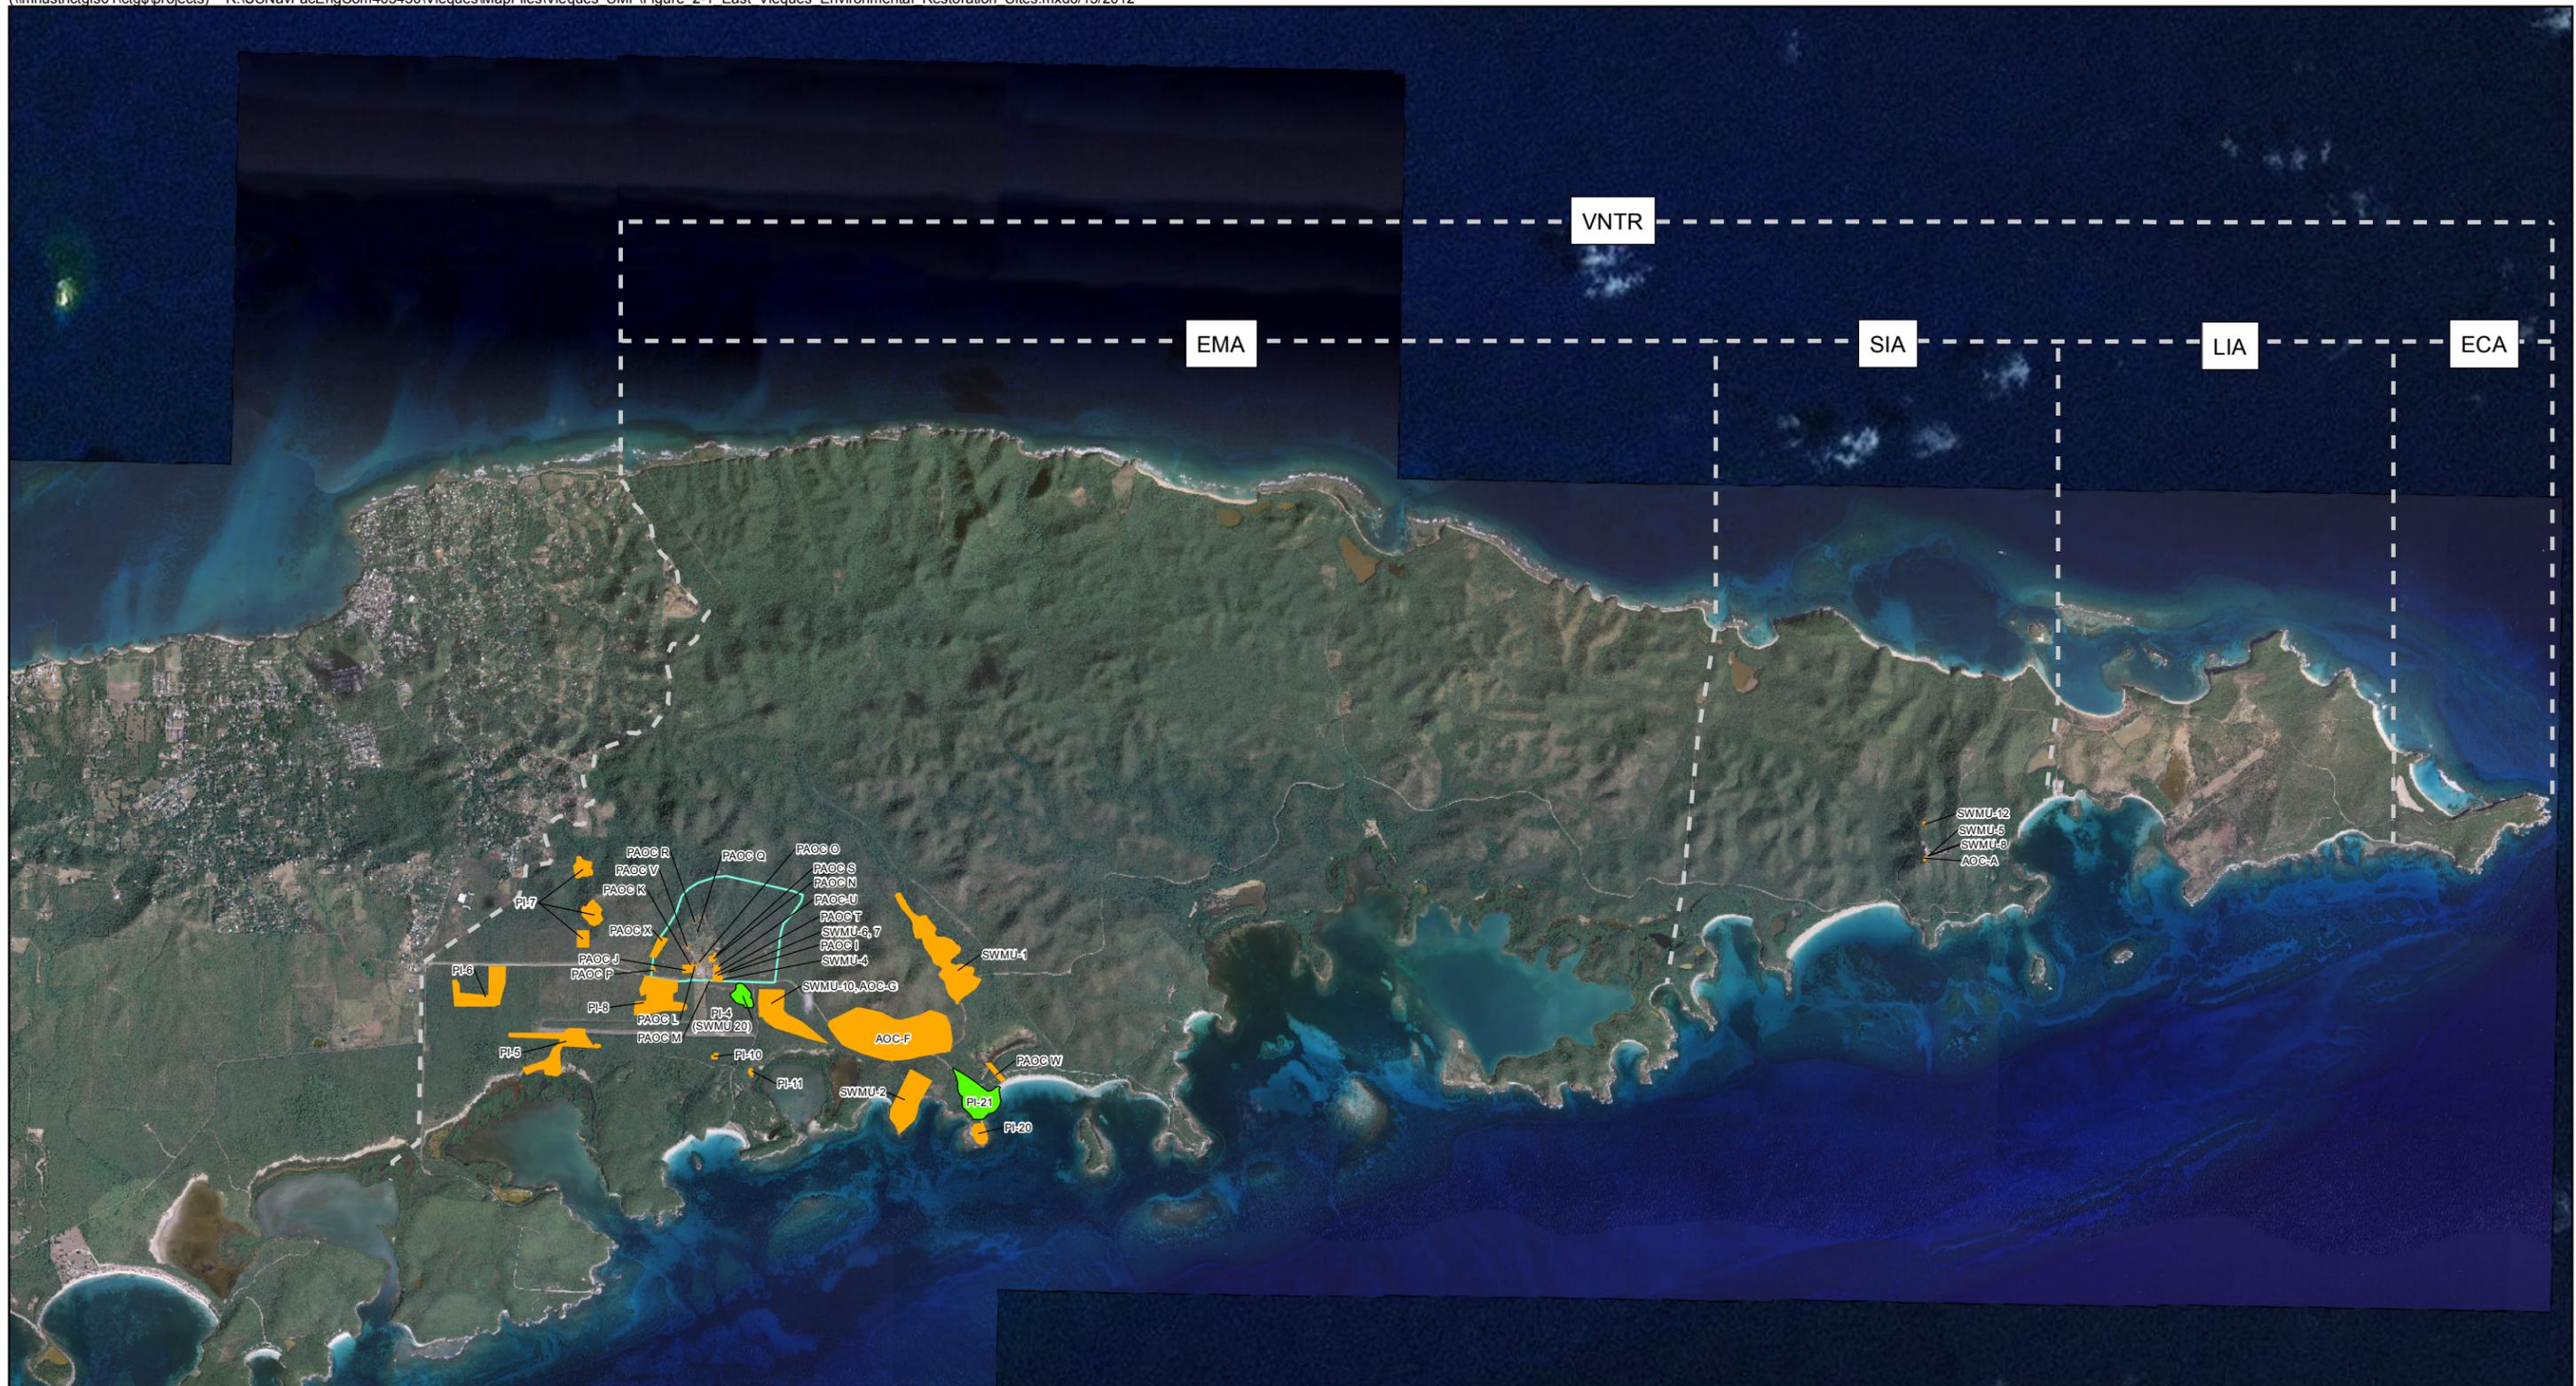
**Figure 2-1**  
**East Vieques Environmental Restoration Sites**  
*Site Management Plan, FY 2013*  
*Vieques, Puerto Rico*

**Legend**  
■ Sites – Decision Document  
■ Sites – Under Investigation  
□ Camp Garcia

During the development of the Description of Current Conditions Report (CH2M HILL, 2001b) and the EBS (NAVFAC, 2003a), several additional potential environmental sites were identified based on the review of historical aerial photographs and facility records. This subsection summarizes the status of the 23 Photo-identified (PI) and 24 Potential Area of Concern (PAOC) sites that were identified, and in most cases, investigated and closed out of the CERCLA process. Additional detail for the two sites (SWMU 20 [formerly PI 4] and PI 21) that are currently under investigation is provided herein. Site-specific detail for sites closed out of the CERCLA process is provided in **Appendix B-1** and past SMPs. The anticipated schedule for deliverable submittal for the following sites, as applicable, is provided in **Figure 3-1**. The locations of the PI sites and PAOCs are shown on **Figure 2-1**.
