Re: Response to EQB letter dated October 12, 2002

Addendum to the Ordnance/Explosives Site Specific Work Plan for SWMU 04, Former NASD, Vieques Island, Puerto Rico

**Interim Data Summary Report
Phase I and Phase II Investigations
SWMU 4, Former NASD
Vieques, Puerto Rico**

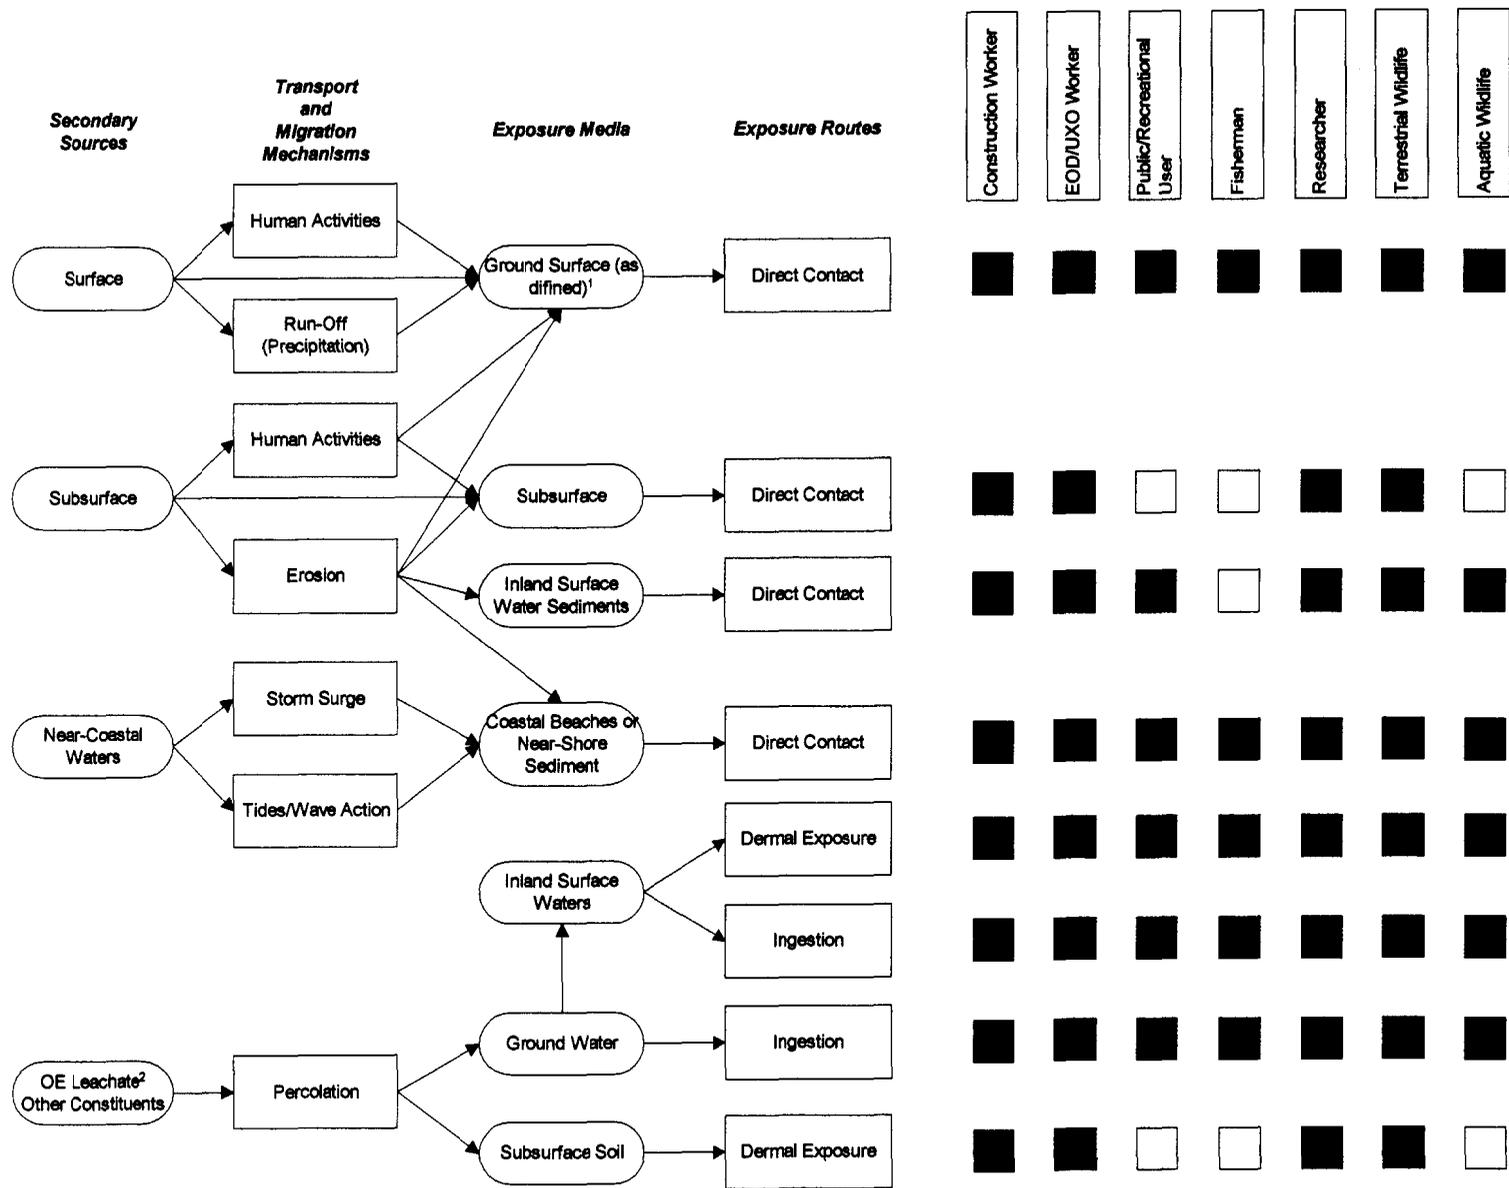
Figure 2, Site Conceptual Model, SWMU 04, Vieques

¹Ground Surface (as defined): For some users "Ground Surface" may include incidental subsurface intrusion (e.g., placing stakes or fence post)
²OE Residue on the surface or subsurface may give an exposure pathway to inland surface waters through Erosion and Run-Off.

Based on the description of the site and the results of the previous investigations at the site a conceptual site model has been developed. The conceptual site model is illustrated in Figure 2 and summarized in Table 1. The primary OE contamination source is OE from the OB/OD pits. The primary OE release mechanism is kickouts of unexploded ordnance and ordnance related scrap from the burn pits and detonation pits. Potential secondary sources include the ground surface, subsurface, near-coastal waters, and OE constituents. Potential transport and migration mechanisms included human activities, run-off, erosion, storm surge, tides/waves, and percolation. Potential exposure media include the ground surface, subsurface, inland surface water/sediments, coastal beaches or near-shore sediment, inland surface waters, groundwater, and subsurface soil. Potential exposure routes included direct contact, dermal exposure, and ingestion, however, these exposure routes have been restricted with the installation of the fence around the perimeter of SWMU 4. Potential receptors include , EOD/UXO workers, recreational users, fishermen, wildlife refuge workers, terrestrial wildlife, and aquatic wildlife.

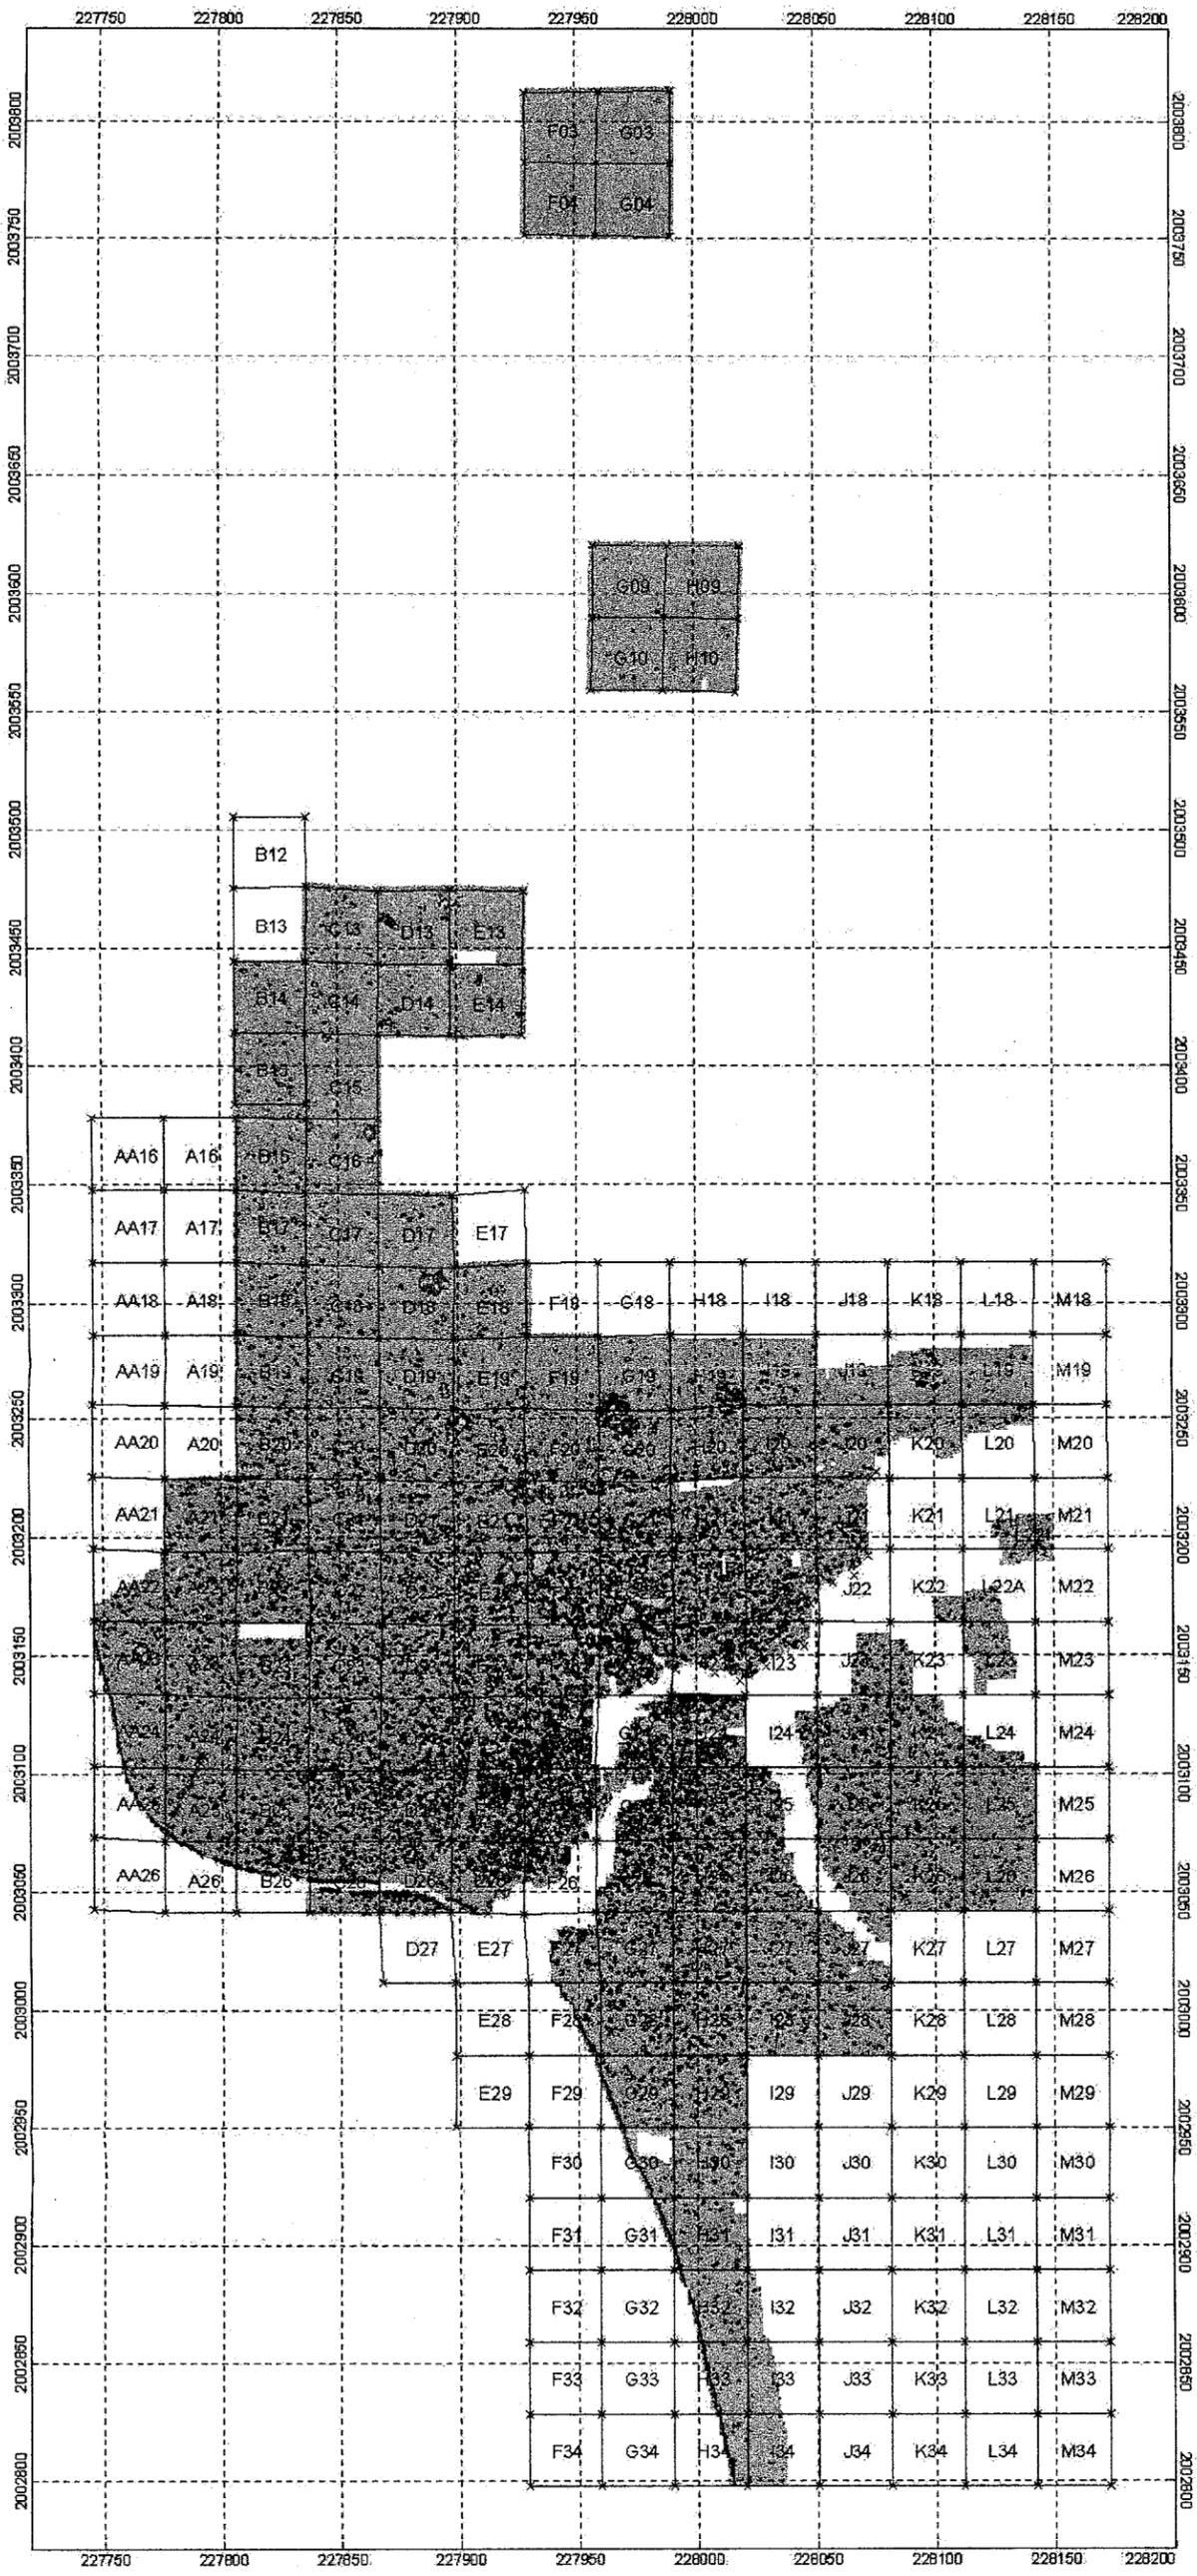
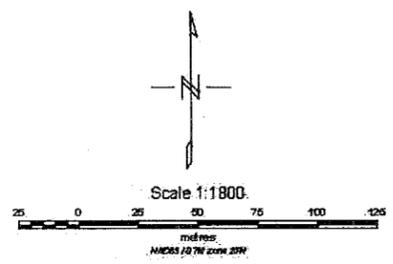
FIGURE 3

Phase I & II Mosaic Illustrating Mapped Anomalies

Current to June 20, 2002

Approximately 20 acres were investigated during the Phase I investigation. The locations of the magnetic anomalies identified by the geophysical surveys are shown on Figure 3. The figure illustrates that a high density of anomalies correlated well with five of the Photo Identified sites of potential OB/OD pit locations that were identified from the aerial photo survey. Figure 3 illustrates that a high density of electromagnetic anomalies, exceeding 400 anomalies per acre were identified in the vicinity of the OB/OD pits. In addition, there is a significant reduction in anomaly density at a distance of approximately 1000 feet from the pit locations. The Phase I work formed the basis of plans for expanding the investigation

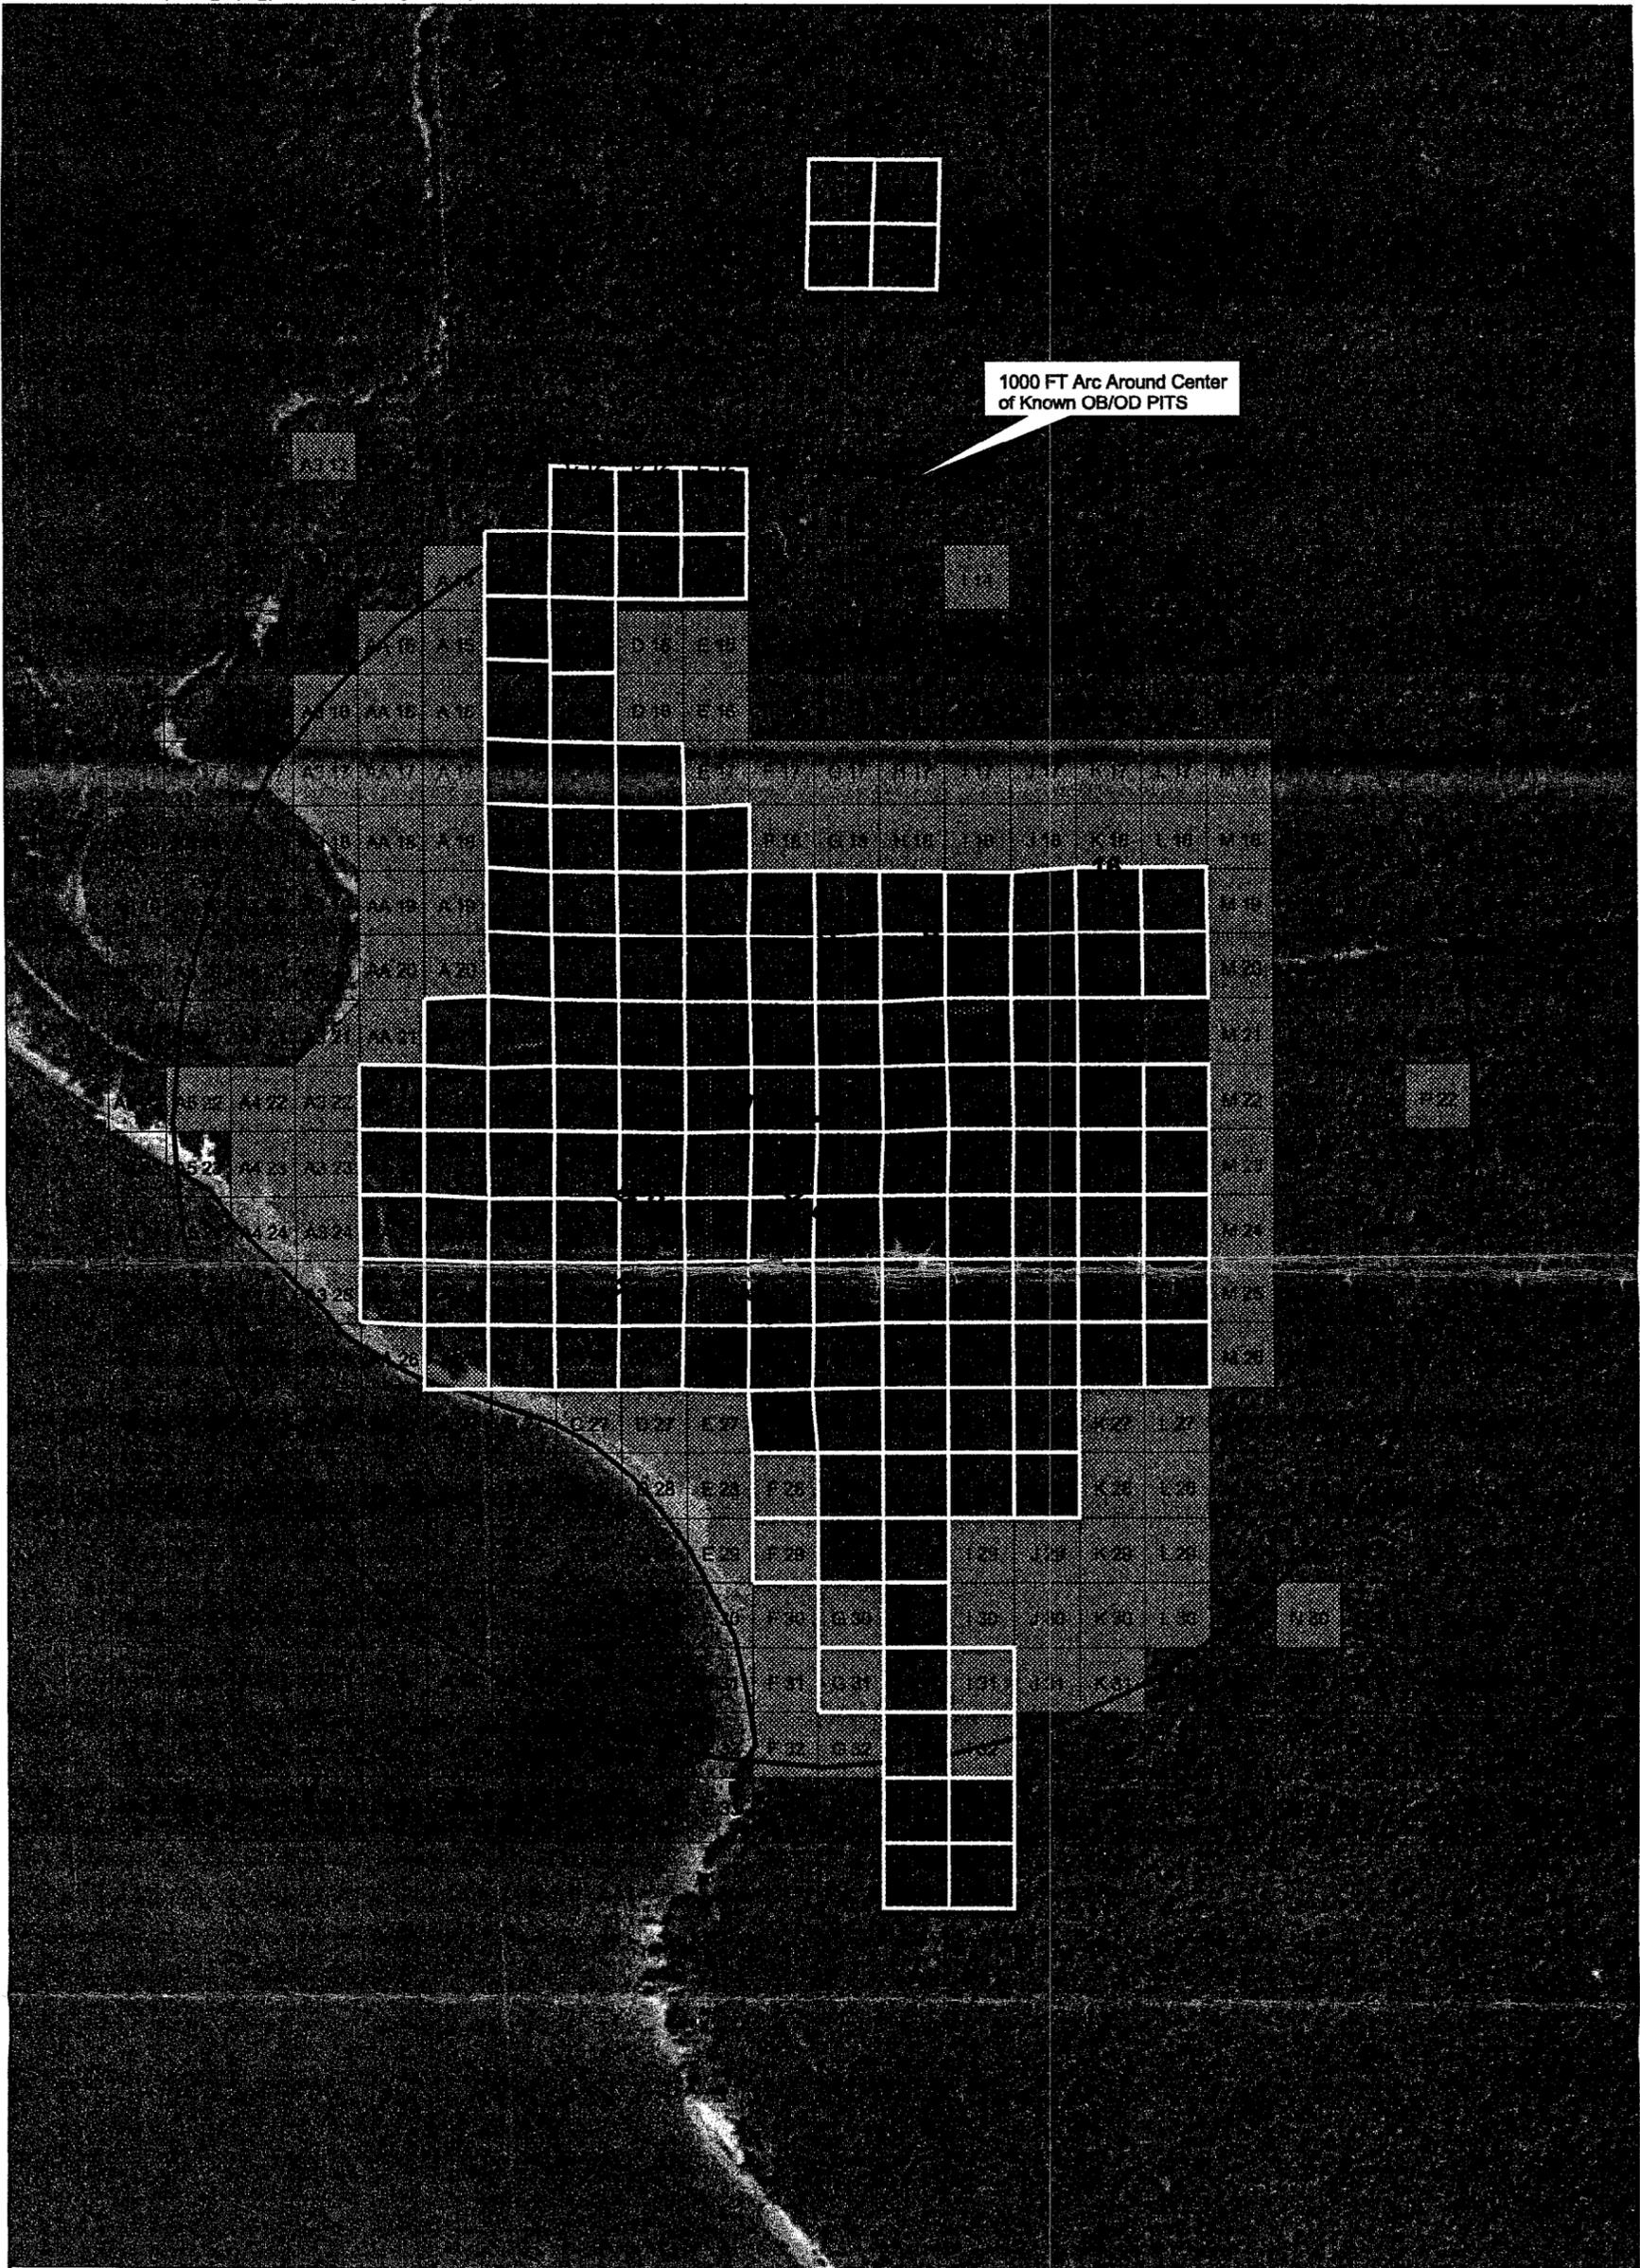
- ⊕ Center of Known OB/OD PITS
- Known OB/OD PITS
- ▭ Quadrants (100' x 100') Investigated During Phase I and II
- ▨ Phase III Expansion Quadrants on Land
- ▩ Quadrants Proposed for Additional Intrusive Investigation During Phase III Operation
- ▧ Quadrants Investigated During Phase I and II That Will Not Be Further Investigated During Phase III

FIGURE 6
Phase III OE/UXO Investigation SWMU 4
Former NASD, Vieques Island, Puerto Rico

- Select, reacquire, and investigate up to 300 additional anomalies per acre from 20 of the original 35 acres completed during Phase I & II Investigations.
- Investigate up to 20 additional acres further away from the OB/OD pits to further delineate the extent of OE/UXO impacts. A number of quadrants outside of the Phase I, II, and proposed Phase III Investigation contiguous area will be selected for investigation to evaluate potential OE/UXO contamination at distances away from the Phase I, II, and III study area.

Figure 6 illustrates the proposed Phase III areas of investigation based on the results of the first two phases of the investigation. An Addendum to the Site Specific OE Work Plan for SWMU 04 will be developed to identify the areas of investigation and describe any proposed changes in the field investigation procedures that have been modified from those defined in the Site Specific OE Work Plan for SWMU 04.
