FINAL RESOURCE CONSERVATION AND RECOVERY ACT PARTIAL CLOSURE REPORT
FOR BUILDING 295 WITH TRANSMITTAL LETTER NAS BRUNSWICK ME
4/16/2010
NAS BRUNSWICK

RCRA PARTIAL CLOSURE REPORT
for
BUILDING 295 - WATER RESERVOIR PUMP HOUSE PARCEL
NAVAL AIR STATION BRUNSWICK, MAINE
USEPA IDENTIFICATION NUMBER ME8170022018
APRIL 2010

**BUILDING INSPECTION FORM
RCRA PARTIAL CLOSURE PROGRAM
NAS BRUNSWICK
BRUNSWICK, MAINE
CTO WE22**

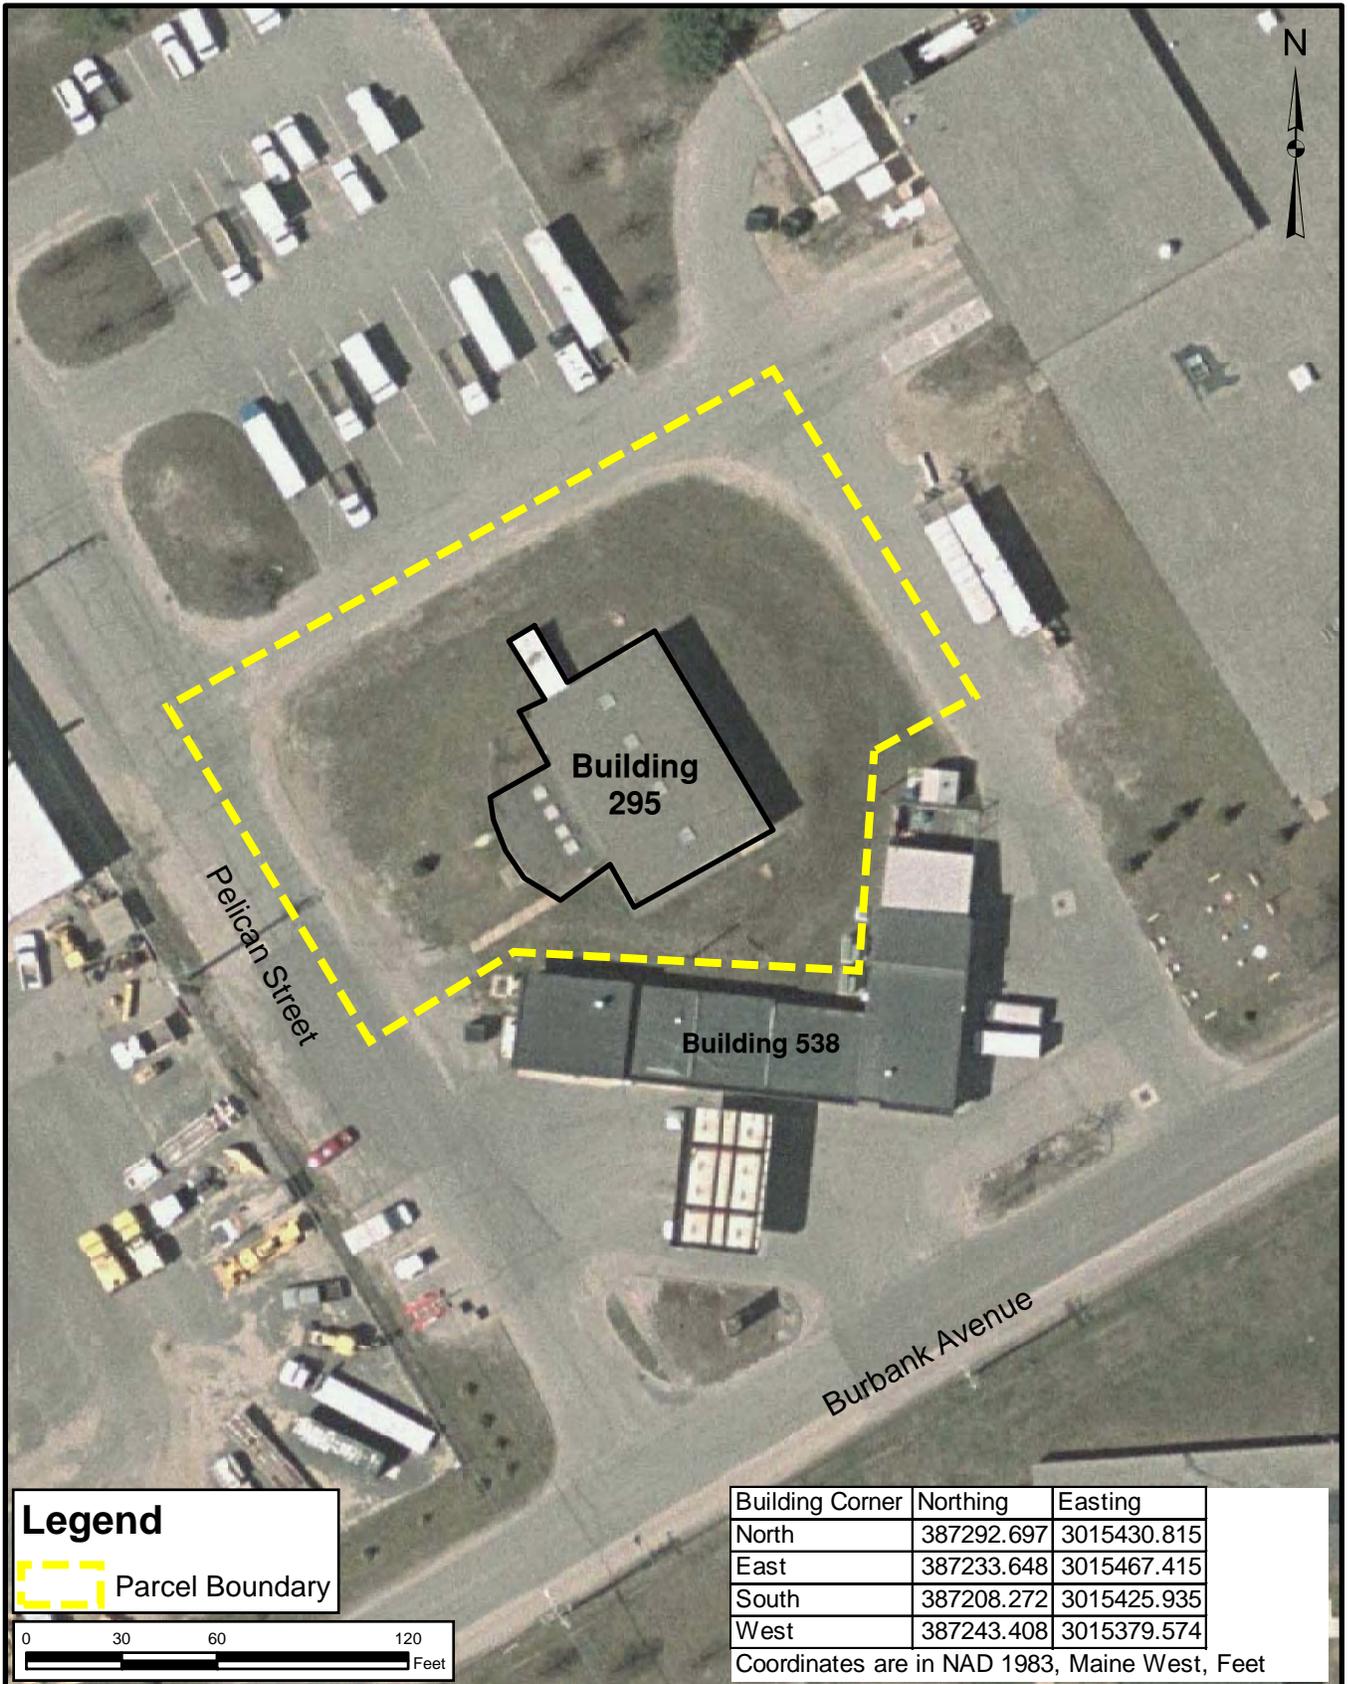
SCALE AS NOTED	
FILE \\.\BLDG_295_ORTHO.MXD	
REV 0	DATE 04/13/10
FIGURE NUMBER FIGURE NO. 2

The Building 295 parcel is located in the central portion of NAS Brunswick (see Figure 1). The approximately 0.7-acre parcel (see Figure 2) is bordered to the west by Pelican Street and to the south by Burbank Avenue. The parcel contains Building 295 (the Water Reservoir Pump House building), the associated earthen-covered water storage tank and the surrounding grass-covered areas. Photographs taken during the site visit are provided in an attachment.

SITE PLAN
BUILDING 295 - WATER RESERVOIR PUMP HOUSE
RCRA PARTIAL CLOSURE REPORT
NAVAL AIR STATION BRUNSWICK, MAINE

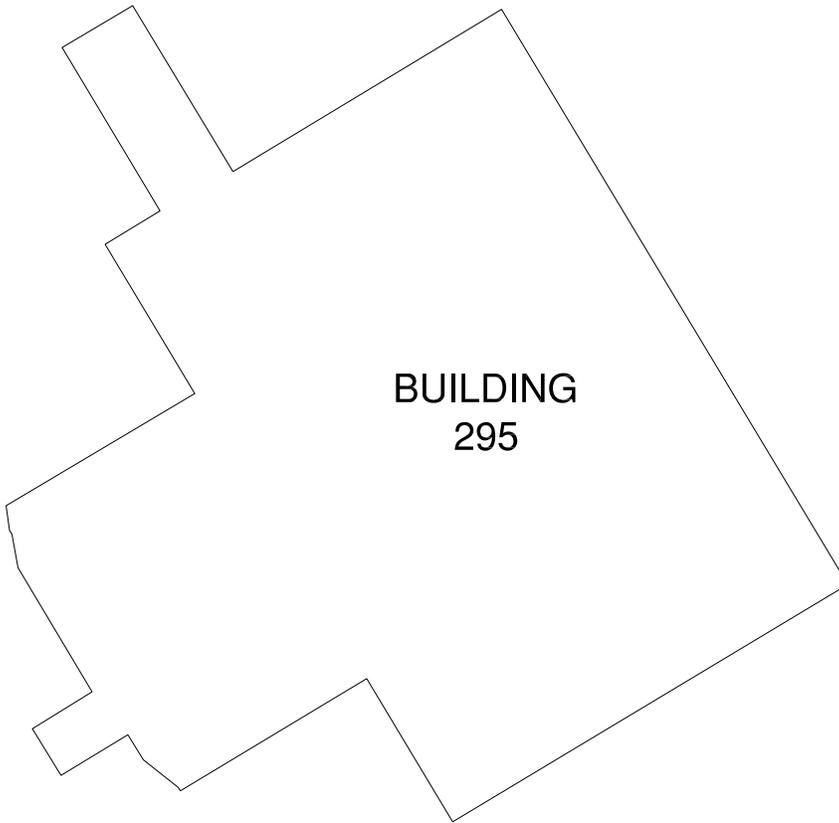
FIGURE NUMBER
3

Because Building 295 was constructed prior to 1979, the transformer pad, located south of the building, could potentially be an area of PCB soil contamination, if there had been an historical transformer leak. On February 23, 2010, Tetra Tech collected surface soil samples from four locations surrounding the transformer pad using a hand auger. Four samples were collected from 0 to 6 inches below ground surface (bgs) [NASB-B295-SB01-0006 through NASB-B295-SB04-0006], three samples were collected from 6 to 12 inches bgs (NASB-B295-SB01-0612 through NASB-B295-SB03-0612) and one sample was collected from 6 to 24 inches bgs (NASB-B295-SB04-0624). Sample locations are presented on Figure 3.

TRANSFORMER
PAD

SB01 ● SHALLOW SOIL SAMPLE LOCATION

FLOOR PLAN
BUILDING 295 - WATER RESERVOIR PUMP HOUSE
RCRA PARTIAL CLOSURE REPORT
NAVAL AIR STATION BRUNSWICK, MAINE

All soil samples were submitted for PCB analysis by Tetra Tech's subcontracted analytical laboratory (Analytics Environmental Laboratory, Portsmouth, New Hampshire). Sample analytical data underwent limited data validation, consisting of field duplicate evaluation, blank contamination evaluation, and completeness evaluation. As presented in the attached Table 1, PCBs were not detected in any of the soil samples collected at Building 295. (The EPA Regional Screening Levels [RSLs] for Residential Soil are included in Table 1 for informational purposes [EPA, 2009].) All concentrations are below the MEDEP RCRA standard for total PCBs in soil of 1 part per million (ppm).

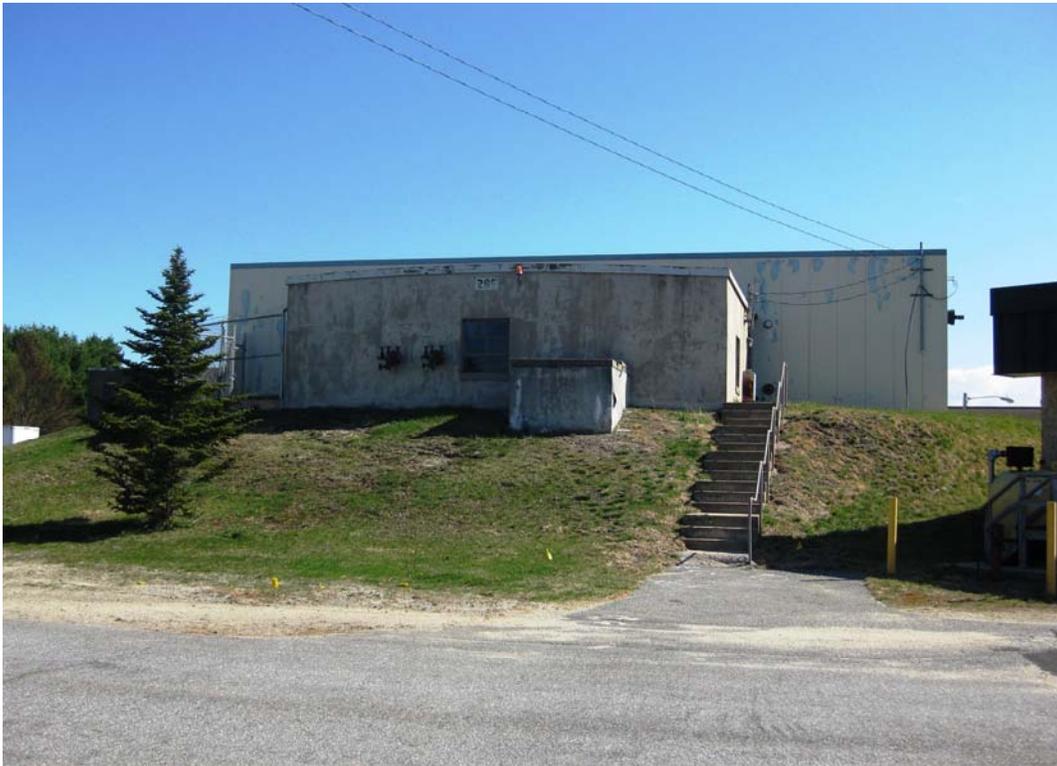
No. 1 Building 295 – NAS Brunswick
Building 295 – Southwest elevation

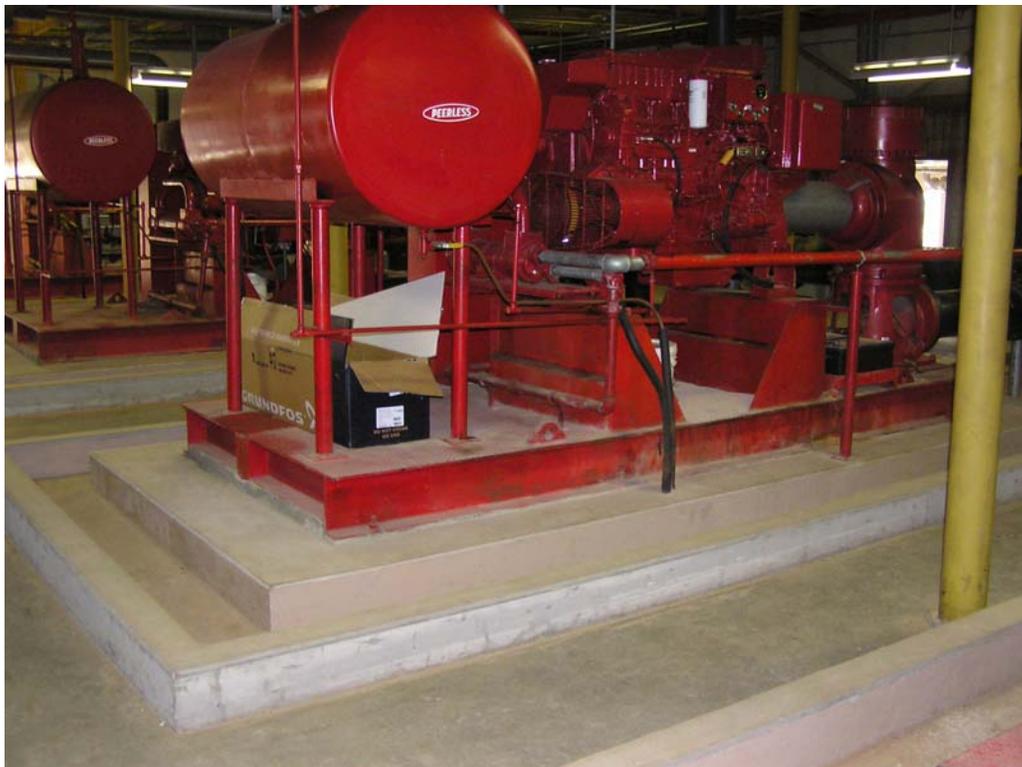
No. 2 Building 295 – NAS Brunswick
Building 295 – fire suppression pumping room interior

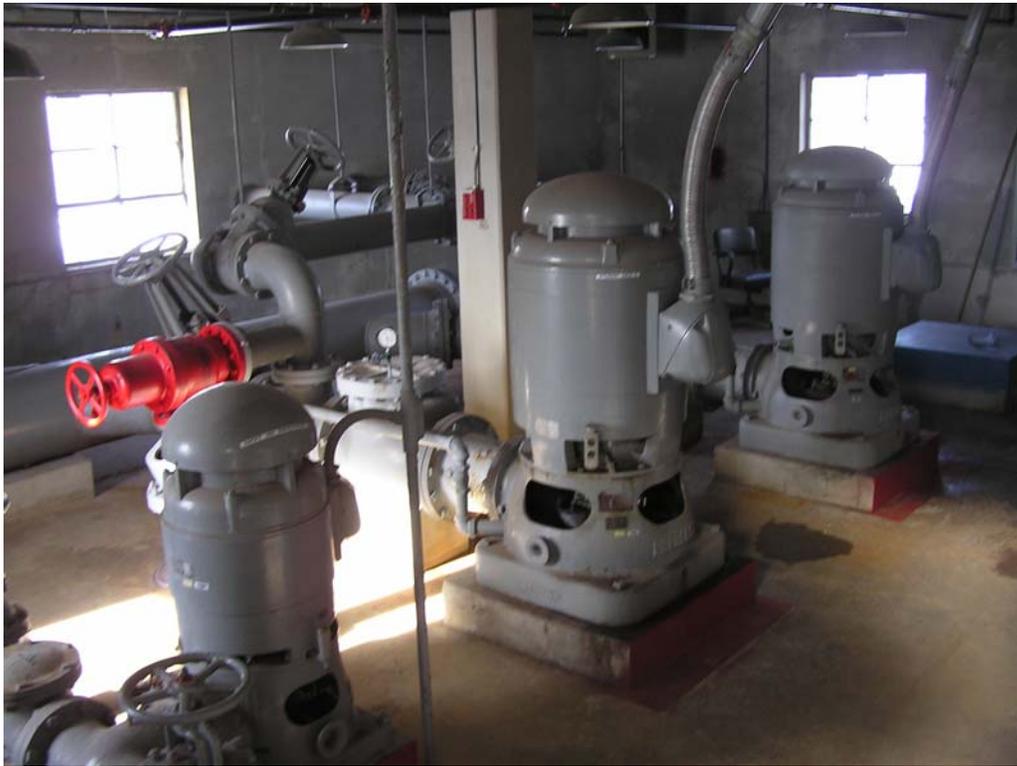
No. 3 Building 295 – NAS Brunswick
Building 295 – Building 295 pump room interior

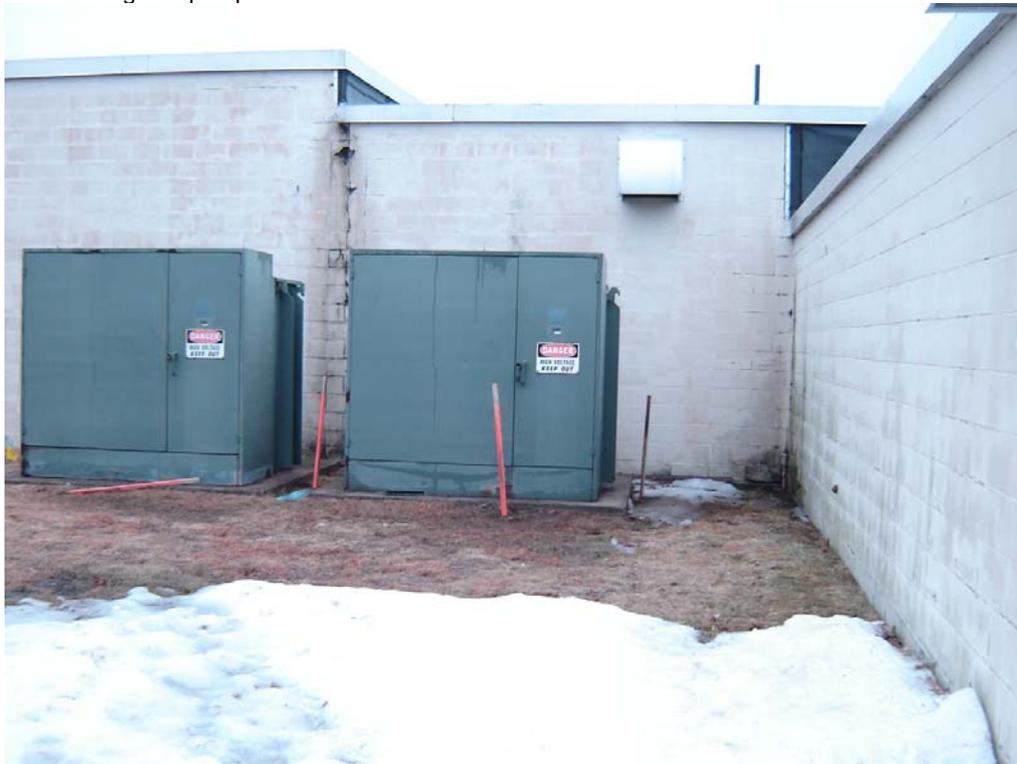
- One pad-mounted transformer location was observed on the south side of the building, adjacent to the Building 538 pad-mounted transformer. No evidence of a past leak from these transformers was observed.

No. 4 Building 295 – NAS Brunswick
Building 295 – Building 295 pad-mounted transformer (left) adjacent to Building 538 transformer (right)

Due to the age of the building, soil sampling around the pad is recommended in order to confirm that the soil is free of PCBs from potential former transformers.
