FINAL RESOURCE CONSERVATION AND RECOVERY ACT PARTIAL CLOSURE REPORT
FOR BUILDINGS 538, 639, 644 AND 649 WITH TRANSMITTAL LETTER NAS BRUNSWICK
ME
4/23/2010
NAS BRUNSWICK

Subj: Final RCRA Partial Closure Report for Buildings 538, 639, 644, and 649

RCRA PARTIAL CLOSURE REPORT
for
BUILDING 538 – NEX SERVICE STATION PARCEL
NAVAL AIR STATION BRUNSWICK, MAINE
USEPA IDENTIFICATION NUMBER ME8170022018
APRIL 2010

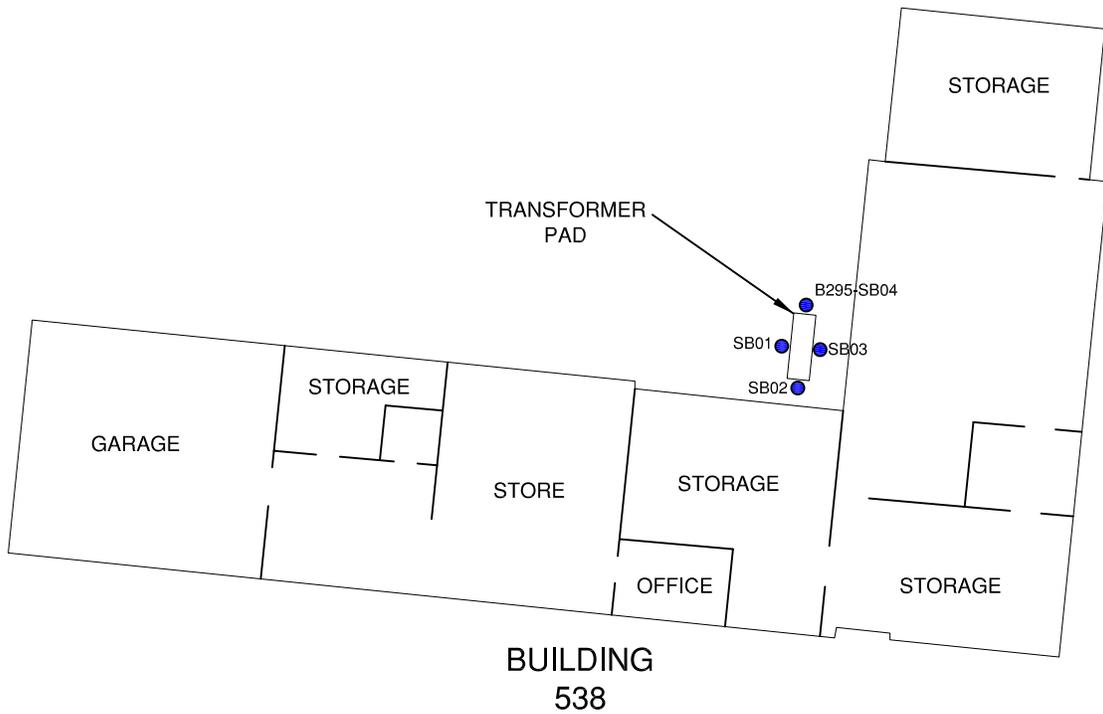
Because Building 538 was constructed prior to 1979, the transformer pad, located north of the building, could potentially be an area of PCB soil contamination, if there had been an historical transformer leak. On February 24, 2010, Tetra Tech collected surface soil samples from four locations surrounding the transformer pad using a hand auger. Due to the close proximity to the transformer pad for Building 295, samples were collected from the fourth sample location for both Building 295 and Building 538. Sample identifications from the fourth location are labeled as Building 295 but reported here since they were collected on the north side of the Building 538 transformer pad. At the transformer pad located south of Building 538, four samples were collected from 0 to 6 inches bgs [NASB-B538-SB01-0006 through NASB-B538-SB03-0006, and NASB-B295-SB04-0006], two samples were collected from 6 to 24 inches bgs [NASB-B538-SB02-0624 and NASB-B295-SB04-0624], one sample from 6 to 18 inches bgs [NASB-B538-SB01-0618] and one sample was collected from 6 to 12 inches bgs (NASB-B538-SB03-0612). Sample locations are presented on Figure 3.

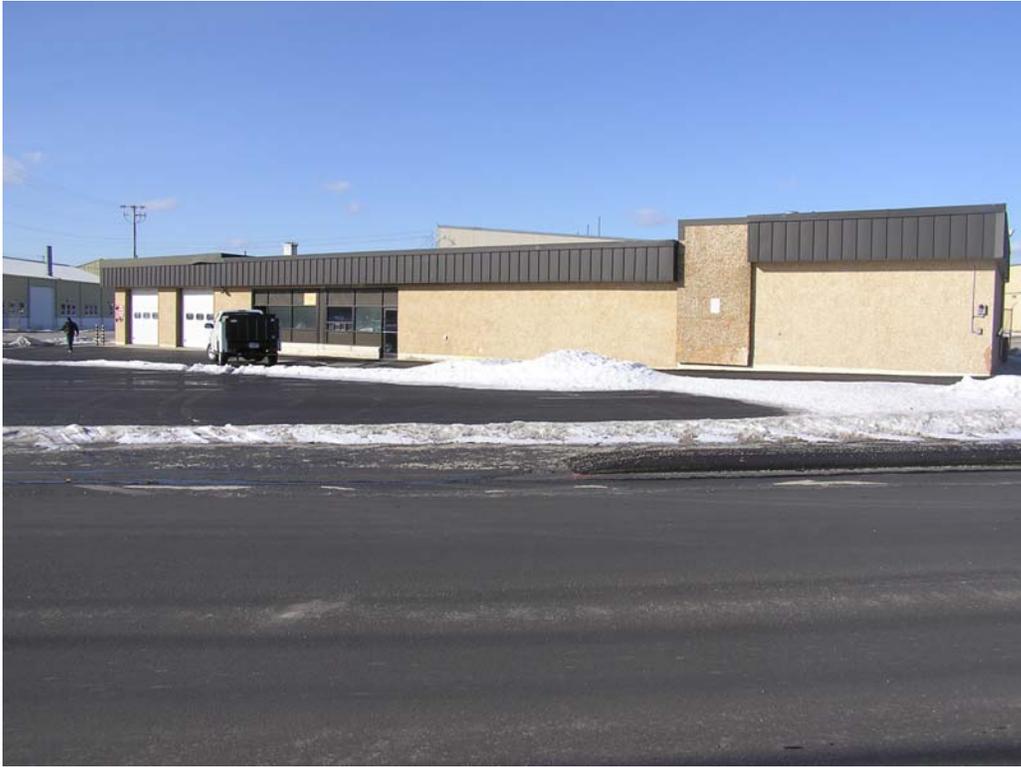
No. 1 Building 538 – NAS Brunswick
Building 538 – Southeast elevation

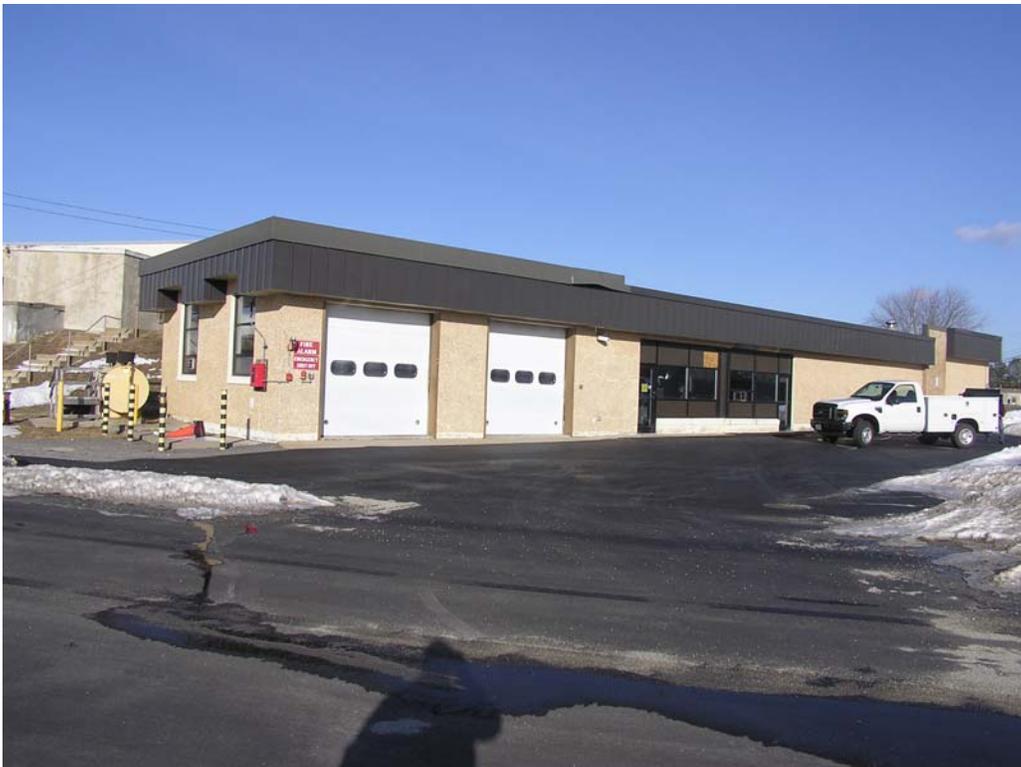
No. 2 Building 538 – NAS Brunswick
Building 538 – Southwest elevation with service bay and retail store.

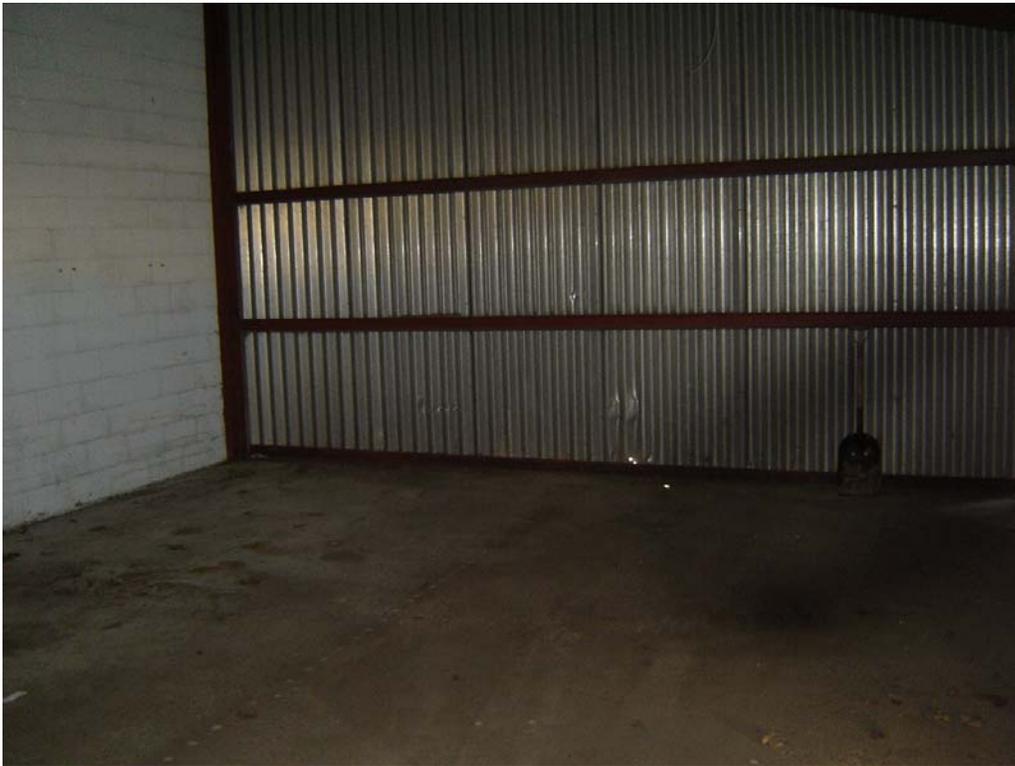
No. 3 Building 538 – NAS Brunswick
Building 538 – Building 538 former bottle and can recycling area interior

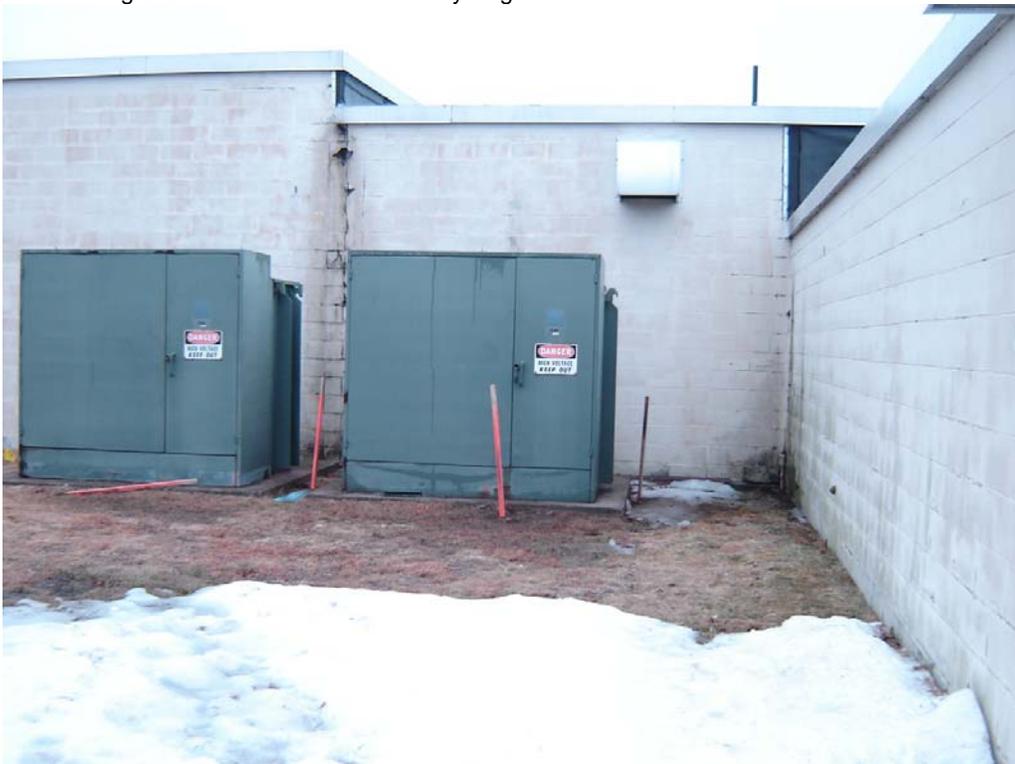
- One pad-mounted transformer location was observed on the north side of the building. No evidence of a past leak from these transformers was observed.

No. 4 Building 538 – NAS Brunswick
Building 538 – Building 295 pad-mounted transformer (left) adjacent to Building 538 transformer (right)

Due to the age of the building, soil sampling around the pad is recommended in order to confirm that the soil is free of PCBs from potential former transformers.

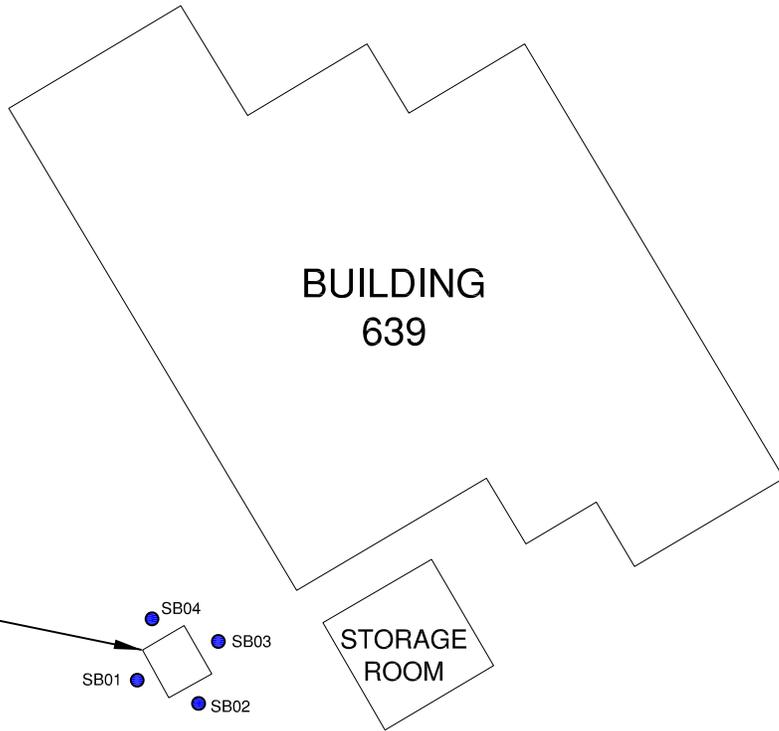
The suspected pad-mounted transformer location on the southwestern side of the building could potentially have been a historical source of PCB soil contamination in the event of a transformer leak. On February 24, 2010, Tetra Tech collected surface soil samples from four locations around the transformer pad at Building 639 as shown on Figure 3. A hand auger was used for the collection of four samples from 0 to 6 inches below ground surface (bgs) [NASB-B639-SB01-0006 through NASB-B639-SB04-0006] and four samples from 6 to 24 inches bgs (NASB-B639-SB01-0624 through NASB-B639-SB04-0624).

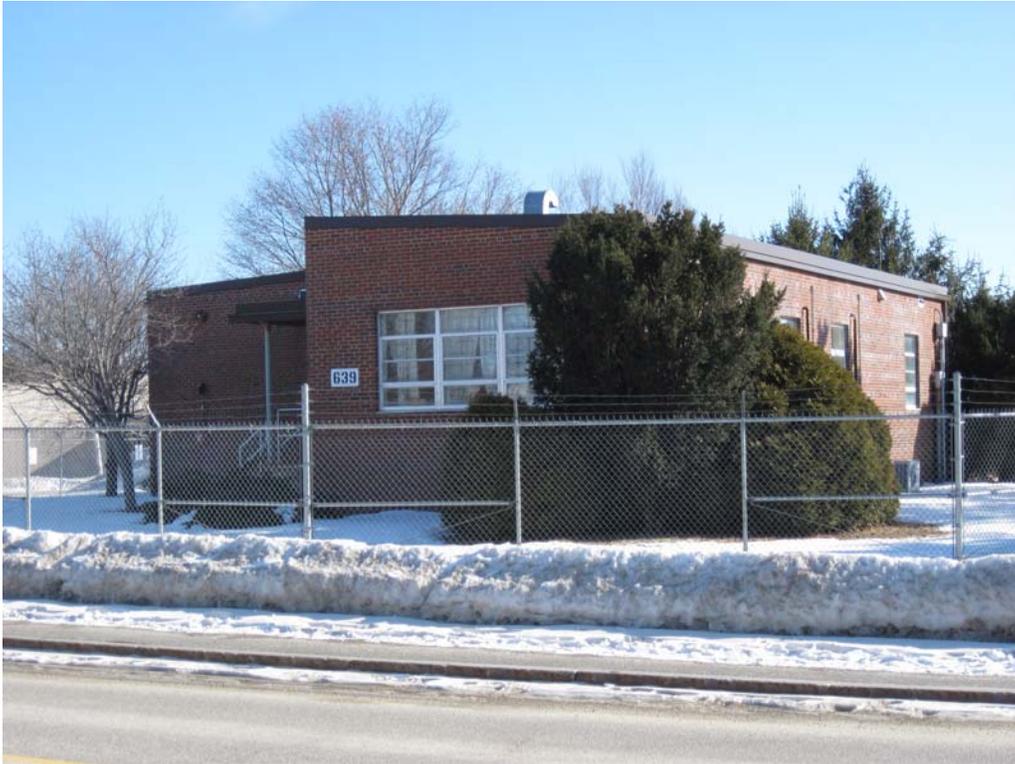
No. 1 Building 639 – NAS Brunswick February 2, 2010
Building 639 – NIOD Building exterior north elevation showing main entrance

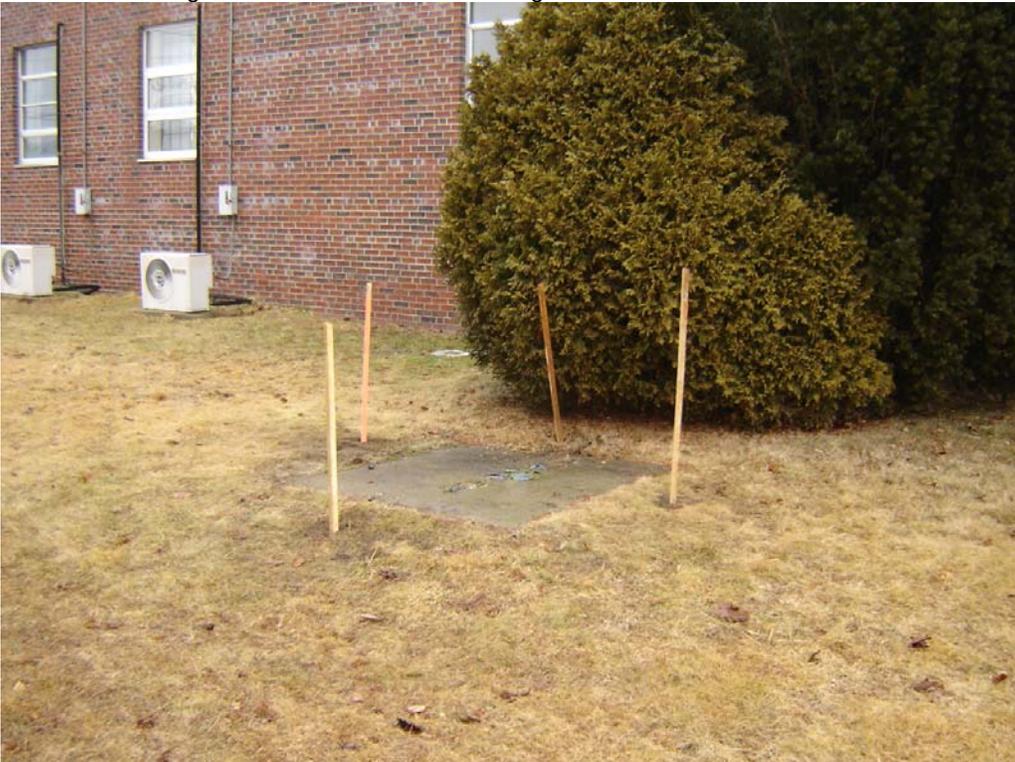
No. 2 Building 639 – NAS Brunswick February 2, 2010
Building 639 - NIOD Building exterior southwest elevation showing suspected former transformer pad and soil sample locations

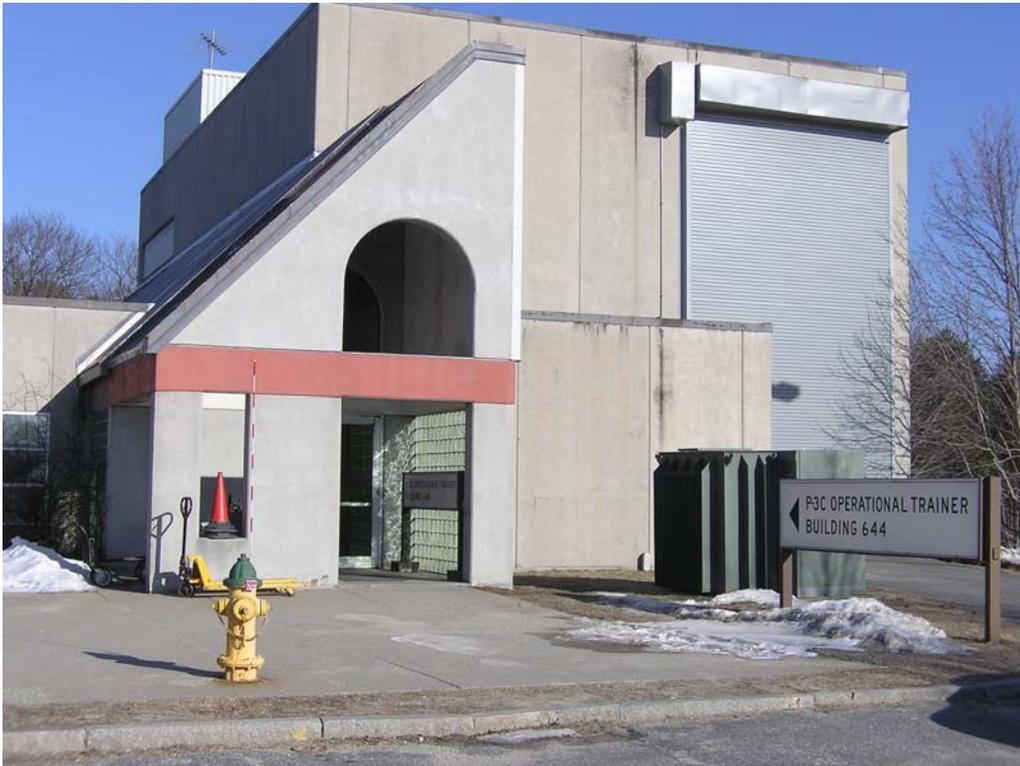
No. 1 Building 644 – NAS Brunswick February 2, 2010
Building 644 – P-3C Operational Trainer Building southwest elevation showing main entrance

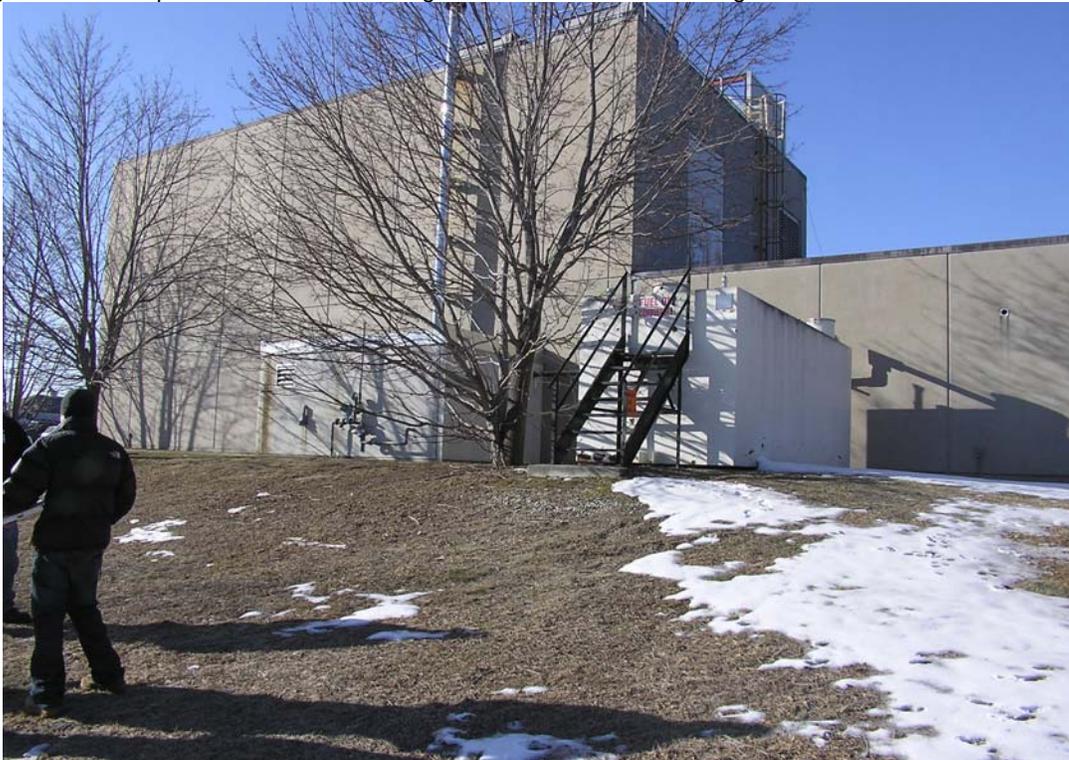
No. 2 Building 644 – NAS Brunswick February 2, 2010
Building 644 – P-3C Operational Trainer Building exterior southeast elevation

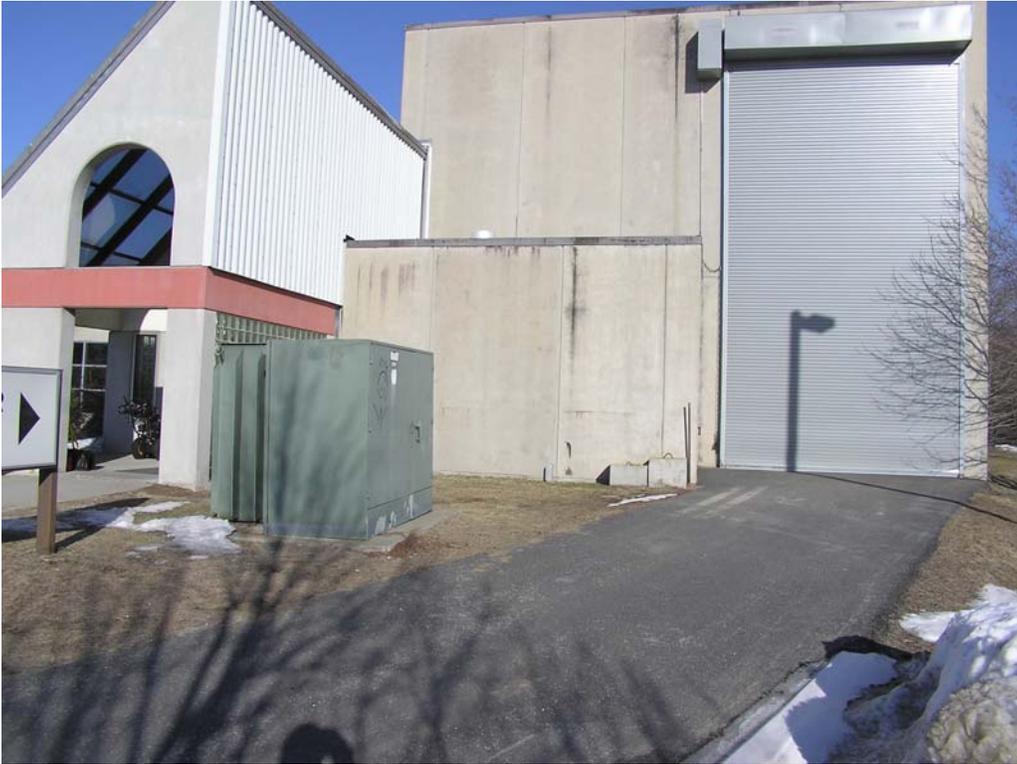
No. 3 Building 644 – NAS Brunswick February 2, 2010
Building 644 P-3C Operational Trainer Building pad-mounted transformer

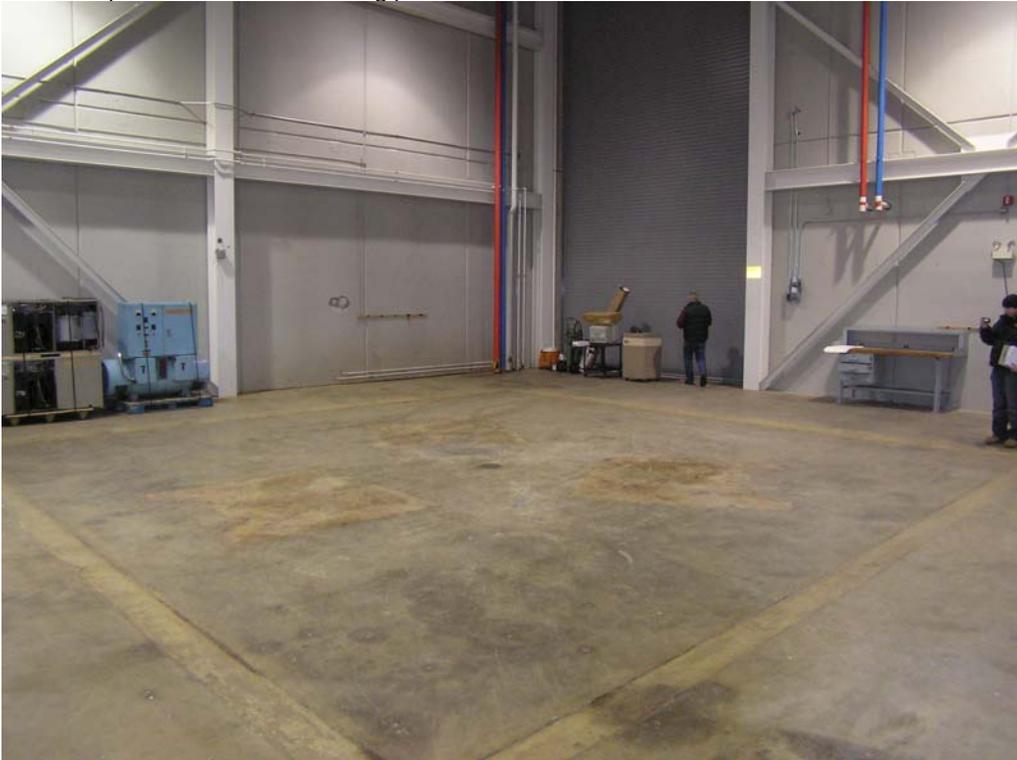
No. 4 Building 644 – NAS Brunswick February 2, 2010
Building 644 P-3C Operational Trainer Building simulator room (after simulator removal)

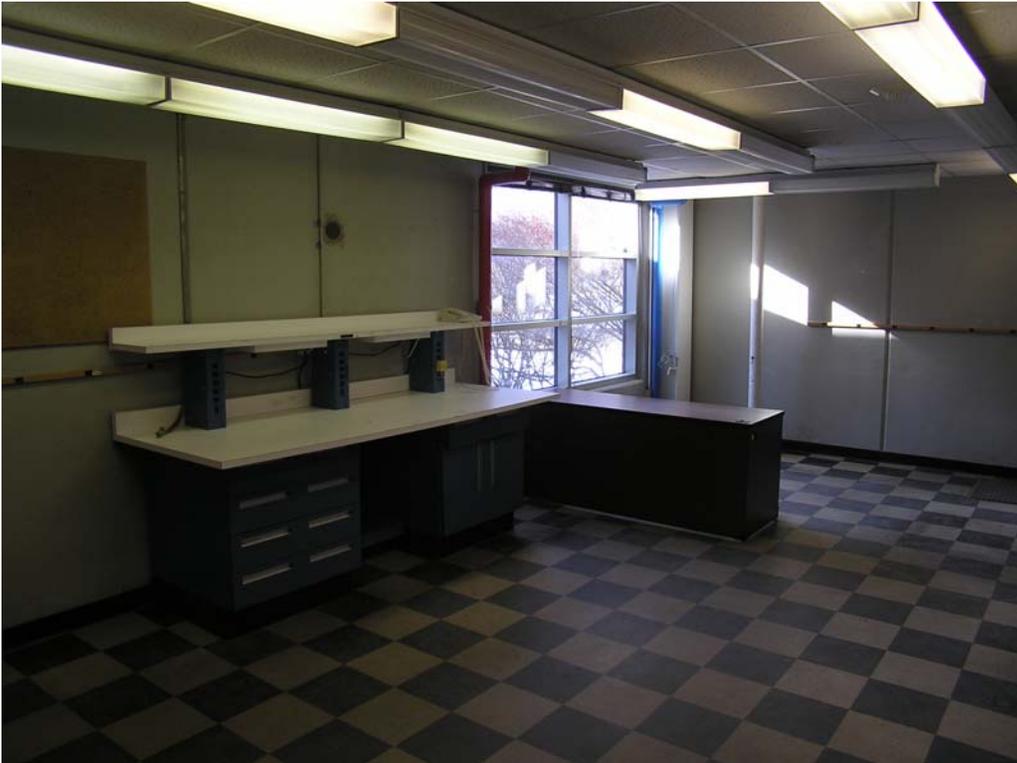
No. 5 Building 644 – NAS Brunswick February 2, 2010
Building 644 P-3C Operational Trainer Building Room 11 (electronics soldering station)

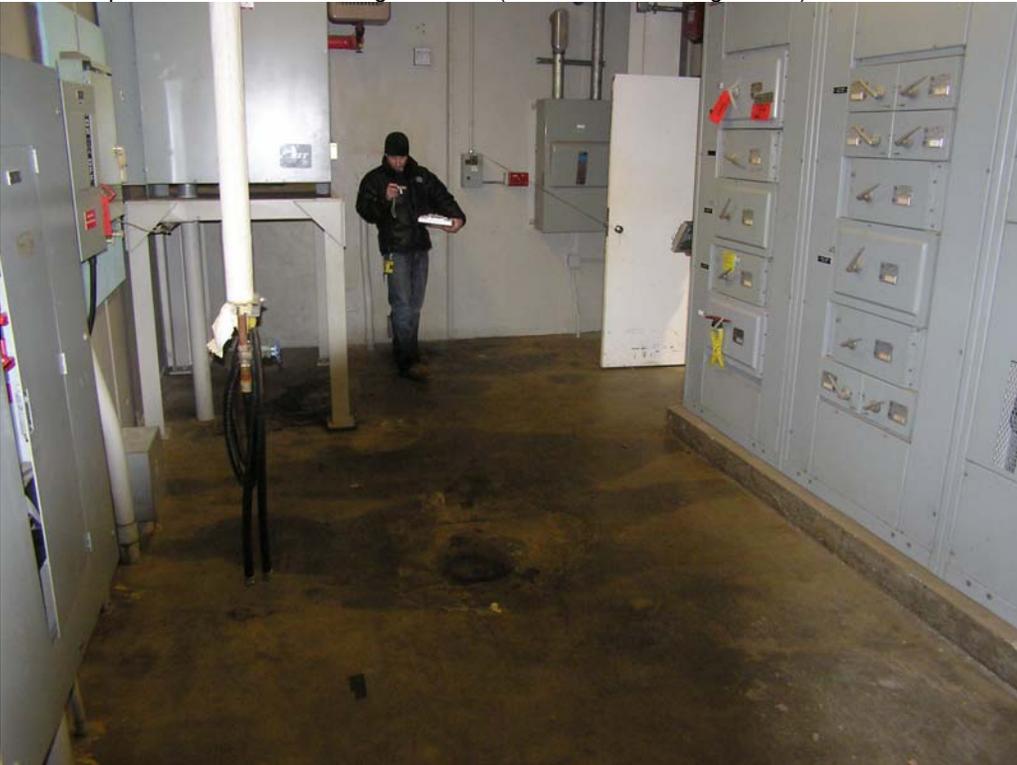
No. 6 Building 644 – NAS Brunswick February 2, 2010
Building 644 – P-3C Operational Trainer Building former flight trainer simulator hydraulics room

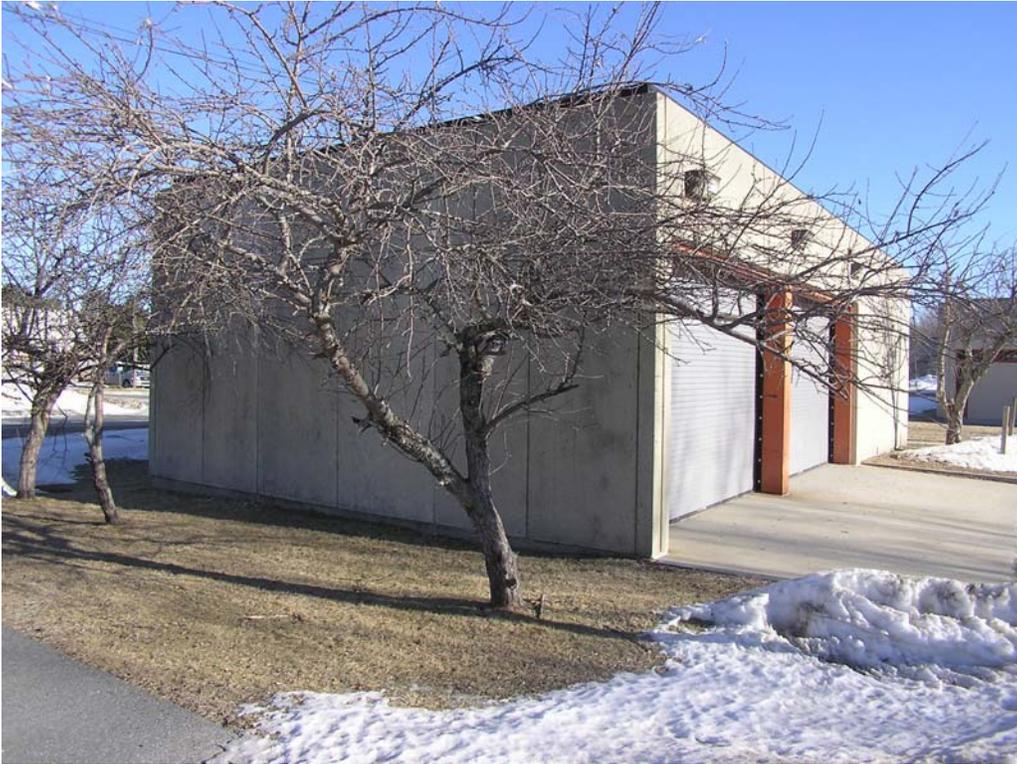
No. 1
Building 649 – NAS Brunswick
Building 649 – Ambulance garage exterior southwest elevation

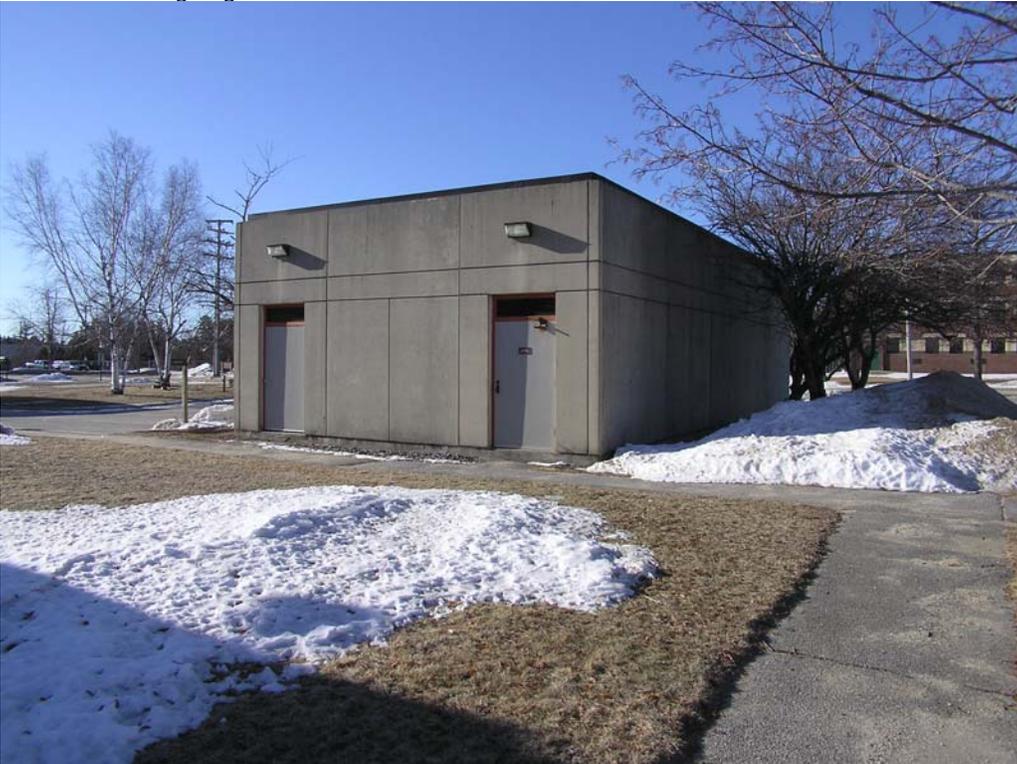
No. 2
Building 649 – NAS Brunswick
Building 649 – Ambulance garage exterior east elevation
