FINAL RESOURCE CONSERVATION AND RECOVERY ACT PARTIAL CLOSURE REPORT
FOR BUILDINGS 229, 601, 602 AND 603 WITH TRANSMITTAL LETTER NAS BRUNSWICK
ME
5/11/2010
NAS BRUNSWICK

RCRA PARTIAL CLOSURE REPORT
for
BUILDING 229 –GCA TURNTABLE
BUILDING 601 – ASOS TOWER
BUILDING 602 – GLIDE SLOPE ANTENNA BUILDING
BUILDING 603 – LOCALIZER ANTENNA SHELTER
NAVAL AIR STATION BRUNSWICK, MAINE
USEPA IDENTIFICATION NUMBER ME8170022018
MAY 2010

**BUILDING INSPECTION FORM
RCRA PARTIAL CLOSURE PROGRAM
NAS BRUNSWICK
BRUNSWICK, MAINE
CTO WE22**

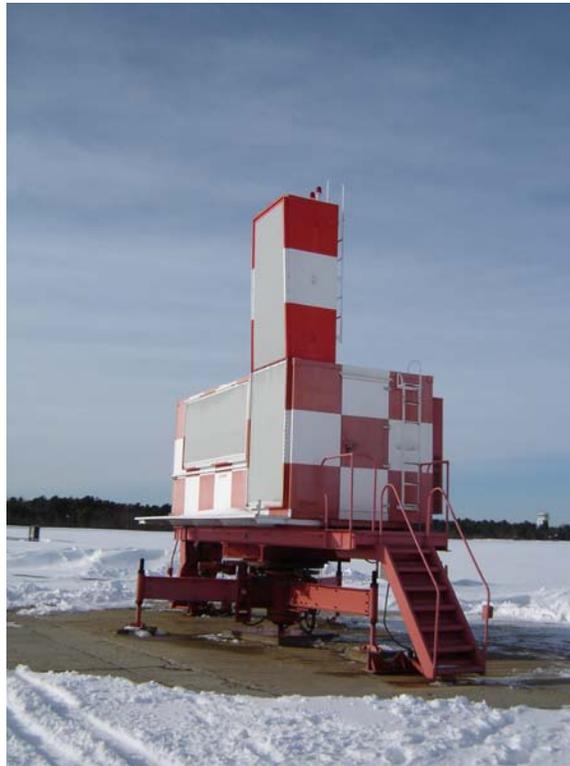
Building 229 appeared in good condition at the time of the site visit. The GCA turntable was removed prior to the 4/28/10 site visit.

No. 1 Building 229 – NAS Brunswick
Building 229 – GCA Turntable building on turntable stand

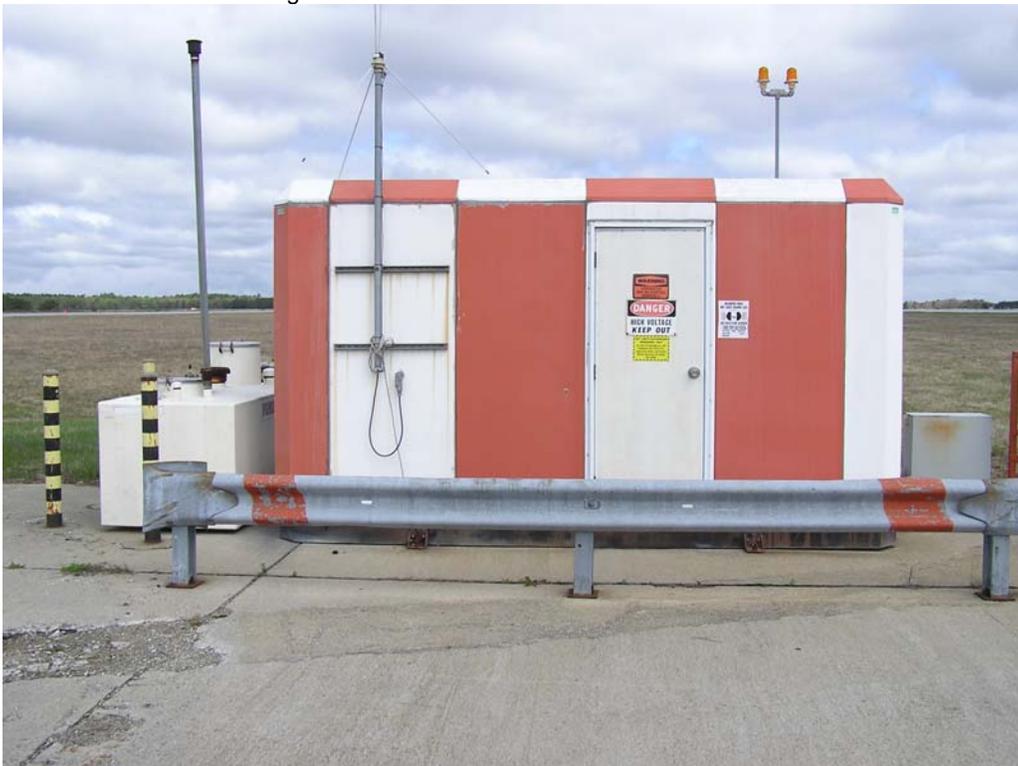
A strong petroleum odor was observed in the generator shed. No modifications to the structure, which may conceal signs of a past release, were observed. Bruce Smith (NASB) indicated that there was a diesel spill in 2007, but no documentation was available.

No. 2 Building 229 – NAS Brunswick
Building 229 – GCA Turntable emergency generator building and diesel-fuel AST

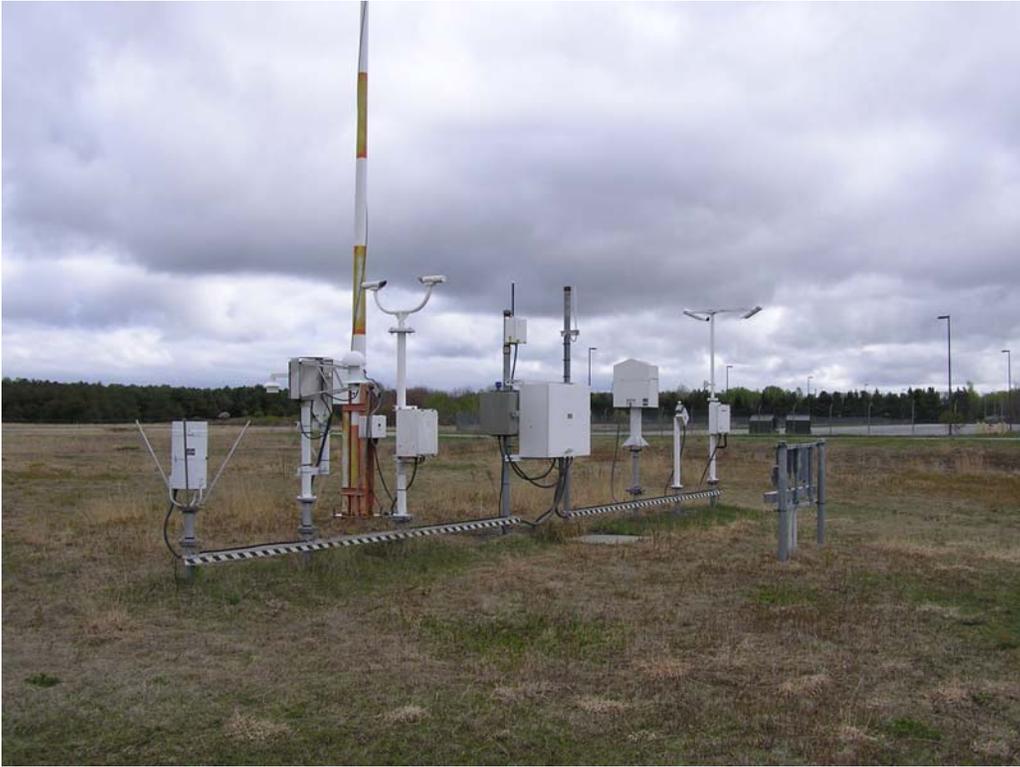
Building 601 appeared in good condition at the time of the site visit.
 No evidence of current or past hazardous waste generation activities was observed.
 No evidence of hazardous waste residues was observed.
 No signs of a past release (staining, unusual odors, stressed vegetation, etc.) were observed. No modifications to the structure, which may conceal signs of a past release, were observed.
 No hazardous waste storage areas or hazardous waste accumulation areas were observed.

No. 1 Building 601 – NAS Brunswick
Building 601 – Automated Surface Observing Station (ASOS) Tower

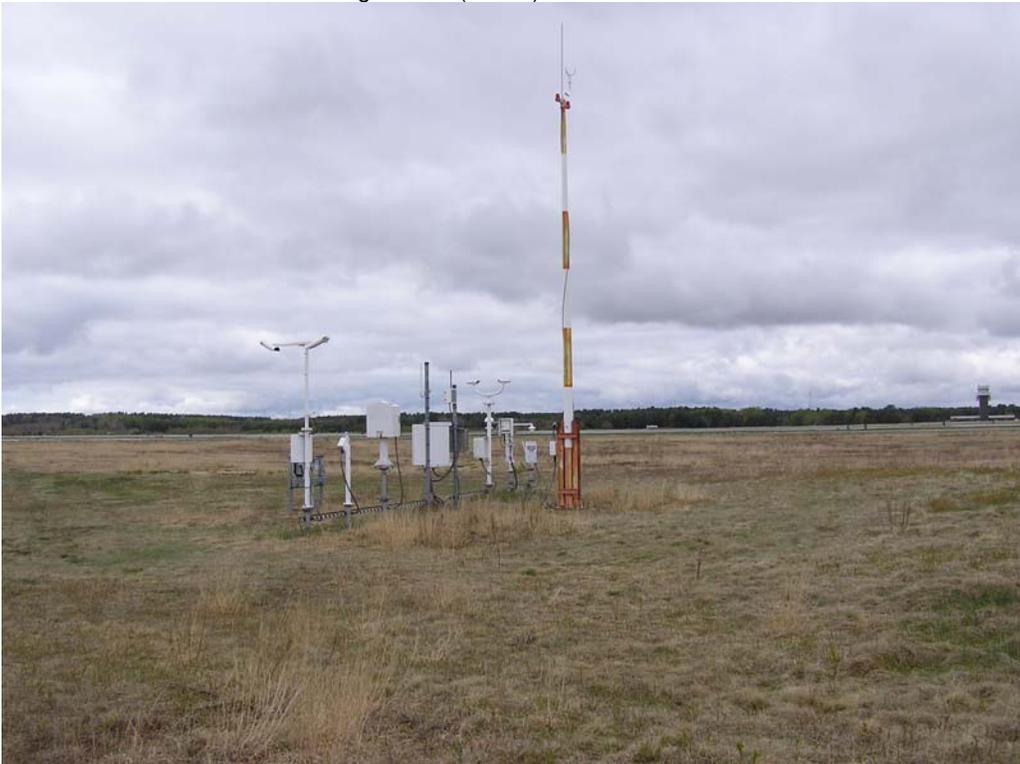
No. 2 Building 601 – NAS Brunswick
Building 601 – ASOS Tower

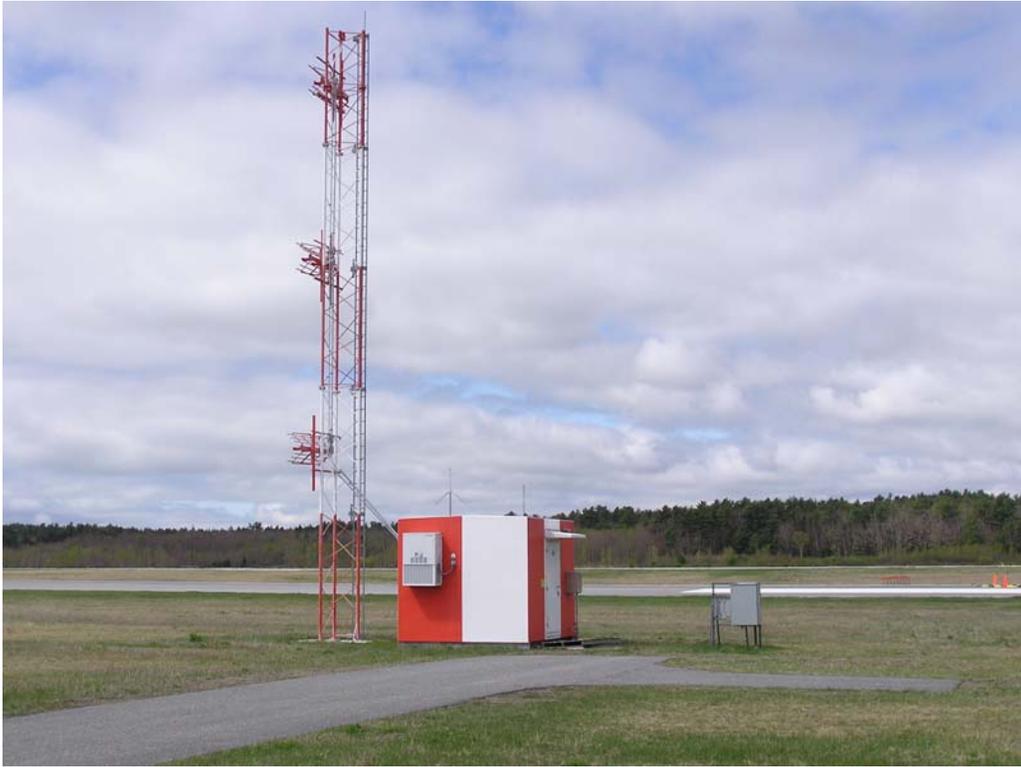
Building 602 appeared in excellent condition at the time of the site visit.
 No evidence of current or past hazardous waste generation activities was observed.
 No evidence of hazardous waste residues was observed.
 No signs of a past release (staining, unusual odors, stressed vegetation, etc.) were observed. No modifications to the structure, which may conceal signs of a past release, were observed.
 No hazardous waste storage areas or hazardous waste accumulation areas were observed.

No. 1 Building 602 – NAS Brunswick
Building 602 – Glide Slope Antenna Building (eastern elevation)

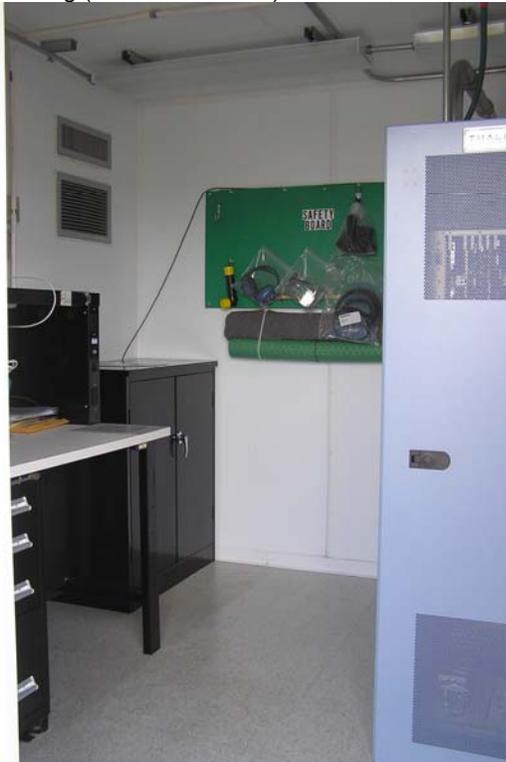
No. 2 Building 602 – NAS Brunswick
Building 602 – Glide Slope Antenna Building interior

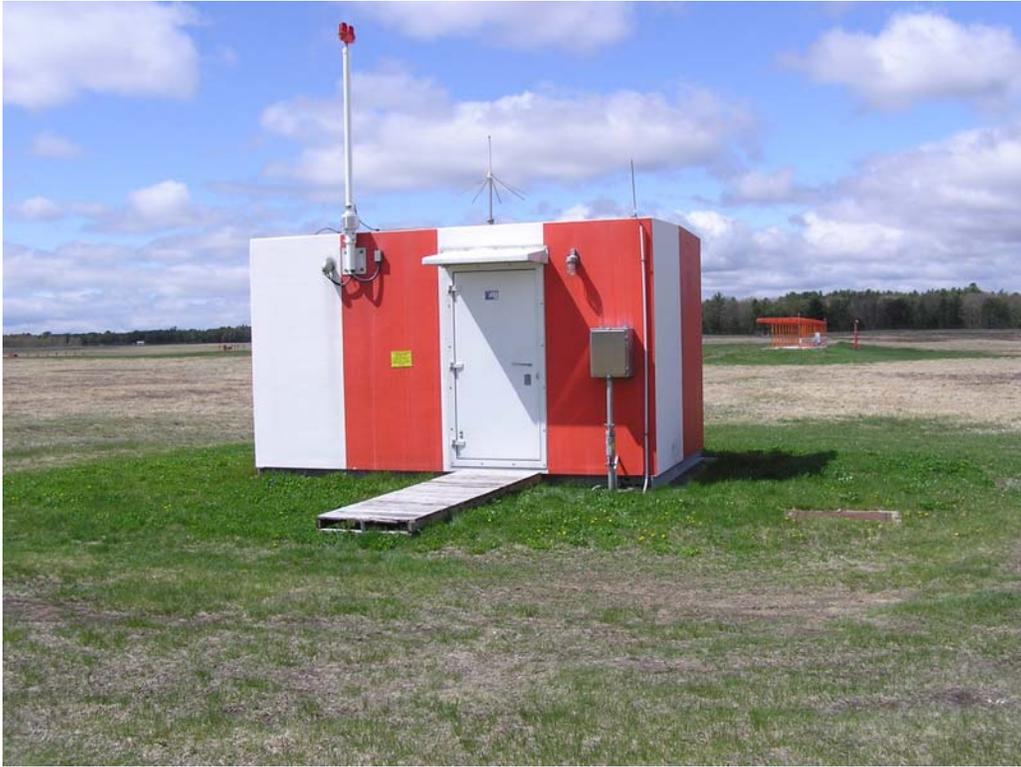
Building 603 appeared in excellent condition at the time of the site visit.

No signs of a past release (staining, unusual odors, stressed vegetation, etc.) were observed. No modifications to the structure, which may conceal signs of a past release, were observed.

No. 1 Building 603 – NAS Brunswick April 28, 2010
Building 603 – Localizer Antenna Shelter (eastern elevation) with localizer antenna array in background

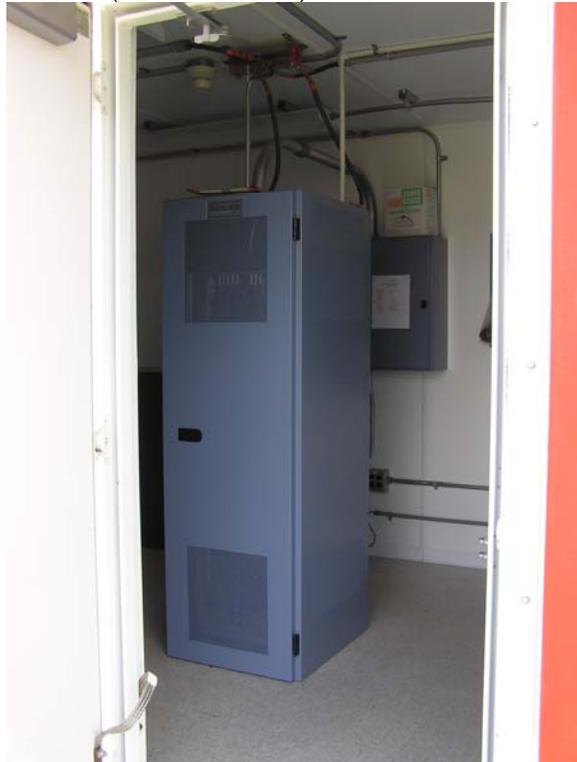
No. 2 Building 603 – NAS Brunswick April 28, 2010
Building 603 – Localizer Antenna Shelter interior
