FINAL RESOURCE CONSERVATION AND RECOVERY ACT PARTIAL CLOSURE REPORT  
FOR BUILDING 226 WITH TRANSMITTAL LETTER NAS BRUNSWICK ME  
6/29/2010  
NAS BRUNSWICK

Subj: Final RCRA Partial Closure Report for Building 226

**RCRA PARTIAL CLOSURE REPORT**  
for  
**BUILDING 226 – SEA CADETS PARCEL**  
**NAVAL AIR STATION BRUNSWICK, MAINE**  
**USEPA IDENTIFICATION NUMBER ME8170022018**  
**JUNE 2010**

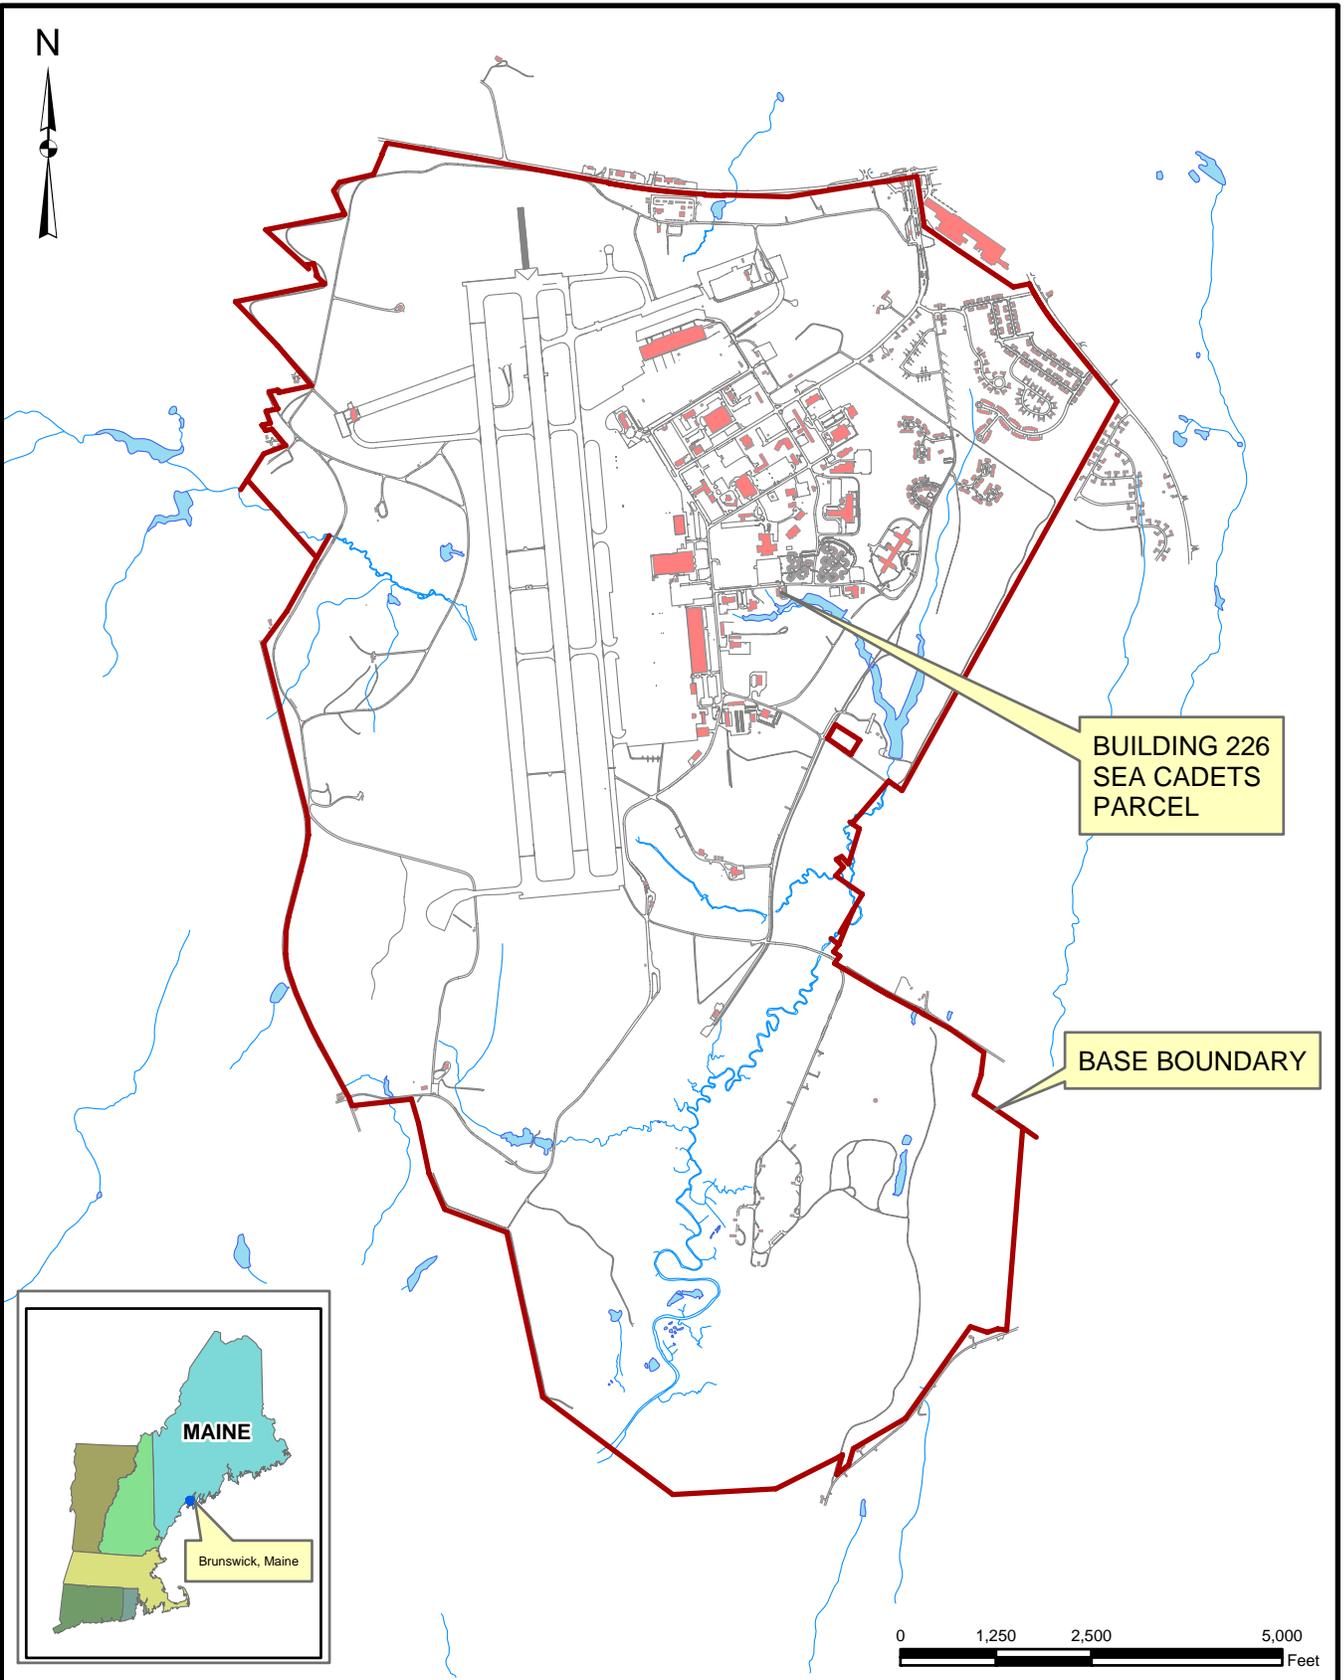
SCALE AS NOTED	
FILE I:\NASB_BLDG_226_LOCUS.MXD	
REV 0	DATE 06/11/10
FIGURE NUMBER 1

The Building 226 parcel is located in the central portion of NAS Brunswick (Figure 1). The parcel also contains Building 221 (Thrift Shop), which has been addressed in a separate RCRA Partial Closure Report, as discussed below in Section 3.

SITE LOCATION MAP  
 BUILDING 226 - SEA CADETS PARCEL  
 RCRA PARTIAL CLOSURE REPORT  
 NAVAL AIR STATION BRUNSWICK, MAINE

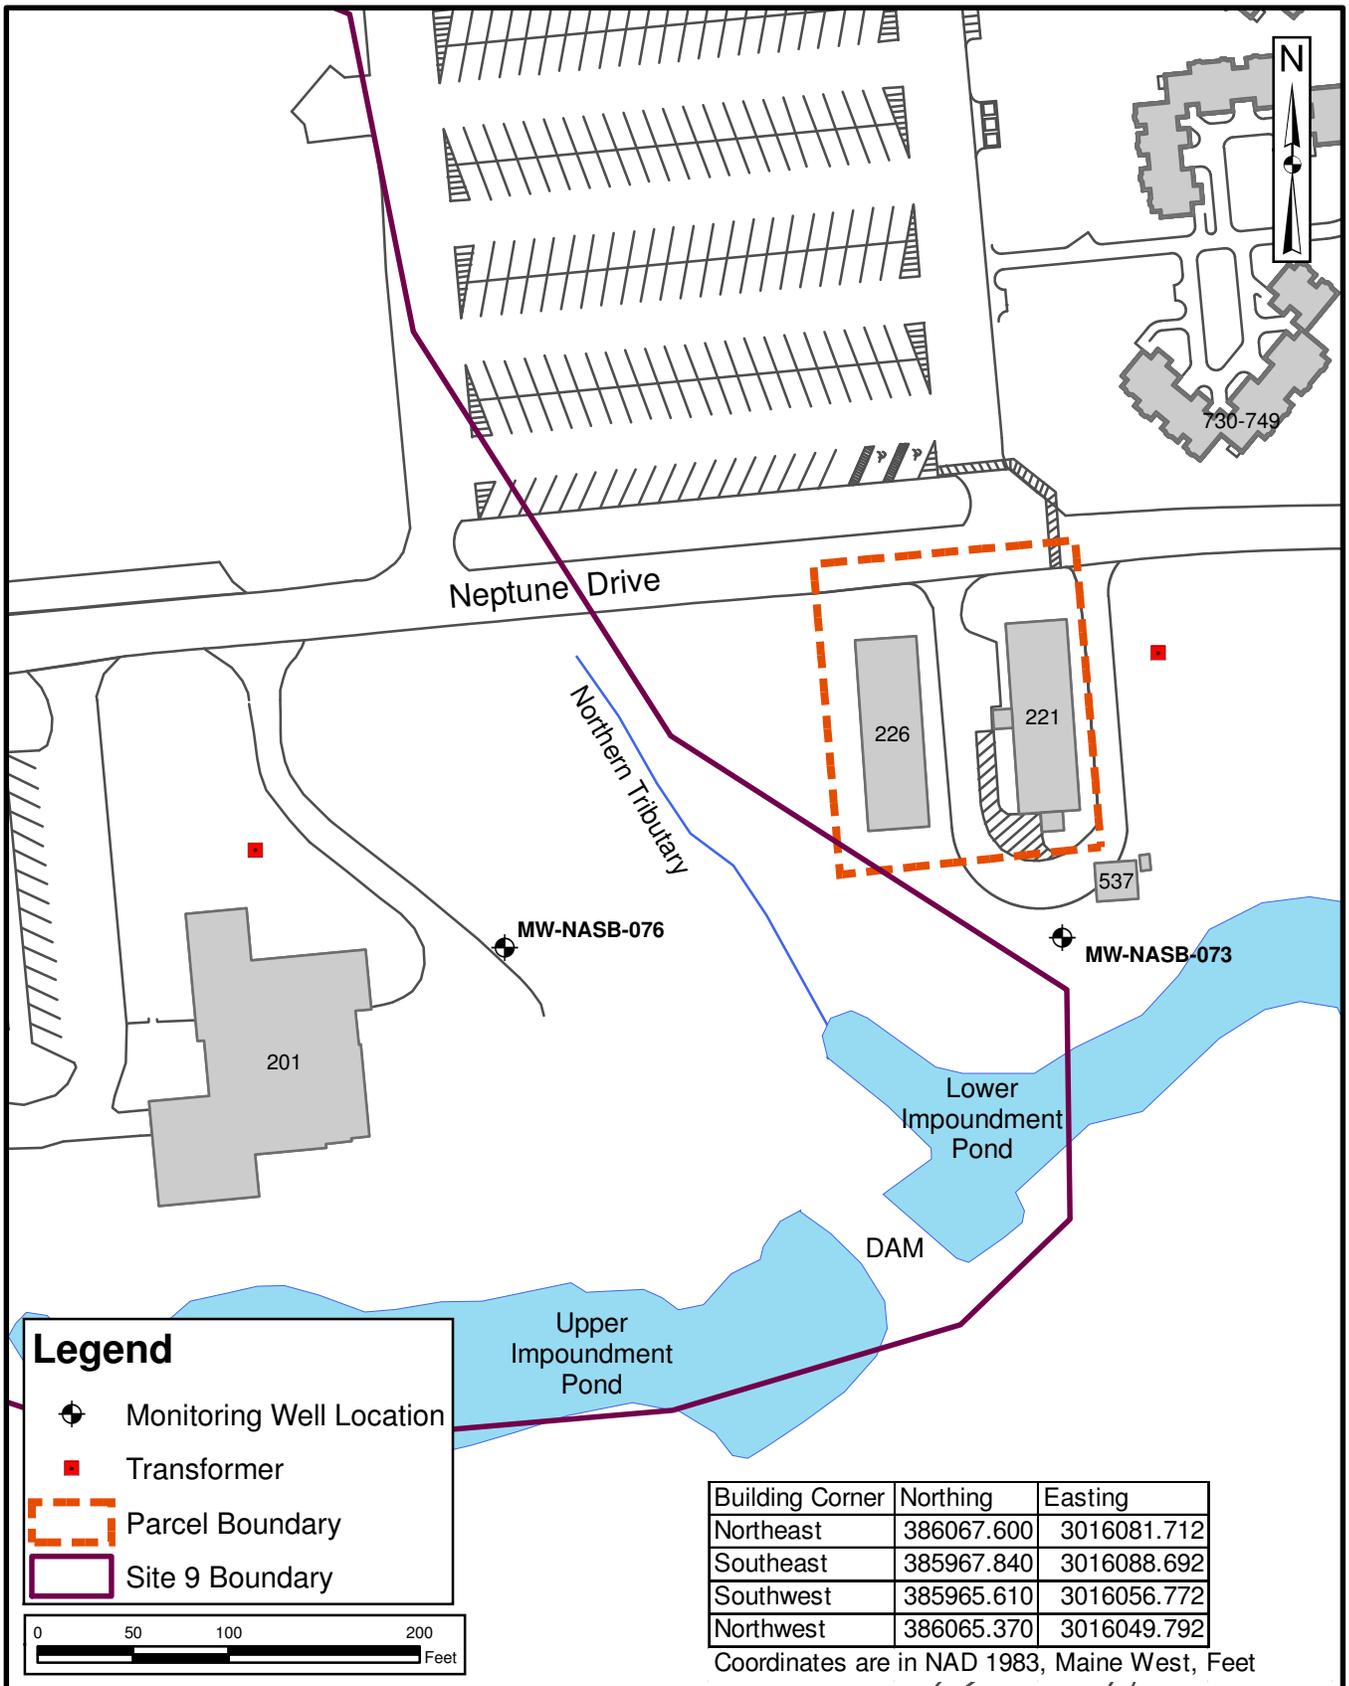
SCALE AS NOTED	
FILE	
I:\CP_DRNASB_BLDG_226_SITE_MAP.MXD	
REV	DATE
0	06/18/10
FIGURE NUMBER	
FIGURE NO. 2

Investigations have been conducted in the vicinity of the Building 226 parcel at Site 9 (Neptune Drive Disposal Site) and Building 201 (Galley/Neptune Hall) located to the northwest and west of the Building 226 parcel, respectively (Figure 2). Two test pits were excavated in 1988 to assess whether landfill materials or other evidence of dumping could be located adjacent to Building 293 (the former theatre). Test pit TP-902 was excavated north of the former Building 293 (between and north of the current Buildings 221 and 226). Test pit TP-901 was excavated approximately 30 feet west of Building 226. No evidence of landfill materials or other dumping was observed in the test pits, although a small quantity of refuse was reportedly identified in 1988 in the embankment south of Building 293 (EC Jordan, 1990). Several inorganics were detected in the soil sample collected from TP-902 (located on the Building 226 parcel); however, the detections were deemed consistent with background levels (EC Jordan, 1990).

This investigation of the hazardous waste closure requirement applies to the Building 226 parcel (as shown on Figure 2) only.

SITE LOCATION MAP  
 BUILDING 226 - SEA CADETS PARCEL  
 RCRA PARTIAL CLOSURE REPORT  
 NAVAL AIR STATION BRUNSWICK, MAINE

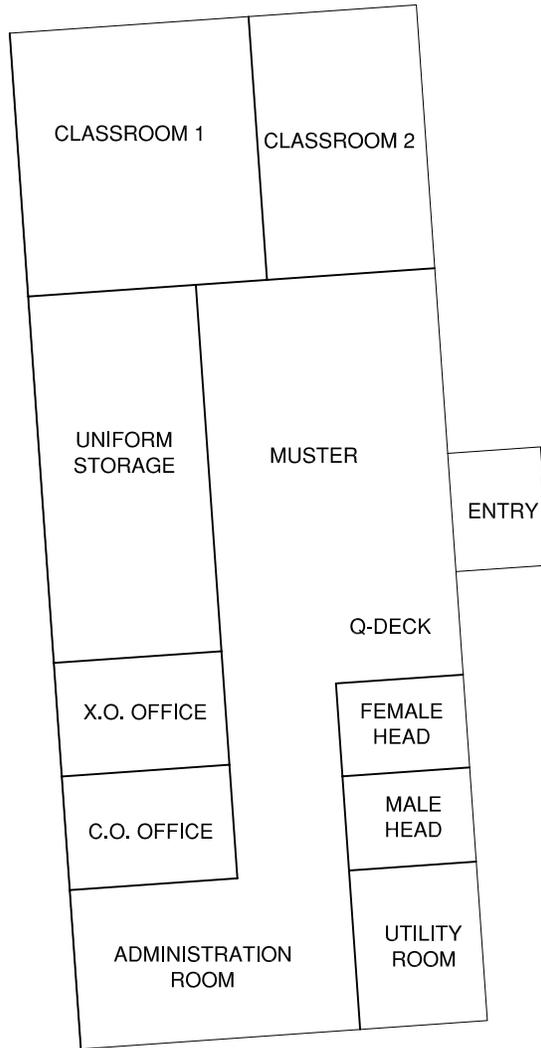
FIGURE NUMBER  
 3

- At the time of inspection, Building 226 was vacant and in good condition.
- The interior consisted of seven main rooms for offices, classrooms, and uniform storage (Figure 3). A mechanical room, containing a hot-water boiler, and a restroom were also present.
- No evidence of current or past hazardous waste generation was observed.
- No evidence of hazardous waste residues was observed.
- No signs of a past release (staining, unusual odors, stressed vegetation, etc.) were observed and no structural modifications, which could conceal signs of a past release, were observed.
- No hazardous waste storage areas or hazardous waste accumulation areas were observed.

FLOOR PLAN  
 BUILDING 226 - SEA CADETS PARCEL  
 RCRA PARTIAL CLOSURE REPORT  
 NAVAL AIR STATION BRUNSWICK, MAINE

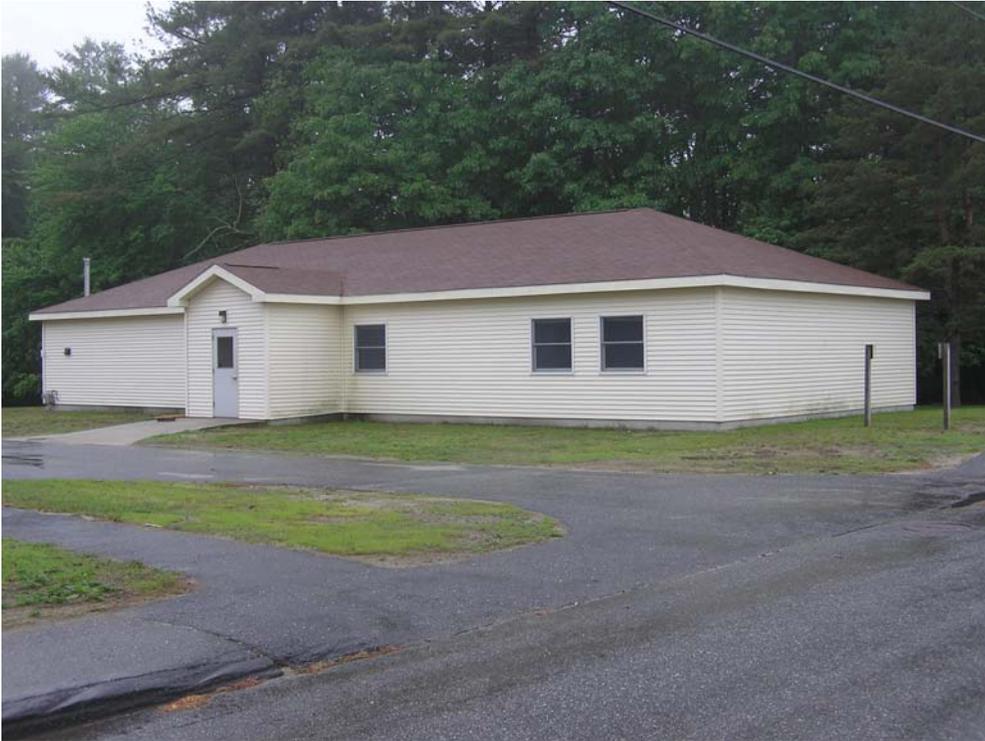
No. 1 Building 226 – NAS Brunswick June 3, 2010  
Sea Cadet Building exterior northeast elevation showing main entrance from Neptune Drive

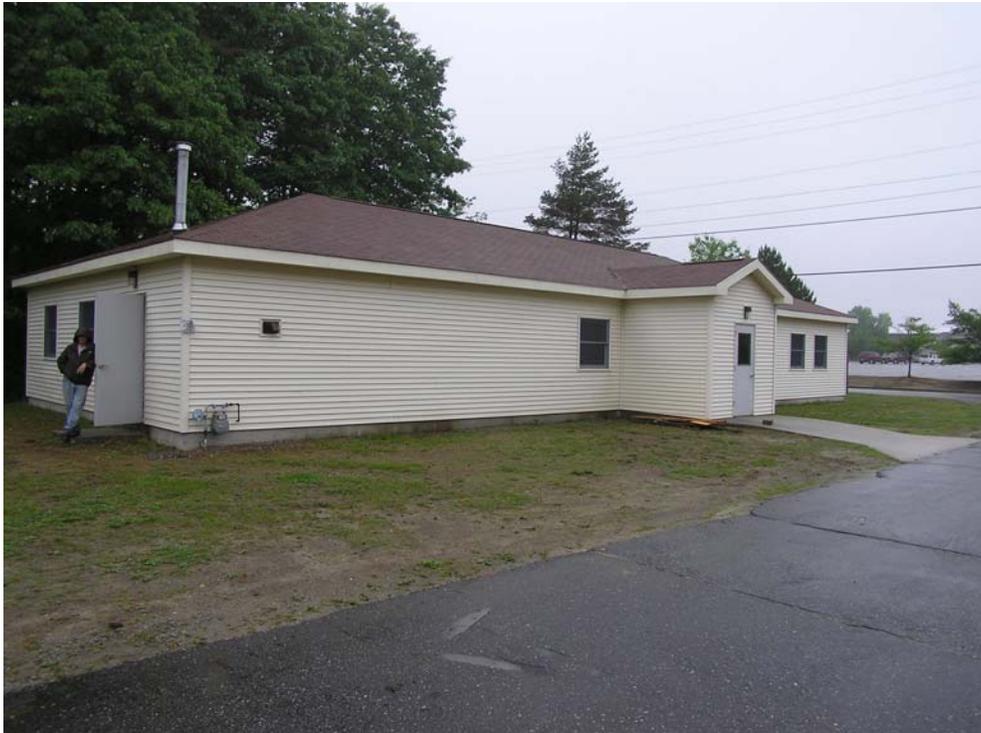
No. 2 Building 226 – NAS Brunswick June 3, 2010  
Sea Cadet Building exterior southeast elevation looking toward Neptune Drive

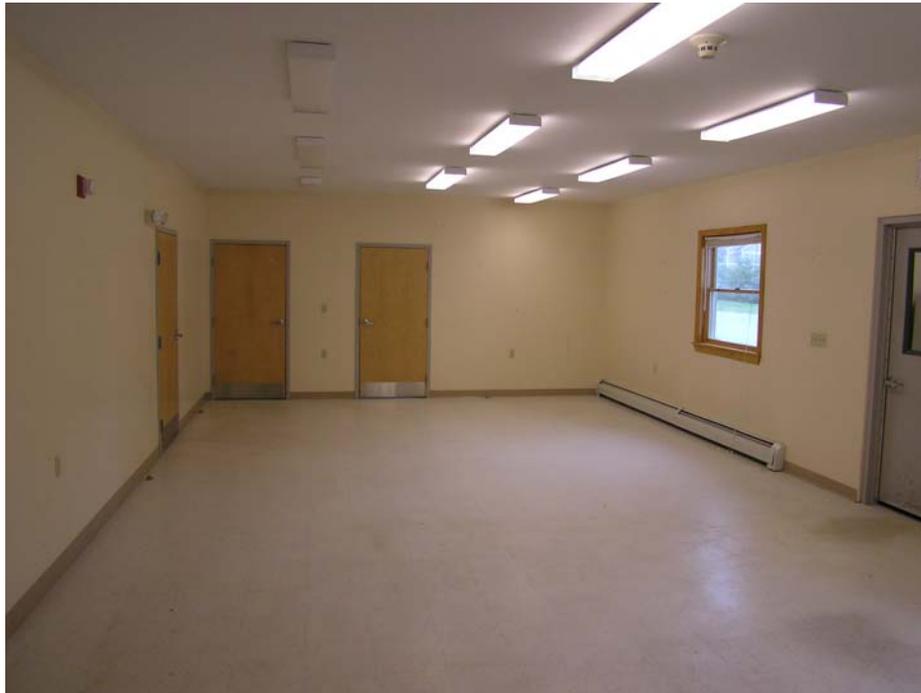
No. 3 Building 226 – NAS Brunswick  
Sea Cadet Building interior muster room

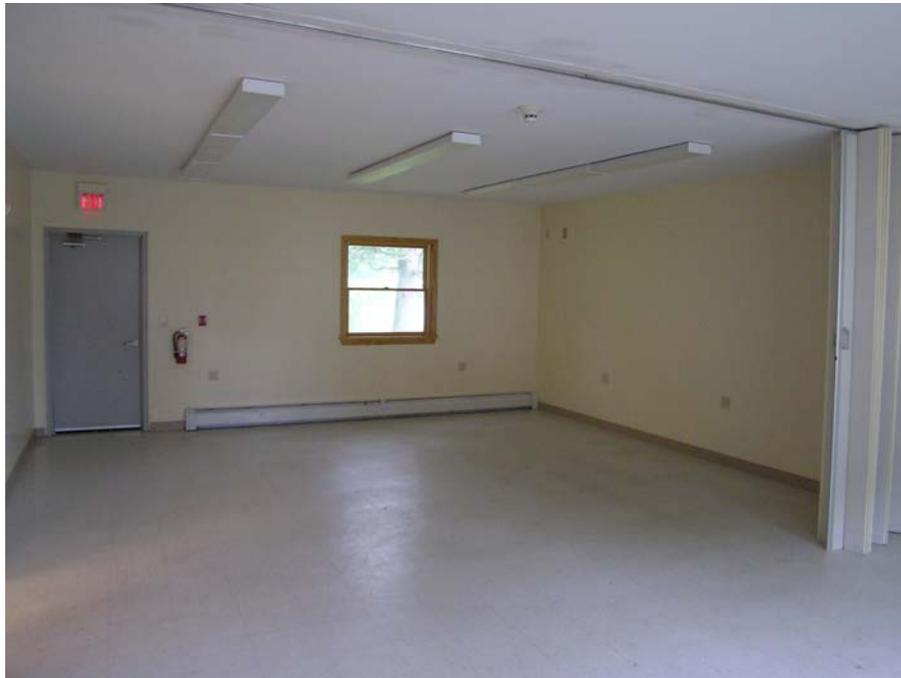
No. 4 Building 226 – NAS Brunswick  
Sea Cadet Building interior classrooms
