FINAL RESOURCE CONSERVATION AND RECOVERY ACT PARTIAL CLOSURE REPORT  
FOR BUILDING 87 WITH TRANSMITTAL LETTER NAS BRUNSWICK ME  
7/30/2010  
NAS BRUNSWICK

Subj: Final RCRA Partial Closure Report for Building 87

**RCRA PARTIAL CLOSURE REPORT  
FOR  
BUILDING 87 – ANTI-SUBMARINE WARFARE OPERATIONS CENTER [ASWOC] PARCEL  
NAVAL AIR STATION BRUNSWICK, MAINE  
USEPA IDENTIFICATION NUMBER ME8170022018  
JULY 2010**

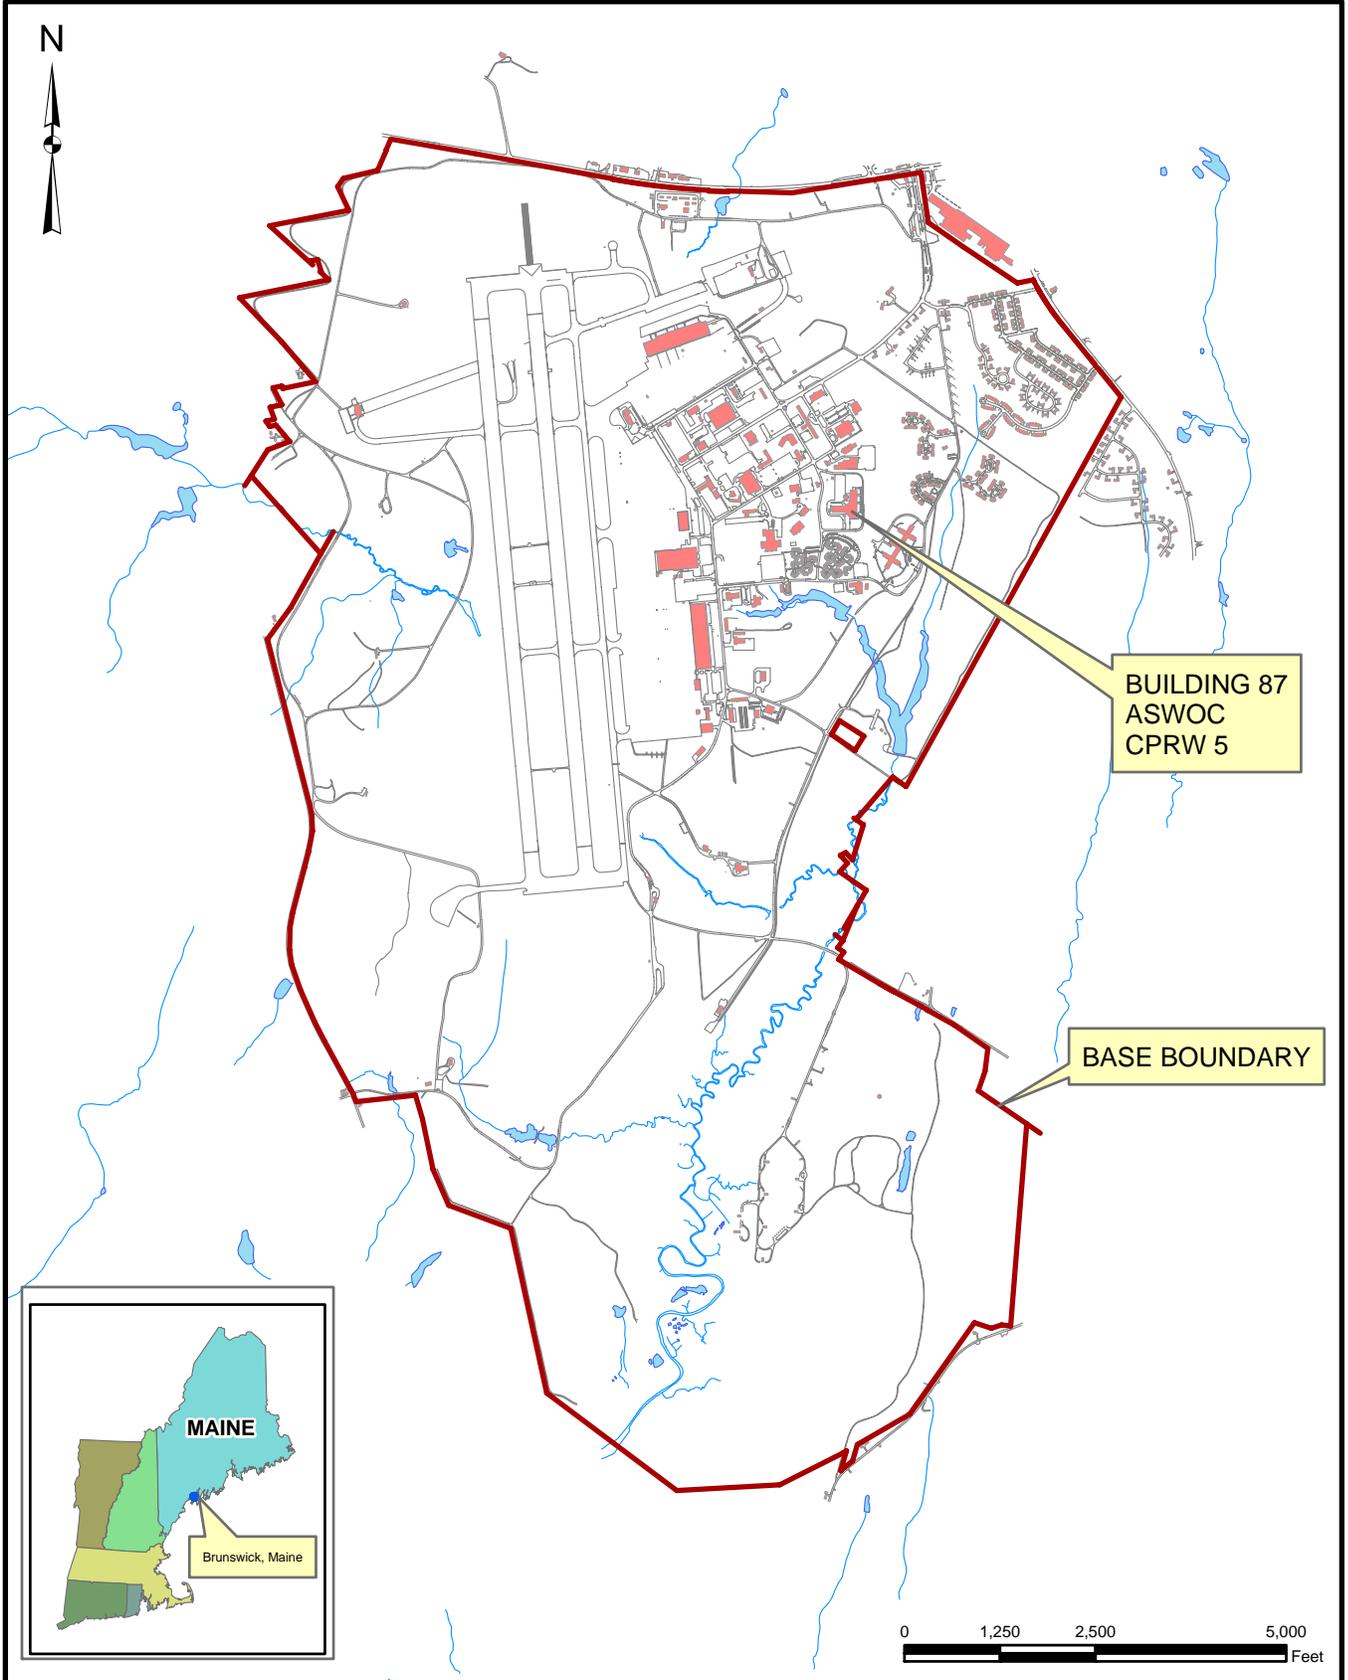
SCALE AS NOTED	
FILE I:\NASB_BLDG_87_LOCUS.MXD	
REV 0	DATE 06/22/10
FIGURE NUMBER 1

The Building 87 parcel is located inside the Command Patrol and Reconnaissance Wing Five (CPRW-5) compound in the north-central portion of NAS Brunswick (Figure 1).

SITE LOCATION MAP  
 BUILDING 87 - ASWOC CPRW 5  
 RCRA PARTIAL CLOSURE REPORT  
 NAVAL AIR STATION BRUNSWICK, MAINE

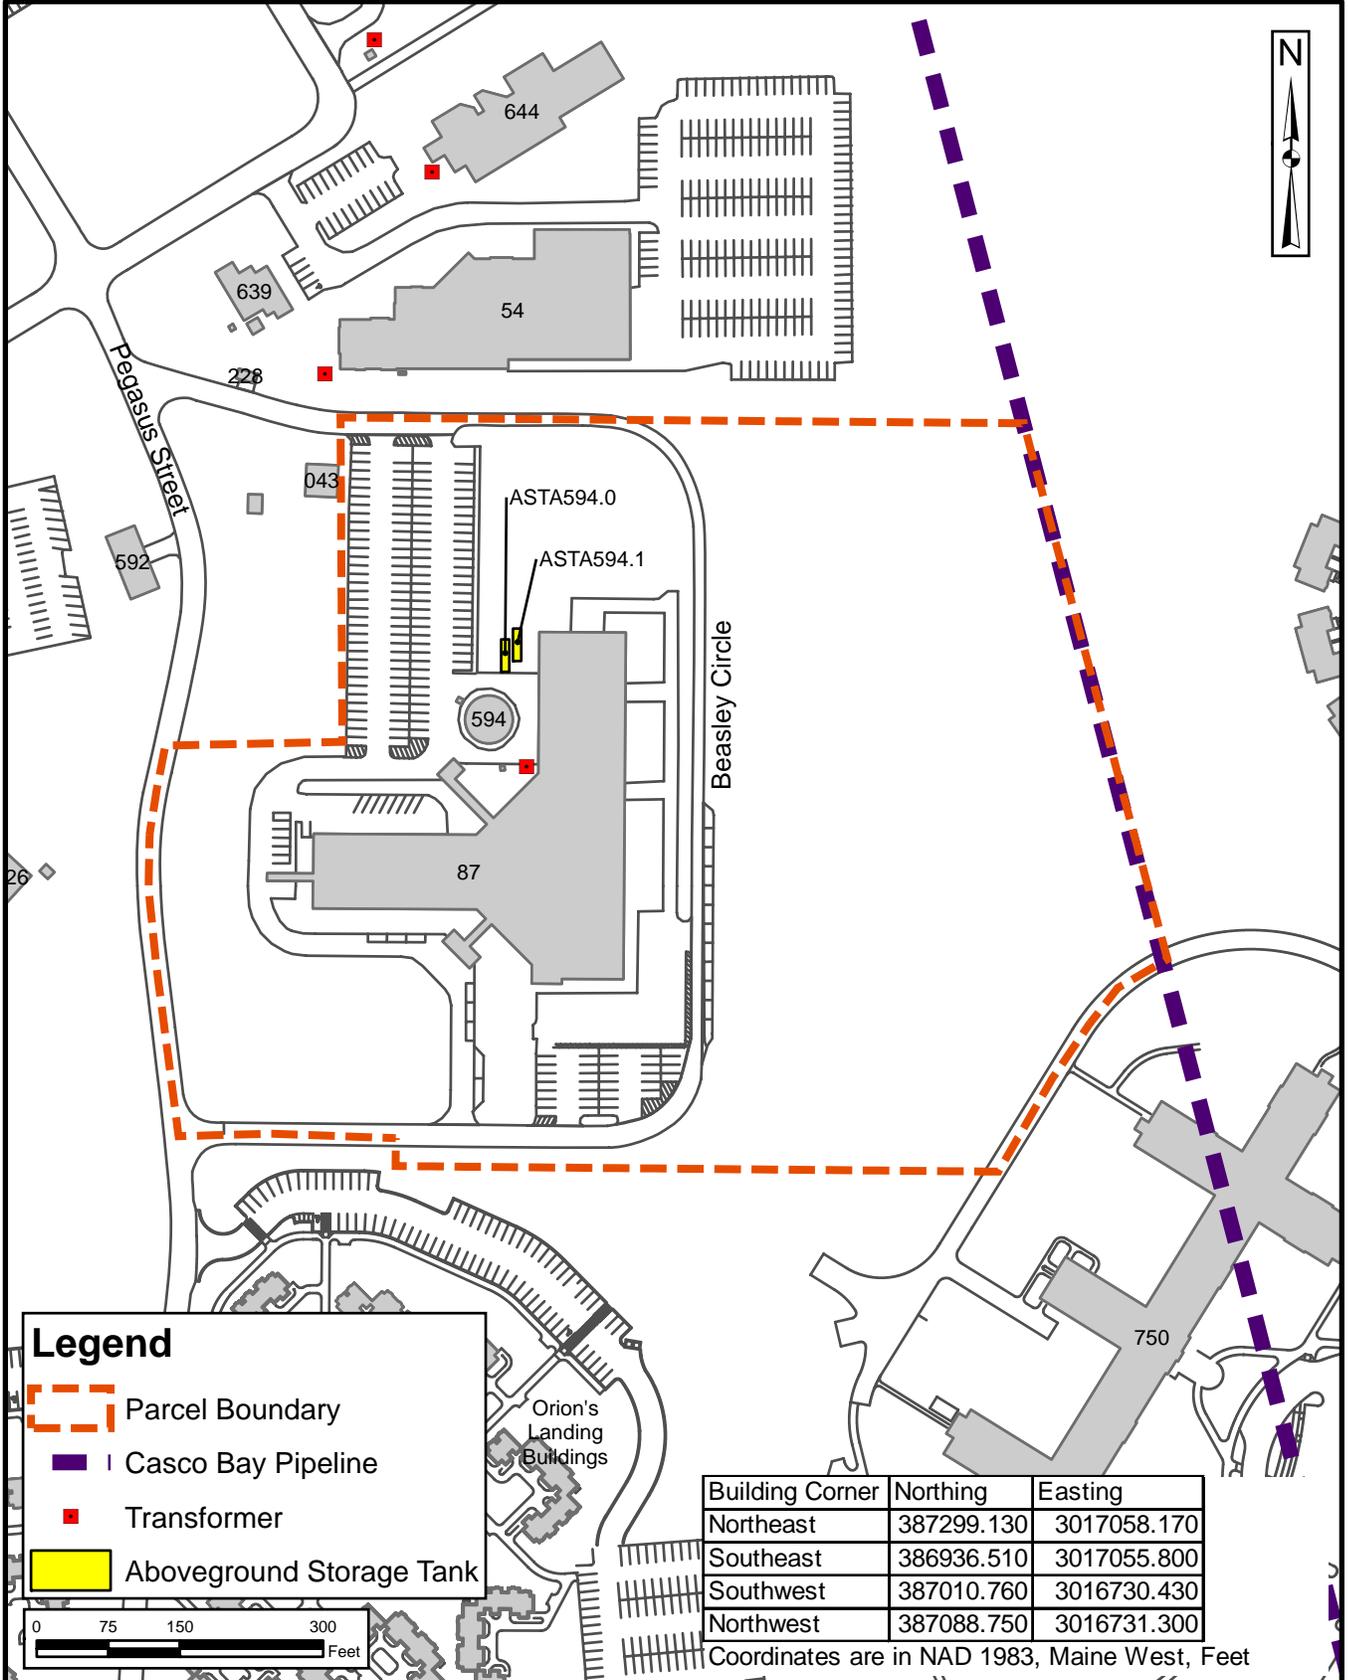
SCALE AS NOTED	
FILE	
VCP_DR\NASB_BLDG_87_SITE_MAP.MXD	
REV	DATE
0	07/12/10
FIGURE NUMBER	
FIGURE NO. 2

The parcel is approximately 15.8 acres in size. To the north, the parcel is bordered by Beasley Circle and the Building 54 (Applied Instrument Building) parcel. The Casco Bay Pipeline (described below in Section 3) and Building 750 (Transient Visitors Quarters) form the parcel border to the east and southeast, respectively. Beasley Circle and the Orion's Landing barracks (Buildings 730 through 749) border the parcel to the south. To the west are Building 43 (Telephone Exchange) and Pegasus Street, with Buildings 26 (Child Care Center) and 592 (Vet Clinic) across Pegasus Street (Figure 2).

Currently there are two ASTs located to the north of Building 594 (see Figure 2). These include a closed 4,000-gallon, double-walled No. 1 fuel oil AST (A594.1) that replaced UST 10045-490 in July 1999. This AST was closed on April 4, 2008. The second AST is a 4,000 gallon diesel unit (A594.0) installed adjacent to AST 594.1 in 1996. It provides diesel fuel to the generators in the boiler room on the first floor of Building 594. (PWD, 2010 and Environmental Department, 2009).

**SITE LOCATION MAP**  
**BUILDING 87 - ASWOC PARCEL**  
**RCRA PARTIAL CLOSURE REPORT**  
**NAVAL AIR STATION BRUNSWICK, MAINE**

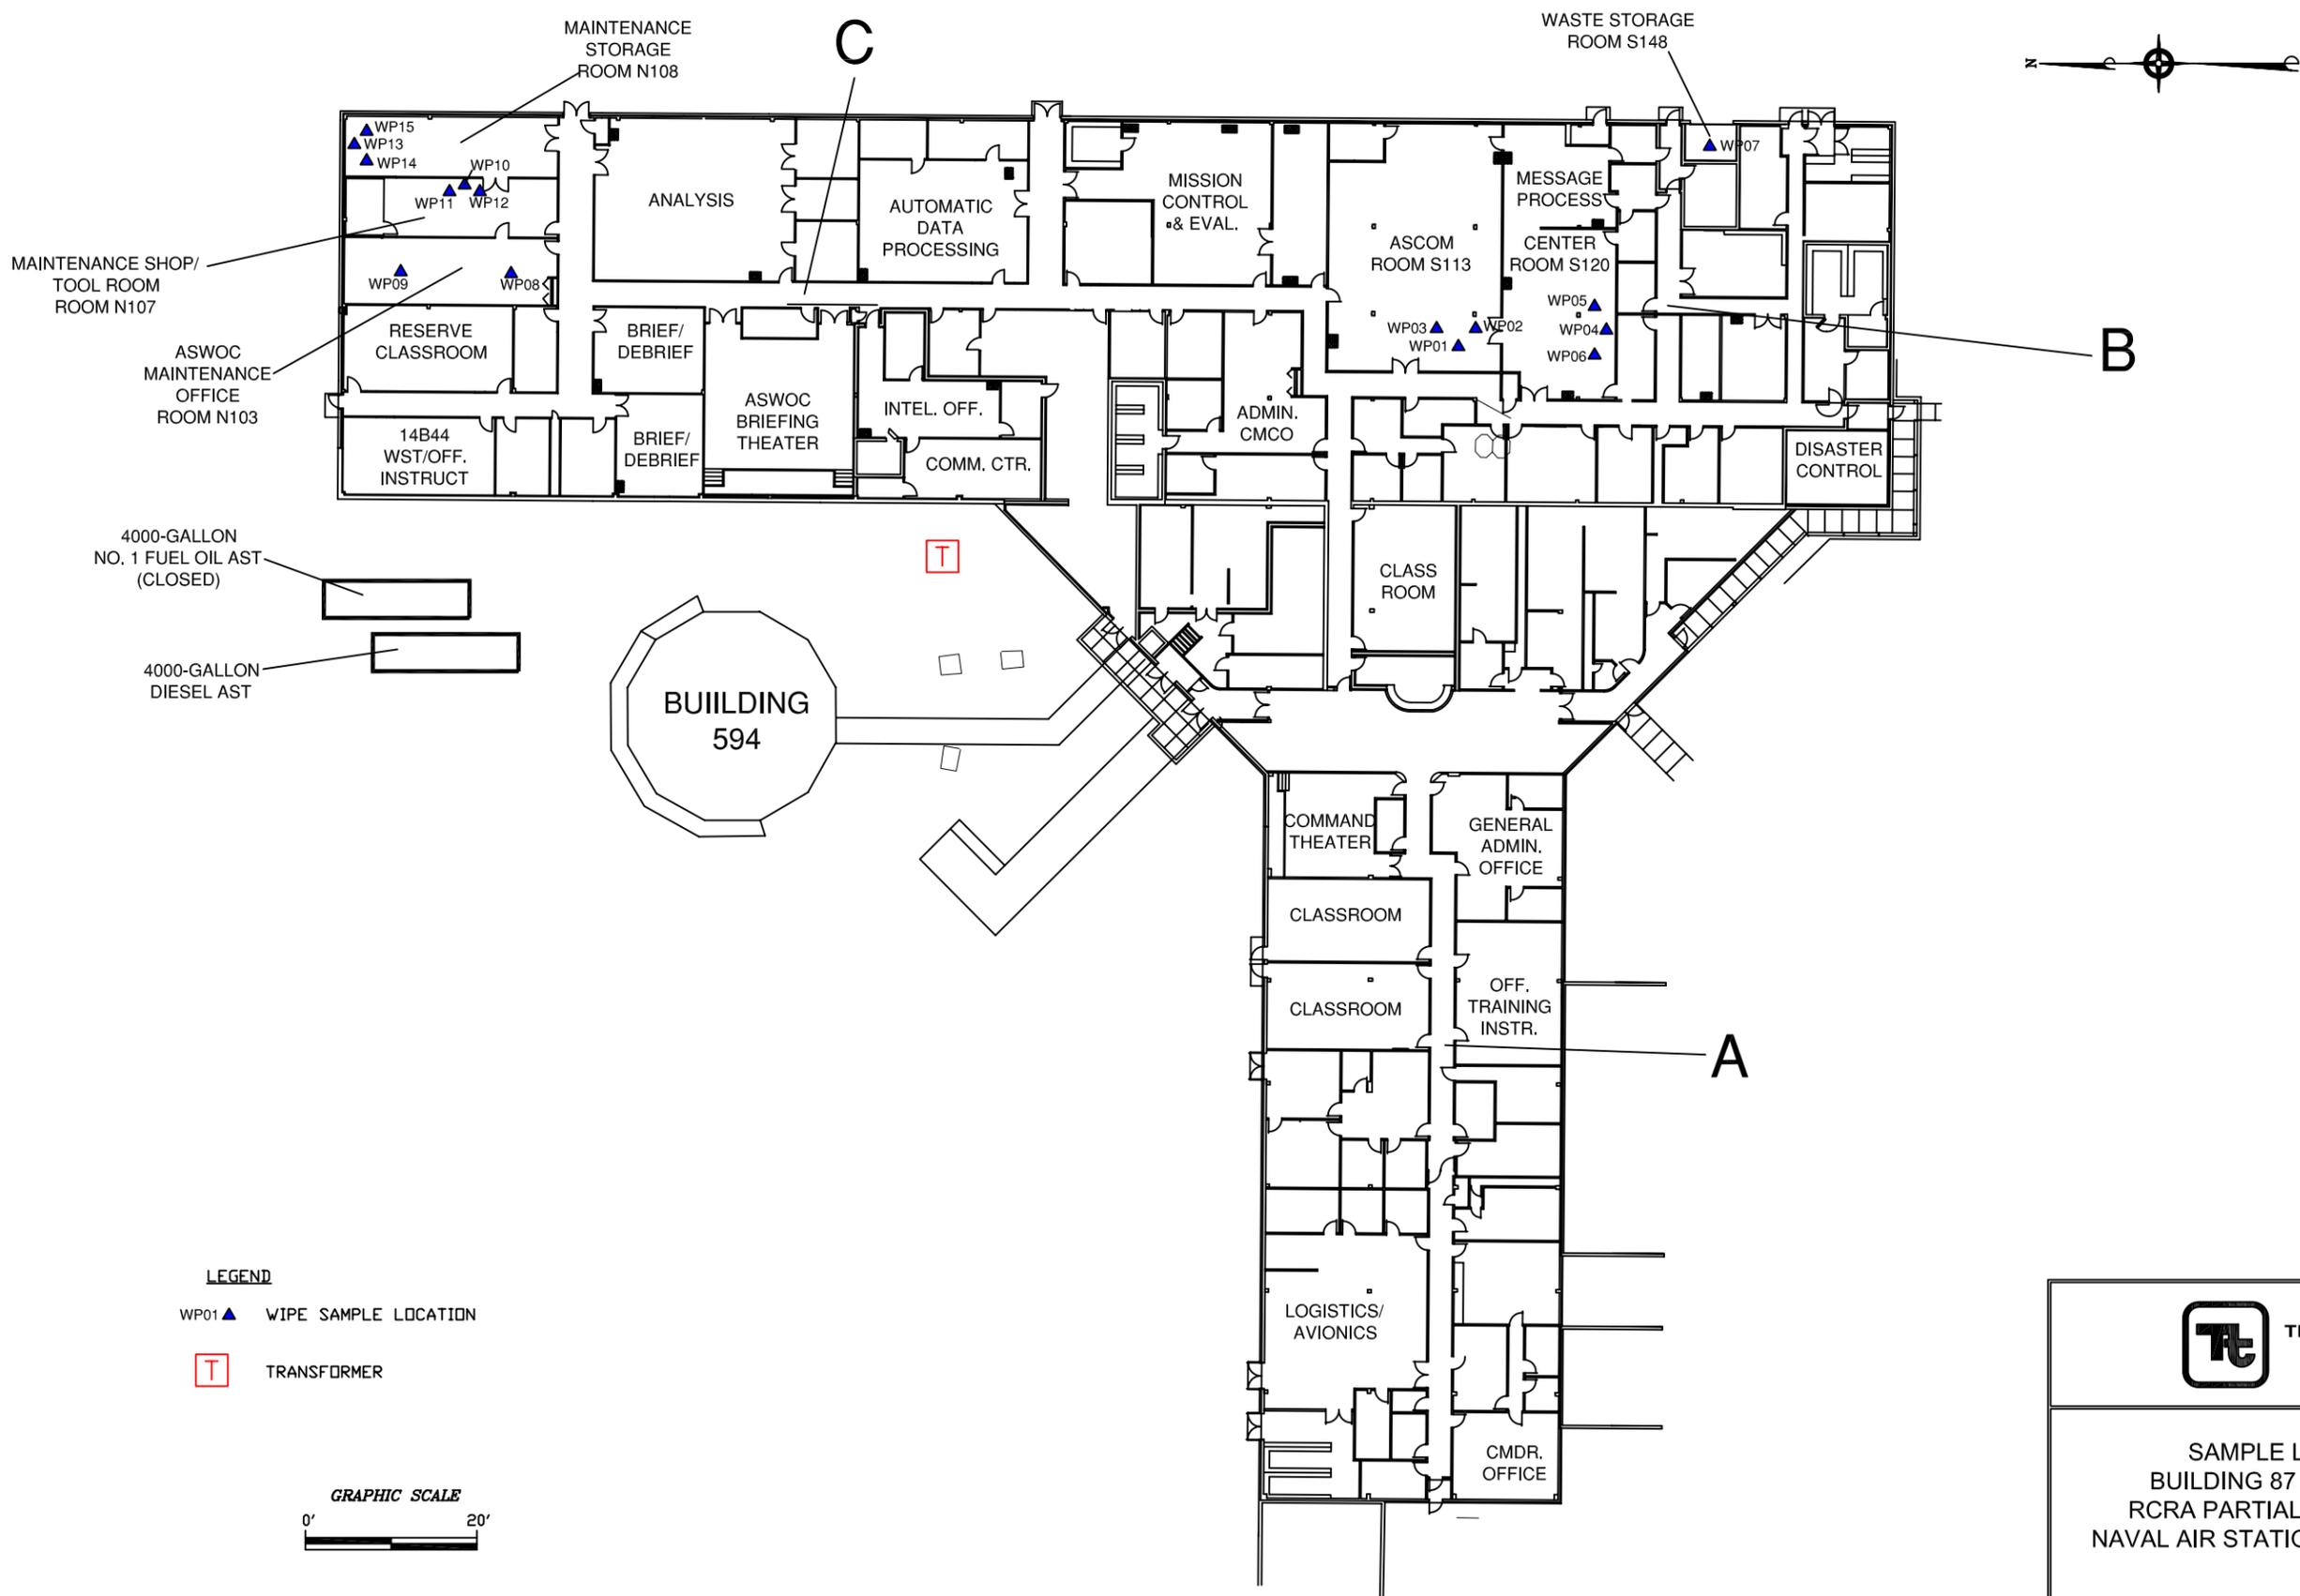
FILE \\.\NASB_BLDG_87_FP.DWG	SCALE AS NOTED
FIGURE NUMBER FIGURE NO. 3	REV DATE 0 07/08/10

Review of the Building 87 Segment B floor plan indicates that one room may have been previously used for solid waste accumulation, based on the identification of the room as "S148, Waste Stor." (Figure 3). (As discussed in Section 4, below, a wipe sample was collected from Room S148 to assess the possible presence of hazardous waste residue.)

On June 16, 2010, Tetra Tech collected wipe samples from fifteen locations at targeted areas, as shown on Figure 3 and identified on Table 1. Wipe samples from all locations were submitted for RCRA 8 metals analysis, with one wipe sample from Room S148 - Waste Storage also submitted for semi-volatile organic compound (SVOC) analysis. Analyses were conducted by Tetra Tech's subcontracted laboratory, Analytics Environmental Laboratory (Analytics), Portsmouth, New Hampshire.

SAMPLE LOCATION MAP  
BUILDING 87 - ASWOC PARCEL  
RCRA PARTIAL CLOSURE REPORT  
NAVAL AIR STATION BRUNSWICK, MAINE

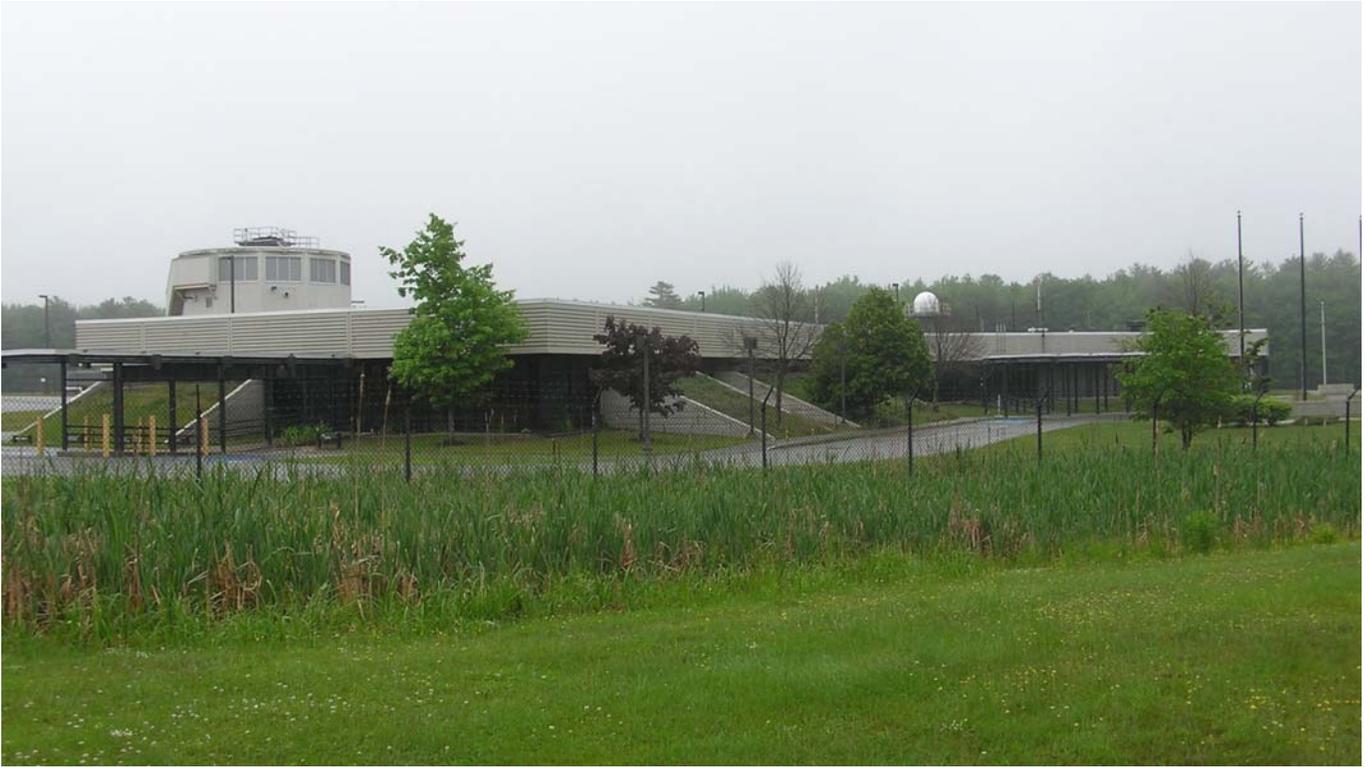
No. 1 Building 87 ASWOC Parcel – NAS Brunswick  
Building 87 southwest elevation; Building 594 in left background

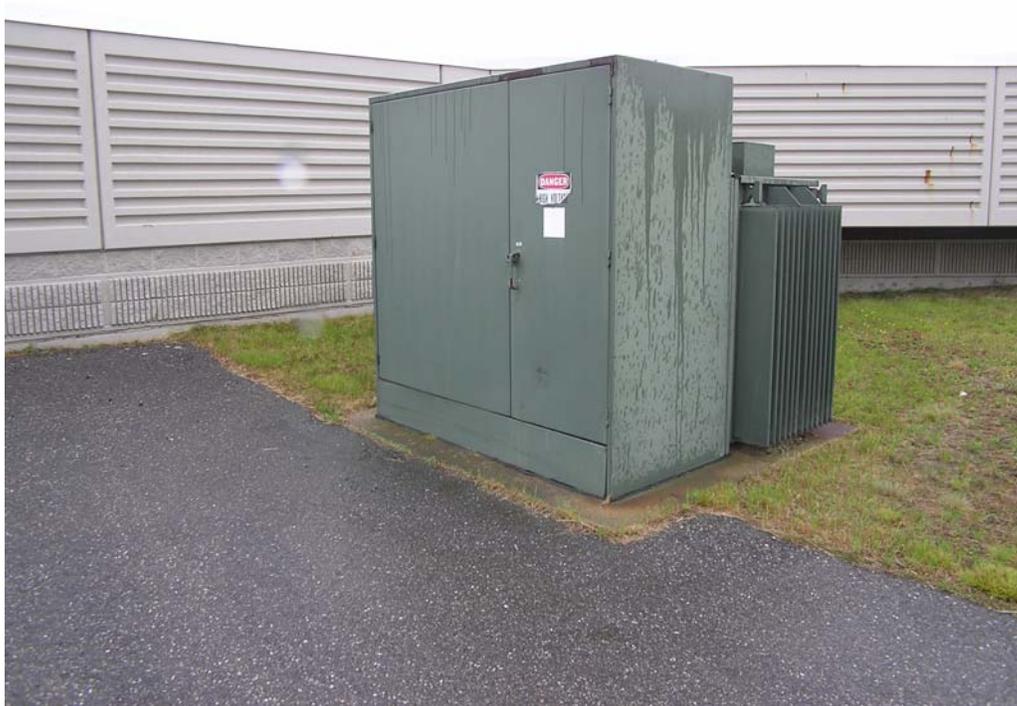
The NAS Brunswick Transformer Database lists one non-polychlorinated-biphenyl (PCB)-containing electrical transformer for Building 87; a 1,000-kVa pad-mounted transformer (I-T-E Serial No. 866004108). The first two digits of the transformer serial number indicate that it was likely manufactured in 1986, and is therefore unlikely to contain PCBs (as of July 1, 1979, the United States Environmental Protection Agency [EPA] prohibited all manufacturing of new PCB electrical equipment [transformers and capacitors]). However, since buildings have been present on the parcel since at least 1946, it is possible

No. 3 Building 87 ASWOC Parcel – NAS Brunswick June 3, 2010  
Transformer located to the northwest side of Building 87

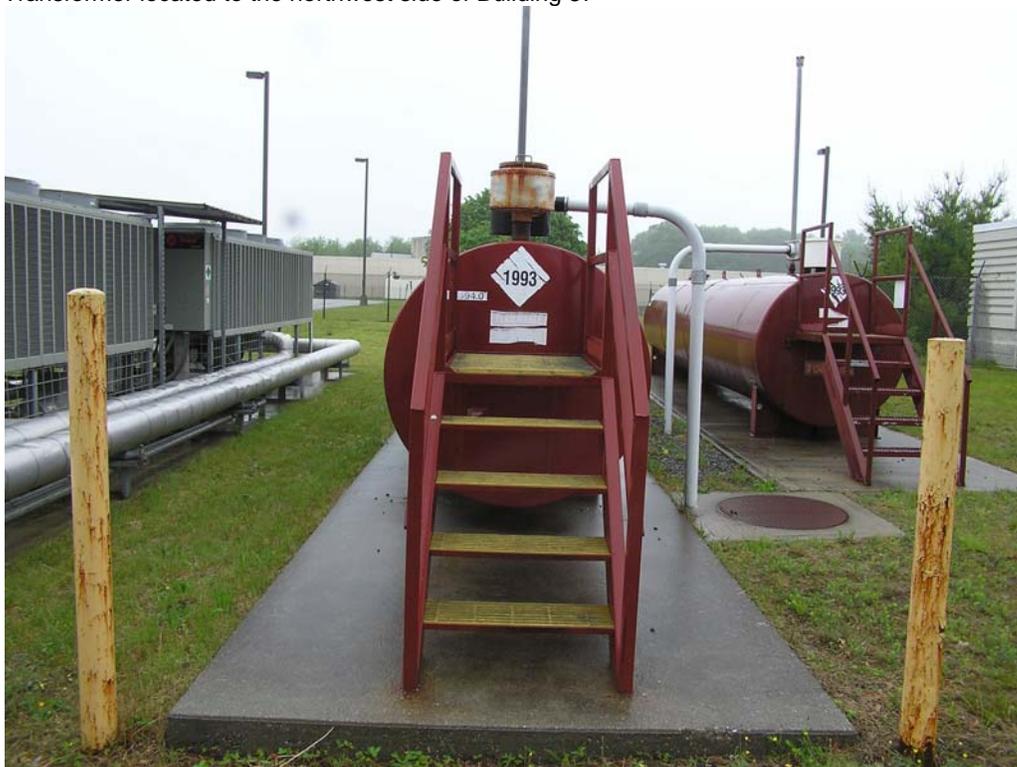
No. 4 Building 87 ASWOC Parcel – NAS Brunswick June 3, 2010  
Building 594 diesel AST (left) and closed No. 1 fuel oil AST (right) located northwest of Building 87

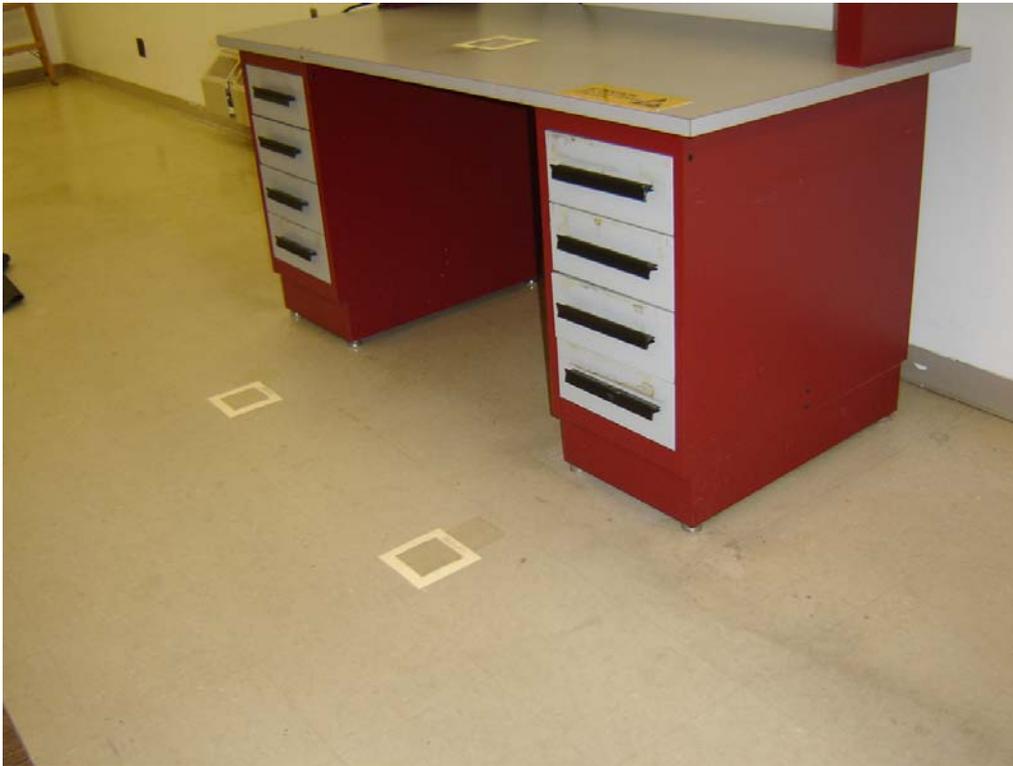
Room N107 - Maintenance Shop: A work bench was observed in the electronics repair shop area where possible historical soldering occurred.

No. 5 Building 87 ASWOC Parcel – NAS Brunswick June 16, 2010  
Building 87 Room N107 (Segment C) work bench area wipe sample locations

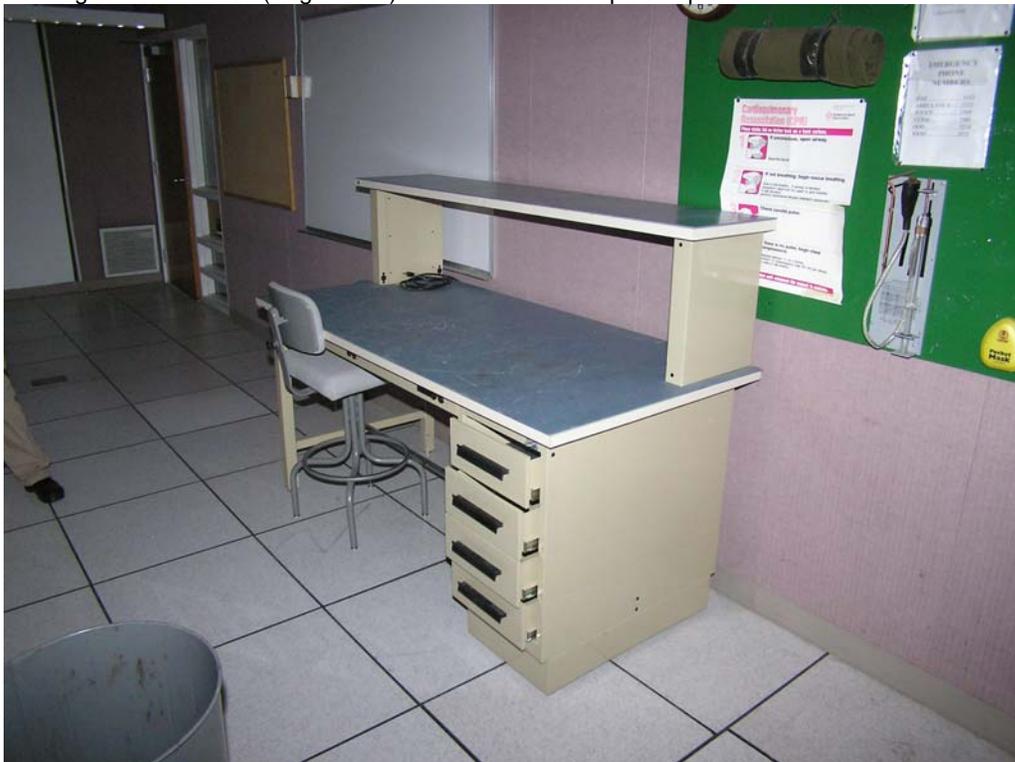
Room S120 - Message Process Center: A work bench was observed in the electronics repair shop area where possible historical soldering occurred.

No. 6 Building 87 ASWOC Parcel – NAS Brunswick June 3, 2010  
Building 87 Room S120 (Segment B) - work bench wipe sample area

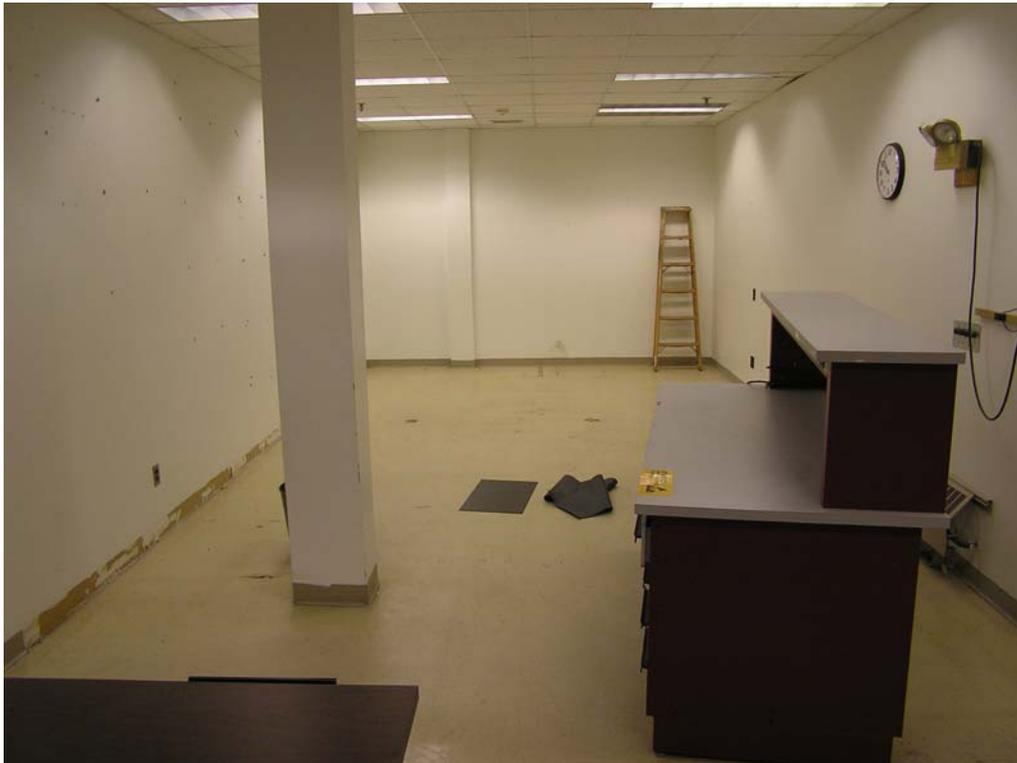
No. 7 Building 87 ASWOC Parcel – NAS Brunswick June 3, 2010  
Room N107 (Segment C) - work bench wipe sample area

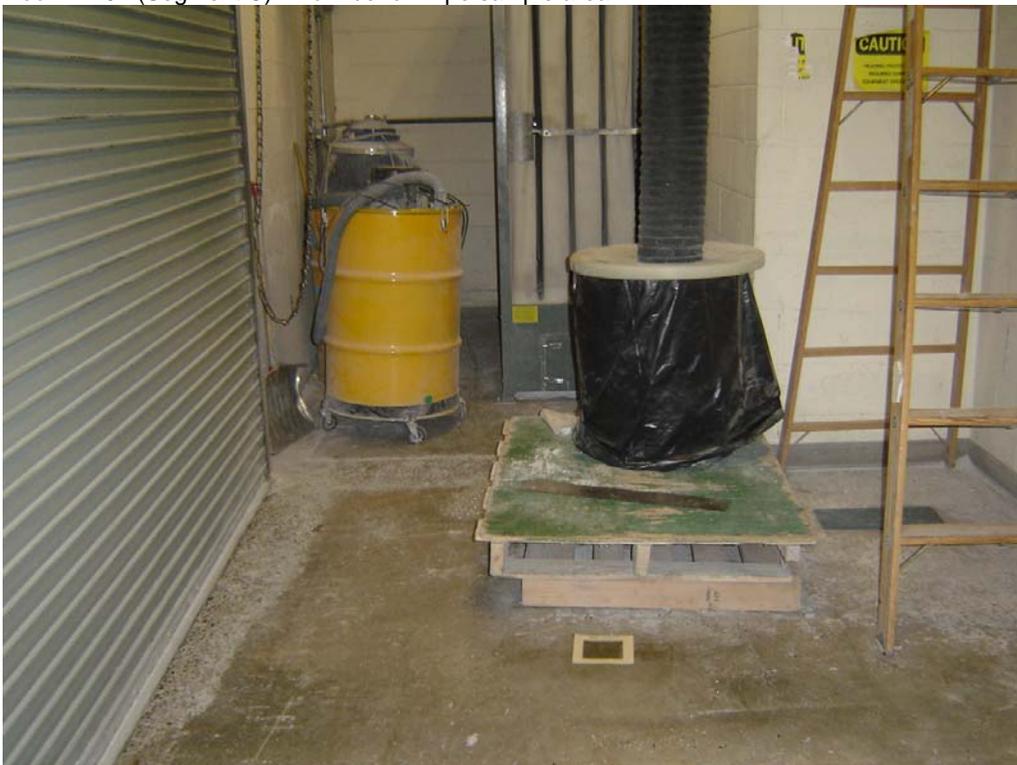
Room S148 - Waste Storage: This room may have been used for historical waste storage.

SVOCs were not detected in the only wipe sample collected for this analysis, the Room S148 wipe sample. The wipe sample results for RCRA 8 metals analysis are presented in Table 2.

No. 8 Building 87 ASWOC Parcel – NAS Brunswick June 16, 2010  
Building 87 Room S148 (Segment B) waste storage area wipe sample location
