FINAL RESOURCE CONSERVATION AND RECOVERY ACT PARTIAL CLOSURE REPORT  
FOR BUILDINGS 431, 432, 490 AND 497 WITH TRANSMITTAL LETTER NAS BRUNSWICK

**RCRA PARTIAL CLOSURE REPORT**  
**for**  
**BUILDING 431 – VR-62 LINE SHACK**  
**BUILDING 432 – VR-62 LINE SHACK**  
**BUILDING 490 – LOCKHEED SUPPORT LINE SHACK**  
**BUILDING 497 – LINE SHACK**  
**NAVAL AIR STATION BRUNSWICK, MAINE**  
**USEPA IDENTIFICATION NUMBER ME8170022018**  
**AUGUST 2010**

SITE LOCATION MAP  
 BUILDINGS 431, 432, 490 AND 497  
 RCRA PARTIAL CLOSURE REPORT  
 NAS BRUNSWICK, MAINE

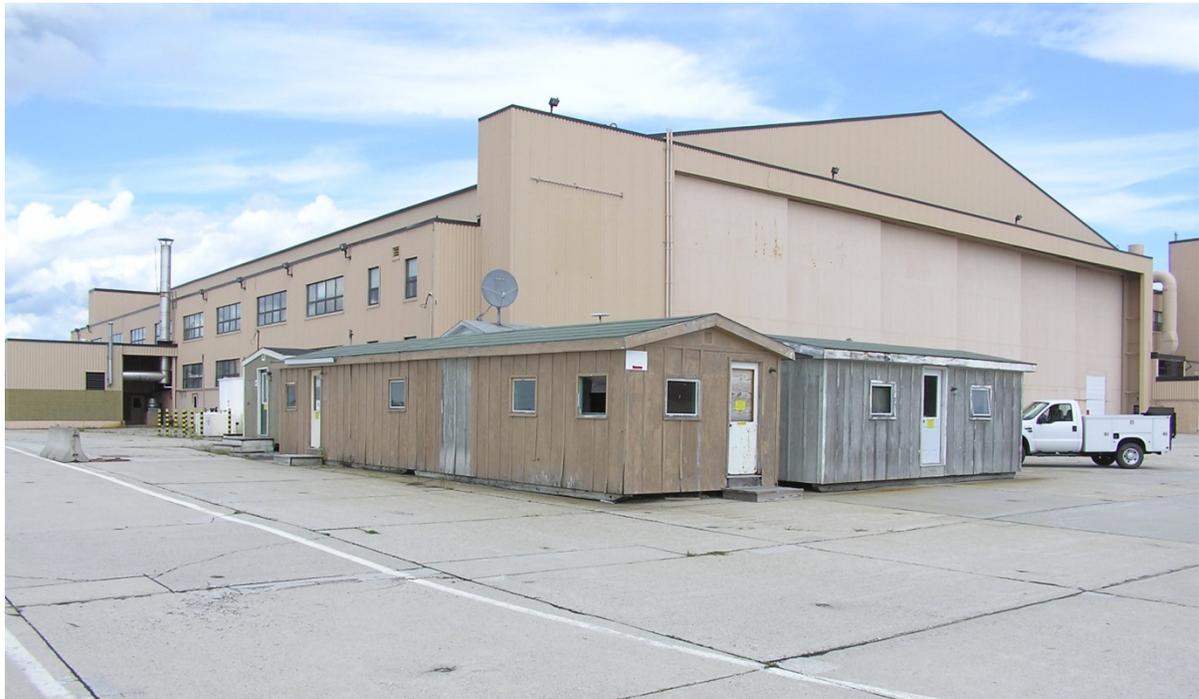
No. 1                      Buildings 431, 432, 490 and 497 – NAS Brunswick                      August 12, 2010  
Viewed from southwest: Buildings 497, 431 and 432 (left to right), with Hangar 4 in background

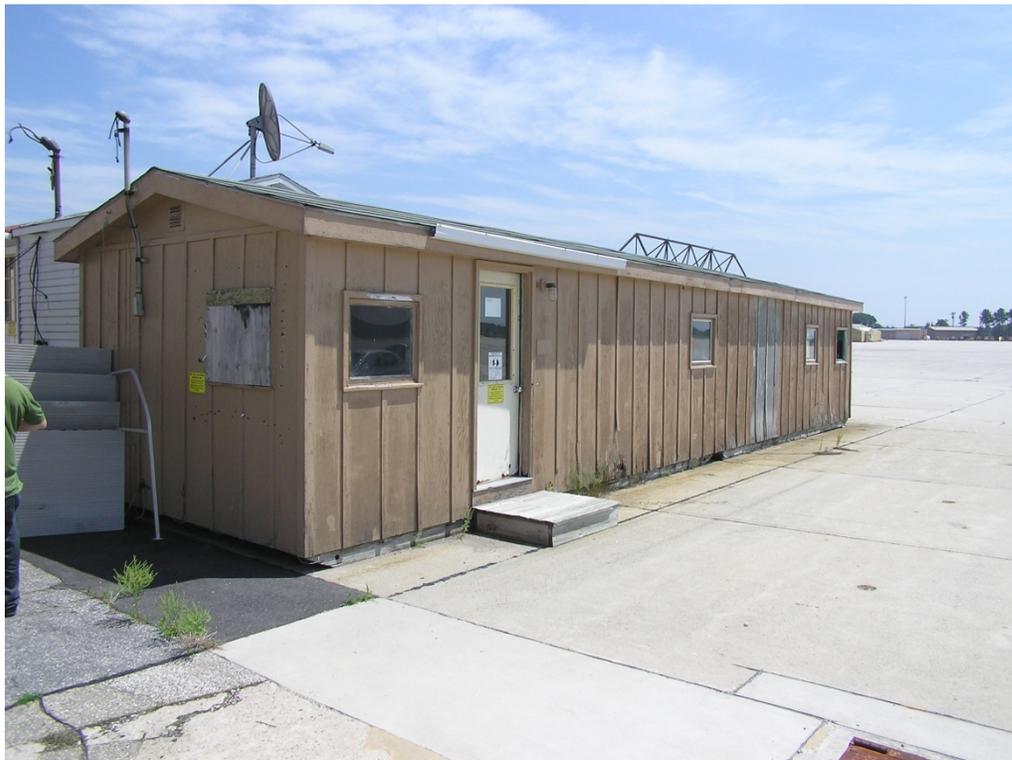
No. 2                      Buildings 431, 432, 490 and 497 – NAS Brunswick                      June 24, 2010  
Building 431 northwest elevation

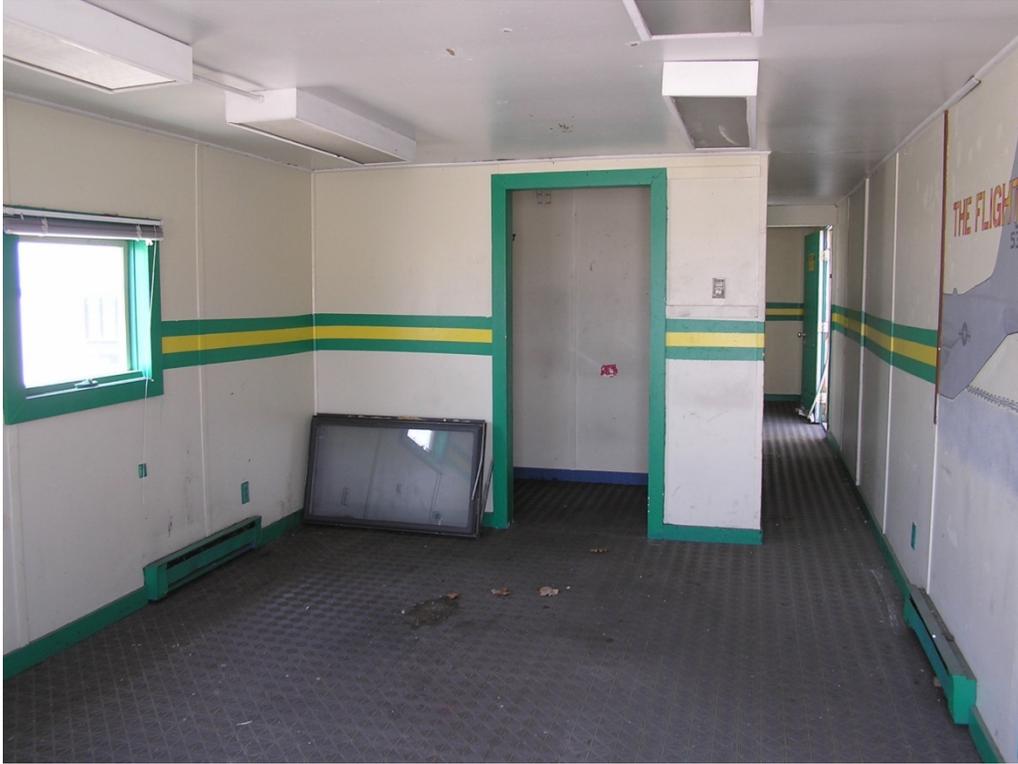
At the time of inspection, Building 431 was vacant and in fair condition; while Structure HH was vacant and in undetermined condition due to our lack of access to the interior of the structure.

No. 3 Buildings 431, 432, 490 and 497 – NAS Brunswick June 24, 2010  
Building 431 interior

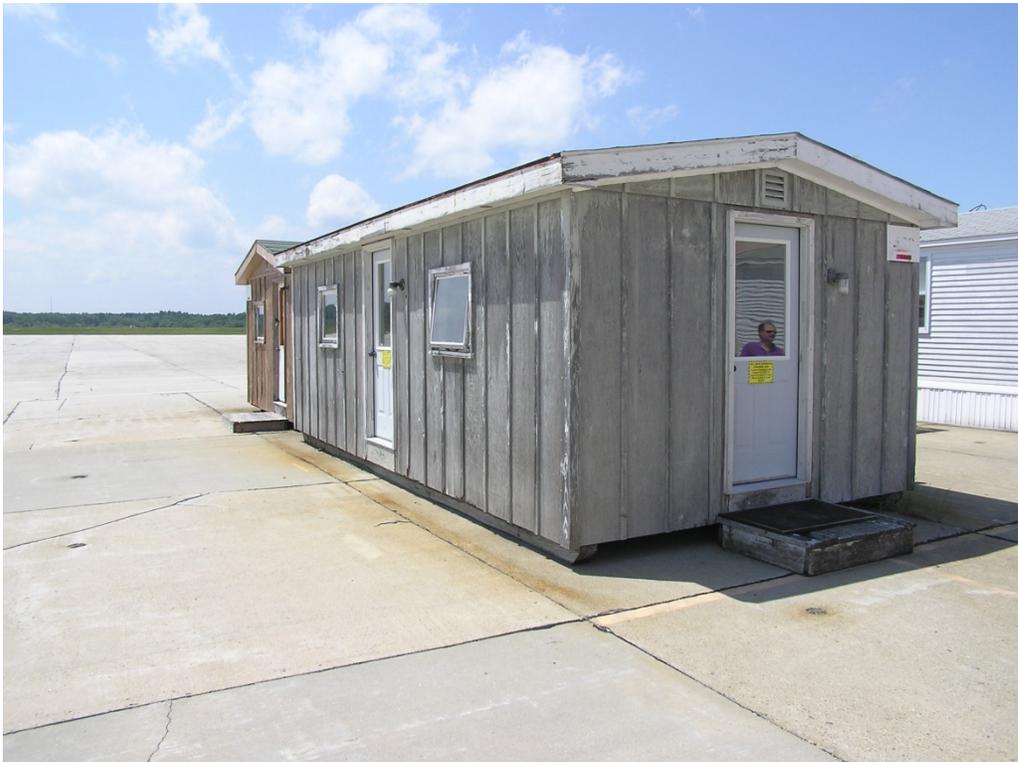
No. 4 Buildings 431, 432, 490 and 497 – NAS Brunswick June 24, 2010  
Building 432 southeast elevation; Building 431 in left background and Building 490 in right background

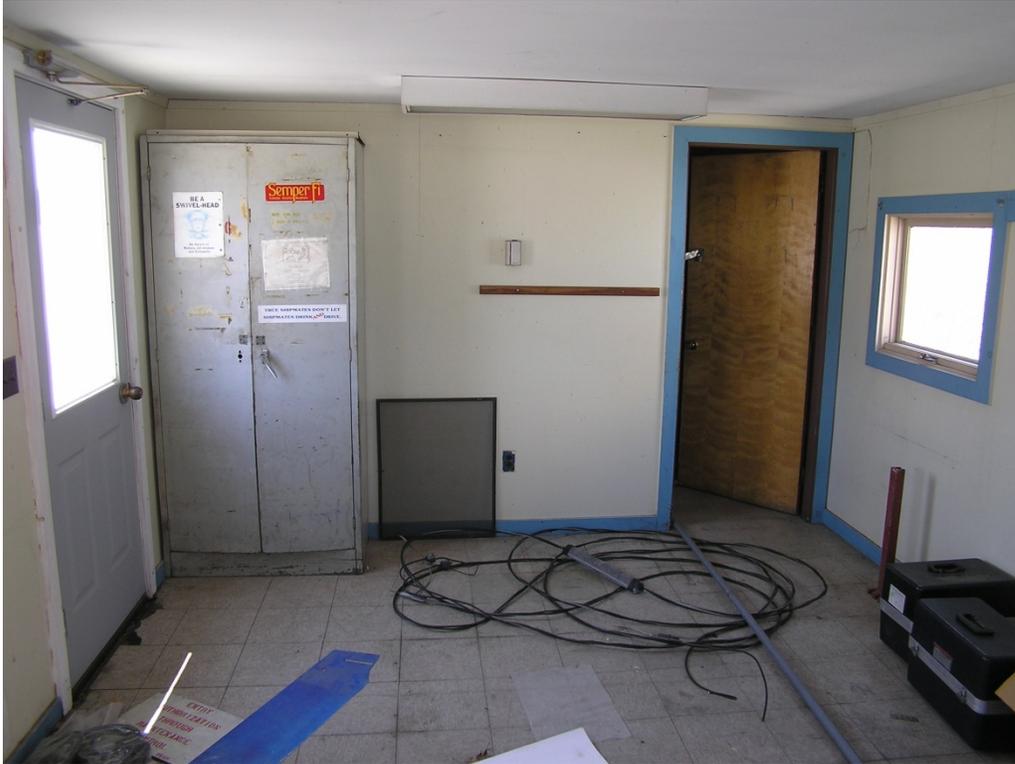
- At the time of the June 24, 2010 site visit, Building 432 was unoccupied and in fair condition.
- Floor tiles, 12-inch by 12-inch, on the floor of Building 432 were observed to be in fair to poor condition. The tiles and adhesive mastic are suspected to be asbestos-containing materials (ACM) based on the estimated building construction date (approximately 1980).
- No evidence of current or past hazardous waste generation was observed.
- No evidence of hazardous waste residues was observed.
- No structural modifications, which could conceal signs of a past release, were observed.
- No hazardous waste storage areas or hazardous waste accumulation areas were observed.
- No transformers that could be a potential source of PCB contamination were observed.
- No ASTs, USTs, or oil/water separators associated with this building were observed.

It is suspected that floor tiles and the adhesive mastic materials observed in Building 432 are ACM, as discussed in Section 4 of this report.

No. 5 Buildings 431, 432, 490 and 497 – NAS Brunswick June 24, 2010  
Building 432 interior

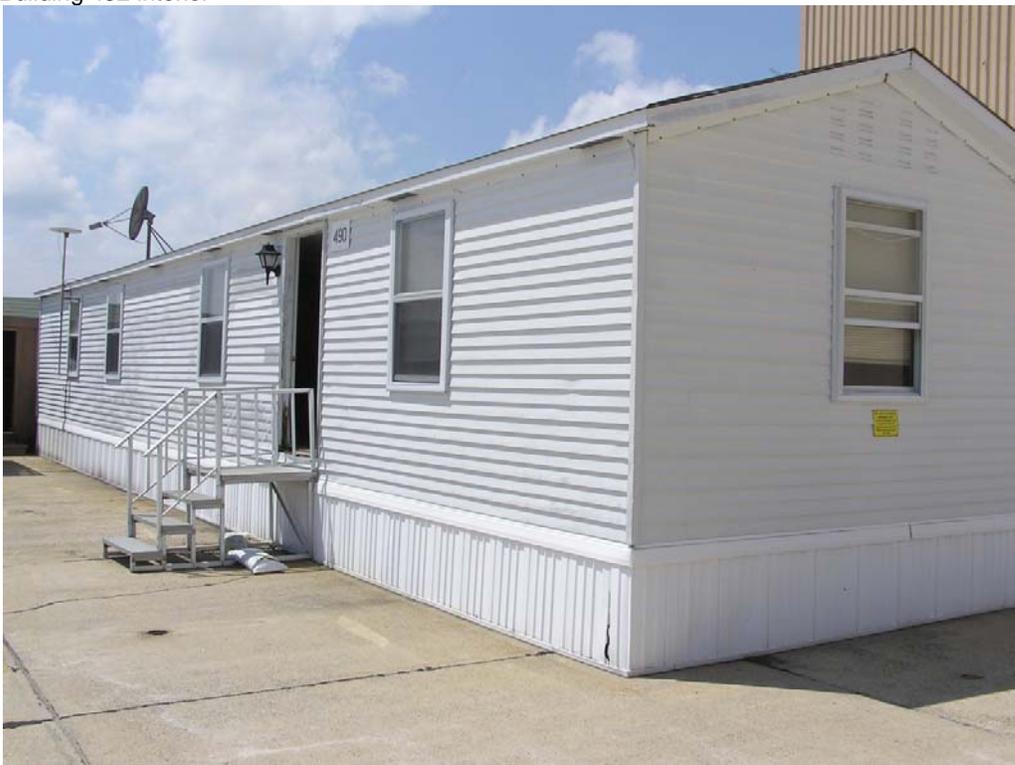
No. 6 Buildings 431, 432, 490 and 497 – NAS Brunswick June 24, 2010  
Building 490 southeast elevation

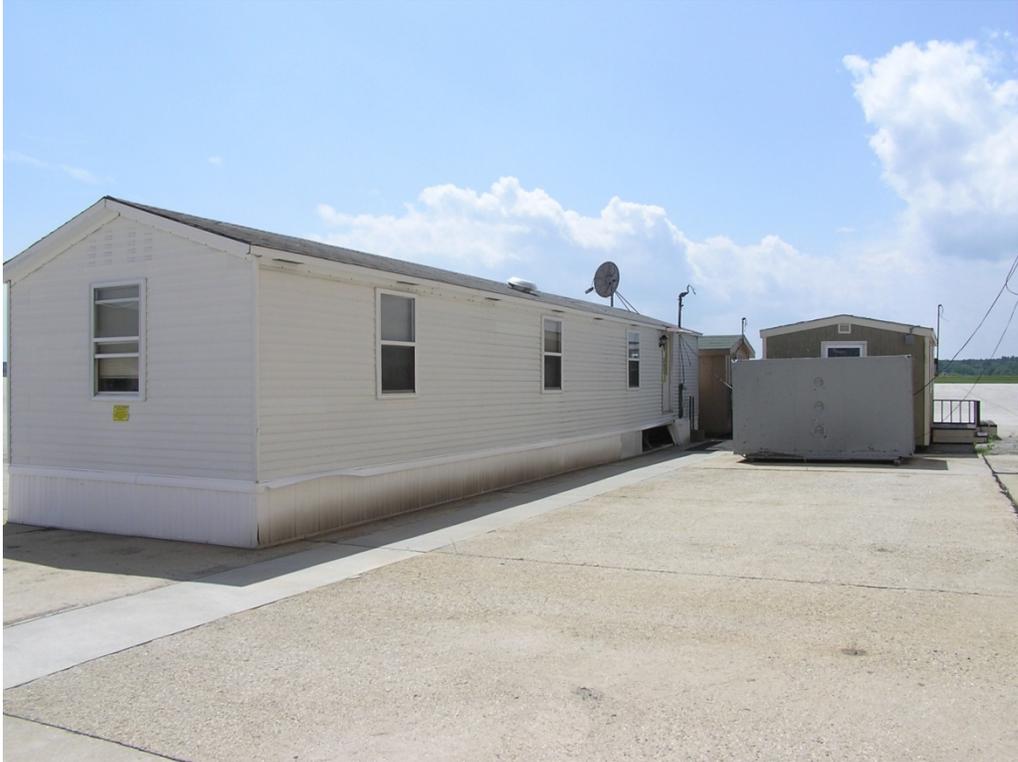
No. 7 Buildings 431, 432, 490 and 497 – NAS Brunswick June 24, 2010  
Building 490 southeast elevation; Structure A10 in right background

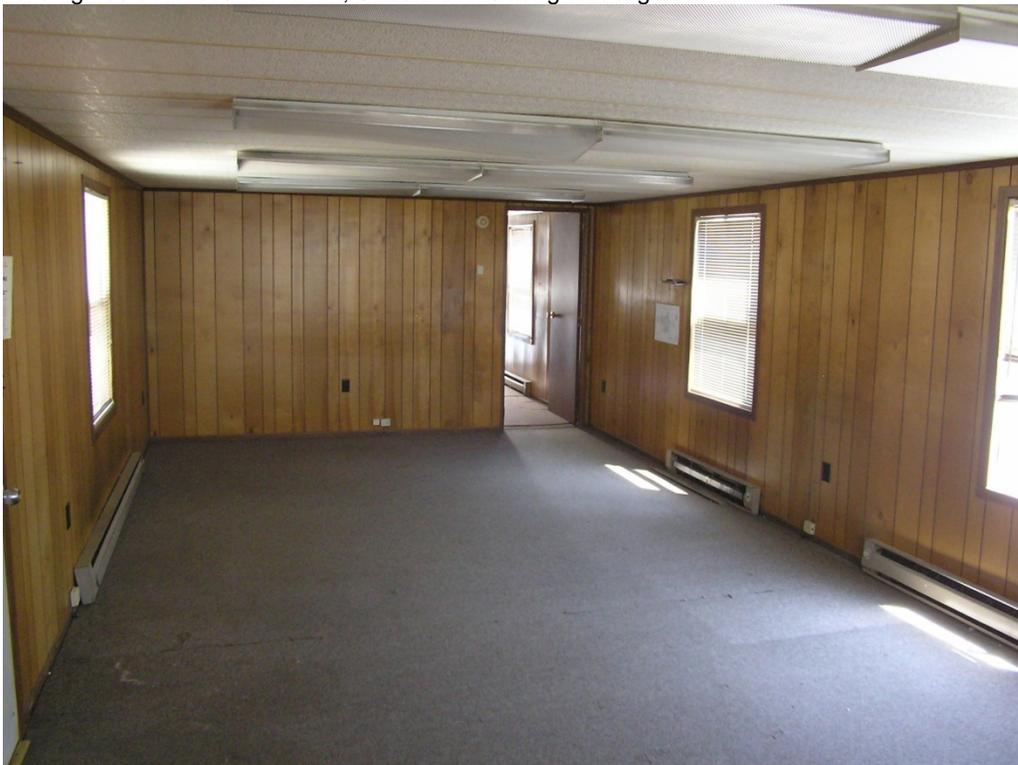
At the time of inspection, Building 490 was vacant and in good condition.

No. 8 Buildings 431, 432, 490 and 497 – NAS Brunswick June 24, 2010  
Building 490 interior

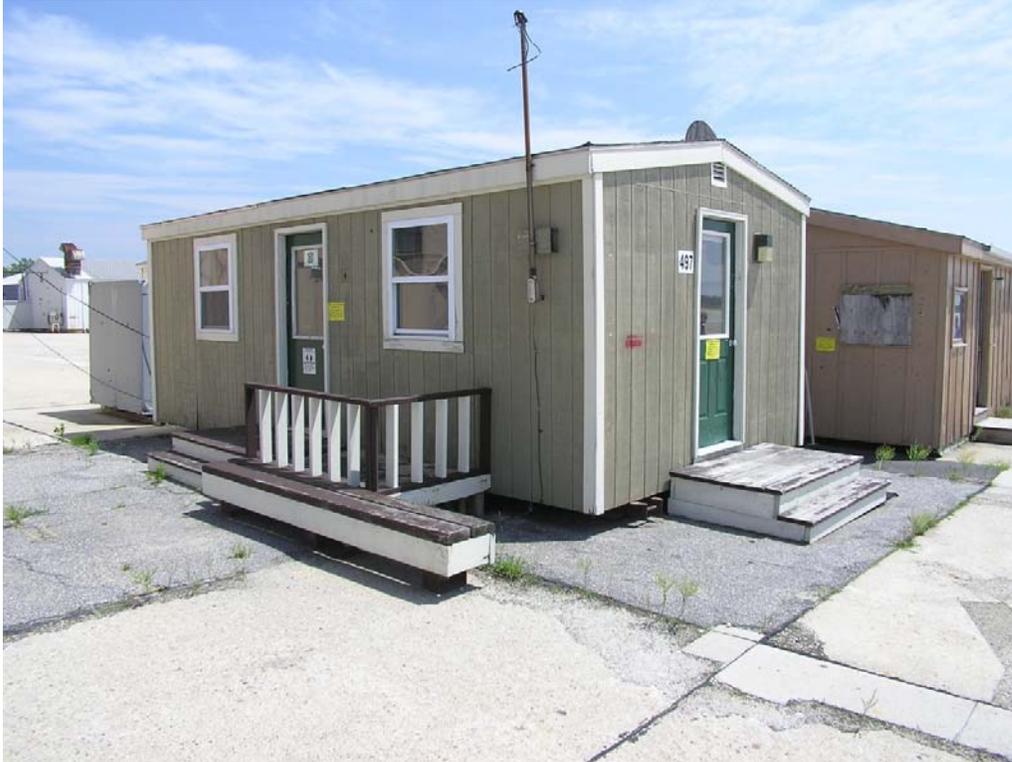
No. 9 Buildings 431, 432, 490 and 497 – NAS Brunswick June 24, 2010  
Building 497 northwest elevation; Building 431 in right background and Structure A10 in left background

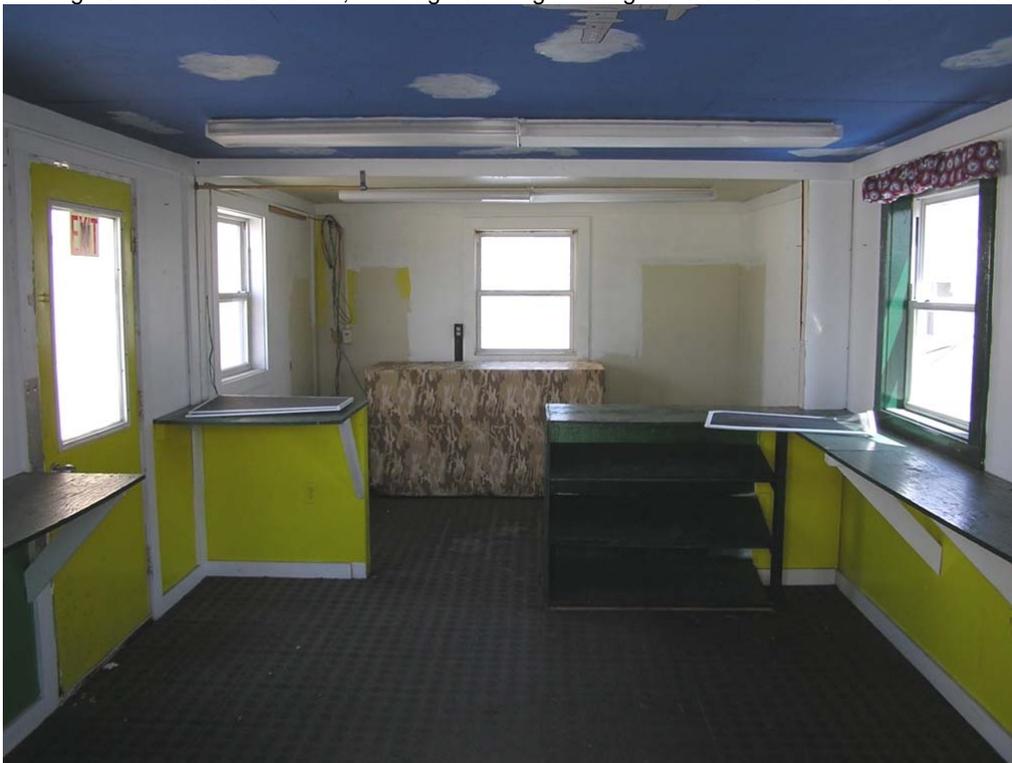
At the time of inspection, Building 497 was vacant and in good to fair condition.

No. 10 Buildings 431, 432, 490 and 497 – NAS Brunswick June 24, 2010  
Building 497 interior

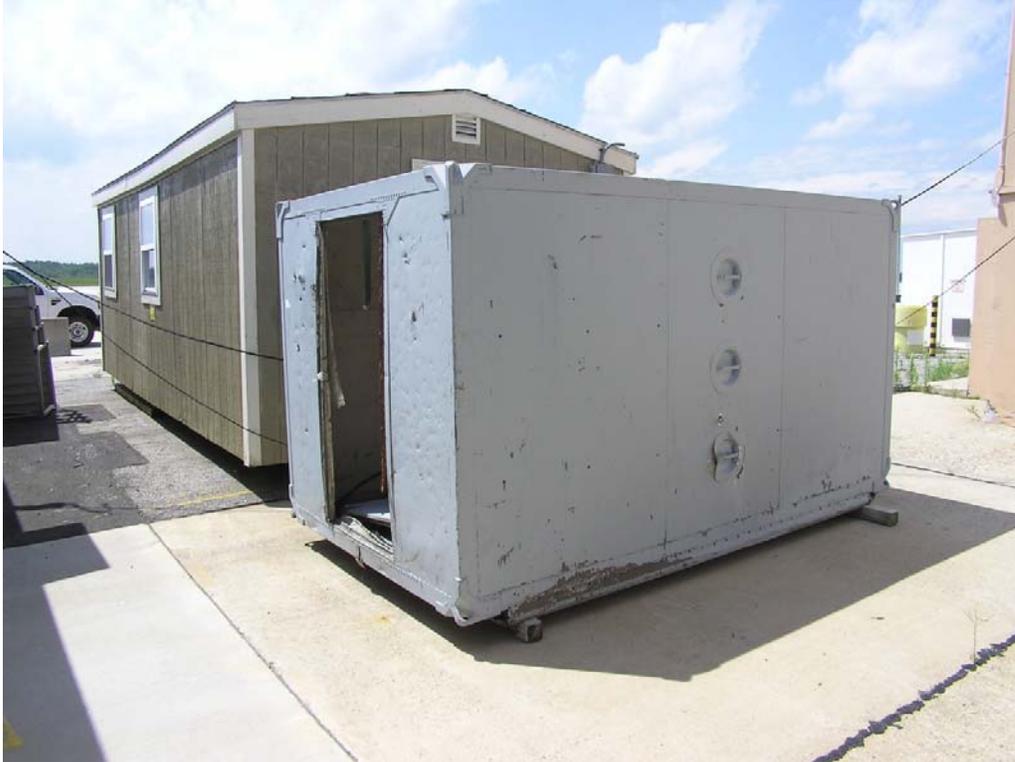
No. 11                      Buildings 431, 432, 490 and 497 – NAS Brunswick                      June 24, 2010  
Structure A10 southeast elevation; Building 497 in background

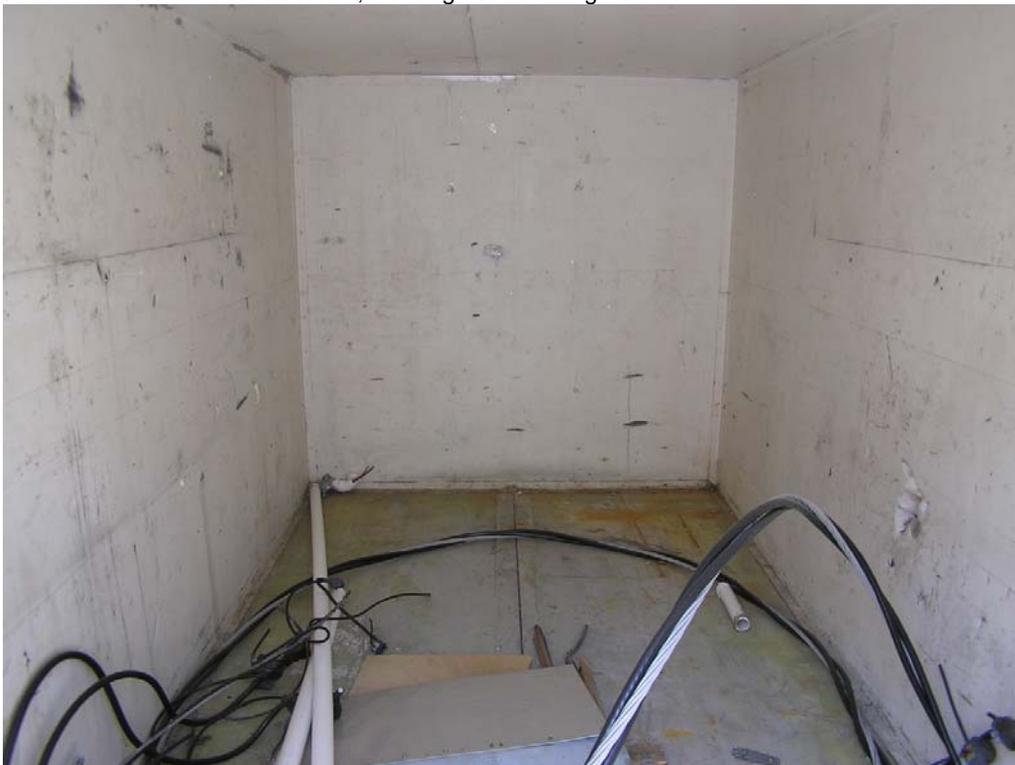
- At the time of the June 24, 2010 site visit, Building 497 was unoccupied and in fair condition.
- Structure A10 was empty and in poor condition, with miscellaneous debris observed within the structure.
- No evidence of current or past hazardous waste generation was observed.
- No evidence of hazardous waste residues was observed.
- No structural modifications, which could conceal signs of a past release, were observed.
- No hazardous waste storage areas or hazardous waste accumulation areas were observed.
- No transformers that could be a potential source of PCB contamination were observed.
- No ASTs, USTs, or oil/water separators associated with Building 497 and/or Structure A10 were observed

No. 12                      Buildings 431, 432, 490 and 497 – NAS Brunswick                      June 24, 2010  
Structure A10 interior

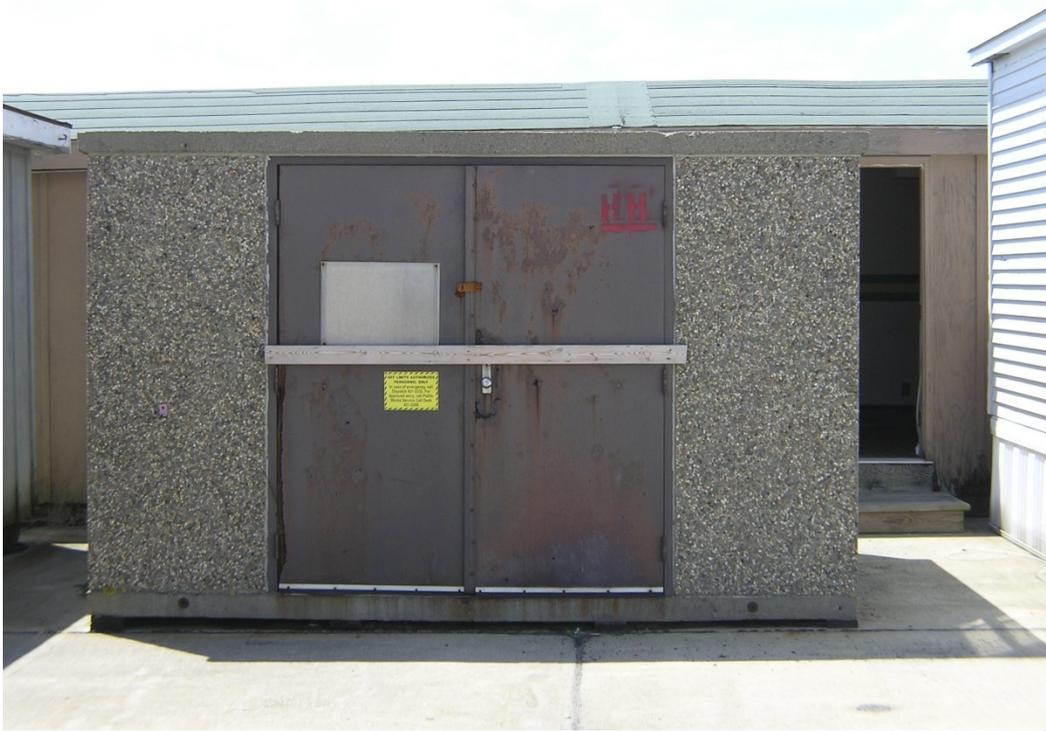
No. 13 Buildings 431, 432, 490 and 497 – NAS Brunswick  
Structure HH east elevation

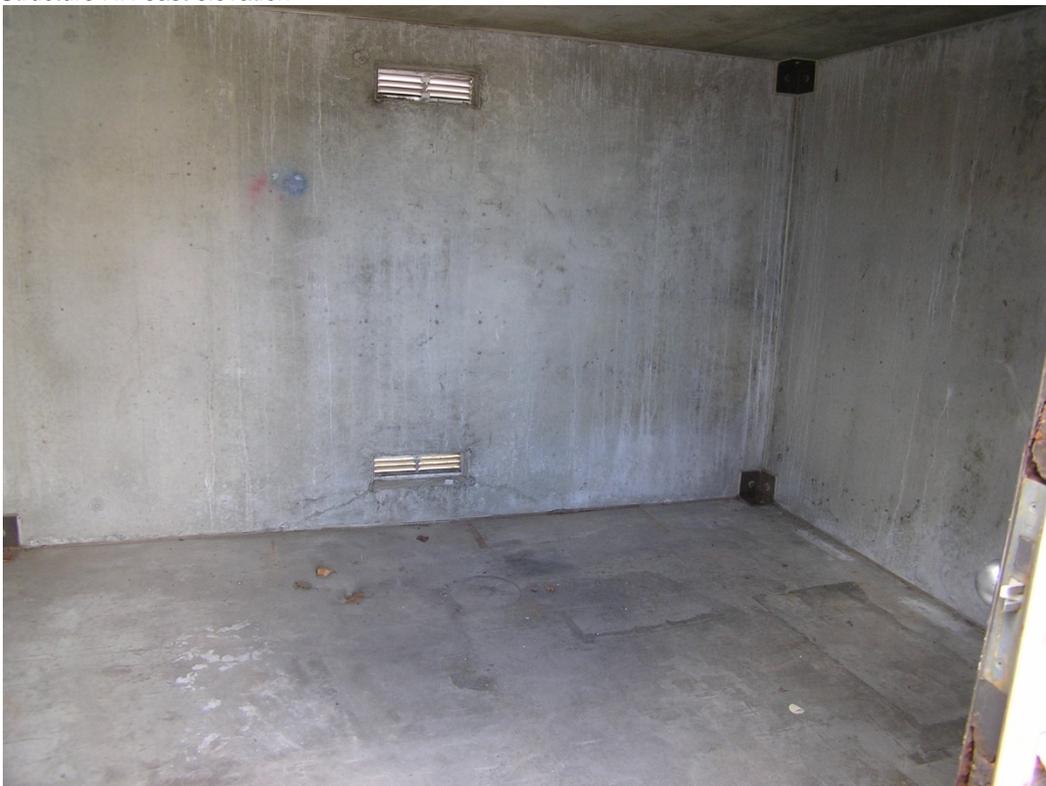
No. 14 Buildings 431, 432, 490 and 497 – NAS Brunswick  
Structure HH interior
