FINAL RESOURCE CONSERVATION AND RECOVERY ACT PARTIAL CLOSURE REPORT
FOR BUILDINGS 117 AND 118 WITH TRANSMITTAL LETTER NAS BRUNSWICK ME
9/8/2010
NAS BRUNSWICK

Subj: Final RCRA Partial Closure Report for Buildings 117 and 118

RCRA PARTIAL CLOSURE REPORT
for
BUILDINGS 117 AND 118 – FILLING STATION PARCEL
NAVAL AIR STATION BRUNSWICK, MAINE
USEPA IDENTIFICATION NUMBER ME8170022018
SEPTEMBER 2010

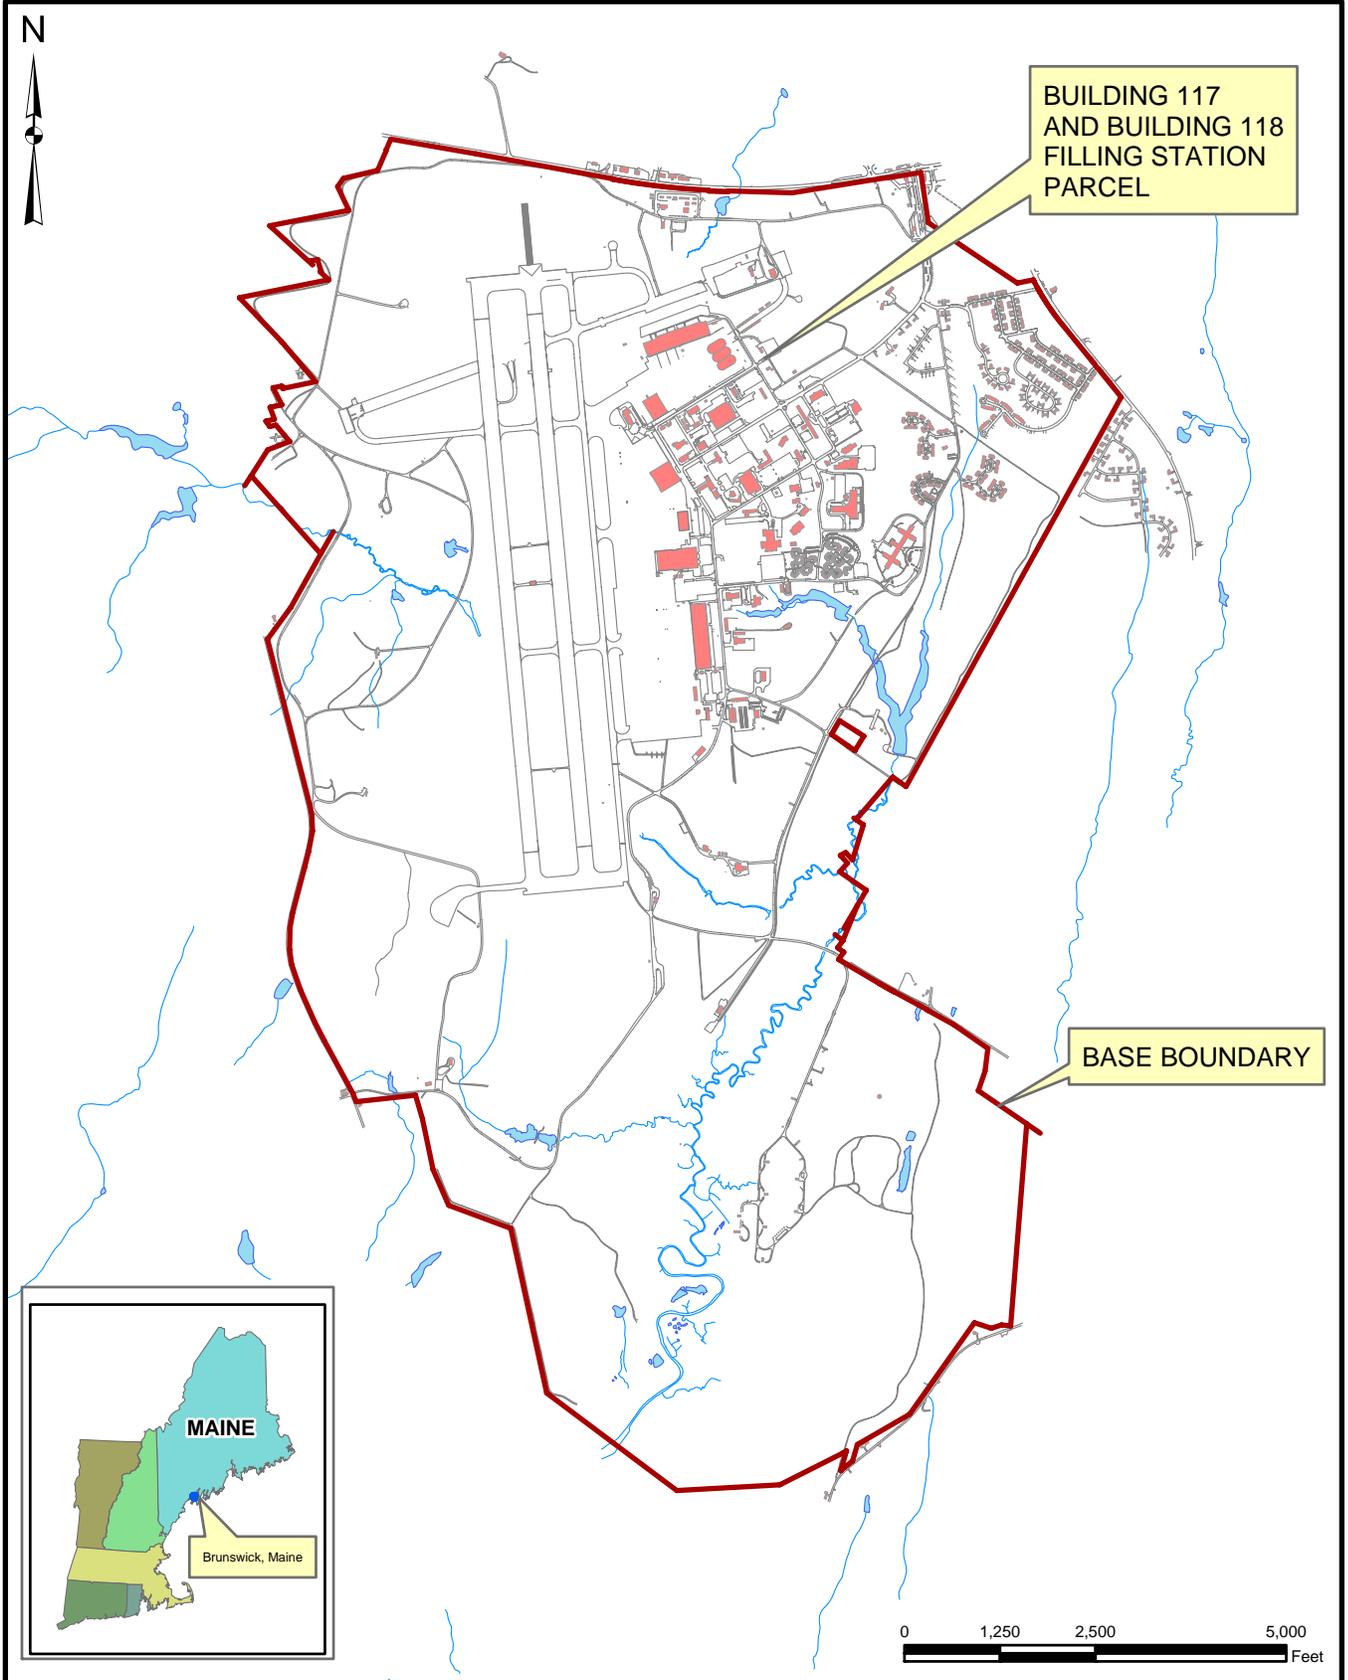
SCALE AS NOTED	
FILE I:_NASB_BLDG_117&118_LOCUS.MXD	
REV 0	DATE 08/24/10
FIGURE NUMBER 1

SITE LOCATION MAP
BUILDING 117 AND BUILDING 118 - FILLING STATION PARCEL
RCRA PARTIAL CLOSURE REPORT
NAVAL AIR STATION BRUNSWICK, MAINE

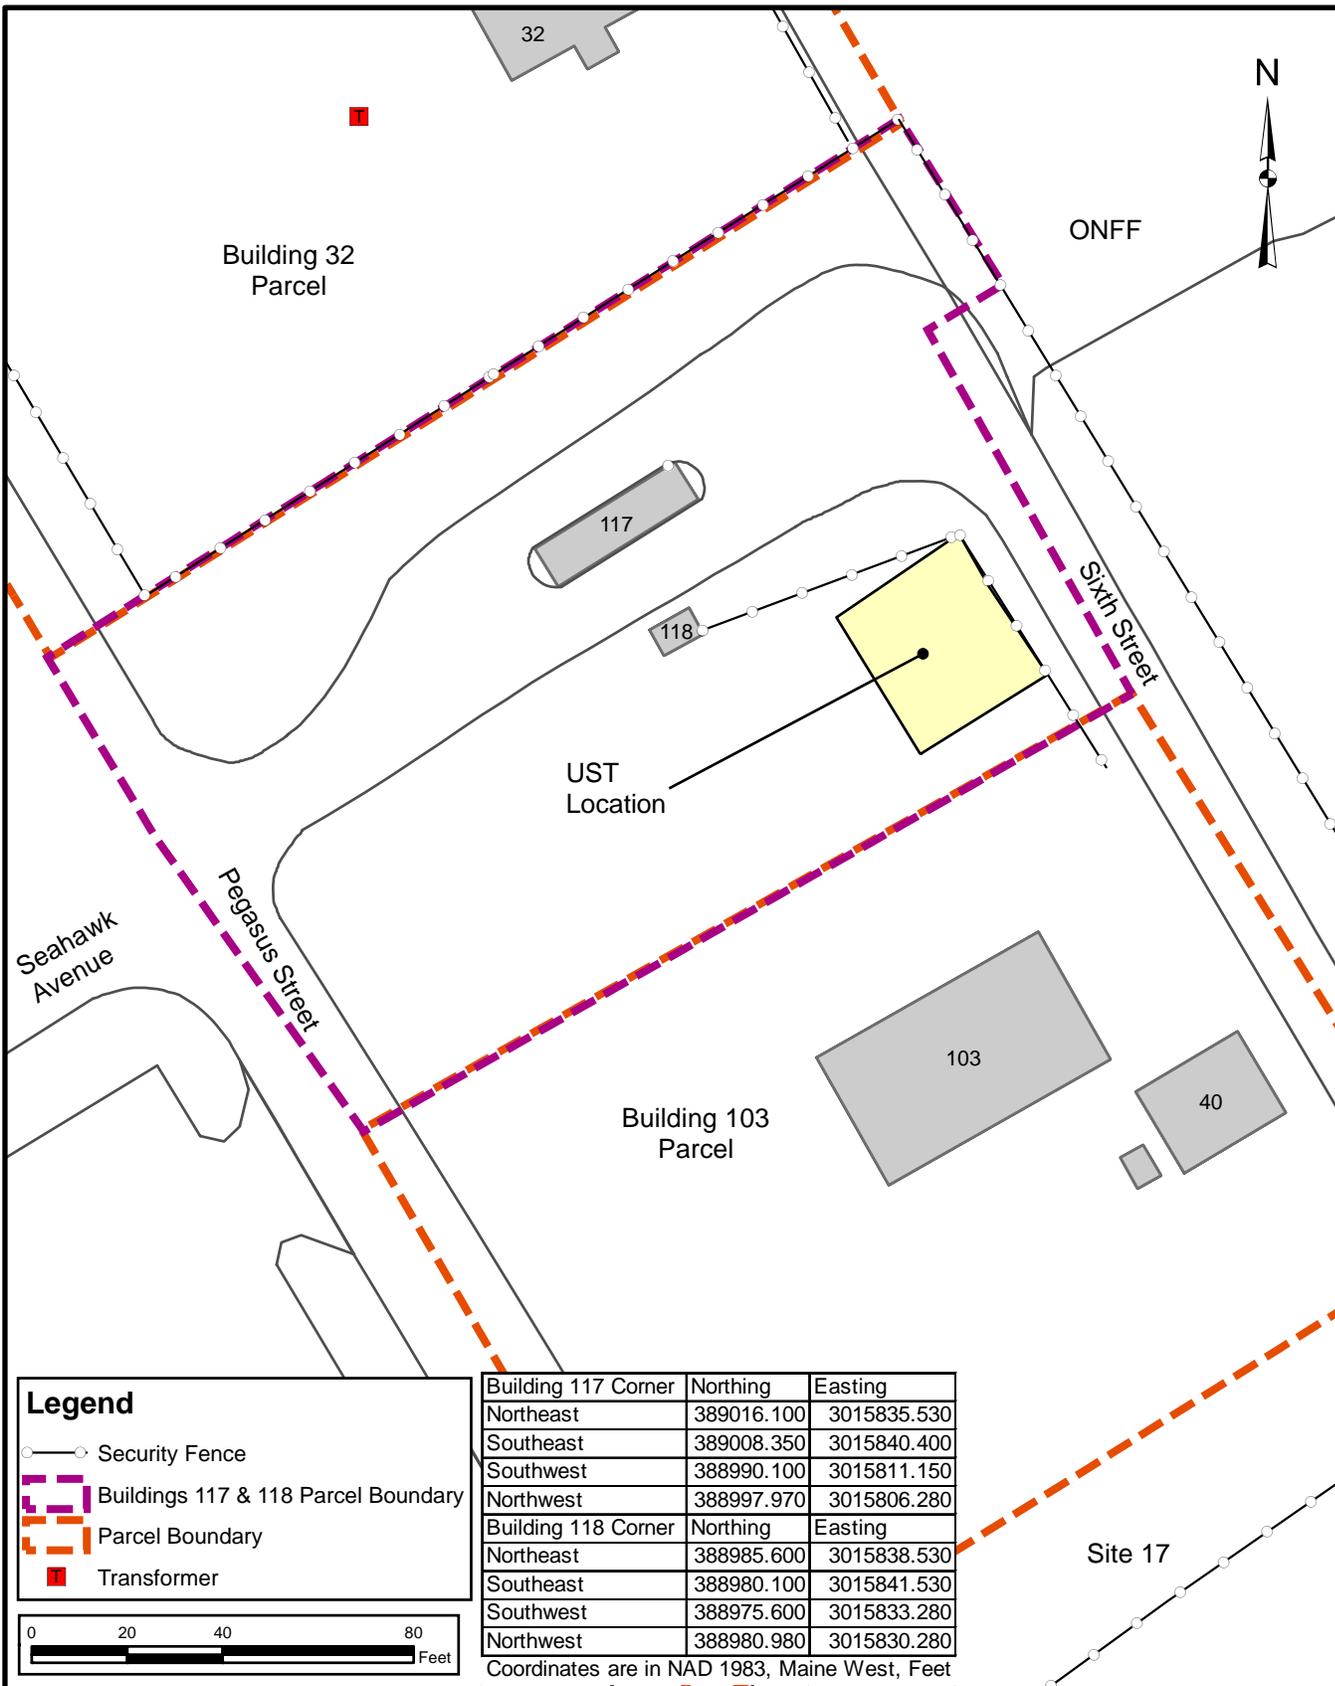
SCALE AS NOTED	
FILE	
I:\N\ASB_BLDG_117&118_ORTHO.MXD	
REV	DATE
0	09/02/10
FIGURE NUMBER	
2

SITE PLAN
BUILDING 117 AND BUILDING 118 - FILLING STATION PARCEL
RCRA PARTIAL CLOSURE REPORT
NAS BRUNSWICK, MAINE

Building 118 is located immediately south of Building 117, as shown on Figure 2. This building was also constructed in 1984 and consists of a 42-square-foot, one-story structure on a concrete slab foundation. This one-room building formerly served as the UST monitoring and control system building, and most recently as the filling station storage facility. Vehicle fluids such as anti-freeze, windshield wiper fluid, oil, etc., were not provided at this facility and no liquids were stored within Building 118, per NAS Brunswick personnel. Photographs of the Building 118 exterior and interior are provided in an attachment.

This investigation of the hazardous waste closure requirement applies to the Buildings 117 and 118 parcel (as shown on Figure 2) only.

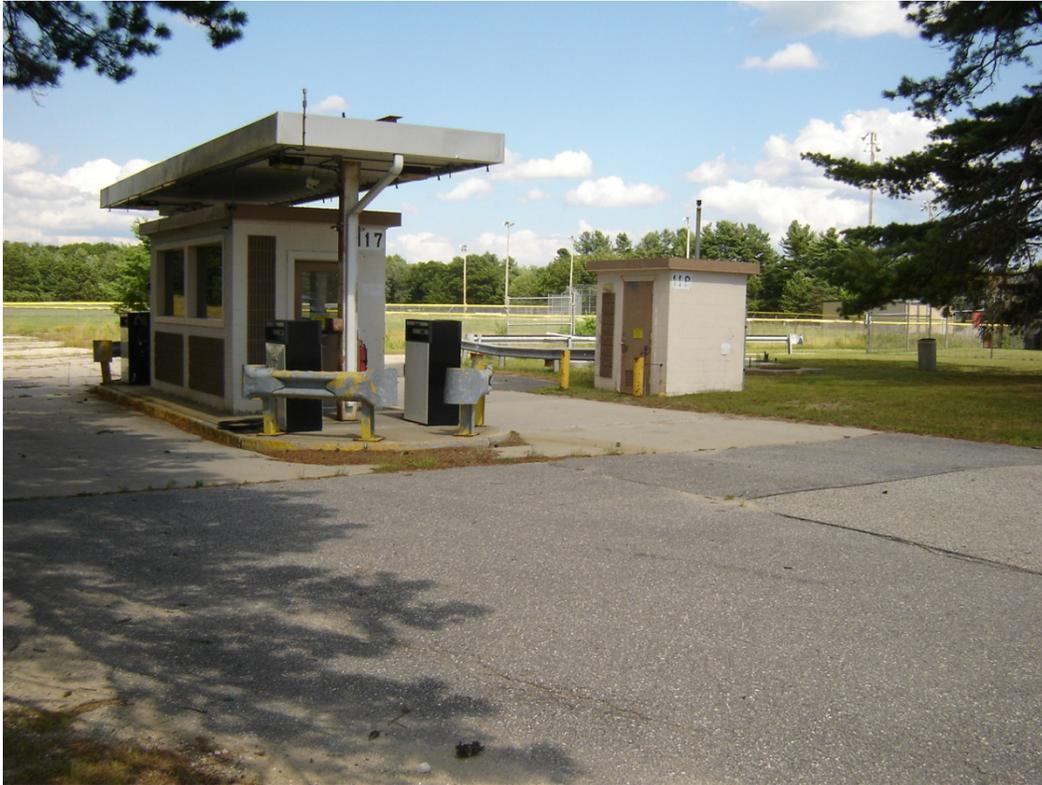
No. 1 Buildings 117 and 118 Parcel – NAS Brunswick July 29, 2010
Filling Station and Filling Station Storage building (background) north elevation

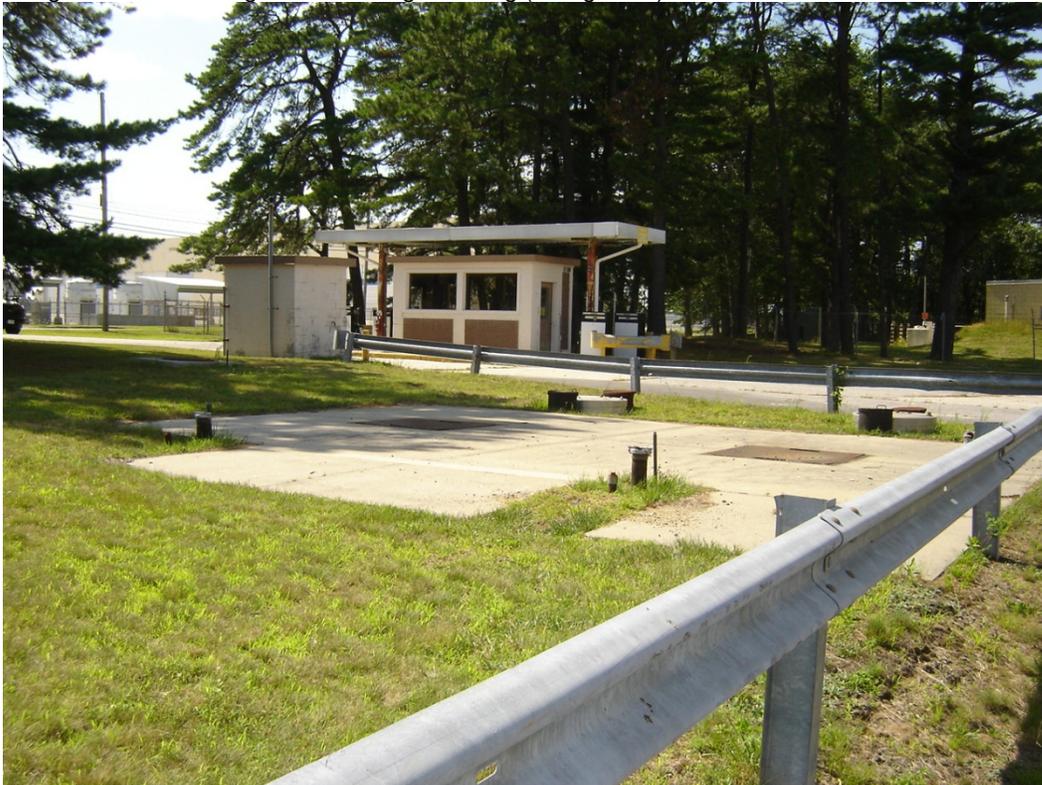
No. 2 Buildings 117 and 118 Parcel – NAS Brunswick July 29, 2010
Northwest view of filling station UST location (within guardrail); Buildings 117 and 118 in background

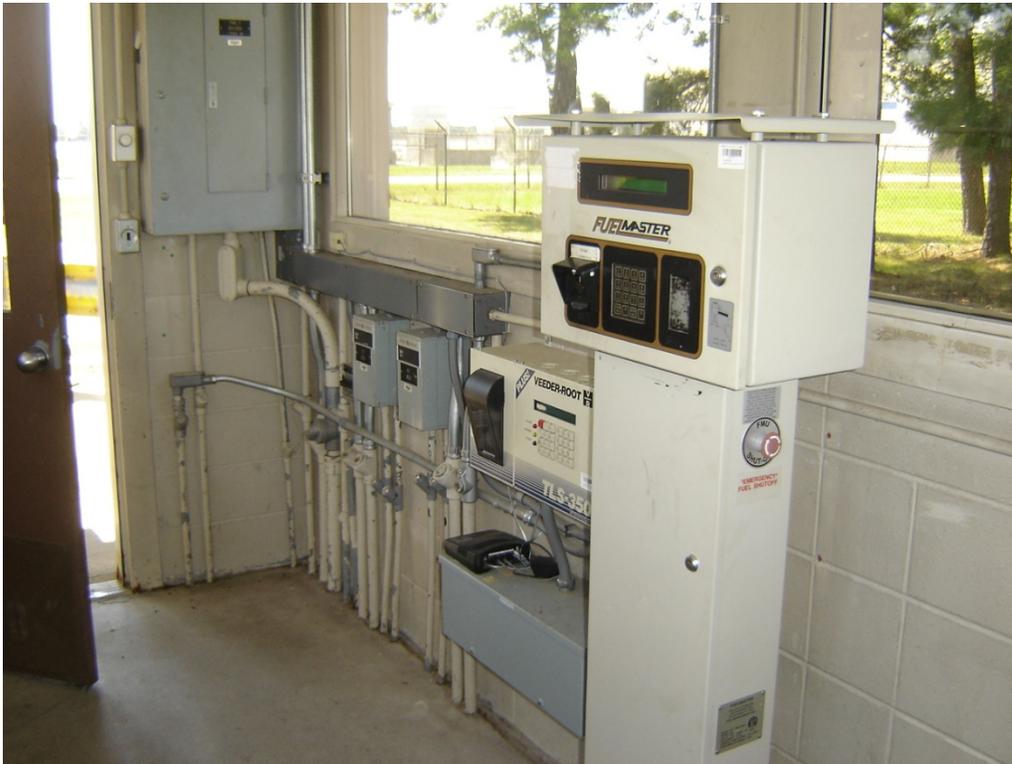
No. 3 Buildings 117 and 118 Parcel – NAS Brunswick
Filling Station Building interior; UST monitoring equipment

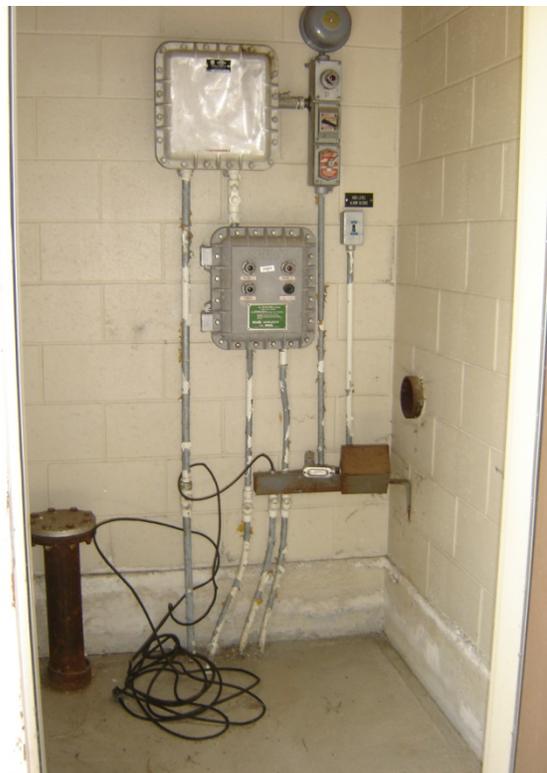
No. 4 Buildings 117 and 118 Parcel – NAS Brunswick
Filling Station Storage Building interior; former UST monitoring equipment
