FINAL RESOURCE CONSERVATION AND RECOVERY ACT PARTIAL CLOSURE REPORT  
FOR BUILDINGS 405, 406 AND 407 WITH TRANSMITTAL LETTER NAS BRUNSWICK ME  
10/1/2010  
NAS BRUNSWICK

Subj: Final RCRA Partial Closure Report for Buildings 405, 406, and 407

**RCRA PARTIAL CLOSURE REPORT**  
for  
**BUILDING 405 – STORAGE SHED**  
**BUILDING 406 – STORAGE SHED**  
**BUILDING 407 – STORAGE TRAILER**  
**NAVAL AIR STATION BRUNSWICK, MAINE**  
**USEPA IDENTIFICATION NUMBER ME8170022018**  
**SEPTEMBER 2010**

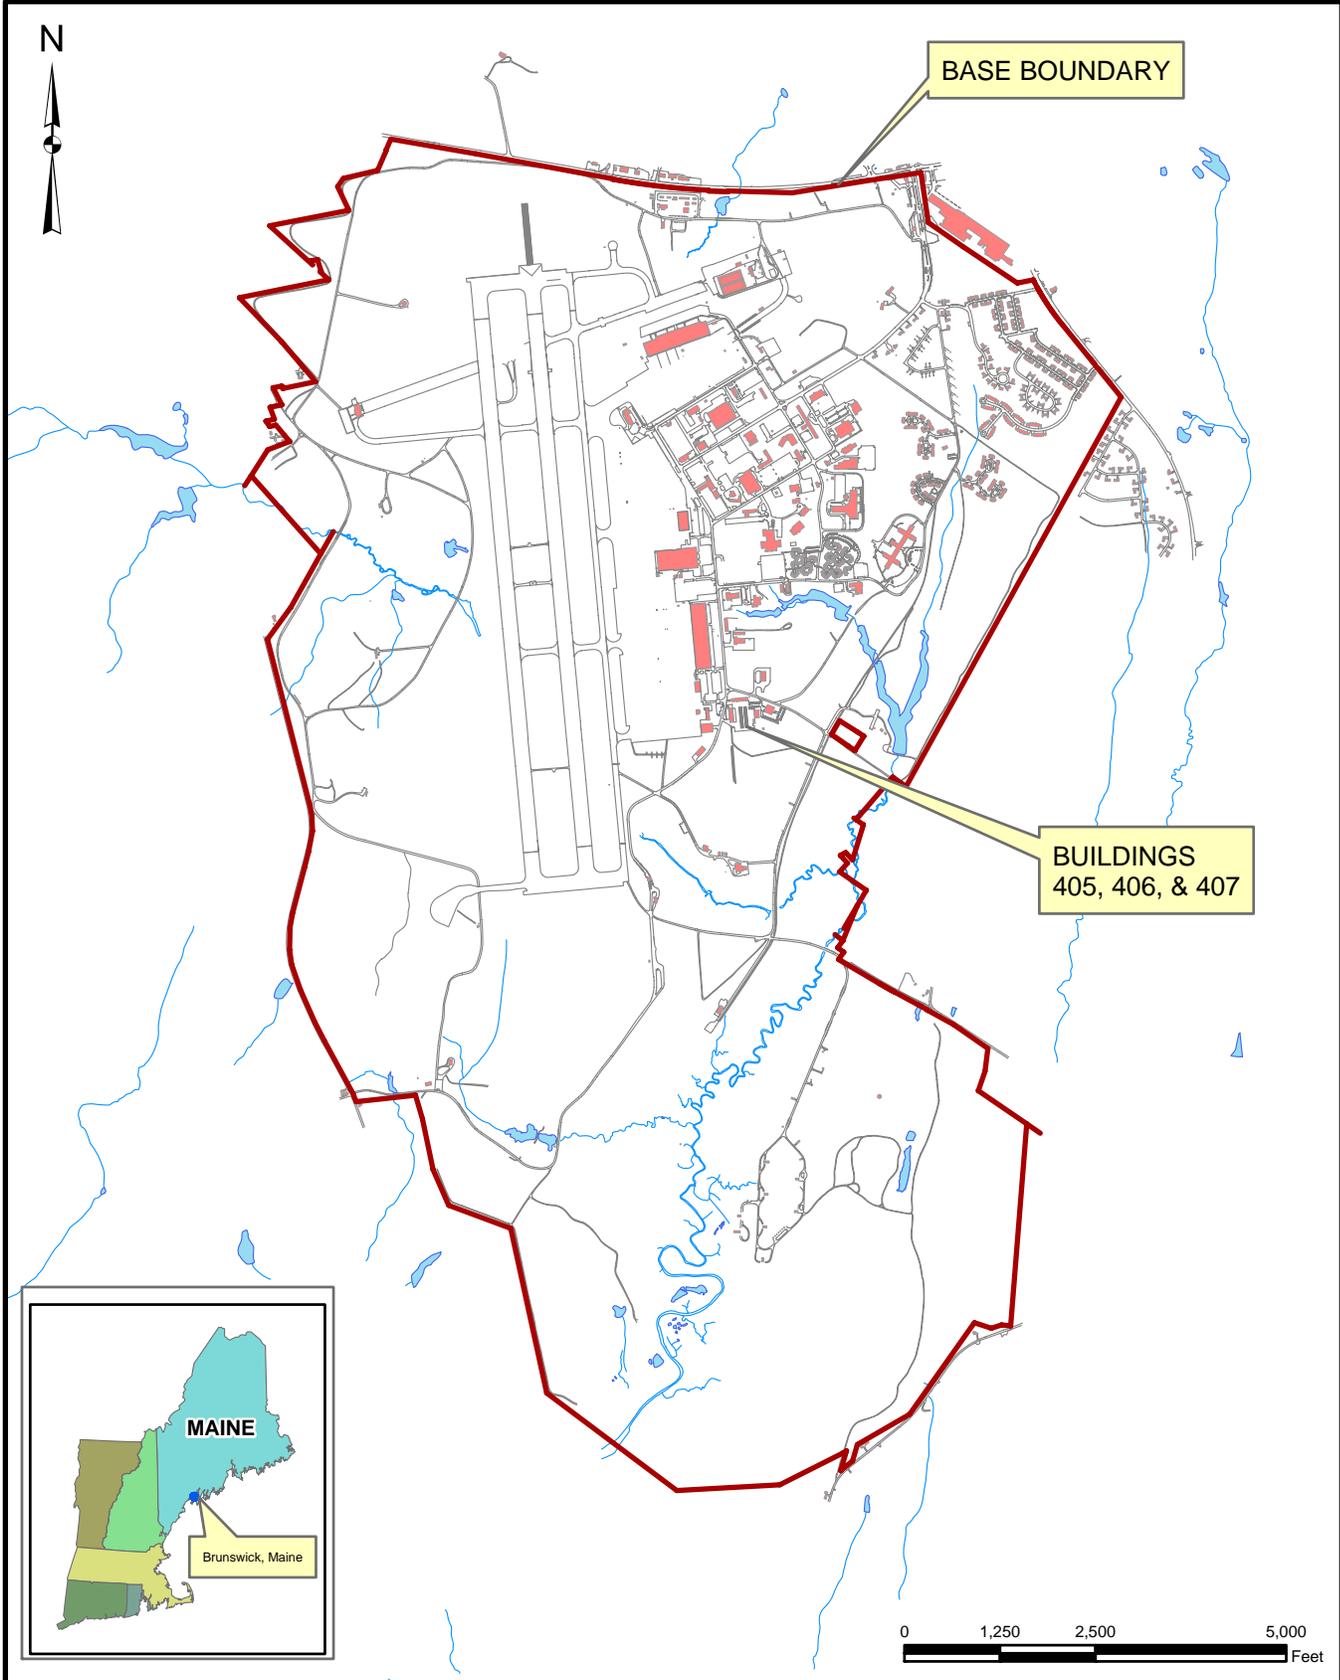
SCALE AS NOTED	
FILE I:\_NASB_BLDG_405,406&407_LOCUS.MXD	
REV 0	DATE 09/28/10
FIGURE NUMBER 1

Buildings 405 and 406 (storage sheds) and Building 407 (storage trailer) are located in the eastern-central portion of NAS Brunswick on the Building 584 (Public Works Building) parcel (Figures 1 and 2). The buildings are located along the south side of the Public Works asphalt-paved parking lot, south of Building 584. Grounds maintenance equipment (small tractors and mowers) are currently stored in the area where the buildings are located.

SITE LOCATION MAP  
 BUILDINGS 405, 406 AND 407  
 RCRA PARTIAL CLOSURE REPORT  
 NAVAL AIR STATION BRUNSWICK, MAINE

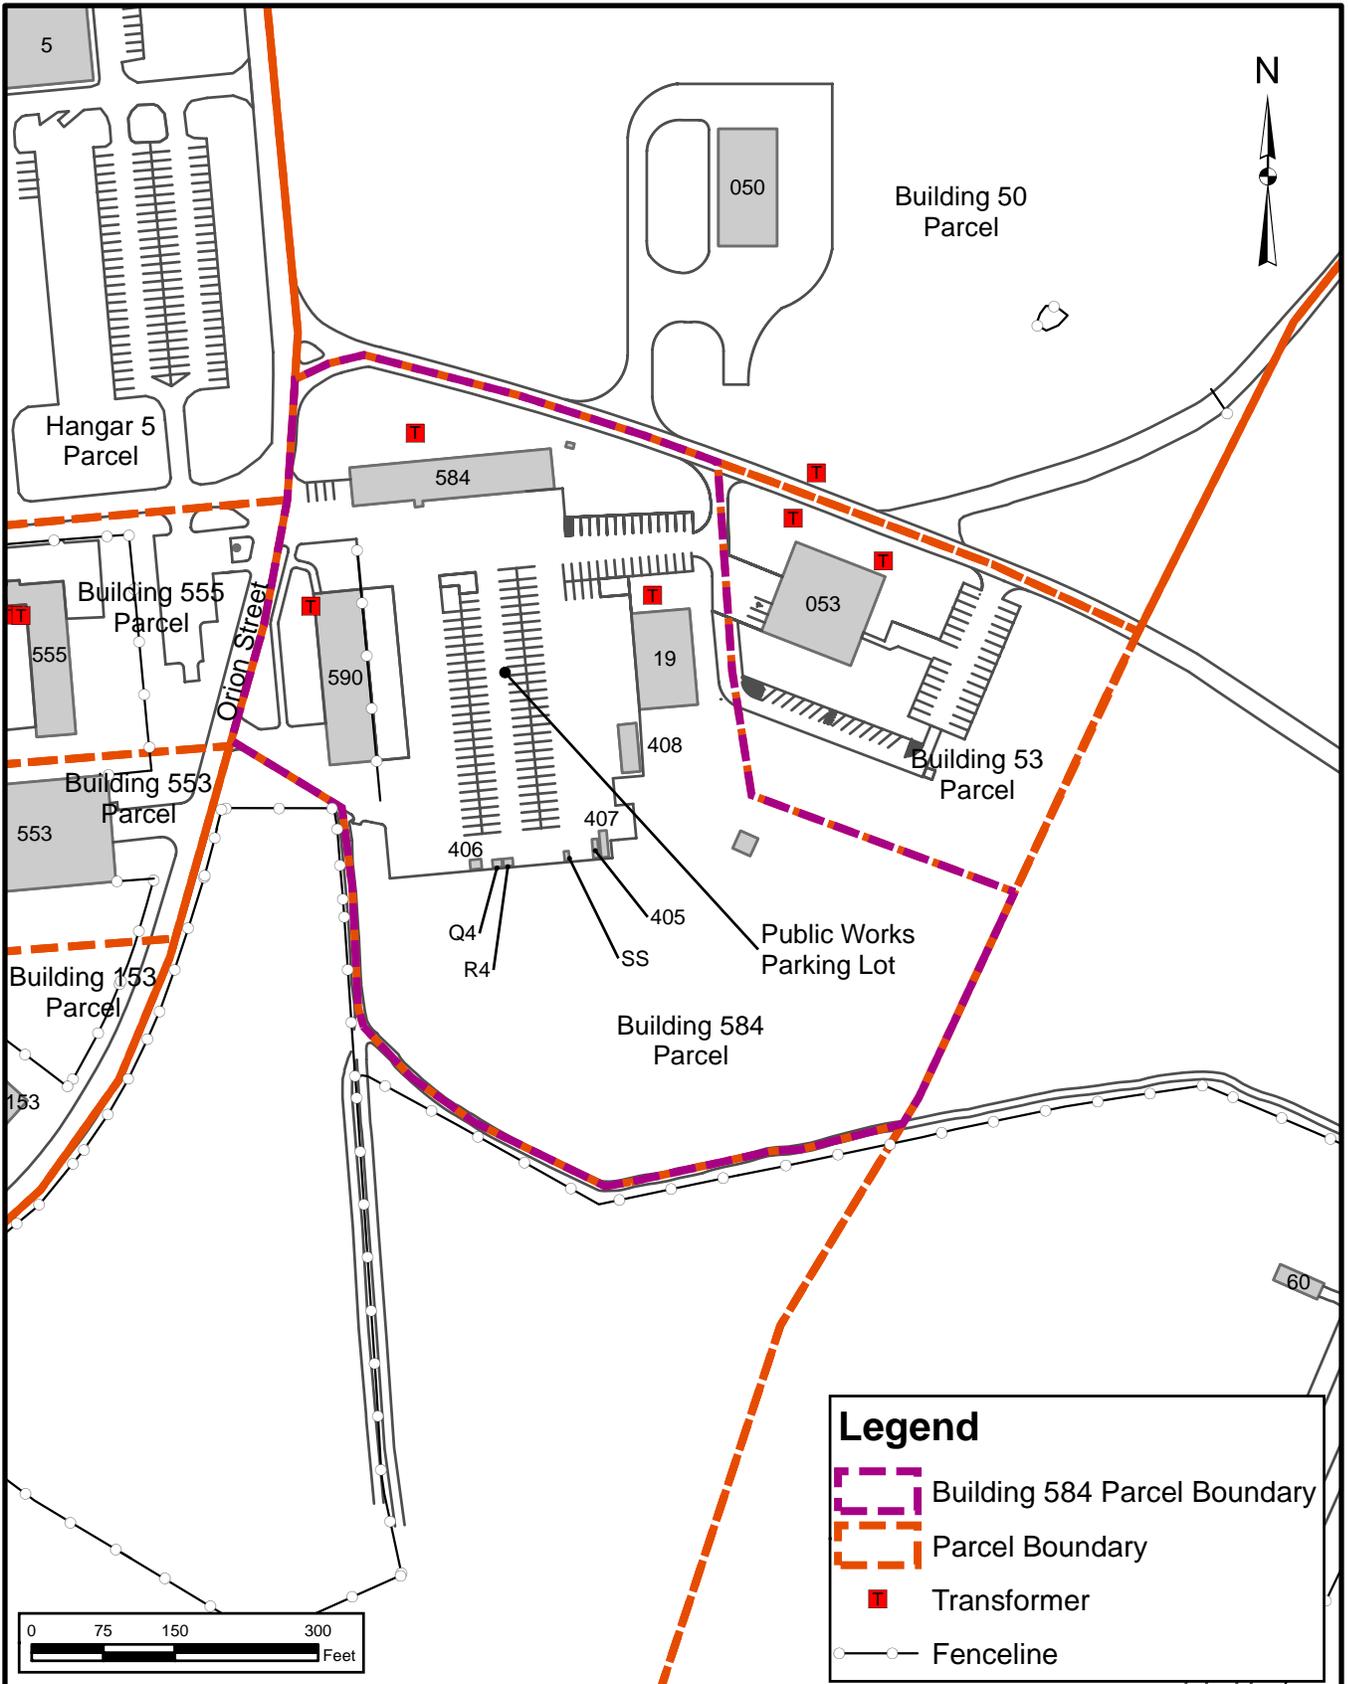
SCALE AS NOTED	
FILE	
I:\WASB_BLDG_405,406&407_SITE_MAP.MXD	
REV	DATE
0	09/29/10
FIGURE NUMBER	
2

The investigation conducted under this report applies only to the building footprints of Buildings 405, 406, and 407 (as shown on Figure 2). The "Building 584 Parcel RCRA Partial Closure Report" addresses the land surrounding and the groundwater underlying Buildings 405, 406, and 407.

This investigation of the hazardous waste closure requirement applies only to the building footprints of Buildings 405, 406, and 407 (building footprints as shown on Figure 2). It does not apply to the land surrounding or the groundwater underlying Buildings 405, 406, and 407. The surrounding land and underlying groundwater are addressed in the "Building 584 Parcel RCRA Partial Closure Report".

**SITE PLAN**  
 BUILDINGS 405, 406 AND 407  
 RCRA PARTIAL CLOSURE REPORT  
 NAS BRUNSWICK, MAINE

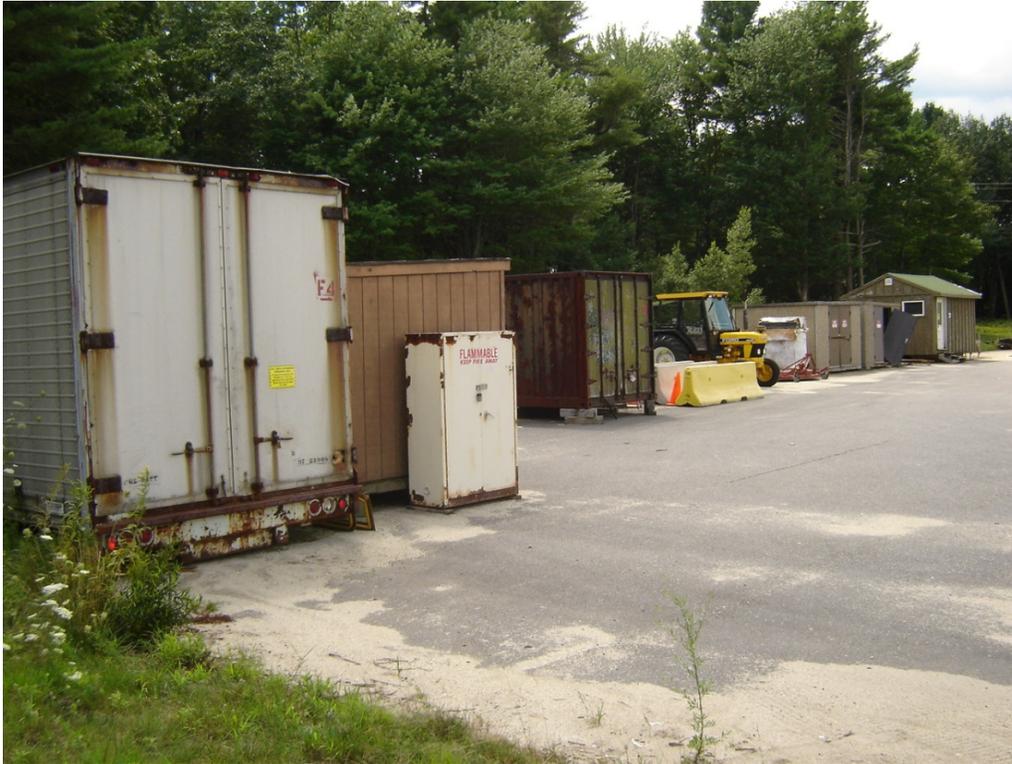
No. 1 Buildings 405, 406 and 407 – NAS Brunswick July 29, 2010  
Northeast elevation: Building 407 and 405; Structures SS, R4, and Q4; and Building 406 (left to right)

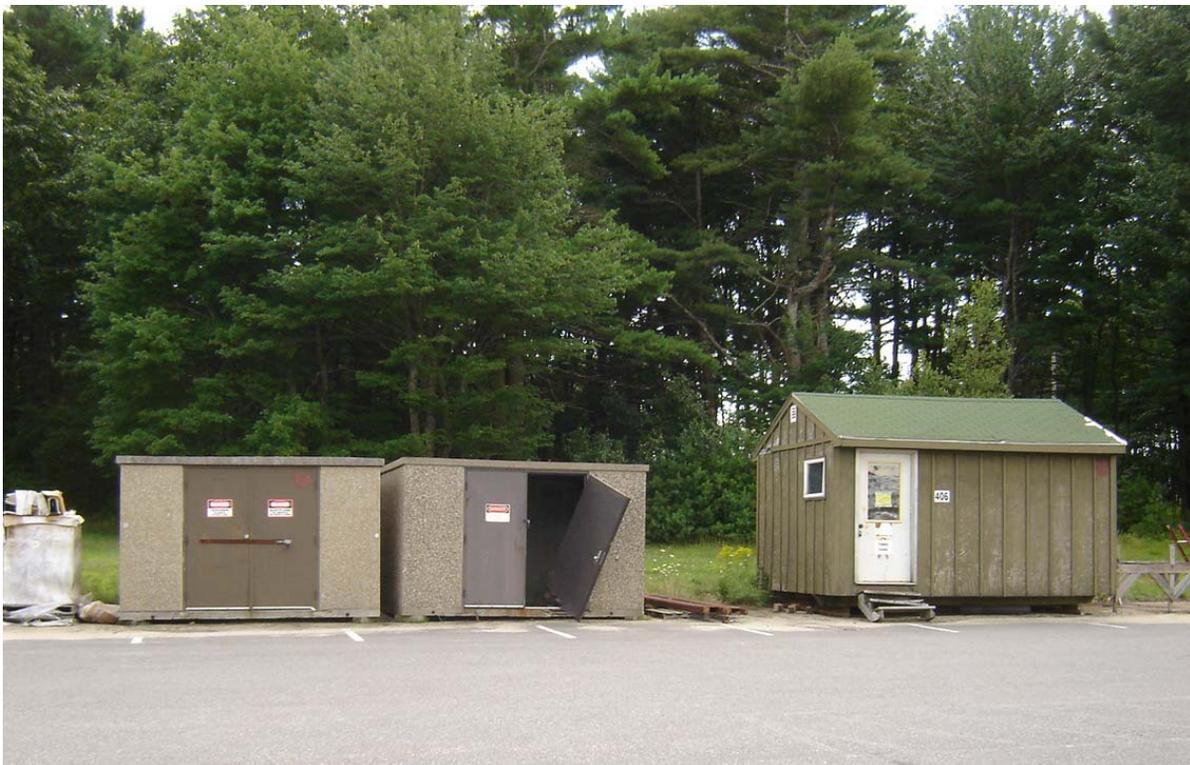
No. 2 Buildings 405, 406, and 407 – NAS Brunswick July 29, 2010  
North elevation: Structures R4, and Q4; and Building 406 (left to right)

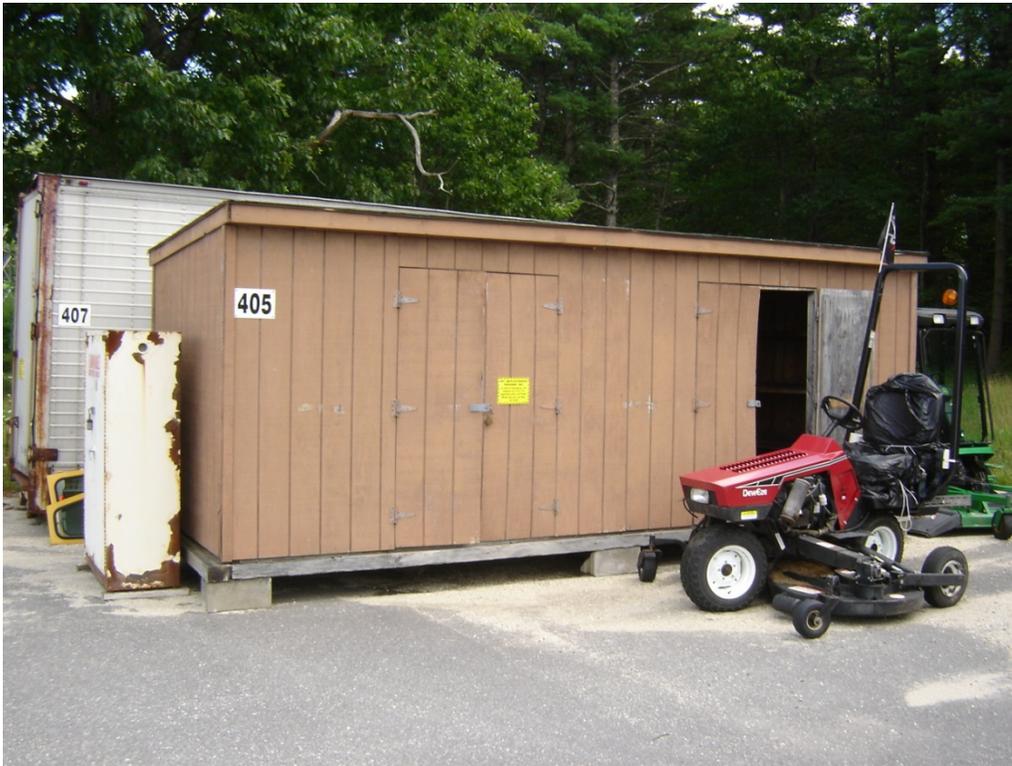
Building 405 is a single story, wood framed structure mounted on concrete blocks, asphalt shingled roof, and wood framing and walls. Building 405 consists of one room with shelving, no hazardous materials were used in its operation and no hazardous waste was generated, according to NAS Brunswick personnel. Building 405 is unheated.

At the time of inspection, Building 405 was vacant and in poor condition.

No. 3 Buildings 405, 406, and 407 – NAS Brunswick July 29, 2010  
Building 405 west elevation, with Building 407 in background

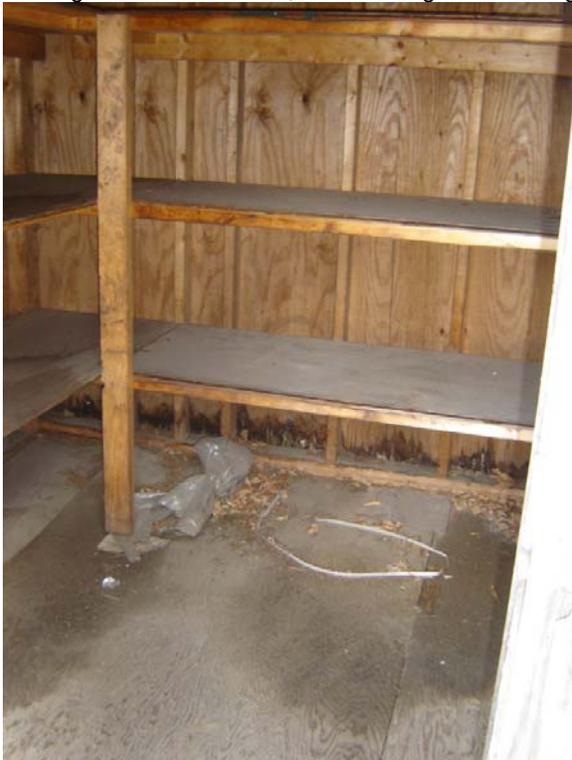
No signs of a past release (staining, unusual odors, etc.) were observed; although minor staining due to landscaper equipment storage was observed. No modifications to the structure, which may conceal signs of a past release, were observed.

No. 4 Buildings 405, 406, and 407 – NAS Brunswick July 29, 2010  
Building 405 interior

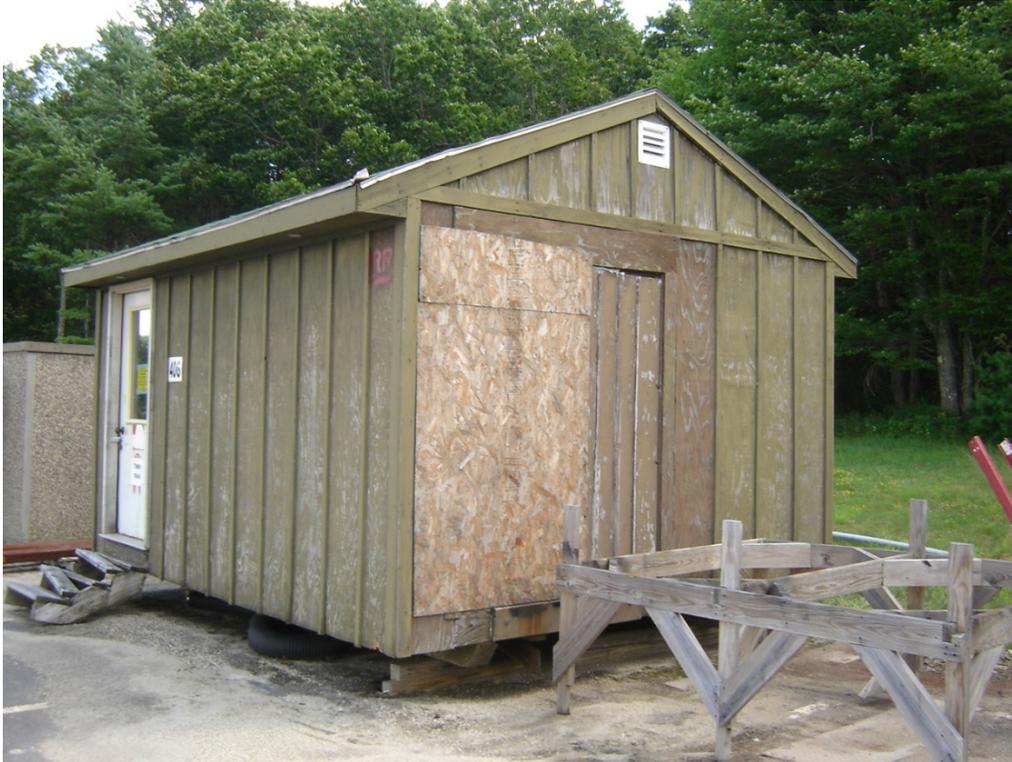
Building 406 is a single story, wood framed structure mounted on wood blocks, asphalt shingled roof, and wood framing and walls. Building 406 consists of one room, no hazardous materials were used in its operation and no hazardous waste was generated, according to NAS Brunswick personnel. Building 407 is unheated.

No. 5 Buildings 405, 406, and 407 – NAS Brunswick July 29, 2010  
Building 406 northwest elevation

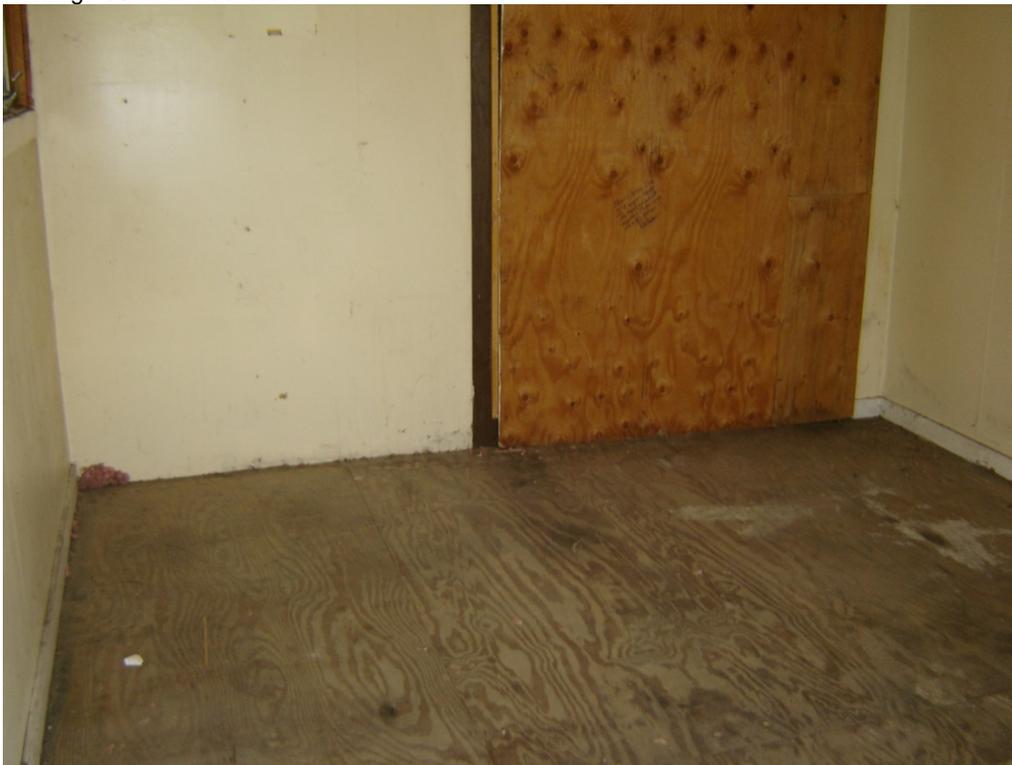
At the time of inspection, Building 406 and Structure Q4 were vacant and in fair to poor condition.

No. 6 Buildings 405, 406, and 407 – NAS Brunswick July 29, 2010  
Building 406 interior

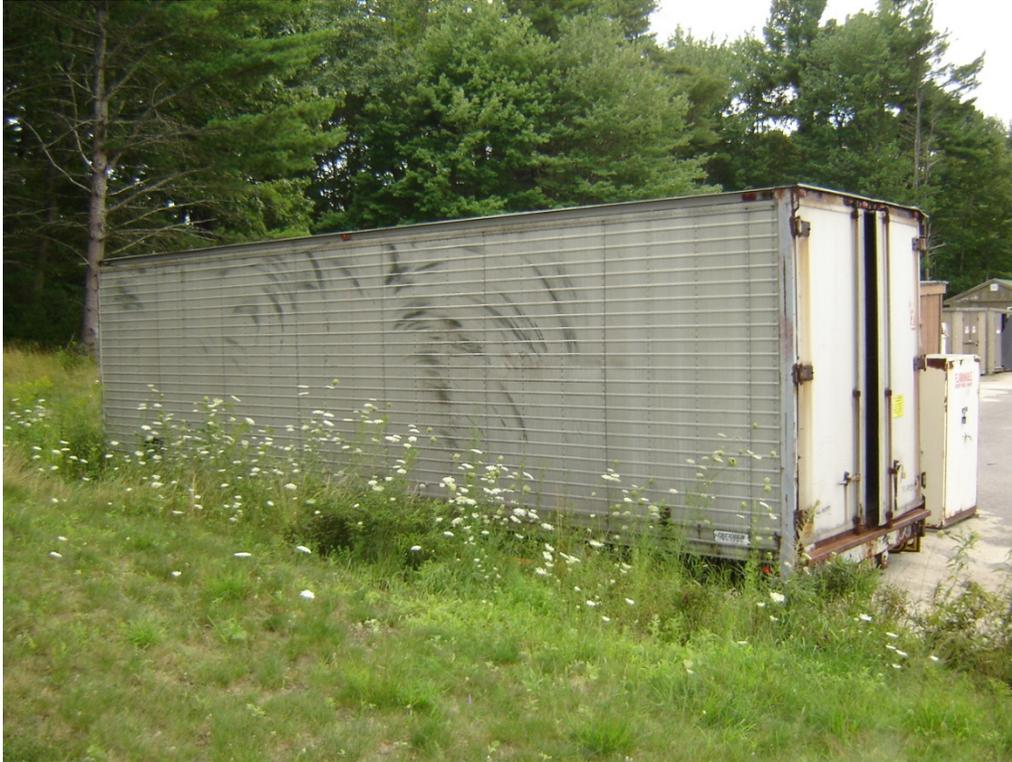
Building 407 is a single story, metal framed structure mounted on wood blocks, with metal roof and outside sheathing, and interior wood walls and floor. Building 407 consists of one room, no hazardous materials were used in its operation and no hazardous waste was generated, according to NAS Brunswick personnel. Building 407 is unheated.

No. 7 Buildings 405, 406, and 407 – NAS Brunswick July 29, 2010  
Building 407 ~~exterior~~interior northeast elevation

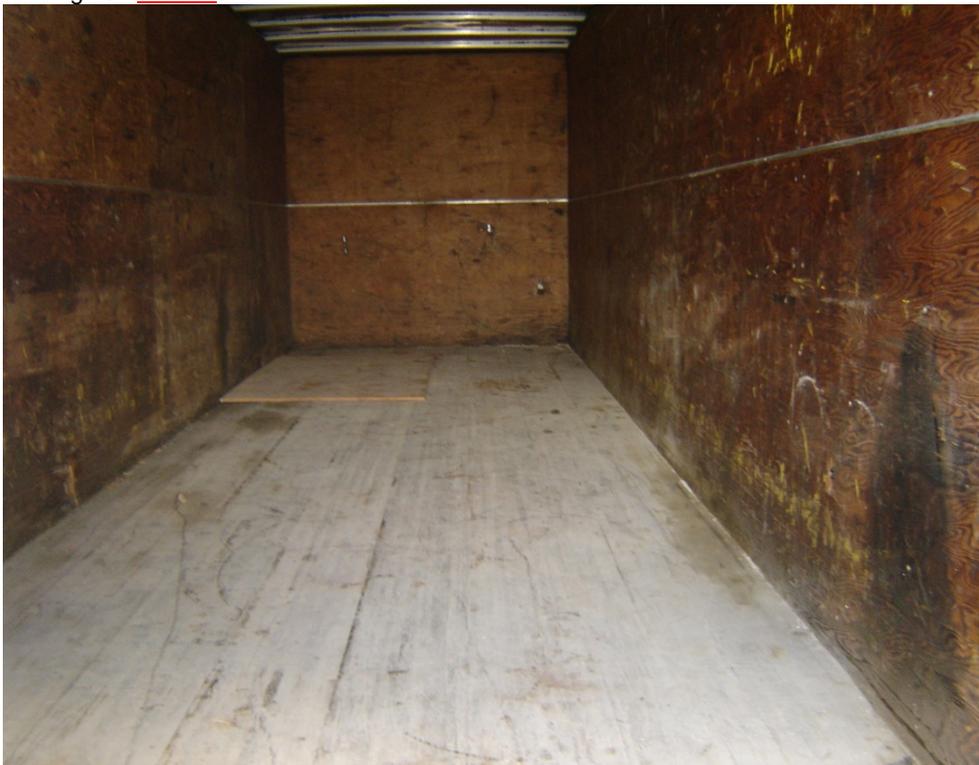
At the time of inspection, Building 407 was vacant and in fair condition.

No. 8 Buildings 405, 406, and 407 – NAS Brunswick July 29, 2010  
Building 407 interior

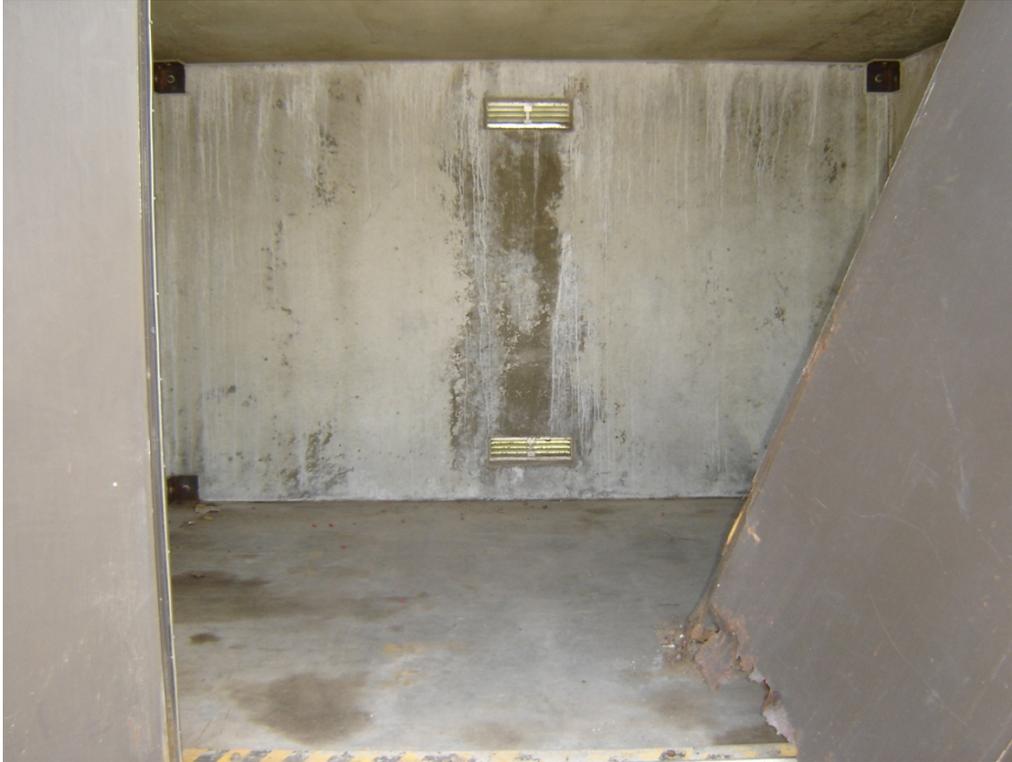
- At the time of the July 29, 2010 site visit, Building 406 was unoccupied and in fair condition.
- At the time of the July 29, 2010 site visit, Structure Q4 was empty and in poor condition (one of the doors was off its hinges); access could not be gained to Structure R4.

No signs of a past release (staining, unusual odors, etc.) were observed; although minor staining due to historical tool and part storage in Structure Q4 was observed. No modifications to the structures, which may conceal signs of a past release, were observed.

No. 9 Buildings 405, 406 and 407 – NAS Brunswick July 29, 2010  
Structure Q4 interior

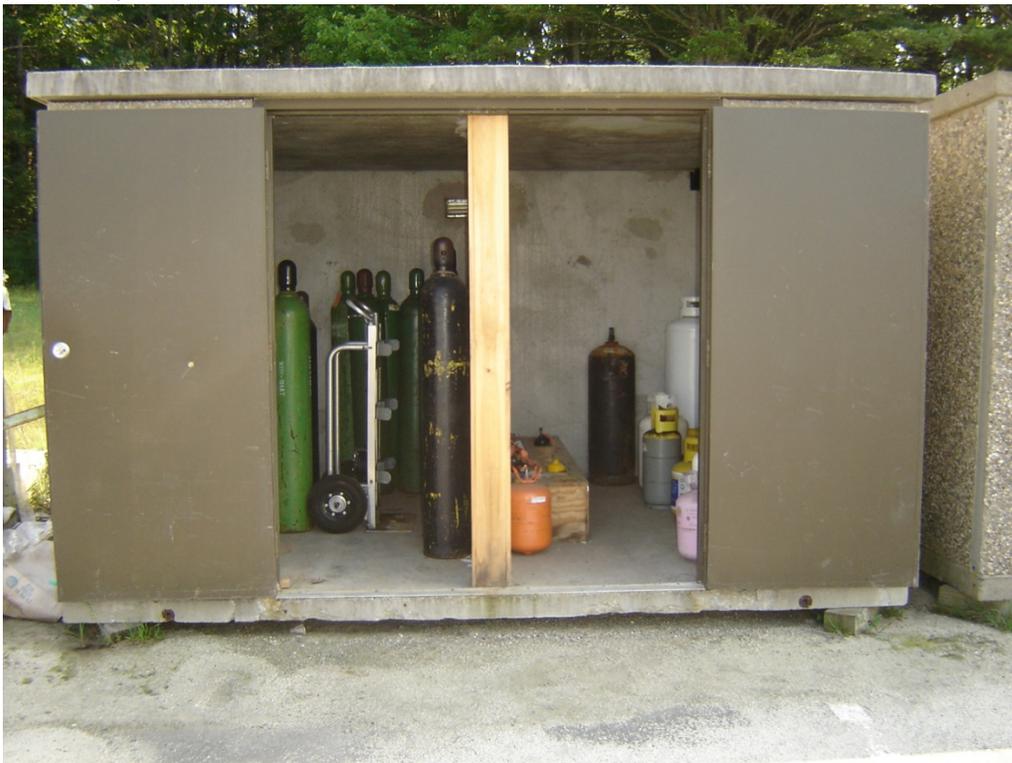
- At the time of the September 1, 2010 site visit, Structure R4 contained flammable and non-flammable gas cylinders, and was in good condition.
- No evidence of current or past hazardous waste generation was observed.

Structure R4 is located immediately east of Structure Q4 and was visited twice, once on July 29<sup>th</sup>, but Tetra Tech was unable to visually inspect the structure's interior; Tetra Tech returned on September 1<sup>st</sup> and inspected the structure's interior. Structure R4 has been partitioned into 2 separate rooms for the storage of gas cylinders. Welding gas cylinders, including acetylene and oxygen, are located on the east side of the structure; while air conditioning and other non-flammable gasses (i.e., CO<sub>2</sub>) are stored on the west side of Structure R4. No hazardous materials were used in its operation and no hazardous waste was generated, according to NAS Brunswick personnel. Its service timeframe is not known.

No. 10 Buildings 405, 406 and 407 – NAS Brunswick September 1, 2010  
Structure R4 interior; with welding gas cylinders left of the partition and miscellaneous gas cylinders to the right

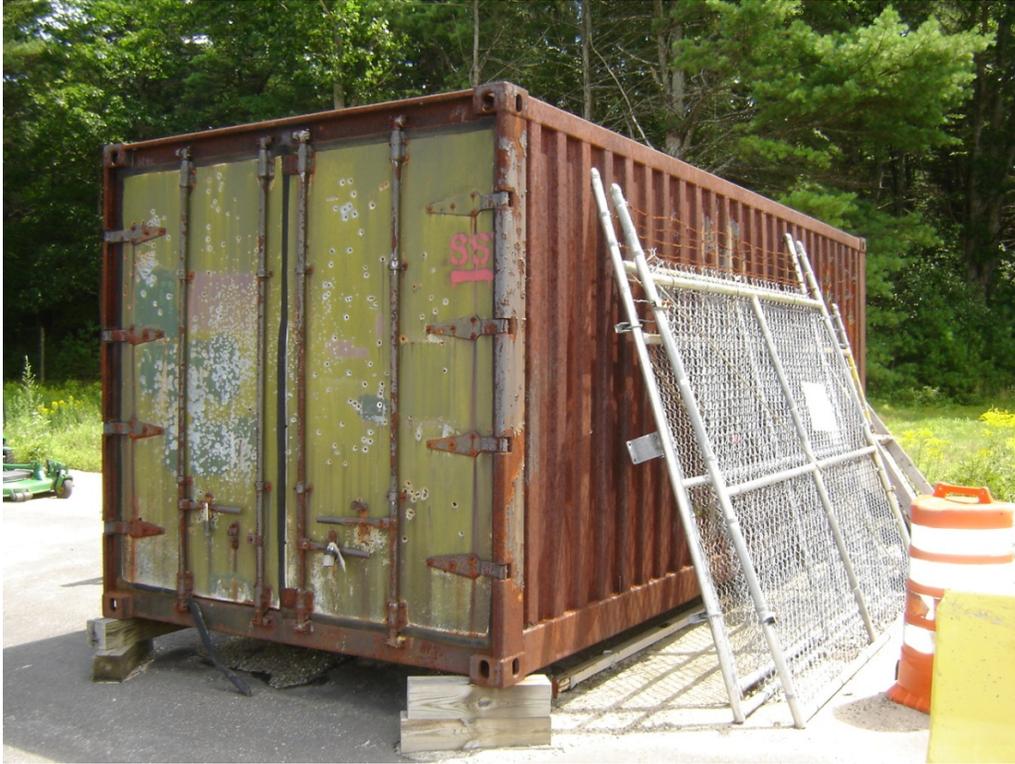
A shipping container, Structure SS, is positioned on the PW asphalt parking lot immediately west of Building 405. This 90-square-foot, unheated metal structure was used for the locksmith's tool and material storage; according to NAS Brunswick records. No hazardous materials were used in its operation and no hazardous waste was generated, according to NAS Brunswick personnel. Its service timeframe is not known.

No. 11 Buildings 405, 406 and 407 – NAS Brunswick  
Structure SS northwest elevation

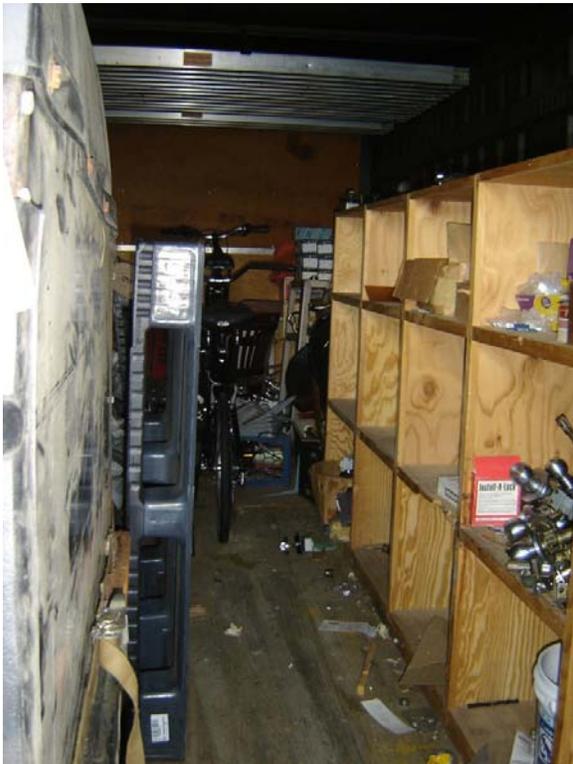
- At the time of the July 29, 2010 site visit, Building 405 was unoccupied and in poor condition.
- At the time of the site visit, Structure SS contained tools, equipment, and supplies for the NAS Brunswick locksmith, and was in fair condition.
- No evidence of current or past hazardous waste generation was observed.
- No evidence of hazardous waste residues was observed.
- No structural modifications, which could conceal signs of a past release, were observed.
- No hazardous waste storage areas or hazardous waste accumulation areas were observed.
- No electrical transformers that could be a potential source of polychlorinated biphenyls (PCB) contamination were observed.
- No ASTs, USTs, or oil/water separators associated with Building 405 and/or Structure SS were observed.

No. 12 Buildings 405, 406 and 407 – NAS Brunswick July 29, 2010  
Structure SS interior (unit used to store miscellaneous locksmith supplies)
