FINAL RESOURCE CONSERVATION AND RECOVERY ACT PARTIAL CLOSURE REPORT  
FOR BUILDINGS 548 AND 549 WITH TRANSMITTAL LETTER NAS BRUNSWICK ME  
10/12/2010  
NAS BRUNSWICK

Subj: Final RCRA Partial Closure Report for Buildings 548 and 549

**RCRA PARTIAL CLOSURE REPORT**  
**for**  
**BUILDING 548 – HIGH EXPLOSIVE MAGAZINE**  
**BUILDING 549 – HIGH EXPLOSIVE MAGAZINE**  
**NAVAL AIR STATION BRUNSWICK, MAINE**  
**USEPA IDENTIFICATION NUMBER ME8170022018**  
**OCTOBER 2010**

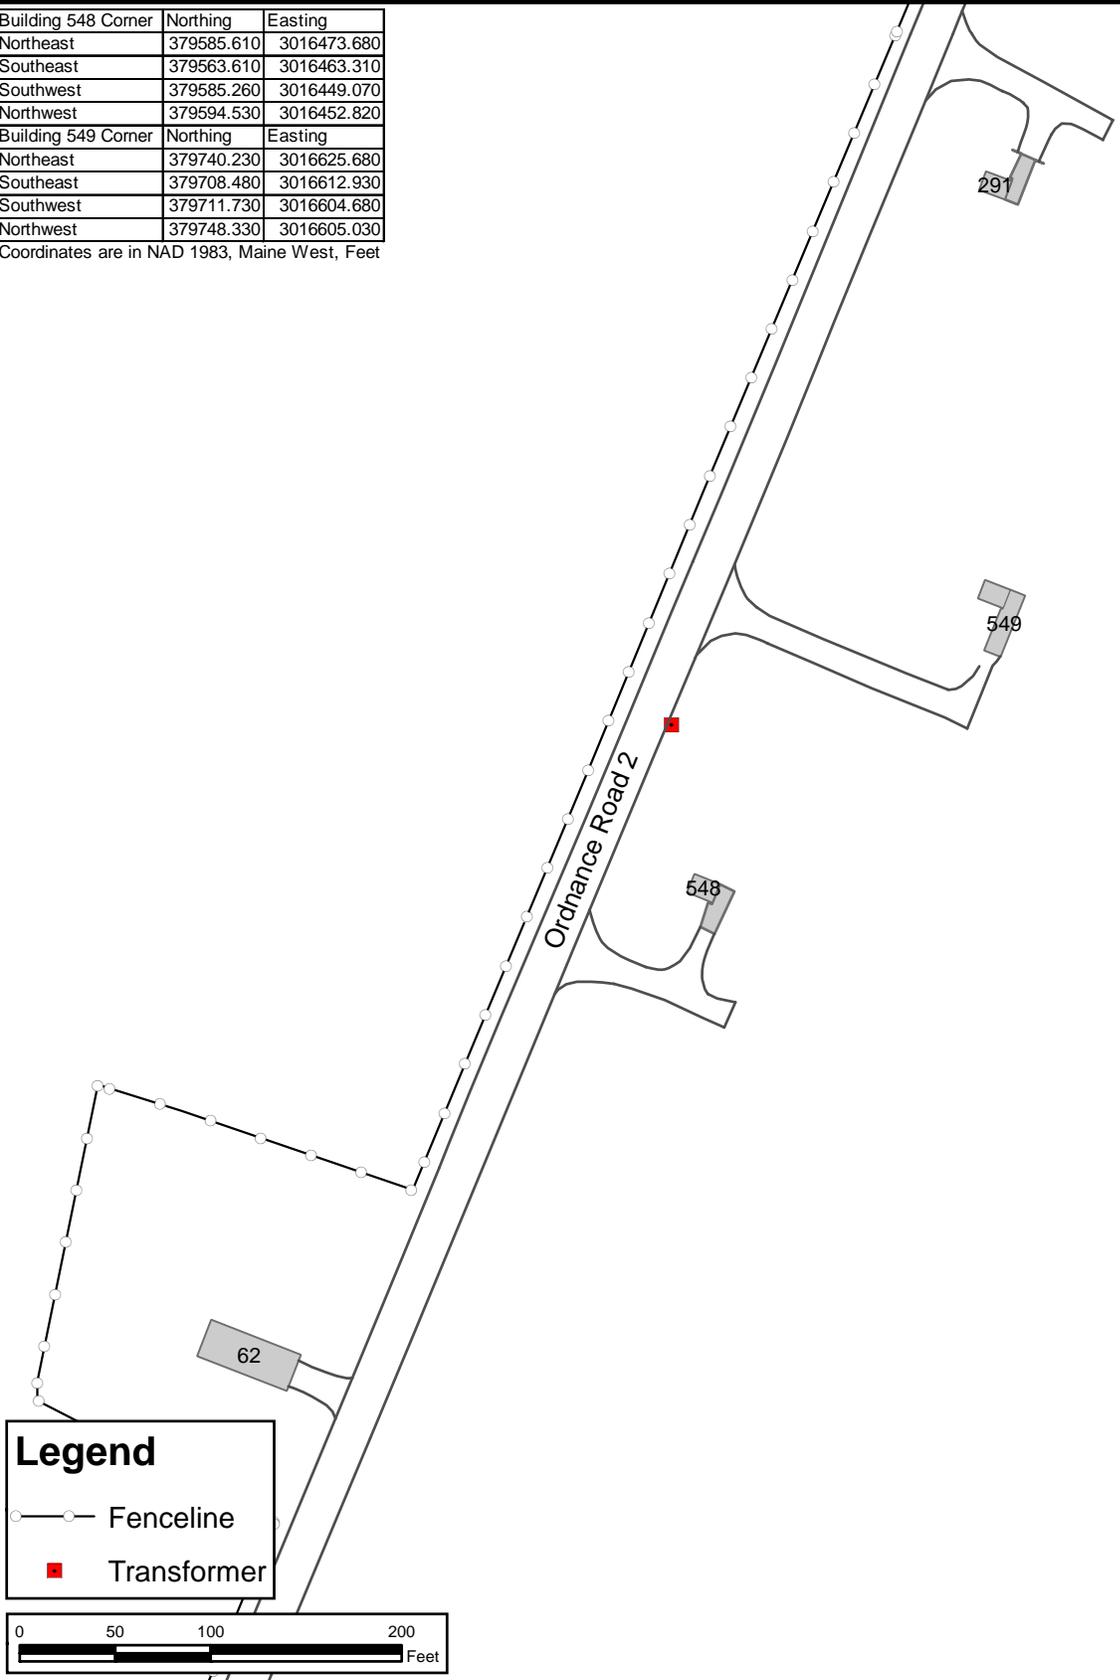
SCALE AS NOTED	
FILE \\NASB_BLDG_548&549_SITE_MAP.MXD	
REV 0	DATE 10/01/10
FIGURE NUMBER 2

The investigation conducted under this report applies only to the building footprints of Buildings 548 and 549 (as shown on Figure 2). The Weapons/Magazine Area Parcel RCRA Partial Closure Report addresses the land surrounding and the groundwater underlying Buildings 548 and 549.

Building 548 Corner		
Corner	Northing	Easting
Northeast	379585.610	3016473.680
Southeast	379563.610	3016463.310
Southwest	379585.260	3016449.070
Northwest	379594.530	3016452.820
Building 549 Corner		
Corner	Northing	Easting
Northeast	379740.230	3016625.680
Southeast	379708.480	3016612.930
Southwest	379711.730	3016604.680
Northwest	379748.330	3016605.030

**SITE PLAN**  
**BUILDINGS 548 AND 549 - WEAPONS BUILDINGS**  
**RCRA PARTIAL CLOSURE REPORT**  
**NAVAL AIR STATION BRUNSWICK, MAINE**

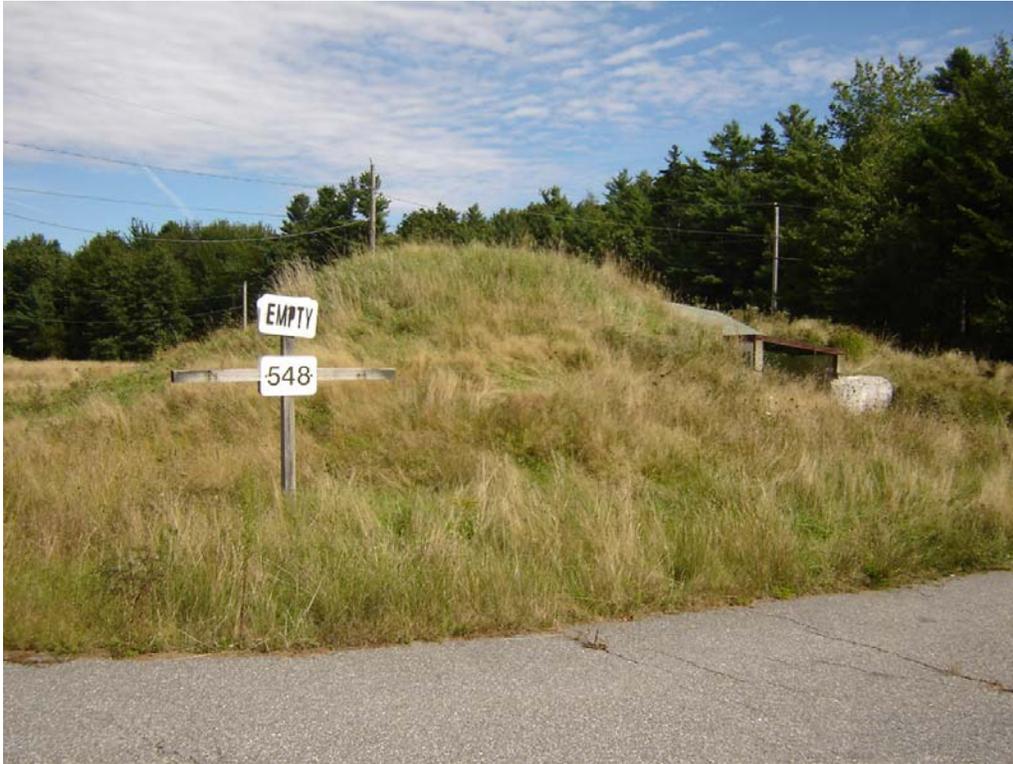
No. 1 Buildings 548 and 549 – NAS Brunswick September 16, 2010  
Building 548 – High Explosive Magazine south elevation

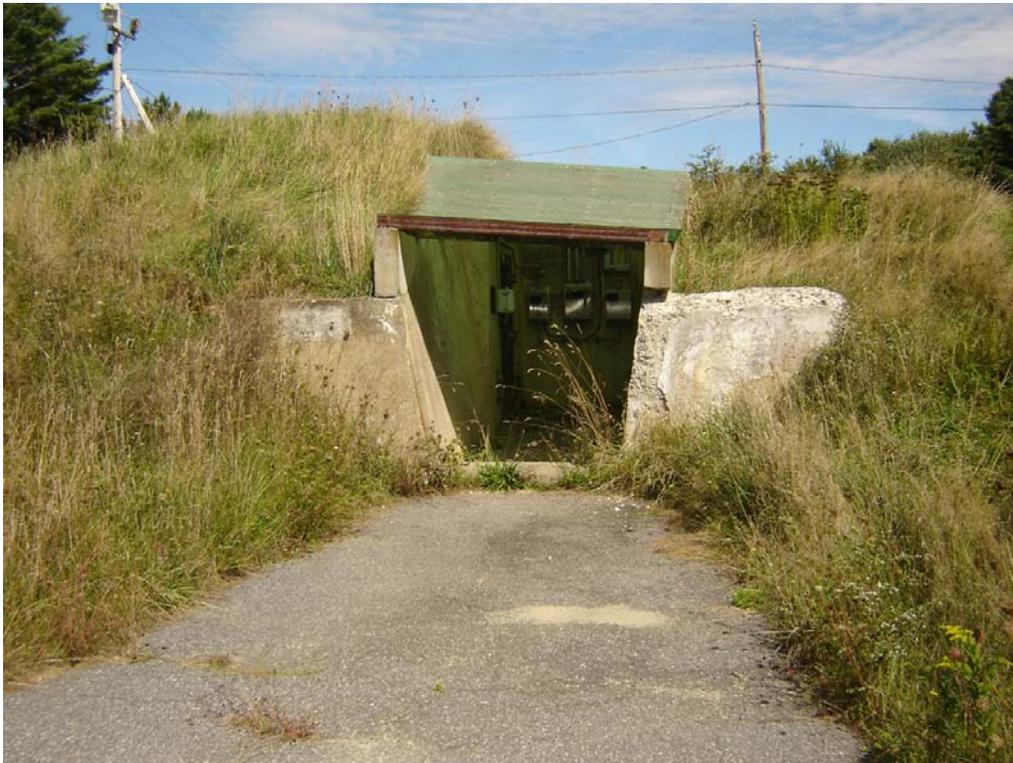
No. 2 Buildings 548 and 549 – NAS Brunswick September 16, 2010  
Building 548 – High Explosive Magazine entrance passageway

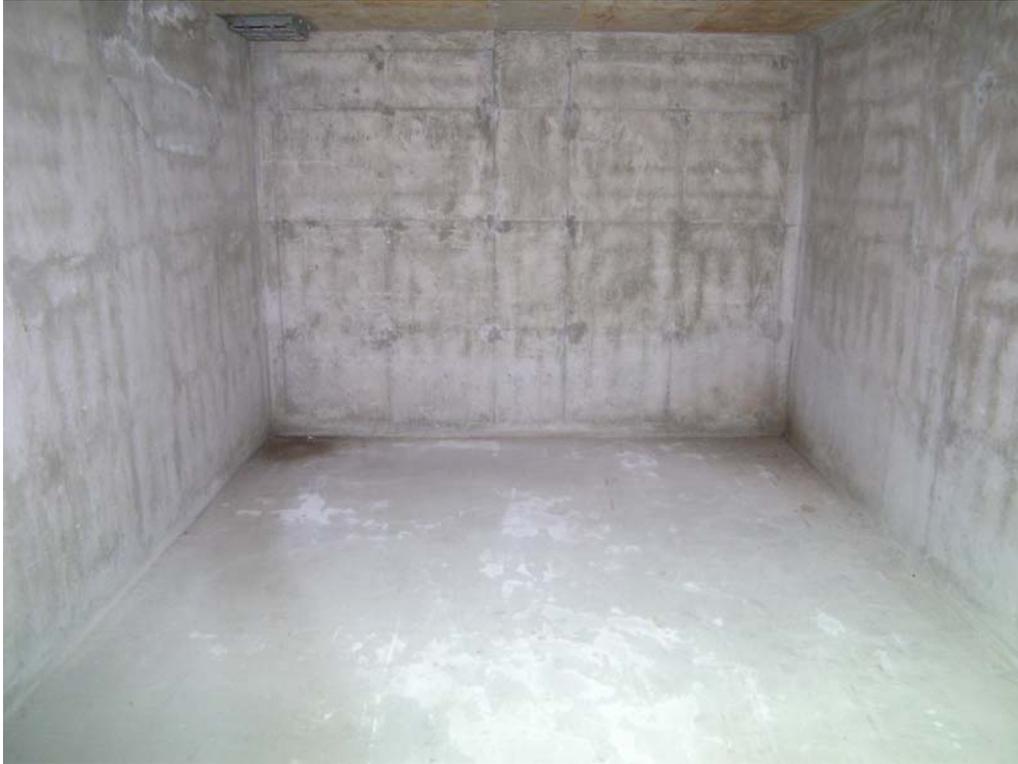
At the time of the site visit, the building appeared in poor condition. The building was empty. No evidence of current or past hazardous waste generation activities was observed. No evidence of hazardous waste residues was observed. No evidence of staining or additions, which may conceal signs of a past release, were observed. No hazardous waste storage areas or hazardous waste accumulation areas were observed.

No. 3 Buildings 548 and 549 – NAS Brunswick September 16, 2010  
Building 548 – High Explosive Magazine interior

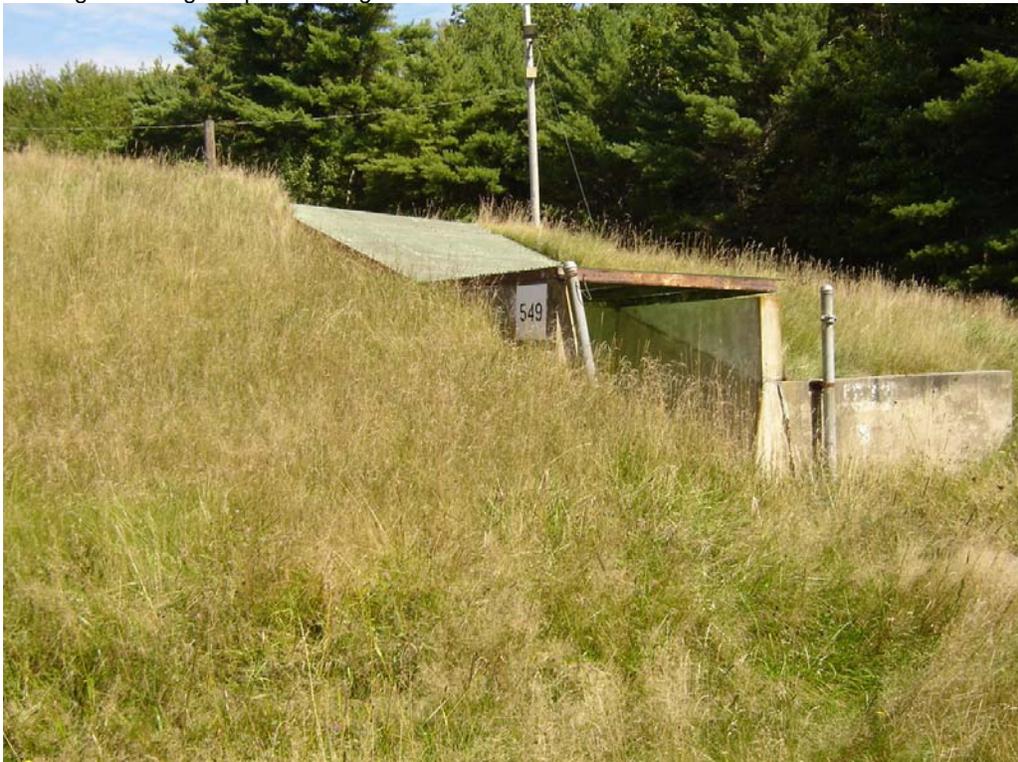
No. 4 Buildings 548 and 549 – NAS Brunswick September 16, 2010  
Building 549 – High Explosive Magazine southwest elevation

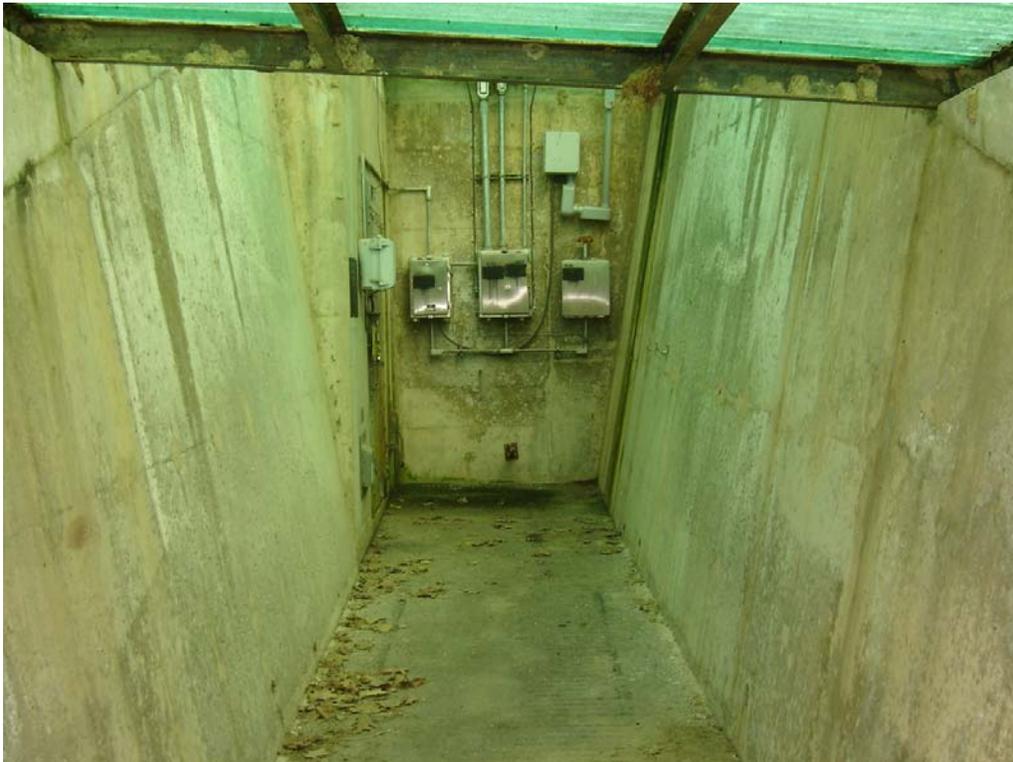
No. 5 Buildings 548 and 549 – NAS Brunswick September 16, 2010  
Building 549 – High Explosive Magazine entrance passageway

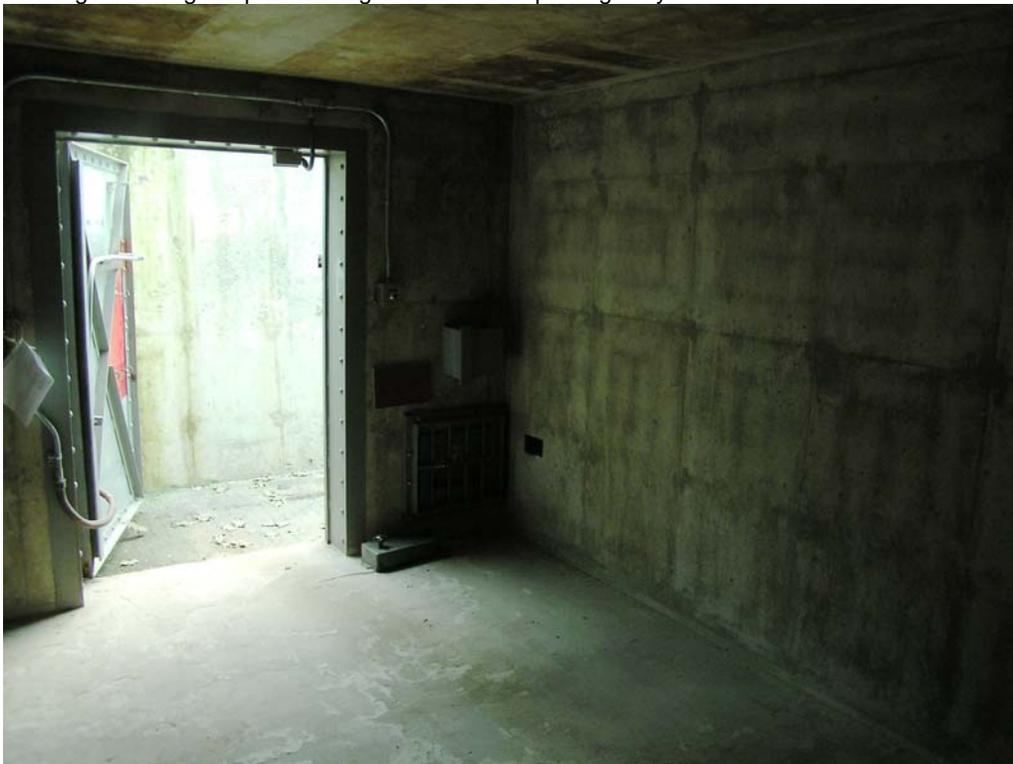
At the time of the site visit, the building appeared in poor condition. The building was empty. No evidence of current or past hazardous waste generation activities was observed. No evidence of hazardous waste residues was observed. No evidence of staining or additions, which may conceal signs of a past release, were observed. No hazardous waste storage areas or hazardous waste accumulation areas were observed.

No. 6 Buildings 548 and 549 – NAS Brunswick September 16, 2010  
Building 549 – High Explosive Magazine interior
