FINAL RESOURCE CONSERVATION AND RECOVERY ACT PARTIAL CLOSURE REPORT
FOR BUILDING 632 WITH TRANSMITTAL LETTER NAS BRUNSWICK ME
10/12/2010
NAS BRUNSWICK

RCRA PARTIAL CLOSURE REPORT
for
BUILDING 632 – NMCB-27/TRAINER BUILDING PARCEL
NAVAL AIR STATION BRUNSWICK, MAINE
USEPA IDENTIFICATION NUMBER ME8170022018
OCTOBER 2010

**HWSA INSPECTION REPORT
HAZARDOUS WASTE STORAGE AREAS CLOSURE
NAS BRUNSWICK
BRUNSWICK, MAINE
CTO WE22**

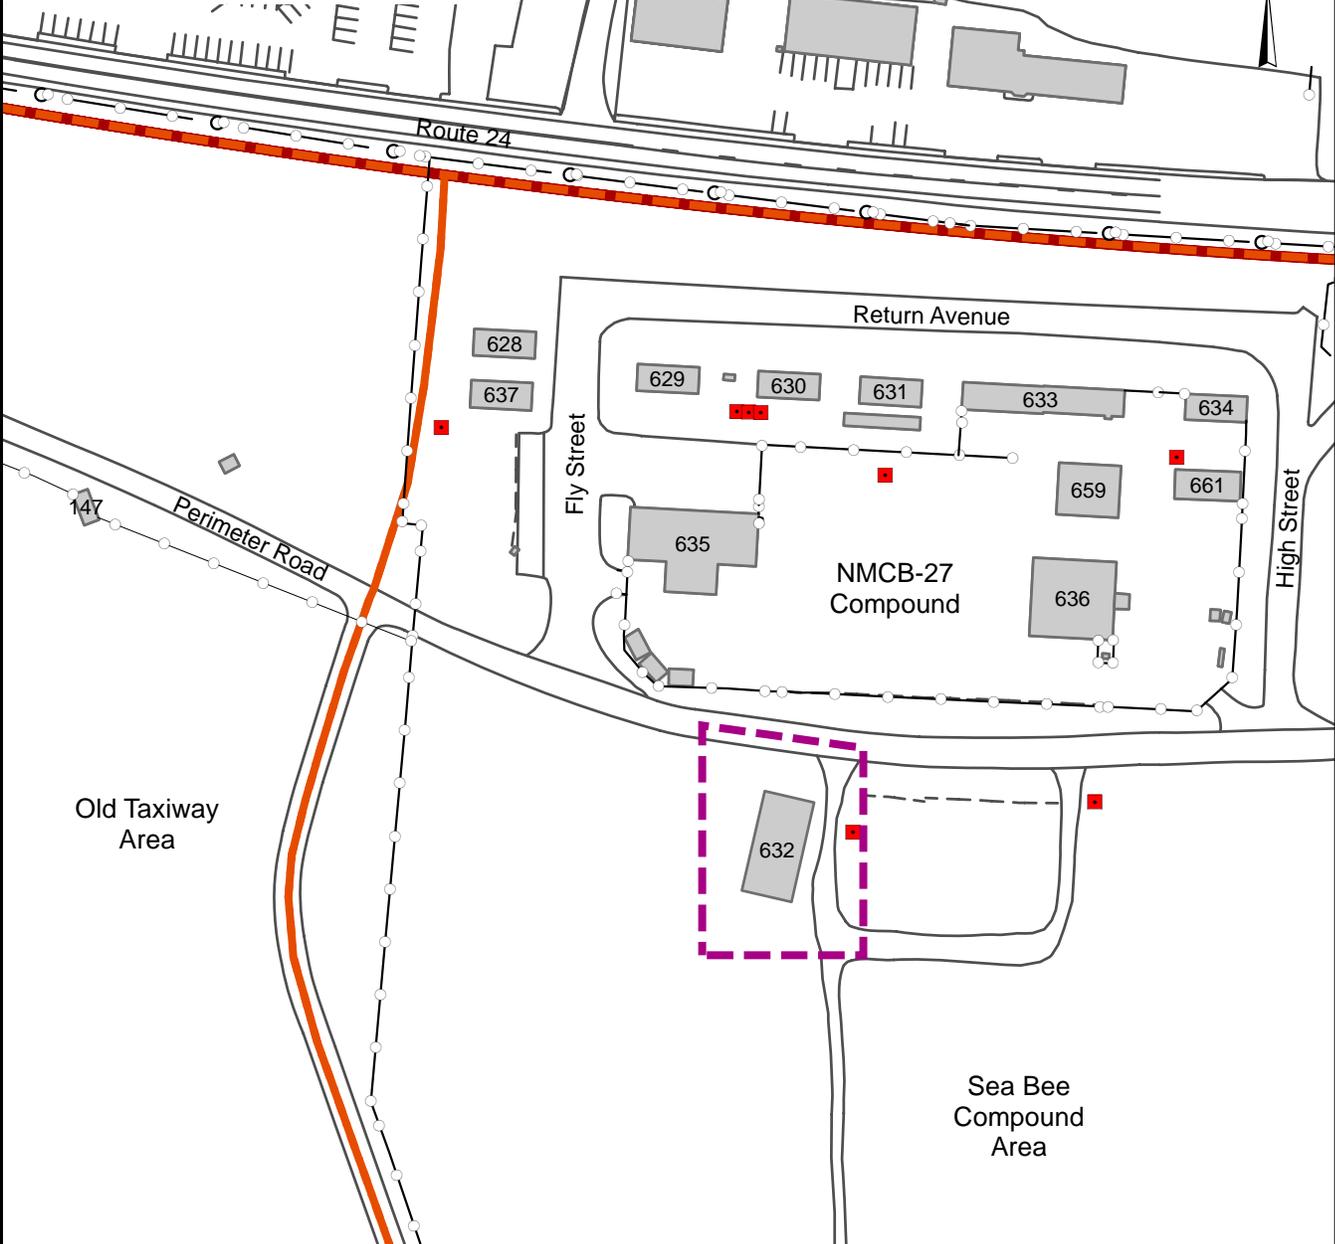
The Building 632 parcel is located in the northern portion of NAS Brunswick (Figure 1). The approximately 0.46-acre parcel is bordered to the north by Perimeter Road and the Naval Mobile Construction Battalion Twenty-Seven (NMCB-27) Compound, also known as the SeaBee Compound; to the east by vacant land; and to the south and west by tree-covered areas (Figure 2).

- Building 632 Parcel Boundary
- Parcel Boundary
- Transformer
- Fenceline
- Base Boundary

This investigation of the hazardous waste closure requirement applies to the Building 632 parcel (as shown on Figure 2) only.

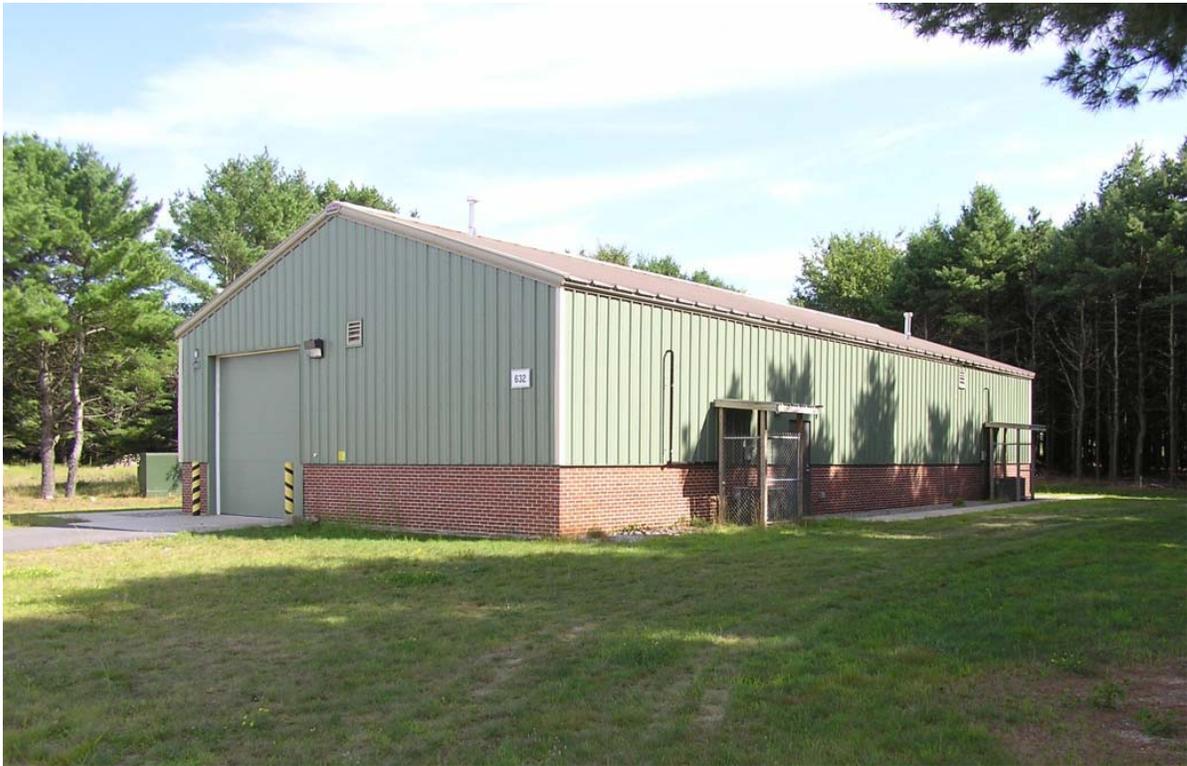
No. 1 Building 632 – NAS Brunswick
Building 632 northwest elevation (front facing perimeter Road)

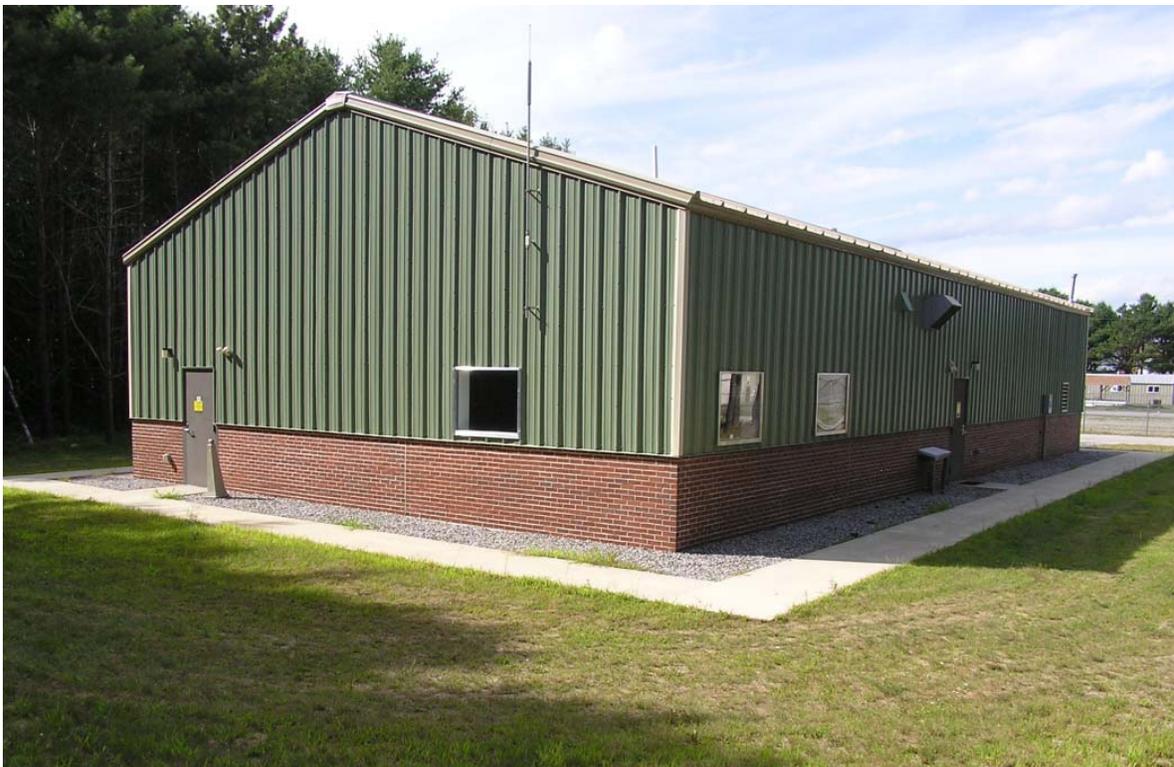
No. 2 Building 632 – NAS Brunswick
Building 632 southeast elevation (rear)

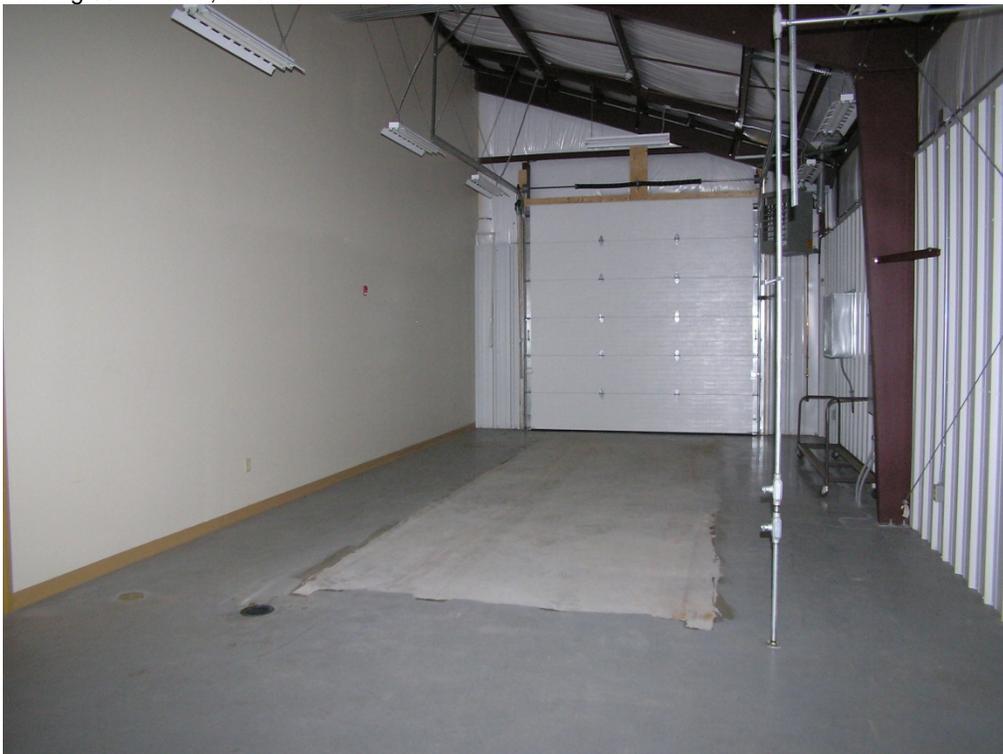
Building 632 is a one story, steel framed, roofed and sided structure on a concrete pad. One floor drain was observed within the garage portion of the structure, which is connected to the sanitary sewer. Building 632 consists of garage, office, class room and function hall spaces; no hazardous materials were used in its operation and no hazardous waste was generated, according to NAS Brunswick personnel. Building 632 is heated via a ceiling mounted natural gas heater in the garage area. Two heat pumps are located on the west side of the structure and provide air conditioning to the structure.

At the time of inspection, Building 632 was vacant and in good condition. No evidence of current or past hazardous waste generation was observed. No evidence of hazardous waste residues was observed. No signs of a past release (staining, unusual odors, etc.) were observed. Minor discolorization was observed on the concrete pad in the garage portion of the structure, which appears to be attributable to the concrete sealant used. No staining was observed on the floor in the area of the floor drain. No modifications to the structure, which may conceal signs of a past release, were observed.

No. 4 Building 632 – NAS Brunswick
Building 632 interior, garage bay in northeast corner; floor drain is present in left foreground

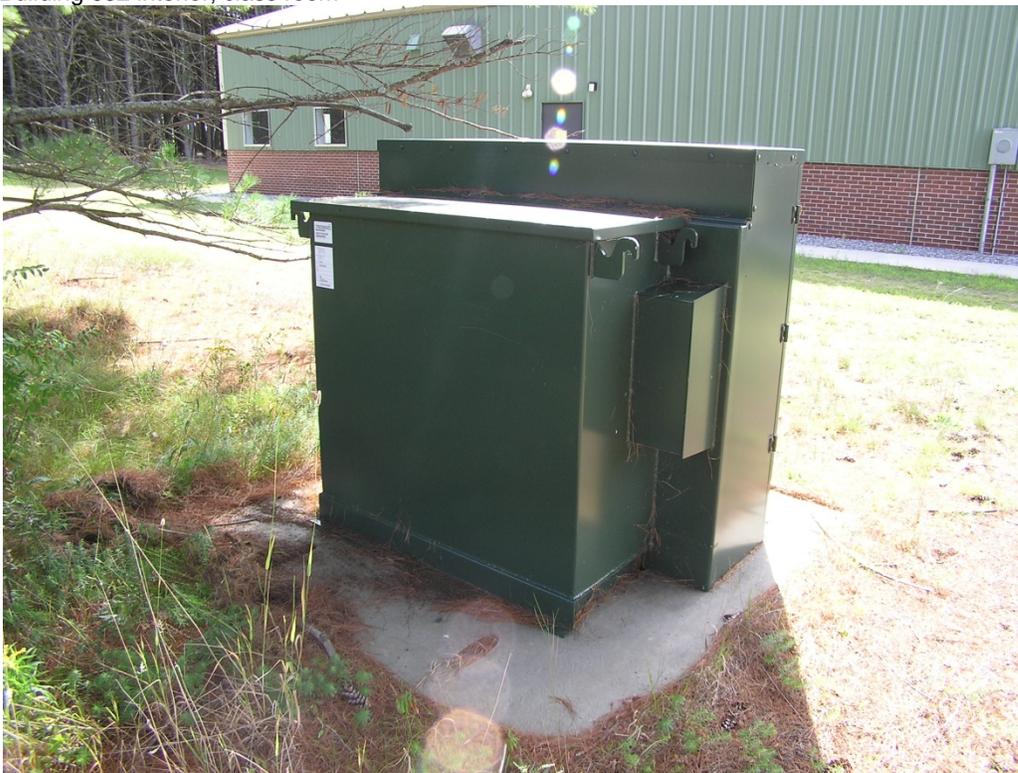
Labeling on the transformer indicates the unit was manufactured by Cooper Power Systems (serial number 0088YP06X89A). The first digits of the serial number indicate that it was manufactured in 1988; therefore, it is unlikely to contain polychlorinated-biphenyls (PCBs). As of July 1, 1979, the United States Environmental Protection Agency (EPA) prohibited all manufacturing of new PCB electrical equipment (transformers and capacitors). In addition, according to an electrical utility guide for identifying non-PCB transformers, all Cooper Power Systems transformers are non-PCB-containing (DTM, 2006). Furthermore, since the building wasn't constructed until 2006, it is unlikely that any PCB-containing transformers have been used at this location.

No transformer that could be a potential source of polychlorinated biphenyls (PCBs) contamination in the event of a leak was observed. One transformer was observed east of Building 632, which was not identified on the NAS Brunswick transformer List (February 2009). This transformer was manufactured by Cooper Power Systems, Serial No. 0088YP06X89A; Since this transformer is identified as manufactured by Cooper Power Systems on the manufacturer's nameplate, and the estimated date of installation coinciding with the construction of Building 632, this transformer is a non-polychlorinated-biphenyl (non-PCB)-containing transformer (DTM, 2006).

No. 6 Building 632 – NAS Brunswick
Transformer east of Building 632 (background)
