FINAL RESOURCE CONSERVATION AND RECOVERY ACT PARTIAL CLOSURE REPORT  
FOR BUILDING 296 WITH TRANSMITTAL LETTER NAS BRUNSWICK ME  
12/1/2010  
NAS BRUNSWICK

**RCRA PARTIAL CLOSURE REPORT**  
for  
**BUILDING 296 – OLD TACAN TRANSMITTER BUILDING**  
**NAVAL AIR STATION BRUNSWICK, MAINE**  
**USEPA IDENTIFICATION NUMBER ME8170022018**  
**NOVEMBER 2010**

**HWSA INSPECTION REPORT  
HAZARDOUS WASTE STORAGE AREAS CLOSURE  
NAS BRUNSWICK  
BRUNSWICK, MAINE  
CTO WE22**

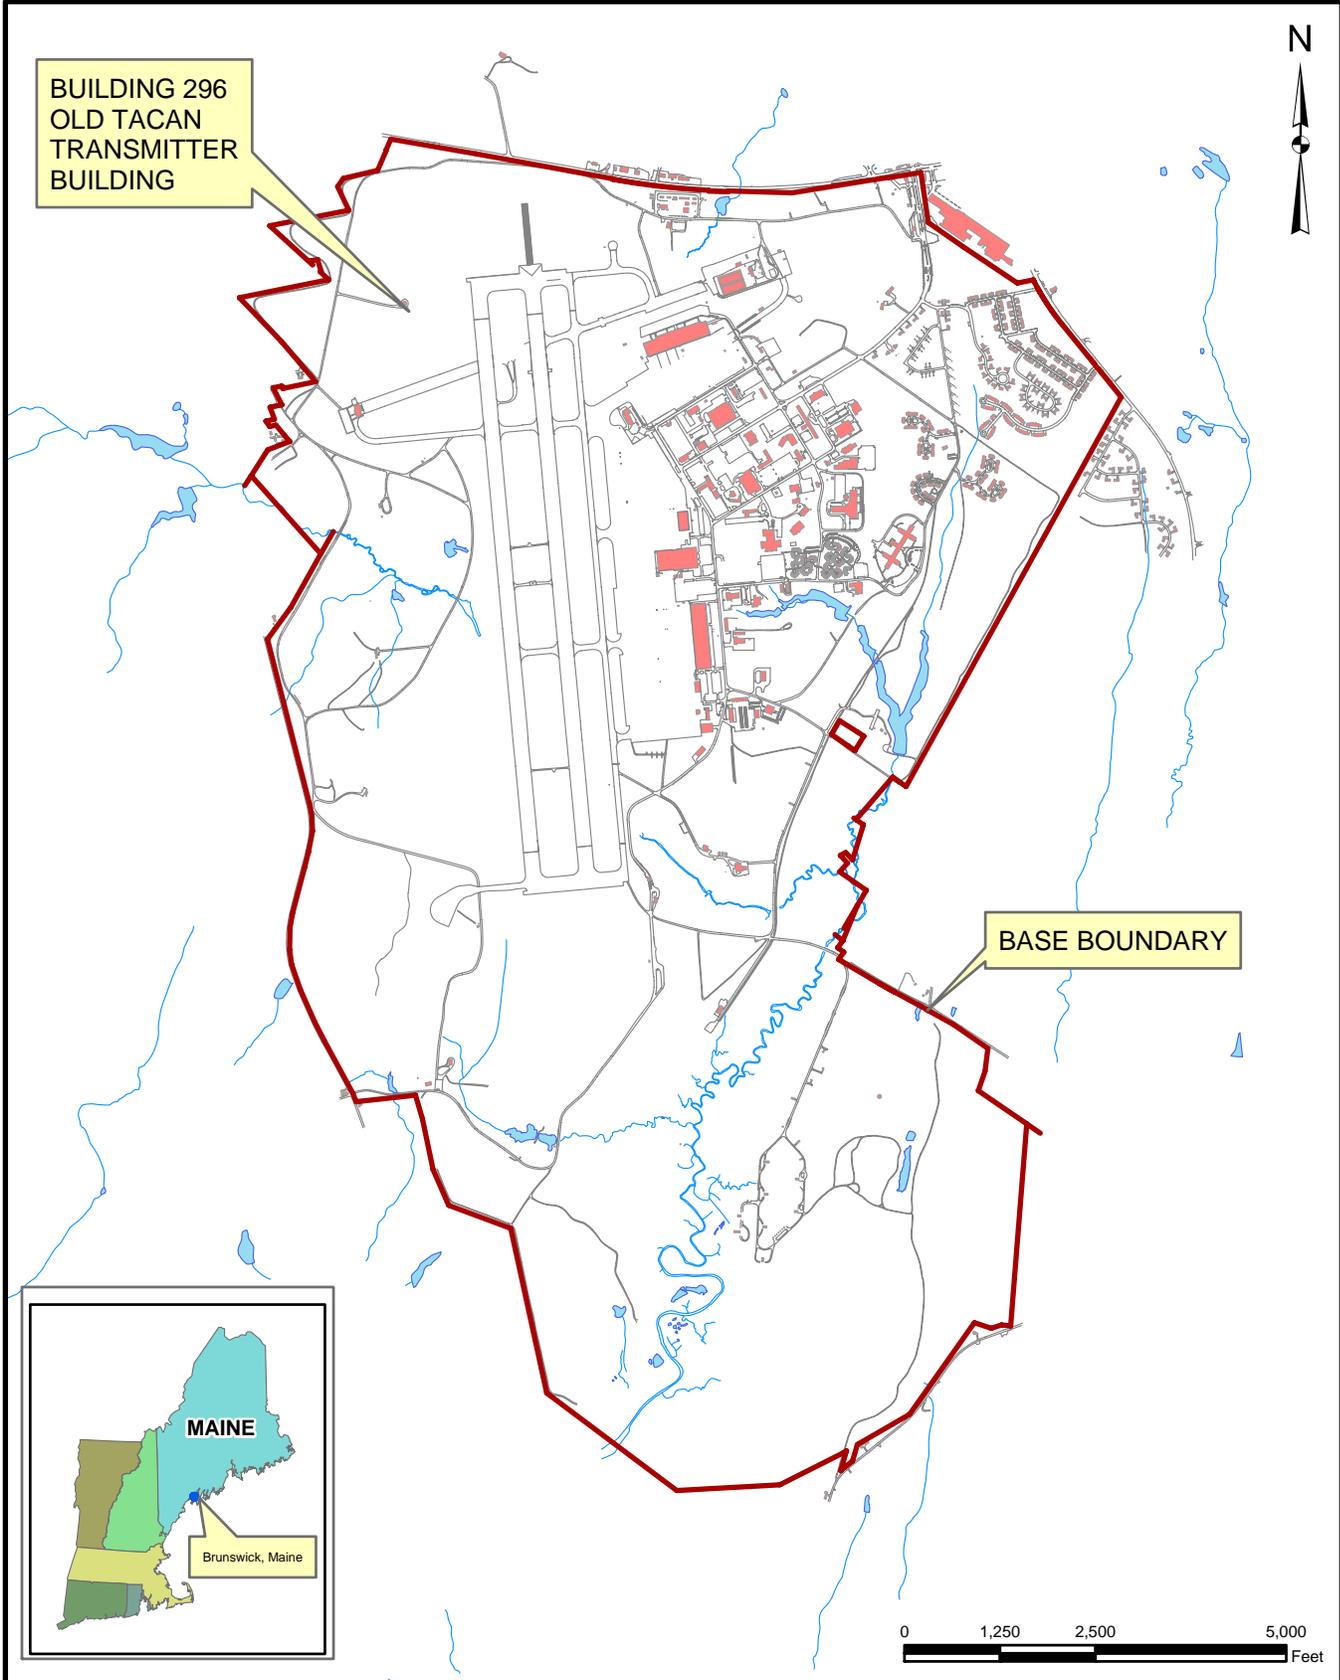
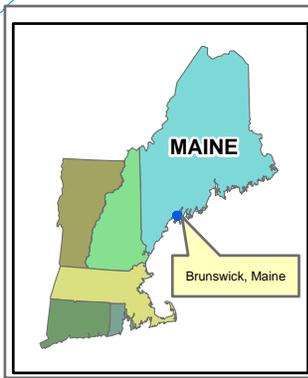
SCALE AS NOTED	
FILE I:\WASB_BLDG_296_LOCUS.MXD	
REV 0	DATE 11/16/10
FIGURE NUMBER 1

SITE LOCATION MAP  
 BUILDING 296 - OLD TACAN TRANSMITTER BUILDING  
 RCRA PARTIAL CLOSURE REPORT  
 NAVAL AIR STATION BRUNSWICK, MAINE

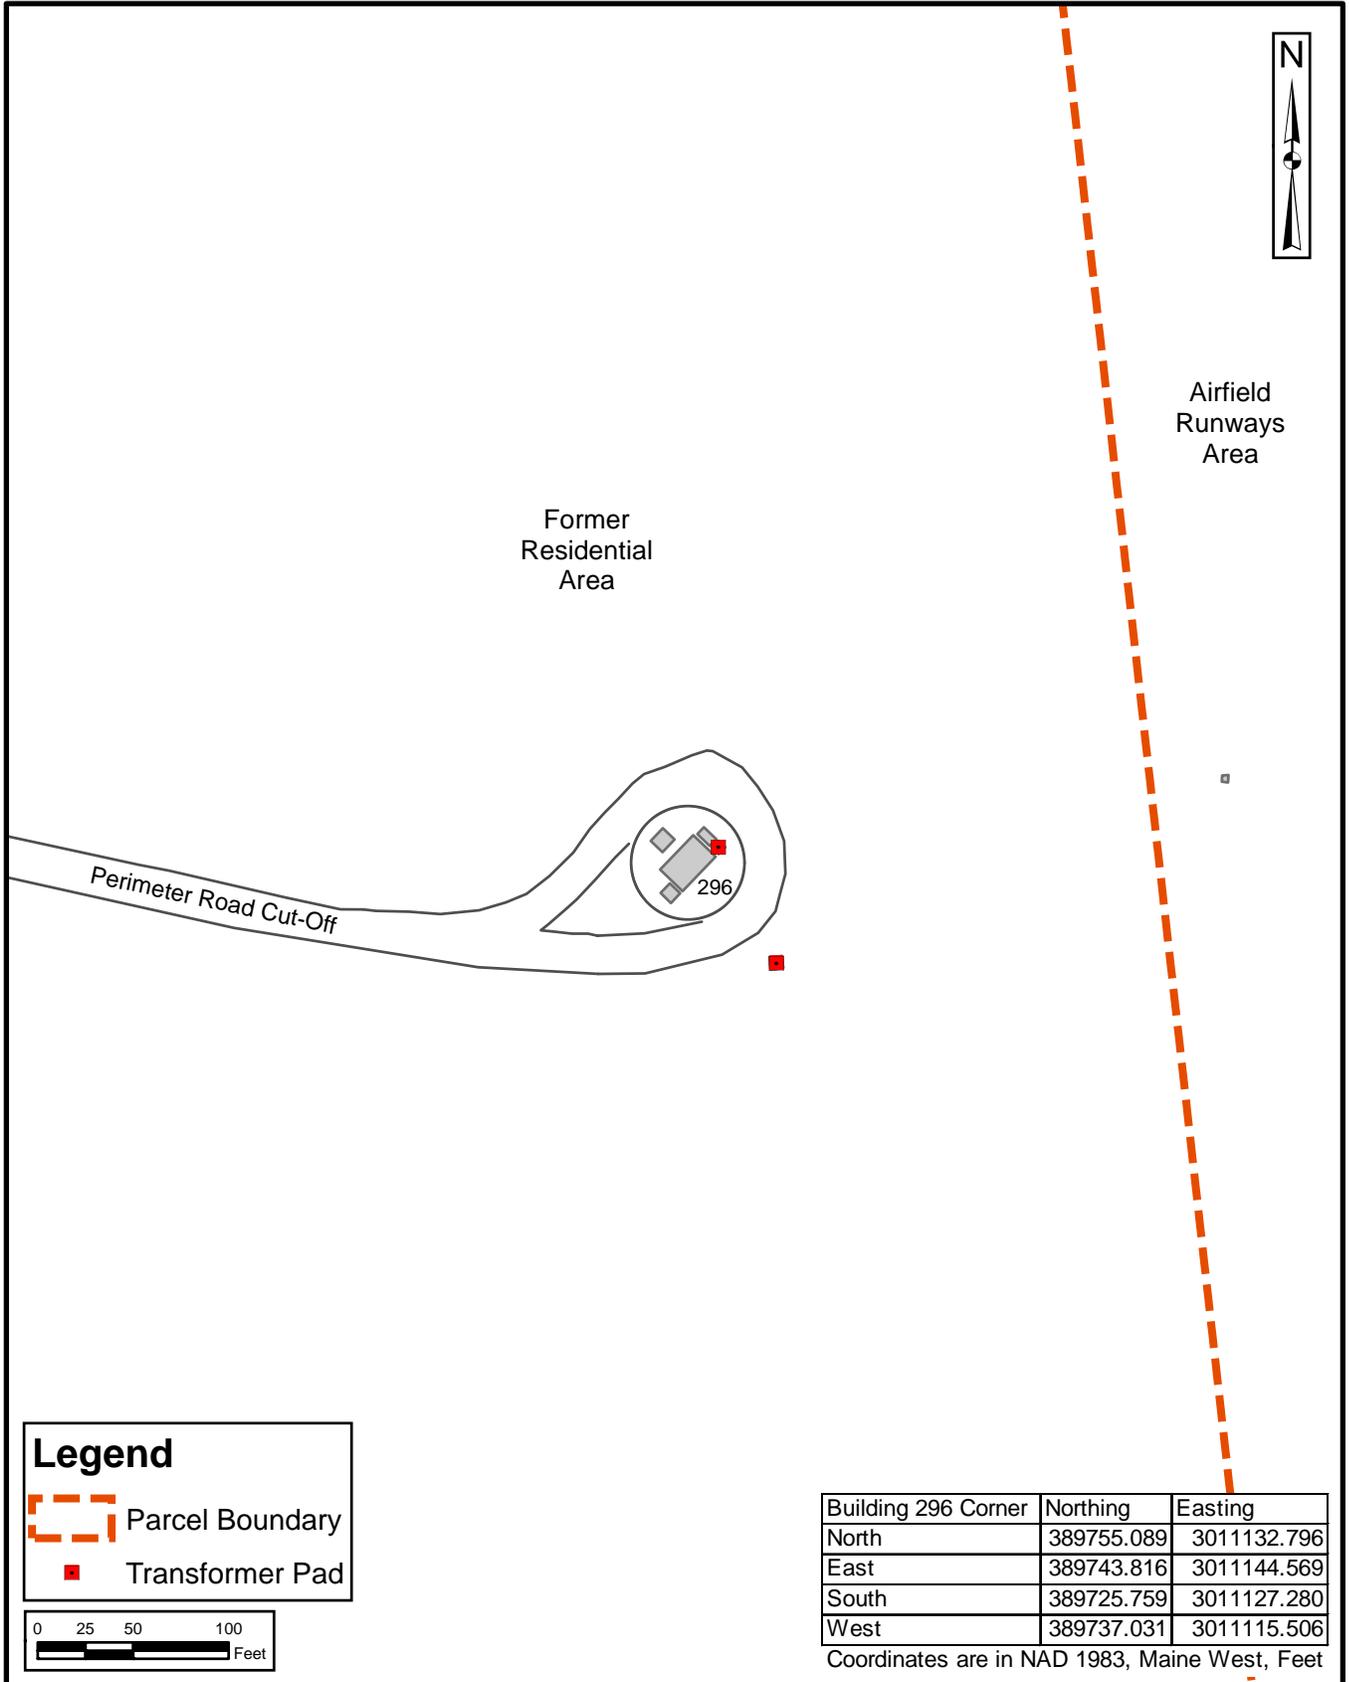
SCALE AS NOTED	
FILE I:\NASB_BLDG_296_SITE_MAP.MXD	
REV 0	DATE 11/18/10
FIGURE NUMBER FIGURE NO. 2

Building 296 Corner	Northing	Easting
North	389755.089	3011132.796
East	389743.816	3011144.569
South	389725.759	3011127.280
West	389737.031	3011115.506

**SITE MAP**  
 BUILDING 296 - OLD TACAN TRANSMITTER BUILDING  
 RCRA PARTIAL CLOSURE REPORT  
 NAVAL AIR STATION BRUNSWICK, MAINE

This investigation of the hazardous waste closure requirement applies to the building footprint of former Building 296 (building footprint as shown on Figure 2). It does not apply to the land surrounding or the groundwater underlying Building 296.

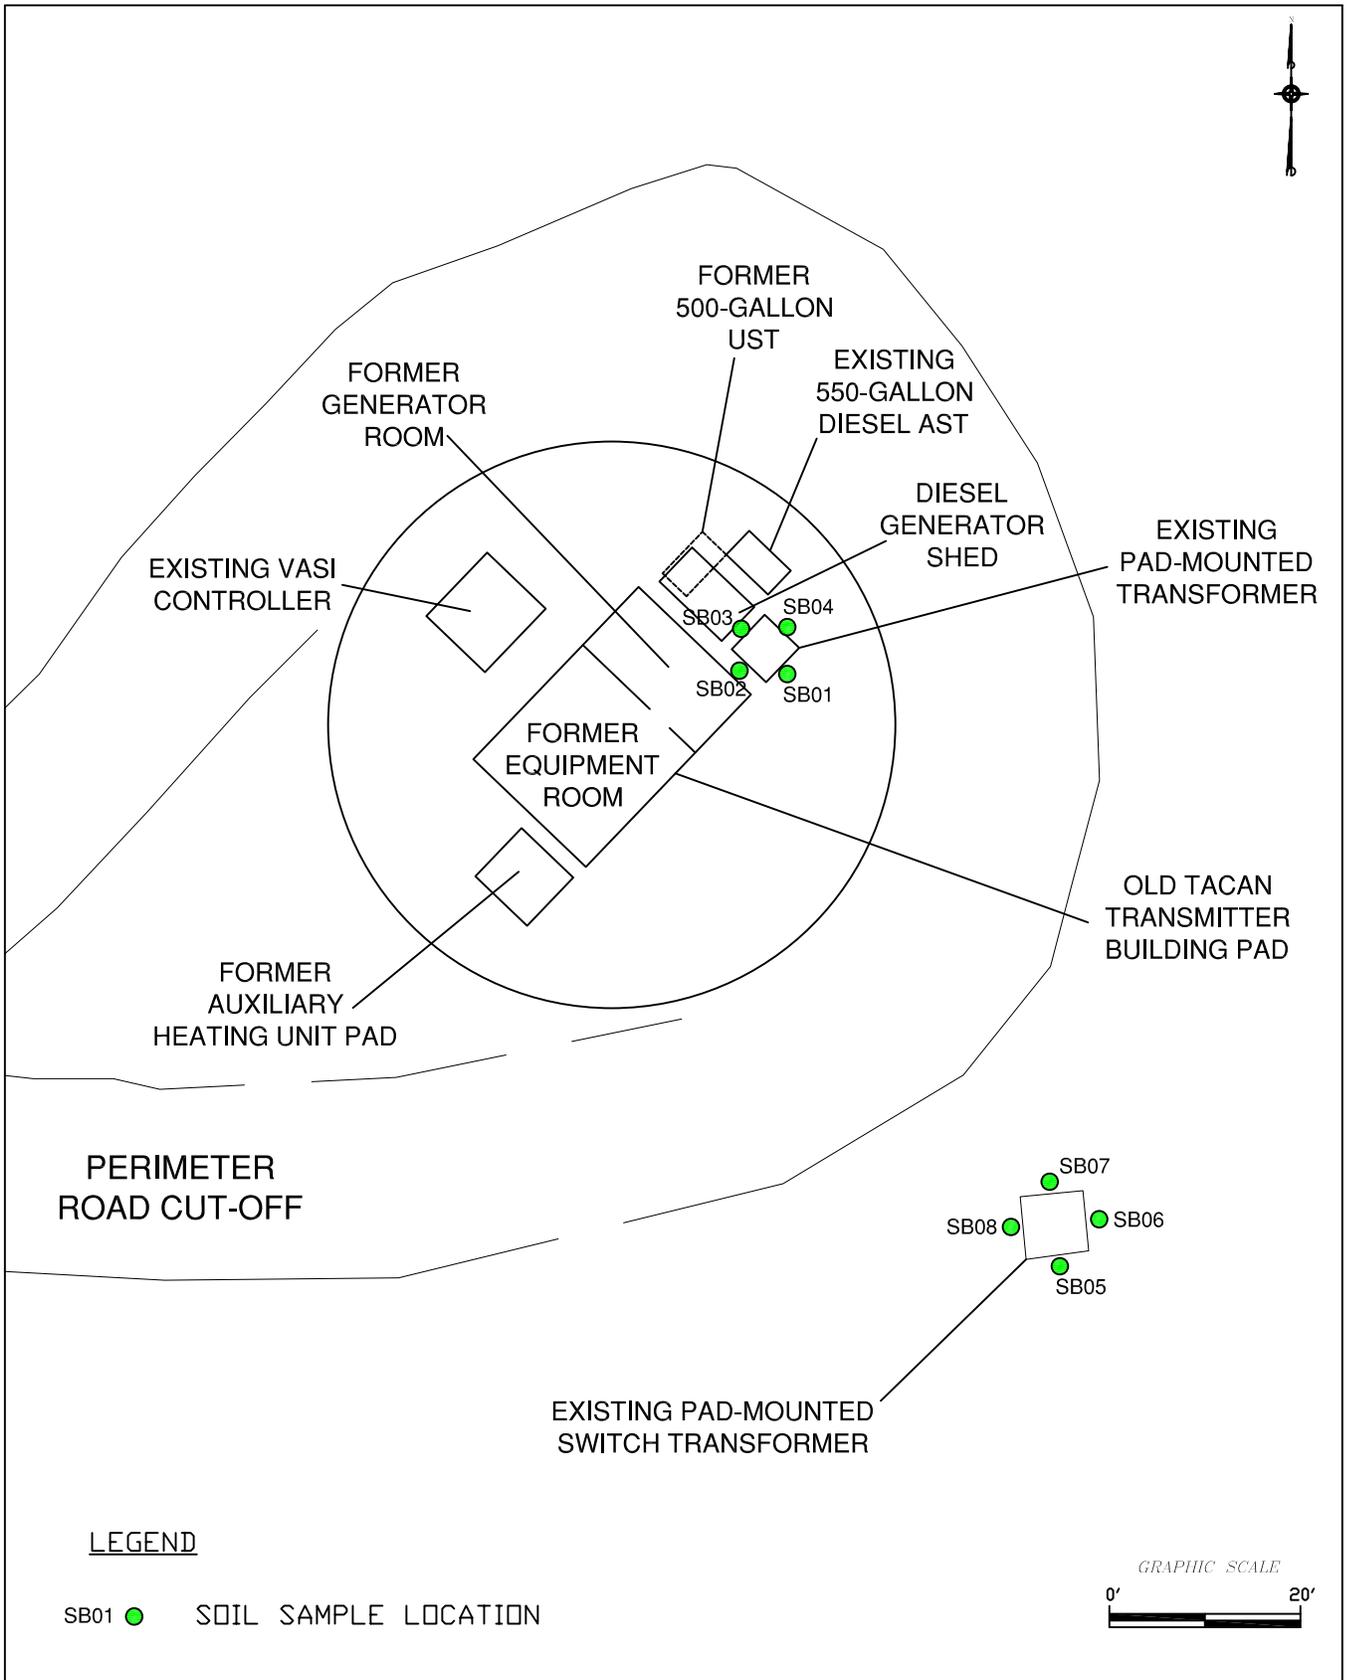
Due to the age of the former building, soil sampling was conducted to evaluate the possibility of a former release from historical transformers. On October 14, 2010, soil samples were collected from each side of each of the two pad-mounted transformers, the transformer in the more northern portion of the Building 296 area, and the switch transformer in the southern area (Figure 3). At each location, hand-augers were used to collect samples from 0- to 6-inches and from 6- to 24-inches below ground surface (bgs).

The soil samples were submitted to Analytics Environmental Laboratory, Portsmouth, New Hampshire for PCB analysis. The analytical results underwent limited data validation, including blank contamination evaluation and completeness evaluation. As presented in Tables 1 and 2, none of the samples contained PCBs at levels above the EPA Regional Screening Levels (RSLs) for Residential Soil or the MEDEP action limit for PCB spills (EPA, 2010).

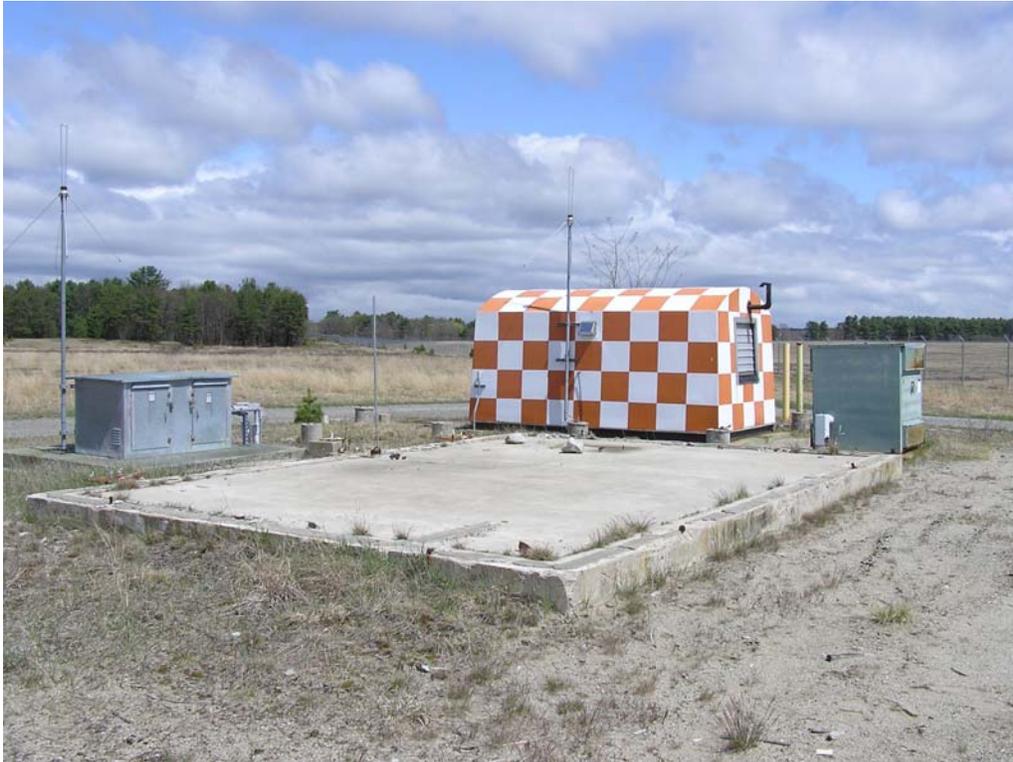
No. 1 Building 296 – Old TACAN Transmitter Building, NAS Brunswick April 28, 2010  
Old TACAN Transmitter Building south elevation; in background from left to right: VASI Controller, generator building and transformer

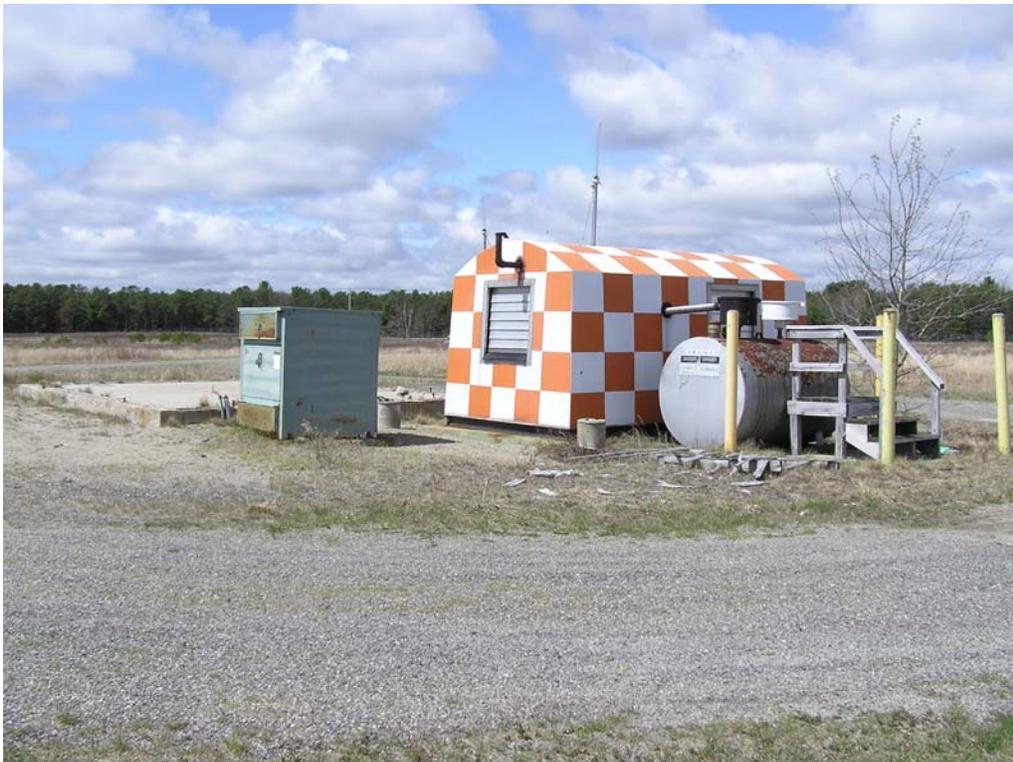
- One concrete-pad-mounted transformer was identified on the northeast side of former Building 296. No evidence of a past leak from this transformer was observed.

No. 2 Building 296 – Old TACAN Transmitter Building, NAS Brunswick April 28, 2010  
Old TACAN Transmitter Building east elevation; transformer, generator building and diesel in foreground

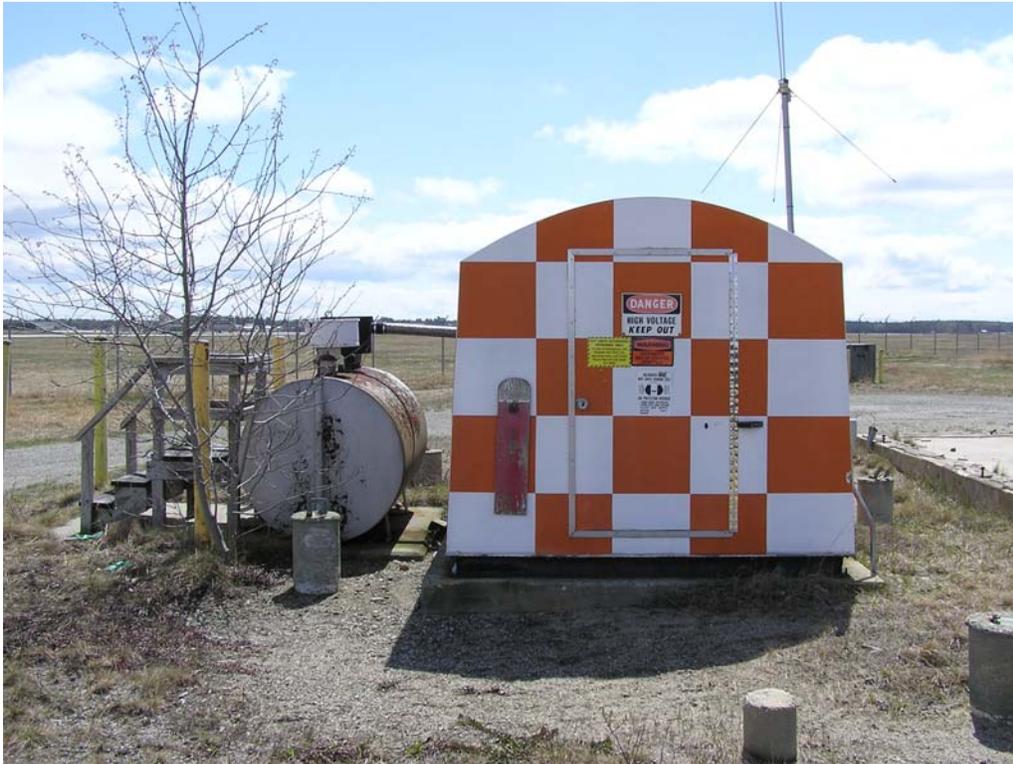
- One AST was identified on the northeastern side of former Building 296. The tank appeared to be in good condition and no evidence of a past leak from this AST was observed. NAS Brunswick Environmental personnel reported that the tank had been emptied and cleaned, but that closure paperwork had not yet been submitted to the MEDEP.

No. 3 Building 296 – Old TACAN Transmitter Building, NAS Brunswick  
Old TACAN Transmitter Building diesel AST and generator building

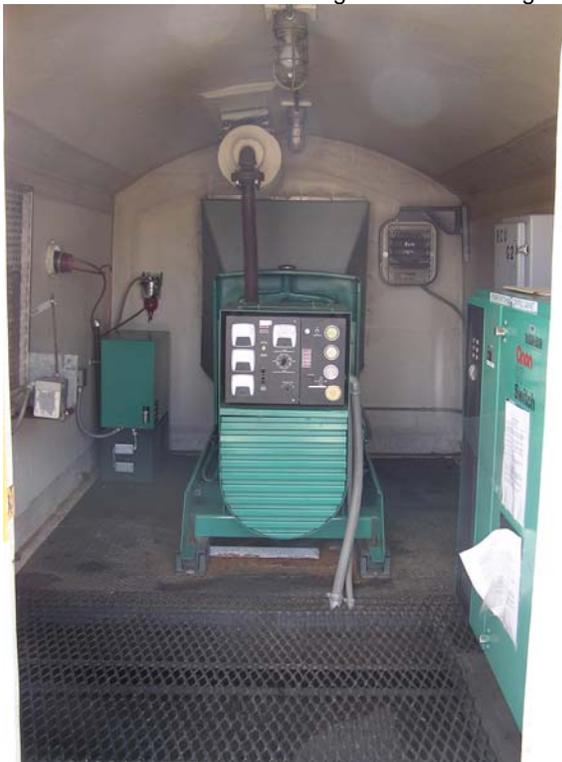
- A petroleum-like odor was detected in the generator building but no staining was observed on the building floor. NAS Brunswick Environmental personnel reported that an internal generator engine coolant leak had leaked coolant to the crankcase. While the generator is not operable, the Navy plans to leave the generator in place for possible engine rebuilding and reuse.

No. 4 Building 296 – Old TACAN Transmitter Building, NAS Brunswick  
Old TACAN Transmitter Building generator building interior

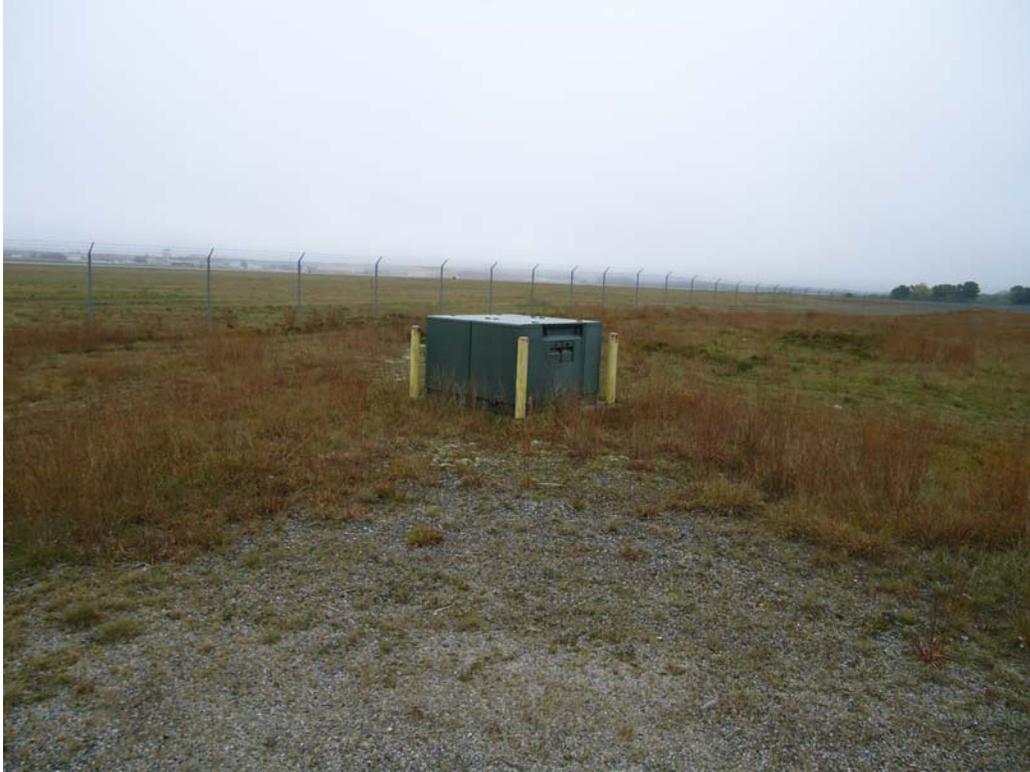
- One concrete-pad-mounted switch transformer was identified southeast of former Building 296. No evidence of a past leak from this transformer was observed.

No. 5 Building 296 – Old TACAN Transmitter Building, NAS Brunswick September 30, 2010  
Old TACAN Transmitter Building non-PCB containing three-way oil switch transformer located southeast of the building slab
