FINAL RESOURCE CONSERVATION AND RECOVERY ACT PARTIAL CLOSURE REPORT  
FOR BUILDING 294 WITH TRANSMITTAL LETTER NAS BRUNSWICK ME  
12/17/2010  
NAS BRUNSWICK

Subj: Final RCRA Partial Closure Report for Building 294

**RCRA PARTIAL CLOSURE REPORT**  
**for**  
**BUILDING 294 – SUPPLY WAREHOUSE PARCEL**  
**NAVAL AIR STATION BRUNSWICK, MAINE**  
**USEPA IDENTIFICATION NUMBER ME8170022018**  
**DECEMBER 2010**

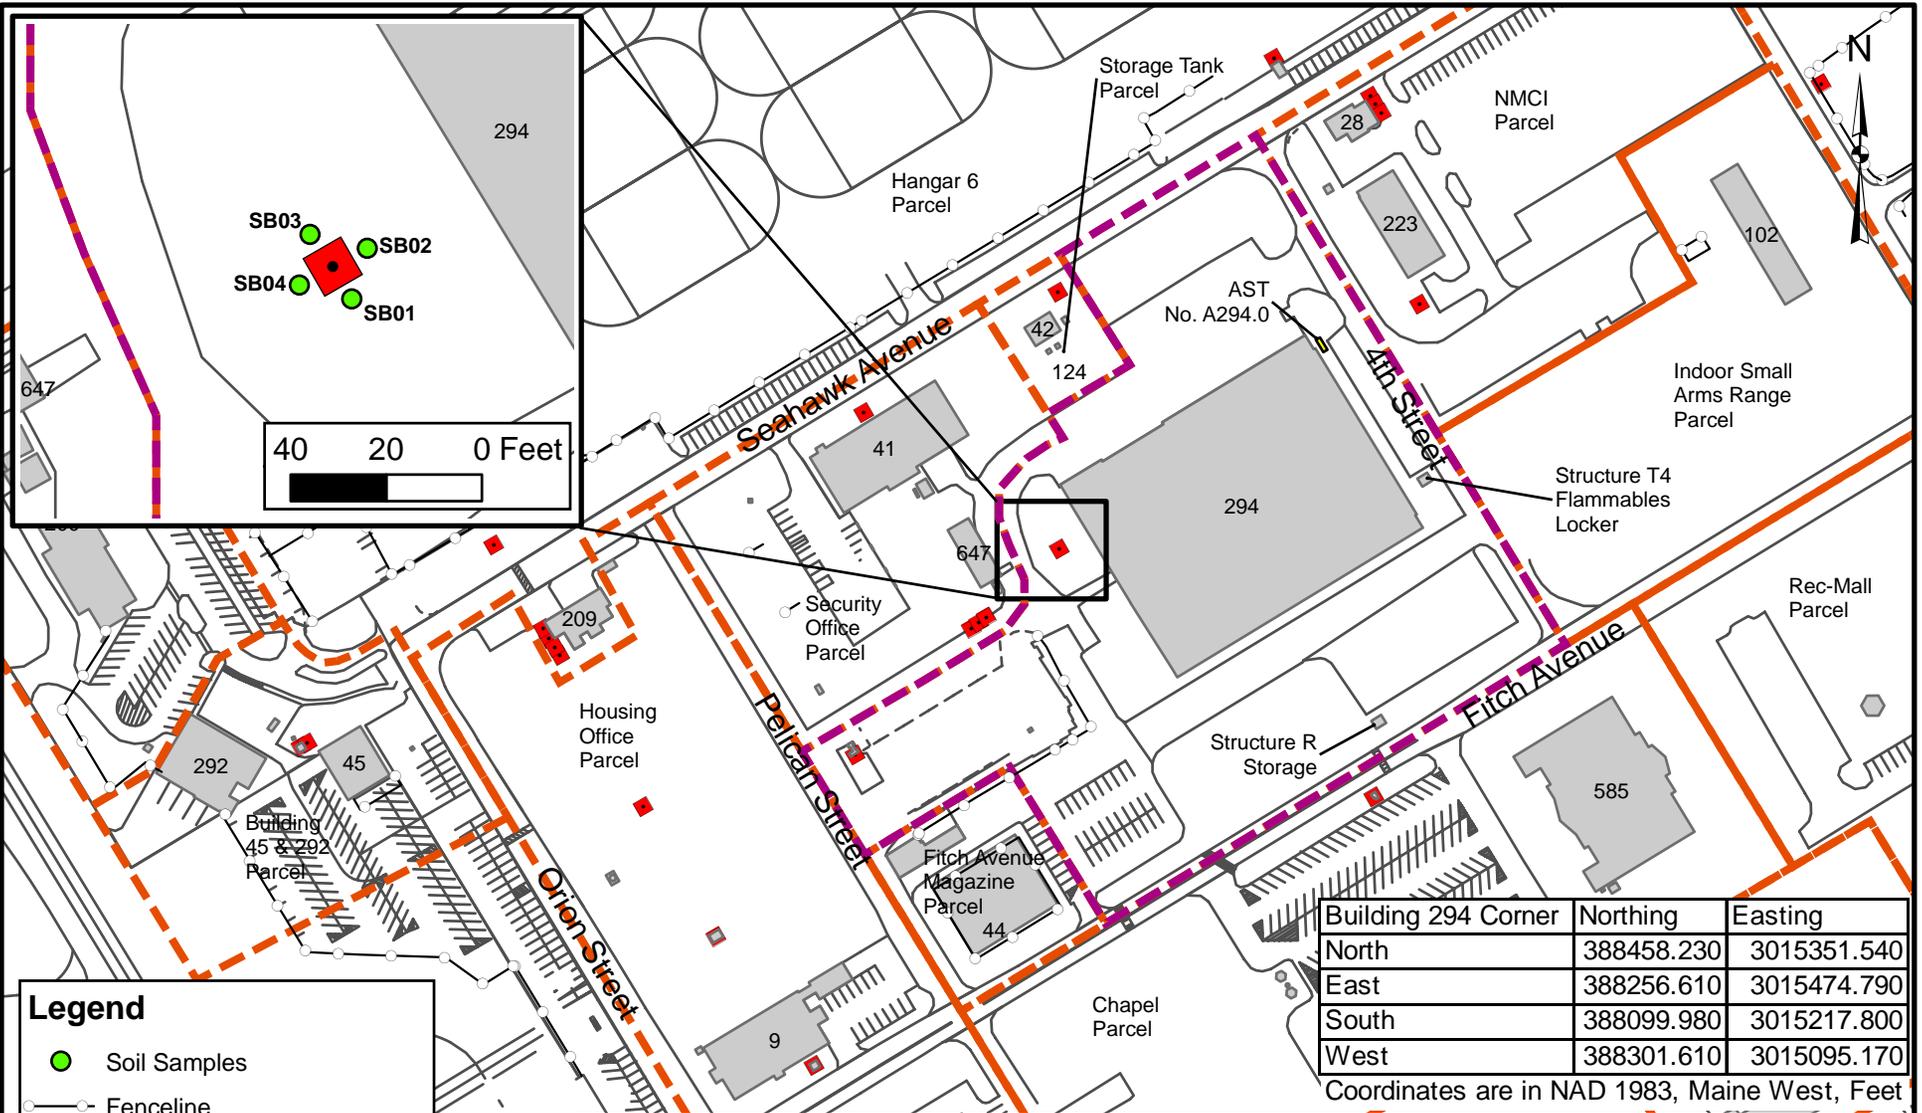
Because Building 294 was constructed prior to 1979 (in 1956), the transformer pad, located south of the building, could potentially be an area of PCB soil contamination if there had been an historical transformer leak. On November 23, 2010, Tetra Tech collected eight surface soil samples from four locations surrounding the transformer pad. A hand auger was used to collect four samples from 0 to 6 inches below ground surface (bgs) and four samples from 6 to 24 inches bgs. Sample locations are presented on Figure 2.

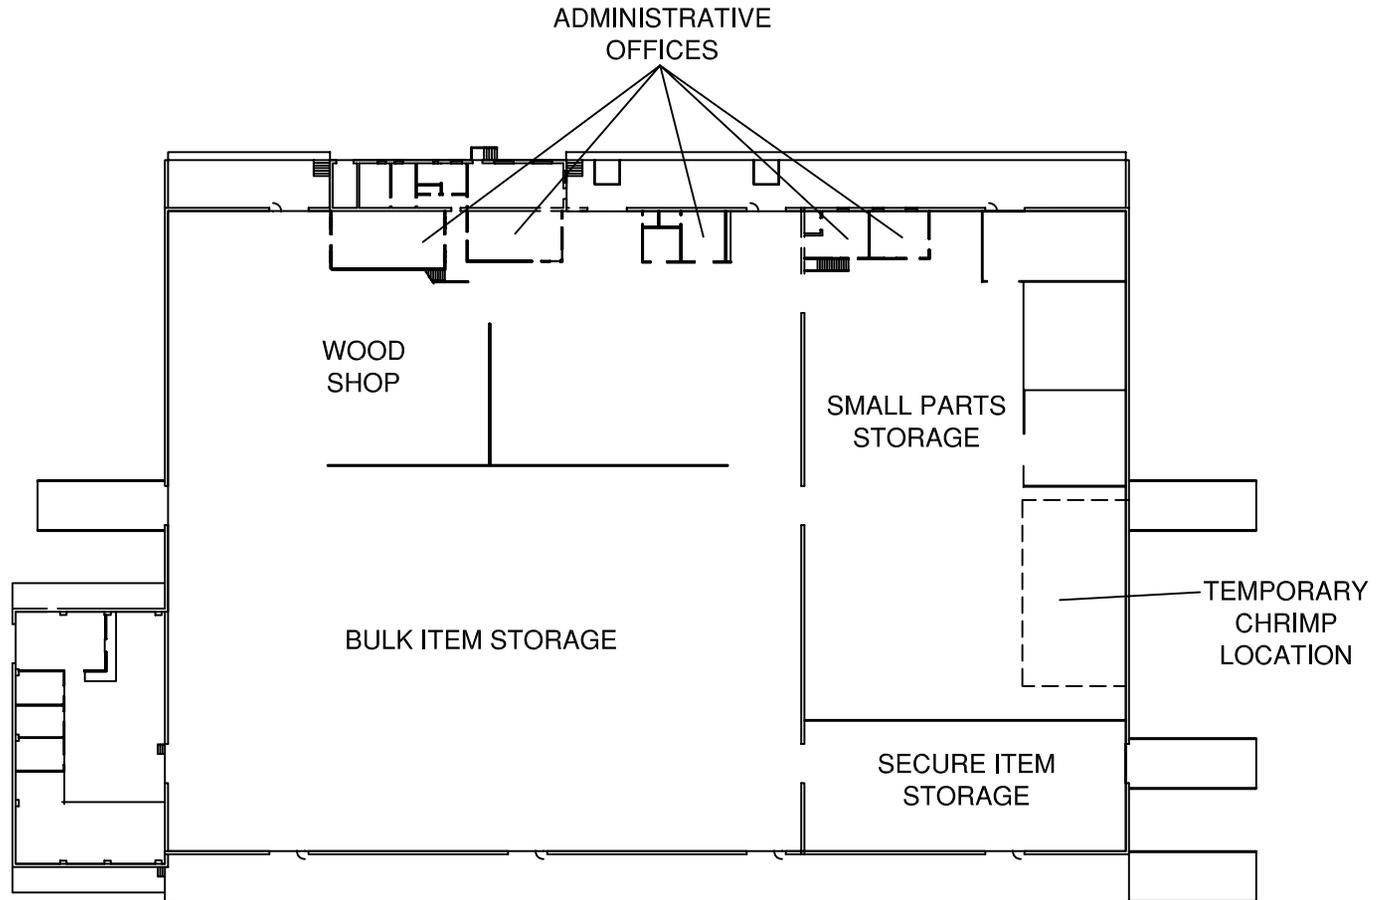
FLOOR PLAN  
 BUILDING 294 - SUPPLY WAREHOUSE  
 RCRA PARTIAL CLOSURE REPORT  
 NAVAL AIR STATION BRUNSWICK, MAINE

Building 294 itself is located in the east-central portion of the parcel (Figure 2). It was constructed in 1956 and is 64,530 square feet in area. The building is two stories, with a steel-truss roof and concrete masonry block exterior on a concrete slab foundation. Building 294 has four dual-fired, hot-air furnaces, two of which are fueled by fuel-oil and two by natural gas. The layout of Building 294 is presented as Figure 3.

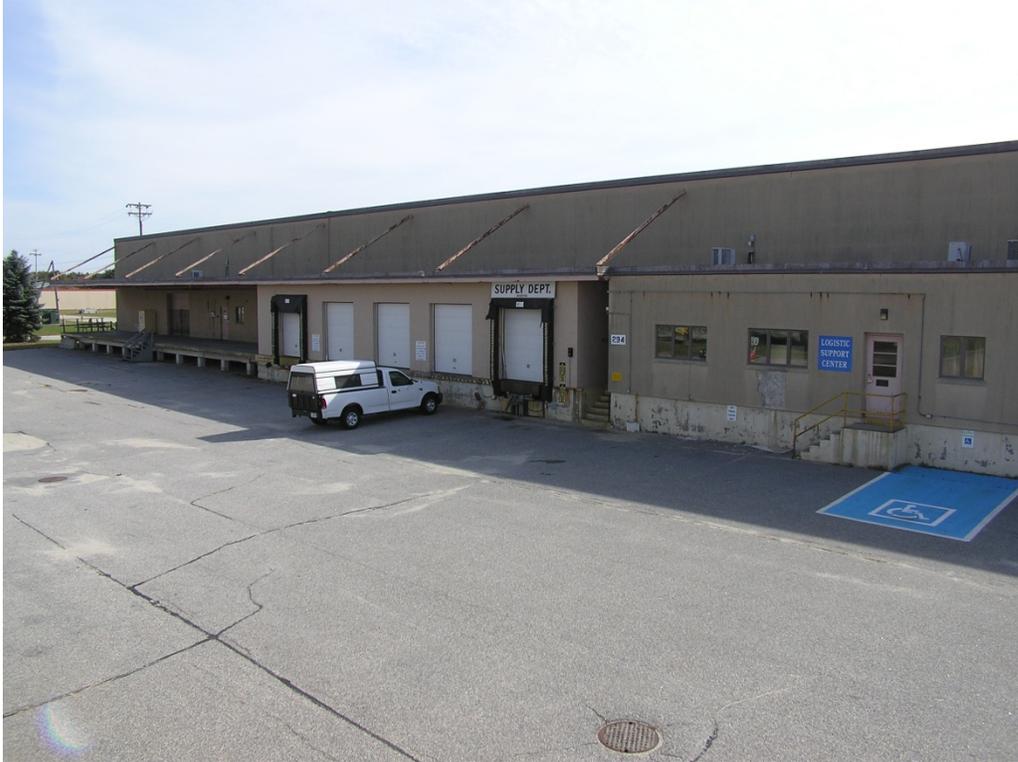
No. 1 Building 294 – Supply Warehouse Parcel, NAS Brunswick October 20, 2010  
Supply Warehouse northwestern elevation

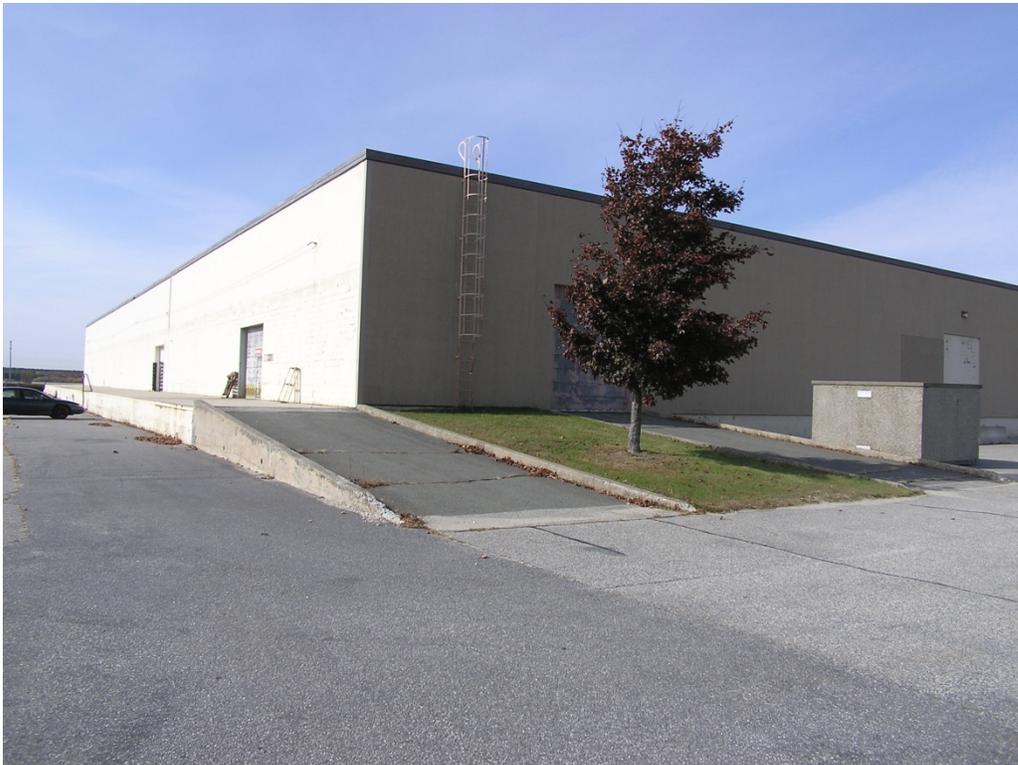
- Structure T4 contained snow removal and grounds maintenance tools and was in poor condition; no evidence of hazardous waste residues was observed.

No. 2 Building 294 – Supply Warehouse Parcel, NAS Brunswick October 20, 2010  
Supply Warehouse southeastern elevation. Structure T4 (flammable locker) in the foreground

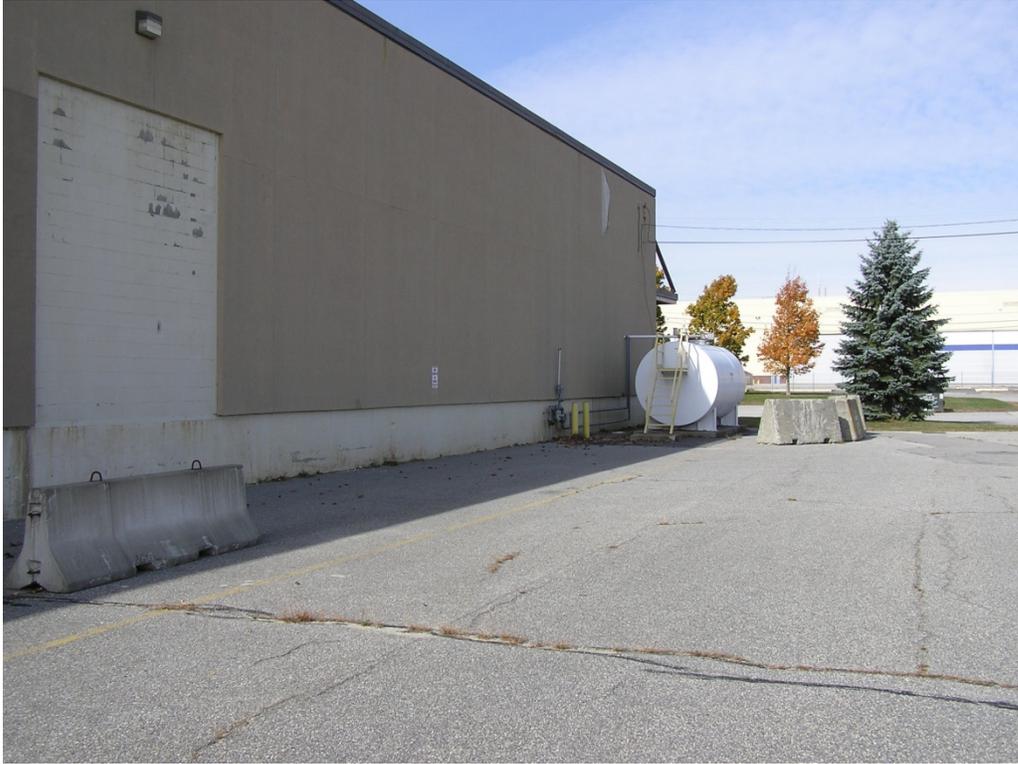
The NAS Brunswick Aboveground Storage Tank (AST) and Underground Storage Tank (UST) inventory records for Building 294 indicate that one AST has been associated with the building (Environmental Department, 2009). The 6000-gallon, double-walled steel AST (A294.0) was

used to store No. 1 heating oil and is located near the northeast corner of the building. It was installed in 1999 and closed in 2009.

No. 3 Building 294 – Supply Warehouse Parcel, NAS Brunswick October 20, 2010  
Supply Warehouse northeastern elevation; closed fuel-oil AST at northeast corner of building

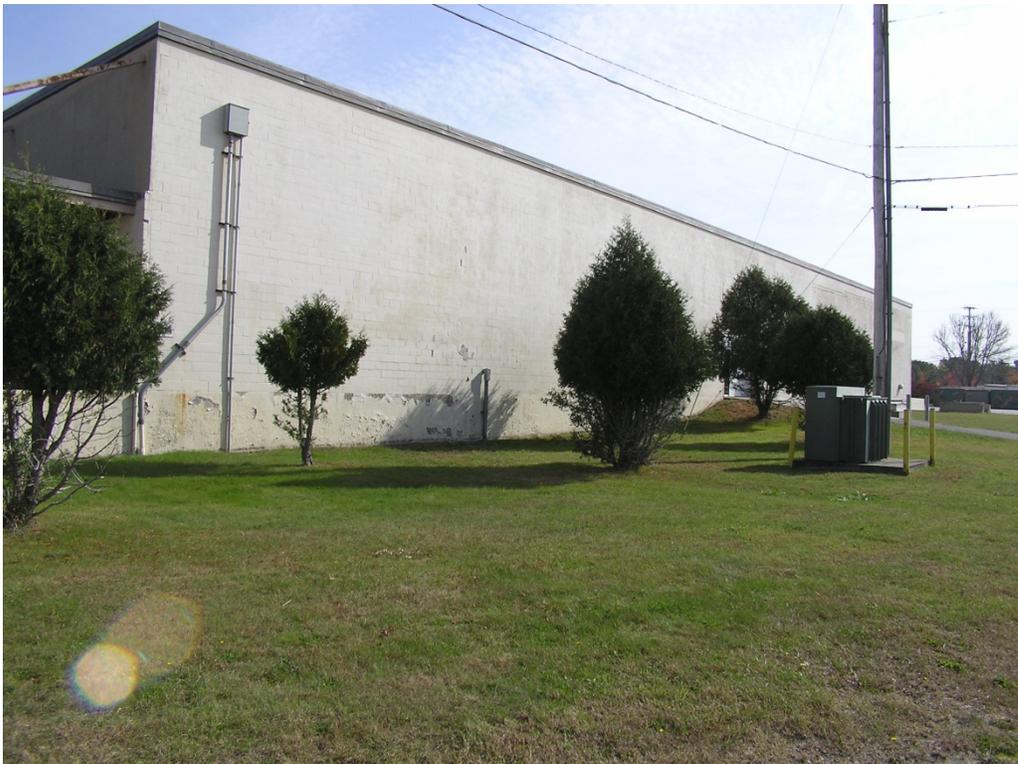
The serial number for the Cooper-manufactured unit indicates that it was manufactured in 1989; it is therefore unlikely to contain PCBs. As of July 1, 1979, the United States Environmental Protection Agency (EPA) prohibited all manufacturing of new PCB electrical equipment (transformers and capacitors). However, due to the age of the building, PCB-containing transformers may have been in service in the past at the Building 294 transformer pad.

No. 4 Building 294 – Supply Warehouse Parcel, NAS Brunswick October 20, 2010  
Building 294 – Supply Warehouse northwestern elevation; transformer at left of frame

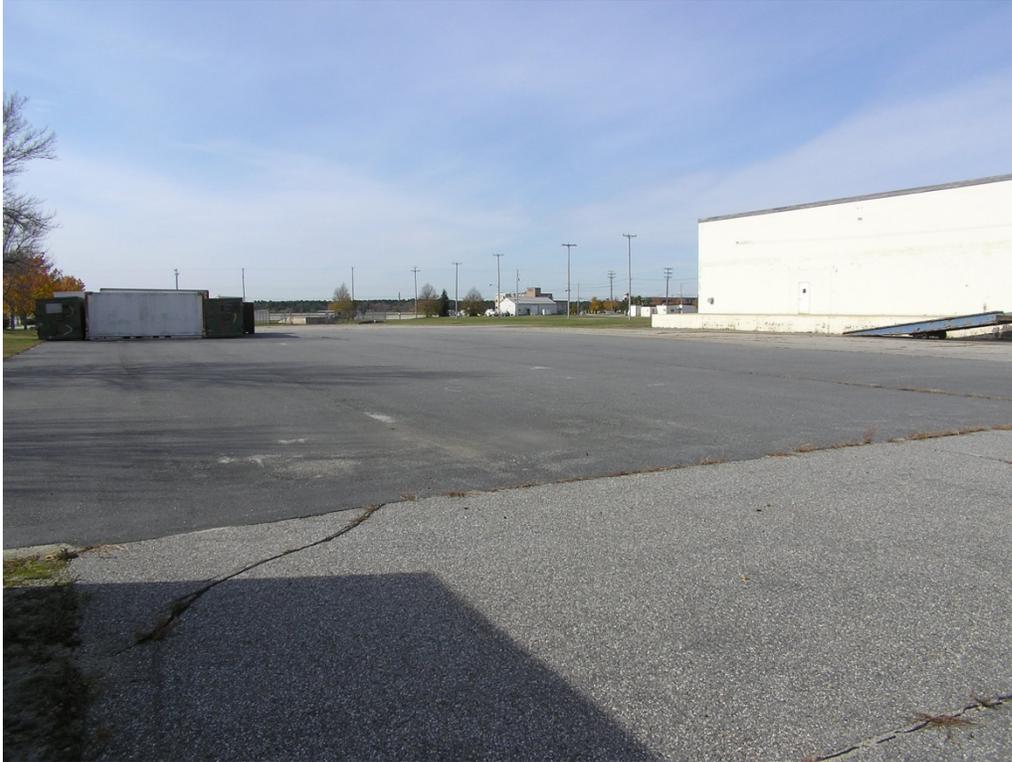
No. 5 Building 294 – Supply Warehouse Parcel, NAS Brunswick October 20, 2010  
Supply Warehouse parcel (parking area) looking southwest; Building 294 in left background

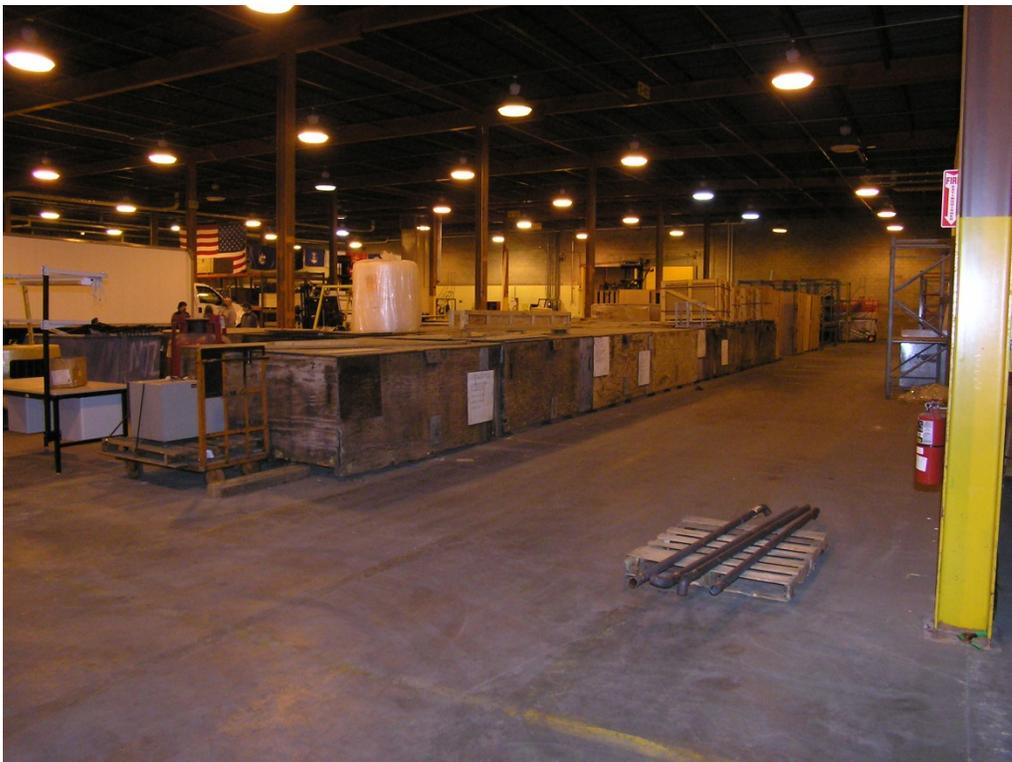
No. 6 Building 294 – Supply Warehouse Parcel, NAS Brunswick October 20, 2010  
Main warehouse area; crated items awaiting shipping

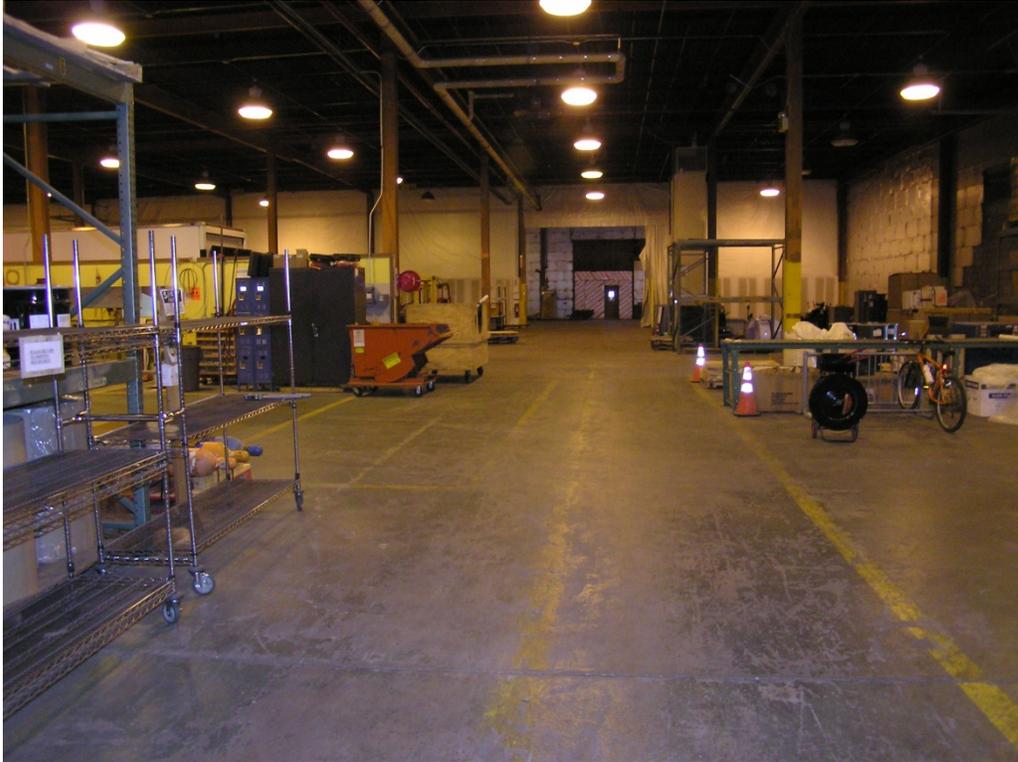
No. 7 Building 294 – Supply Warehouse Parcel, NAS Brunswick October 20, 2010  
Main warehouse area

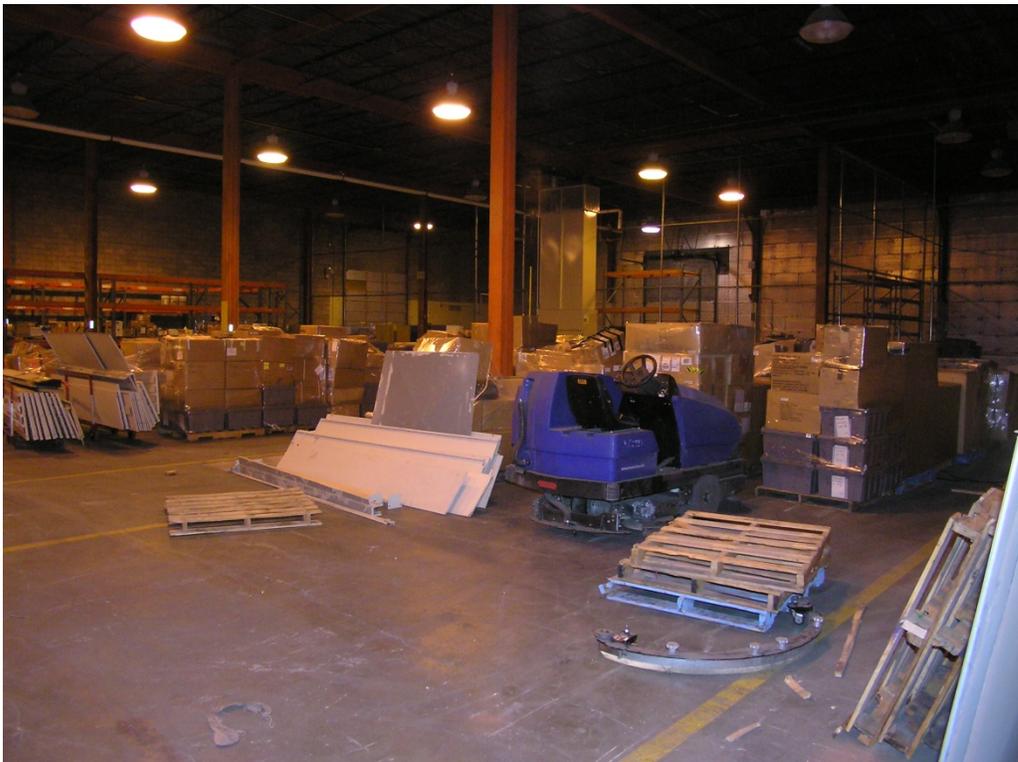
No. 8 Building 294 – Supply Warehouse Parcel, NAS Brunswick October 20, 2010  
Main warehouse area with shipping containers awaiting pickup

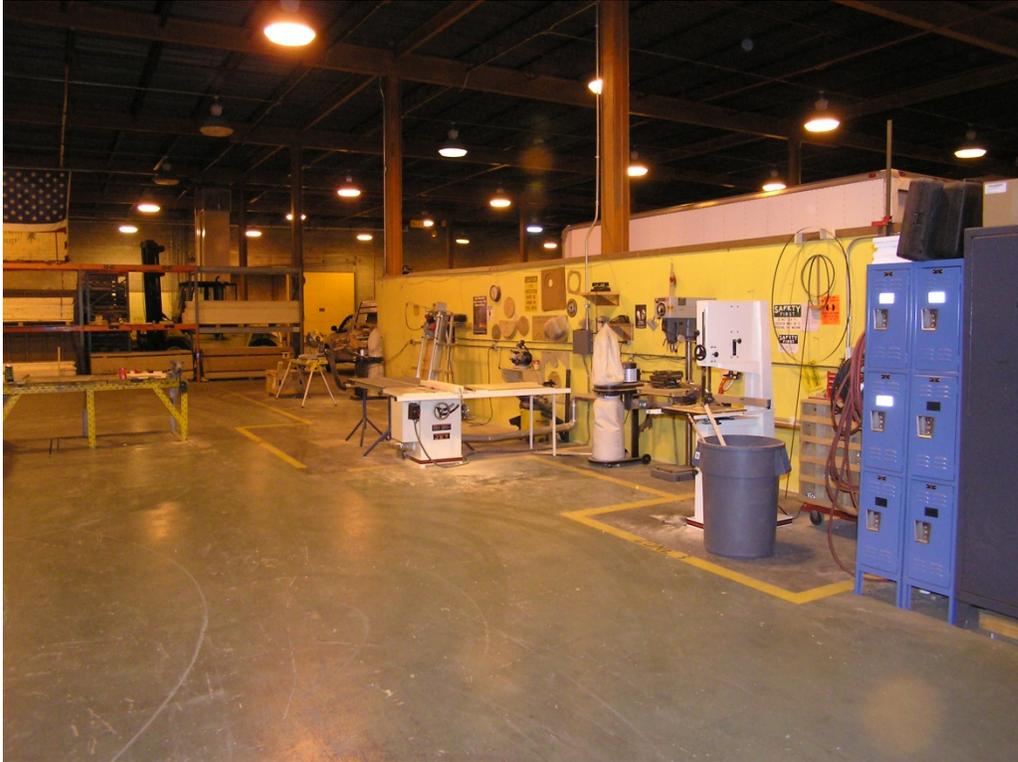
No. 9 Building 294 – Supply Warehouse Parcel, NAS Brunswick October 20, 2010  
Wood shop; used for shipping crate for construction

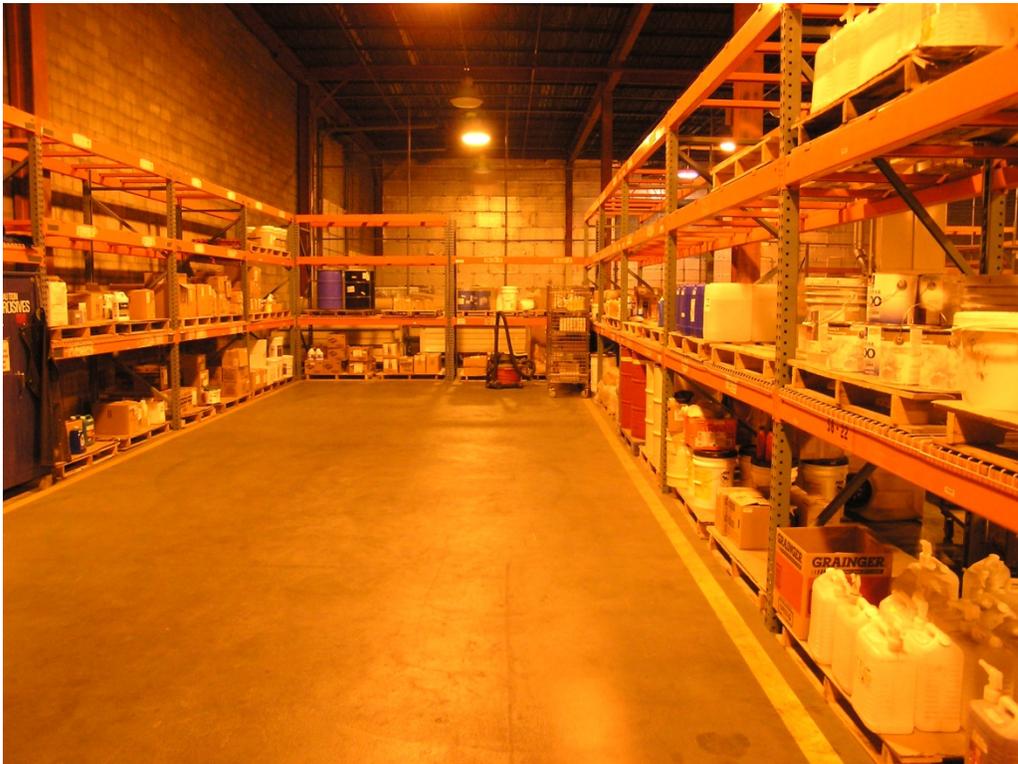
In 2010, the operations of the Consolidated Hazardous Material Reutilization and Inventory Management Program (CHRIMP) were transferred from Building 81 (which was then closed) to Building 294. The CHRIMP oversaw the use, supply, and collection of all hazardous materials used by the squadrons and maintenance organizations at NAS Brunswick, including materials such as petroleum products, cleaning solvents, and various paints and coatings. This centralized, hazardous materials program thereby controlled hazardous materials acquisition and inventory, reducing the generation and disposal of hazardous waste. Hazardous materials, typically small quantities (less than a week's supply), were signed-out from the Building 294 CHRIMP area, with unused/excess quantities also returned to the CHRIMP area in Building 294. Expired and

No. 10 Building 294 – Supply Warehouse Parcel, NAS Brunswick October 20, 2010  
Hazardous materials storage area; temporary location of CHRIMP operation

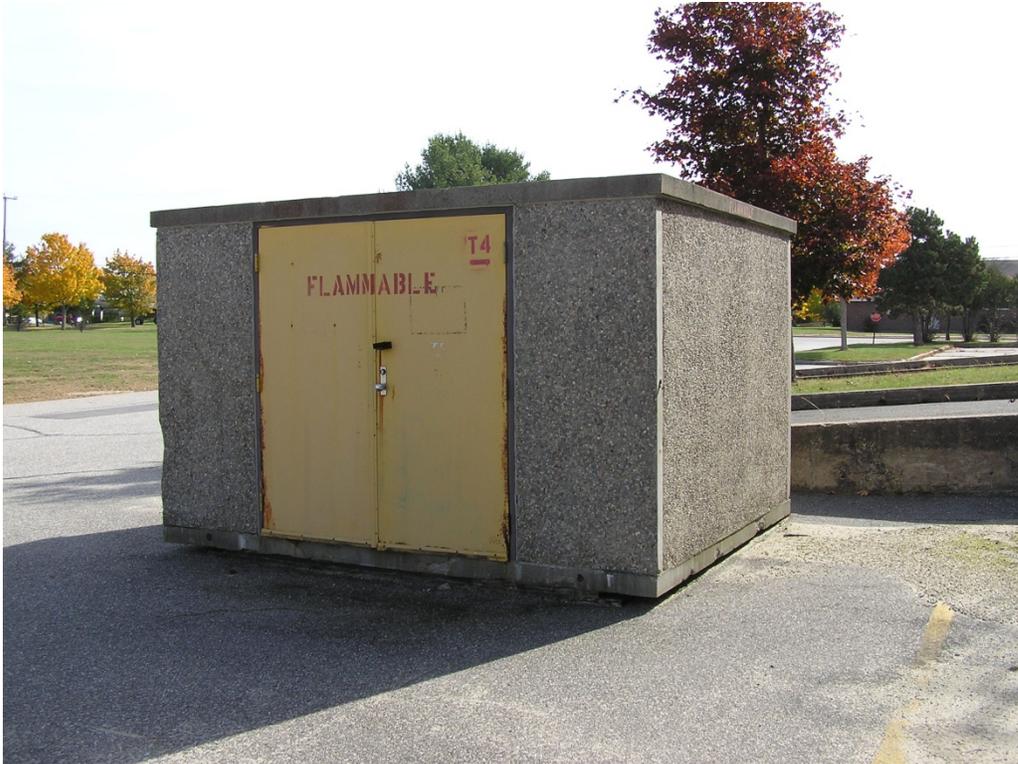
No. 11 Building 294 – Supply Warehouse Parcel, NAS Brunswick October 20, 2010  
Structure T4 – flammable storage cabinet exterior

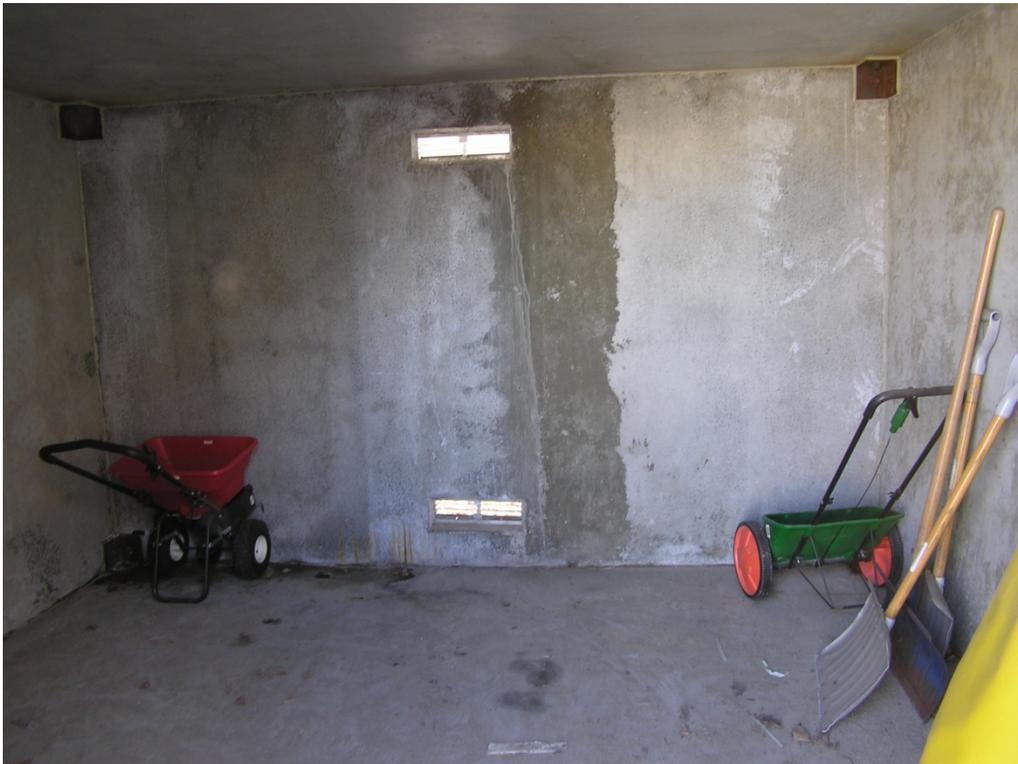
No. 12 Building 294 – Supply Warehouse Parcel, NAS Brunswick October 20, 2010  
Structure T4 – flammable storage cabinet interior

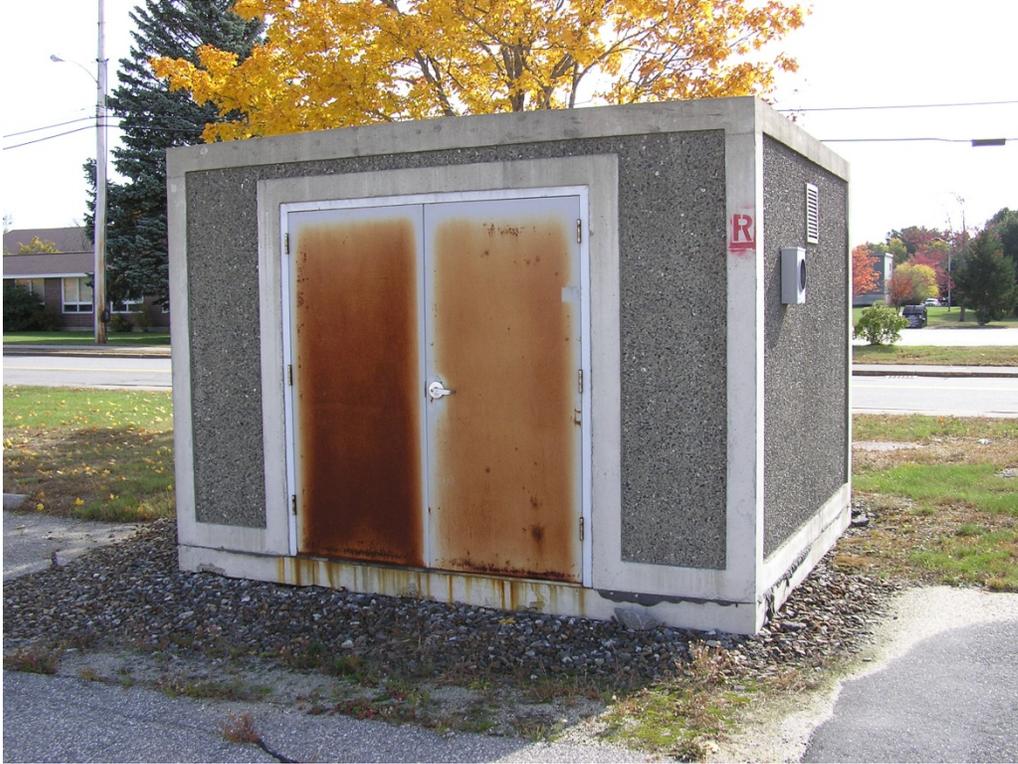
- Structure R contained equipment for the Navy Marine Corps Intranet (NMCI) system and was in fair condition; no evidence of hazardous waste residues was observed.

No. 13 Building 294 – Supply Warehouse Parcel, NAS Brunswick October 20, 2010  
Structure R – Communications equipment storage exterior

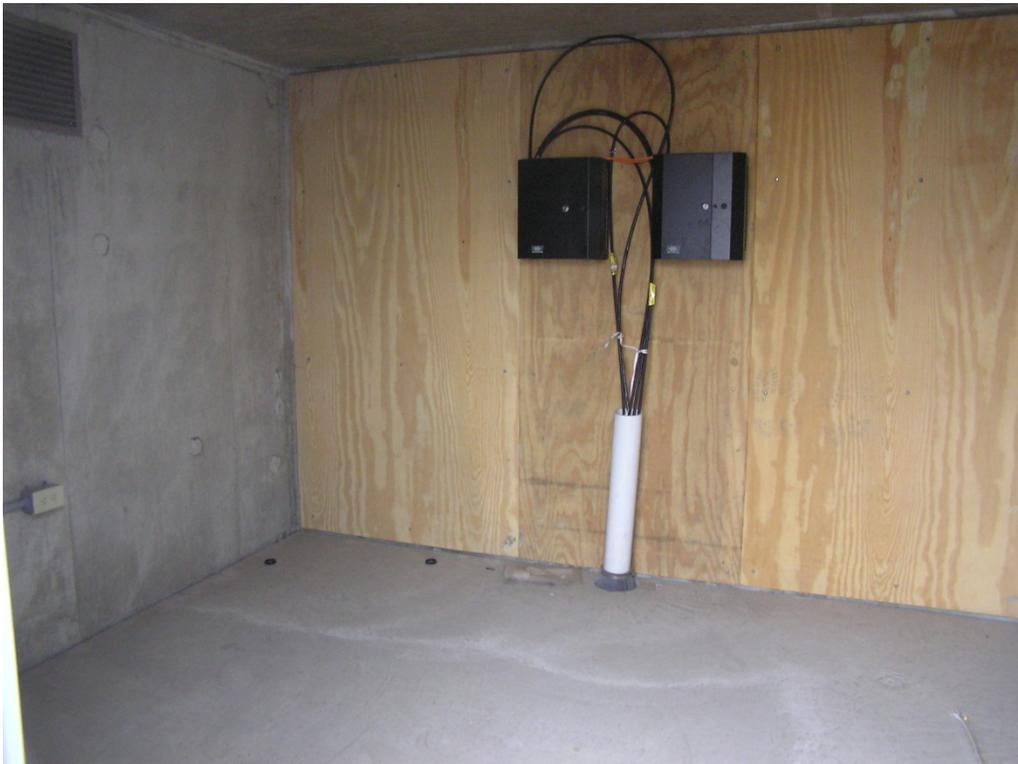
No. 14 Building 294 – Supply Warehouse Parcel, NAS Brunswick November 23, 2010  
Structure R – Communications equipment storage interior
