FINAL RESOURCE CONSERVATION AND RECOVERY ACT PARTIAL CLOSURE REPORT
FOR BUILDING 35 WITH TRANSMITTAL LETTER NAS BRUNSWICK ME
12/17/2010
NAS BRUNSWICK

RCRA PARTIAL CLOSURE REPORT
for
BUILDING 35 – MAIN GATE SENTRY HOUSE
NAVAL AIR STATION BRUNSWICK, MAINE
USEPA IDENTIFICATION NUMBER ME8170022018
DECEMBER 2010

**HWSA INSPECTION FORM
HAZARDOUS WASTE STORAGE AREAS CLOSURE
NAS BRUNSWICK
BRUNSWICK, MAINE
CTO WE22**

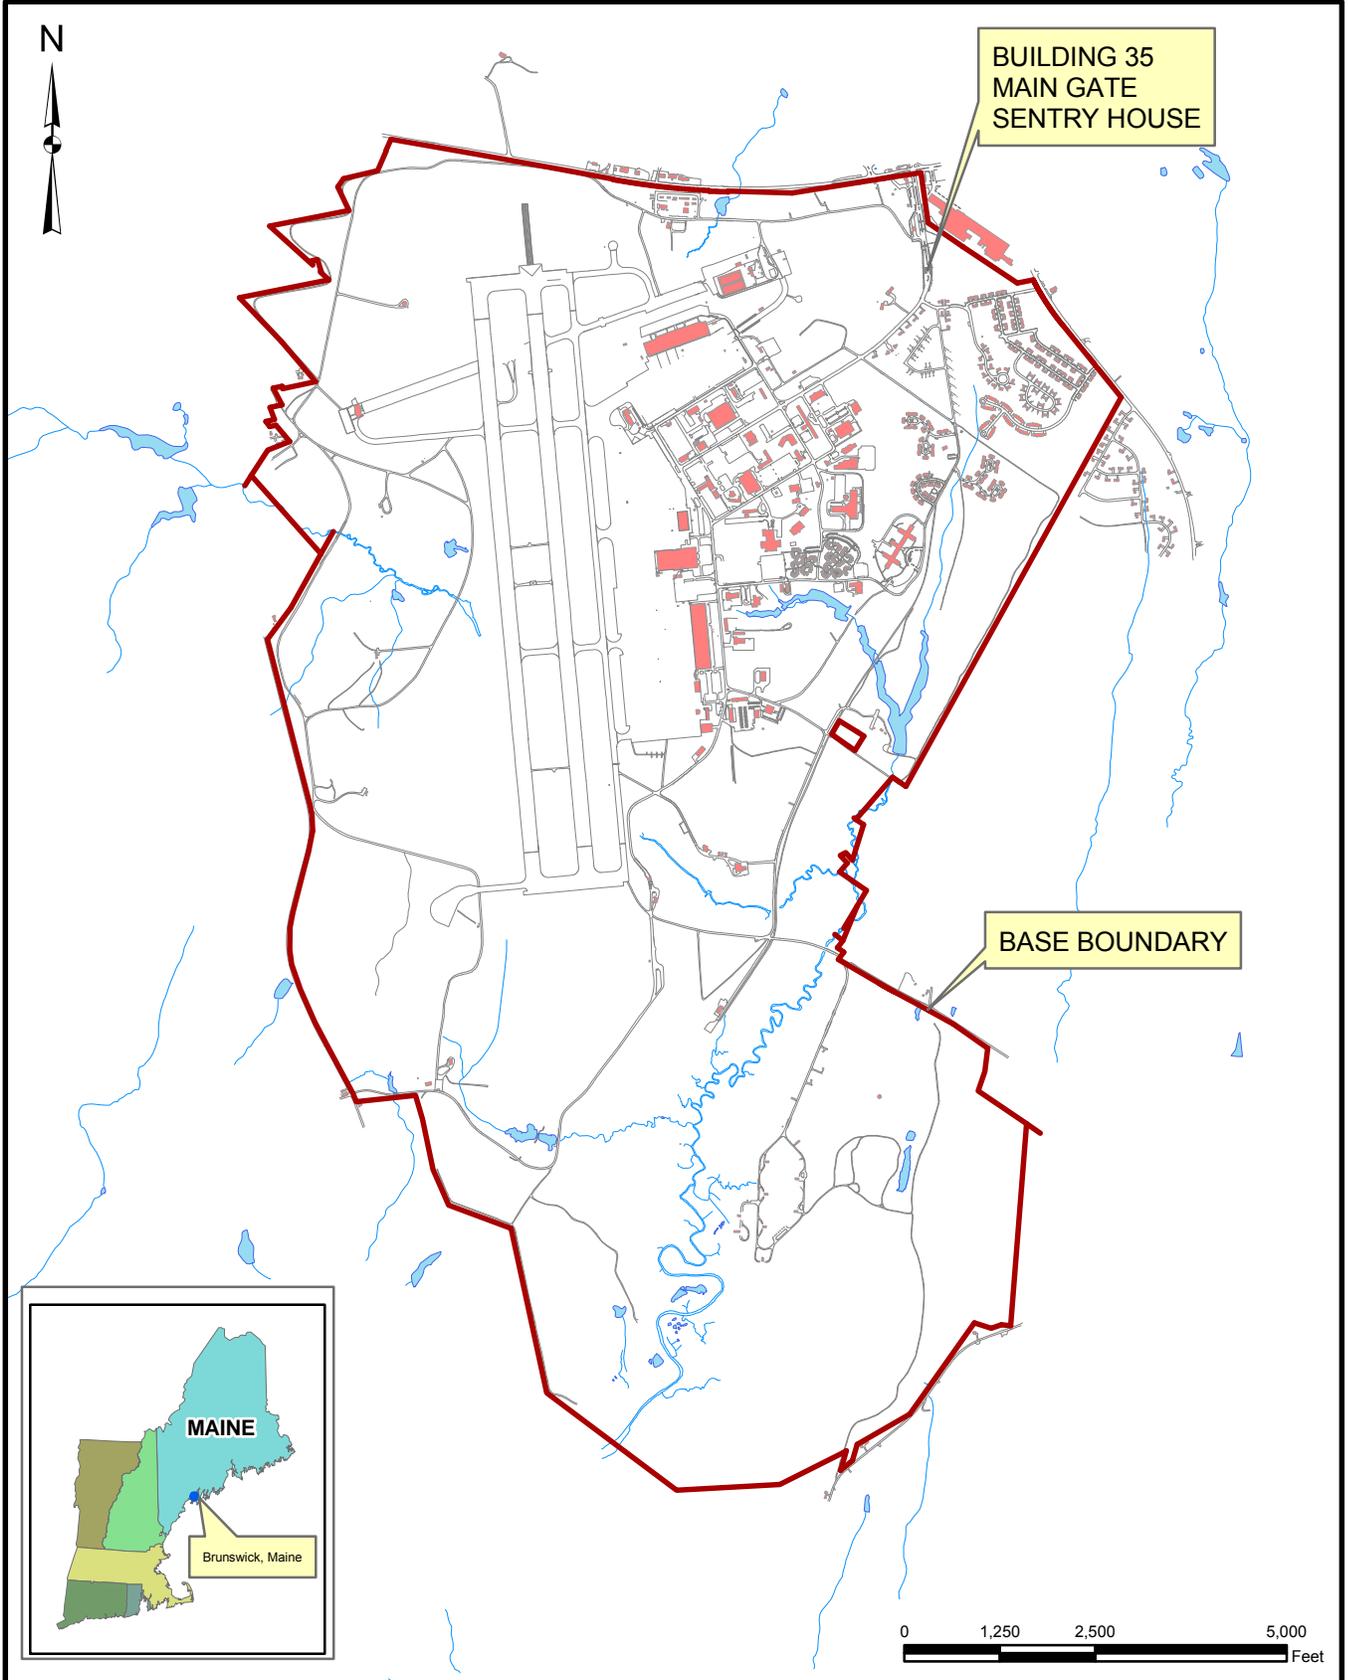
SCALE AS NOTED	
FILE I:\02258\ASB_BLDG_35_LOCUS.MXD	
REV 0	DATE 12/13/10
FIGURE NUMBER 1

Building 35, known as the Main Gate Sentry House, is located in the northeastern portion of NAS Brunswick in the Main Gate Area (Figure 1). The building is located in the median of Fitch Avenue and is bordered to the north by Building 33 (Front Gate Security Building) and the Building 37 (Midcoast Regional Redevelopment Association [MRRA] parcel, to the east and west by grass- and tree-covered areas, and to the south by Fitch Avenue and housing areas (Figure 2).

SITE LOCATION MAP
 BUILDING 35 - MAIN GATE SENTRY HOUSE
 RCRA PARTIAL CLOSURE REPORT
 NAVAL AIR STATION BRUNSWICK, MAINE

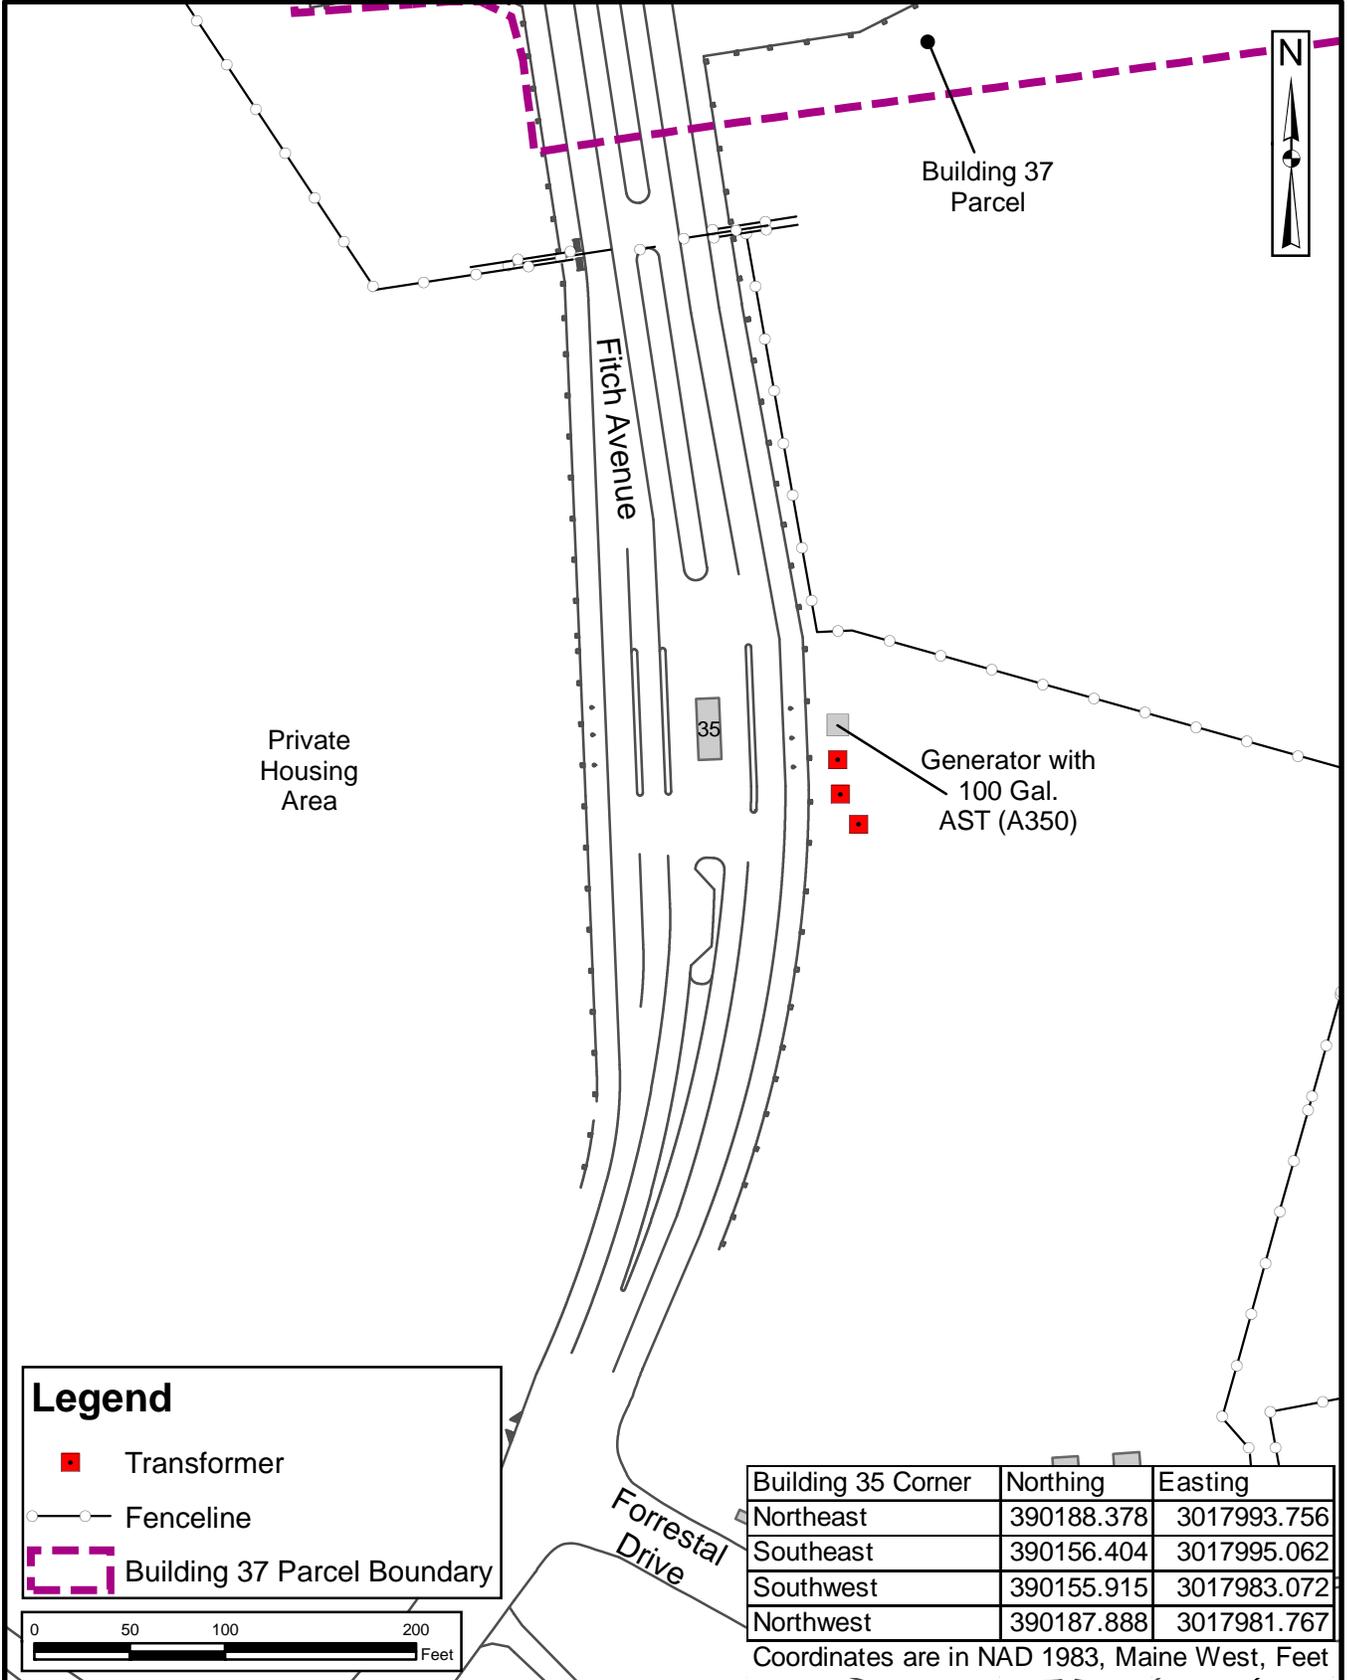
Tetra Tech NUS, Inc.	SITE MAP BUILDING 35 - MAIN GATE SENTRY HOUSE RCRA PARTIAL CLOSURE REPORT NAVAL AIR STATION BRUNSWICK, MAINE	SCALE AS NOTED
		FILE L:\NASB_BLDG_35_SITE_MAP.MXD
	REV 0	DATE 12/14/10
	FIGURE NUMBER FIGURE NO. 2

This investigation of the hazardous waste closure requirement applies to the footprint of Building 35 (as shown on Figure 2), only. It does not apply to the land surrounding or the groundwater underlying Building 35.

Building 35 Corner	Northing	Easting
Northeast	390188.378	3017993.756
Southeast	390156.404	3017995.062
Southwest	390155.915	3017983.072
Northwest	390187.888	3017981.767

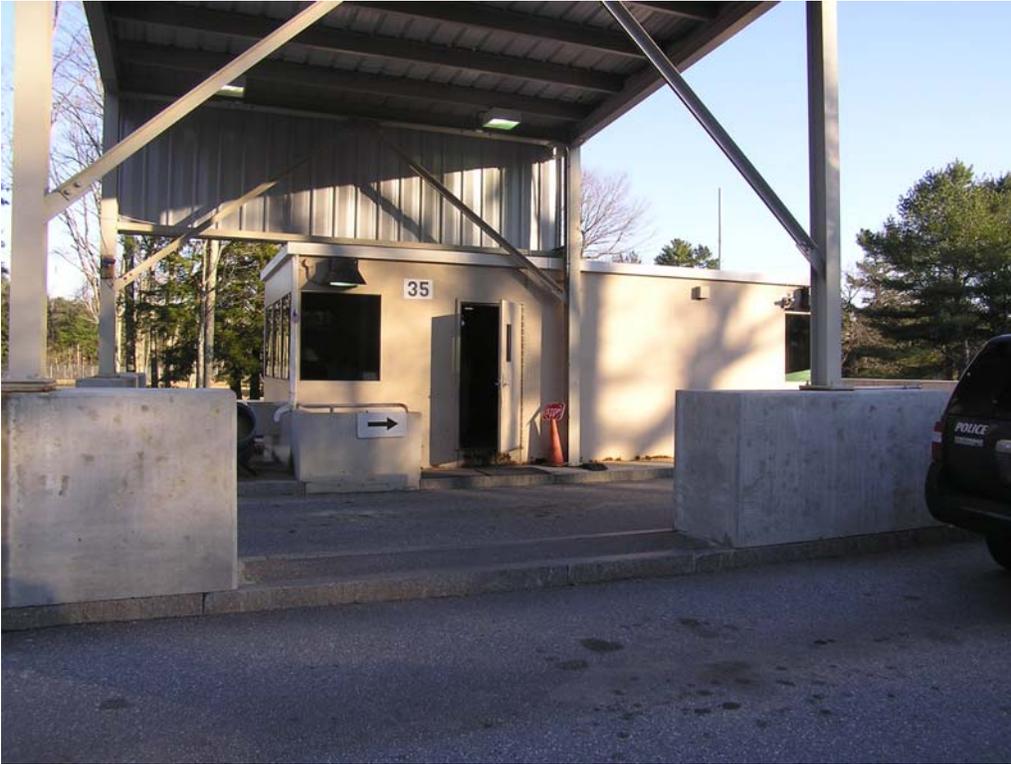
- At the time of inspection, Building 35 was in service and occupied and in good condition.
- No evidence of current or past hazardous waste generation activities was observed.
- No signs of a past release (staining, unusual odors, stressed vegetation, etc.) were observed.
- No modifications to the structure, which may conceal signs of a past release, were observed.
- No peeling or flaking paint was observed on the exterior or interior of the building.
- The emergency generator unit was observed east the buildings; three transformers serving the Private Housing Area are located south of the generator unit.

No. 1 Building 35 – Main Gate Sentry Building, NAS Brunswick December 2, 2010
Main Gate Sentry Building west elevation

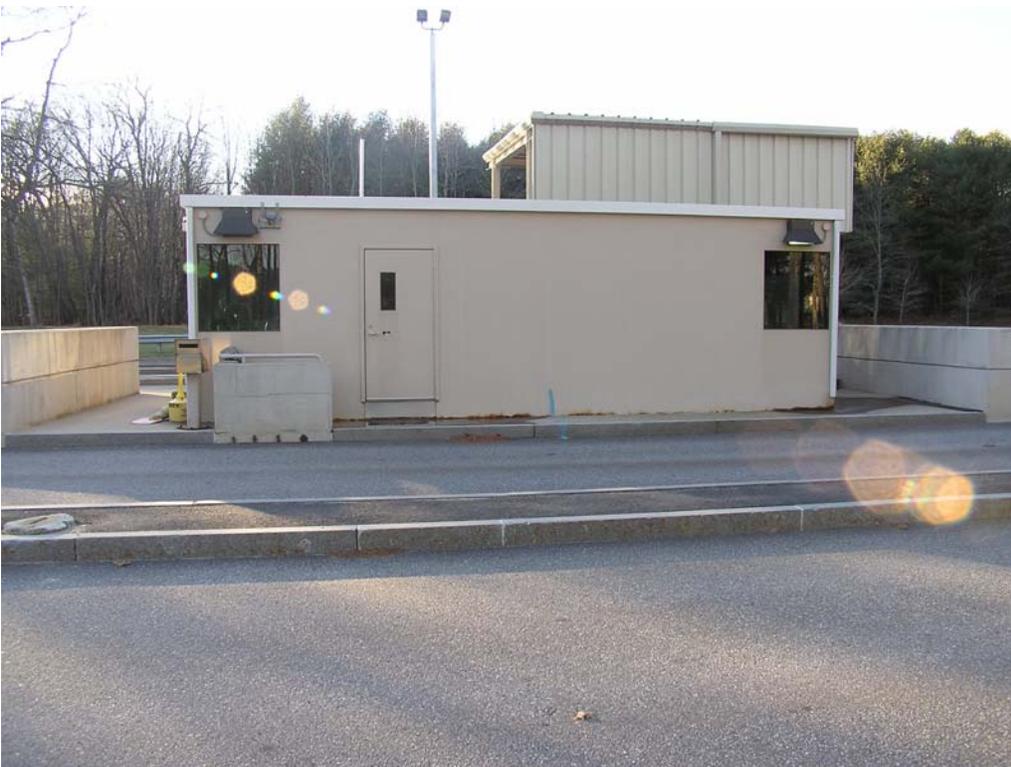
No. 2 Building 35 – Main Gate Sentry Building, NAS Brunswick December 2, 2010
Main Gate Sentry Building east elevation

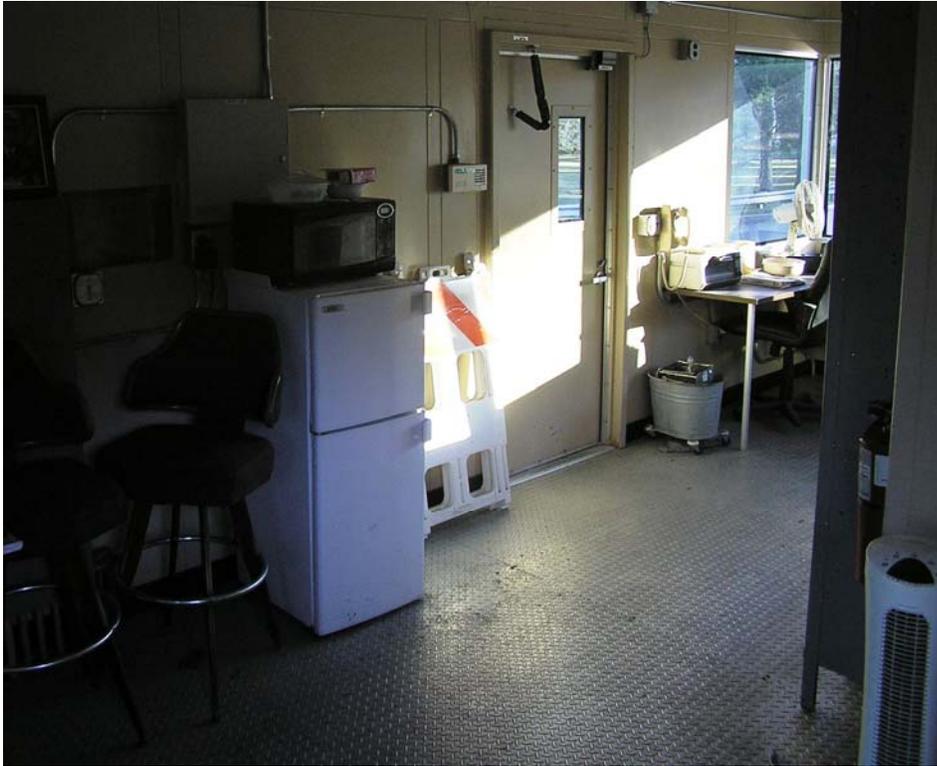
No record of hazardous waste stored at Building 35.
At the time of inspection, Building 35 was in good condition.
No evidence of current or past hazardous waste generation activities was observed.
No evidence of hazardous waste residues was observed.
No signs of a past release (staining, unusual odors, stressed vegetation, etc.) were observed. No modifications to the structure, which may conceal signs of a past release, were observed.
No hazardous waste storage areas or hazardous waste accumulation areas were observed.

No. 3 Building 35 – Main Gate Sentry Building, NAS Brunswick December 2, 2010
Main Gate Sentry Building interior

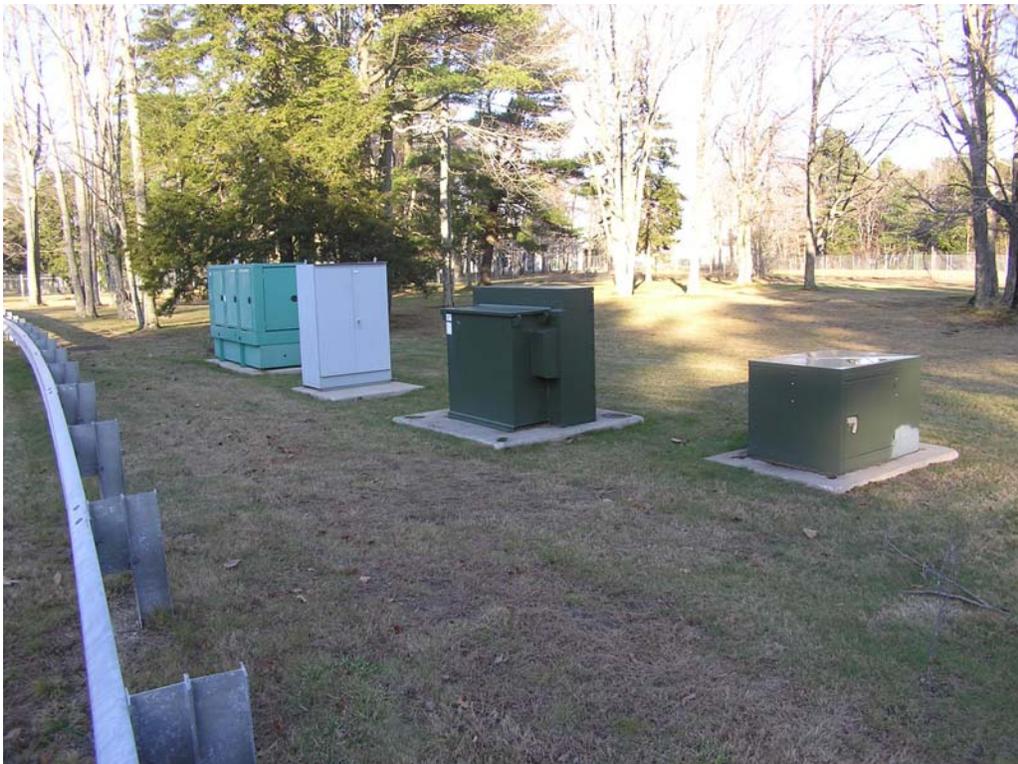
The NAS Brunswick Aboveground Storage Tank (AST) and Underground Storage Tank (UST) inventory records list a 100-gallon, double-walled steel AST (A35.0) containing diesel fuel for the generator at the main gate location (Environmental Department, 2009). This pad-mounted emergency generator (with 100-gallon day tank) enclosure is located east of Building 35. It was installed in 2004 and is active.

No OWS were present at Building 35 according to NASB records.
No USTs were present at Building 35 according to NASB records.
The generator east of Building 35 is associated with Building 35 and contains a 100 gallon DWS AST (A35.0) containing diesel for the generator (installed in 2004, active)

No. 4 Building 35 – Main Gate Sentry Building, NAS Brunswick December 2, 2010
Generator (far left) and transformers east of Main Gate Sentry Building
