FINAL RESOURCE CONSERVATION AND RECOVERY ACT PARTIAL CLOSURE REPORT
FOR BUILDING 750 WITH TRANSMITTAL LETTER NAS BRUNSWICK ME
12/17/2010
NAS BRUNSWICK

RCRA PARTIAL CLOSURE REPORT
for
BUILDING 750 – TRANSIENT VISITOR QUARTERS
NAVAL AIR STATION BRUNSWICK, MAINE
USEPA IDENTIFICATION NUMBER ME8170022018
DECEMBER 2010

**HWSA INSPECTION REPORT
HAZARDOUS WASTE STORAGE AREAS CLOSURE
NAS BRUNSWICK
BRUNSWICK, MAINE
CTO WE22**

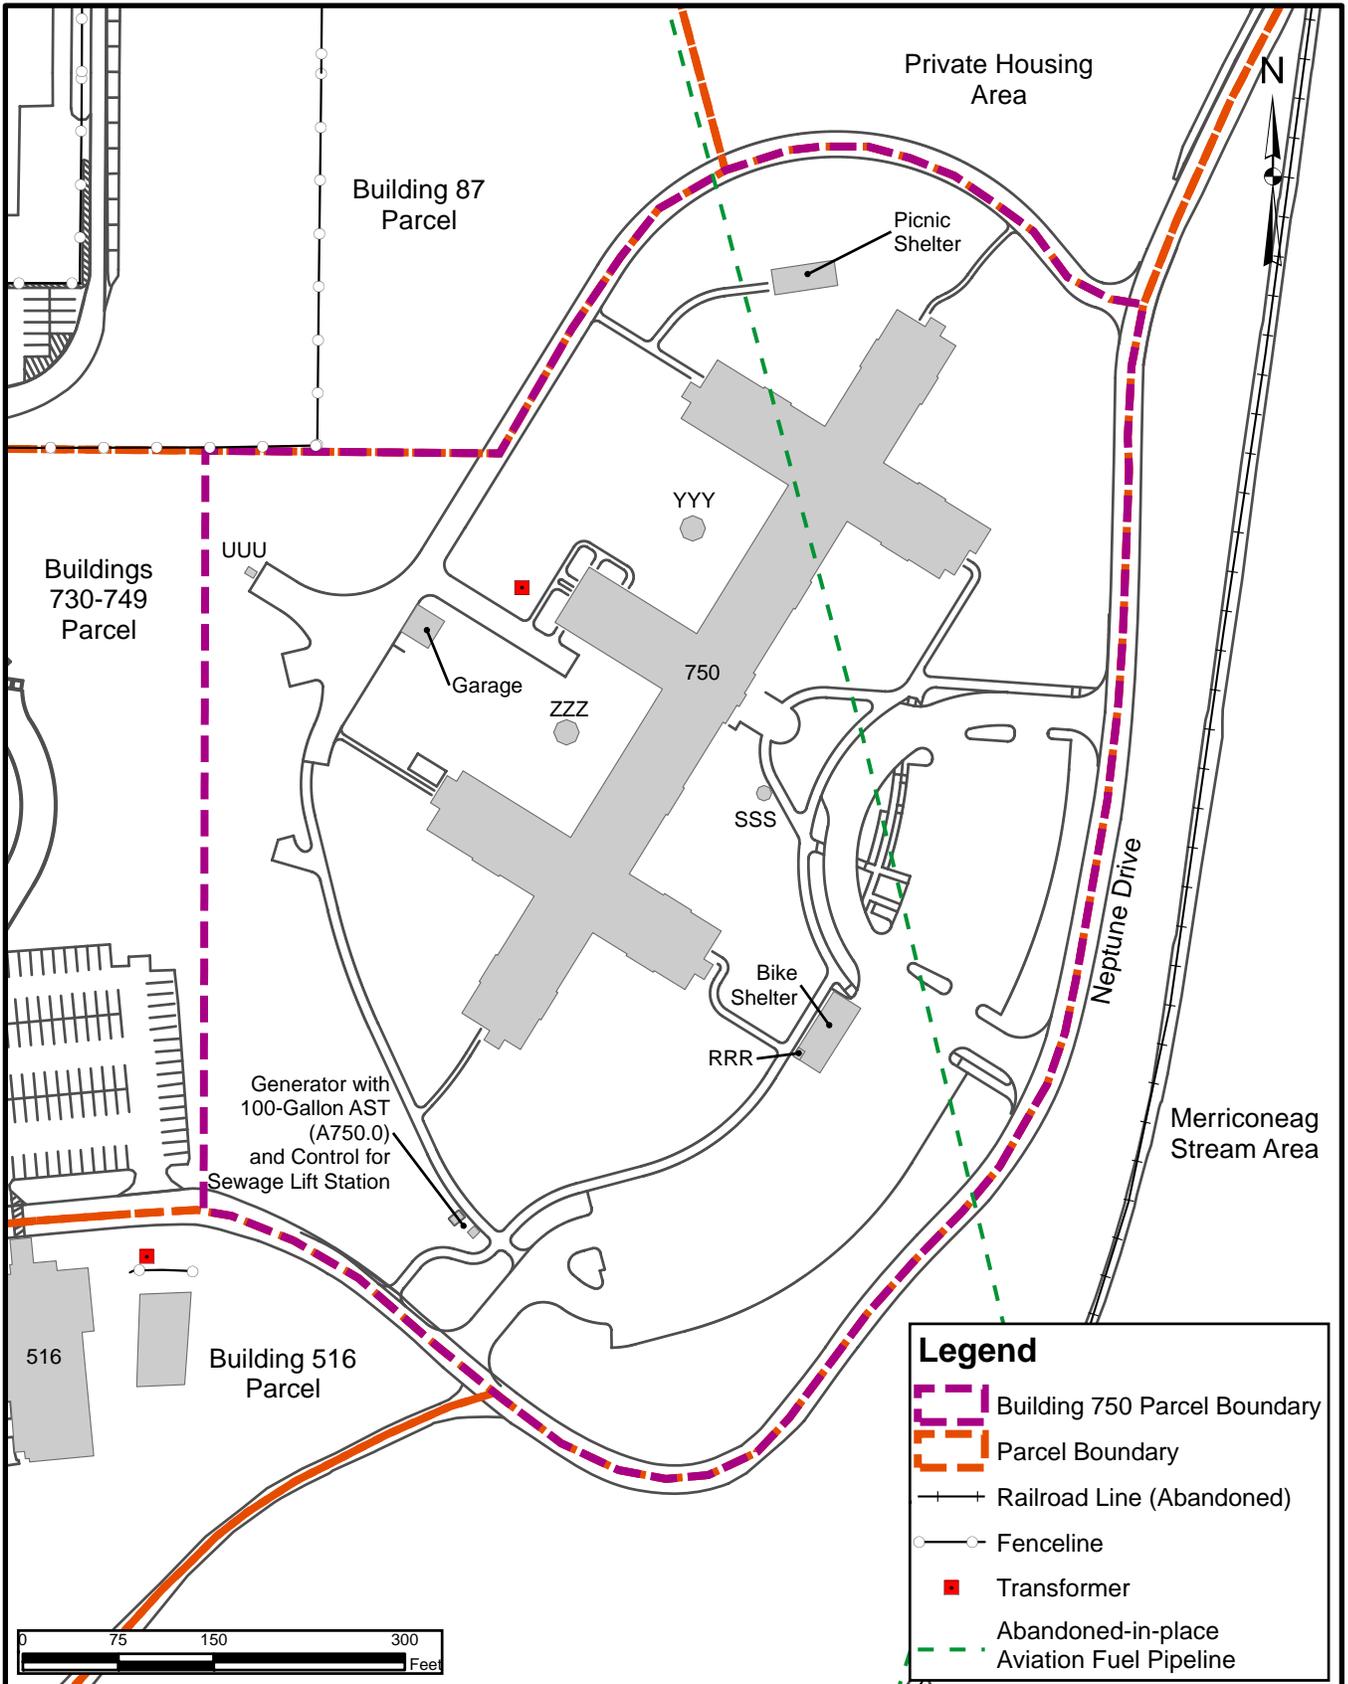
| FIGURE NUMBER 2 | |

SITE PLAN
BUILDING 750 - TRANSIENT VISITOR QUARTERS PARCEL
RCRA PARTIAL CLOSURE REPORT
NAVAL AIR STATION BRUNSWICK, MAINE

This investigation of the hazardous waste closure requirement applies to the Building 750 parcel (as shown on Figure 2) only.

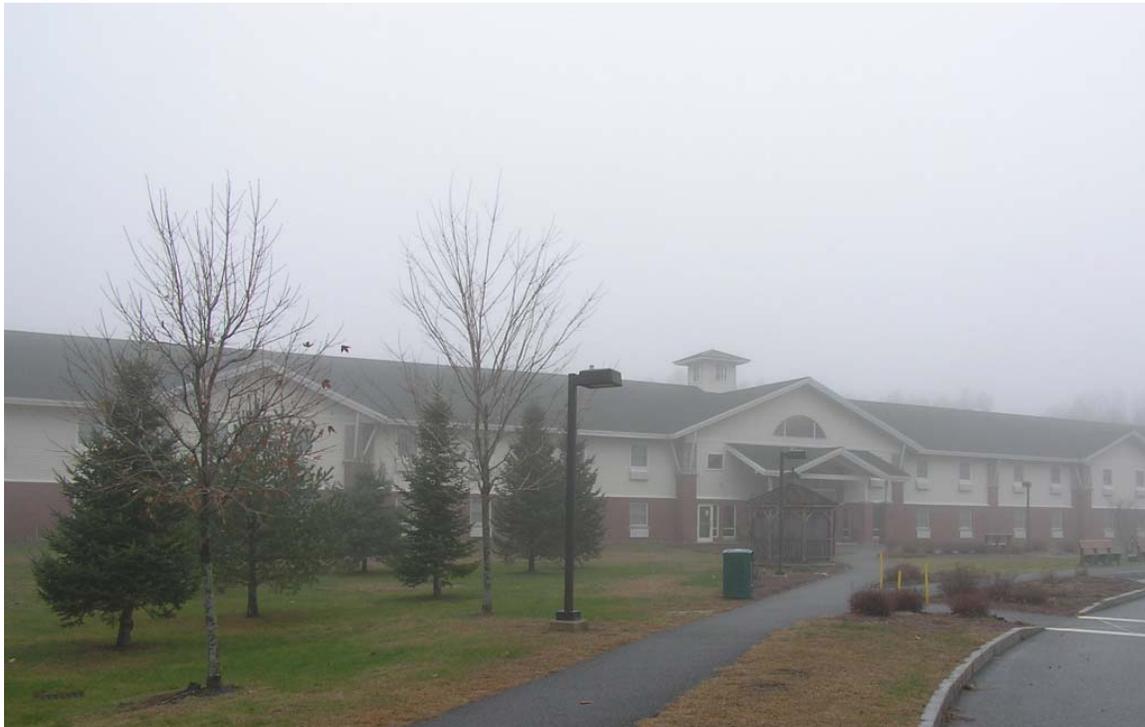
No.1 Building 750 – Transient Visitors Quarters, NAS Brunswick
View from south east parking lot, showing main entrance and Structure SSS

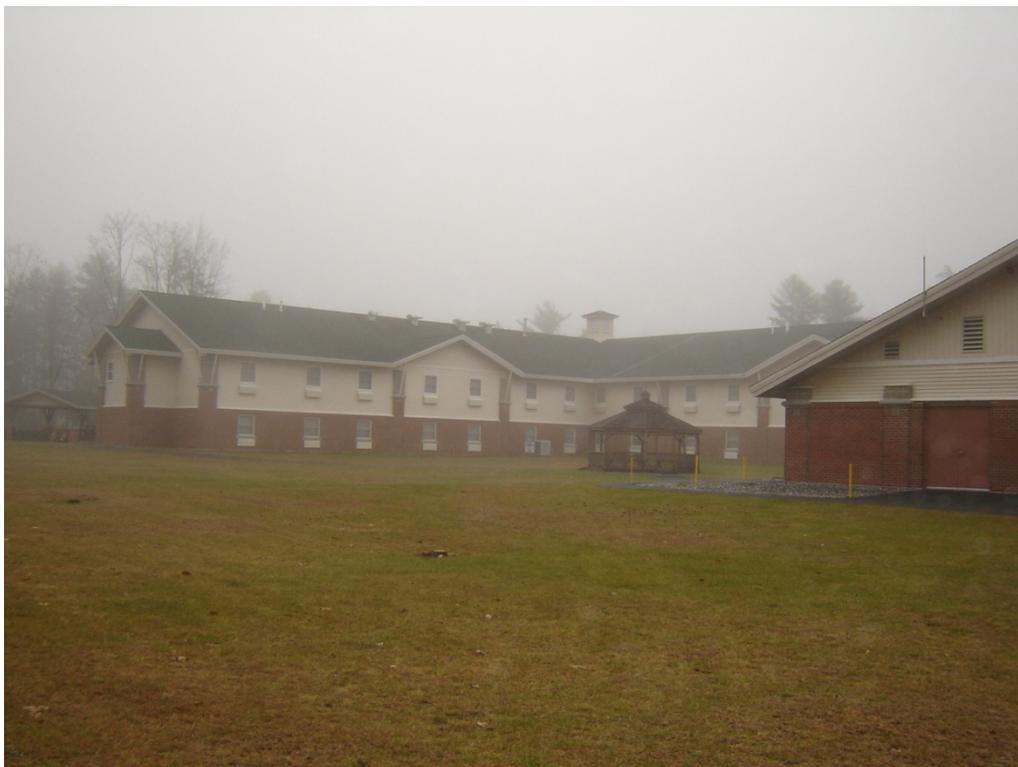
No.2 Building 750 – Transient Visitors Quarters, NAS Brunswick
View from southwest, showing northwest wing and picnic shelter in the distance with Structure YYY and west central wing in foreground

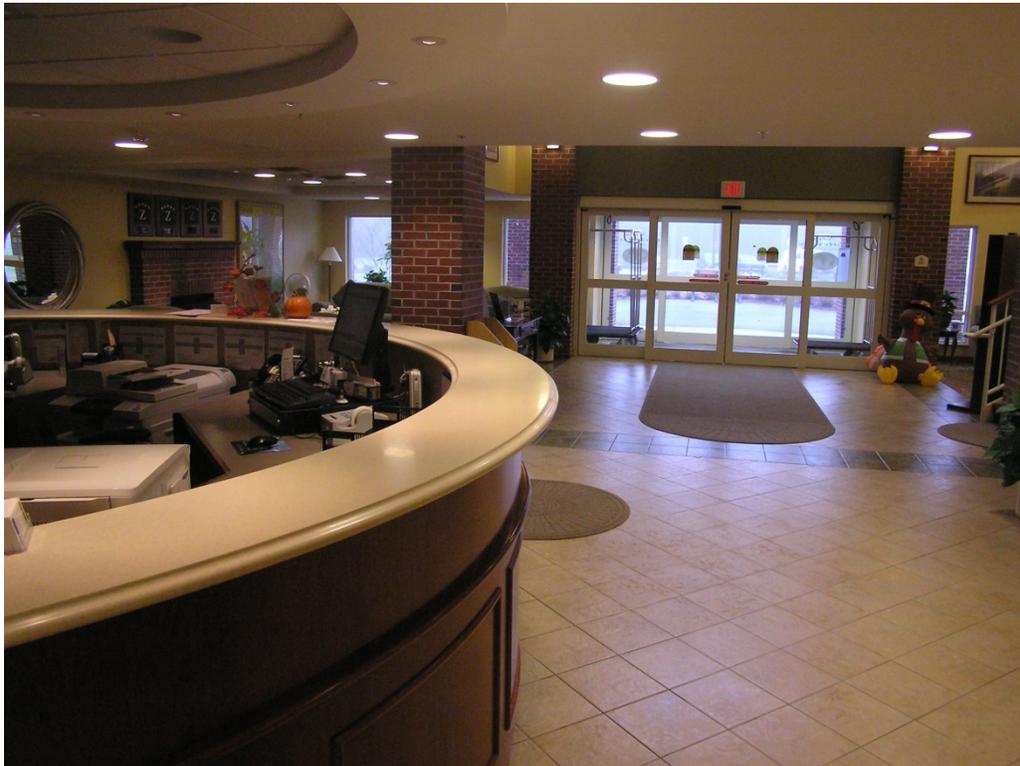
No.3 Building 750 – Transient Visitors Quarters, NAS Brunswick
Main entrance and lobby, facing east towards parking lot

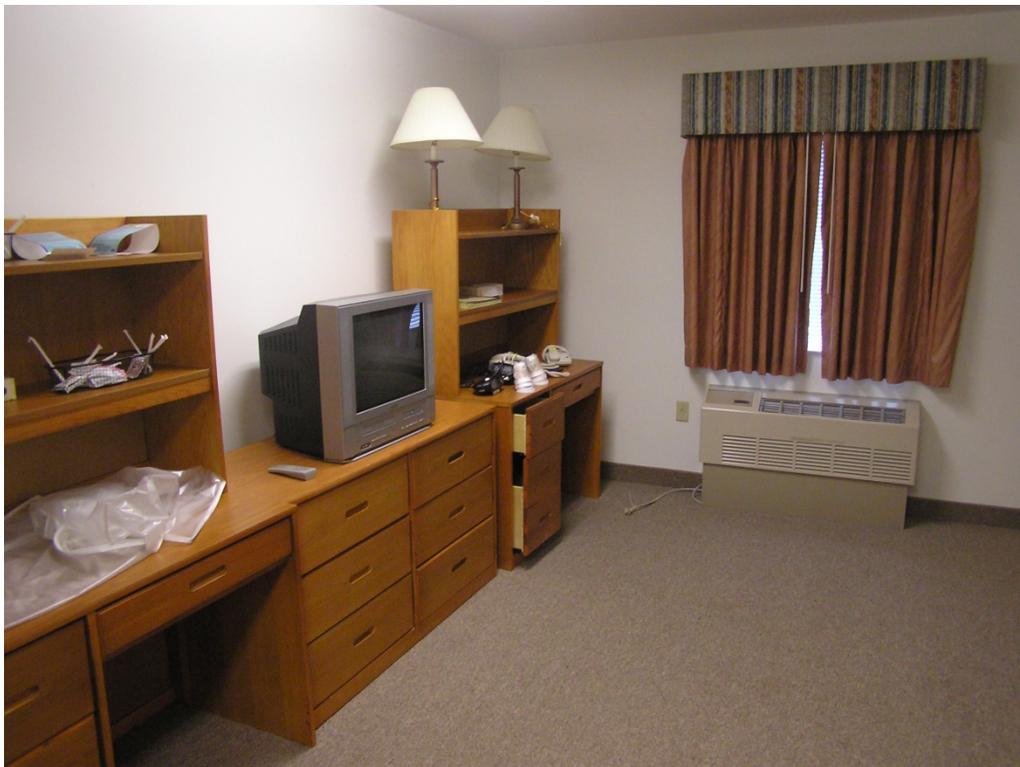
- No paint chips or loose, peeling, or flaking paint conditions were observed.
- Ceramic floor-tiles and carpet on concrete flooring were observed throughout most of the building and appeared to be in good condition.

No.4 Building 750 – Transient Visitors Quarters, NAS Brunswick
Typical room (temporary living quarters) within Building 750

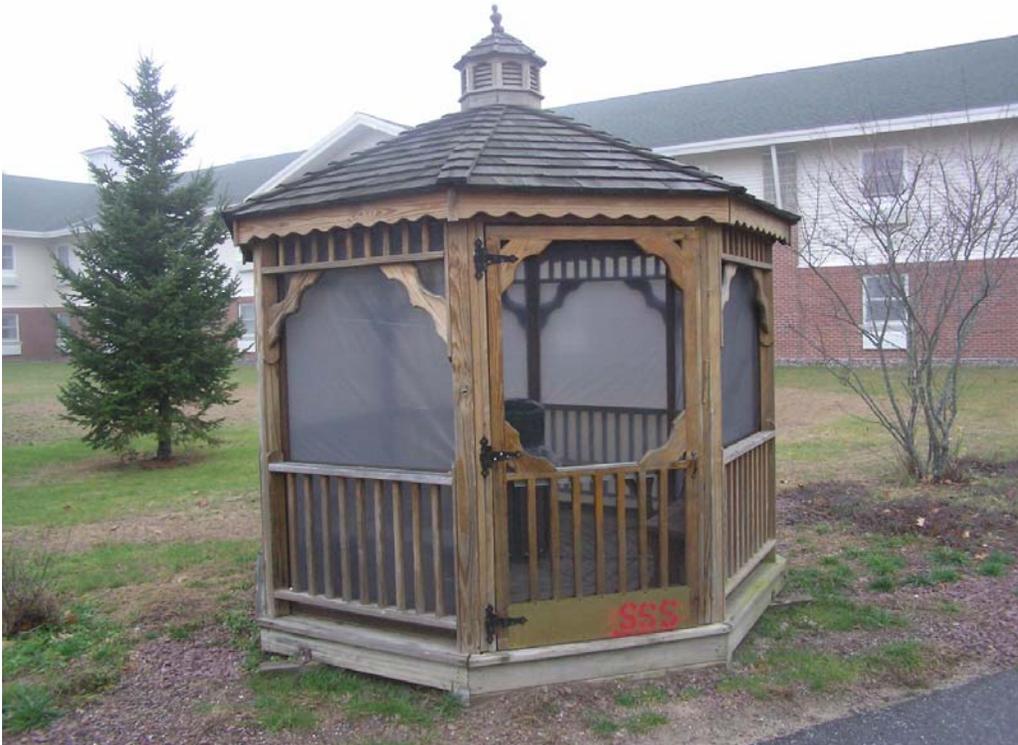
- A small, screened-in, smoking-area gazebo (Structure SSS) was observed to the east of the building, near the main entrance. This structure was empty.

No. 5 Building 750 – Transient Visitors Quarters, NAS Brunswick
Smoking area gazebo (Structure SSS) on eastern side of building near main entrance

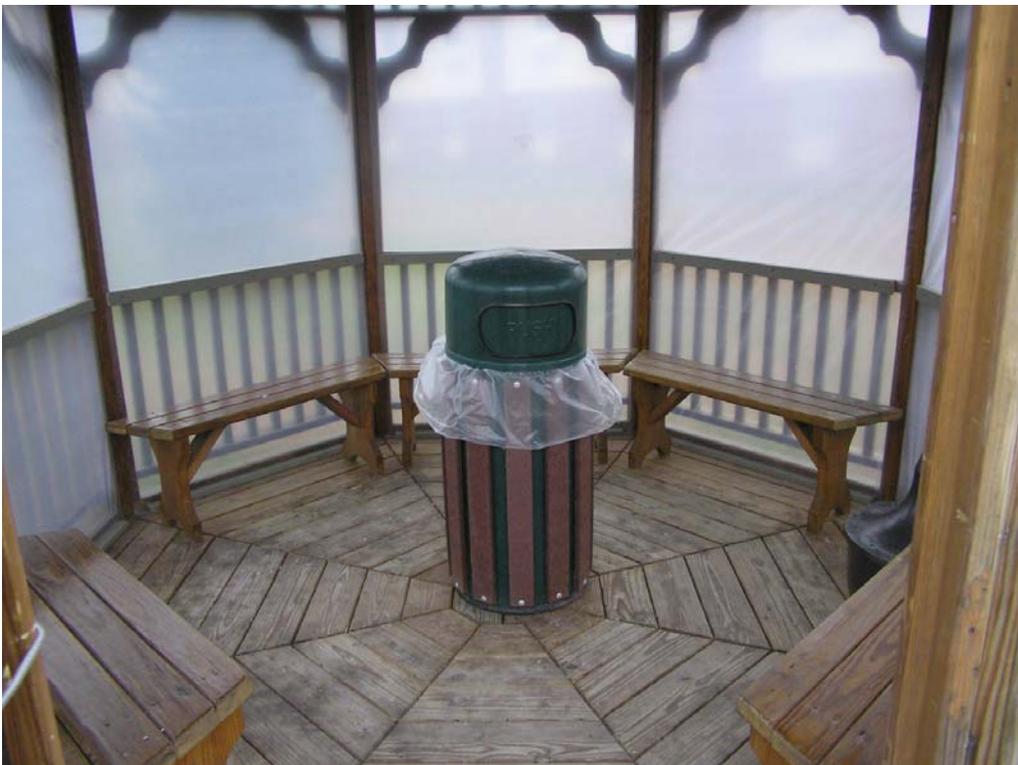
No. 6 Building 750 – Transient Visitors Quarters, NAS Brunswick
Interior of Structure SSS (interior typical of larger gazebos YYY and ZZZ)

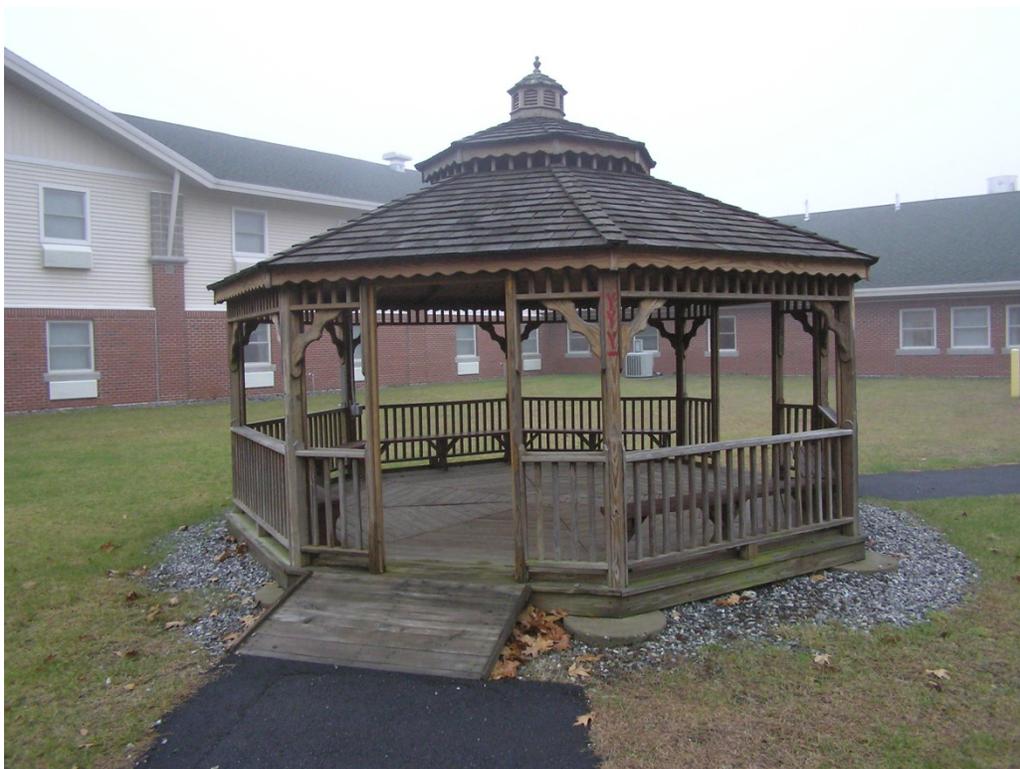
- Two large, smoking-area, wooden gazebos (Structures YYY and ZZZ) were located at the rear of Building 750, on either side of the west-central wing. Both were empty, and Structure ZZZ was screened-in, while Structure YYY was open.

No. 7 Building 750 – Transient Visitors Quarters, NAS Brunswick
Smoking area gazebo (Structure YYY) near northwest wing of building

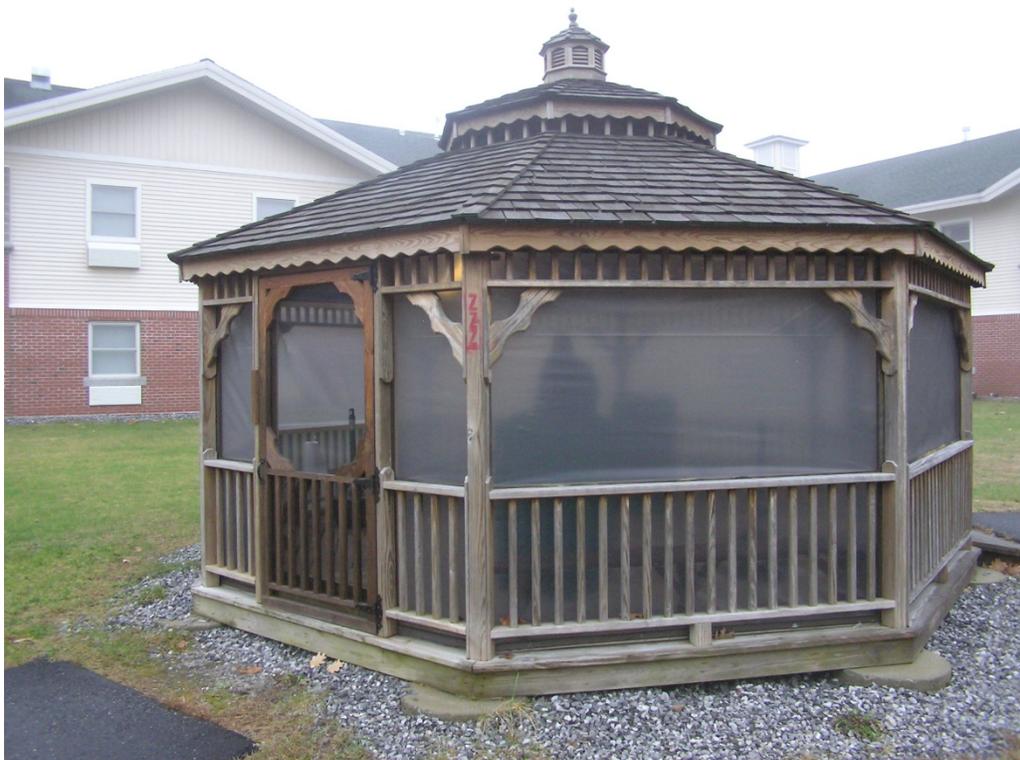
No. 8 Building 750 – Transient Visitors Quarters, NAS Brunswick
Smoking area gazebo (Structure ZZZ) near south west wing of building

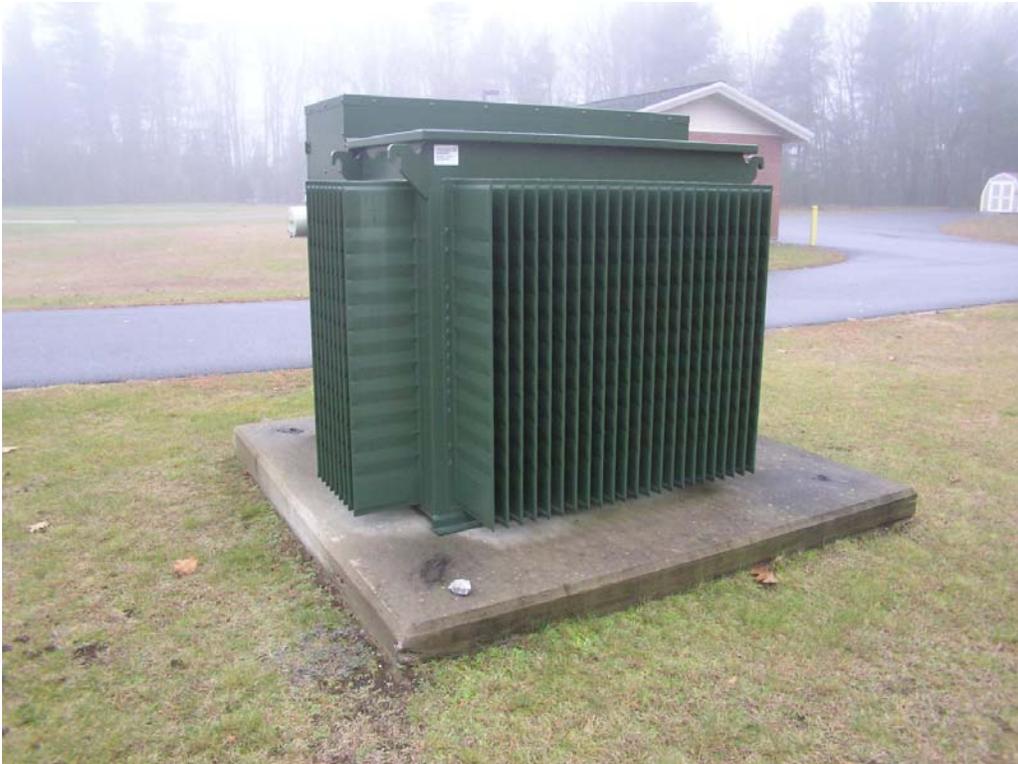
- One concrete-pad-mounted transformer was identified at the rear of the building, across from the west-central wing of the building. No staining or other evidence of a release from this transformer was observed and it appeared to be relatively new.

One pad-mounted transformer was observed on the grass to the west of the building on this parcel. Due to the construction date (2005) of the building, it is not suspected to contain PCBs.

No. 9 Building 750 – Transient Visitors Quarters, NAS Brunswick November 23, 2010
Transformer located west of west central wing. Garage (partially obscured by transformer) and Structure UUU in the distance

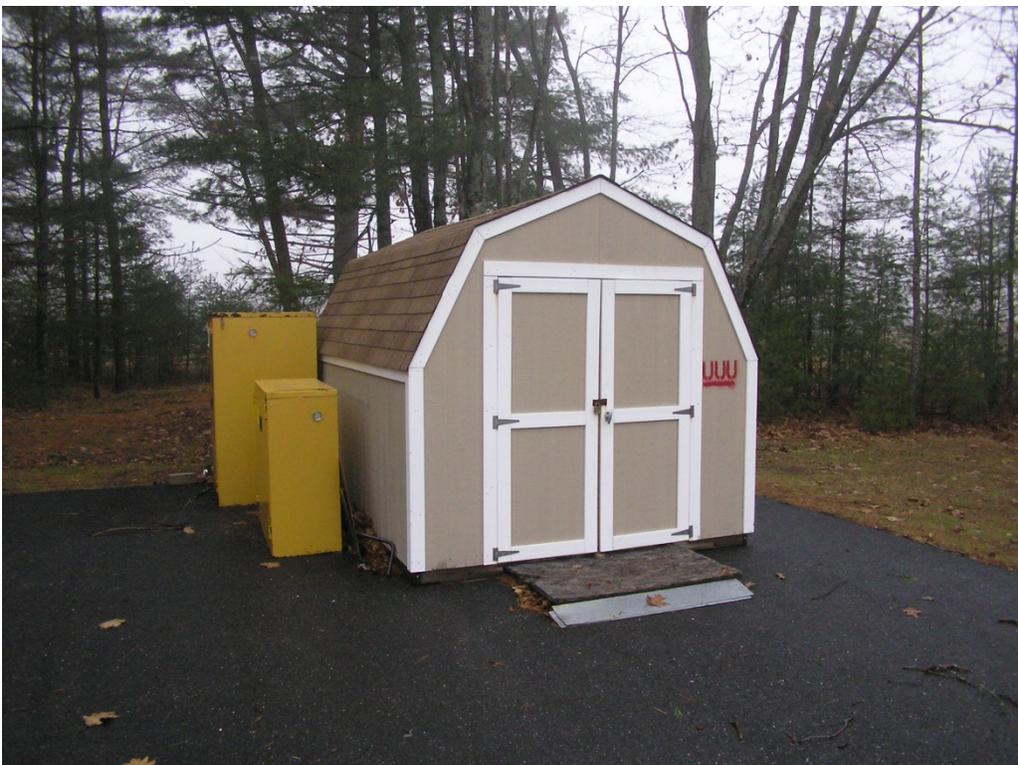
- A brick-faced garage with a locked, bin-storage area, and a wooden storage shed (Structure UUU) were observed at the western edge of the property, on opposite sides of the asphalt-paved roadway. In the garage, hand tools, a snow blower, lawn equipment, and a drill-press were observed, among other equipment. Structure UUU, the storage shed, contained general yard maintenance equipment. Two flame lockers, outside of and adjacent to the south wall of the storage shed, reportedly contained gasoline and motor oil. No staining or evidence of any release was observed in these areas.

No. 10 Building 750 – Transient Visitors Quarters, NAS Brunswick November 23, 2010
Structure UUU with two flame lockers (with gasoline and motor oil) against south side of shed

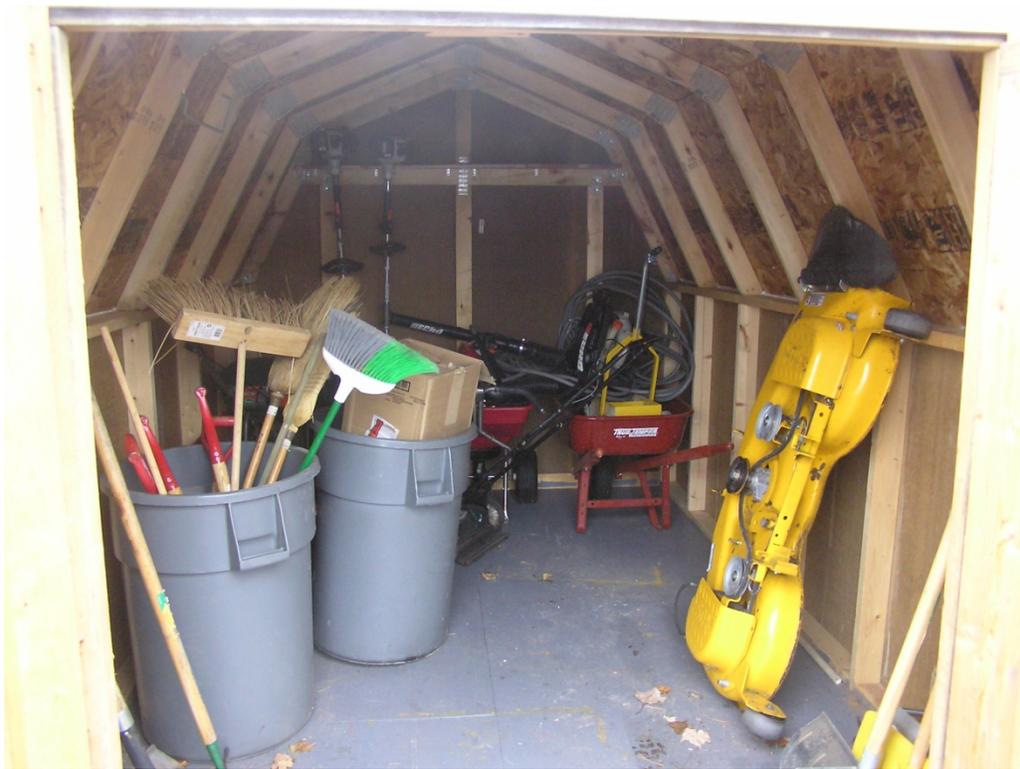
No. 11 Building 750 – Transient Visitors Quarters, NAS Brunswick
Interior of Structure UUU (storage shed)

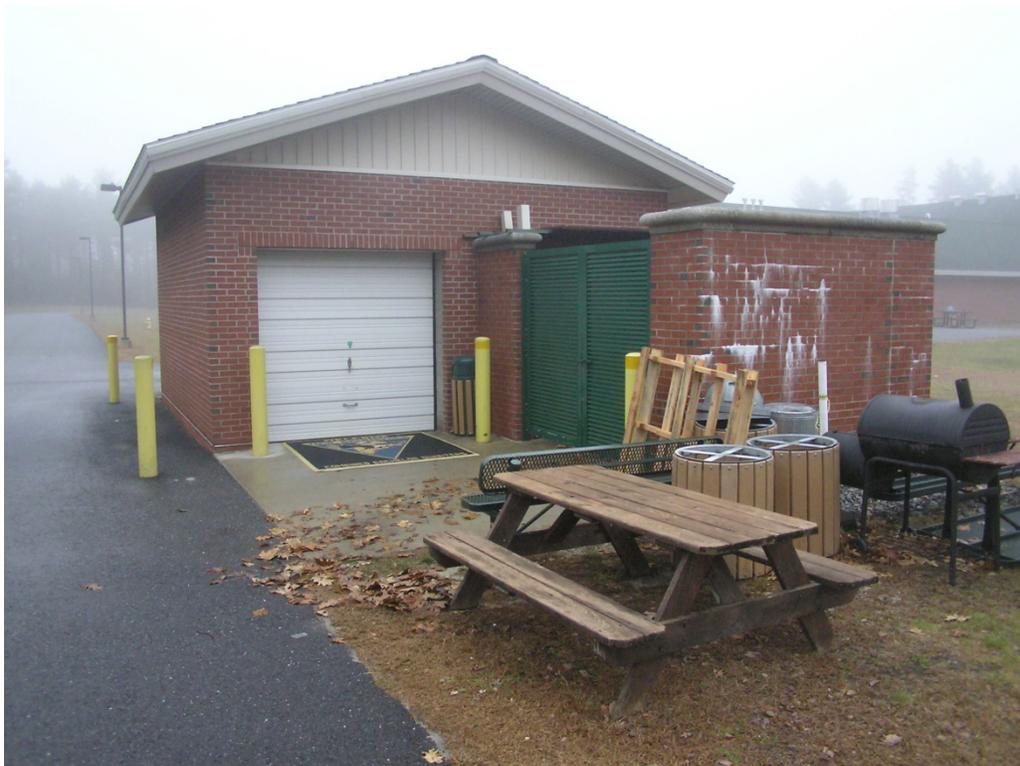
No. 12 Building 750 – Transient Visitors Quarters, NAS Brunswick
Garage w/ locked bin storage area

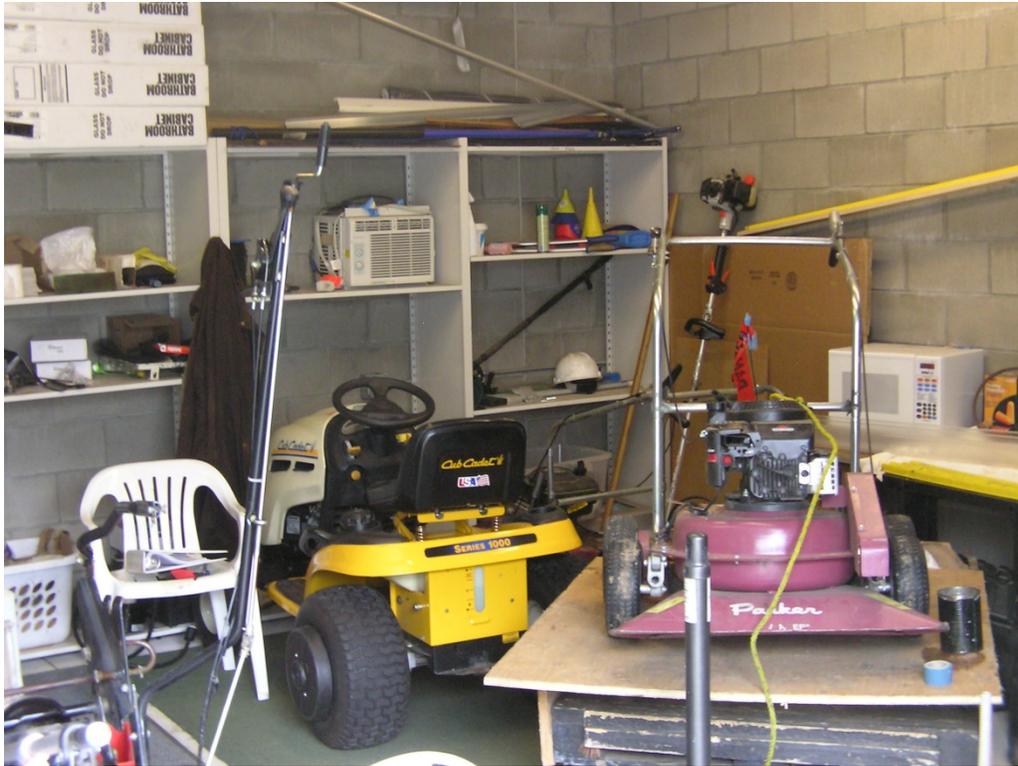
No. 13 Building 750 – Transient Visitors Quarters, NAS Brunswick November 23, 2010
Garage interior

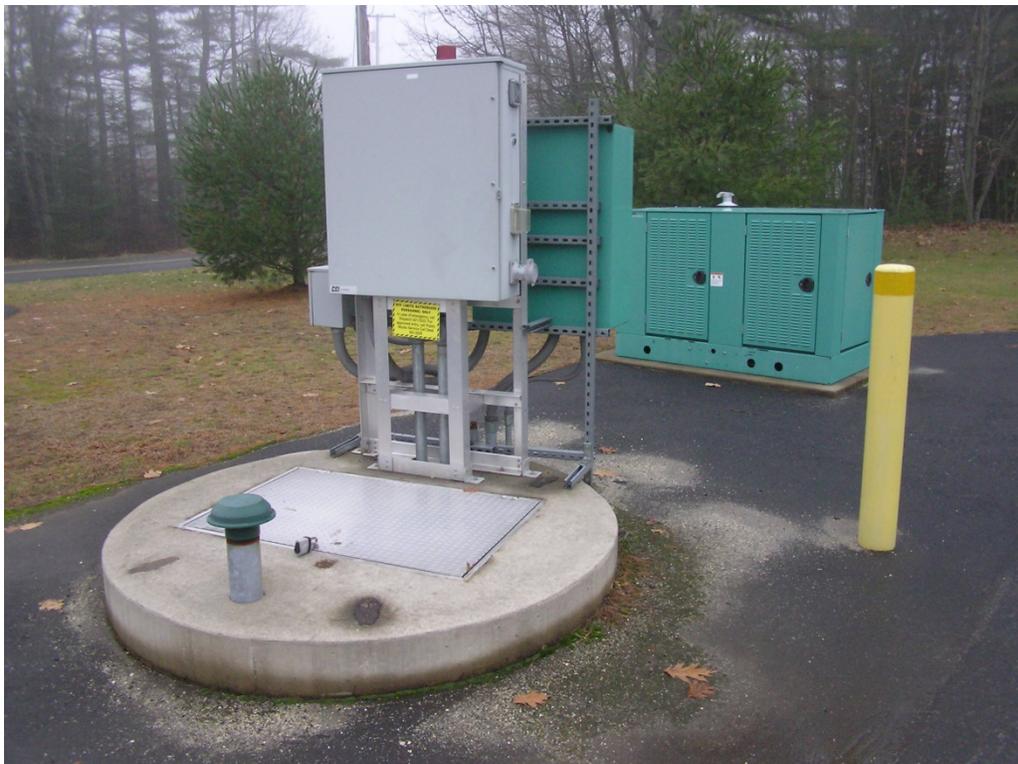
- An emergency generator and associated control panel for the sewer lift station were observed south of the building, near the southwestern boundary of the Building 750 parcel. A bike shelter and a metal storage shed (Structure RRR) are located in the southeast section of the parcel, at the edge of the parking lot. Structure RRR sits on the concrete pad of the bike shelter and, at the time of the site visit, contained three heavy-duty snow-blowers and a gasoline can.

According to NASB records the generator south of building 750 contains a 100-gallon DWS steel AST (A750.0) that contains diesel for the generator (installed in 2004, active). Two USTs, associated with the former Building 35 were removed from the property in 1998 (a 1,000 gallon FRP tank that stored No.2 fuel oil) and in 2003 (a 550-gallon steel tank of unknown contents). The MEDEP spills database did not report any leaks related to these USTs.

No. 14 Building 750 – Transient Visitors Quarters, NAS Brunswick November 23, 2010
Emergency generator (with 100-gal AST) and control panel for Sewage Lift Station (south of building)

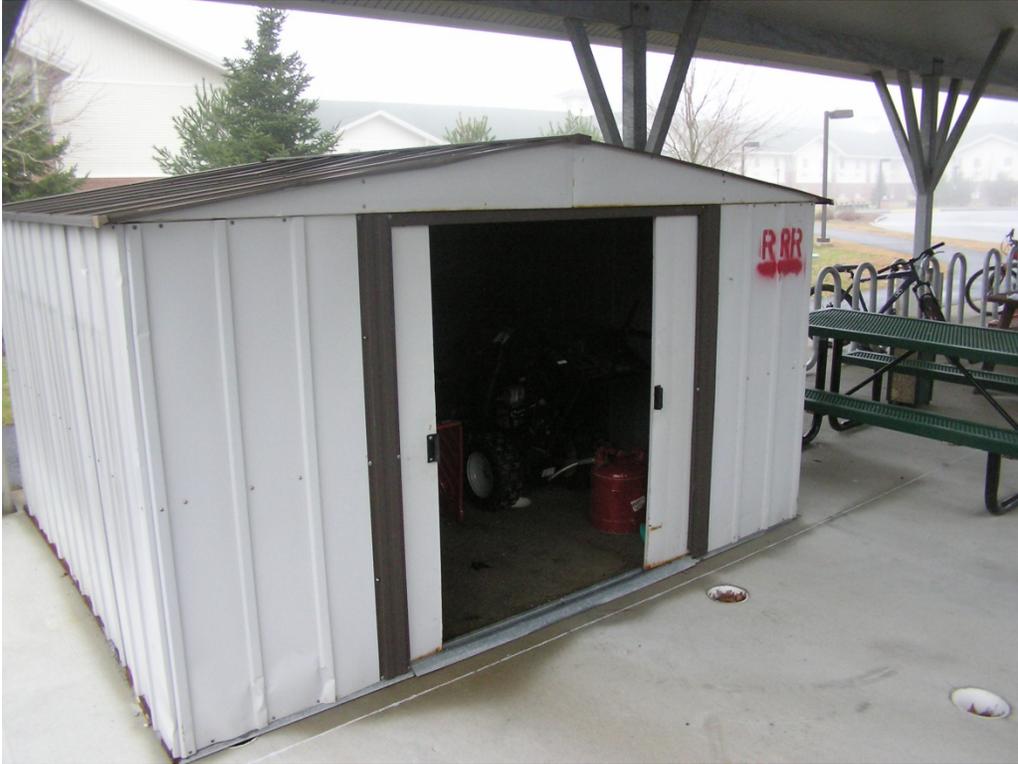
No. 15 Building 750 – Transient Visitors Quarters, NAS Brunswick
Metal storage shed (Structure RRR) located under roof of Bike Shelter

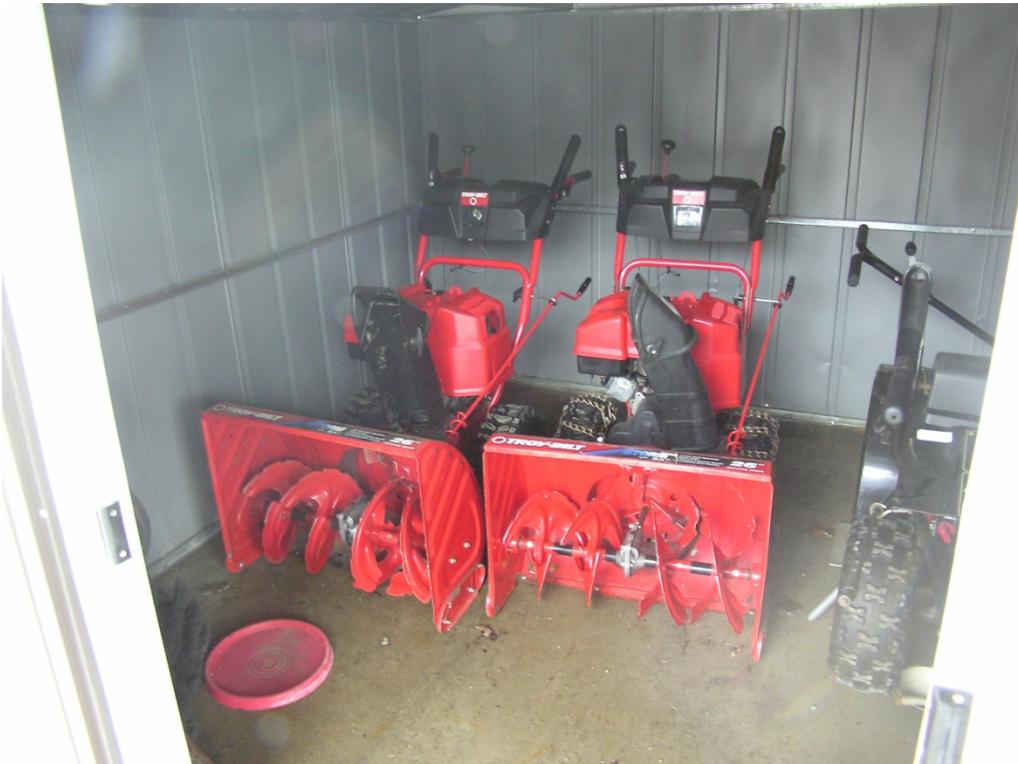
No. 16 Building 750 – Transient Visitors Quarters, NAS Brunswick
Interior of Structure RRR

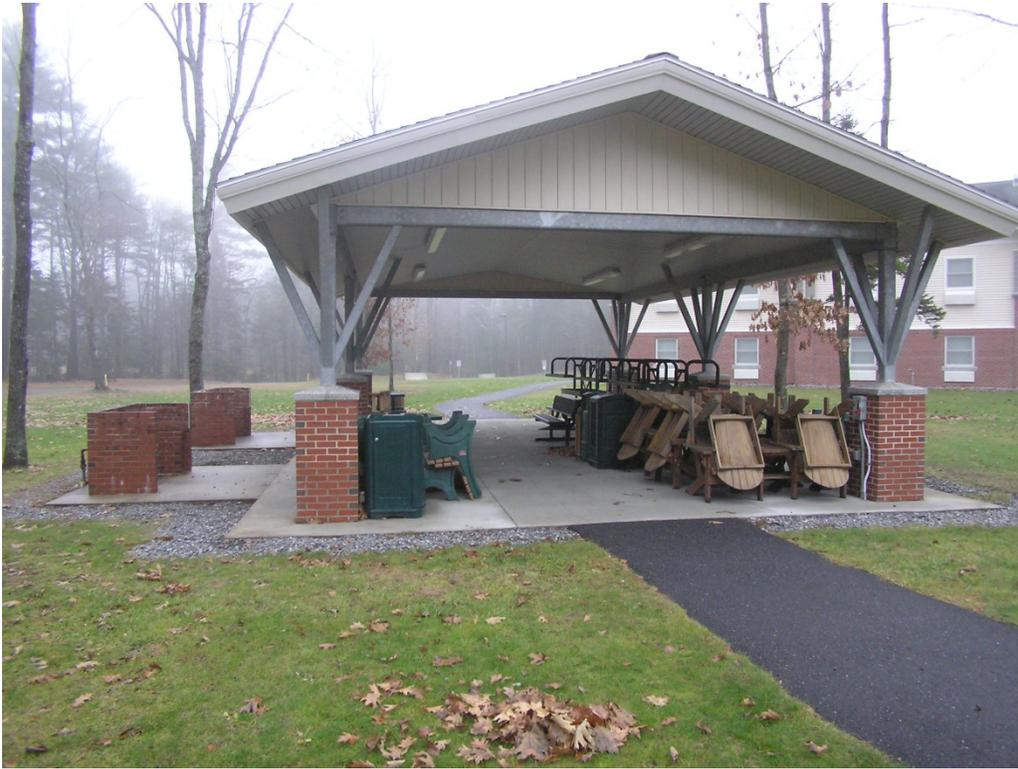
- A picnic shelter (of similar construction to the bike area) with a concrete base is located to the northwest of the building. A number of chairs and tables were stored in this area.

No. 17 Building 750 – Transient Visitors Quarters, NAS Brunswick
Picnic Shelter near northwest wing of building
