FINAL RESOURCE CONSERVATION AND RECOVERY ACT PARTIAL CLOSURE REPORT
FOR BOWDOIN COLLEGE LOT 2 AREA WITH TRANSMITTAL LETTER NAS BRUNSWICK
ME
12/17/2010
NAS BRUNSWICK

Subj: Final RCRA Partial Closure Report for Bowdoin College Lot 2 Area

RCRA PARTIAL CLOSURE REPORT
for
BOWDOIN COLLEGE LOT 2 AREA
NAVAL AIR STATION BRUNSWICK, MAINE
USEPA IDENTIFICATION NUMBER ME8170022018
DECEMBER 2010

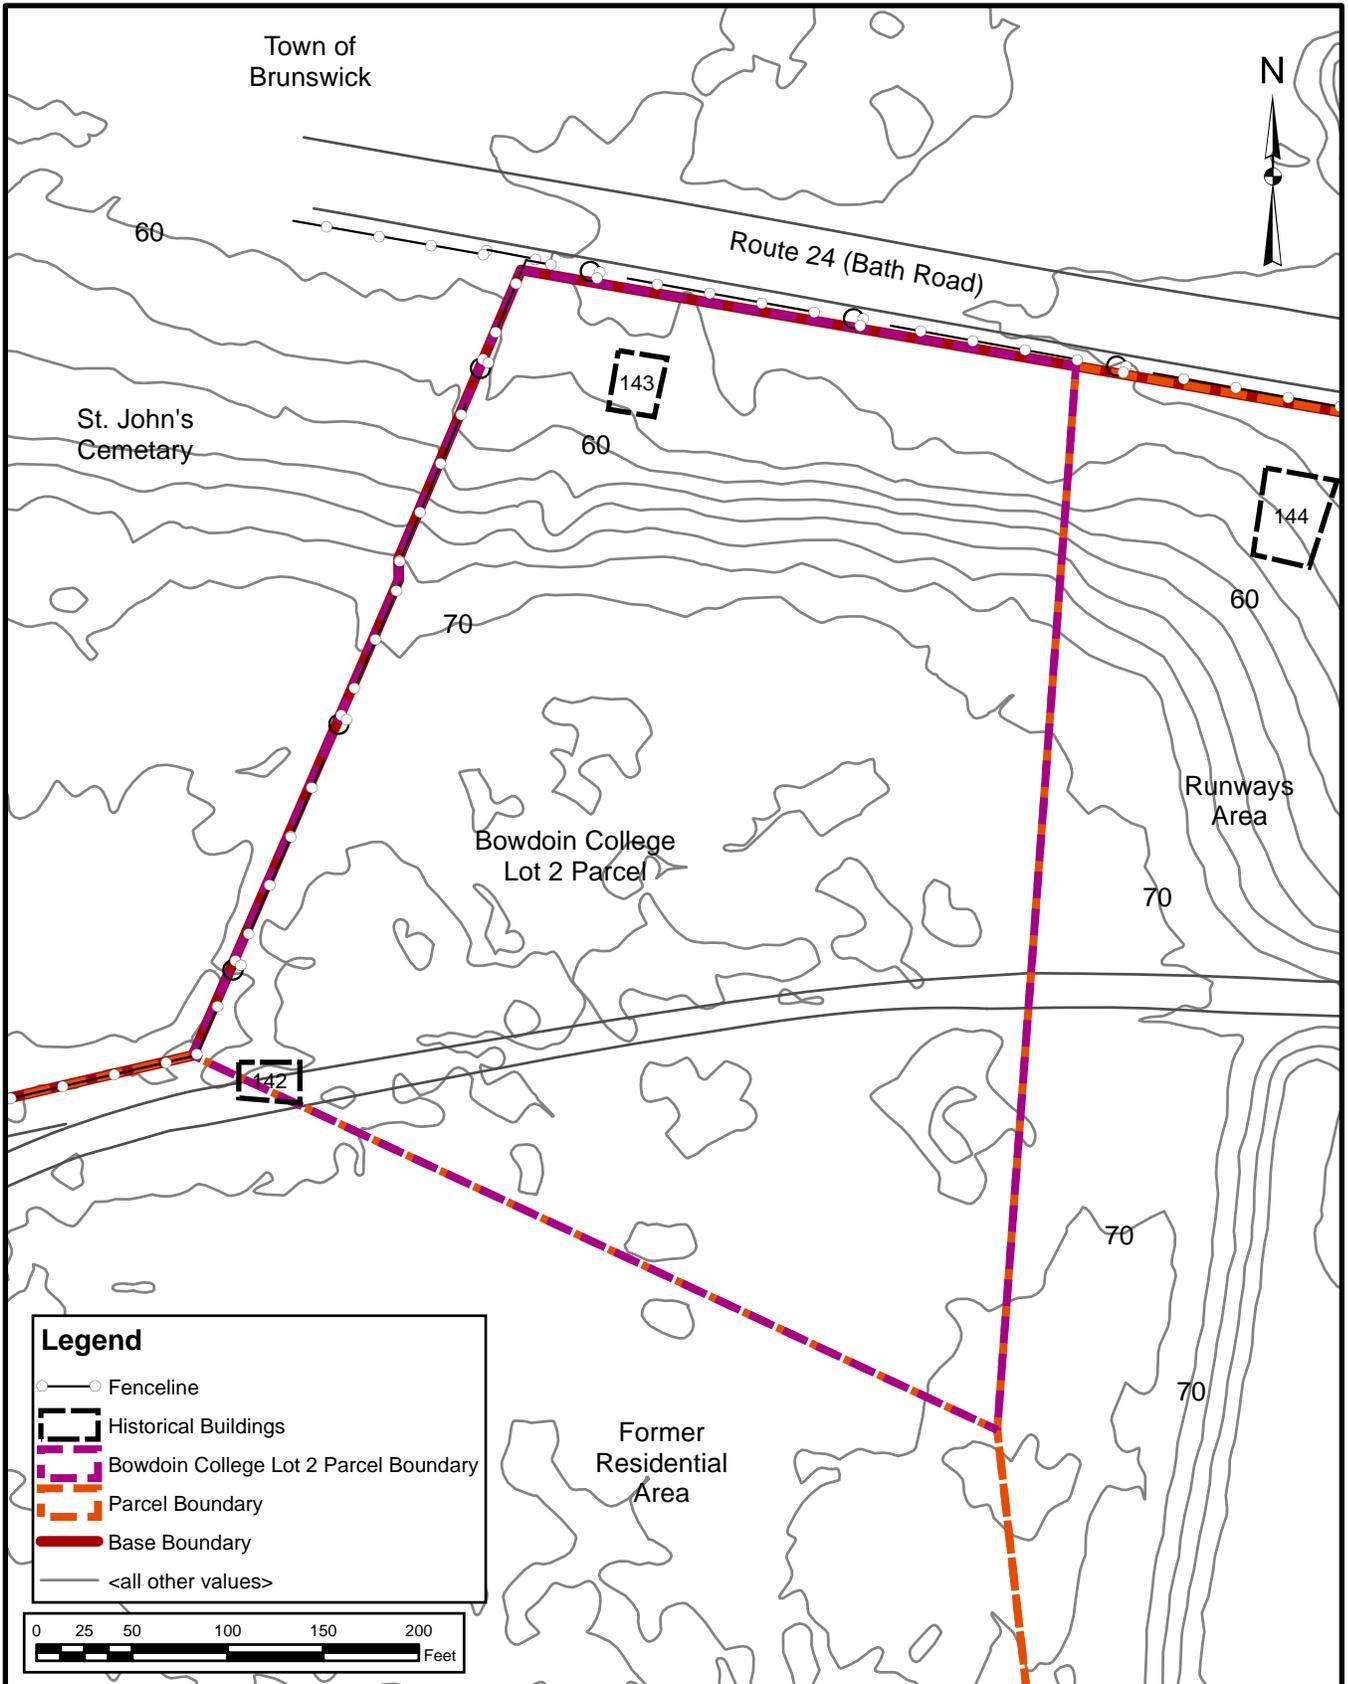
SCALE AS NOTED	
FILE L:\NASB_PARCEL_17_SITE_PLAN.MXD	
REV 0	DATE 12/10/10
FIGURE NUMBER 2

SITE PLAN
BOWDOIN COLLEGE LOT 2 AREA
RCRA PARTIAL CLOSURE REPORT
NAVAL AIR STATION BRUNSWICK, MAINE

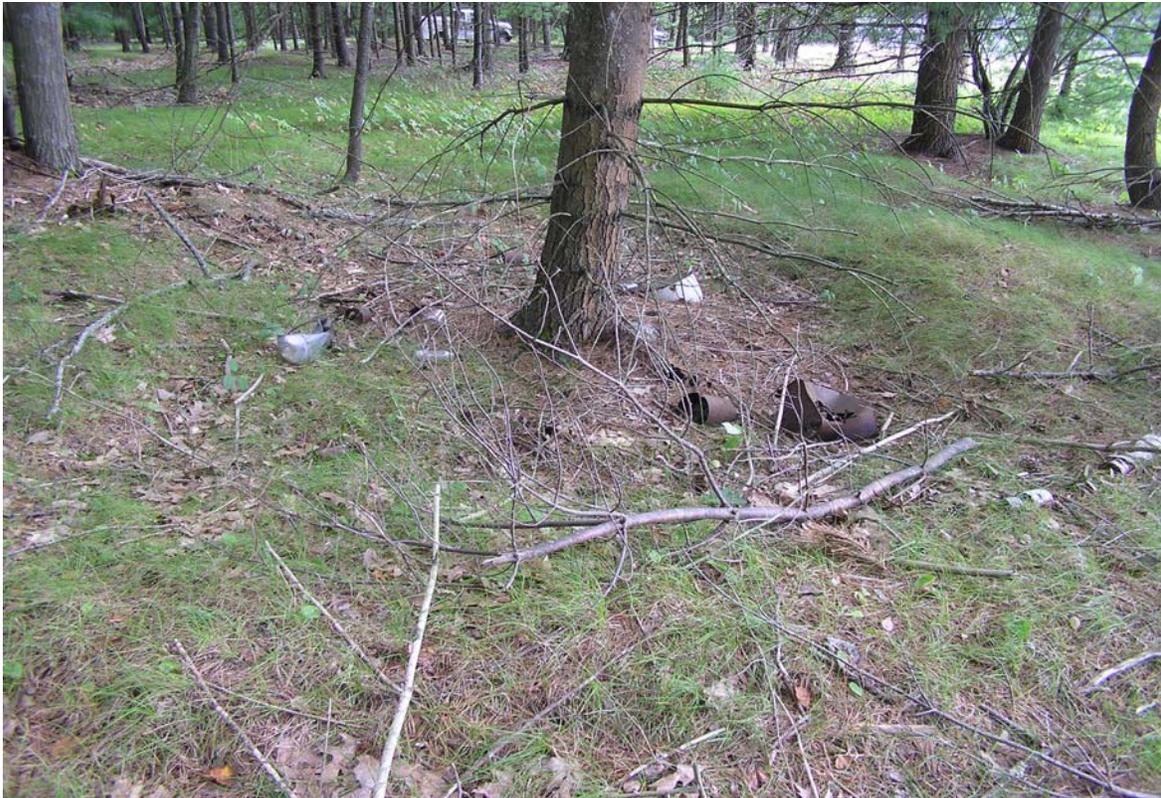
No. 6 Bowdoin College Lot 2 Area, NAS Brunswick
Isolated area of discarded household items in the southwest area of the parcel

- A larger, apparently man-made depression (approximately 20 feet by 10 feet), possibly a former house foundation, was observed in the northwest area.
- A few isolated areas of discarded household items were observed north and south of Perimeter Road. In these areas, items were observed scattered along the ground surface, including corroded metal pots and pans, corroded metal cans, old glass bottles and jars, and broken porcelain items.

Based on the records research findings and site visit observations, the historical use of the area has been residential. There is no evidence or record of commercial or industrial activity on the Bowdoin College Lot 2 Area. The nature and frequency of discarded household items appears to be an insignificant remnant of the former residential use of the parcel, before it was acquired by the federal government to establish NAS Brunswick. Therefore, it was determined that neither further inspection nor sampling of the Bowdoin College Lot 2 Area is required to complete the MEDEP hazardous waste closure requirements.

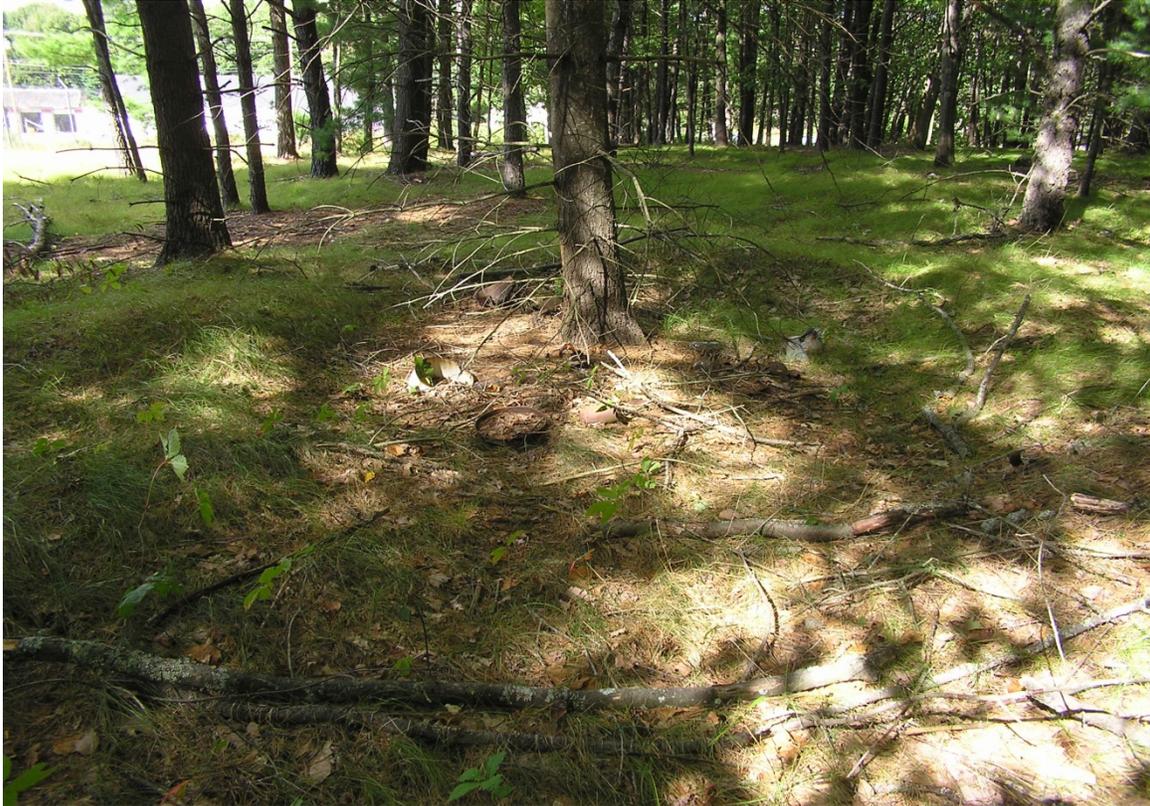
No. 7 Bowdoin College Lot 2 Area, NAS Brunswick September 9, 2010
Isolated area of discarded household items in the west-central area of the parcel

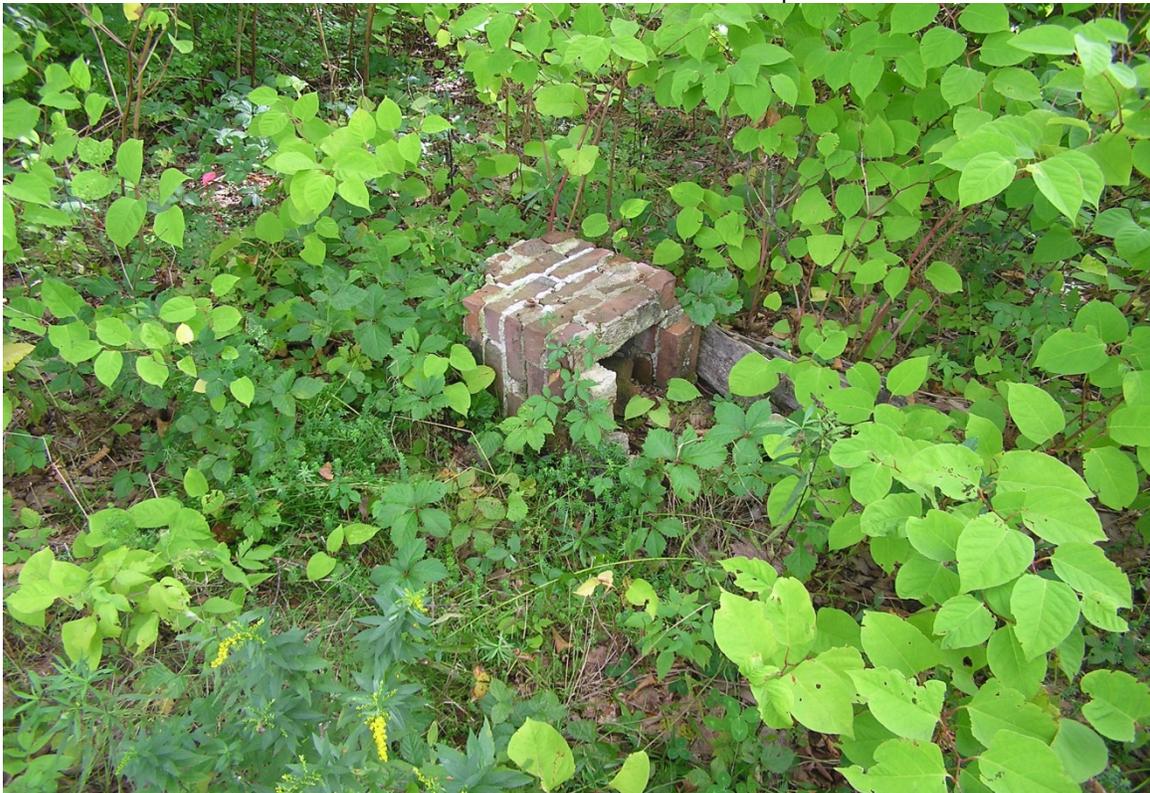
No. 8 Bowdoin College Lot 2 Area, NAS Brunswick September 9, 2010
Remnant of a former chimney in the northwest area of the parcel

- In the northwest area, a chimney remnant was observed.

At the time of inspection, parcel 17 was vacant and the grounds in good condition. Evidence of the parcels prior residential use was observed, including a section of a former brick and cement chimney, and several piles of half buried metal cans and bottles, which have the appearance of household trash. No evidence of current or past hazardous waste generation was observed. No evidence of hazardous waste residues was observed. No signs of a past release (staining, unusual odors, etc.) were observed.
