FINAL RESOURCE CONSERVATION AND RECOVERY ACT PARTIAL CLOSURE REPORT  
FOR FORMER QUARTERS C AREA LAND PARCEL WITH TRANSMITTAL LETTER NAS  
BRUNSWICK ME  
12/21/2010  
NAS BRUNSWICK

Subj: Final RCRA Partial Closure Report for Former Quarters C Area Land Parcel

**RCRA PARTIAL CLOSURE REPORT**  
for  
**FORMER QUARTERS C AREA**  
**NAVAL AIR STATION BRUNSWICK, MAINE**  
**USEPA IDENTIFICATION NUMBER ME8170022018**  
**DECEMBER 2010**

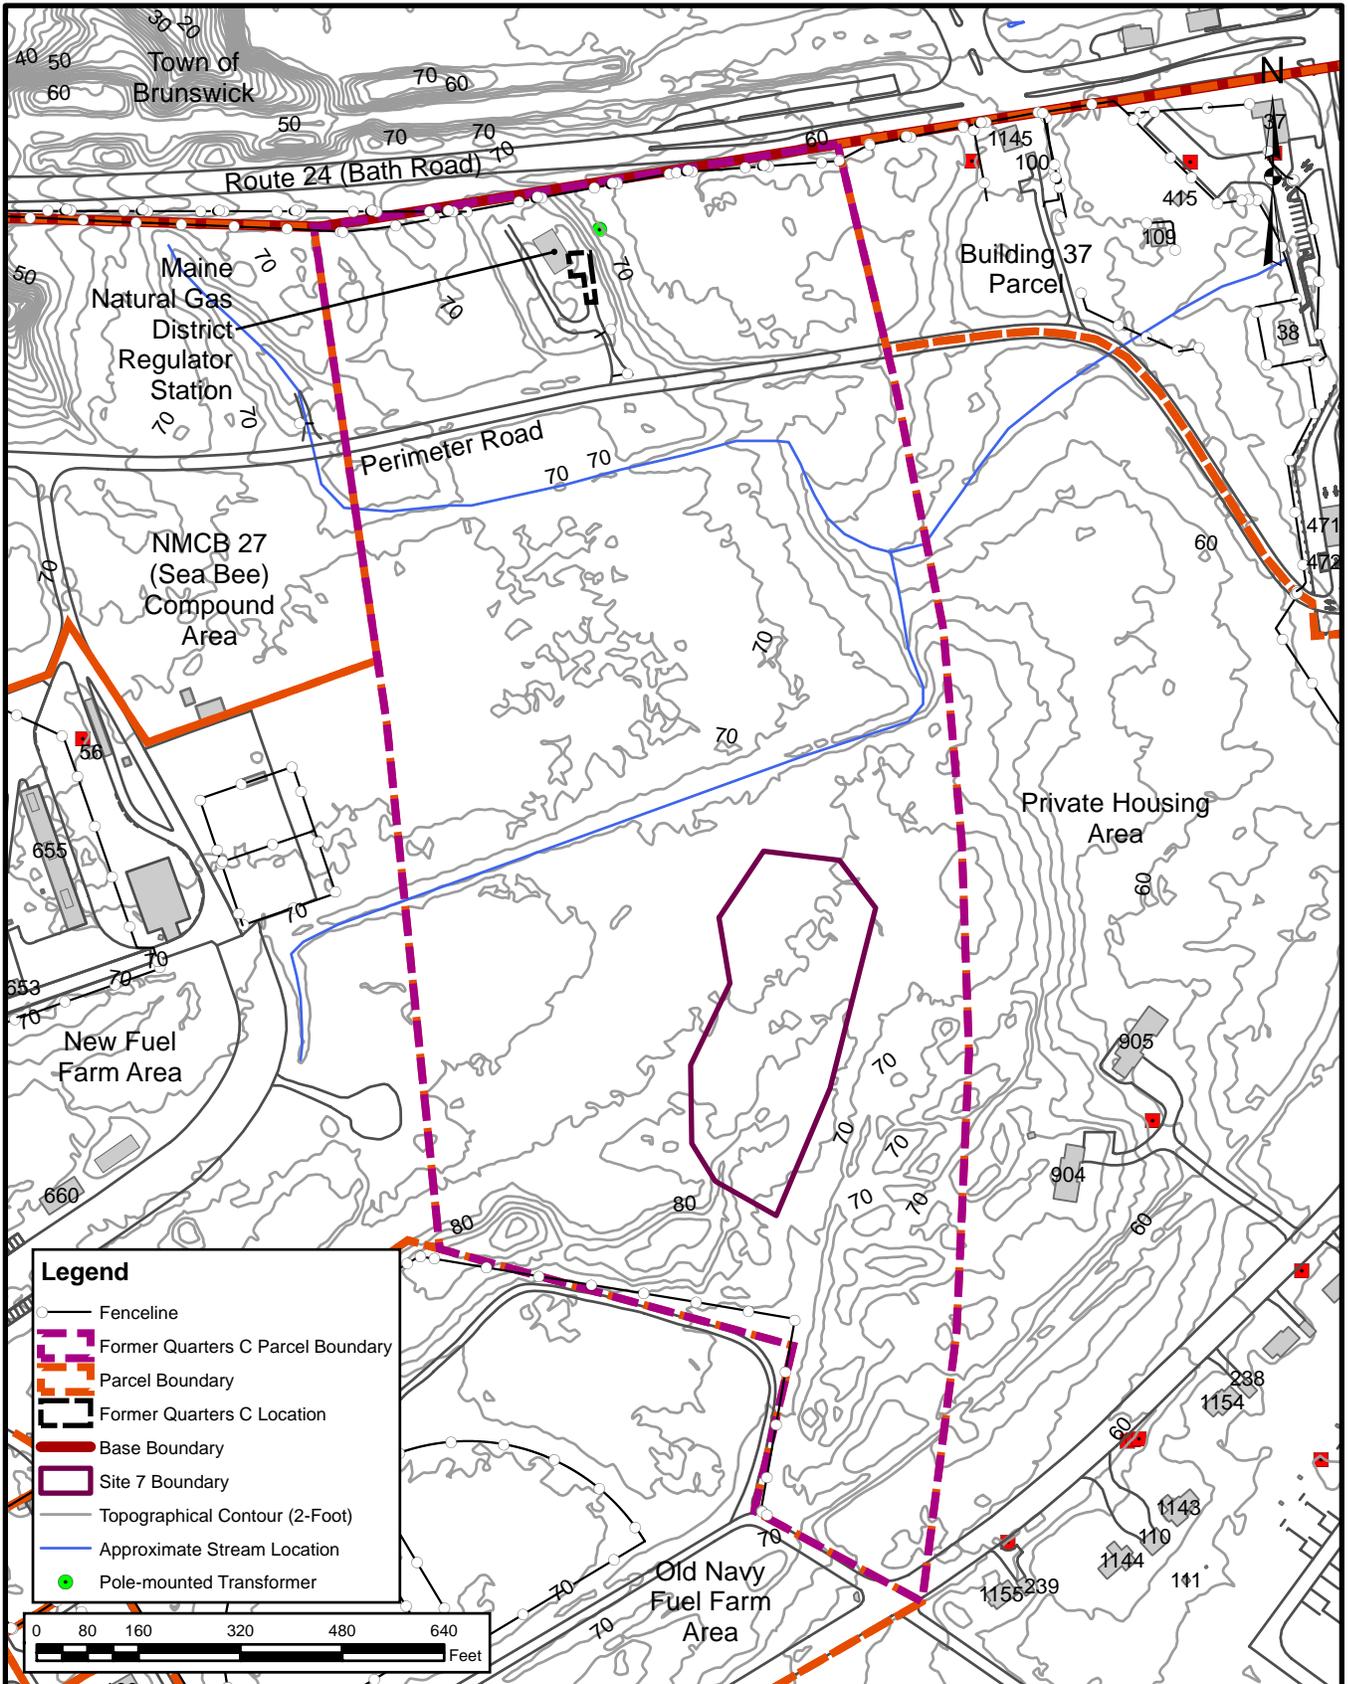
**SITE PLAN**  
**FORMER QUARTERS C AREA**  
**RCRA PARTIAL CLOSURE REPORT**  
**NAVAL AIR STATION BRUNSWICK, MAINE**

The Former Quarters C Area is located in the northeastern portion of NAS Brunswick, bordering the northern boundary of the base (Figure 1). The approximately 37.3-acre parcel is bordered to the north by Route 24 (Bath Road) and Town of Brunswick land beyond, to the east by the Building 37 parcel and the Private Housing Area; to the south by the Old Navy Fuel Farm (ONFF) Area and Fitch Avenue; and to the west by the Sea Bee Compound and the New Fuel Farm Areas. Installation Restoration Program (IRP) Site 7, the Old Acid/Caustic Pit, is located in the southern portion of the Former Quarters C Area (Figure 2).

- IRP Site 7 (Old Acid/Caustic Pit), located in the southern portion of the area (Figures 2 and 3), was reportedly an unlined pit used for liquid waste disposal from 1952 to 1969 (E.C. Jordan 1990). The precise location of the IRP Site 7 pit does not appear to have been documented, but the location was estimated based on site investigation activities. Extensive debris was identified on the aerial photograph dated 1965 (see attachment). Wastes reportedly included transformer oil, battery acid, caustics, solvents, and other miscellaneous liquids.

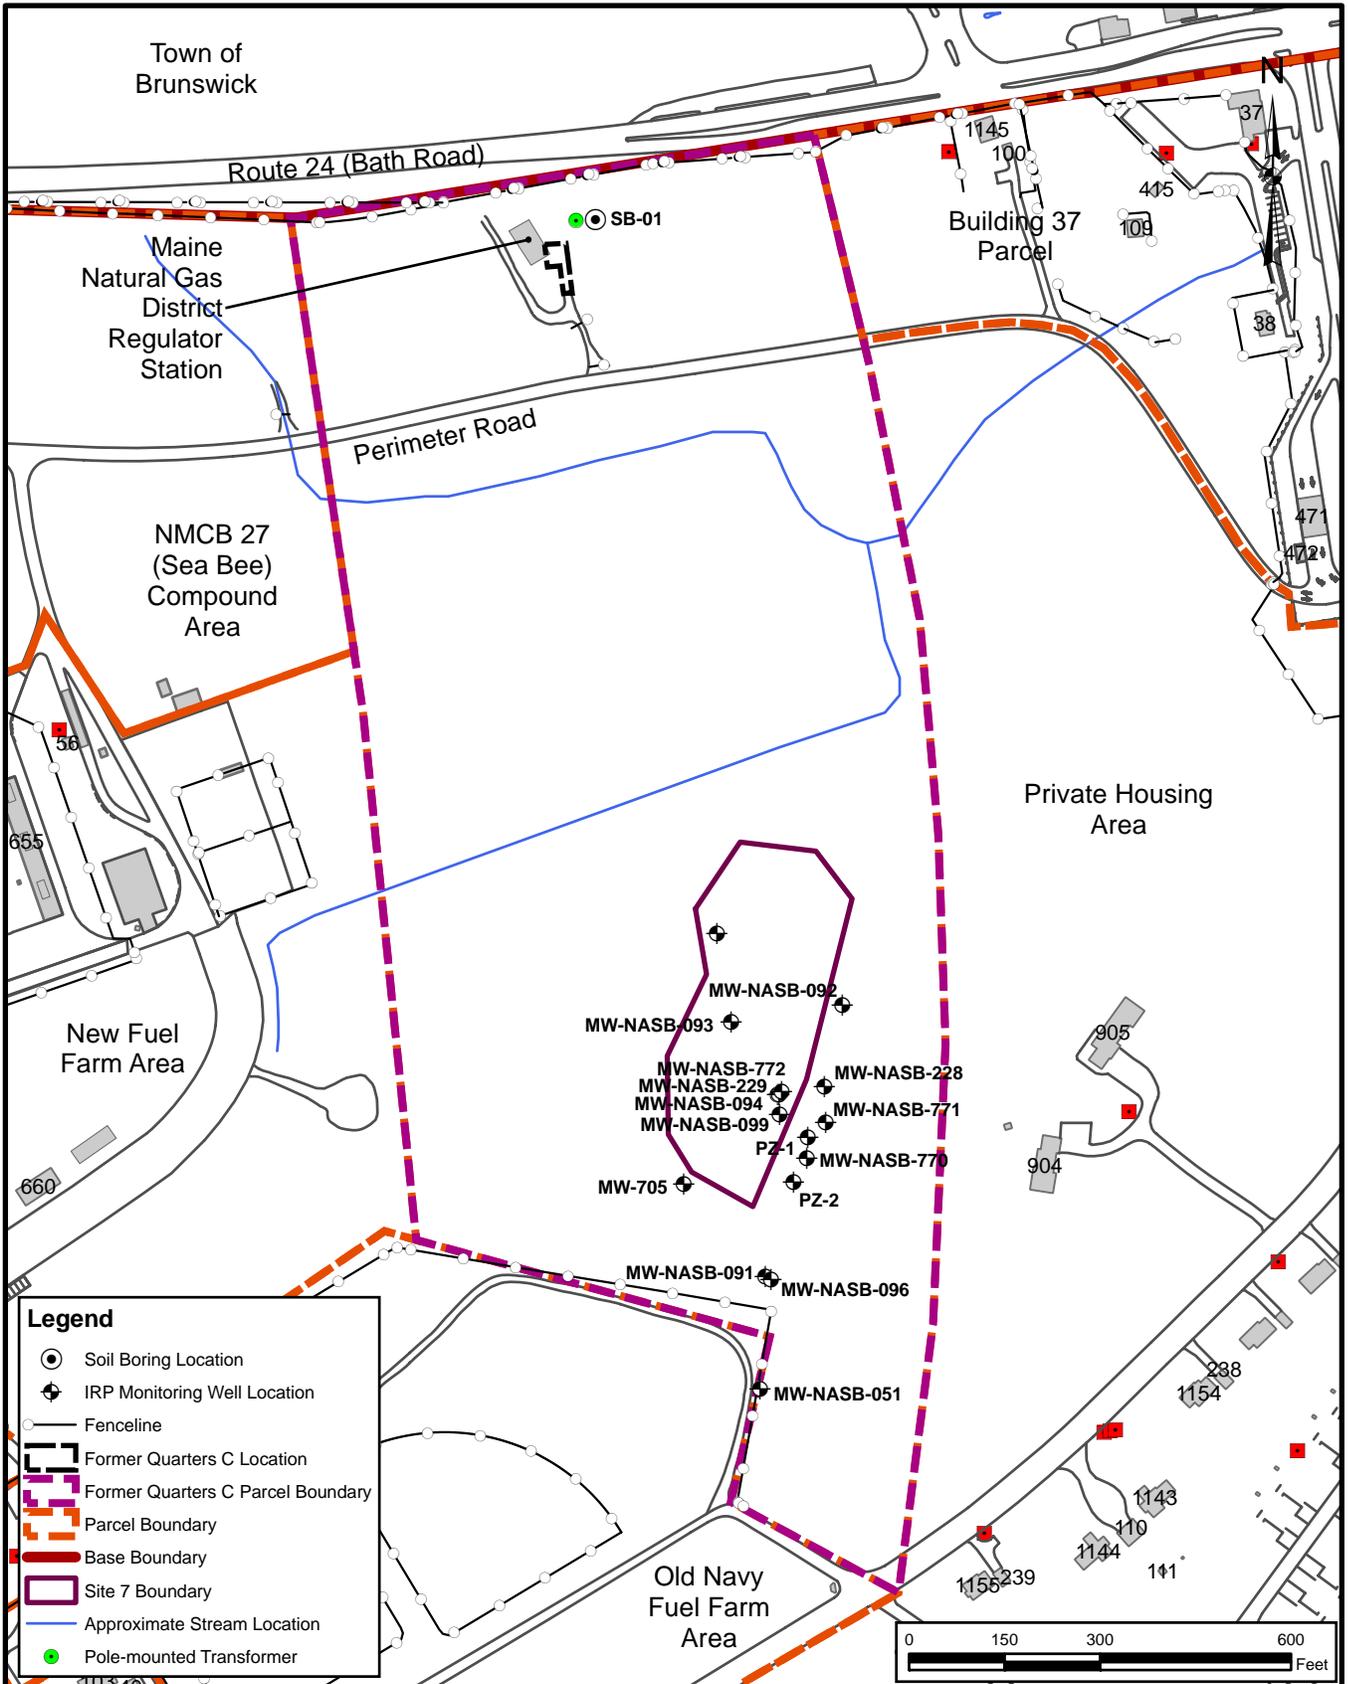
**SAMPLE LOCATIONS**  
**FORMER QUARTERS C AREA**  
**RCRA PARTIAL CLOSURE REPORT**  
**NAVAL AIR STATION BRUNSWICK, MAINE**

- Several monitoring wells were identified in the vicinity of IRP Site 7, located in the southern area of the parcel (see Figure 3).
- A pole-mounted transformer was identified adjacent to the northeast side of the MNG district regulator station (see Figure 3).

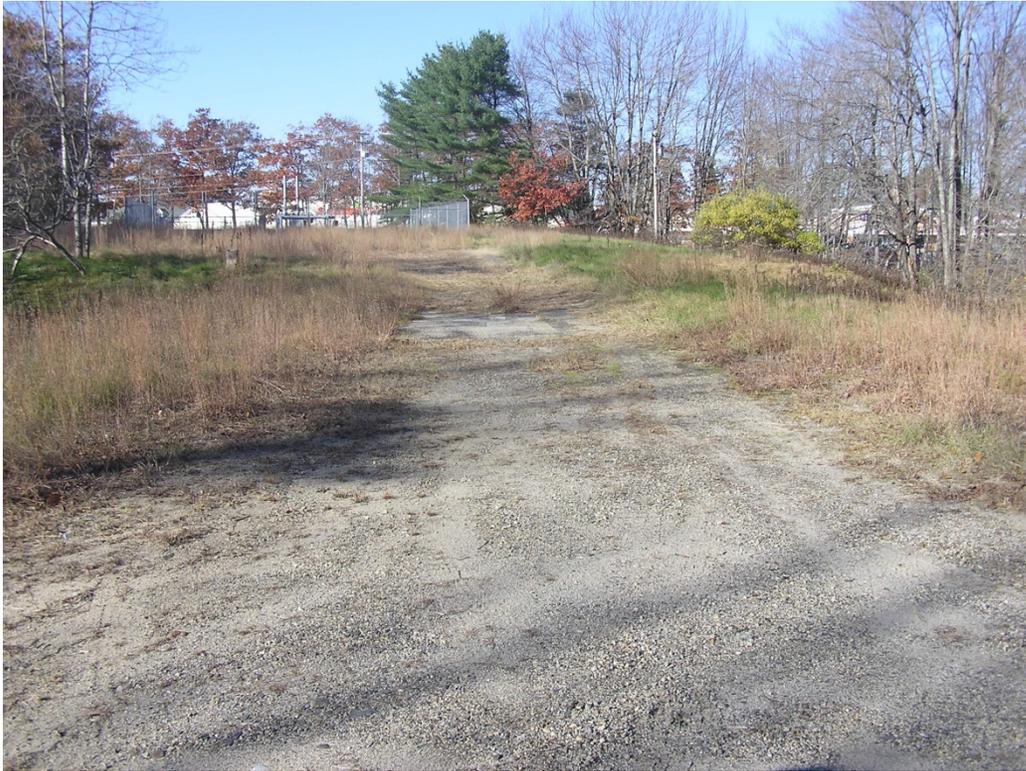
No. 4                      Former Quarters C Area, NAS Brunswick                      November 2, 2010  
Former Quarters C building area from perimeter Road; MNG district regulator station in background

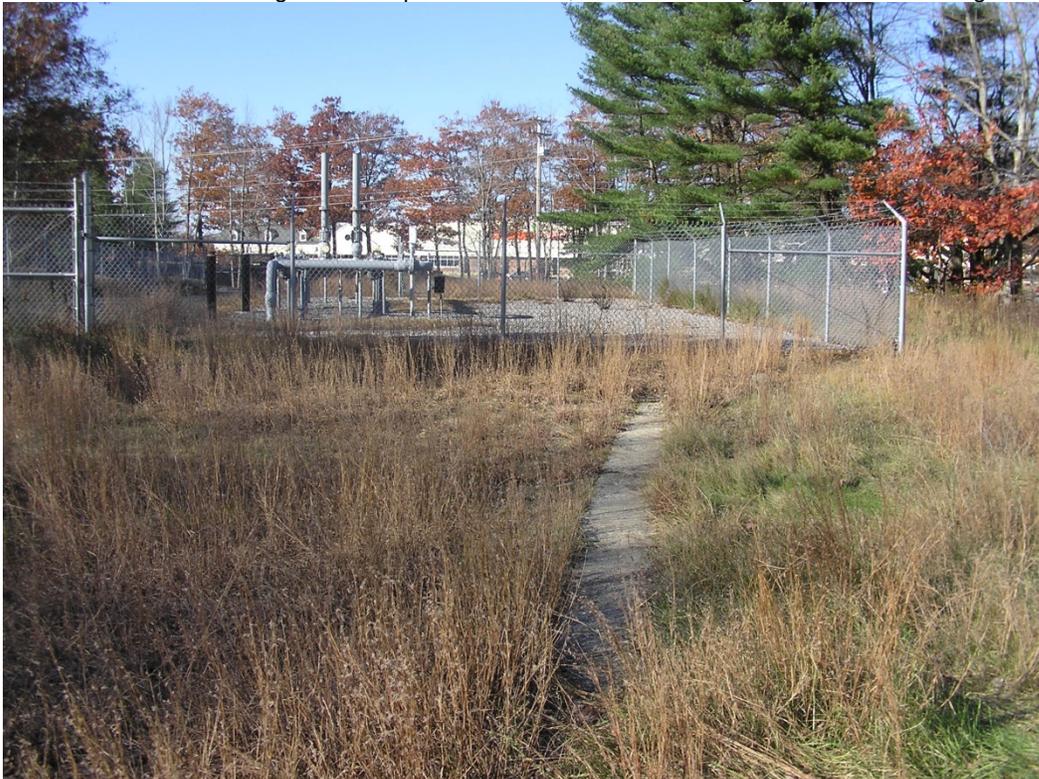
No. 1                      Former Quarters C Area, NAS Brunswick                      November 2, 2010  
MNG district regulator station located north of Perimeter Road; possible former Quarter C concrete structure remnant in foreground and pole-mounted transformer in background

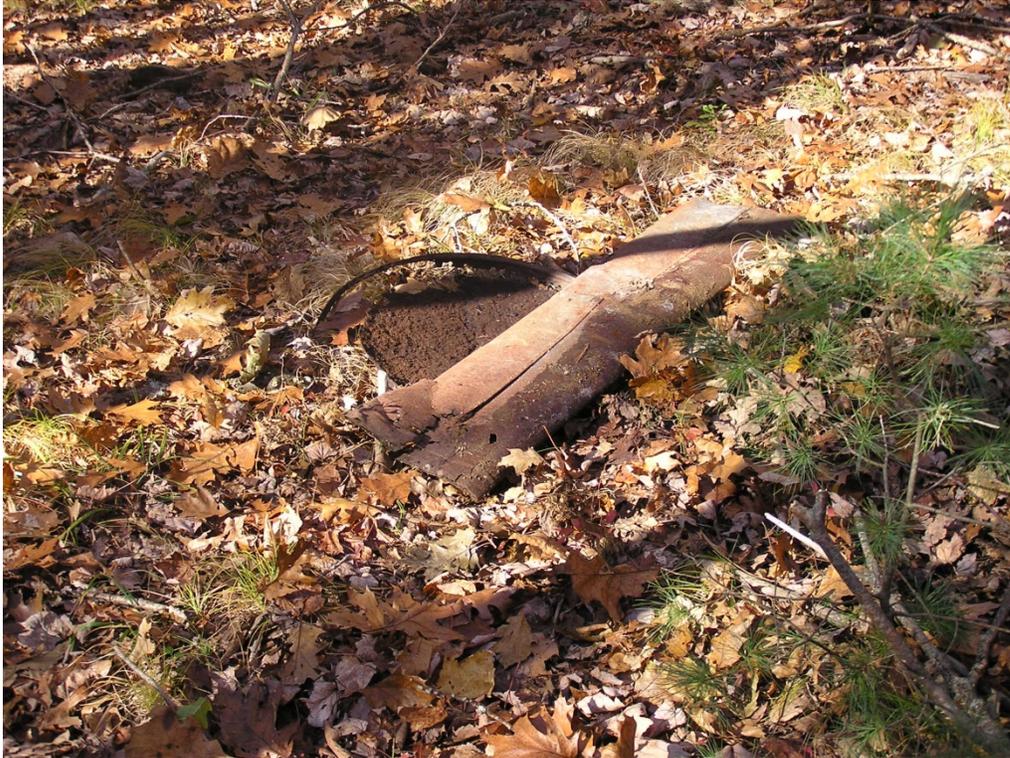
- The remnants of the foundation of the former Quarters C building were identified in the northern section of the parcel.
- Some miscellaneous debris was identified in the area west of the former Quarters C building area.

No. 6                      Former Quarters C Area, NAS Brunswick                      November 2, 2010  
Metal debris at location west of former Quarters C building area

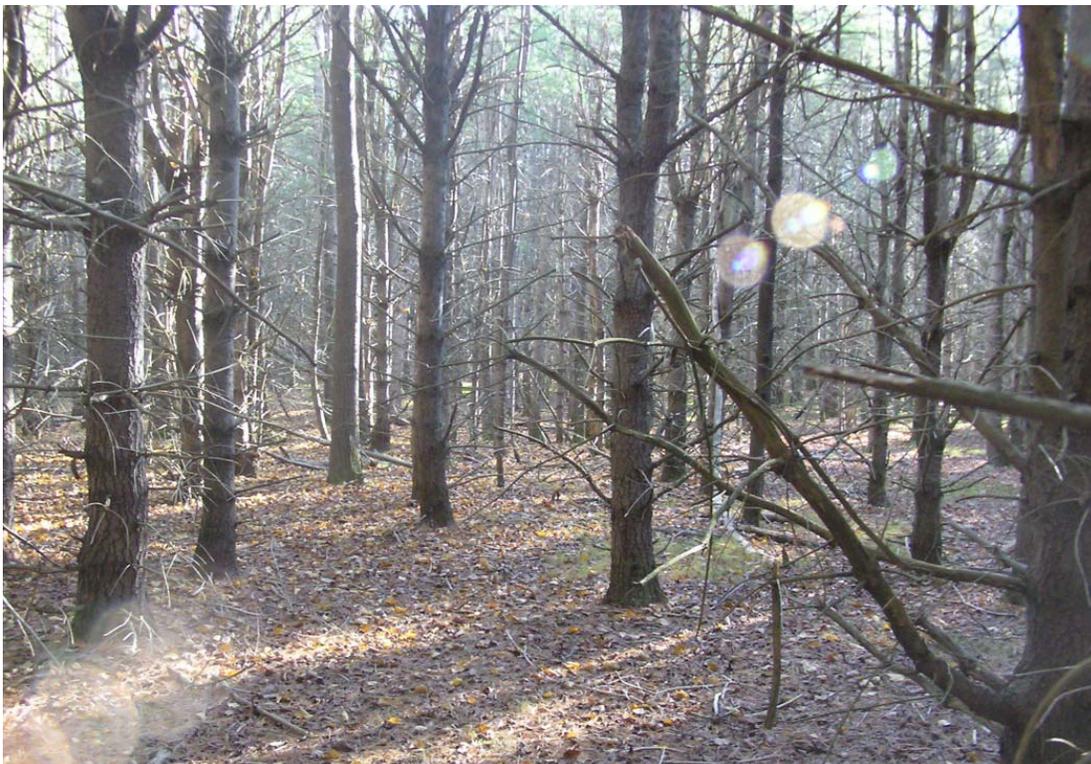
No. 2                      Former Quarters C Area, NAS Brunswick                      November 2, 2010  
Tree-covered area south Perimeter Road and north of unnamed stream

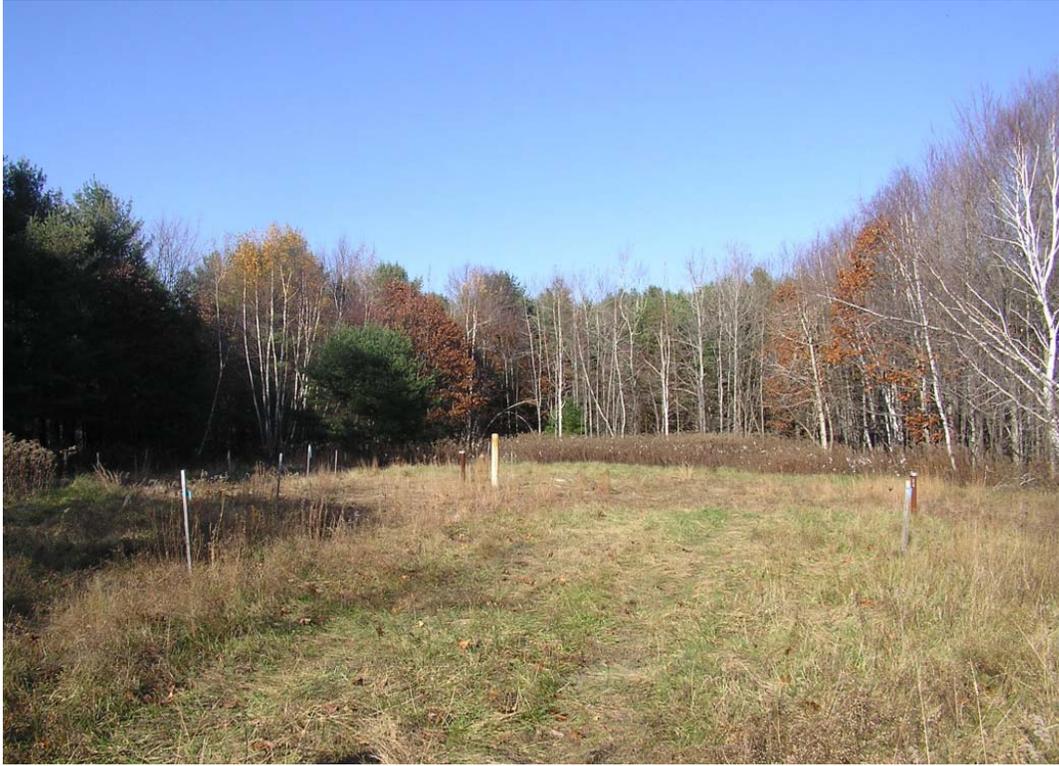
No. 5 Former Quarters C Area, NAS Brunswick  
IRP Site 7 (Old Acid/Caustic Pit) area from south
