FINAL RESOURCE CONSERVATION AND RECOVERY ACT PARTIAL CLOSURE REPORT
FOR BUILDING 551 WITH TRANSMITTAL LETTER NAS BRUNSWICK ME
12/22/2010
NAS BRUNSWICK

RCRA PARTIAL CLOSURE REPORT
for
BUILDING 551 – SECURITY GENERATOR BUILDING
NAVAL AIR STATION BRUNSWICK, MAINE
USEPA IDENTIFICATION NUMBER ME8170022018
DECEMBER 2010

**HWSA INSPECTION REPORT
HAZARDOUS WASTE STORAGE AREAS CLOSURE
NAS BRUNSWICK
BRUNSWICK, MAINE
CTO WE22**

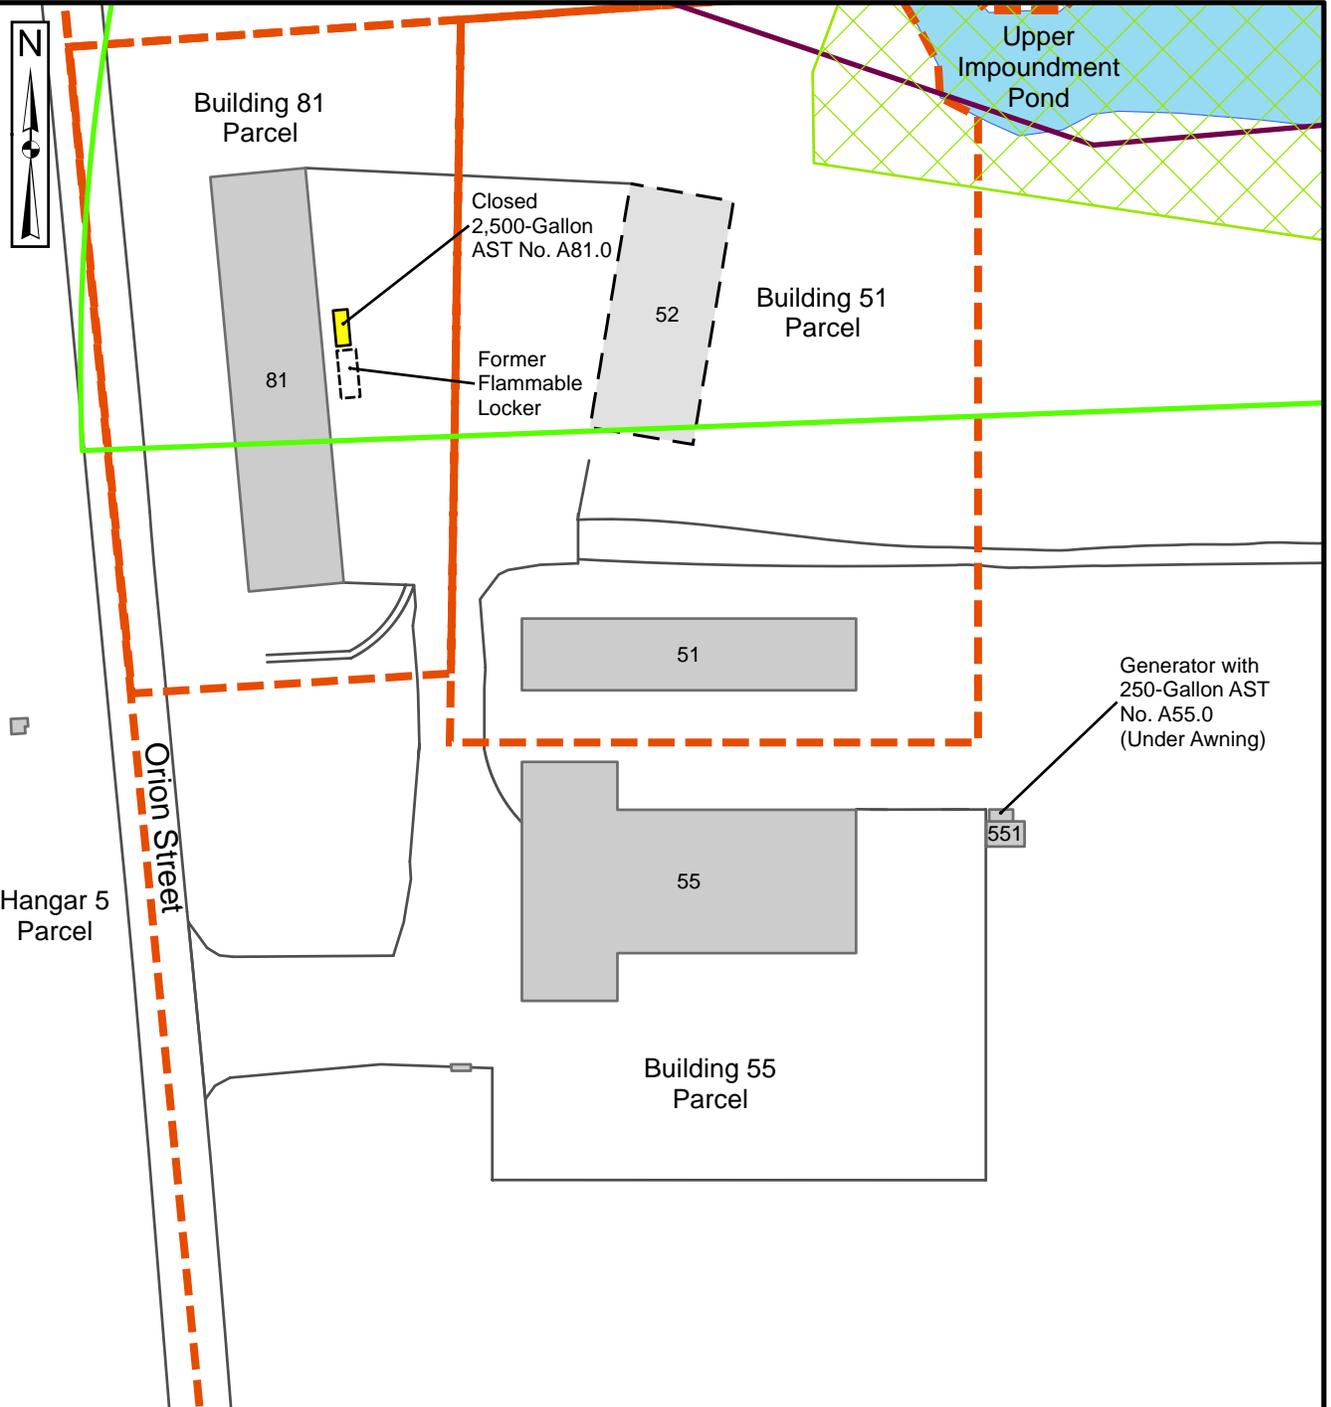
Tetra Tech NUS, Inc.	SITE MAP BUILDING 551 - SECURITY GENERATOR BUILDING RCRA PARTIAL CLOSURE REPORT NAVAL AIR STATION BRUNSWICK, MAINE	SCALE AS NOTED
		FILE L:\NASB_BLDG_551_SITE_MAP.MXD
		REV DATE 0 12/21/10
		FIGURE NUMBER FIGURE NO. 2

Building 551 Corner	Northing	Easting
Northeast	385356.428	3015658.261
Southeast	385345.928	3015658.261
Southwest	385345.928	3015642.261
Northwest	385356.428	3015642.261

Coordinates are in NAD 1983, Maine West, Feet

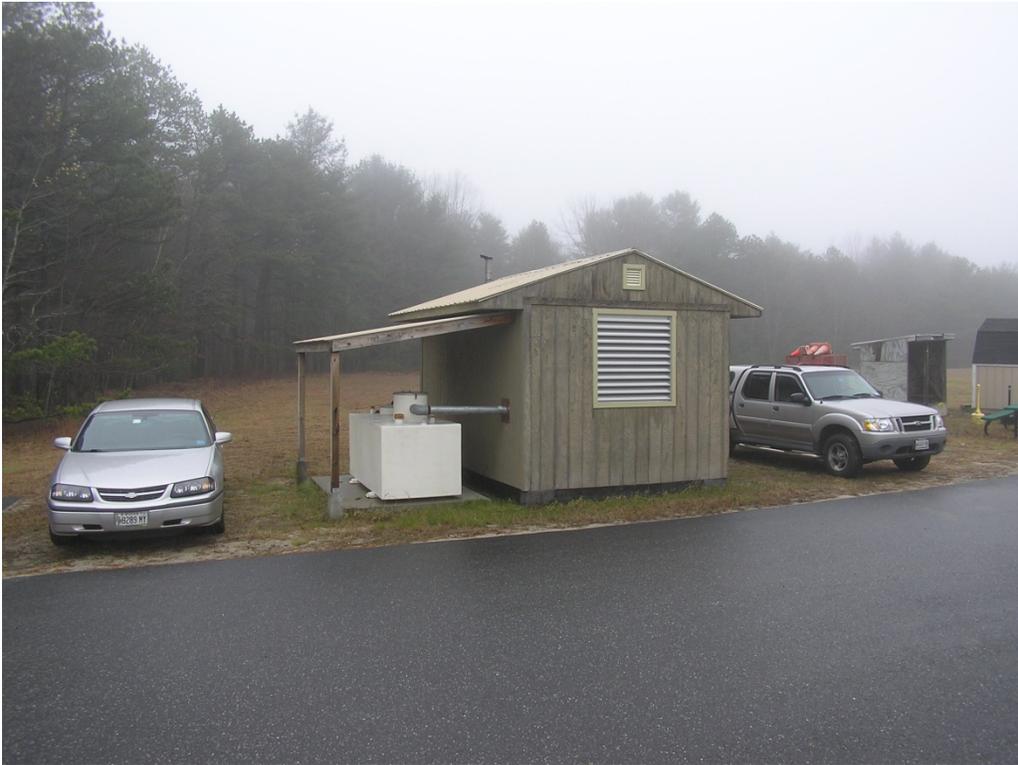
No.1 Building 551 – Security Generator Building, NAS Brunswick November 23, 2010
North and west elevations (looking towards southeast); AST on northern side of building under awning

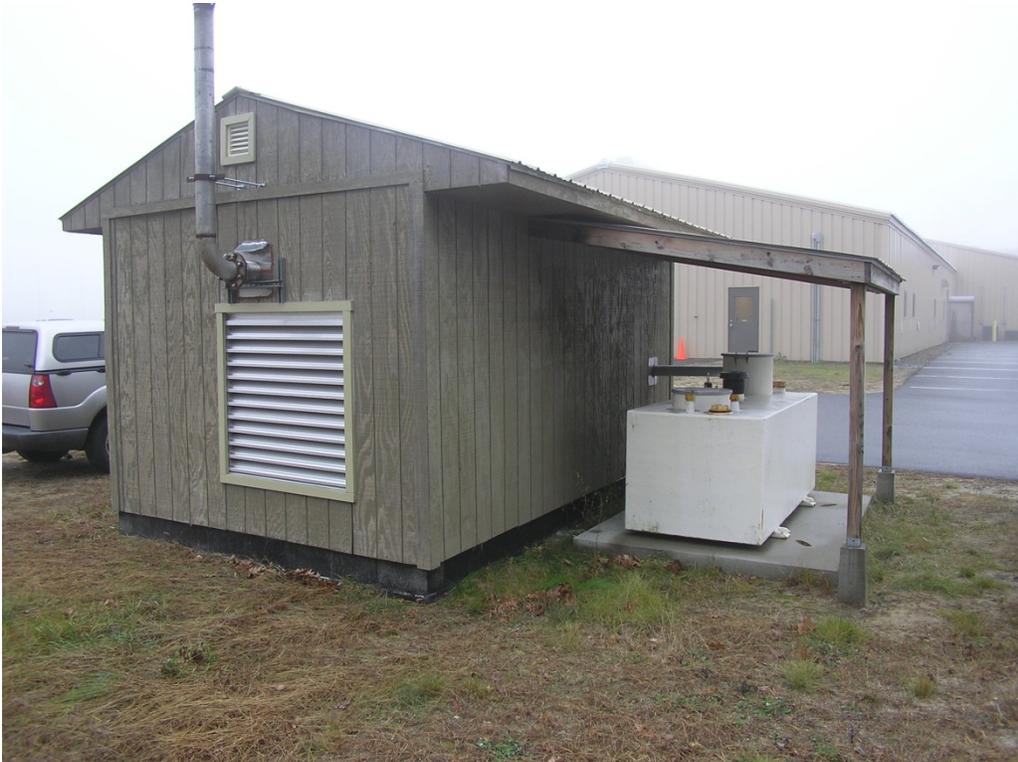
No.2 Building 551 – Security Generator Building, NAS Brunswick November 23, 2010
North and east elevations; looking west towards Building 55 in background

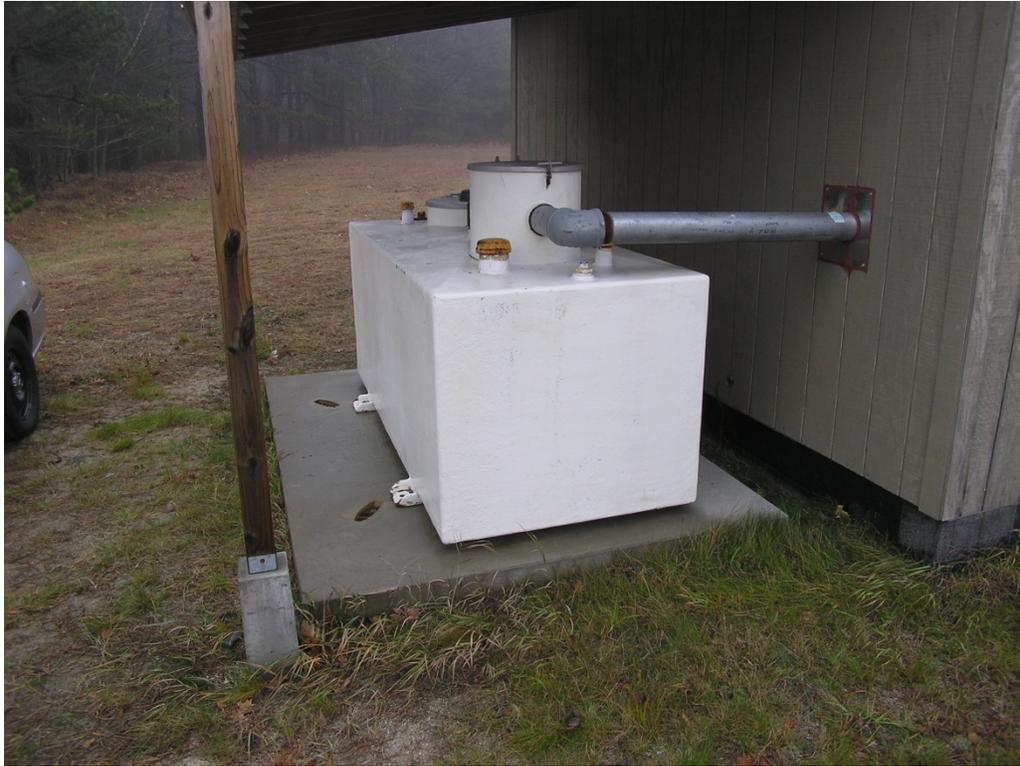
- An emergency generator, manufactured by Caterpillar and rated as 45 kVA, was housed in Building 551.
- A 250-gallon, double-walled steel tank was located outside the building on a concrete pad, under the awning, and was connected to the generator by piping that runs through the northern wall of the building. No evidence of past leaks or spills at this tank was observed.

No.3 Building 551 – Security Generator Building, NAS Brunswick
250-gallon double-walled steel AST under awning

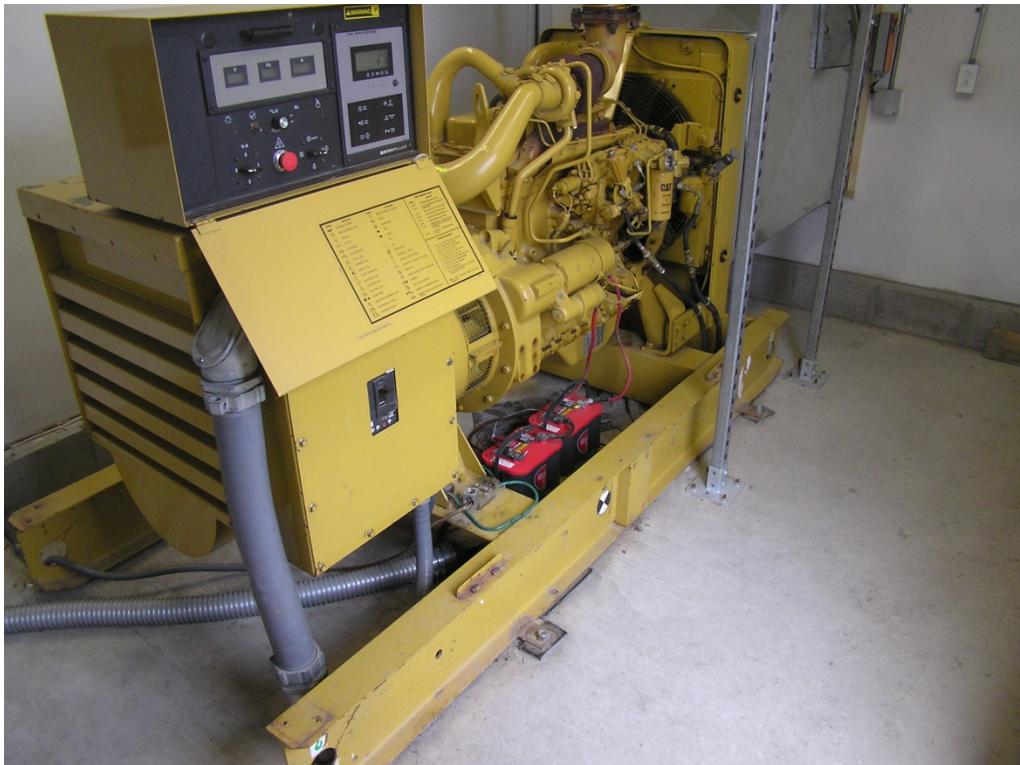
- No evidence of hazardous waste residues was observed. Minor staining was observed on the floor below the generator.
- No structural modifications, which could conceal signs of a past release, were observed.

No.4 Building 551 – Security Generator Building, NAS Brunswick
Security Generator Building interior; generator and control panel
