FINAL RESOURCE CONSERVATION AND RECOVERY ACT PARTIAL CLOSURE REPORT
FOR FORMER RESIDENTIAL AREA LAND AREA 16 WITH TRANSMITTAL LETTER NAS
BRUNSWICK ME
2/11/2011
NAS BRUNSWICK

Subj: Final RCRA Partial Closure Report for Former Residential Area (Land Area 16)

RCRA PARTIAL CLOSURE REPORT
for
FORMER RESIDENTIAL AREA
NAVAL AIR STATION BRUNSWICK, MAINE
USEPA IDENTIFICATION NUMBER ME8170022018
JANUARY 2011

**HWSA INSPECTION REPORT
HAZARDOUS WASTE STORAGE AREAS CLOSURE
NAS BRUNSWICK
BRUNSWICK, MAINE
CTO WE22**

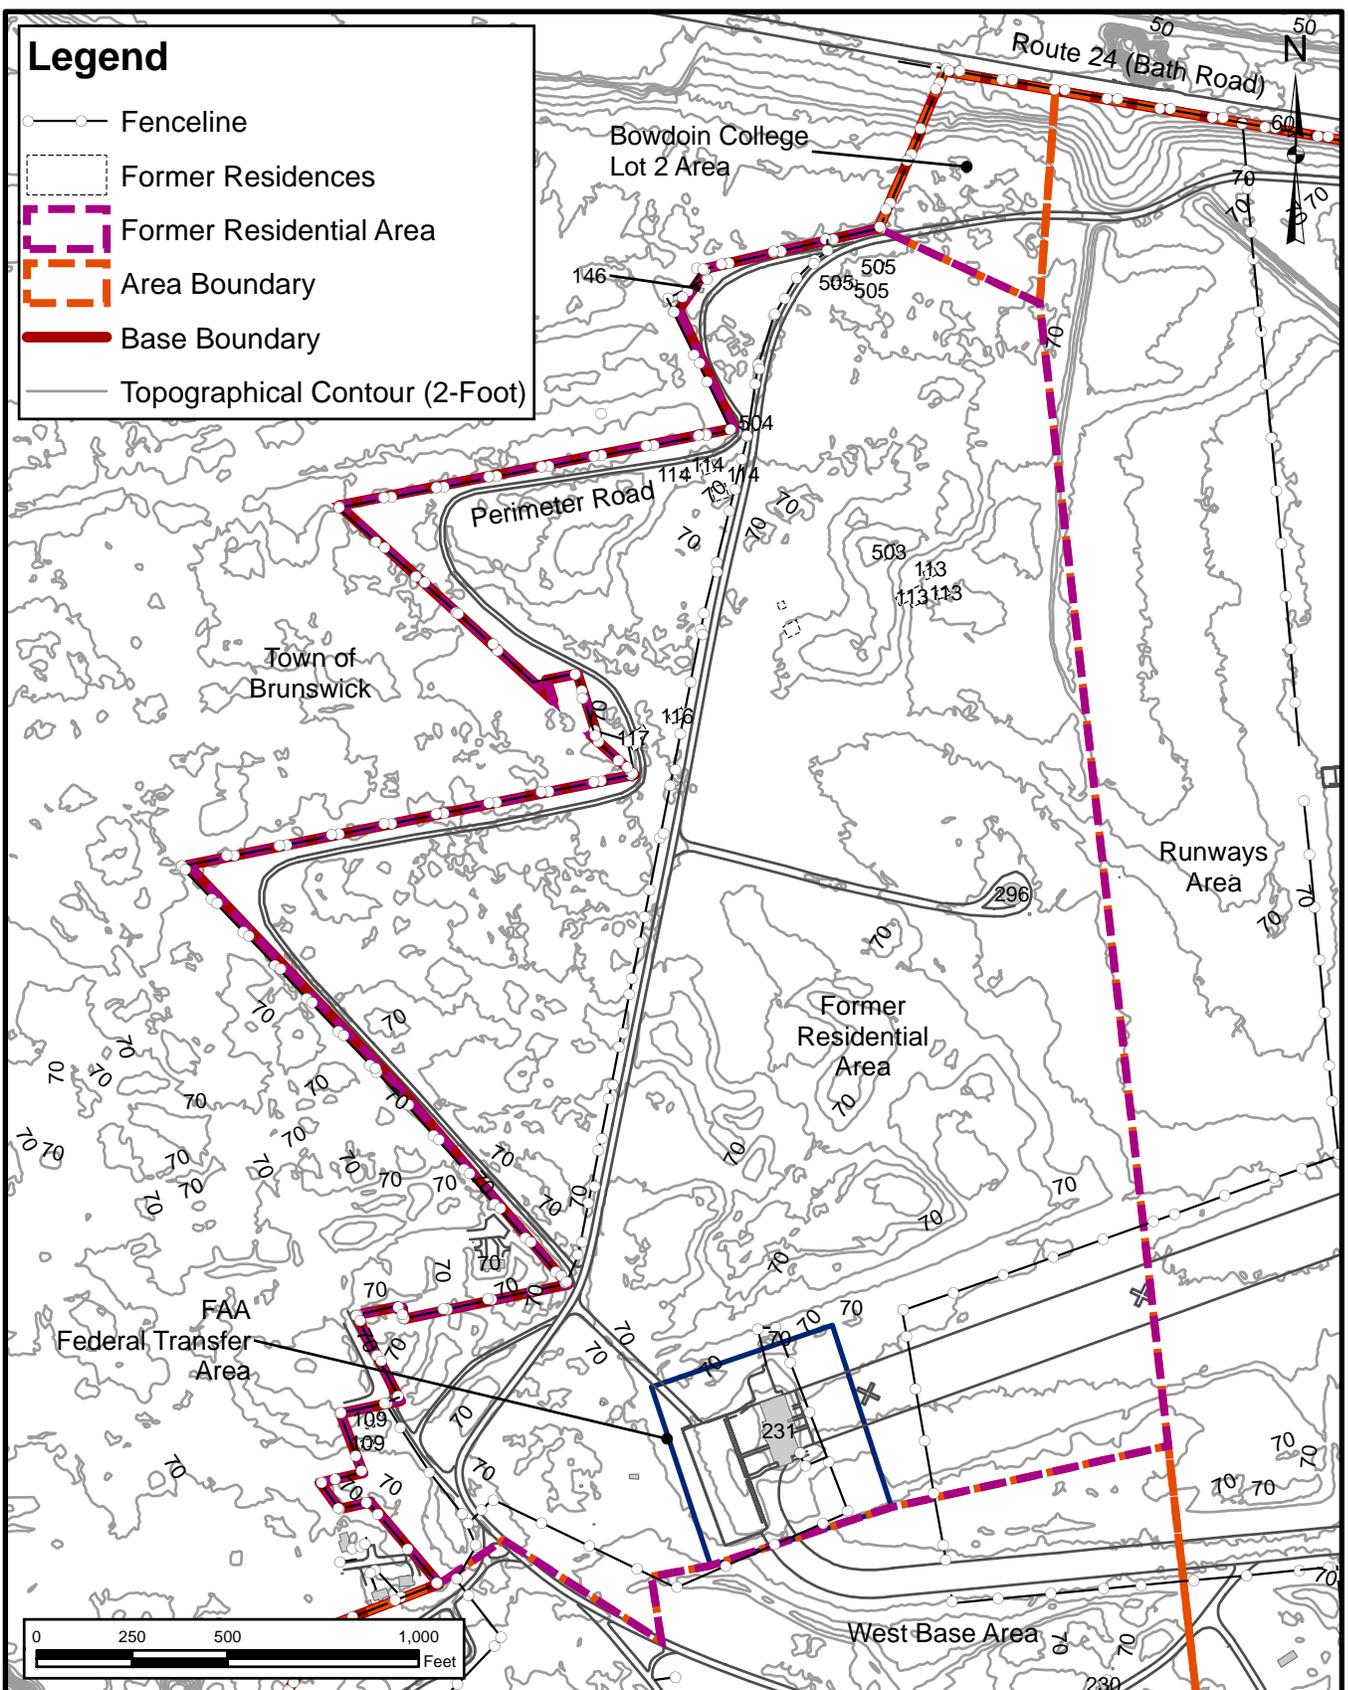
SCALE AS NOTED	
FILE L:\NASB_PARCEL_16_SITE_PLAN.MXD	
REV	DATE
0	01/28/11
FIGURE NUMBER	
2

It is noted that the three buildings or facilities listed below (also indicated in Figures 2 and 3) are located within the physical boundaries of the Former Residential Area, but have been addressed under separate RCRA Partial Closure Reports or have been transferred to another Federal Facility.

SITE PLAN
FORMER RESIDENTIAL AREA
RCRA PARTIAL CLOSURE REPORT
NAVAL AIR STATION BRUNSWICK, MAINE

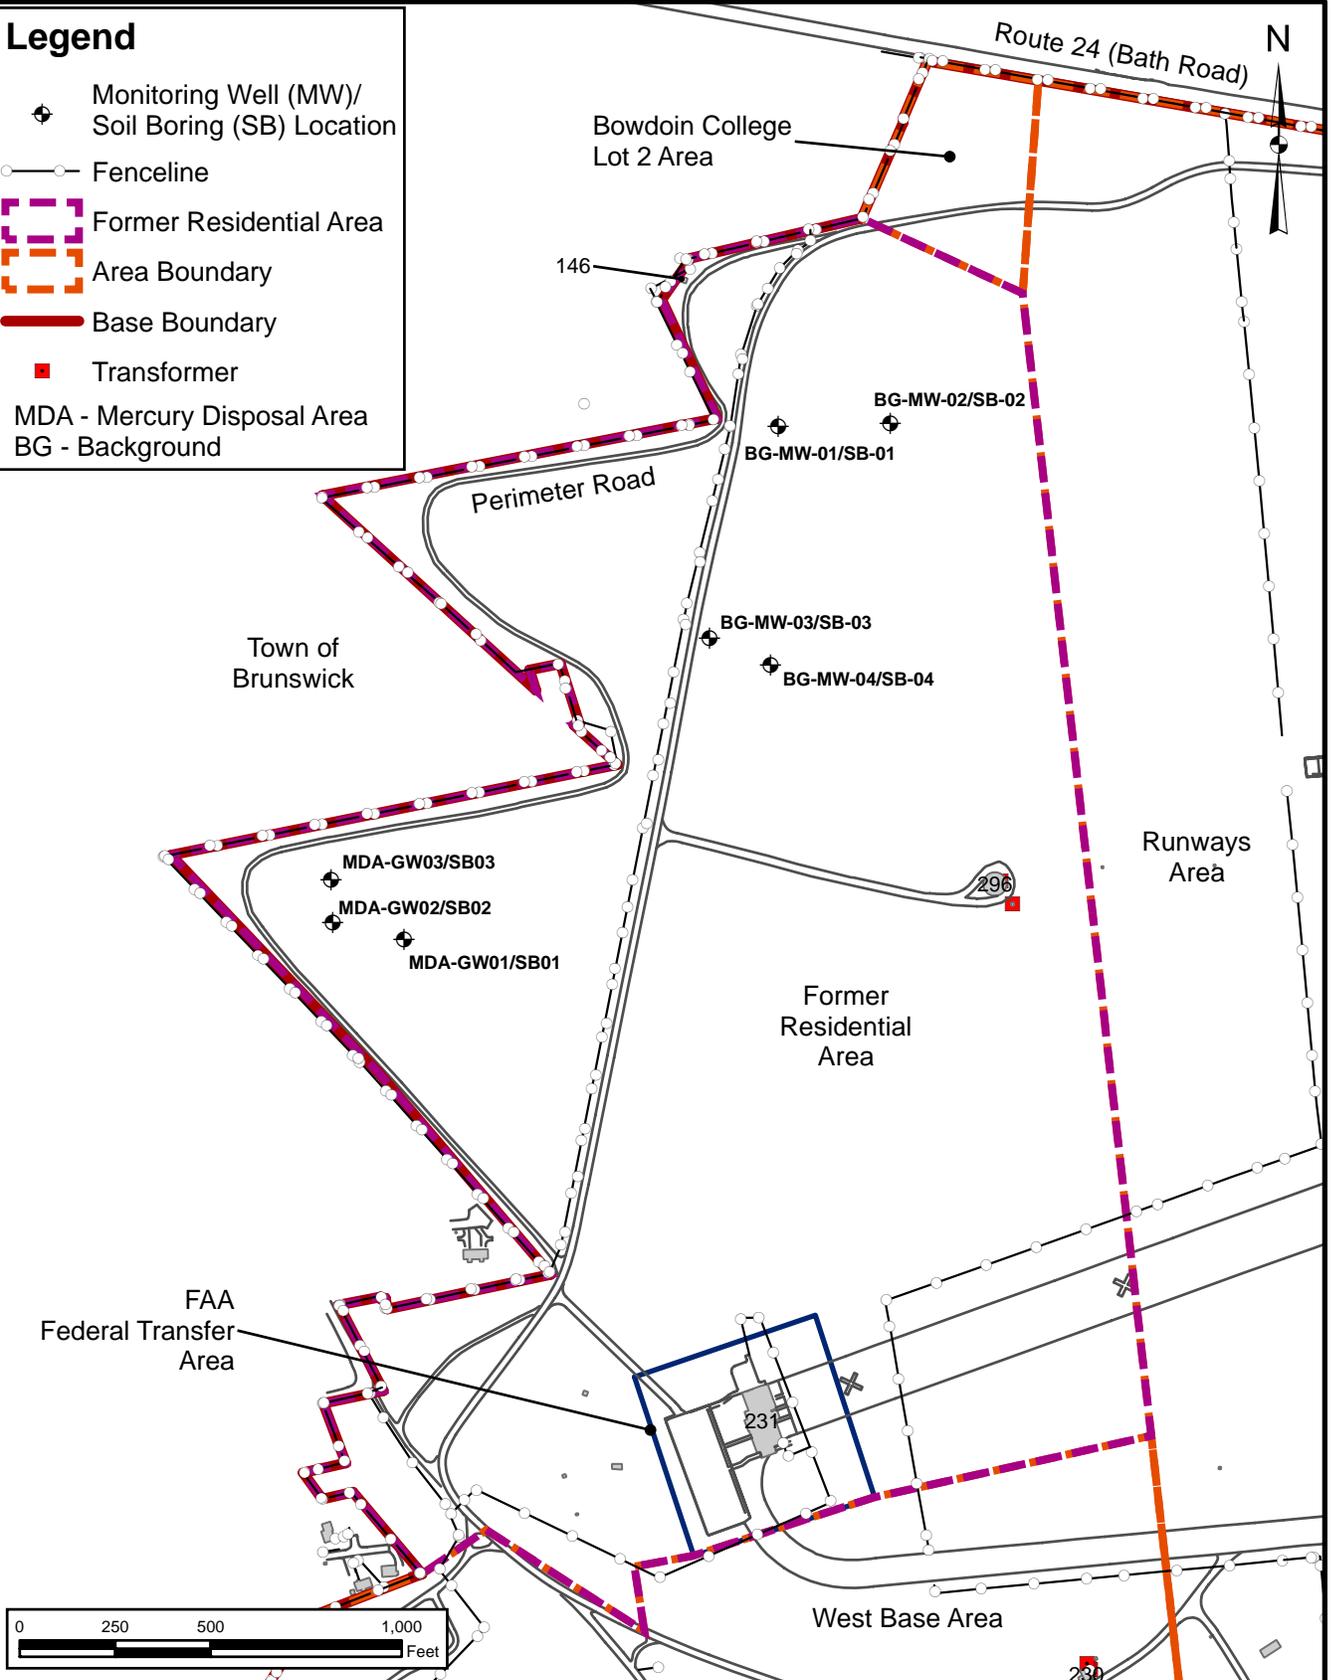
SCALE AS NOTED	
FILE L:\NASB_PARCEL_16_SITE_MAP.MXD	
REV	DATE
0	01/28/11
FIGURE NUMBER	
3

From the Soil Background Study for NAS Brunswick, soil data are available for five soil boring sample locations within the Former Residential Area (Tetra Tech, 2010d). Preliminary groundwater data from four monitoring well locations within the Former Residential Area has been collected as part of an ongoing NAS Brunswick background investigation. Additional preliminary data is available from an ongoing screening investigation of AOPIs that included the MDA, located within the Former Residential Area (Figure 3). This data includes six soil samples and four groundwater samples (including one duplicate sample) collected from three boring locations that were completed as temporary monitoring wells, as described in the Work Plan for the AOPI Screening Investigation (Tetra Tech, 2010e). The soil and groundwater sampling locations within the Former Residential Area are shown on Figure 3 and are summarized below.

SAMPLING LOCATIONS - OTHER INVESTIGATIONS
FORMER RESIDENTIAL AREA
RCRA PARTIAL CLOSURE REPORT
NAVAL AIR STATION BRUNSWICK, MAINE

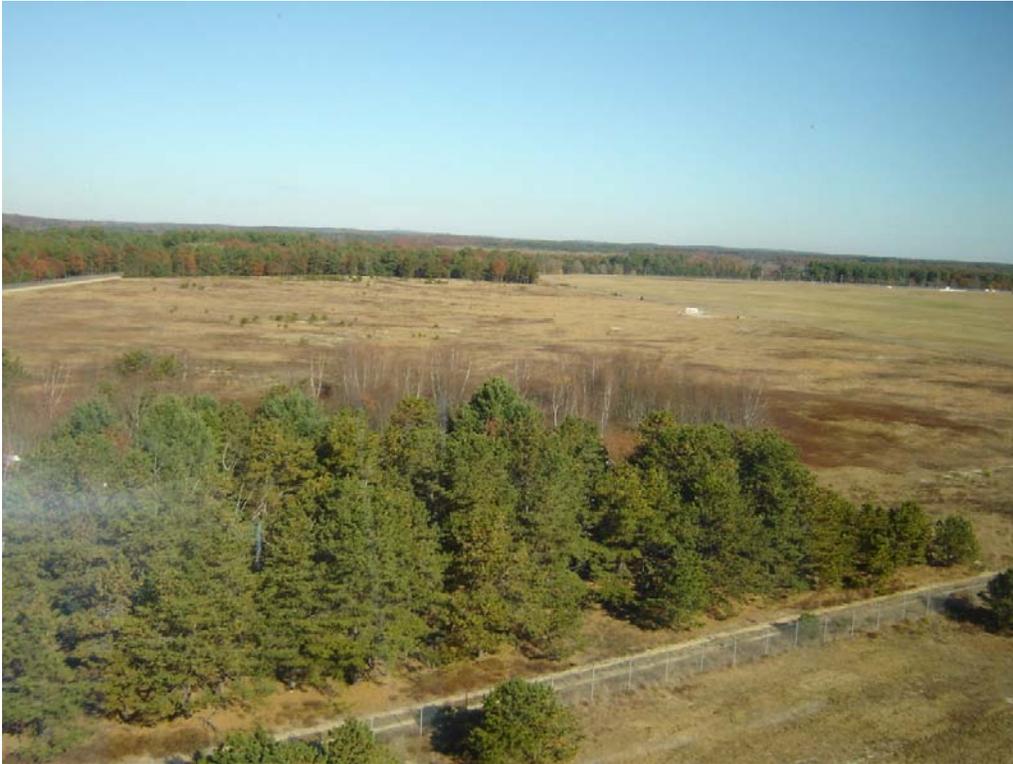
No. 1 Former Residential Area, NAS Brunswick November 3, 2010
View north from Building 231 - Air Traffic Control Tower; Building 296 visible in right background

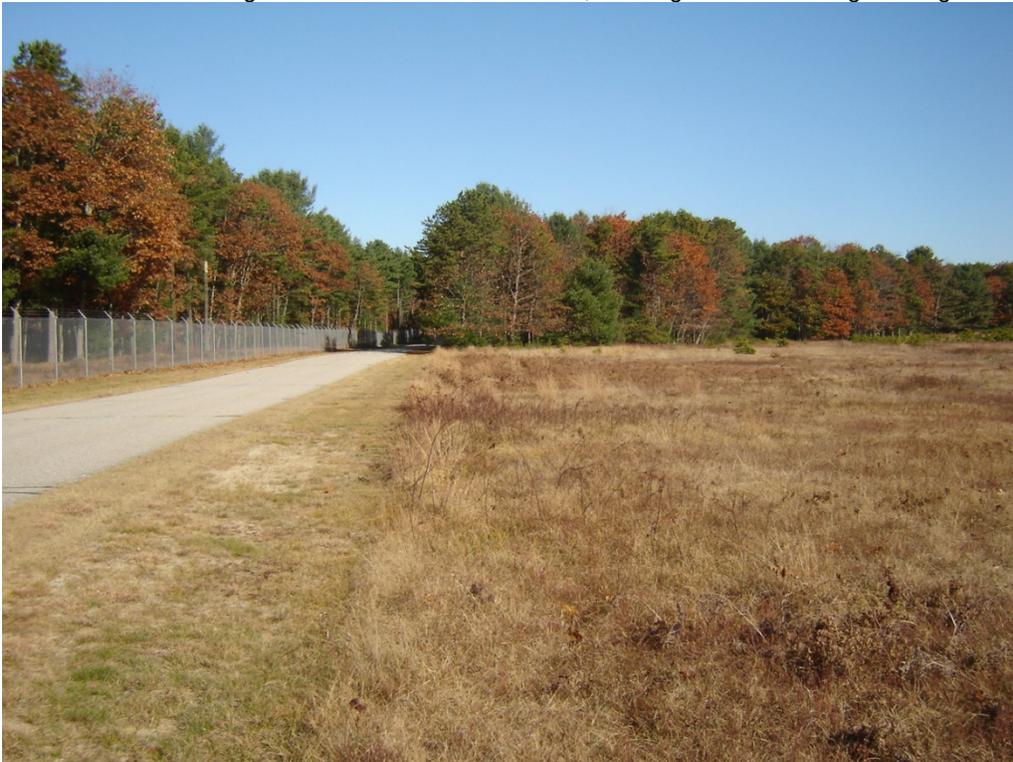
No. 2 Former Residential Area, NAS Brunswick November 3, 2010
View north along inner Perimeter Road

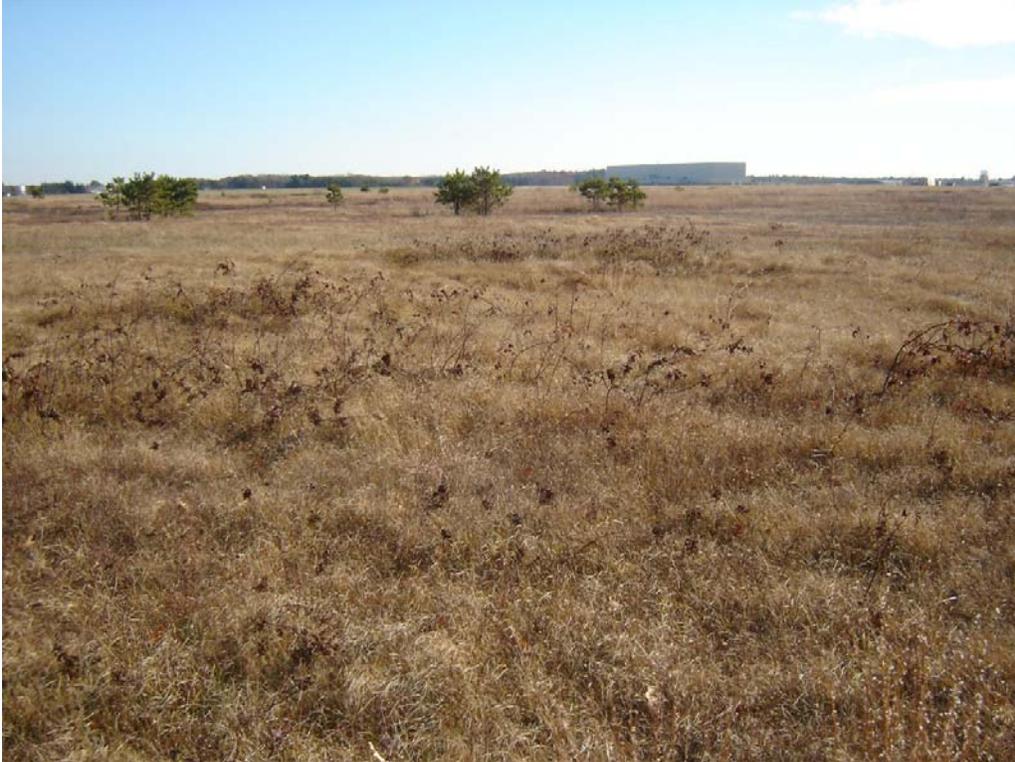
No. 3 Former Residential Area, NAS Brunswick November 3, 2010
View east from inner Perimeter Road; Hangar 6 in background

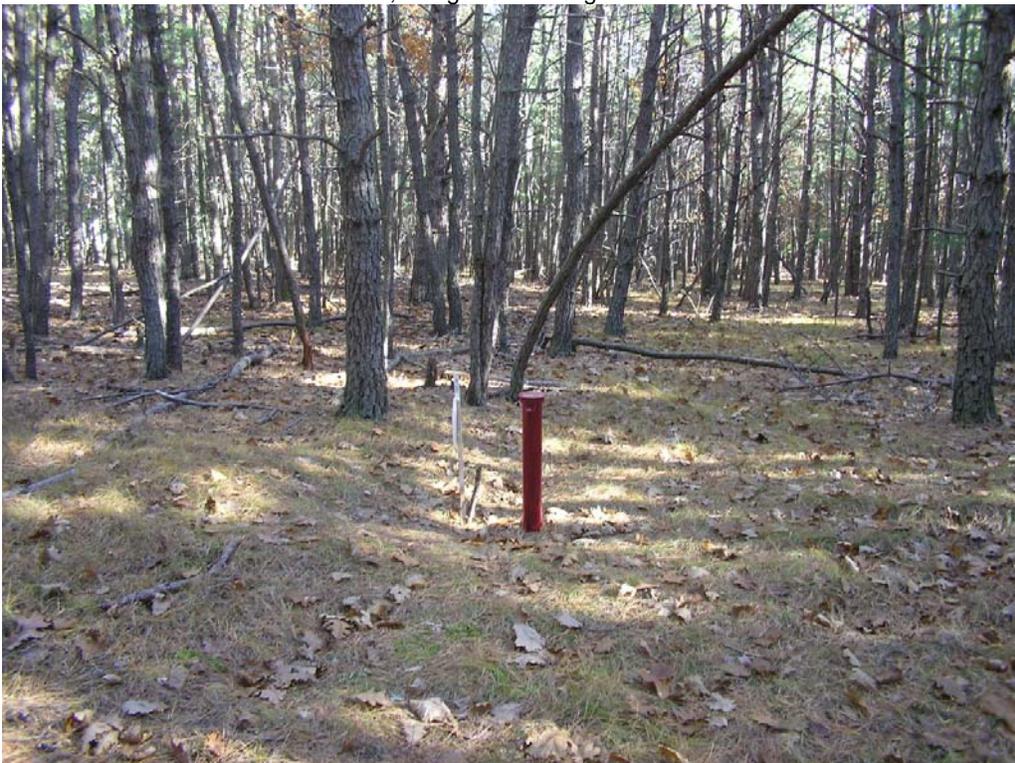
- One suspected hazardous waste disposal area (the Mercury Disposal Area) in the western portion of the Former Residential Area was inspected and three monitoring wells were observed near that location.

No. 4 Former Residential Area, NAS Brunswick November 3, 2010
AOPI mercury disposal area monitoring well location MW01

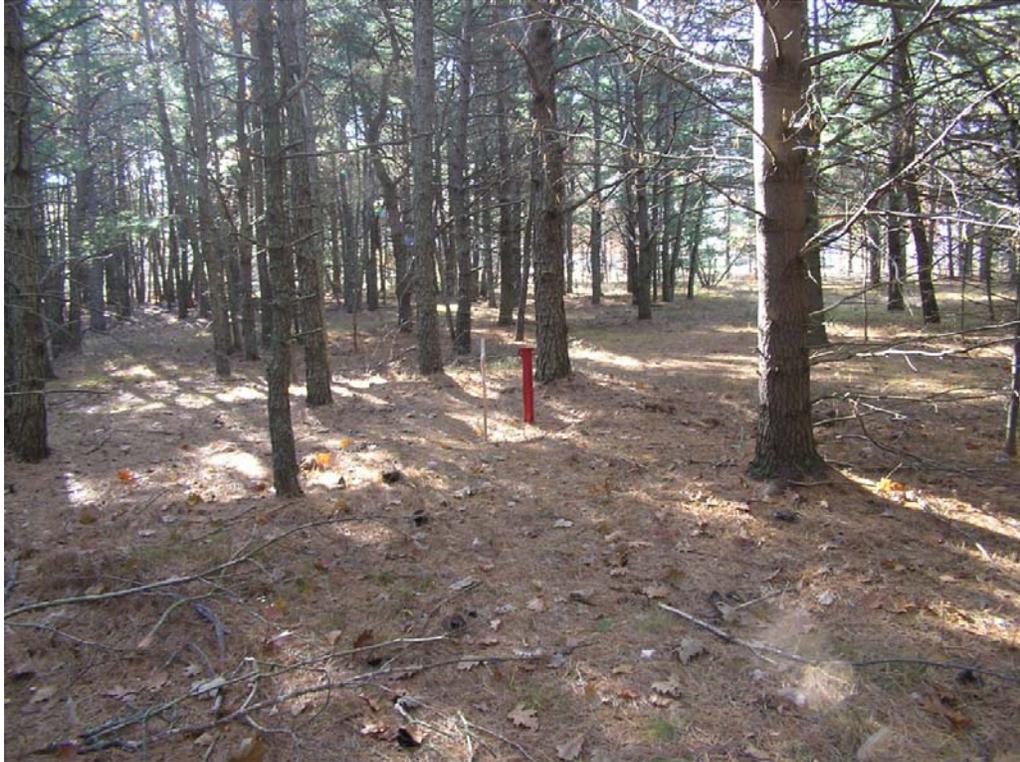
No. 5 Former Residential Area, NAS Brunswick November 3, 2010
AOPI mercury disposal area monitoring well location MW02

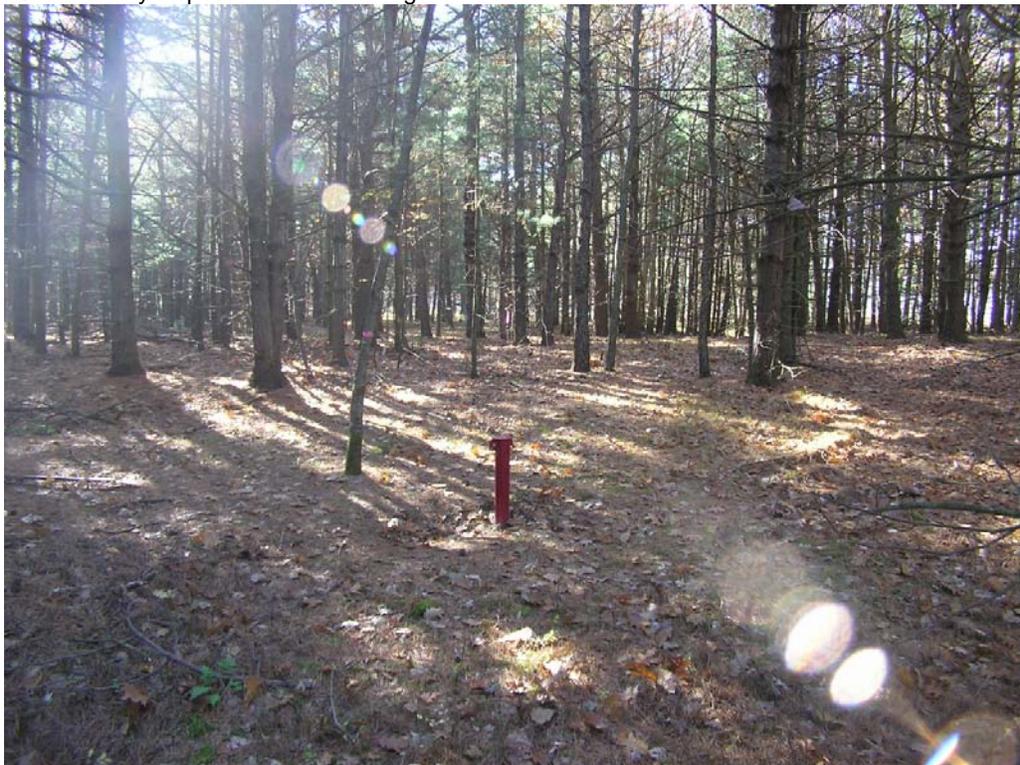
No. 6 Former Residential Area, NAS Brunswick November 3, 2010
AOPI mercury disposal area monitoring well location MW03
