FINAL RESOURCE CONSERVATION AND RECOVERY ACT PARTIAL CLOSURE REPORT
FOR BUILDING 11 WITH TRANSMITTAL LETTER NAS BRUNSWICK ME
3/14/2011
NAS BRUNSWICK

RCRA PARTIAL CLOSURE REPORT
for
BUILDING 11 – NEX RETAIL COMPLEX PARCEL
NAVAL AIR STATION BRUNSWICK, MAINE
USEPA IDENTIFICATION NUMBER ME8170022018
FEBRUARY 2011

**HWSA INSPECTION REPORT
HAZARDOUS WASTE STORAGE AREAS CLOSURE
NAS BRUNSWICK
BRUNSWICK, MAINE
CTO WE22**

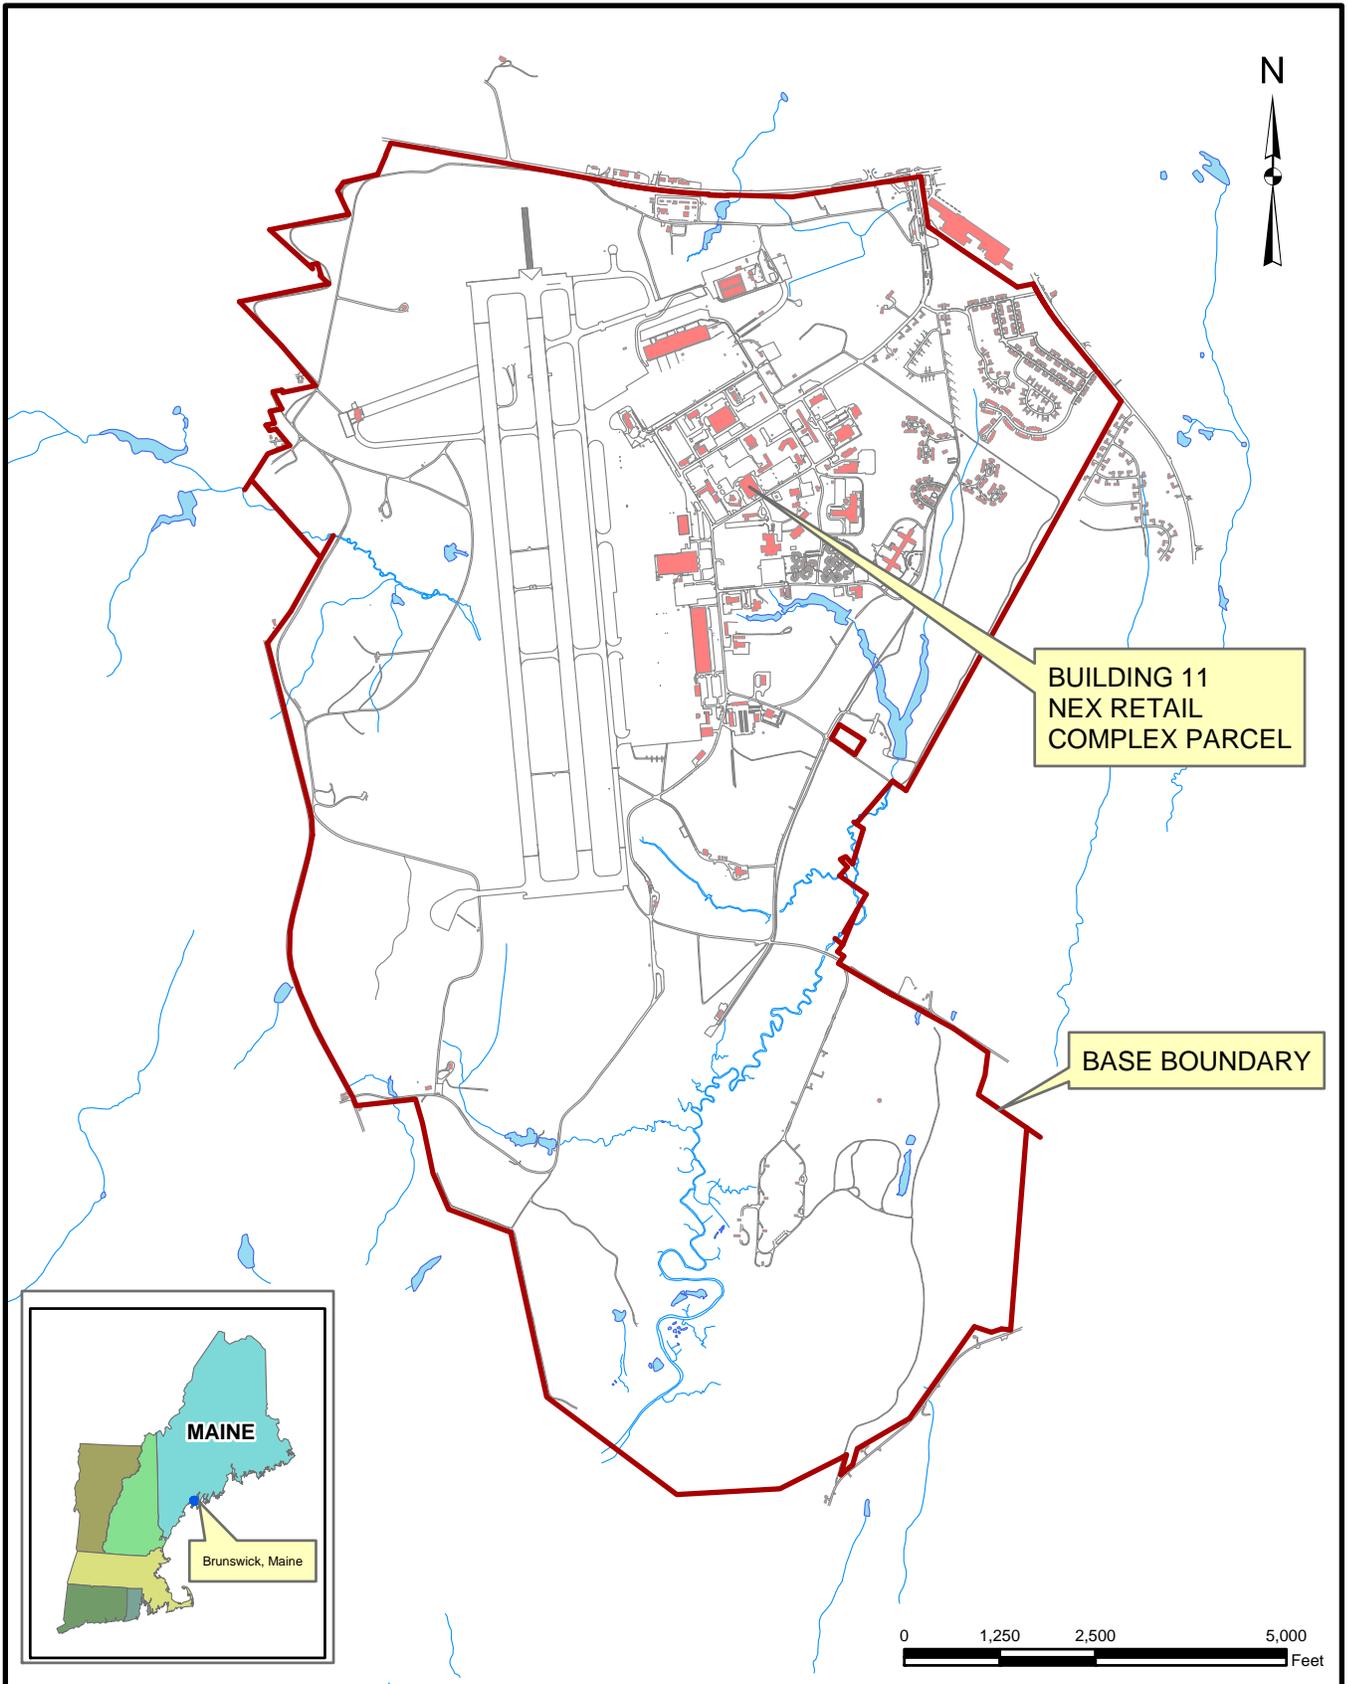
SCALE AS NOTED	
FILE I:_NASB_BLDG_11_LOCUS.MXD	
REV 0	DATE 2/22/11
FIGURE NUMBER 1

The Building 11 (NEX Retail Complex) parcel is located in the central portion of NAS Brunswick (Figure 1). The approximately 9.6-acre parcel is bordered to the north by the Building 585 (Chapel) parcel, the Building 20 (Navy College Office) parcel, and the Building 583 (Bowling Center/Recreation Mall) parcel; to the east by Pegasus Street and the Building 512 (Bachelor Officers' Quarters) parcel, beyond; to the south by Burbank Avenue and the Buildings 27 and 30 (Family Services Center) parcel, the Building 23 (Car Wash) parcel, and the Building 24 (Personal Support Detachment [PSD] Building) parcel; and to the west by the Building 538 (NEX Service Station) parcel, the Building 295 (Water Reservoir Pump House) parcel, and by Pelican Street and the Buildings 225 and 252 (Transportation) parcel, beyond (Figure 2).

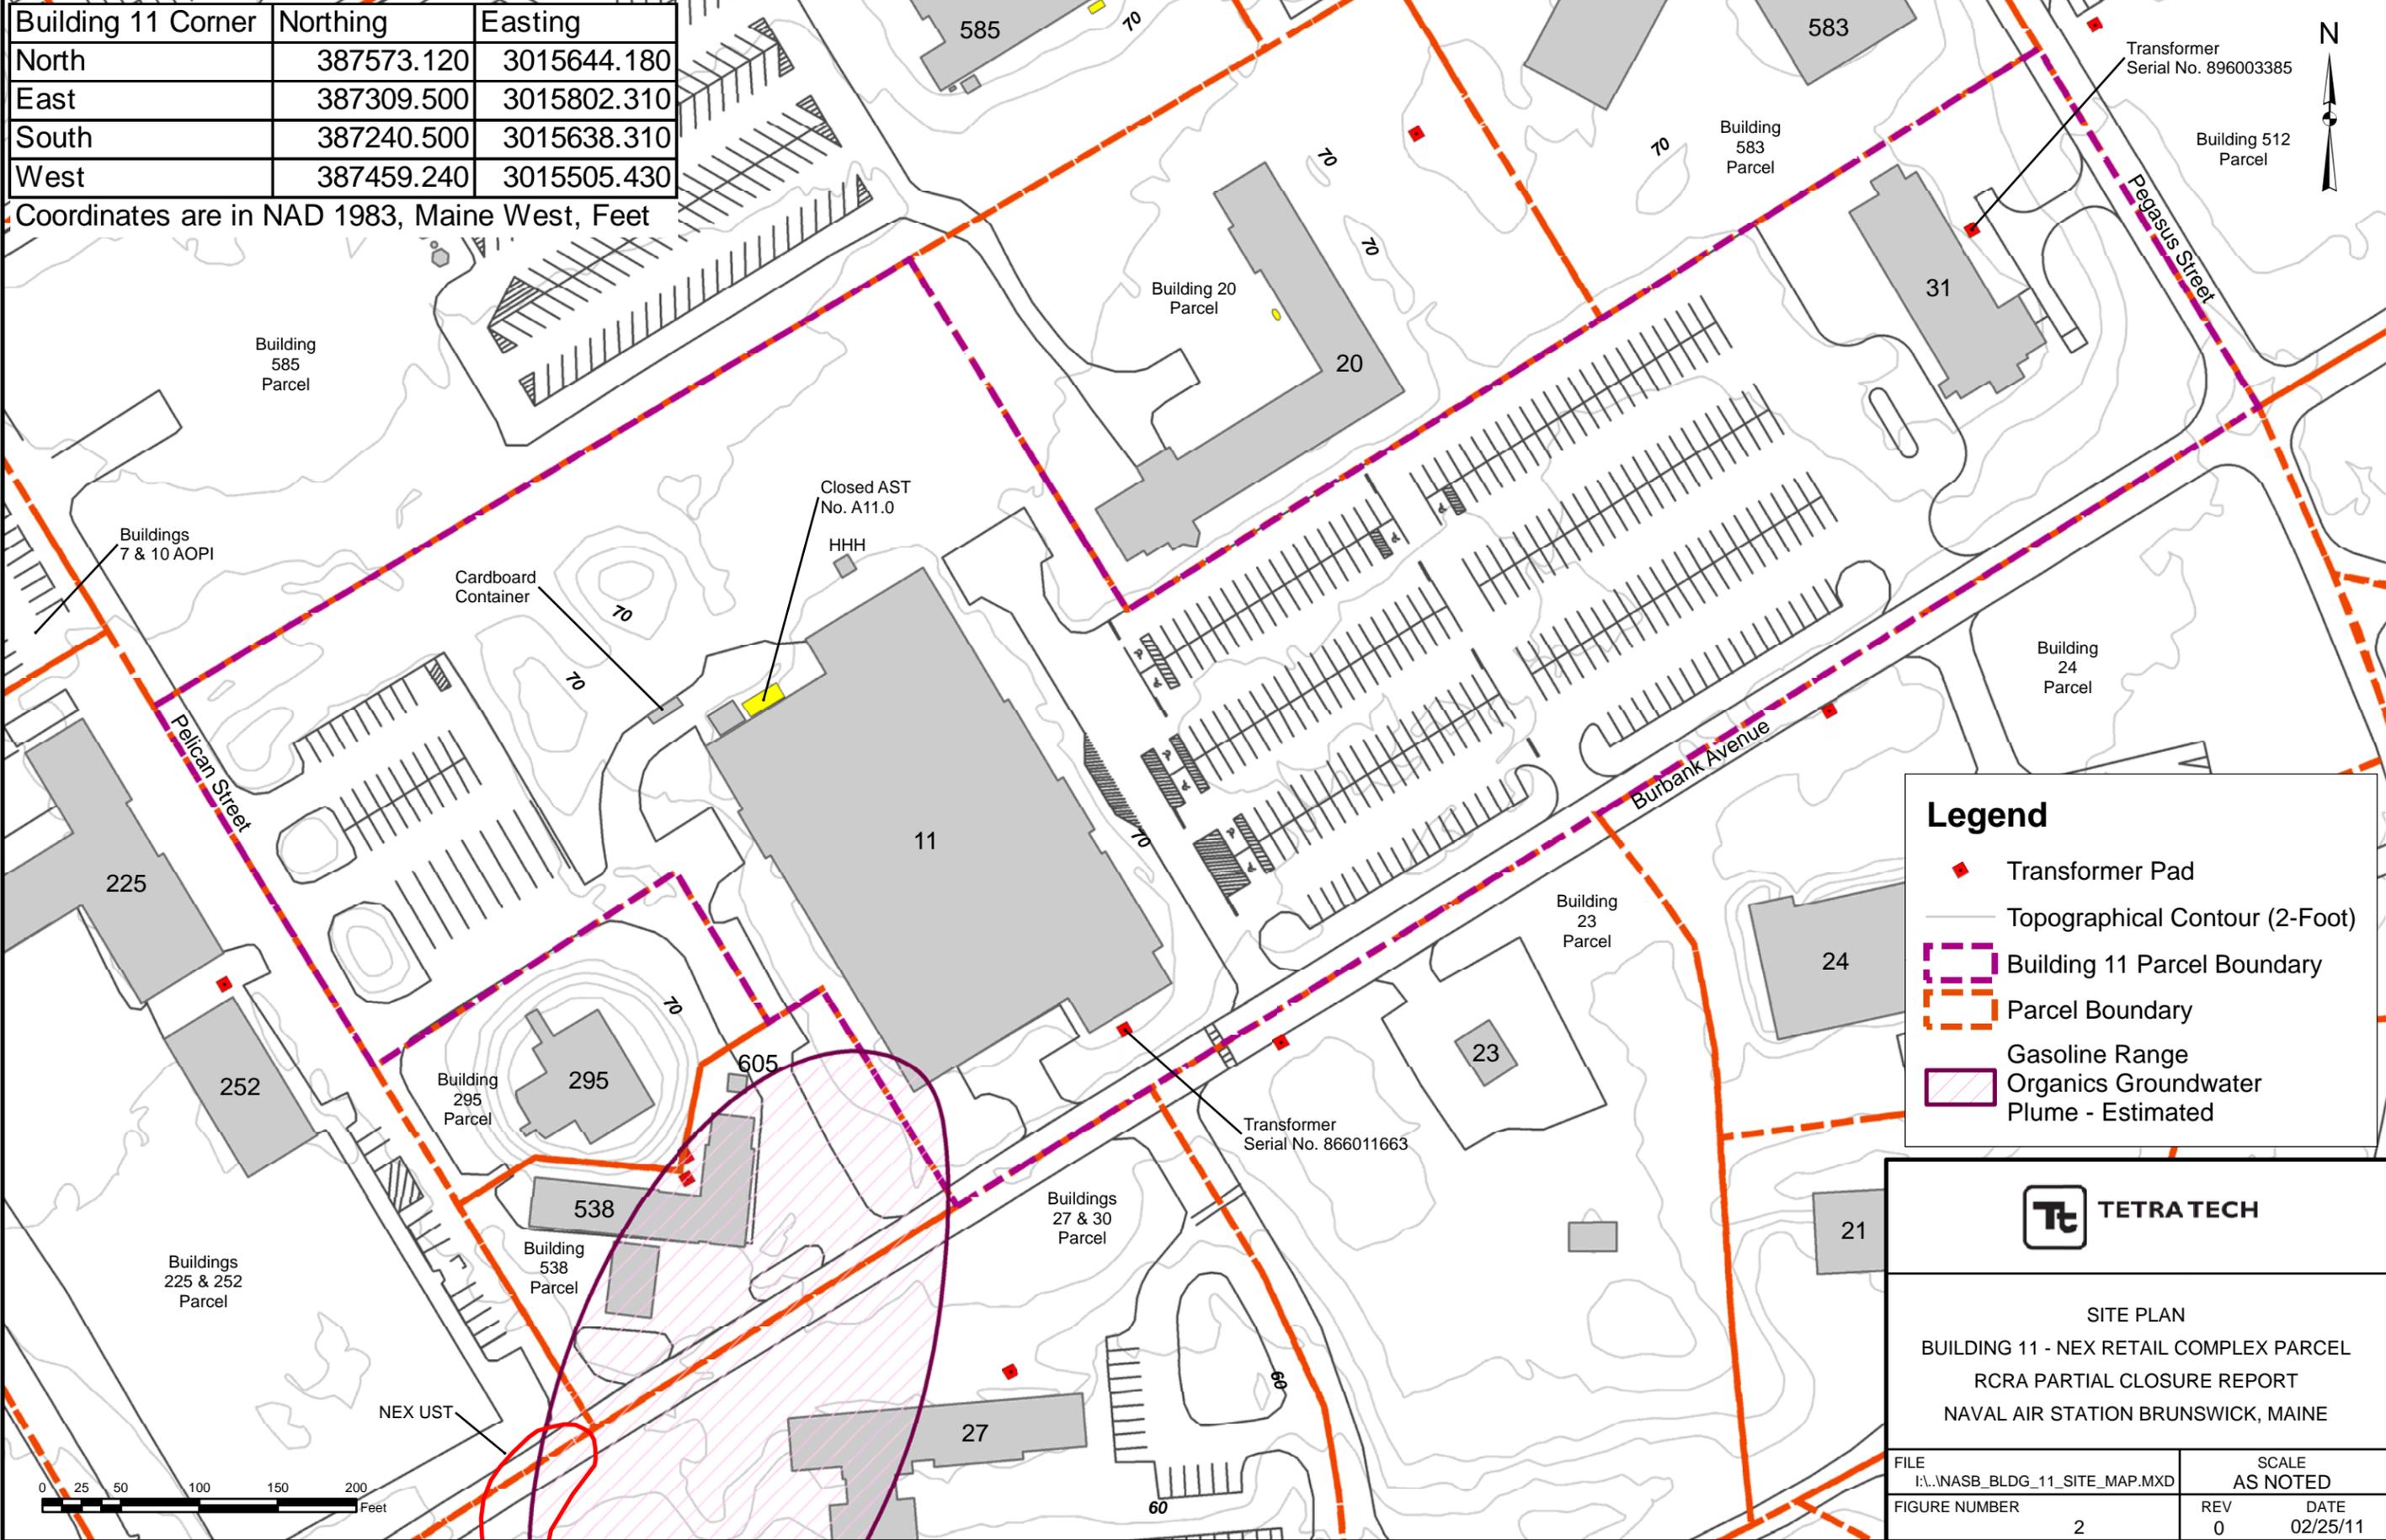
FILE I:\N.ASB_BLDG_11_SITE_MAP.MXD	SCALE AS NOTED
FIGURE NUMBER 2	REV DATE 0 02/25/11

This investigation of the hazardous waste closure requirement applies to the Building 11 parcel (as shown on Figure 2) only.

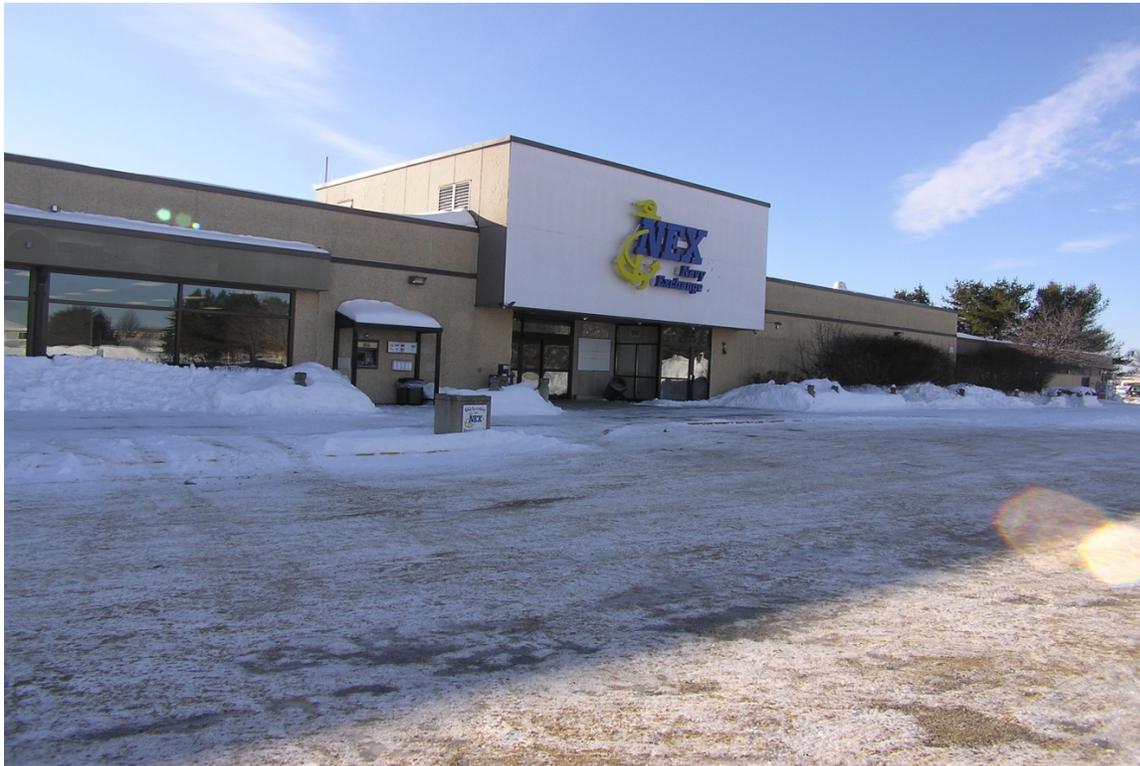
Building 11 is a one story, load bearing block wall structure, with steel roof framing and decking, and with stucco panels for siding; on a concrete foundation. Two by four ceiling tiles are located throughout the building; with 12 inch by 12 inch vinyl floor tiles located on a majority of the floor space area. The building interior walls are sheathed with dry wall and have painted surfaces. Building 11 consists of multiple retail and service center (cash cage, game room) spaces; no hazardous materials were used in its operation and no hazardous waste was generated, according to NAS Brunswick personnel. Building 11 is heated via two natural gas hot water boilers located in a Boiler Room addition on the western end of the building's north elevation, with facility air conditioning provide by roof-top units in the Mezzanine located immediately above the main facility entrance within the east elevation.

No. 1 Building 11 – NEX Retail Complex, NAS Brunswick January 24, 2011
NEX Retail Complex (Building 11) east elevation, with facility main entrance

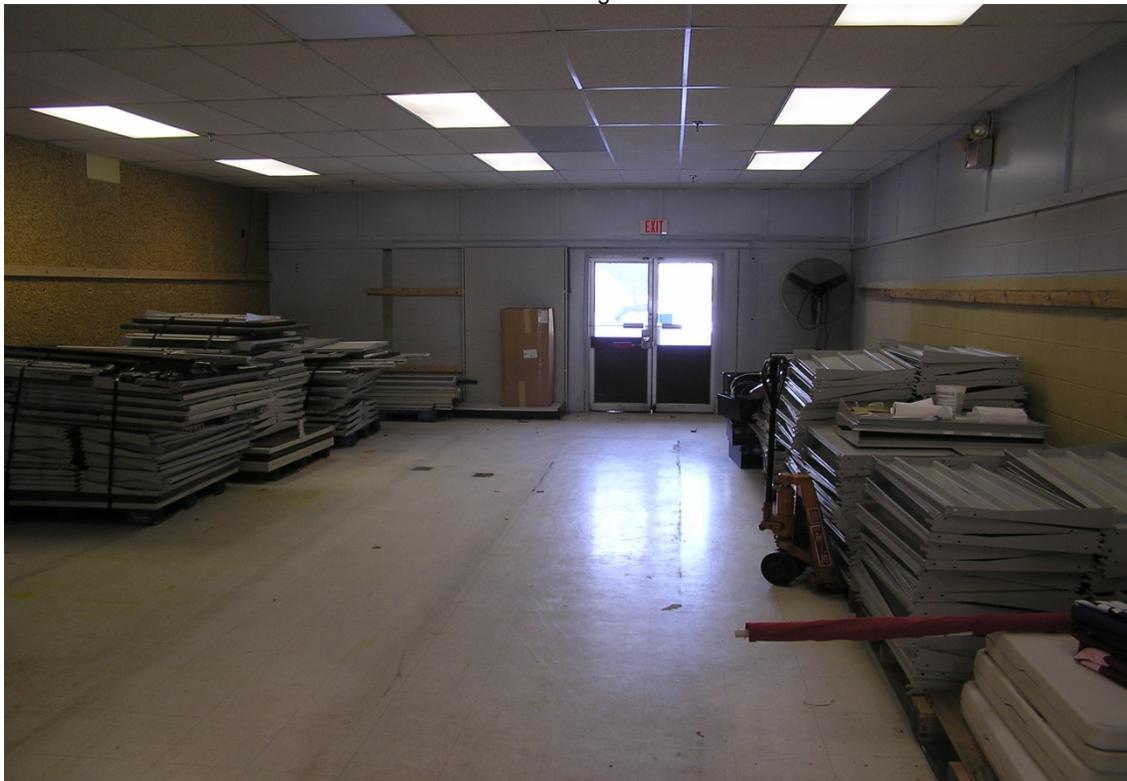
- Floor drains were observed in the Garden Shop, located in the northern portion of Building 11. Neither odors nor staining were observed in the area of the floor drain. The Garden Shop was used for the retail sale of plants and shrubs, along with manufacturer pre-packaged fertilizers and pesticides.

No. 6 Building 11 – NEX Retail Complex, NAS Brunswick January 24, 2011
Garden shop area, located in the northeast corner of Building 11

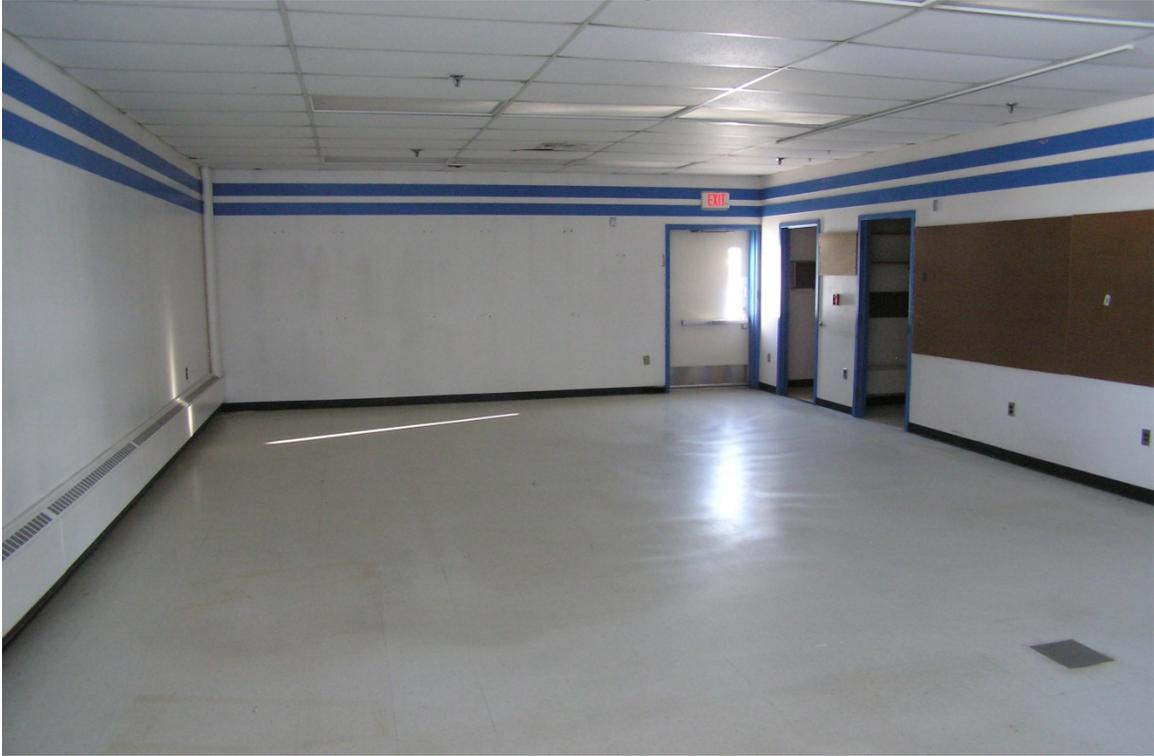
- A tailor and retail dry-cleaning drop-off/pick-up operation was previously located in the vacant retail space in the southeast corner of Building 11. Mr. Anderson stated that no on-site dry cleaning occurred in Building 11; this location served as a

storefront/distribution center for the private tailor/dry-cleaning store, which was located off-base.

No. 8 Building 11 – NEX Retail Complex, NAS Brunswick January 24, 2011
Retail cleaner's distribution area, southeast corner of Building 11

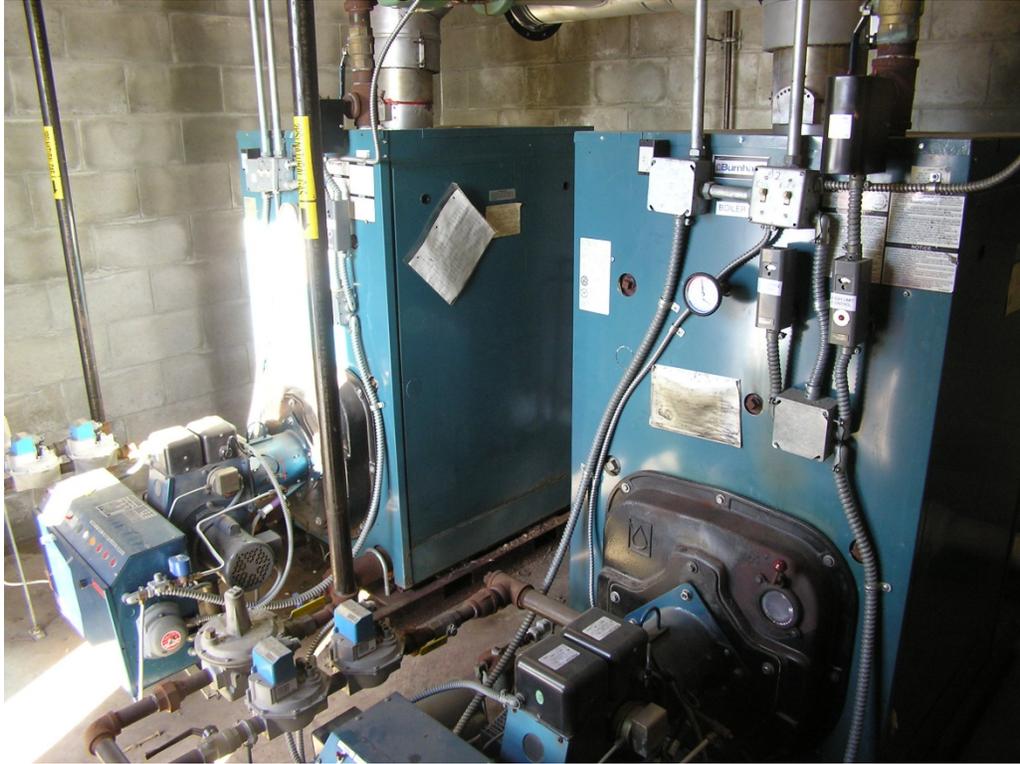
- The footprint of Building 11 changed in approximately 2009, when a new boiler room was constructed as an addition to the facility, on the western portion of the north side of the structure. This estimated time frame for the boiler room construction is based on the April 2009 closure date of the above ground storage tank (AST) servicing the building, which contained fuel oil for the facility's heating units.

No. 9 Building 11 – NEX Retail Complex, NAS Brunswick January 24, 2011
Two natural gas fired boilers in Boiler Room, northwest corner of Building 11

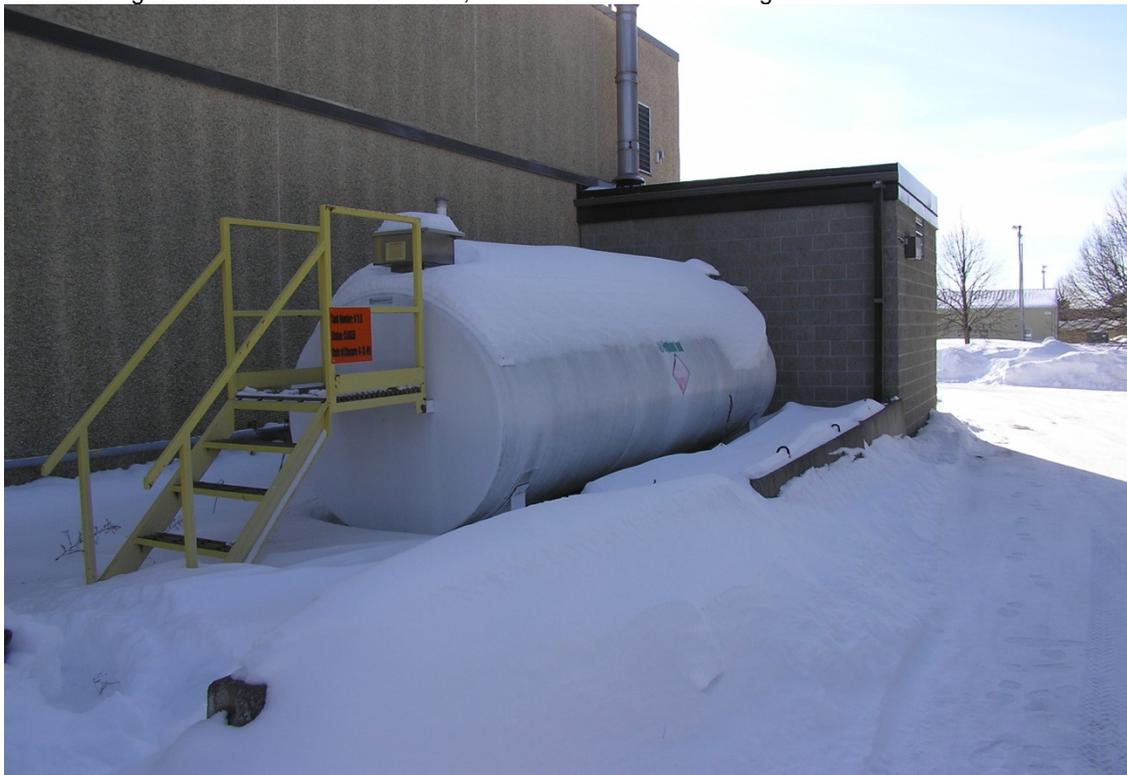
- One closed 3,000-gallon AST was identified on the north side of Building 11, immediately east of the boiler room addition. The tank appeared to be in good condition and no evidence of a past leak from this AST was observed.

A 3,000-gallon closed above ground storage tank (AST), number A 11.0 was observed and appeared to be in good condition with no significant corrosion and no peeling/chipping paint observed. No petroleum stains were observed on the AST or associated concrete pad. The AST was reported as closed, per the tank identification sign, on April 14, 2009.

No. 10 Building 11 – NEX Retail Complex, NAS Brunswick January 24, 2011
Closed AST (3,000-gallon), east of boiler room at northwest corner of Building 11

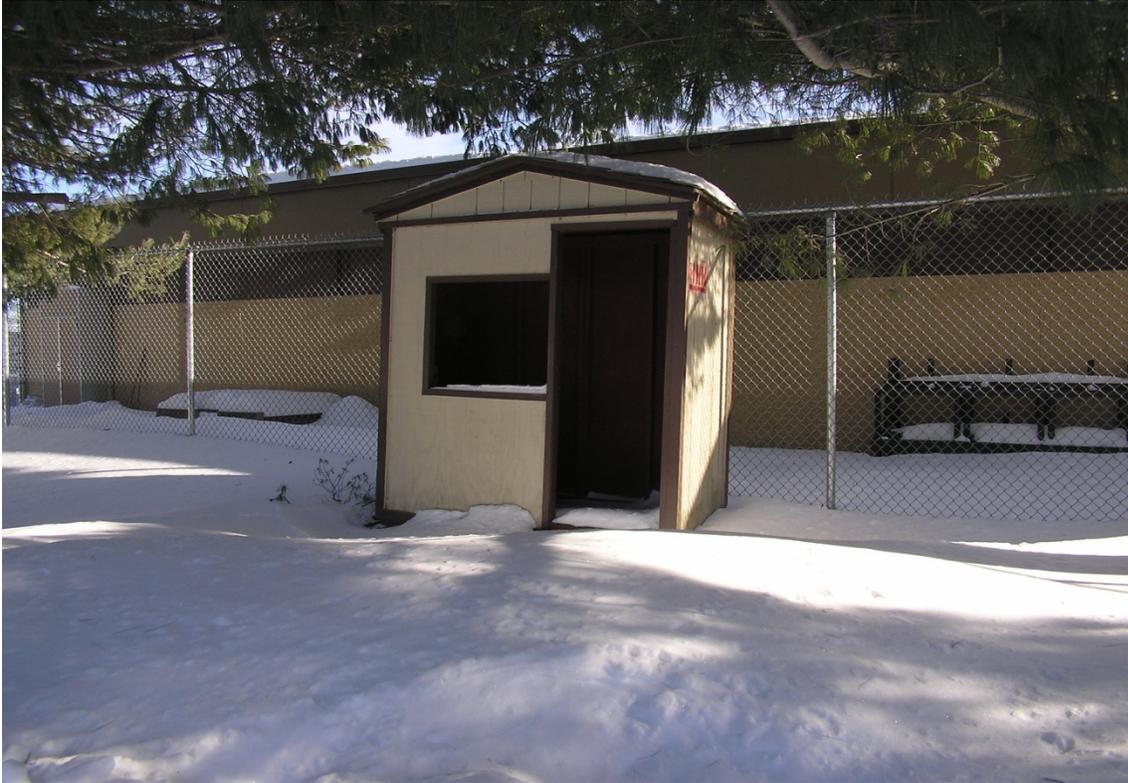
A designated smoking area shed is located immediately north of Building 11. The shed is labeled HHH, and is an 18 SF unheated wooden structure. No hazardous materials were used in its operation and no hazardous waste was generated, according to NAS Brunswick personnel.

No. 11 Building 11 – NEX Retail Complex, NAS Brunswick January 24, 2011
Structure HHH (smoking area), north end of Building 11

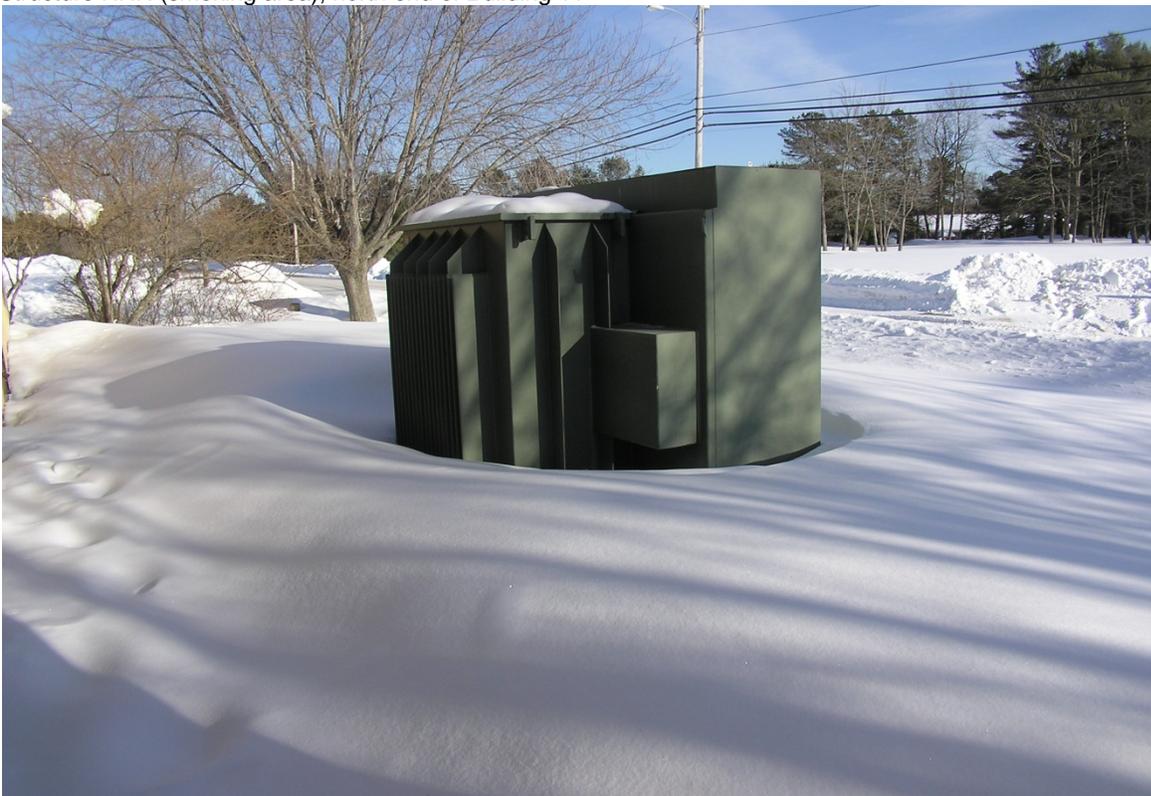
- No hazardous waste storage was observed.
- One concrete-pad-mounted transformer was identified on the south side of Building 11. No evidence of a past leak from this transformer was observed.

One pad-mounted transformer was observed onsite, on the southern side of Building 11 (ID No. 127). According to NASB records the observed 500 KVA transformer was reported to have been manufactured in 1986 by RTE with S/N 866011663, and containing mineral oil. No signs of a past release (staining, unusual odors, stressed vegetation, etc.) were observed.

No. 12 Buildings 11 – NEX Retail Complex, NAS Brunswick January 24, 2011
Southwest elevation of Building 11 transformer, located on the south side of the building
