FINAL RESOURCE CONSERVATION AND RECOVERY ACT PARTIAL CLOSURE REPORT
FOR BUILDING 611 WITH TRANSMITTAL LETTER NAS BRUNSWICK ME
4/6/2011
NAS BRUNSWICK

Subj: Final RCRA Partial Closure Report for Building 611

RCRA PARTIAL CLOSURE REPORT
for
BUILDING 611 – AIMD ENGINE TEST CELL PARCEL
NAVAL AIR STATION BRUNSWICK, MAINE
USEPA IDENTIFICATION NUMBER ME8170022018
FEBRUARY 2011

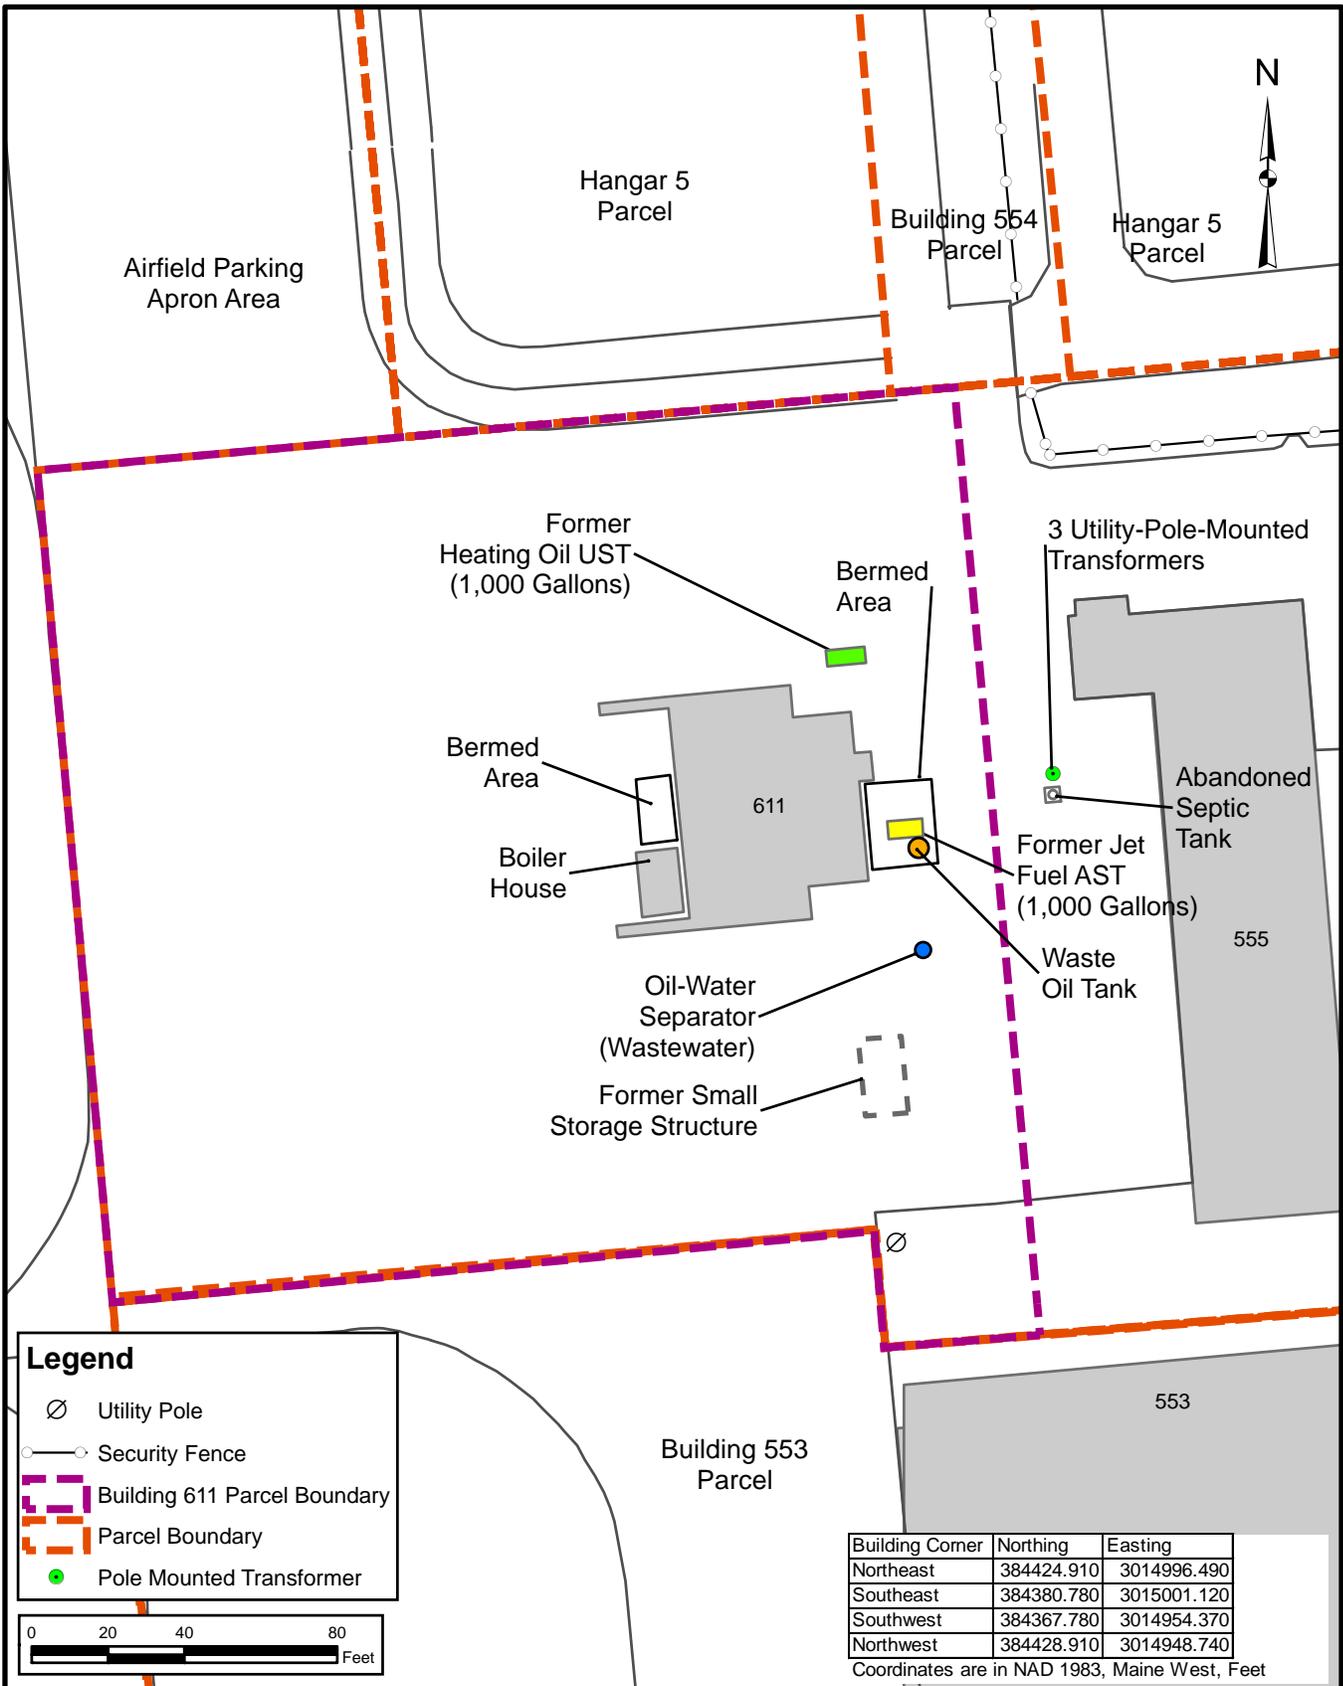
SCALE AS NOTED	
FILE	
L:\NASB_BLDG_611_SITE_MAP.MXD	
REV	DATE
0	02/18/11
FIGURE NUMBER	
2

SITE PLAN
BUILDING 611 - AIMD ENGINE TEST CELL PARCEL
RCRA PARTIAL CLOSURE REPORT
NAVAL AIR STATION BRUNSWICK, MAINE

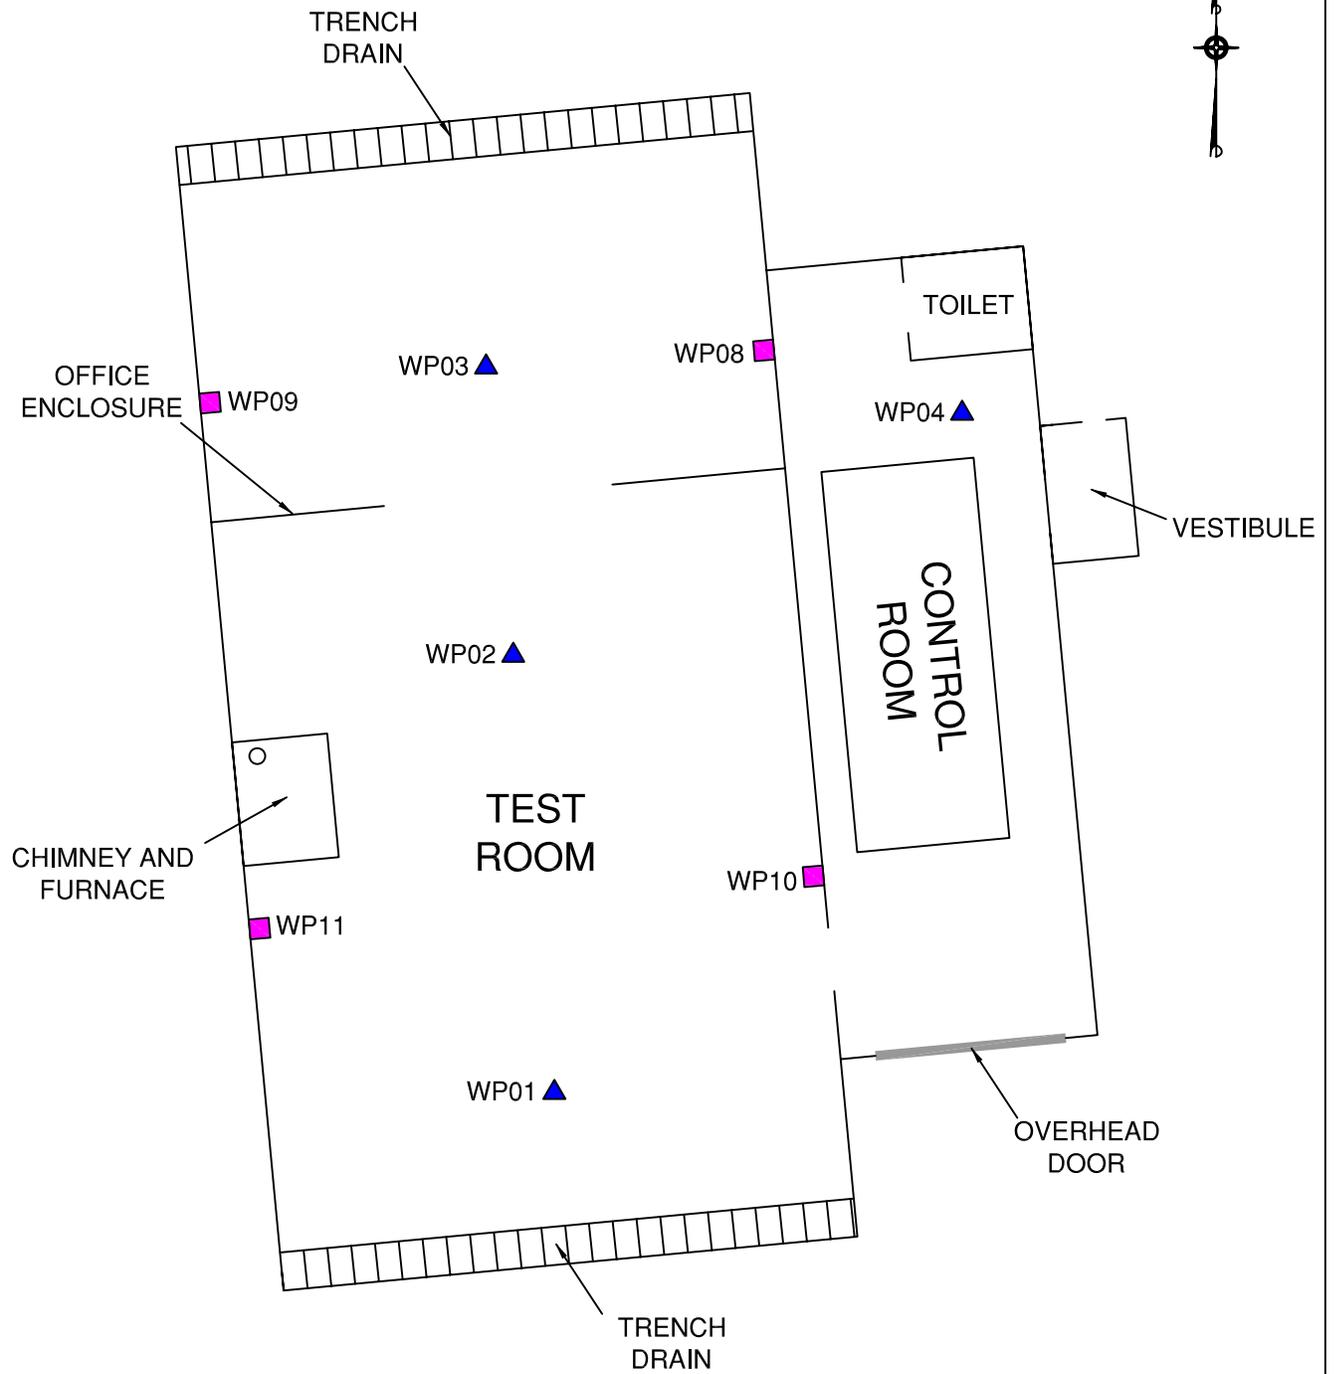
SCALE AS NOTED	
FILE \\.\NASB_BLDG_611_PRE_SAMP.DWG	
REV 0	DATE 02/17/11
FIGURE NUMBER 3

- WP01 ▲ FLOOR WIPE SAMPLE LOCATION (02/24/10)
- WP08 ■ WALL WIPE SAMPLE LOCATION (09/09/10)

PRE-CLEANING WIPE SAMPLE LOCATION MAP
 BUILDING 611 - AIMD ENGINE TEST CELL PARCEL
 RCRA PARTIAL CLOSURE REPORT
 NAVAL AIR STATION BRUNSWICK, MAINE

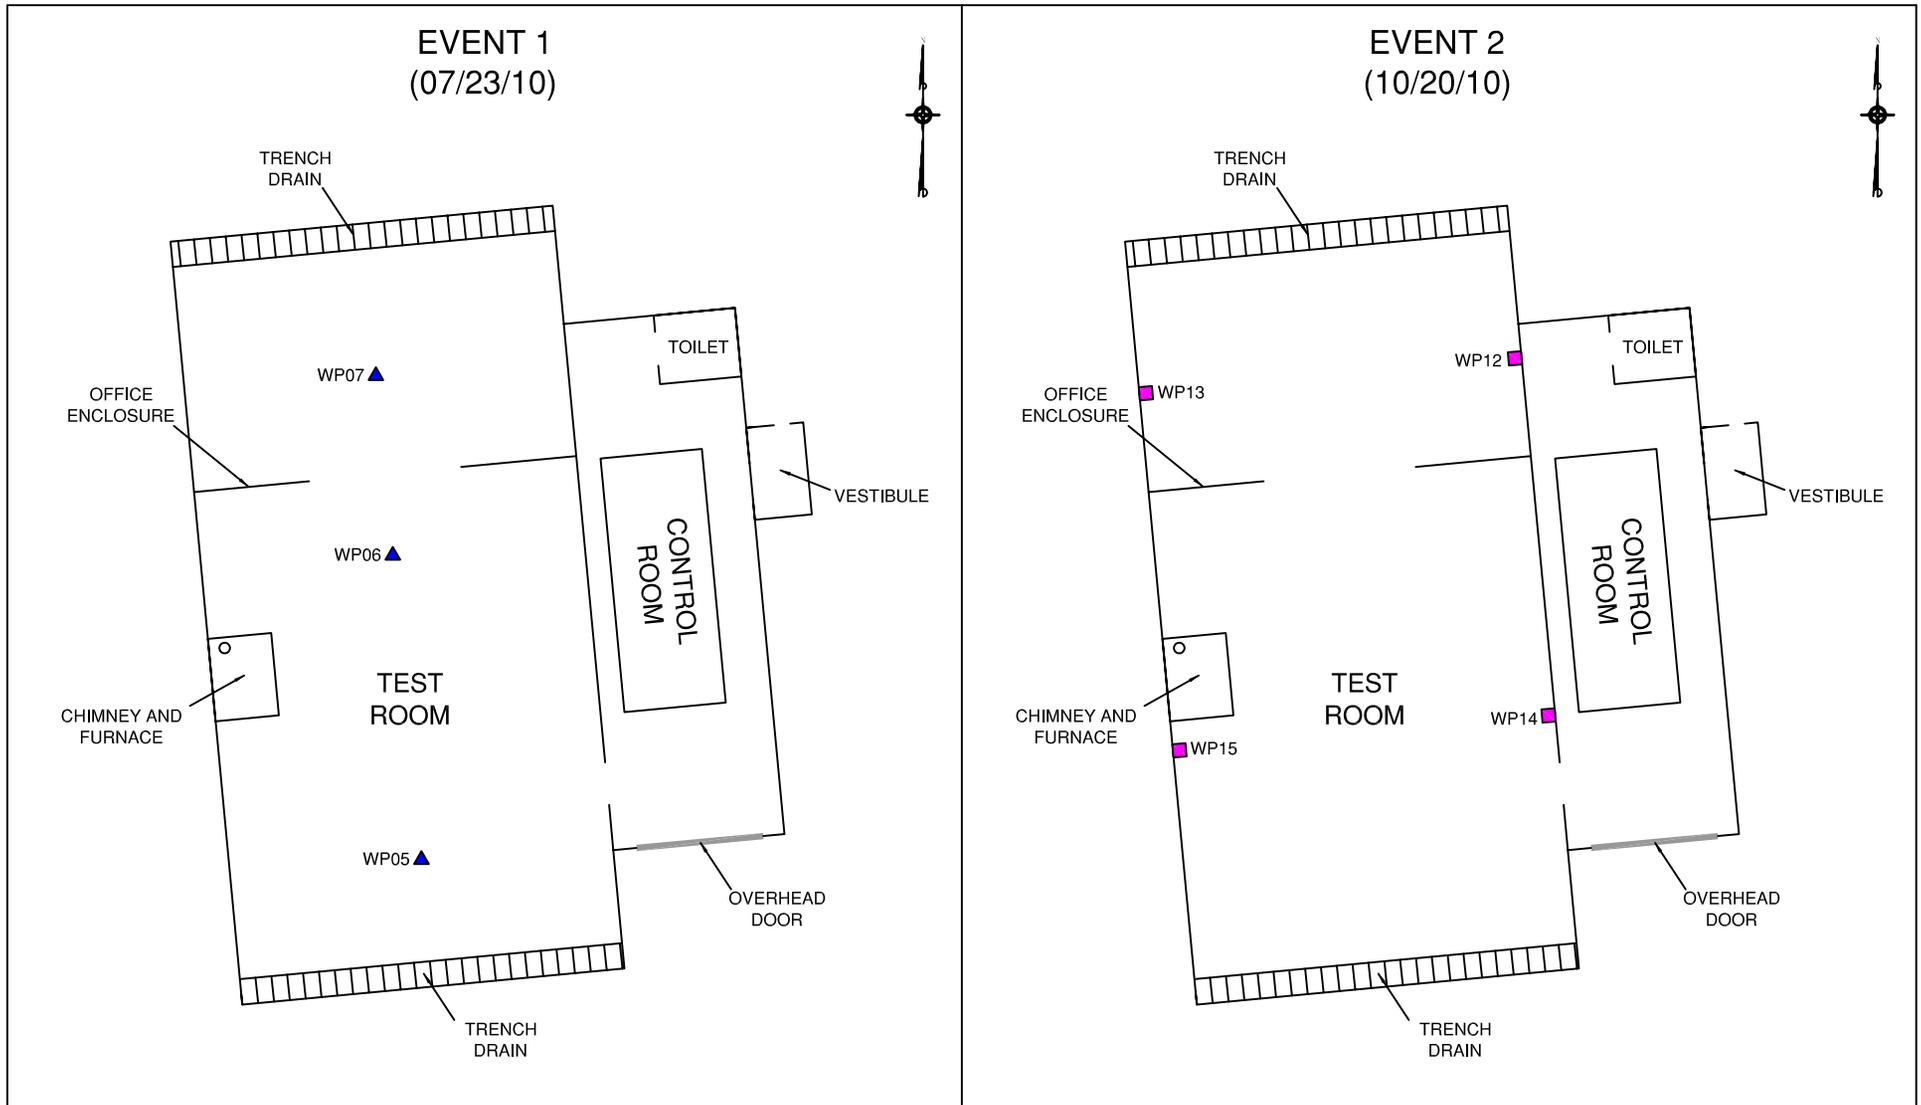
SCALE AS NOTED	
FILE \\.\NASB_BLDG_611_POST1.DWG	
REV 0	DATE 02/17/10
FIGURE NUMBER 4

LEGEND
 WP05 ▲ FLOOR WIPE SAMPLE LOCATION
 WP08 ■ WALL WIPE SAMPLE LOCATION

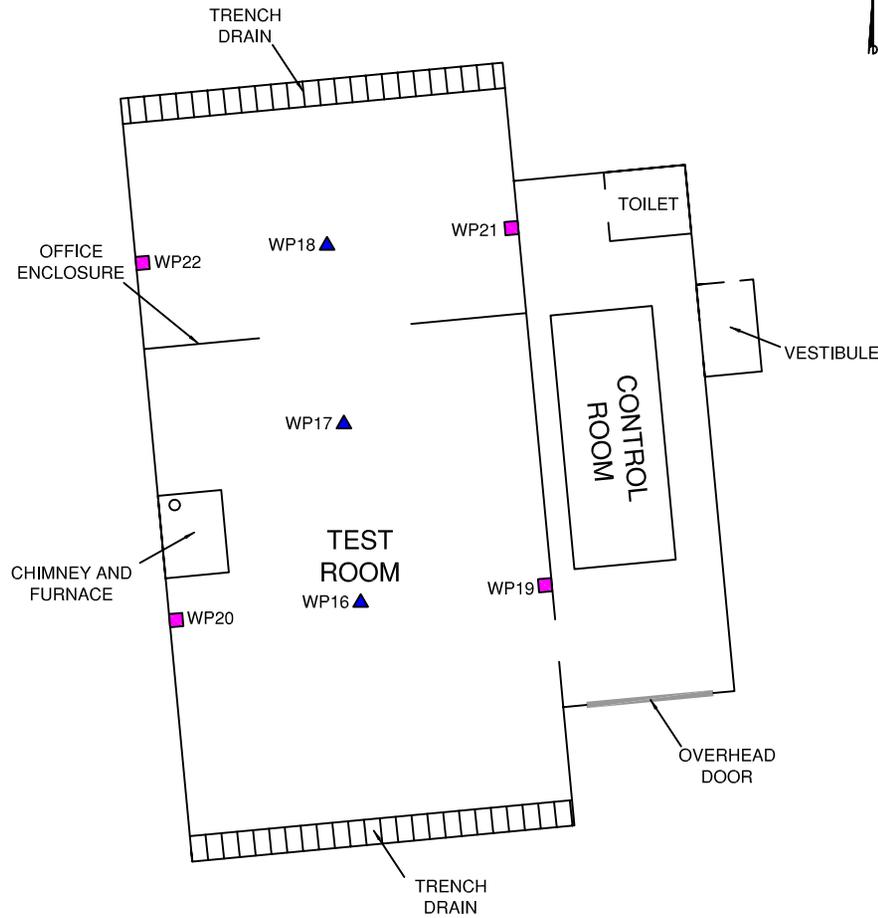
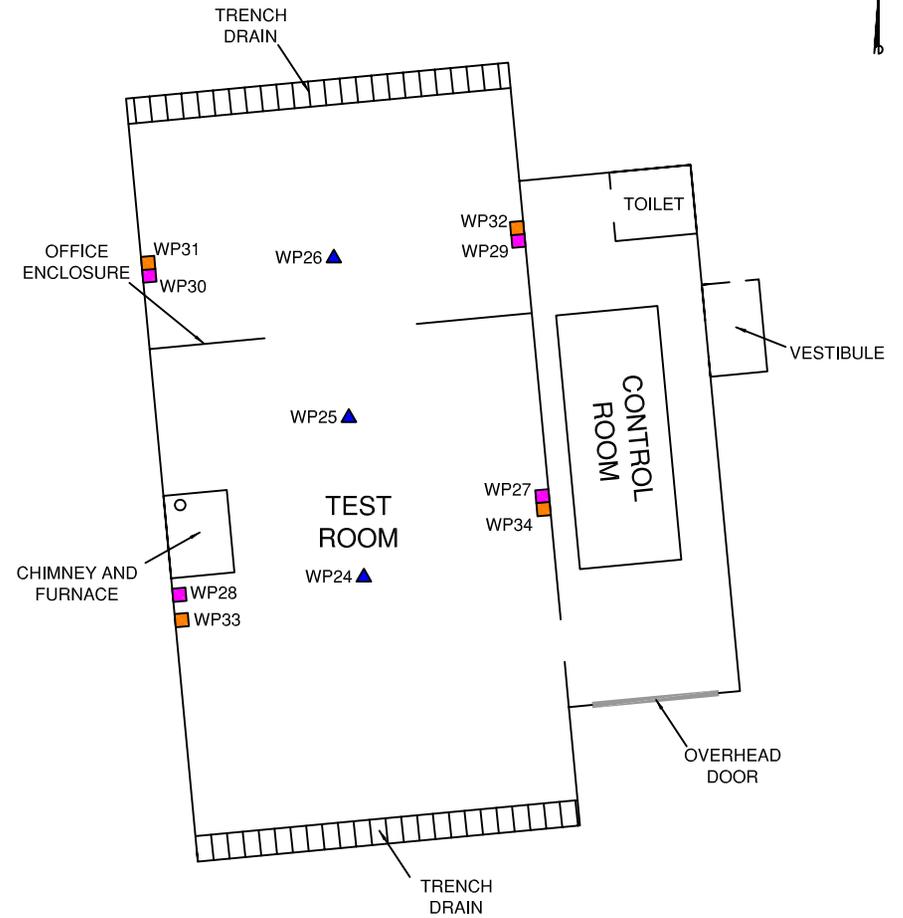
EVENT 3 (01/11/11)

EVENT 4 (01/21/11 & 02/01/11)

- WP16 ▲ FLOOR WIPE SAMPLE LOCATION
- WP21 ■ WALL WIPE SAMPLE LOCATION
- WP31 ■ WALL WIPE SAMPLE LOCATION (02/01/11)

Based on Event 3 results, a fourth decontamination event (Event 4) was conducted at Building 611 on January 20, 2011. Floors and walls were cleaned again, using the procedures described above. All cleaning wastewater was containerized using a wet-vacuum, placed in six 55-gallon drums, and transferred to the NAS Brunswick hazardous waste department for disposal. Upon completion, the Tetra Tech field representative performed a visual inspection of the cleaned areas. After the work areas were allowed to dry, post-cleaning confirmatory wipe samples (Event 4) were collected on January 21, 2011. Three floor-wipe samples and four wall-wipe samples (plus one blind duplicate) were collected (Figure 5) for lead analysis by Analytics. Resulting analytical data underwent limited data validation. Event 4 wipe sample results (Table 5) showed that lead levels in the post-cleaning confirmatory floor-wipe samples were below the associated MEDEP floor criterion. However, lead was still detected at levels exceeding the associated MEDEP criterion for walls in all of the Event 4 wall-wipe samples.

It is suspected that the diluted nitric acid used to saturate the wipe sample gauze caused lead transfer from the galvanized steel during sampling resulting in false lead levels in the wall wipe sample results that exceeded the closure criteria of $250 \mu\text{g}/\text{ft}^2$. According to multiple references, lead is a common impurity in zinc coatings used on galvanized steel. In addition, lead has been detected in samples of galvanized steel (Kim and Leidheiser, 1977). Therefore, four additional confirmatory wall-wipe samples were collected on February 21, 2011, using wipes saturated in de-ionized water. Lead levels in these samples results (Table 5) were well below the associated MEDEP wall criterion. As these results are more representative of the lead residue level, additional closure action is not warranted at Building 611.

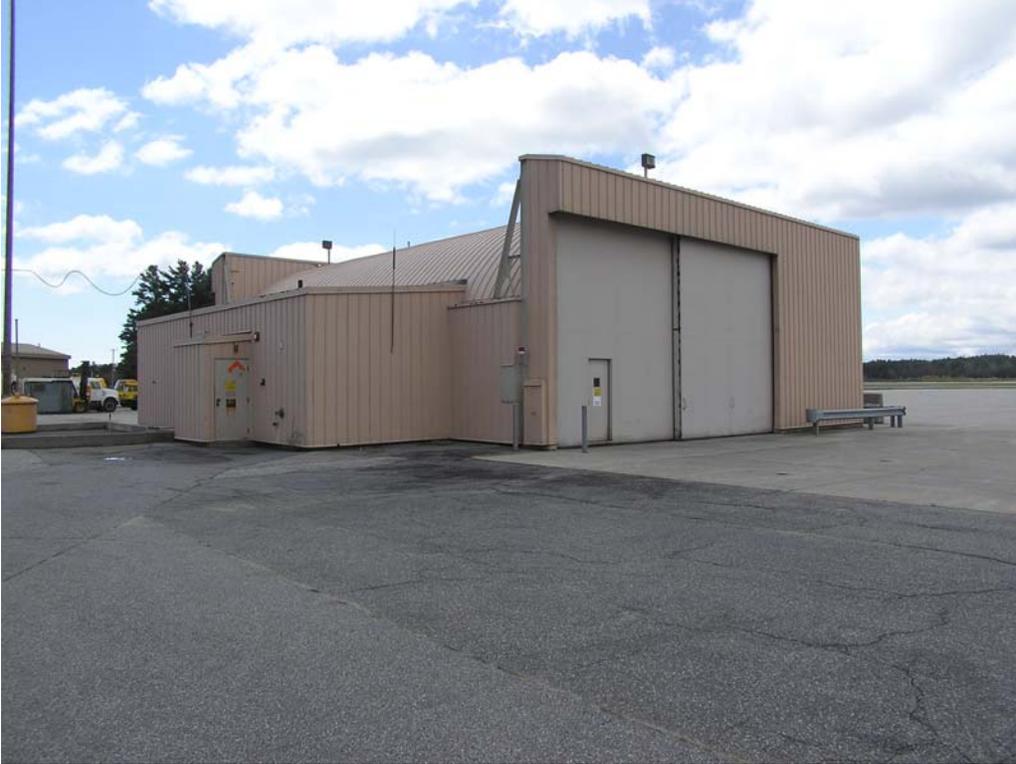
No. 1 Building 611 – AIMD Engine test Cell, NAS Brunswick April 28, 2010
Engine Test Cell Building northeast elevation

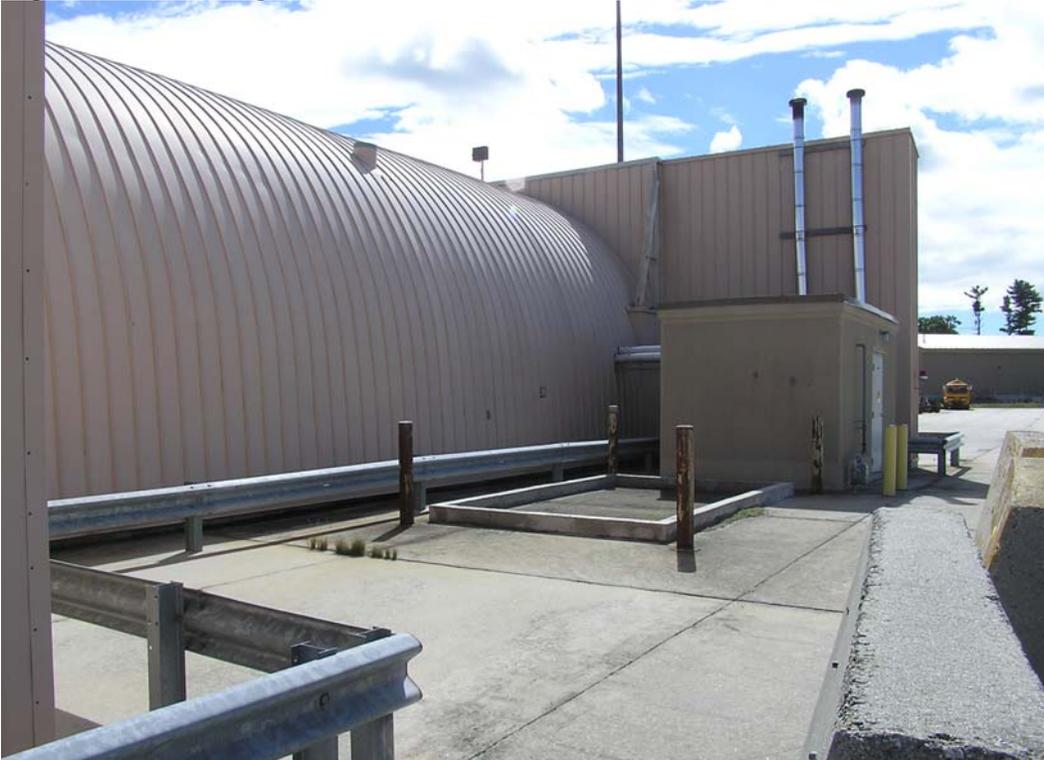
- A concrete-bermed, paved area located west of Building 611 was empty; no evidence of hazardous waste residue was observed.
- Trench drains were observed in the floor on the north and south sides of the engine test cell room.

No. 2 Building 611 – AIMD Engine test Cell, NAS Brunswick September 9, 2010
Engine Test Cell Building northwest elevation; west bermed area and detached boiler house

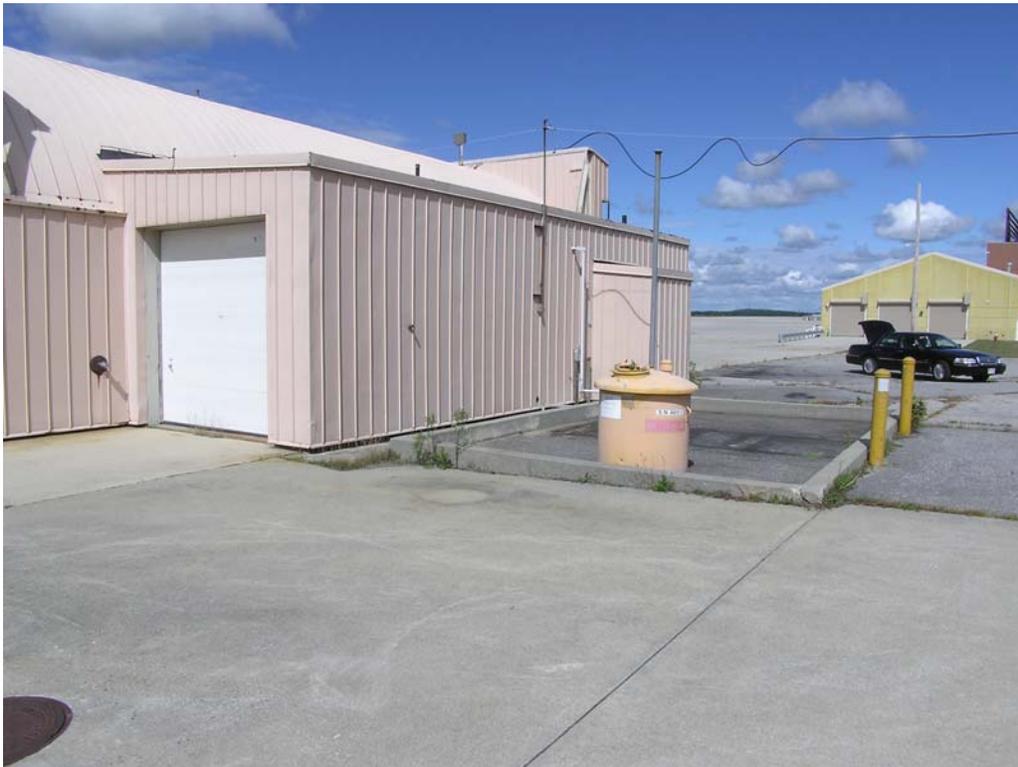
- Structural modifications that could conceal signs of a past release were not observed.
- A concrete-bermed, paved area with a 185-gallon AST (A611.1) is located east of Building 611. The tank is labeled "used oil, aircraft fuel, hydraulic oil, engine oil", as observed on April 28, 2010. (A 1,000-gallon JP8 tank was formerly located inside the bermed area.)

No. 3 Building 611 – AIMD Engine test Cell, NAS Brunswick September 9, 2010
Engine Test Cell Building east bermed area; inactive AST 611.1 shown

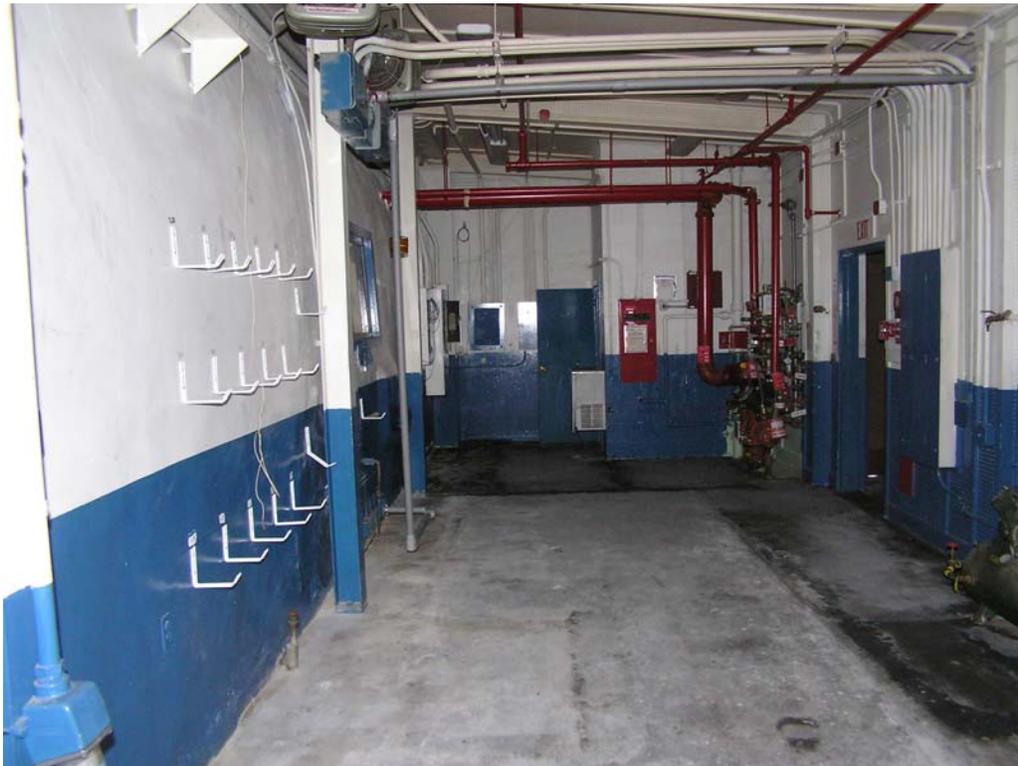
No. 4 Building 611 – AIMD Engine test Cell, NAS Brunswick September 9, 2010
Engine Test Cell Building control room

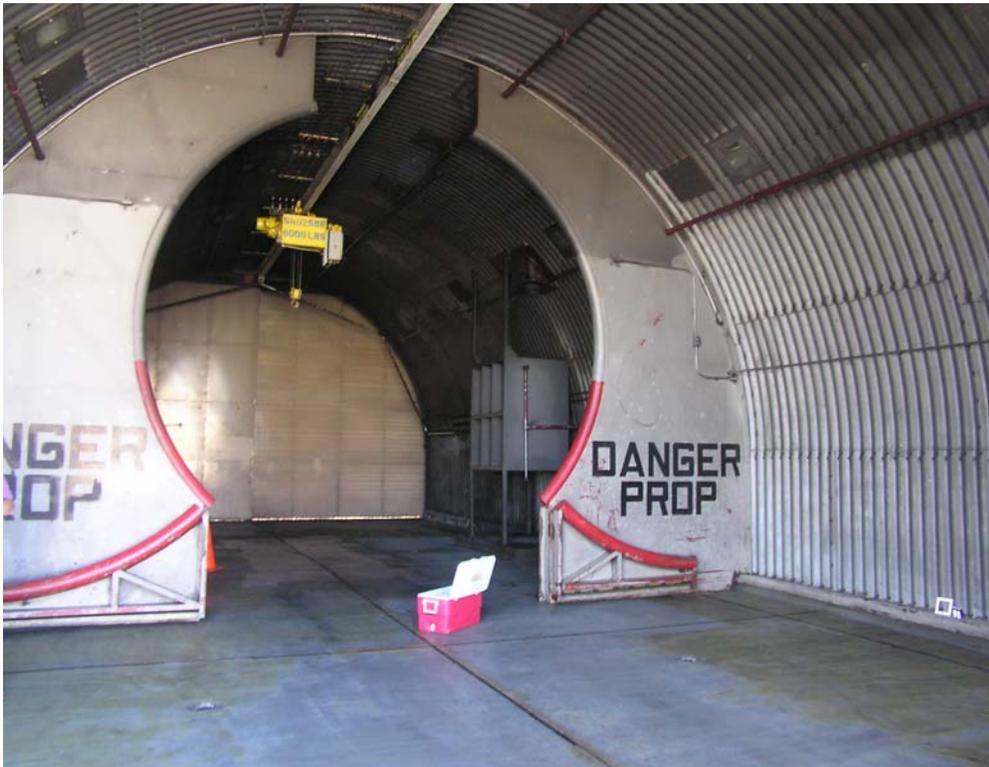
- Control room equipment and office furniture were present in the building.
- Some staining of the engine test cell floor was observed and the floor was coated with a greasy film.

No. 5 Building 611 – NAS Brunswick
Engine test room after cleaning (view to south)

Since wall-wipe samples collected on September 9, 2010 were found to be above the associated MEDEP criterion, a second decontamination event (Event 2) was conducted at Building 611 between October 18 and October 20, 2010. Floors were scrubbed, and the floor, walls and the overhead surface were sprayed with a 2-percent, lead-specific detergent solution, and floors, and pressure-washed, using a 5,000-psi steam cleaner. All cleaning wastewater was containerized using a wet-vacuum, placed in fifteen 55-gallon drums, and transferred to the NAS Brunswick hazardous waste department for disposal. Upon completion, the Tetra Tech field representative performed a visual inspection of the cleaned areas.

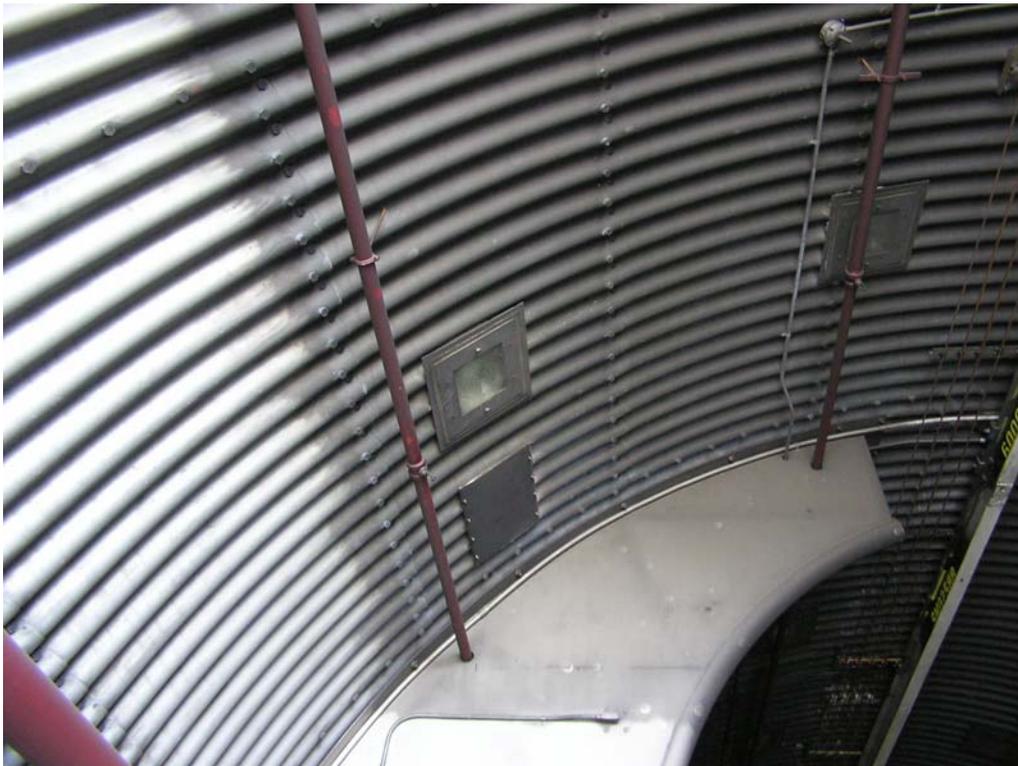
- The walls and overhead areas of the engine test room were coated with a dark-grey residue, likely aircraft engine exhaust deposits.
- At the concrete apron, north and south of the engine test cell, some evidence of engine-exhaust staining was observed, but significantly less than seen in historical aerial photographs.

No. 6 Building 611 – NAS Brunswick
Engine test Cell interior; test room roof after cleaning

Based on Event 2 results, a third decontamination event (Event 3) was conducted at Building 611 on January 11, 2011. Test room floors and walls were cleaned again, using the procedures described above. The overhead test room surfaces were also cleaned to meet the visibly clean criterion. All cleaning wastewater was containerized using a wet-vacuum, placed in five 55-gallon drums, and transferred to the NAS Brunswick hazardous waste department for disposal. Upon completion, the Tetra Tech field representative performed a visual inspection of the cleaned areas. After the work areas were allowed to dry, three floor-wipe samples (plus one blind duplicate) and four wall-wipe samples were collected for lead analysis by Analytics (Figure 5). The resulting analytical data underwent limited data validation. For the Event 3 confirmatory samples, lead was detected at levels exceeding the associated MEDEP criterion for floor-wipes or wall-wipes at two of the three floor-wipe locations and three of the four wall-wipe locations (Table 4).
