FINAL HISTORICAL RADIOLOGICAL ASSESSMENT HISTORY OF THE USE OF GENERAL  
RADIOACTIVE MATERIALS FROM 1943 TO 2011 NAS BRUNSWICK ME  
3/1/2014  
NAVSEA YORKTOWN

***Naval Air Station Brunswick  
Brunswick, Maine***

**FINAL  
HISTORICAL  
RADIOLOGICAL ASSESSMENT**

**History of the Use of General Radioactive Materials  
1943 to 2011**

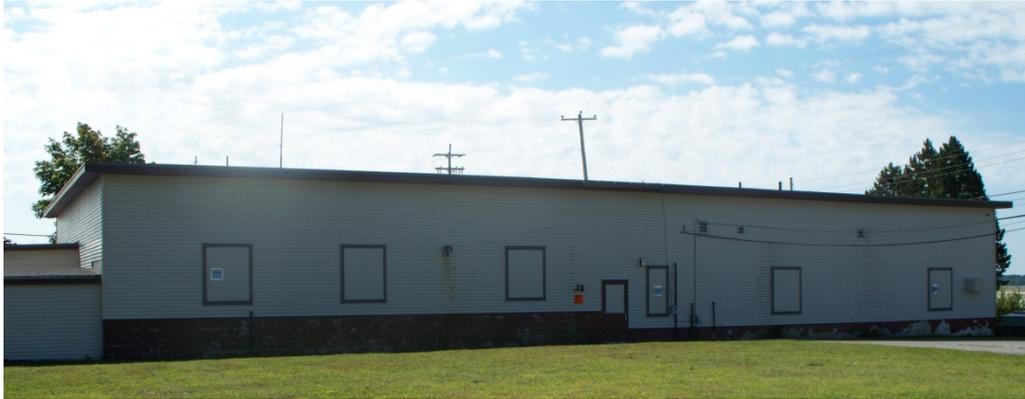
### 8.2.1 MWR CPO Wardroom / VPU / Electronics and Ordnance Shop

**Site Description:** The Morale, Welfare and Recreation (MWR) CPO Wardroom (Building 9) was used from 2006 to 2011 as a lounge and mess facility for non-commissioned officers. This building was originally built as a laundry facility and later housed the Electronic and Ordnance Shop (1950s - 1960s) and the Patrol Squadron Special Unit (VPU) (1970s-1980s). The building was constructed in 1943 and its area is approximately 8,888 ft<sup>2</sup>. Historical floor plans for this building were reviewed to determine the locations of operational activities within the building ([HRA-0433](#)).

**Recommended Actions:** Conduct scoping surveys of building and drains.

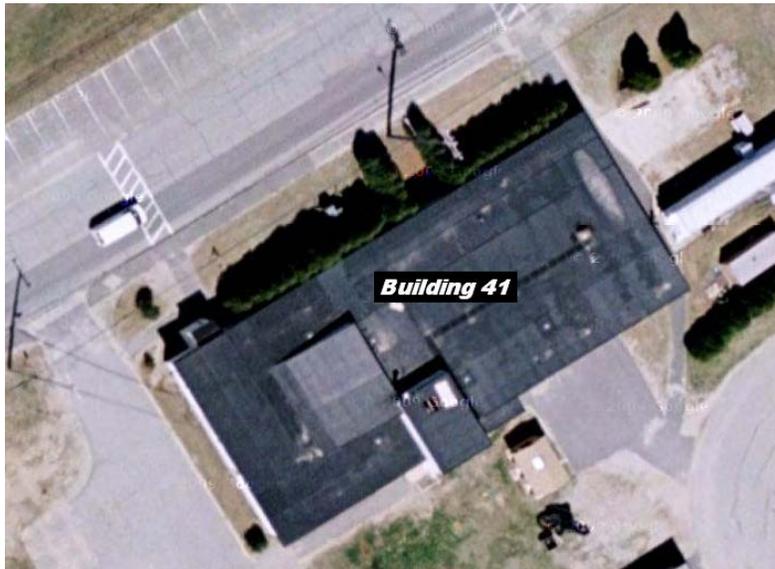
### 8.2.2 Police Station / Old Parachute Shop

**Site Description:** The Police Station is currently designated Building 41, but the same building was divided and designated Buildings 41 and 43 on maps from 1944 until 1973. During these years, the half of the building designated Building 41 was used for an unknown type of training and the half of the building designated Building 43 was used for parachute maintenance operations. The size of the building as currently configured is approximately 10,526 ft<sup>2</sup>, but only the portion of the building used for parachute maintenance is presumed to be impacted. Historical floor plans for this building were reviewed to determine the locations of operational activities within the building ([HRA-0434](#)).

**Recommended Actions:** Conduct scoping surveys of the building.

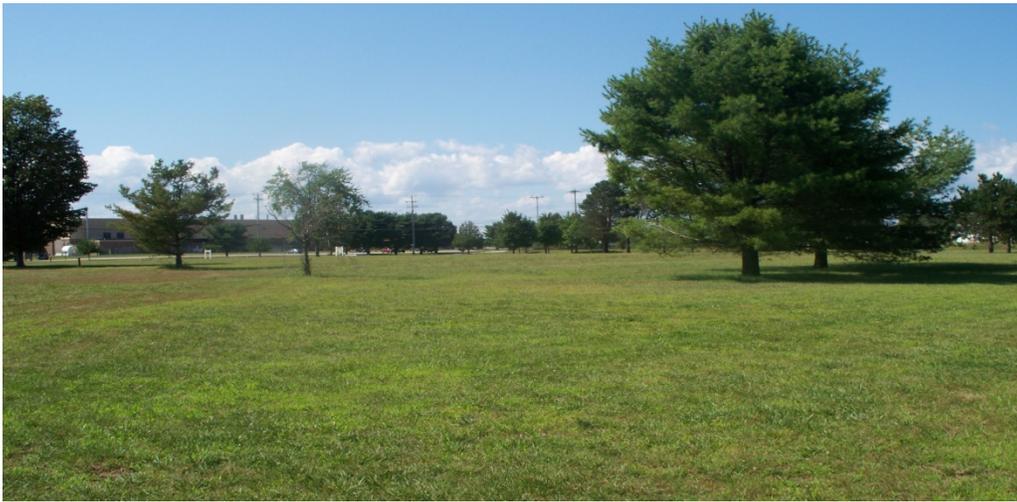
### 8.2.3 Incinerator

**Site Description:** The Incinerator Building (Building 31) was built in 1943 and ceased operations in 1953 ([HRA-0319](#)). The square footage is unknown and the building was demolished sometime after 1983 ([HRA-0518](#)). The building number was re-used for the new the Navy Lodge, which is not impacted. The area where the original building once stood is now vacant. No historical floor plans were available for this building.

**Recommended Actions:** Review (and revise as necessary) the Land Use Control Implementation Plan (LUCIP) to address radiological issues.

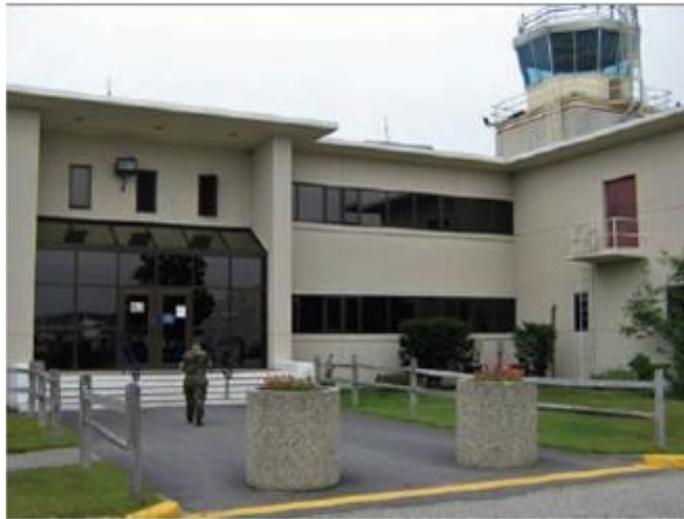
#### 8.2.4 Control Tower and Operations Building

**Site Description:** A second air traffic control tower (Building 200) was built in 1952 to house Air Operations and replace the original Old Control Tower, which was just to the northwest. Building 200 was renovated with new paint flooring, and fixtures in 1985. The control tower and adjacent operations building combined total 22,409 ft<sup>2</sup>. A new tower and facility were built in 2005 and Air Operations and the station's air traffic control were moved from Building 200 to the new facility. The building was being used as a passenger terminal and weather office when the Station closed. Historical floor plans for this building were reviewed to determine the locations of operational activities within the building ([HRA-0435](#)).

**Recommended Actions:** Conduct scoping surveys of the building.

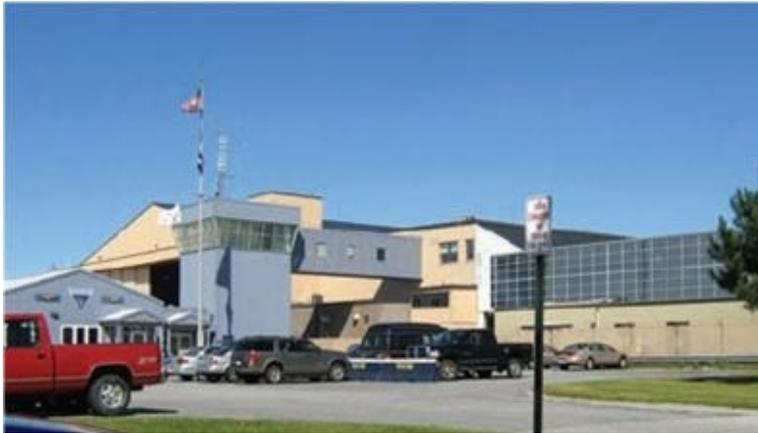
### 8.2.5 Aircraft Hangar 4 / AIMD Shop

**Site Description:** Hangar 4 (Building 250) is a steel structure on a concrete slab. Review of historical drawings indicates that the building was originally constructed in 1956. The hangar was originally connected to the Avionics Shop by an enclosed hallway ([HRA-0091](#)). Additions, including a second floor, were made to the building in 1985 and the entire structure was renamed Building 250 ([HRA-0091](#)). The Avionics Shop became the Aircraft Intermediate Maintenance Department (AIMD) around 1974, which was the central location for heavy electronics repair and maintenance of avionics component boxes from P-3 Orion aircraft. This facility also housed the parachute shop and welding/fabrication shops. When the parachute shop moved into Building 250 in 1973, Ra-226 compasses and Ra-226/Sr-90 personnel markers were no longer in use. The building remains undisturbed and was in use until closure of the Station. This facility is approximately 184,400 ft<sup>2</sup> in area, with approximately half of the area being the hangar deck and half being the AIMD building. Historical floor plans for this building were reviewed to determine the locations of operational activities within the building ([HRA-0436](#)).

**Recommended Actions:** Conduct scoping surveys of the hangar, shops, and drains.

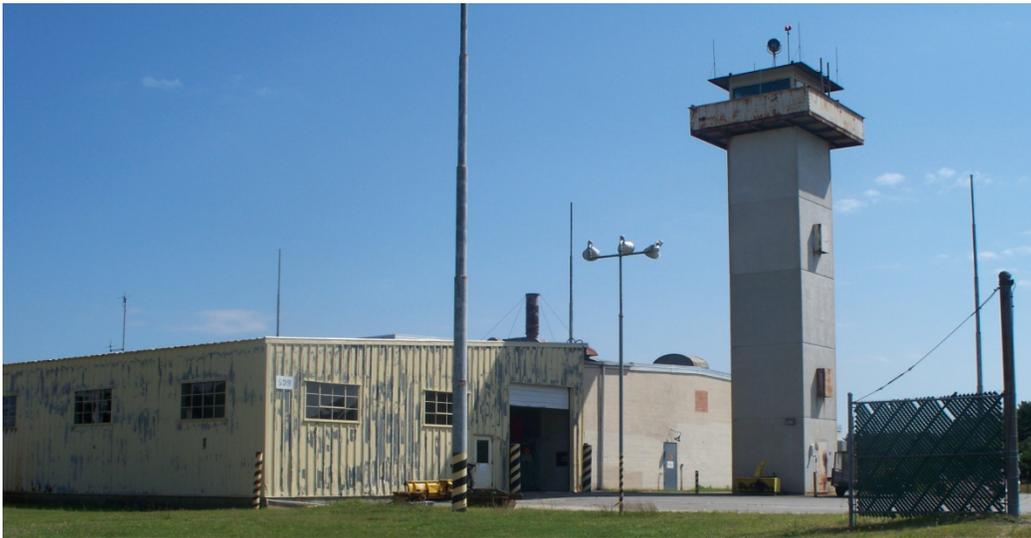
### 8.2.6 Explosives Administration and Armory / AUW Shop

**Site Description:** Building 539 housed the Explosives Administration and Armory. The armory was originally built in 1958 and an addition was built in the 1960s that nearly doubled the building's size (HRA-0091). The square footage of the building is currently 10,311 ft<sup>2</sup> (HRA-0305). Historical floor plans for this building were reviewed to determine the locations of operational activities within the building (HRA-0437). Its use between 1958 and 1989 is unknown, but records indicate that it housed the AUW shop in 1989.

**Recommended Actions:** Conduct scoping surveys of the building.

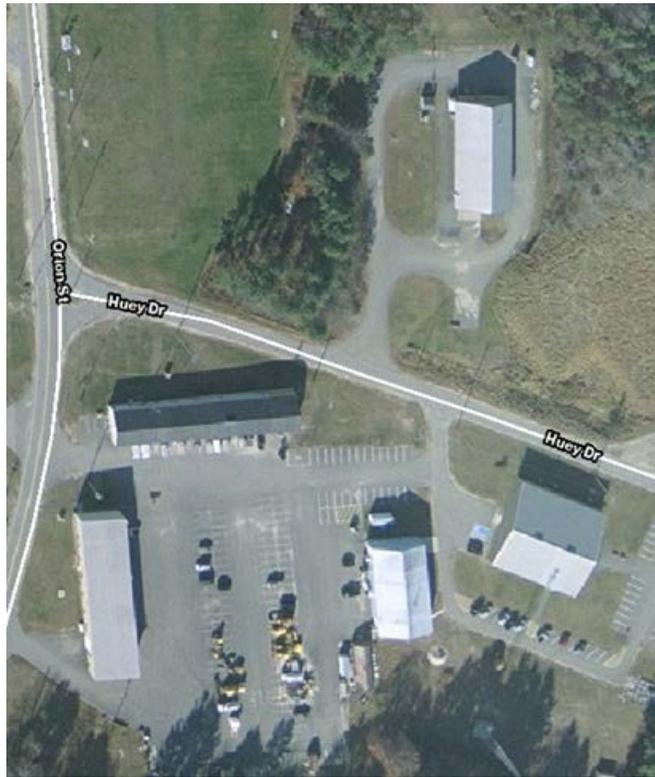
### 8.2.7 Defense Reutilization and Marketing Office

**Site Description:** The DRMO Area consists of Building 584 (DRMO) and the adjacent DRMO yard. The DRMO yard was a paved, fenced enclosure that is approximately 84,000 ft<sup>2</sup> (HRA-0102). The DRMO coordinated sale or disposal for the Navy's hazardous waste and surplus materials. IR Sites 4 and 13 are located in the area occupied by this operation. IR Site 13 encompasses the majority of the DRMO building, the DRMO yard, the Public Works Buildings, and a regularly used storage and equipment lay-down area, which was located in a small clearing south of the paved DRMO yard. IR Site 4 is adjacent to DRMO enclosure on the north and was investigated due to the presence of an acid/caustic pit that was used between 1969 and 1974 (HRA-0102; HRA-0406). Building 584 was built in 1965 within the current IR Site 13 and was added onto in approximately 1975 (HRA-0305; HRA-0406). The square footage of the building is 7,200 ft<sup>2</sup> (HRA-0305). Historical floor plans for this building were reviewed to determine the locations of operational activities within the building (HRA-0438). The eastern portion of the building was built on top of the acid/caustic pit, now located within IR Site 4, so the building today is contained in both IR Sites 4 and 13 (HRA-0155; HRA-0102). IR Site 13 also contains

**Recommended Actions:** Conduct scoping surveys of the building and surrounding paved area.

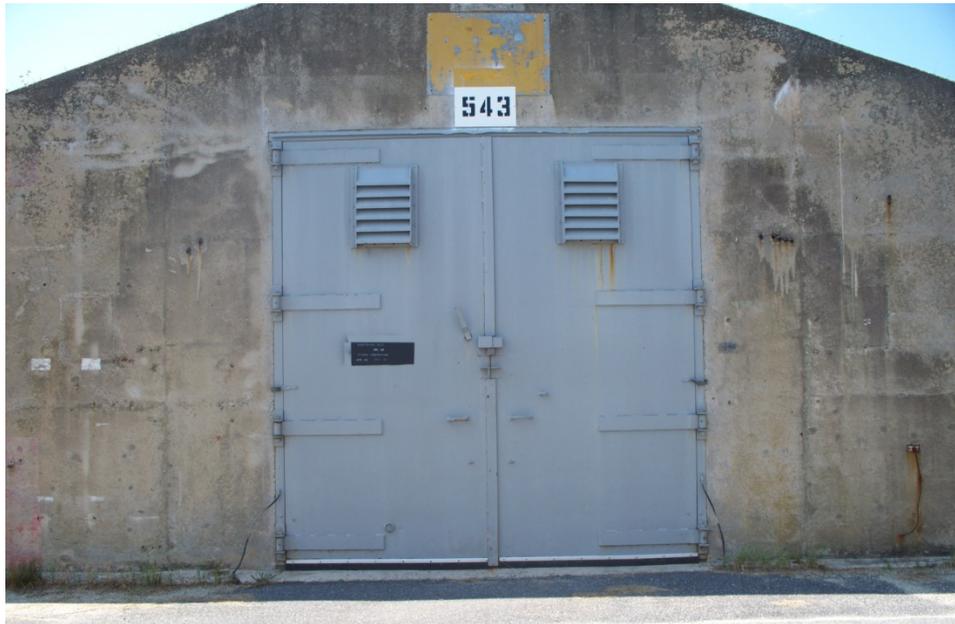
### 8.2.8 Weapons Magazine 543

**Site Description:** Building 543 is a 1,232-square-foot weapons magazine that was built in 1958 ([HRA-0089](#)). Although the building did not show up on maps until 1983, dated documents show that the structure was used as an AUW magazine in 1966 ([HRA-0403](#)). A 1957 drawing shows that this magazine was located in a high security area with guarded entry ([HRA-0321](#)). Later maps and lists show that the magazine was used for high explosive storage ([Appendix F](#)). No historical floor plans were available for this building.

**Recommended Actions:** Conduct scoping surveys of the building.

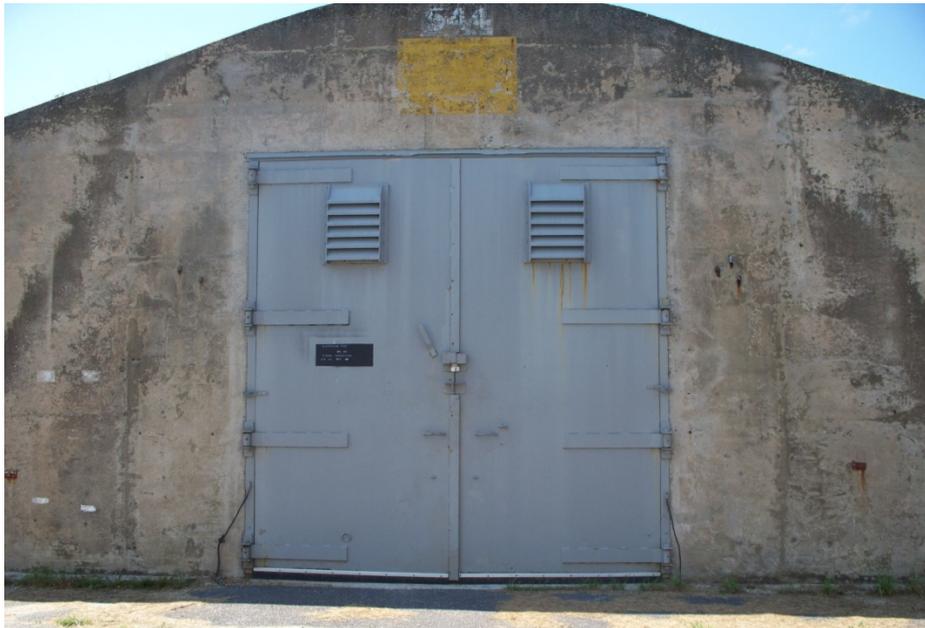
### 8.2.9 Weapons Magazine 544

**Site Description:** Building 544 is a 2,252-square-foot weapons magazine that was built in 1958 ([HRA-0089](#)). Although the structure did not show up on maps until 1983, dated documents show that the building was used as an AUW magazine in 1966 ([HRA-0403](#)). A 1957 drawing shows that this magazine was located in a high security area with guarded entry ([HRA-0321](#)). Later maps and lists show that the magazine was used for high explosive storage ([Appendix F](#)). No historical floor plans were available for this building.

**Recommended Actions:** Conduct scoping surveys of the building.

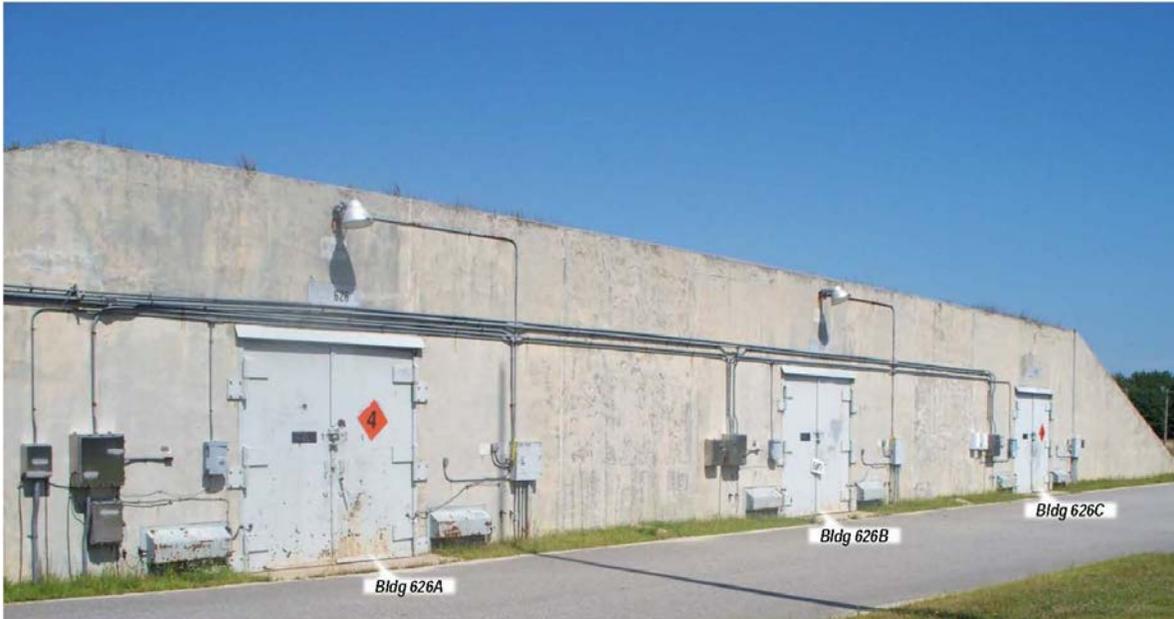
### 8.2.10 Inert Ordnance Storage / Weapons Magazines

**Site Description:** This structure was built in 1973 and houses three 3,198-square-foot weapons magazines ([HRA-0091](#)). These magazines have been designated at different times as 626, 627, and 628, and as 626A, 626B, and 626C. The magazines were constructed in the AUW compound in 1973 near the AUW shop and were initially used as AUW magazines ([Appendix F](#)). Magazine 626/626A was later used for inert ordnance storage and 628/626C was used by the Naval Reserve Cold Weather Mobile Construction Battalion (NMCB-27), also known as the SkiBees beginning in 2006 ([Appendix F](#)). No historical floor plans were available for this building.

**Recommended Actions:** Conduct scoping surveys of the building.

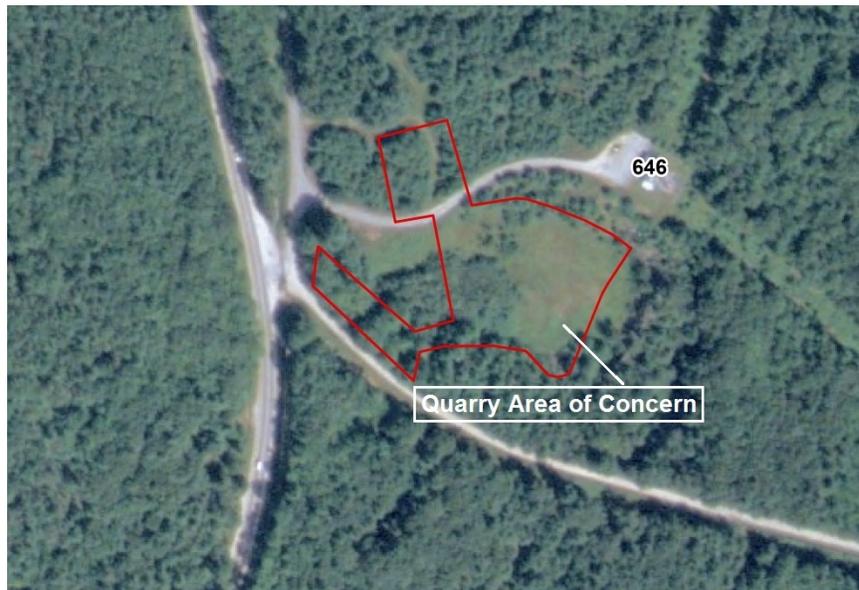
### 8.2.11 Quarry Area of Concern

Note: Aerial photo only shows the general area of the impacted area and does not define the actual boundaries.

**Recommended Actions:** Conduct scoping surveys of the area.

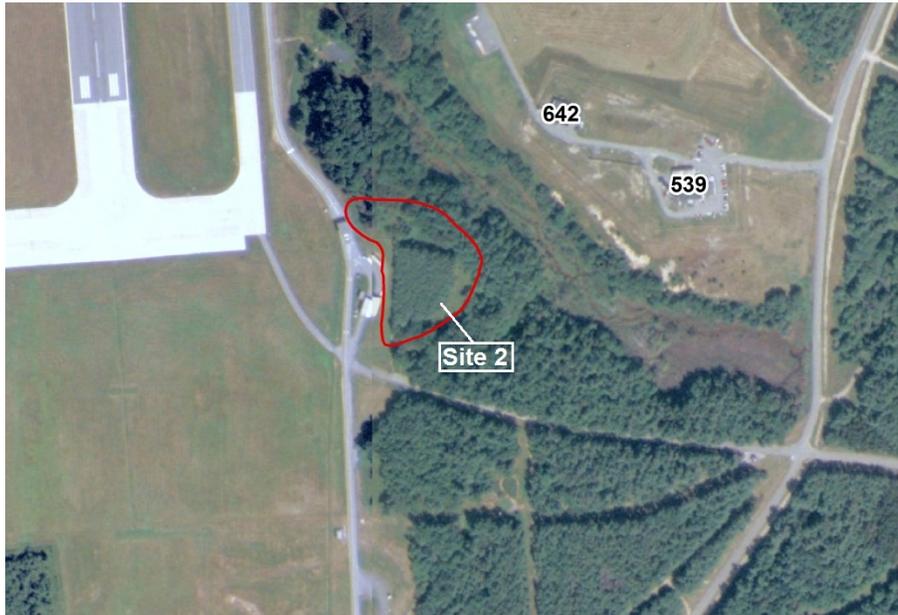
### 8.2.12 IR Site 2 /Orion Street Landfill (South)

Note: Aerial photo only shows the general area of the impacted area and does not define the actual boundaries.

**Recommended Actions:** Review (and revise as necessary) the Land Use Control Implementation Plan (LUCIP) to address radiological issues.

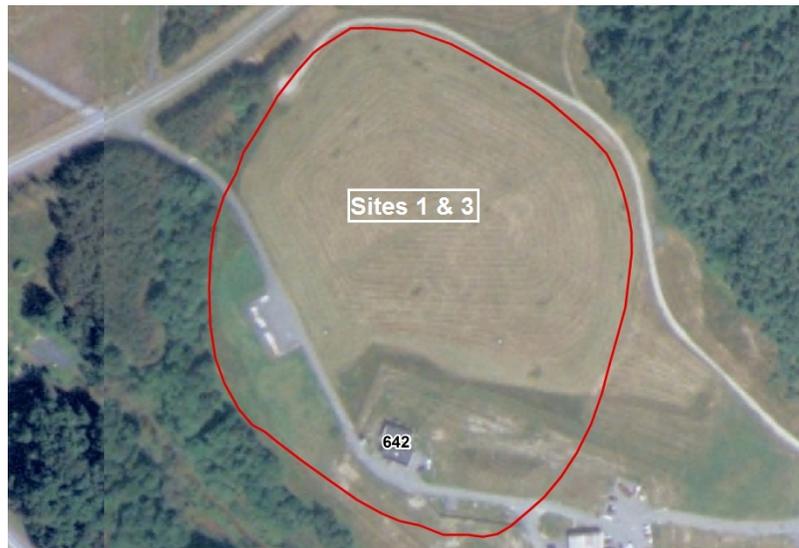
### 8.2.13 IR Sites 1 and 3 Hazardous Waste Burial Area

Note: Aerial photo only shows the general area of the impacted area and does not define the actual boundaries.

**Recommended Actions:** Review (and revise as necessary) the Land Use Control Implementation Plan (LUCIP) to address radiological issues.

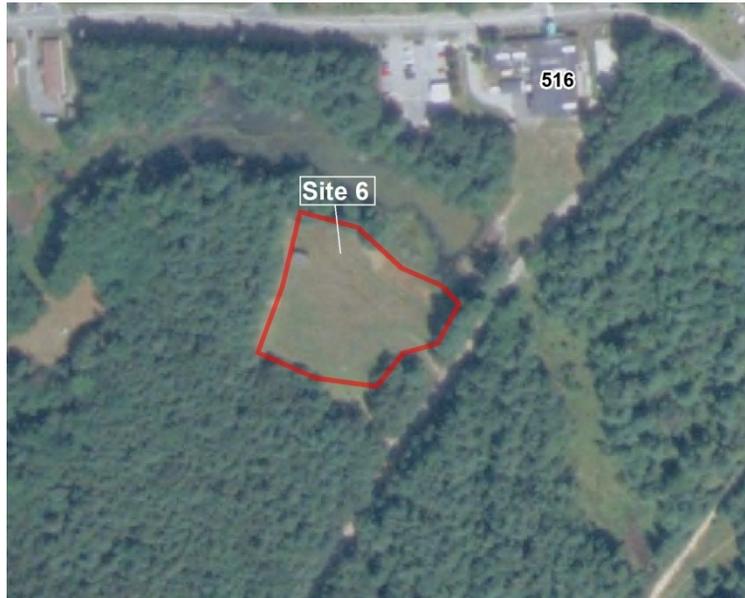
#### 8.2.14 IR Site 6 Sandy Road Rubble and Asbestos Disposal Site

Note: Aerial photo only shows the general area of the impacted area and does not define the actual boundaries.

**Recommended Actions:** Conduct scoping surveys of the area.

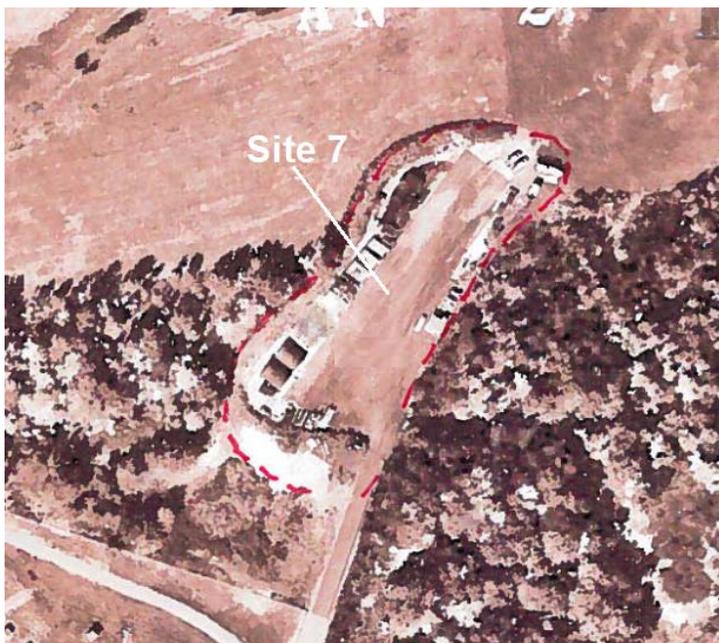
### 8.2.15 IR Site 7 Old Acid/Caustic Pit

Note: Aerial photo only shows the general area of the impacted area and does not define the actual boundaries.

**Recommended Actions:** Conduct scoping surveys of the area.

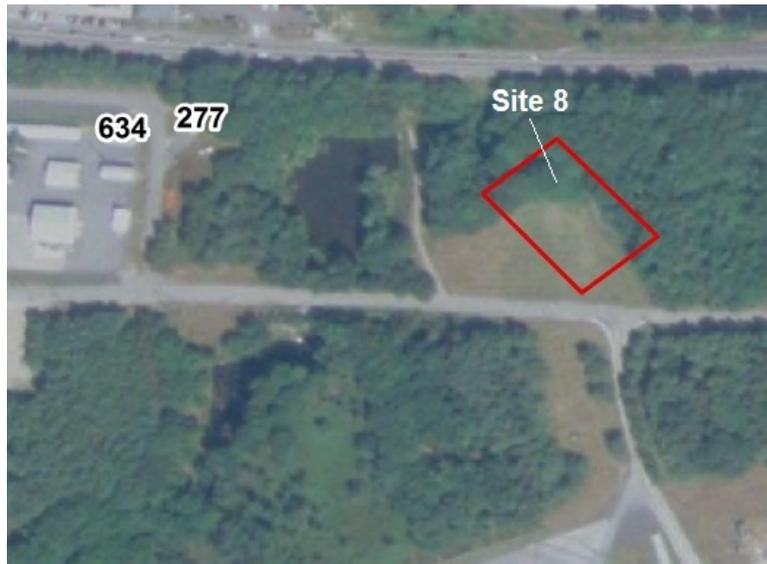
### 8.2.16 IR Site 8 Perimeter Road Landfill

Note: Aerial photo only shows the general area of the impacted area and does not define the actual boundaries.

**Recommended Actions:** Conduct scoping surveys of the area.

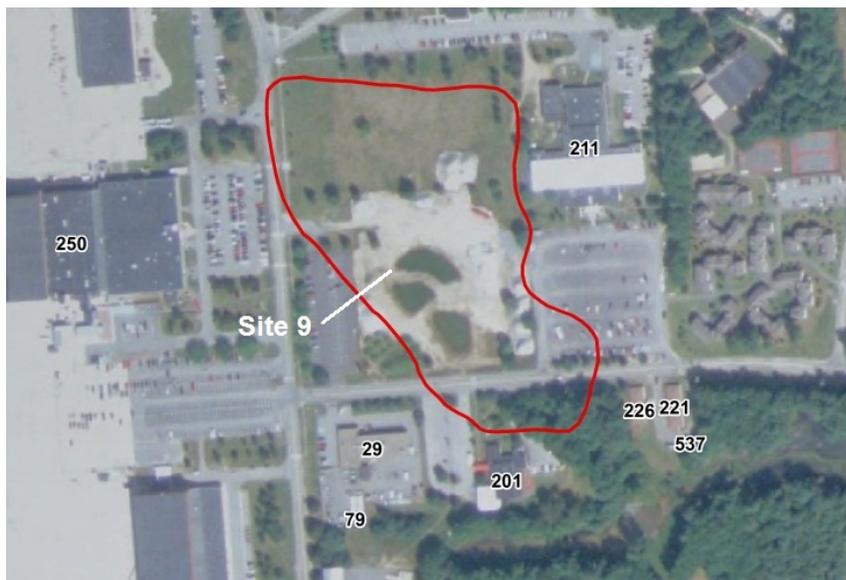
### 8.2.17 IR Site 9 Neptune Drive Disposal Area

Note: Aerial photo only shows the general area of the impacted area and does not define the actual boundaries.

**Recommended Actions:** Review (and revise as necessary) the Land Use Control Implementation Plan (LUCIP) to address radiological issues and conduct scoping surveys of the area.

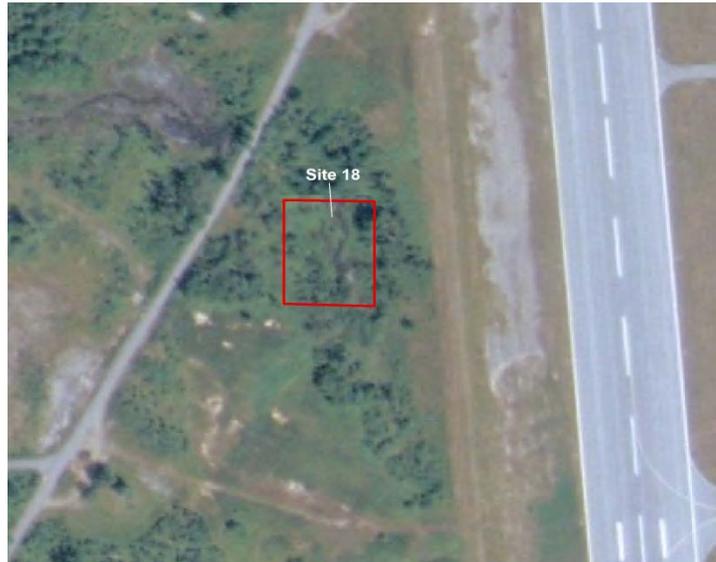
### 8.2.18 IR Site 18 West Runway Site

Note: Aerial photo only shows the general area of the impacted area and does not define the actual boundaries.

**Recommended Actions:** Conduct scoping surveys of the area.

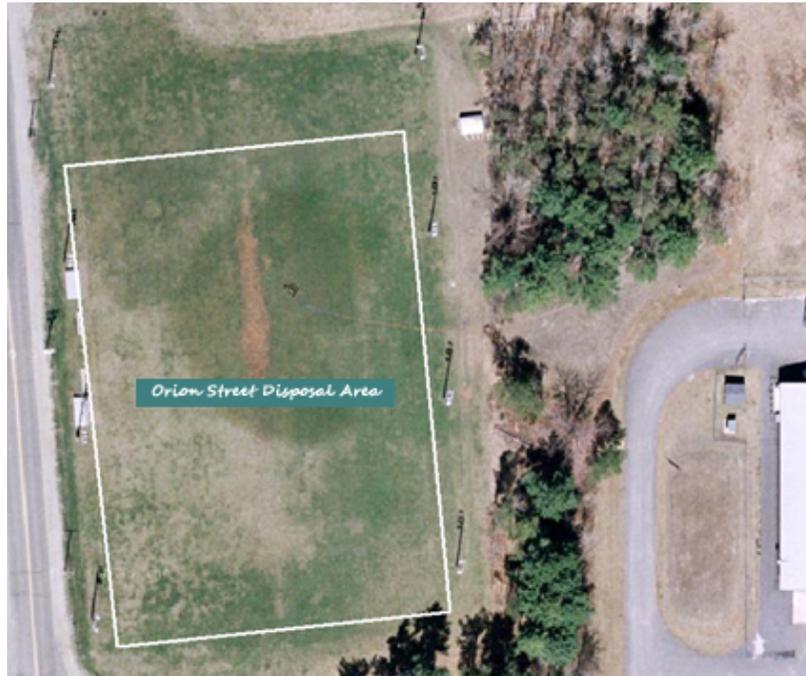
### 8.2.19 Undocumented Former Orion Street Disposal Area

Note: Aerial photo only shows the general area of the impacted area and does not define the actual boundaries.

**Recommended Actions:** Conduct scoping surveys of the area.
