MINUTES AND AGENDA FOR RESTORATION ADVISORY BOARD MEETING HELD 12
MARCH 2009 NAS SOUTH WEYMOUTH MA
03/12/2009
NAVAL AIR STATION SOUTH WEYMOUTH

Naval Air Station South Weymouth, MA Restoration Advisory Board (RAB) Meeting Minutes March 12, 2009

**Update: Review Item Area 111
Old Hangar 2
Restoration Advisory Board
Meeting
March 12, 2009**

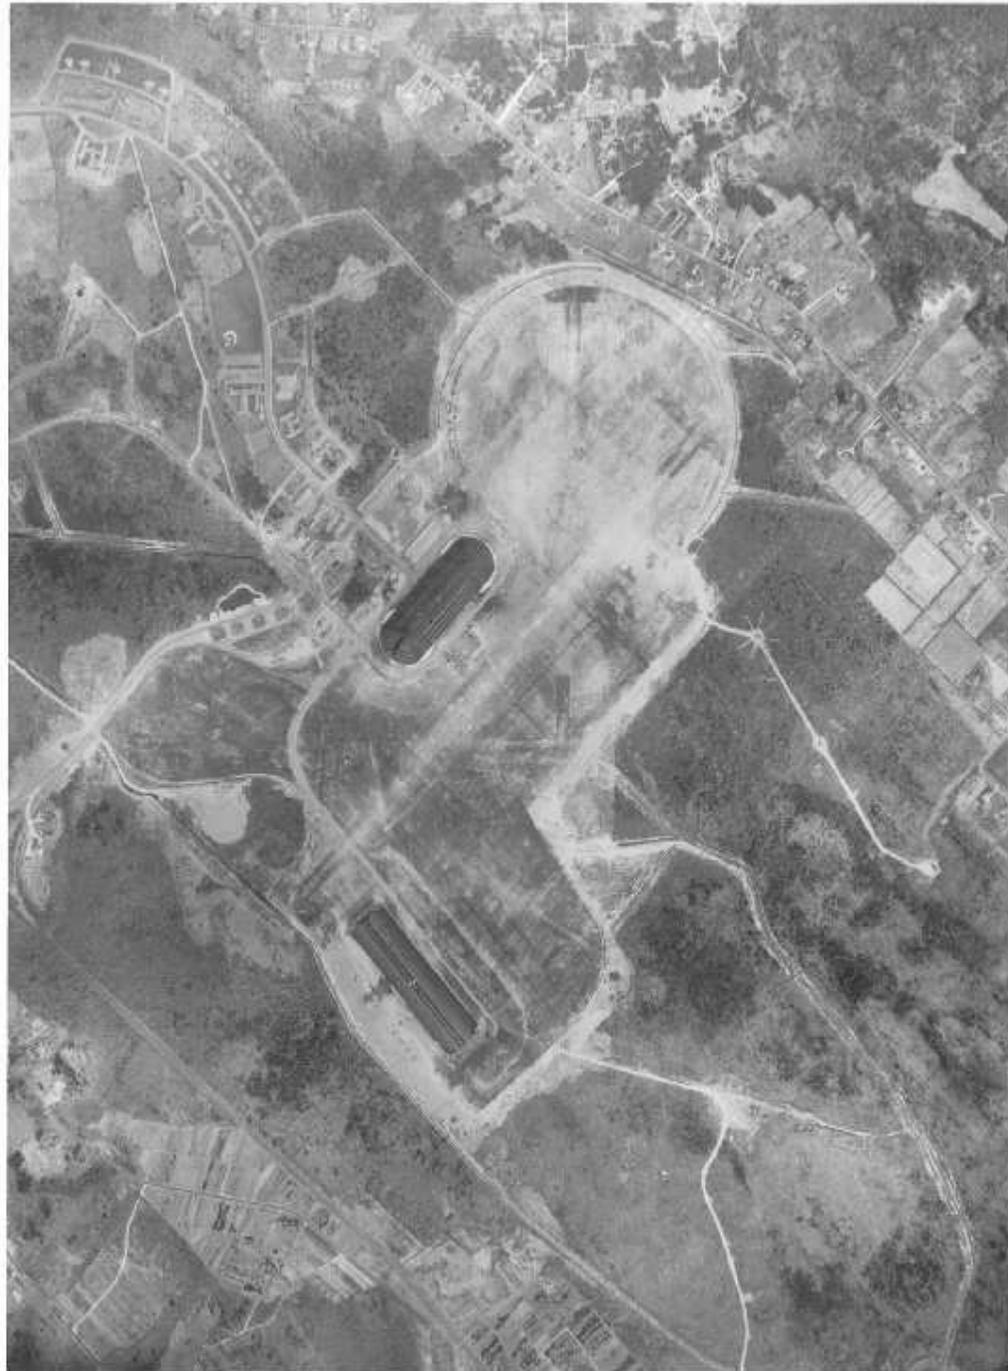
**1949 Aerial
Photo:**

**Hangar 2 at
bottom,
Hangar 1 in
center**

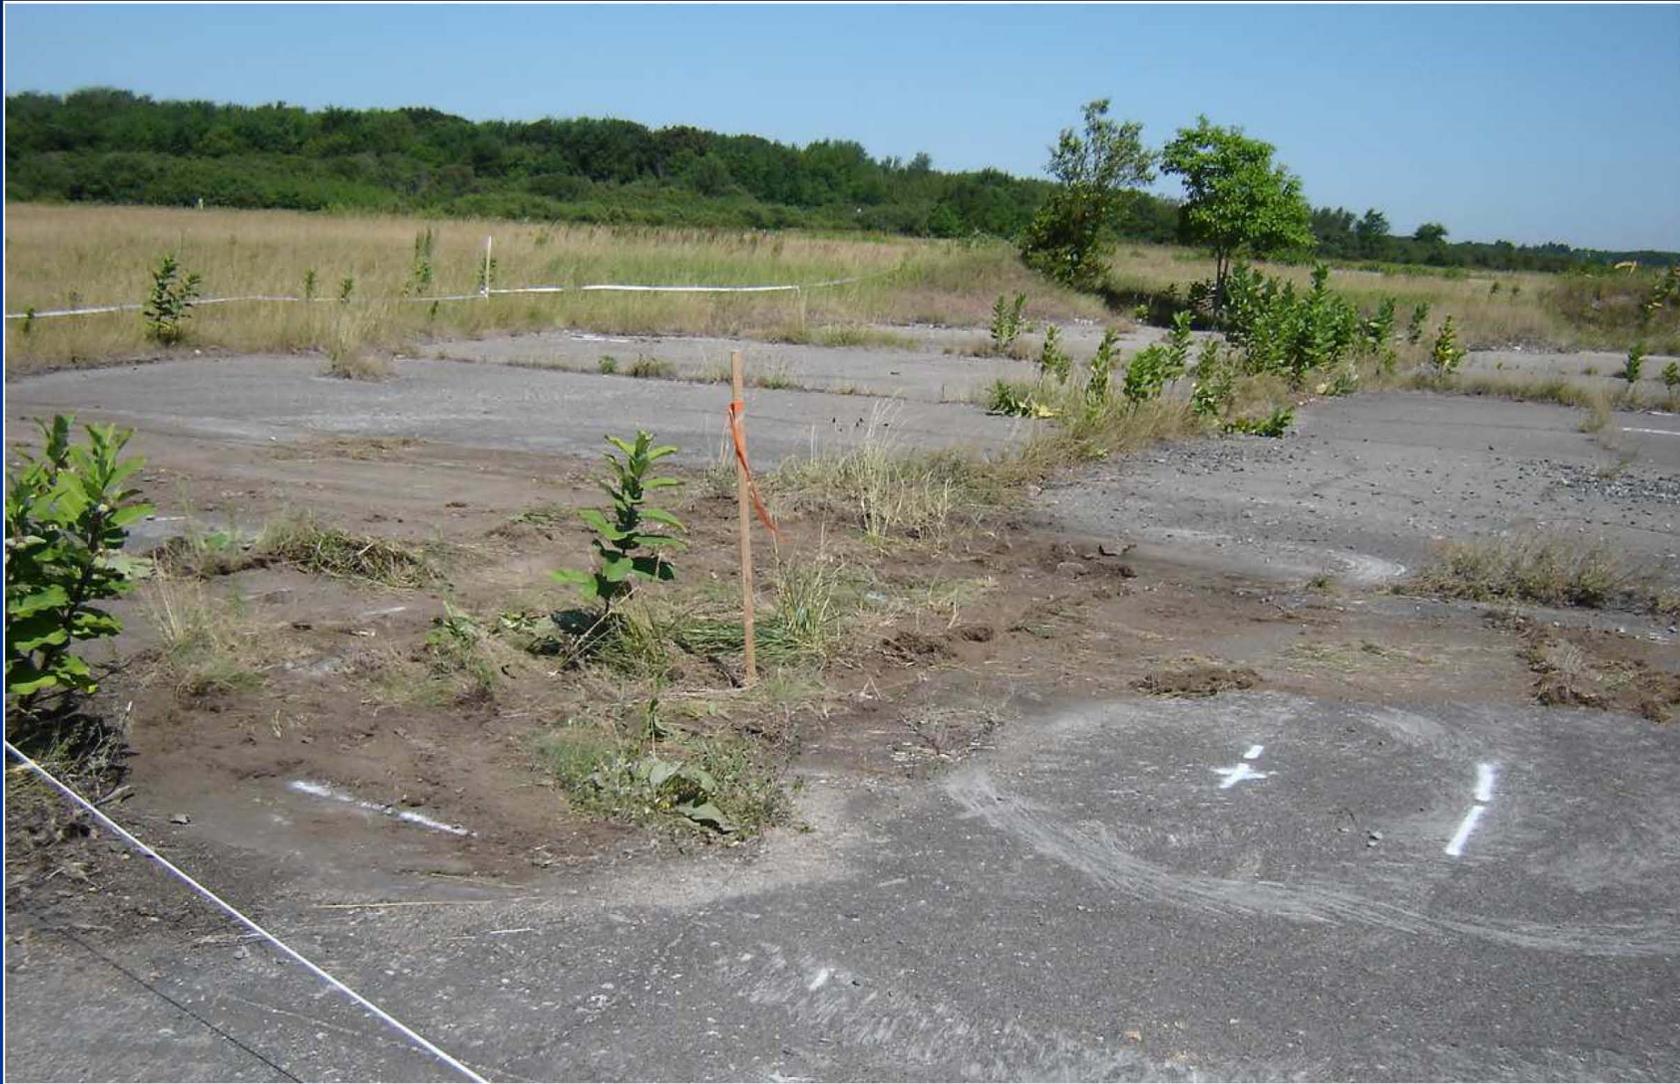
DP-26 Sample Location, looking NW

- **Draft Decision Document issued May 2008.**
- **Data were screened against EBS human health and ecological benchmarks and base background values.**
- **Concluded that concentrations of arsenic and benzo(a)pyrene at one location (DP26) were of concern; recommended further action.**
- **Navy proposed a data gap investigation to address the concern.**
- **Data gap sampling plan issued July 2008.**

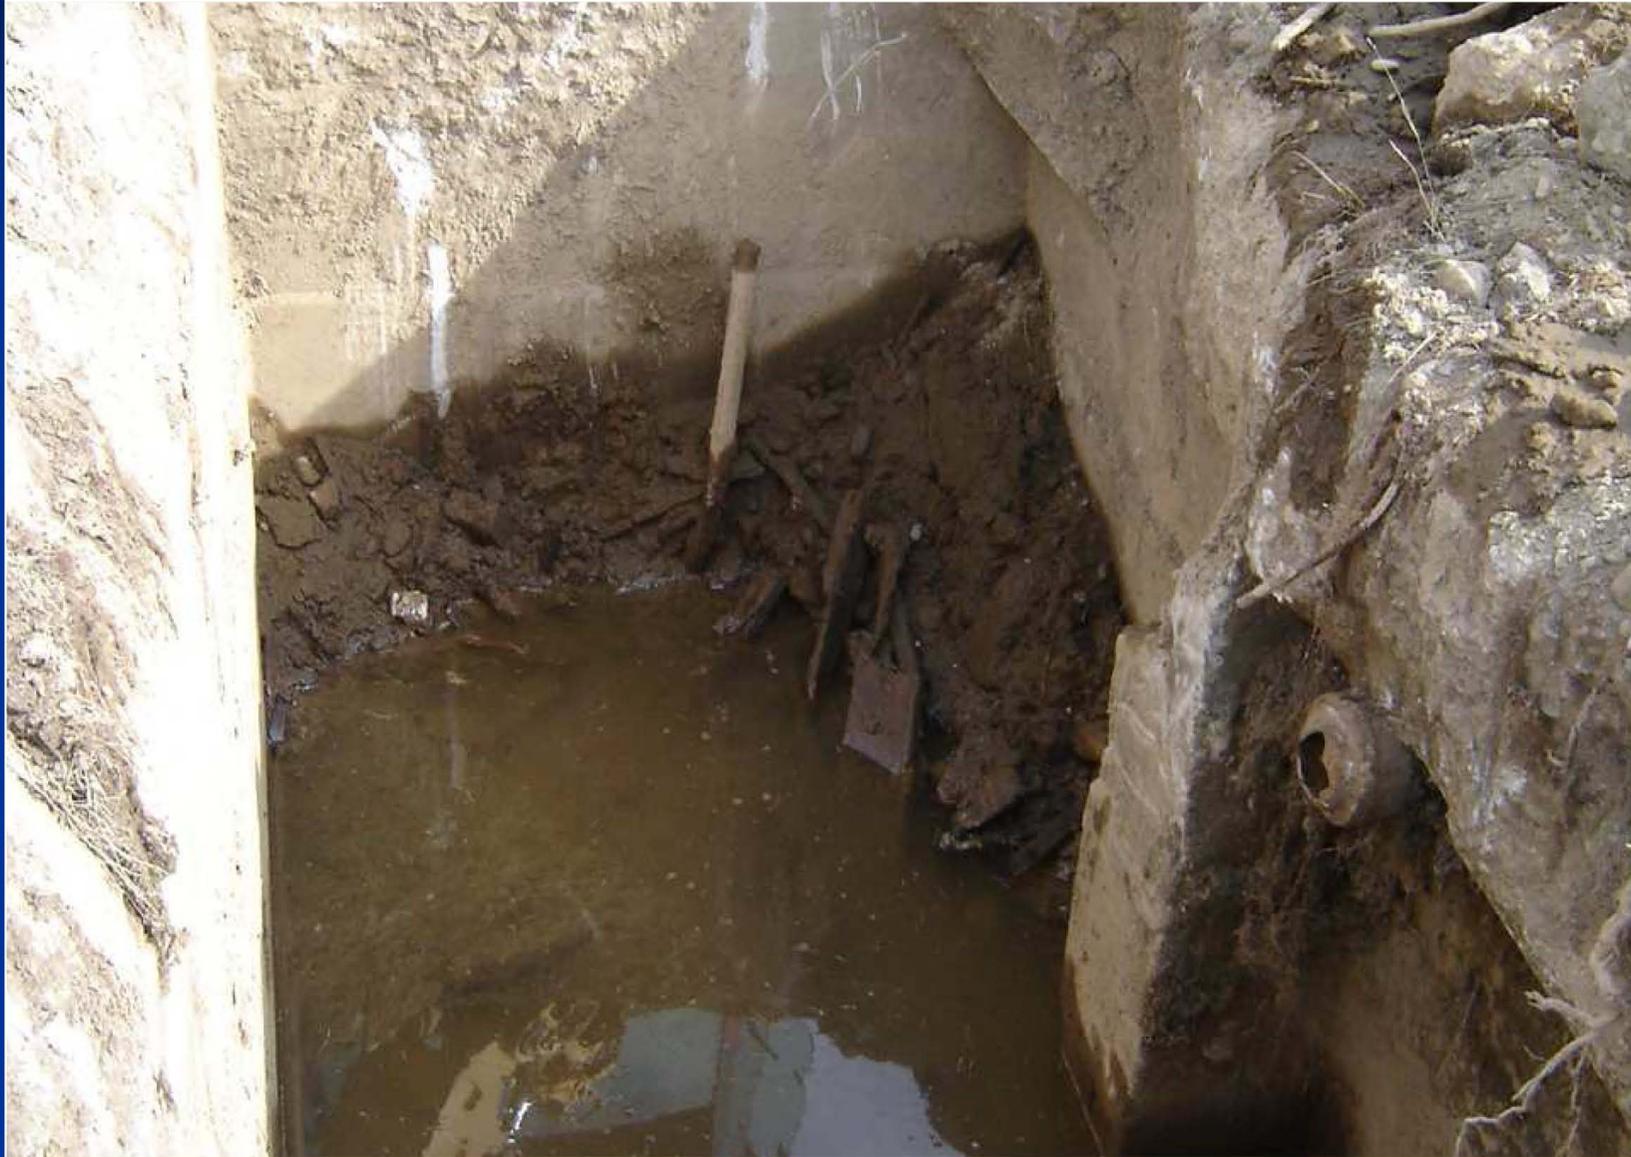
Vault – looking at north wall

- **Field activities: test pit near DP26; soil borings near catch basins; collection of subsurface soil samples.**
- **Samples analyzed for PAHs and metals.**
- **Test pit (TP-1) excavation encountered a vault, the purpose has not been determined.**
- **Navy directed excavation of the vault and a second test pit (TP-2) immediately downgradient of TP-1.**
- **Vault: 11ft x 5.3ft x 6ft; concrete walls and floor, open top; filled with soil and debris.**

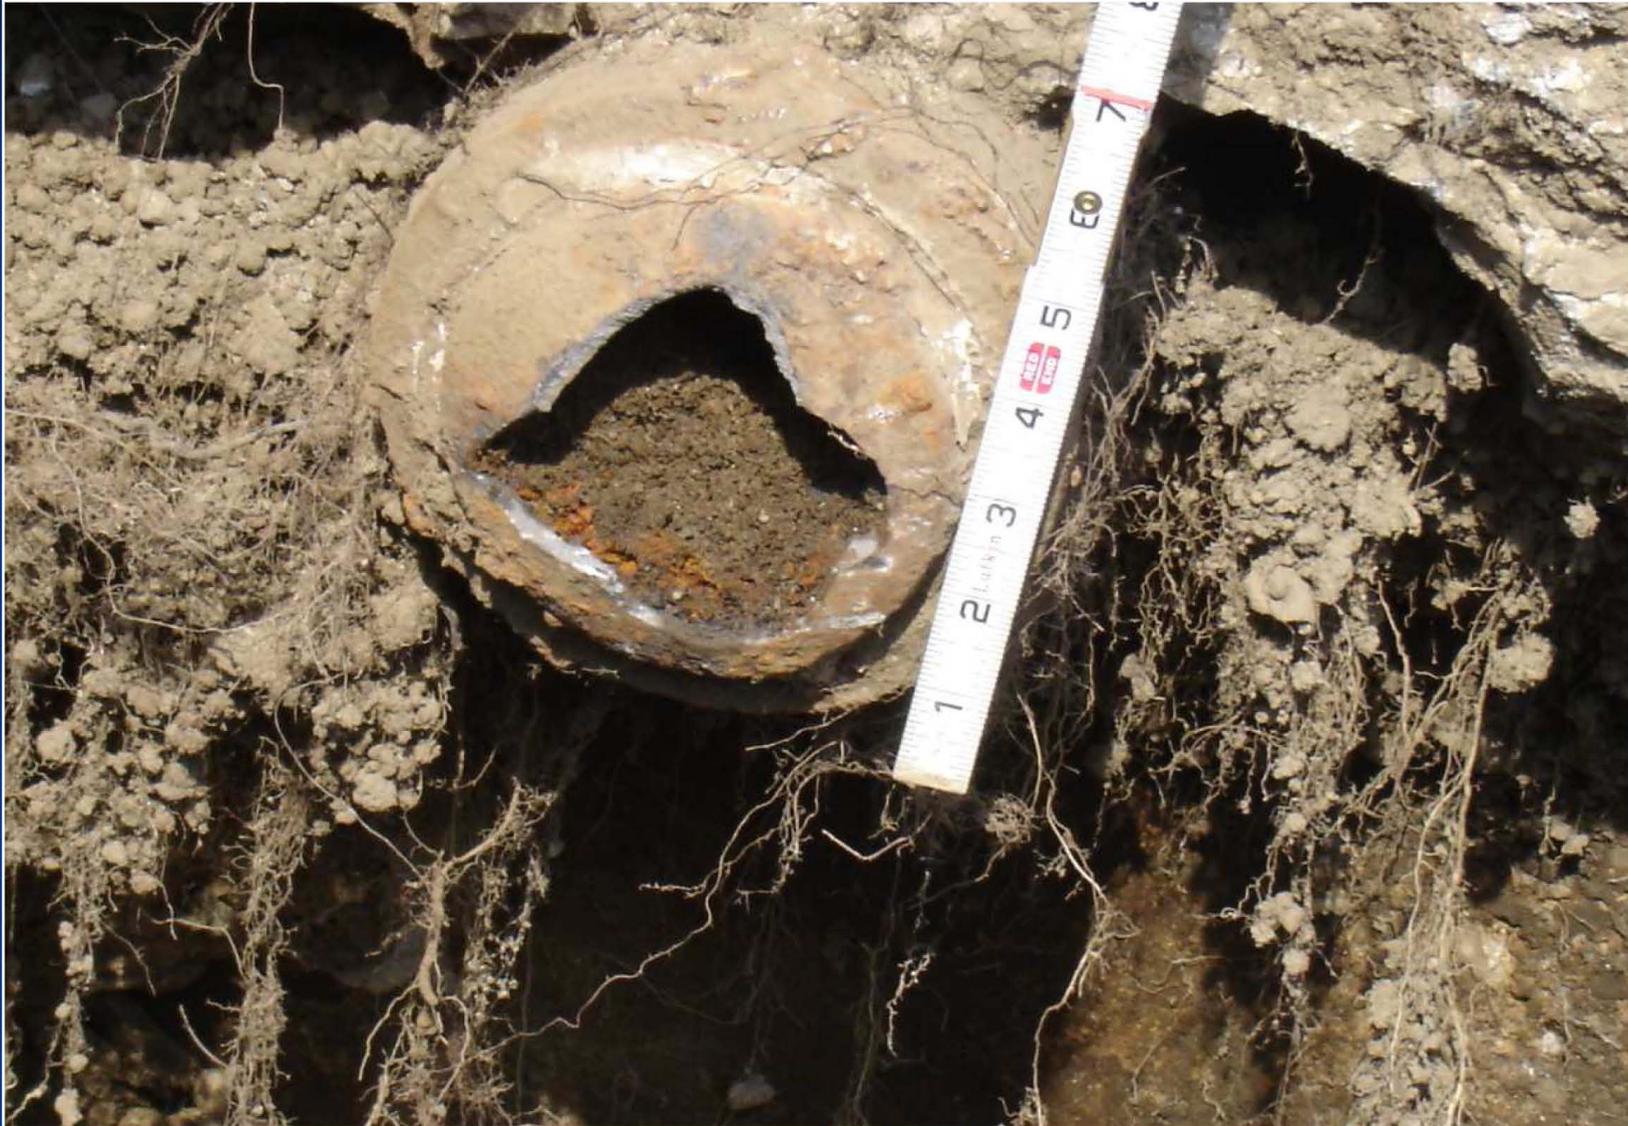
Vault – east wall, upper pipe

M. Bromberg asked if there was a known source for the arsenic and benzo(a)pyrene. P. Call stated that the location was below the concrete pad and no source is known, but the planned investigations will be designed to provide more information. The GPR survey is intended to show where the two pipes encountered in the vault terminate and the additional test pits will be located to determine the source.

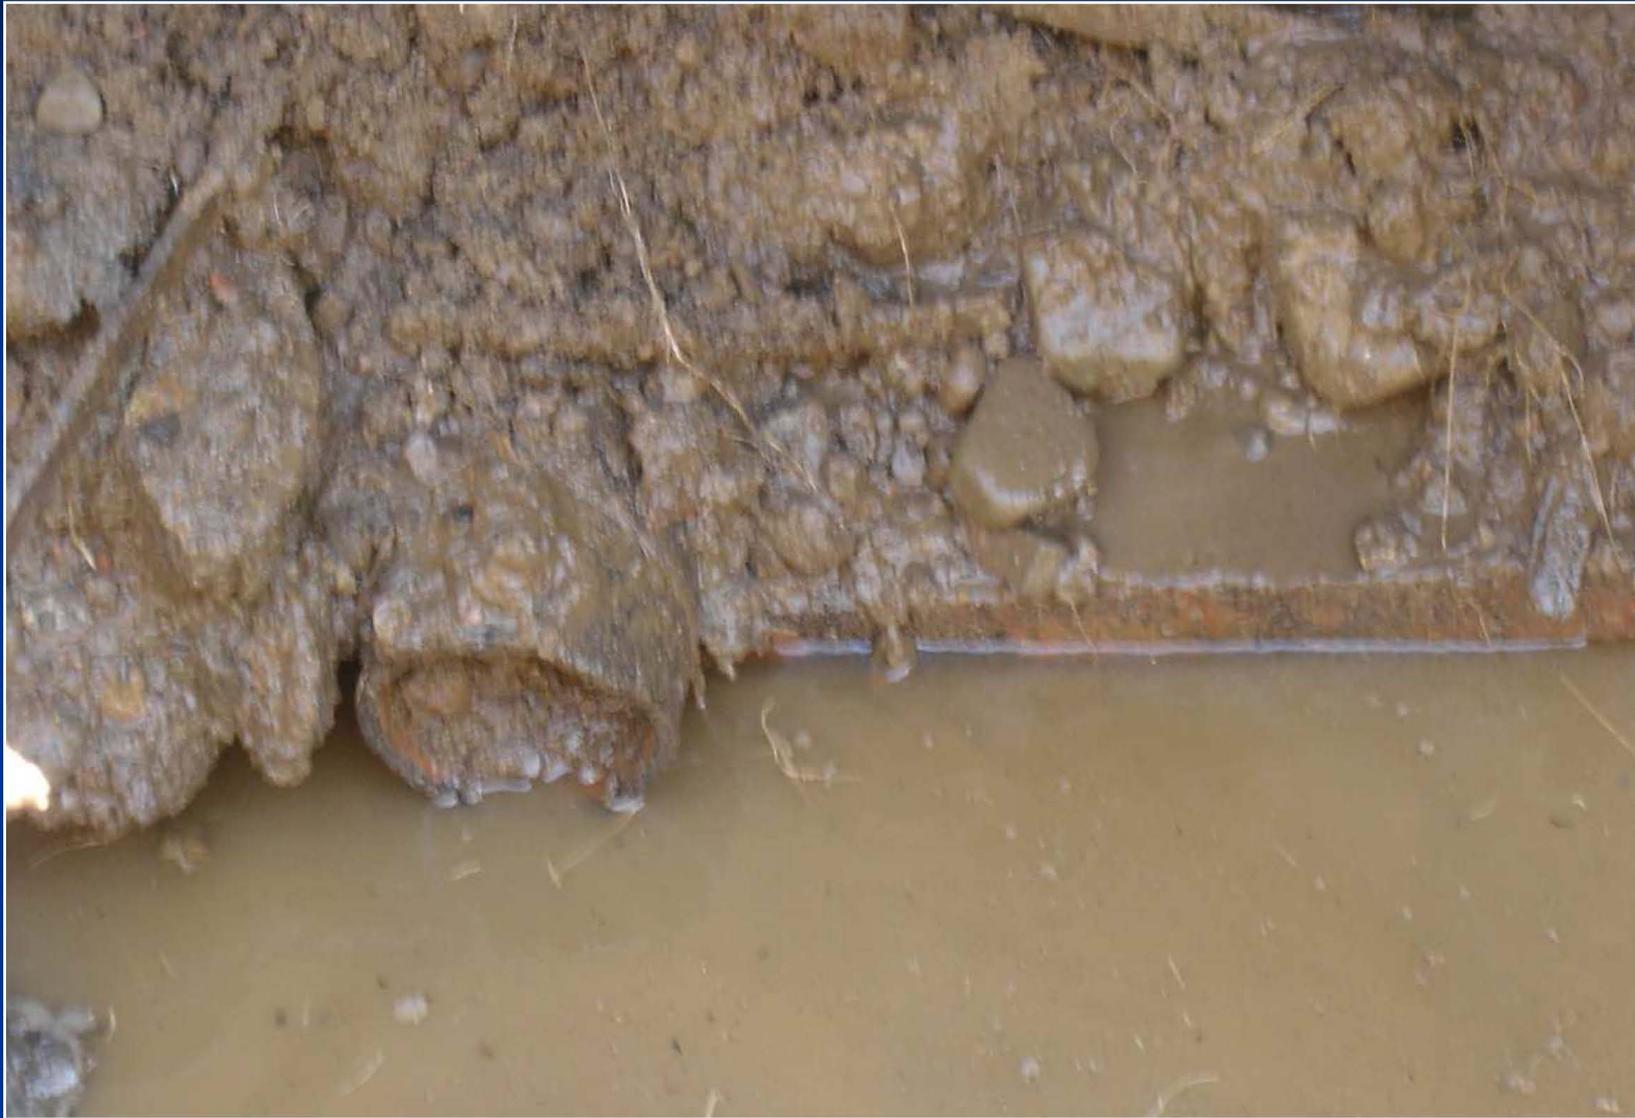
Vault – east wall, lower cast iron pipe

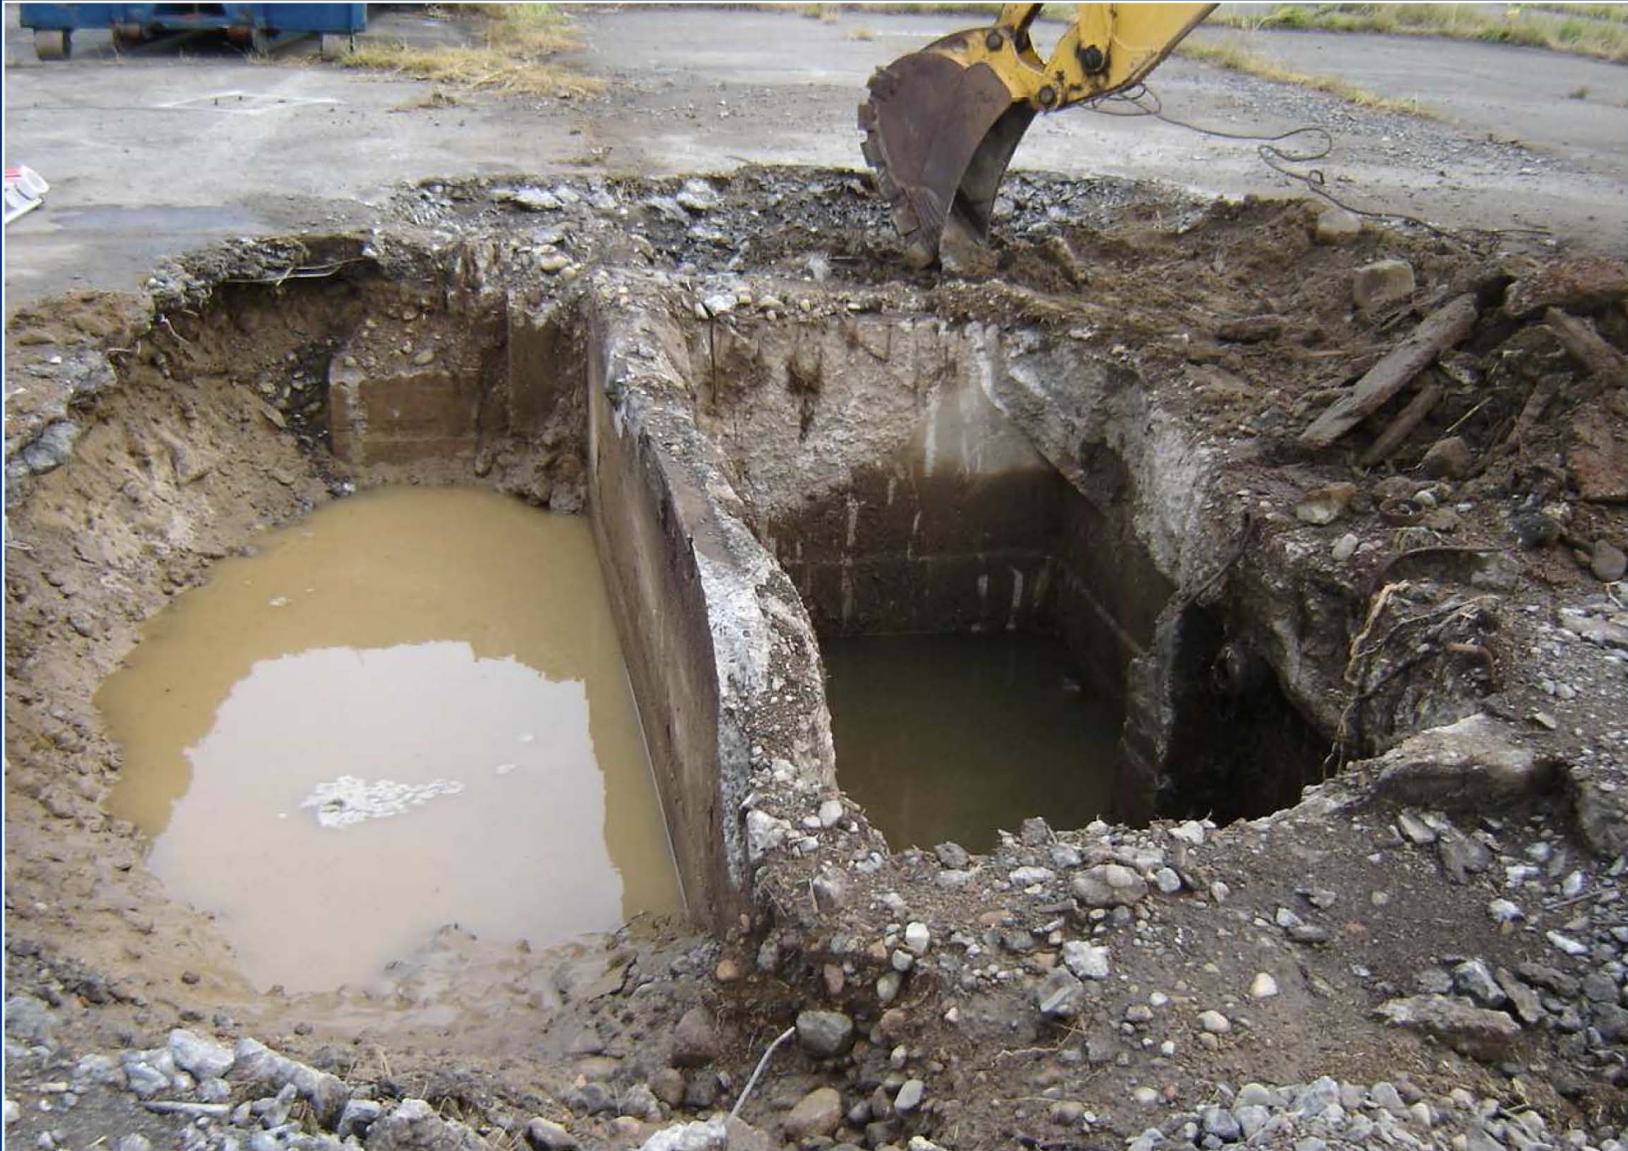
Looking North – TP-2 left, TP-1 right

The Data Gap investigation included excavation of a test pit near DP26, soil borings near the catch basins, and collection of subsurface soil samples (Slide 6). Samples were analyzed for PAHs and metals. During the test pit excavation a vault was encountered. Under the direction of the Navy, the extent of the vault was determined, and a second test pit was added directly downgradient. The vault was 11 ft x 5.3 ft x 6 ft with concrete walls and floor. It contained soil and debris, which were removed and stockpiled nearby prior to off-site disposal. Slide 7 shows the north wall of the vault and a pipe entering the vault that was not connected to any of the known floor drains. Another open-ended pipe was located right above the floor of the vault. Slide 8 shows the excavated vault and the second downgradient test pit. Both test pits were backfilled with clean soil after sampling was completed.

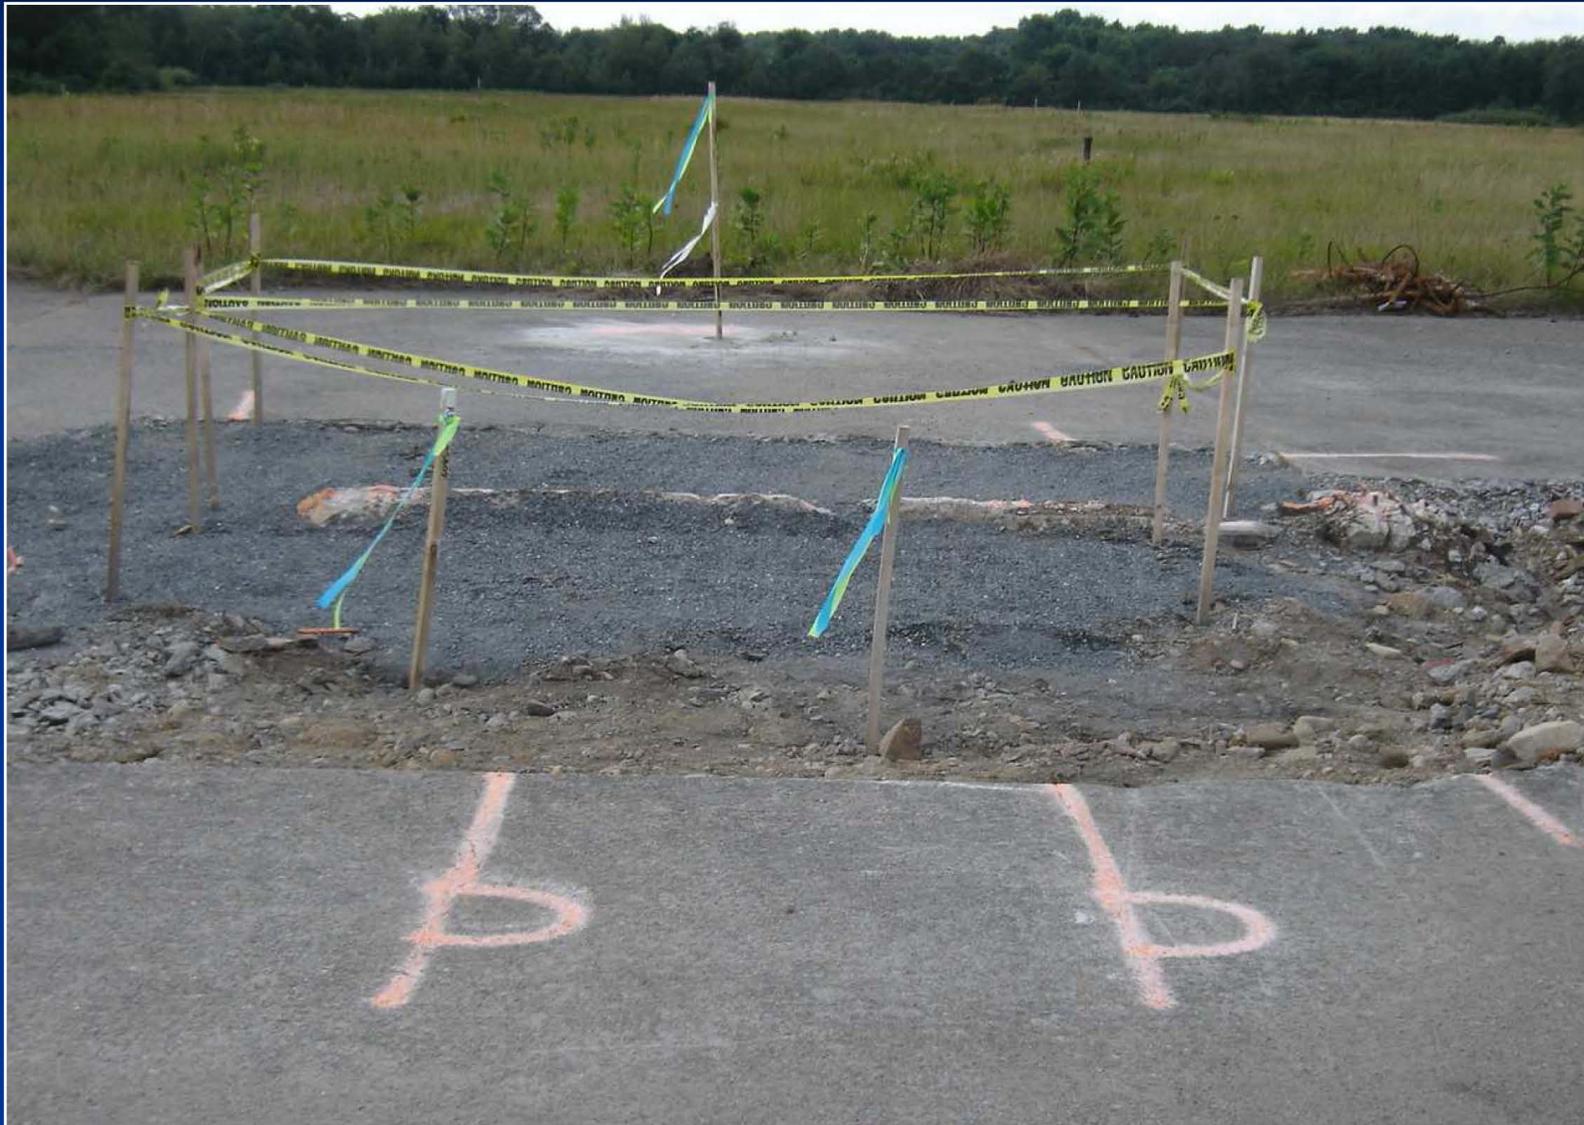
Backfilled test pits looking west

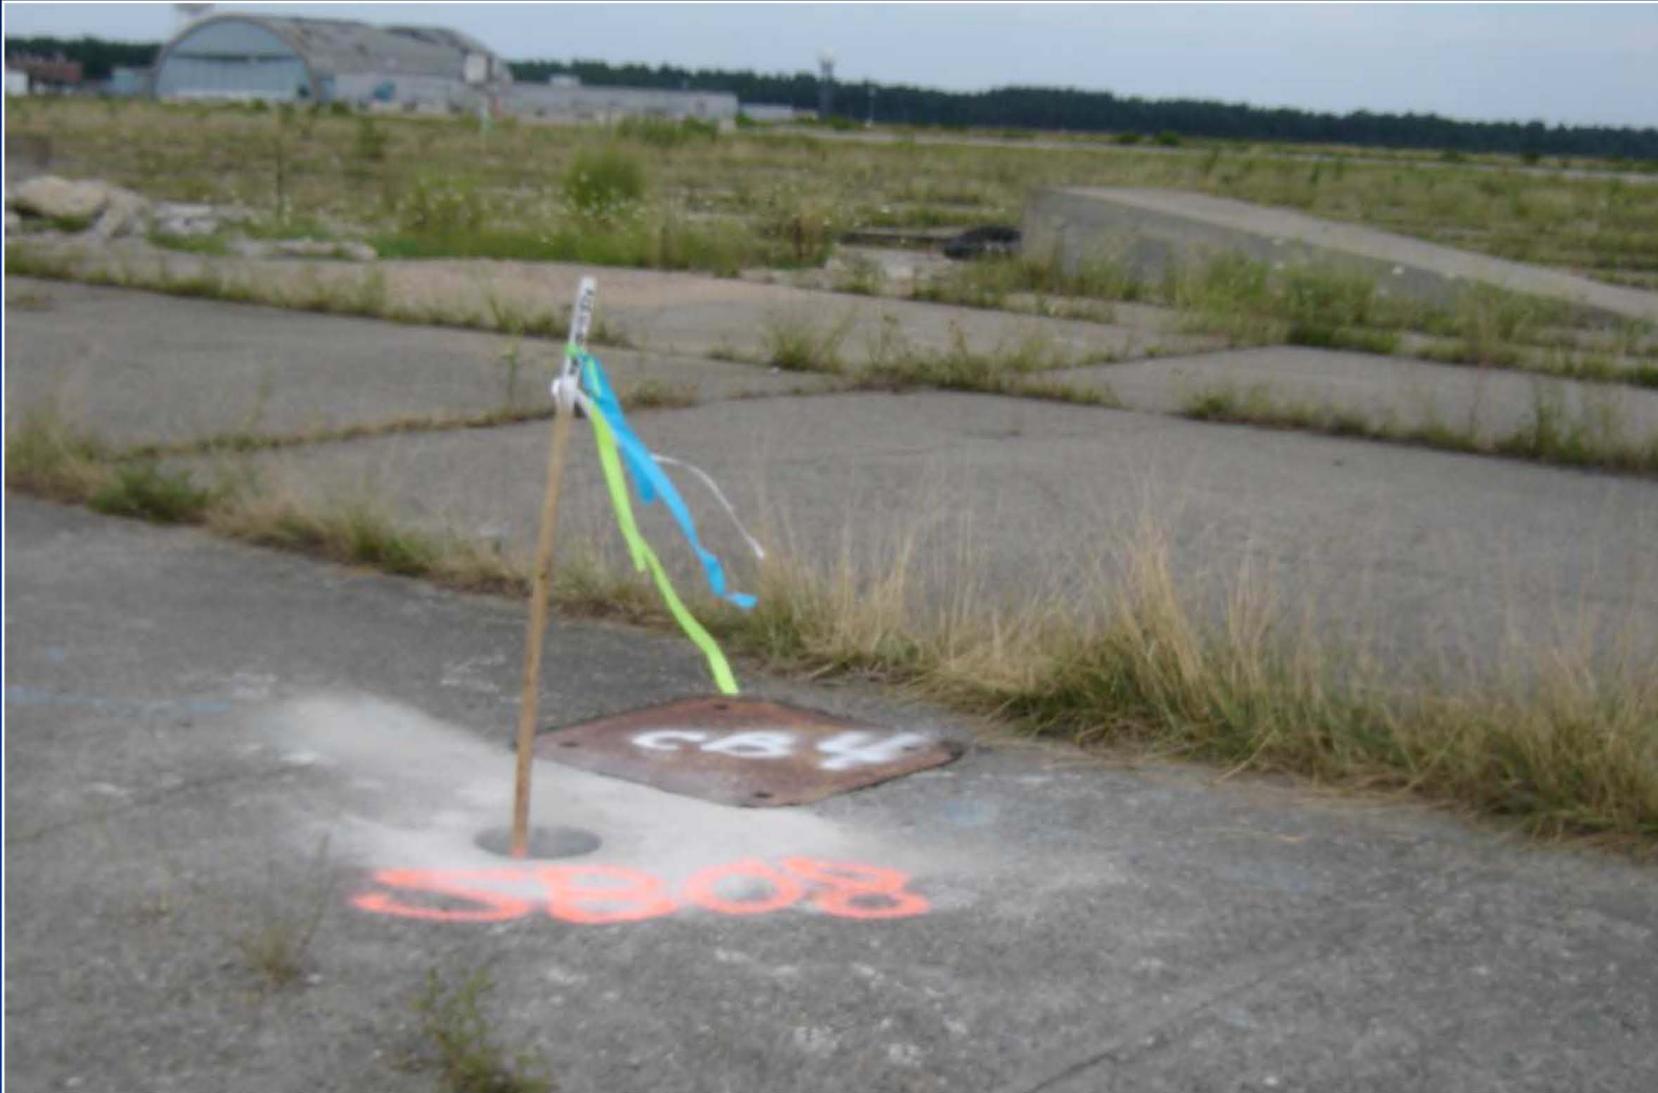
Catch Basin 4, stake indicates SB08

M. Bromberg asked why they chose to drill borings downgradient of the catch basins. K. Jalkut stated that the boring locations targeted the downgradient side because that is the direction of groundwater flow. If there were contaminants in the catch basin, this is the direction they would be migrating. D. Barney added that the Navy did sample inside the catch basins as well (during the 2002 through 2004 investigations).
