FINAL FIVE-YEAR REVIEW NAS WILLOW GROVE PA (PUBLIC DOCUMENT)  
9/1/2013  
TETRA TECH

# **Five-Year Review**

## **Former NAS JRB Willow Grove Horsham, Pennsylvania**

**September 2013**

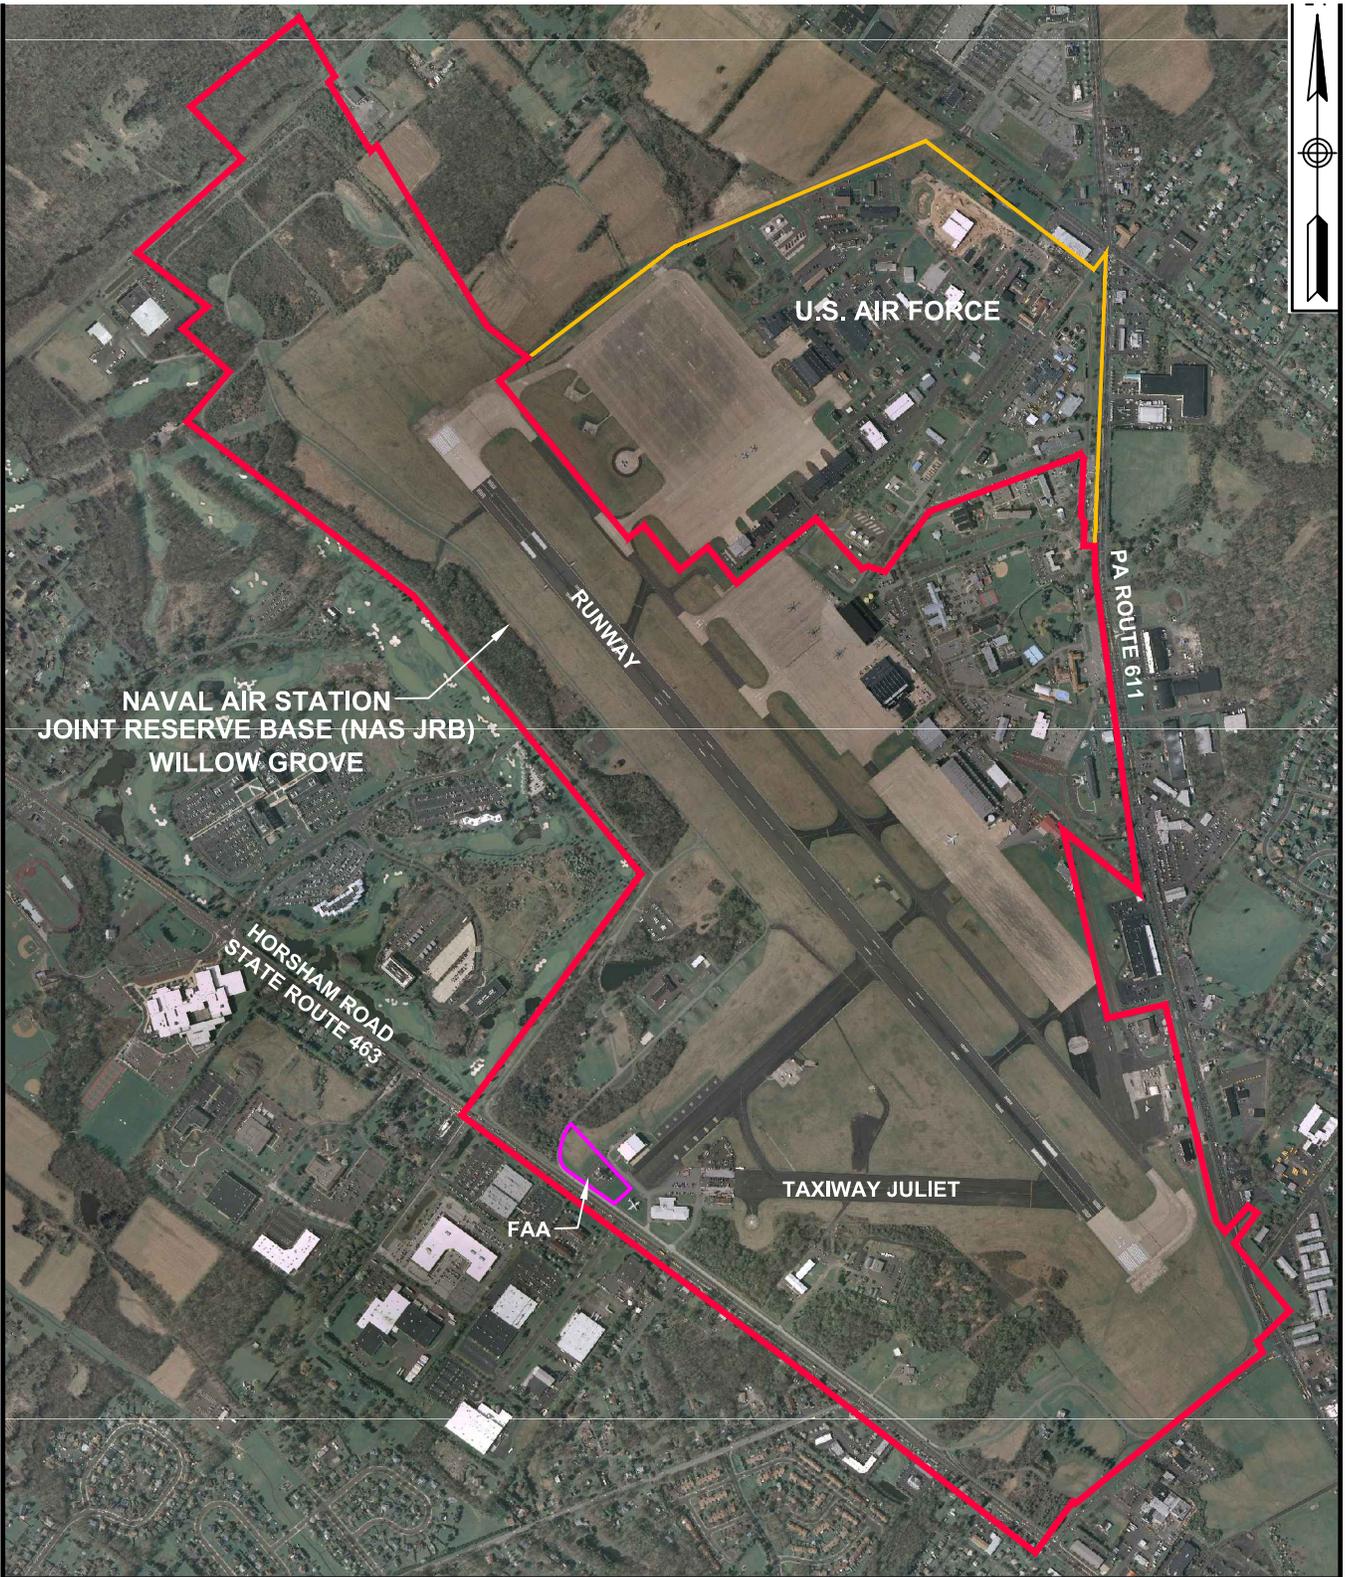
SCALE AS NOTED	
FILE 112G02014BM01	
REV 0	DATE 05/01/13
FIGURE NUMBER FIGURE 1-1

FACILITIES LOCATION MAP  
 NAS JRB WILLOW GROVE  
 WILLOW GROVE, PENNSYLVANIA

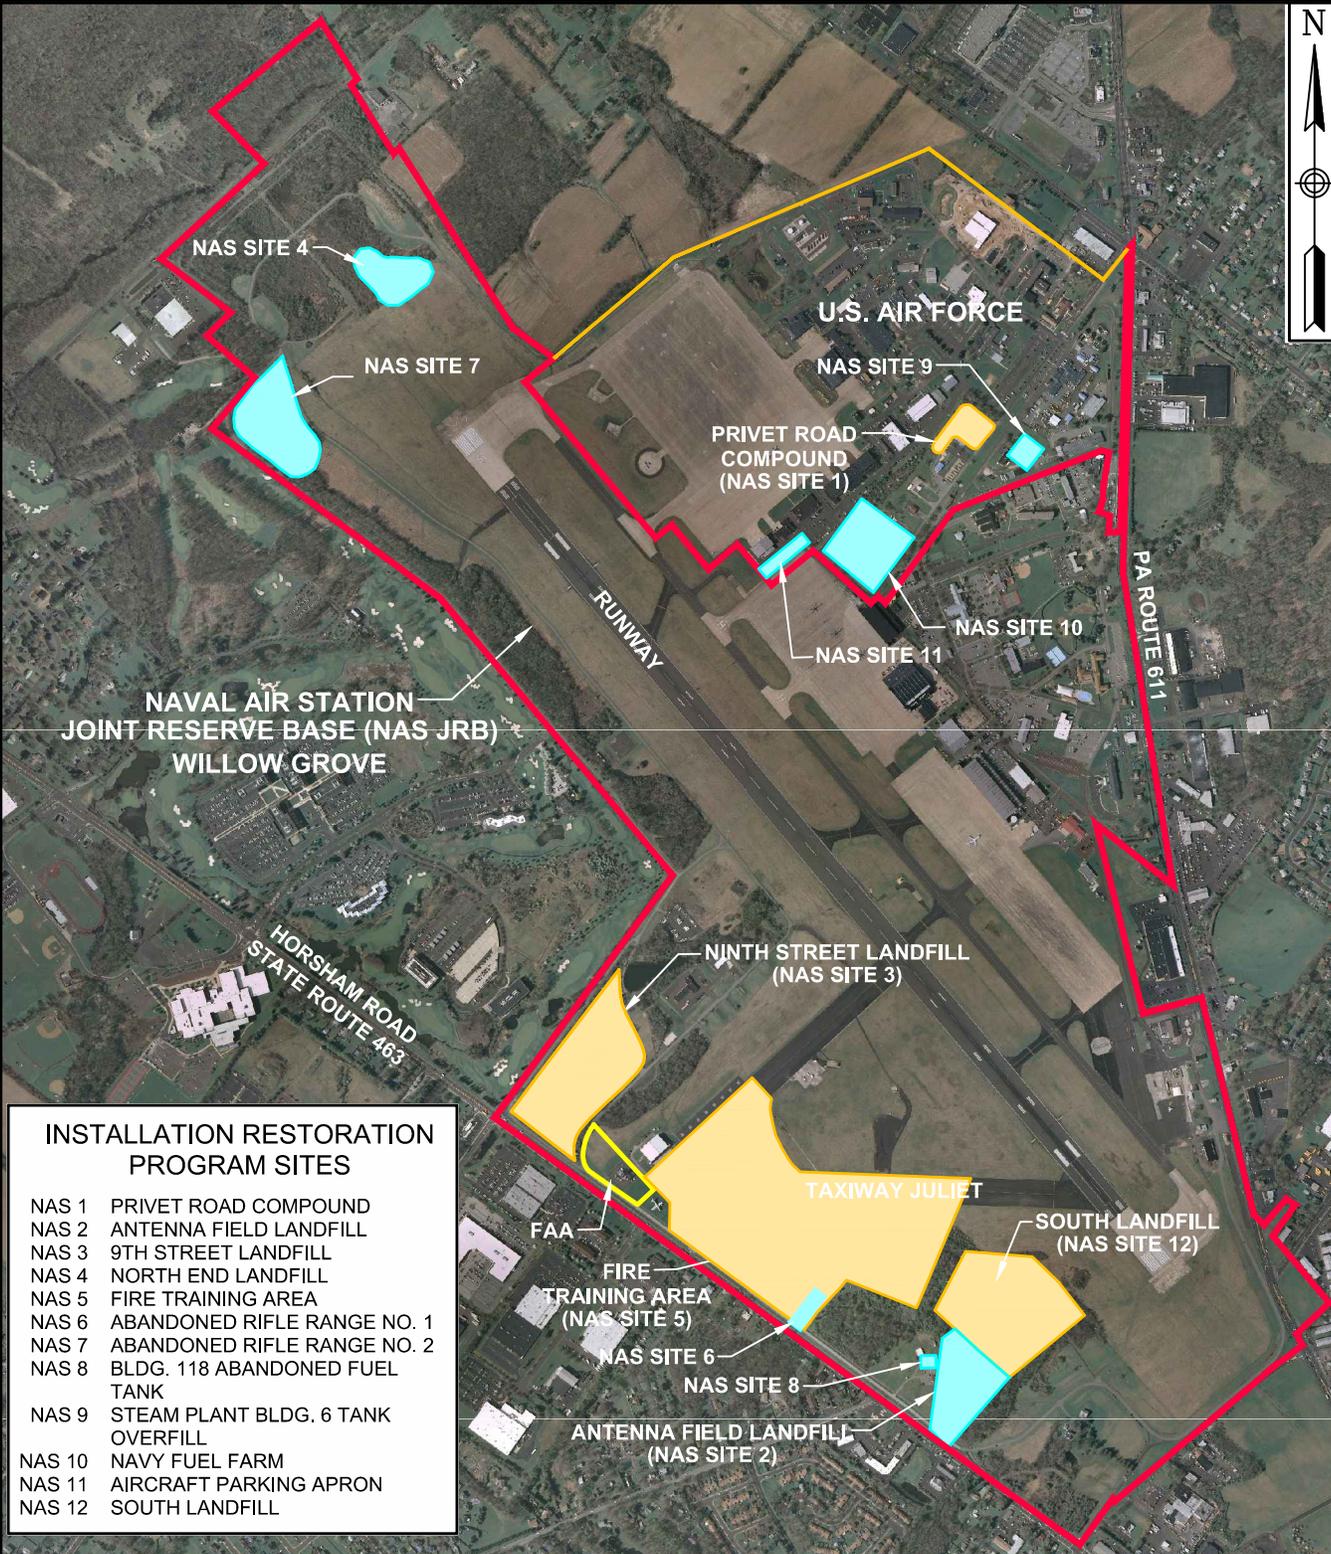
**INSTALLATION RESTORATION PROGRAM SITES**

NAS 1	PRIVET ROAD COMPOUND
NAS 2	ANTENNA FIELD LANDFILL
NAS 3	9TH STREET LANDFILL
NAS 4	NORTH END LANDFILL
NAS 5	FIRE TRAINING AREA
NAS 6	ABANDONED RIFLE RANGE NO. 1
NAS 7	ABANDONED RIFLE RANGE NO. 2
NAS 8	BLDG. 118 ABANDONED FUEL TANK
NAS 9	STEAM PLANT BLDG. 6 TANK OVERFILL
NAS 10	NAVY FUEL FARM
NAS 11	AIRCRAFT PARKING APRON
NAS 12	SOUTH LANDFILL

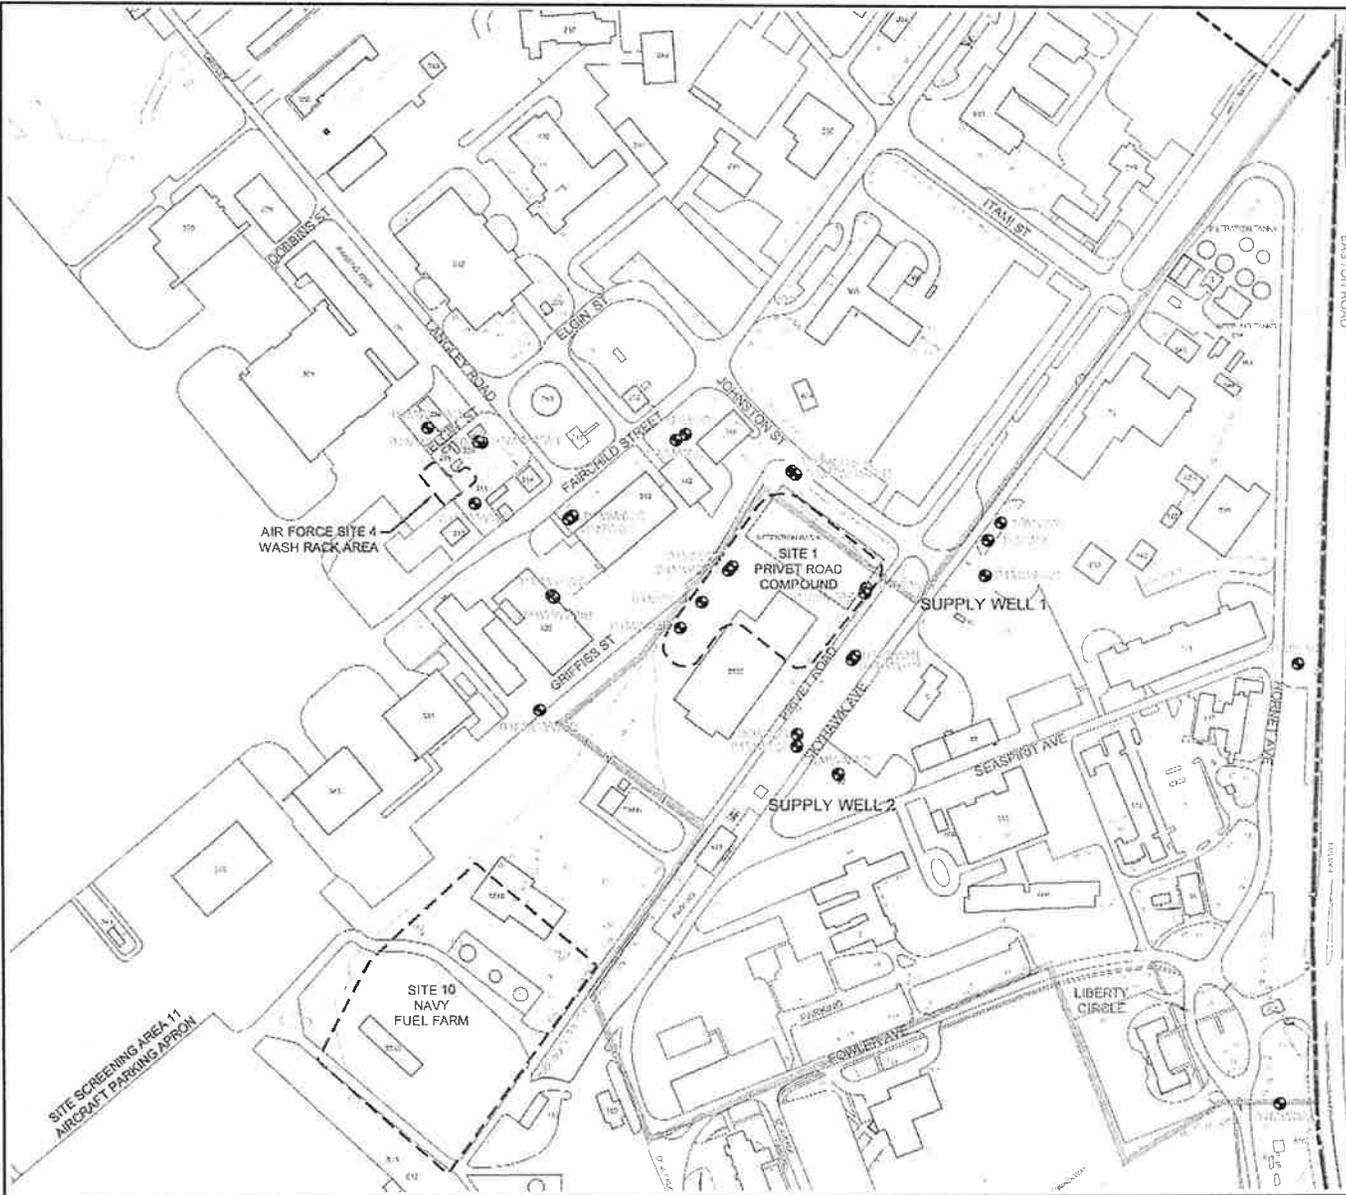
- MONITORING WELL LOCATION
- PERIODIC GROUNDWATER MONITORING WELL LOCATION
- BOUNDARY OF INSTITUTIONAL CONTROLS

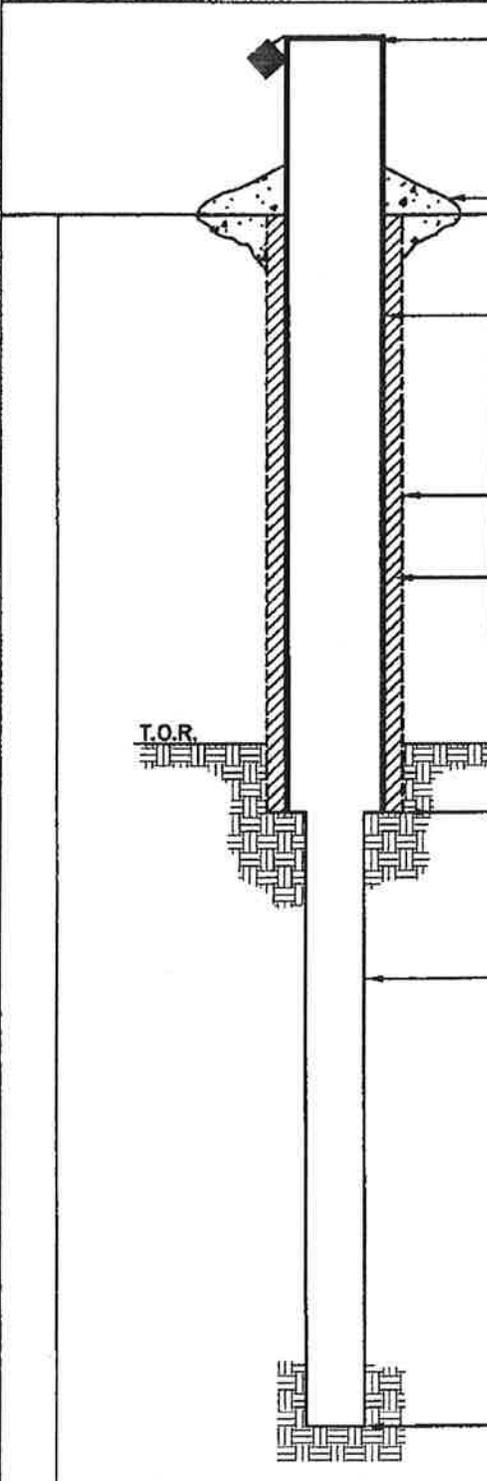
ELEVATION/HEIGHT OF TOP OF SURFACE CASING: 13

TYPE OF SURFACE SEAL: CONCRETE
