RESOURCE CONSERVATION AND RECOVERY ACT FACILITY ASSESSMENT VOLUME VI
REVISION 1 CNC CHARLESTON SC
2/1/2001
NAVAL FACILITIES ENGINEERING COMMAND

**RCRA
FACILITY
ASSESSMENT**

**CHARLESTON NAVAL COMPLEX
CHARLESTON, SOUTH CAROLINA**

Subj: RCRA FACILITY ASSESSMENT FOR AREAS OF CONCERN 711 THROUGH 718

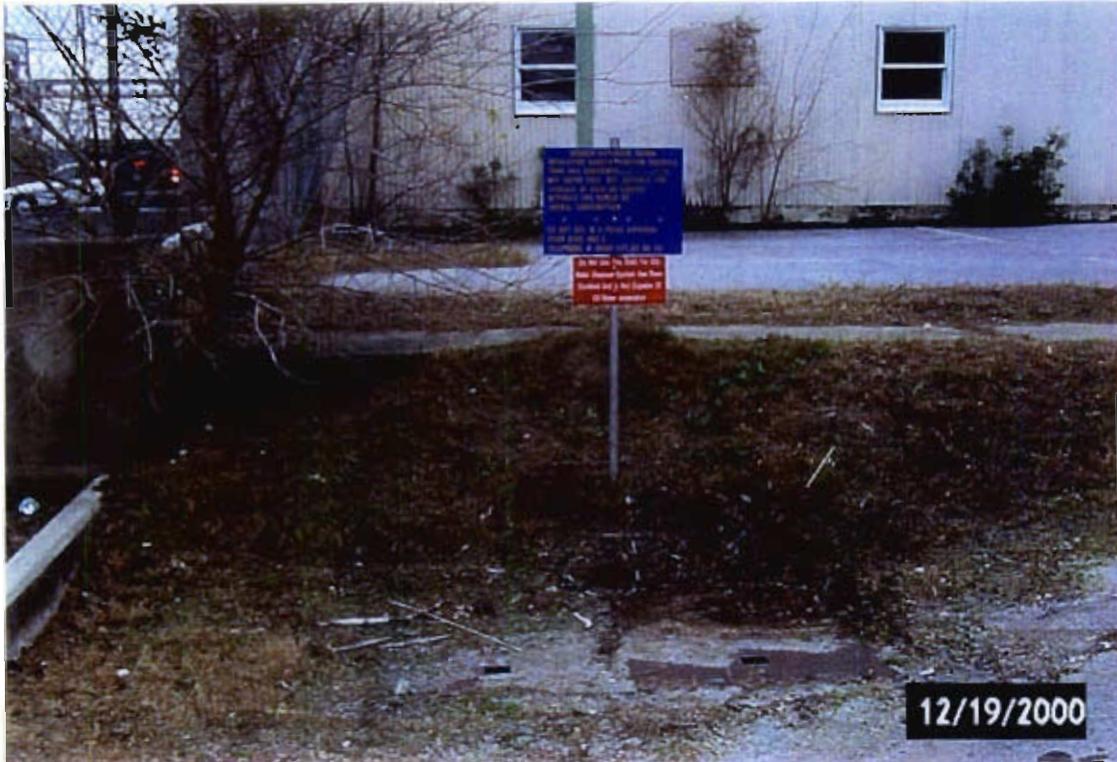
This is a view looking southeast at the UST adjacent to the wash area behind NS 200. The red and blue signs warn individuals about the tank and who to contact in the event of an emergency.

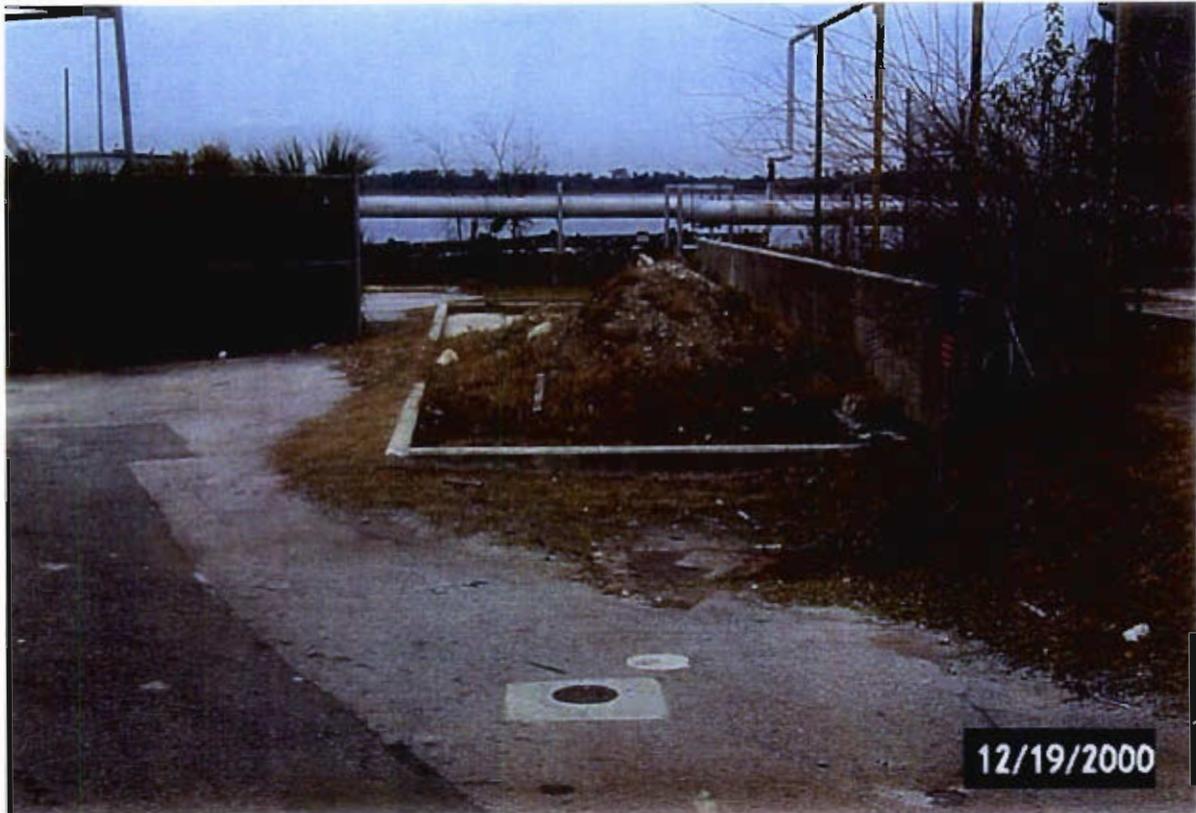
This is a view looking due east toward the Cooper River behind Building NS 200. The monitoring well in the foreground was installed during the UST site assessment.

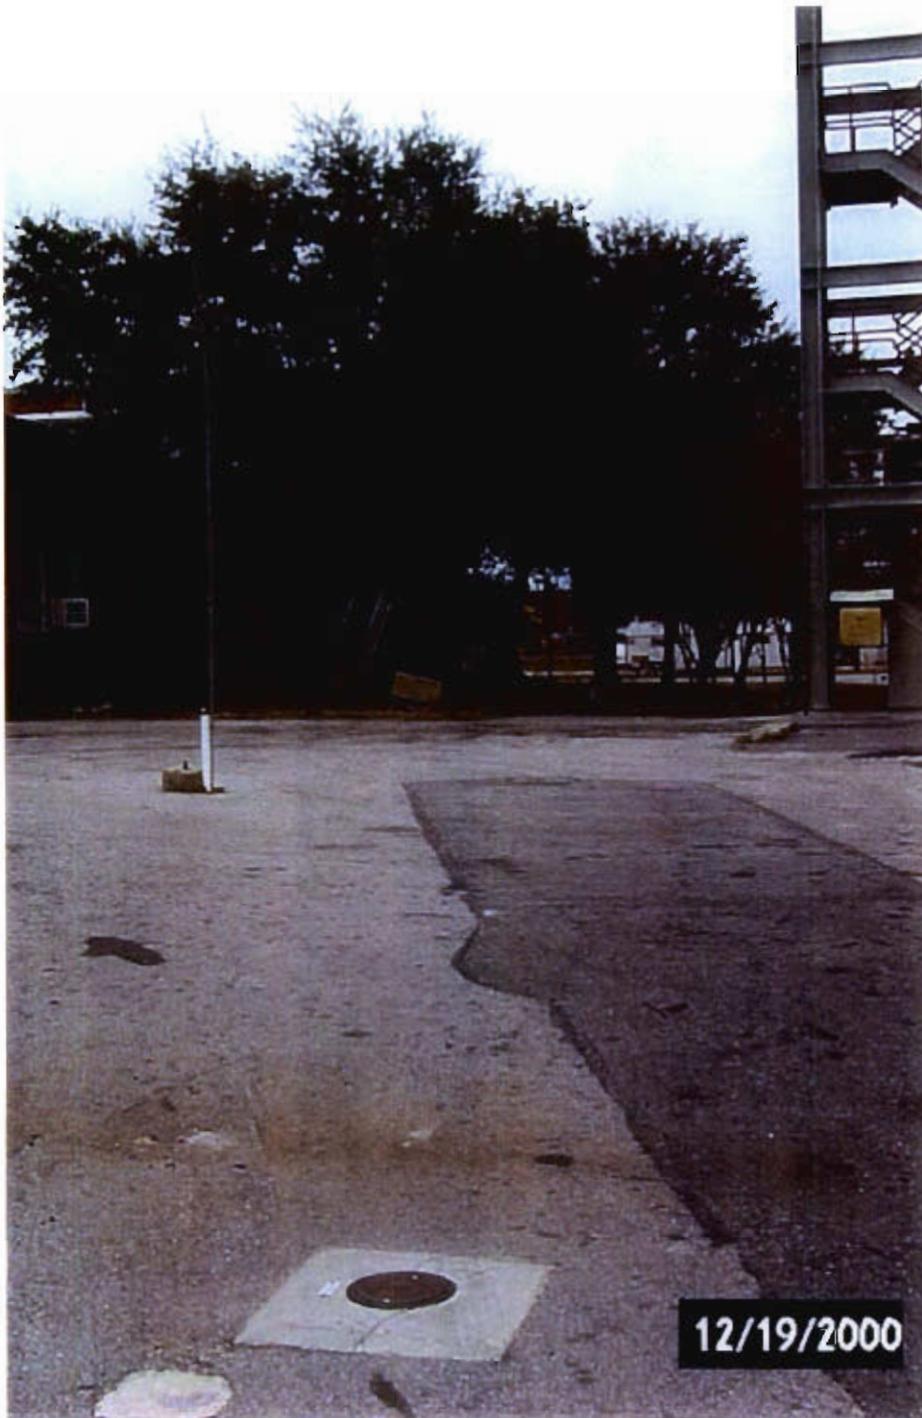
This is a view looking due west toward Hobson Avenue from behind NS 200. In the foreground is a permanent monitoring well and beyond that is a temporary monitoring well. Several other wells including these at the site were used for assessment of the groundwater contamination found during the removal of the Diesel Fuel Oil UST from an area in the upper right portion of the asphalt paving of this photo.

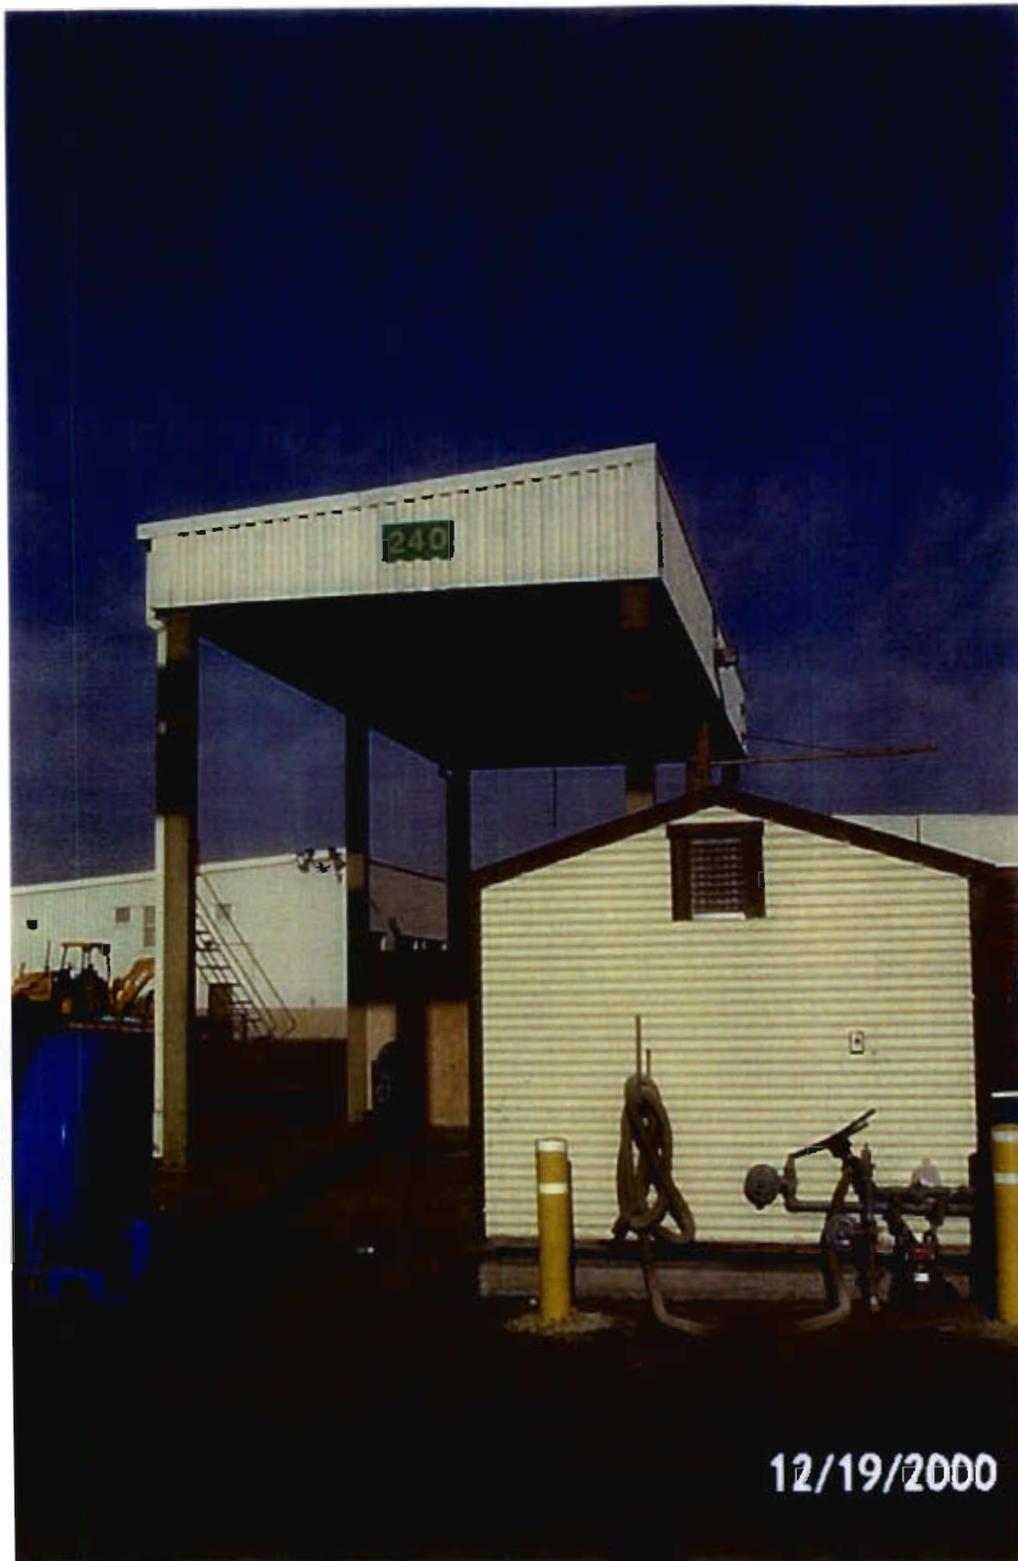
This is a view looking Northwest at Facility 240. In the foreground is a utility building which services wash area. The gas supply is assumed to be for a water heater however this could not be verified

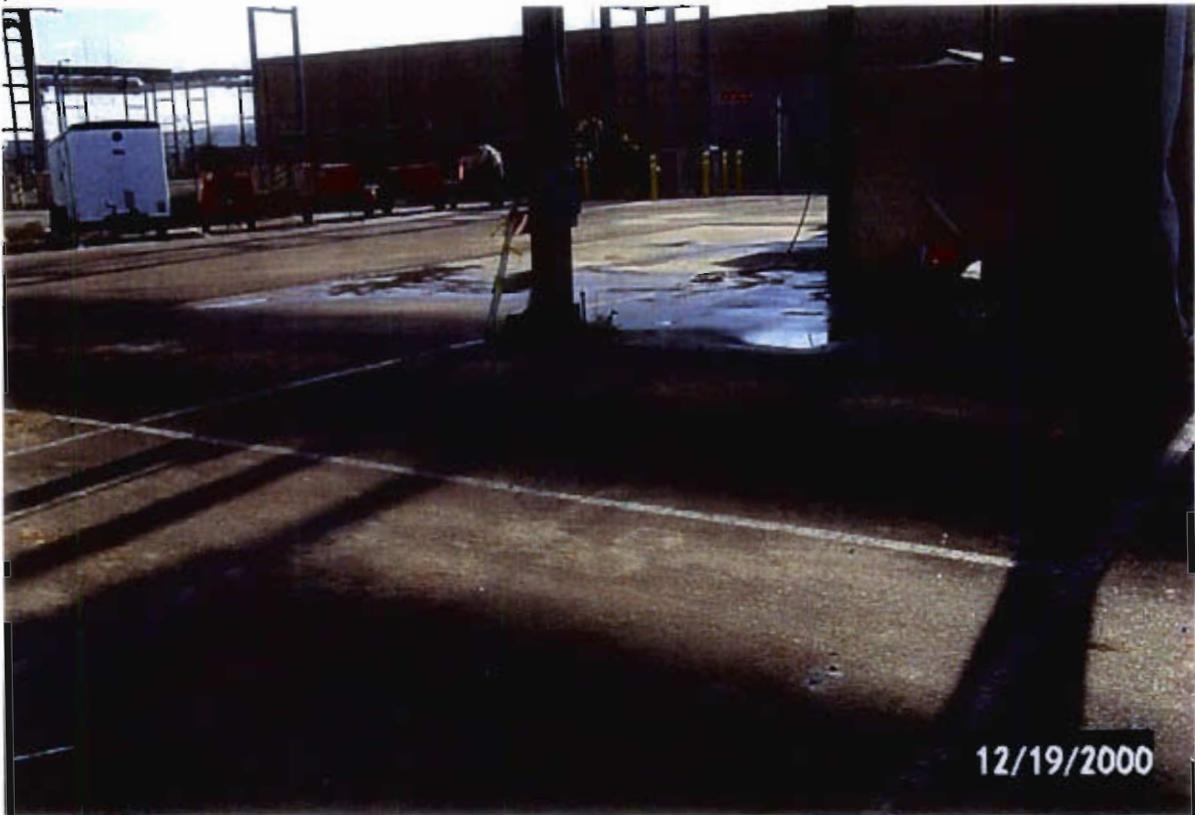
This is a view looking South east at the Facility 240 wash area. A monitoring well can be seen at the left of the photo.

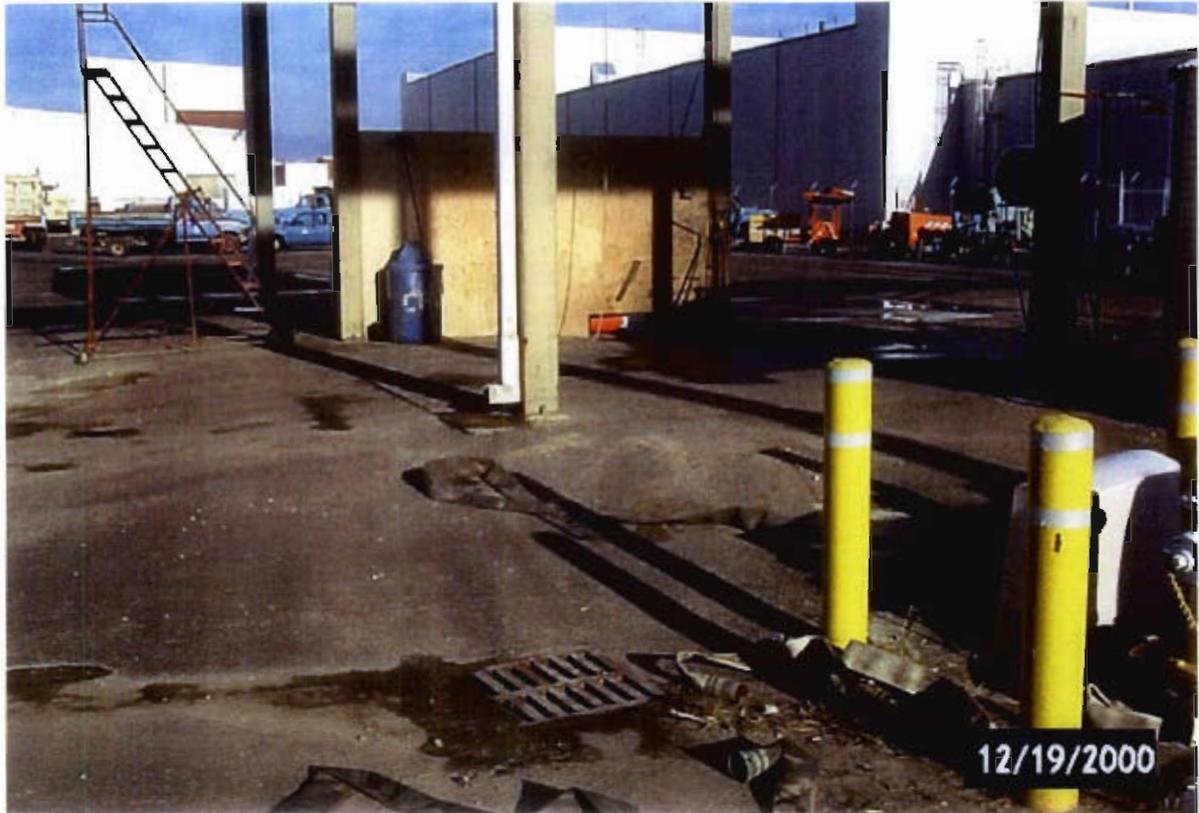
This is a view of Facility 240 looking Northwest. In the foreground is a storm sewer inlet adjacent to the fire hydrant protective posts.

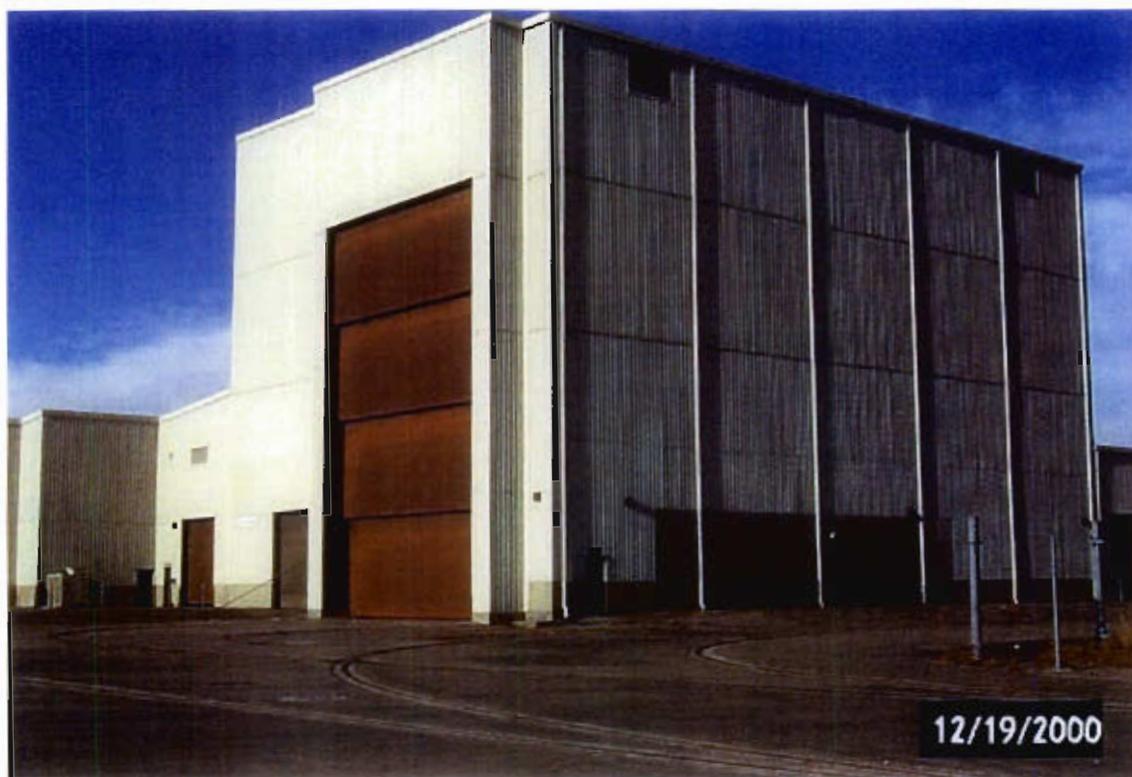
This is a view looking West at Building 241. A wash area was located on this side of the building to the right of the large crane doors.

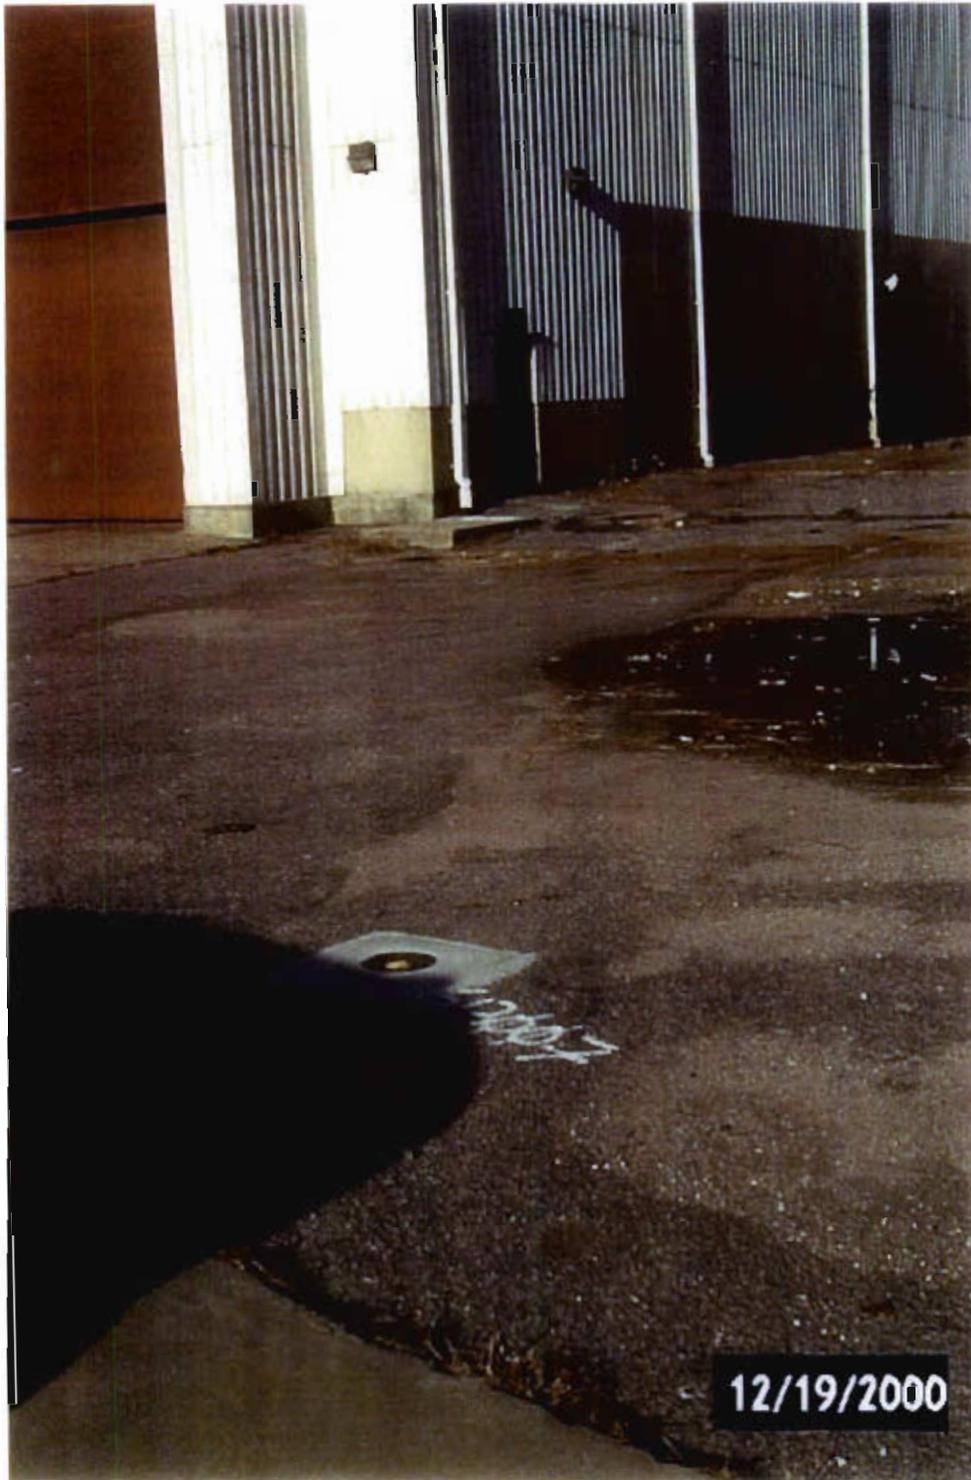
This view shows the location of AOC 713 monitoring well 007 in relation to the Building 241 and wash area.

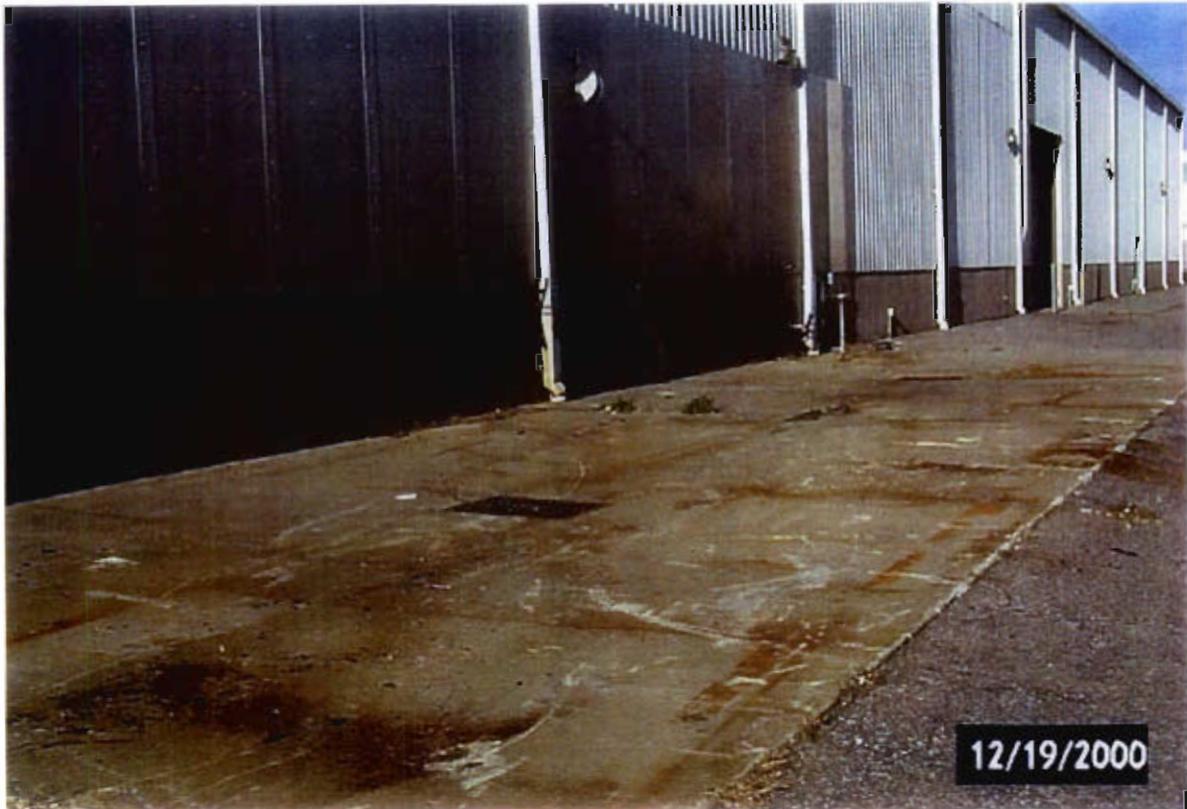
This is a view looking West at Building 241. The wash area has two collection sumps that connect to an Oil/Water Separator that connects to the sanitary sewer system. These Oil/Water Separators are not connected to a waste oil UST and therefore have not had any specific sampling in the vicinity.

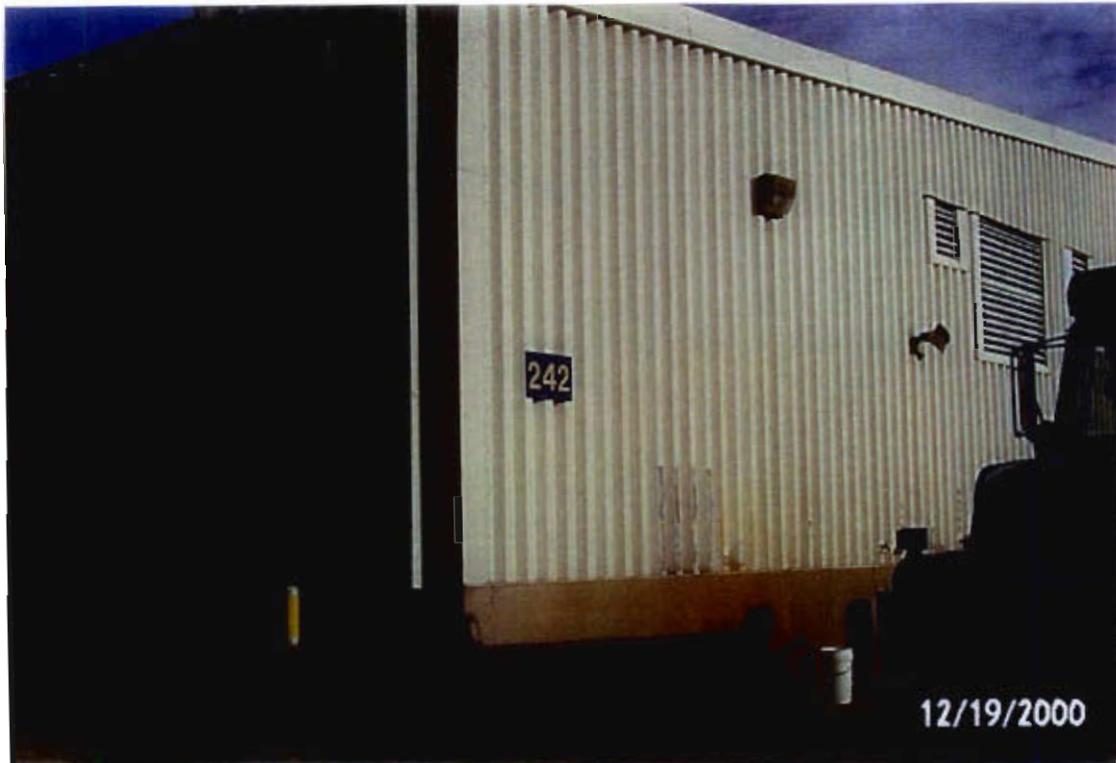
This is a view looking North at the front of Building 242. There are two Oil/Water separators located in the front of the building that were not associated with any UST removal or specific groundwater investigation.

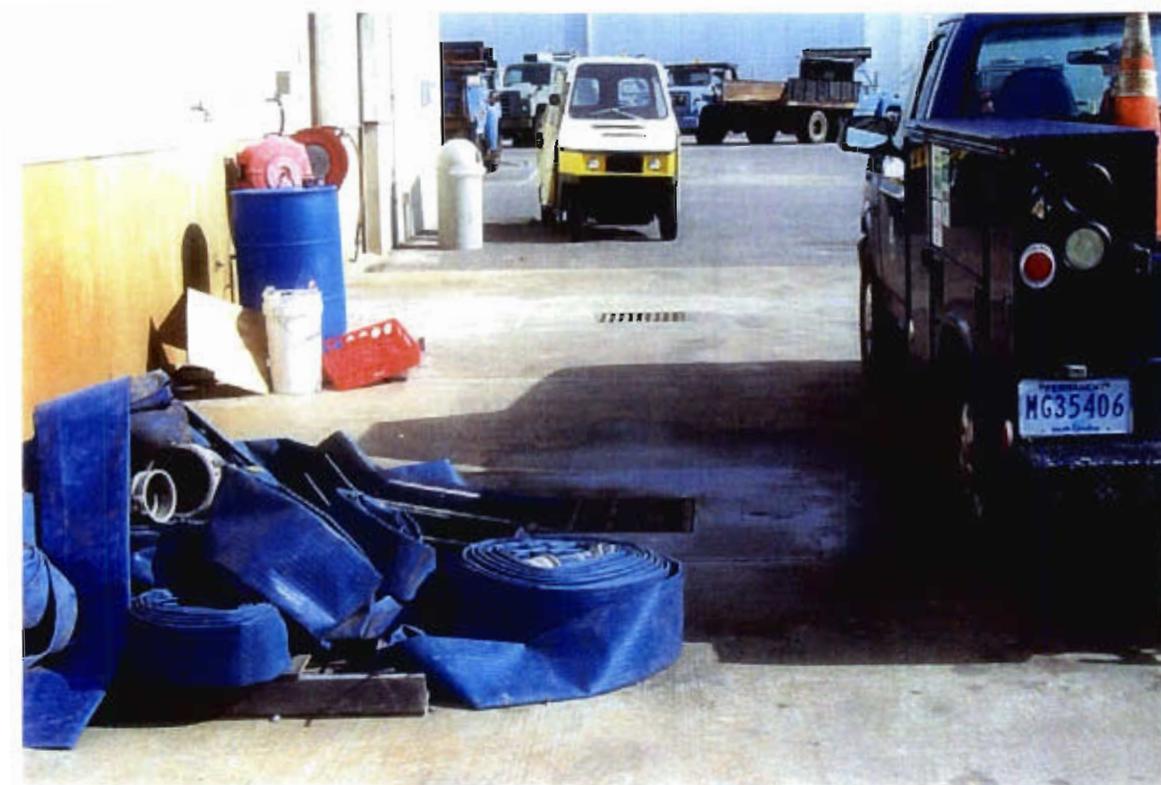
Looking west at the washrack, on the southeastern part of Building 242.

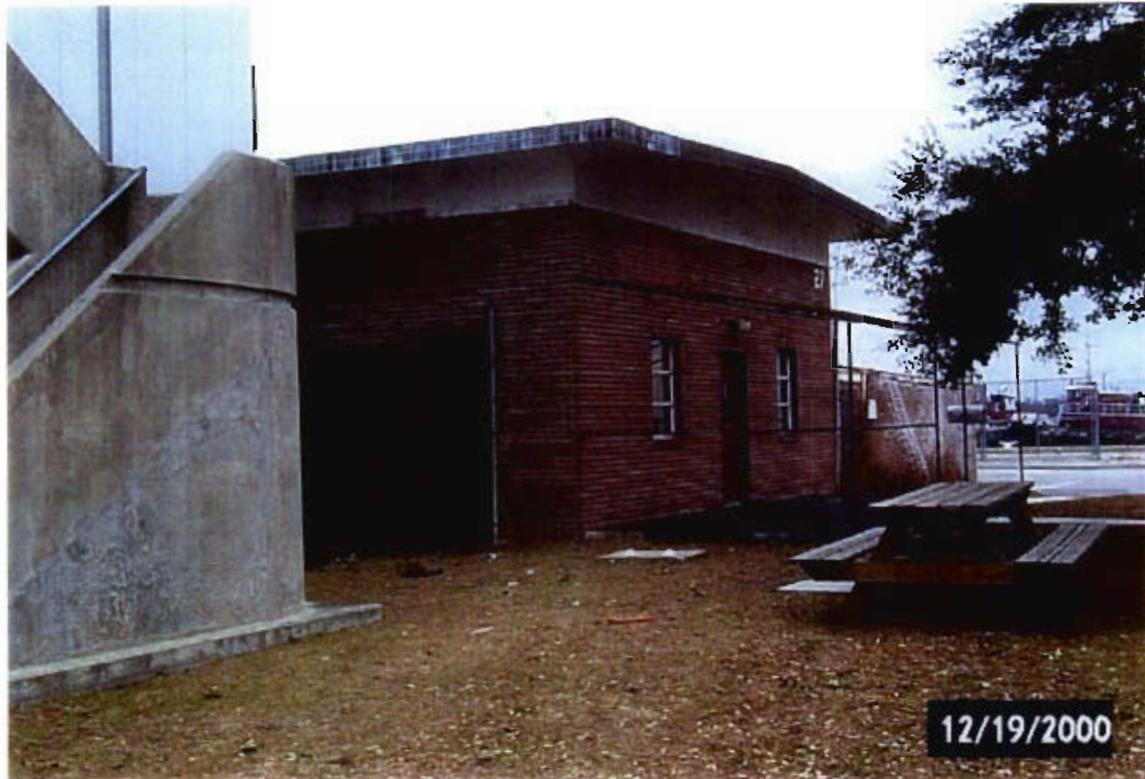
This is view looking Northwest at the corner of Building 681 and Building NS 27. An Oil/Water Separator was reportedly located between these two buildings near the small concrete pad with the two PVC plugs in the foreground.

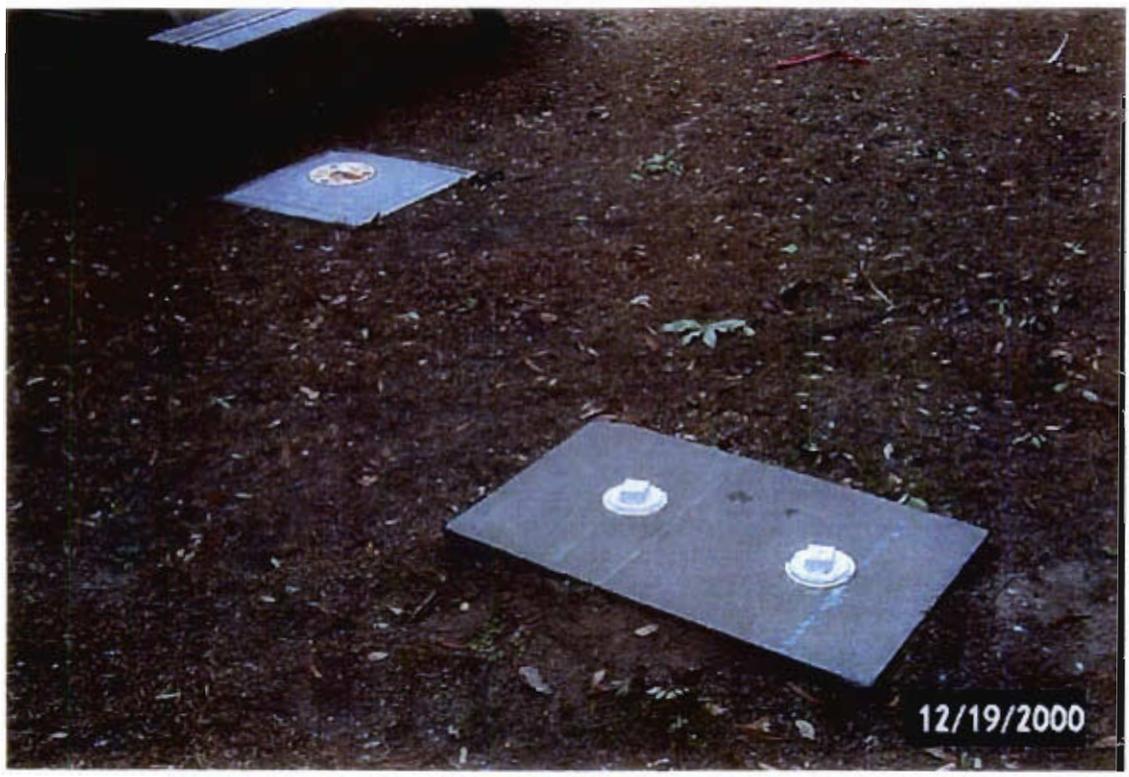
This is a view looking Southeast at the small concrete pad suspected to be an Oil/Water separator and an adjacent monitoring well.

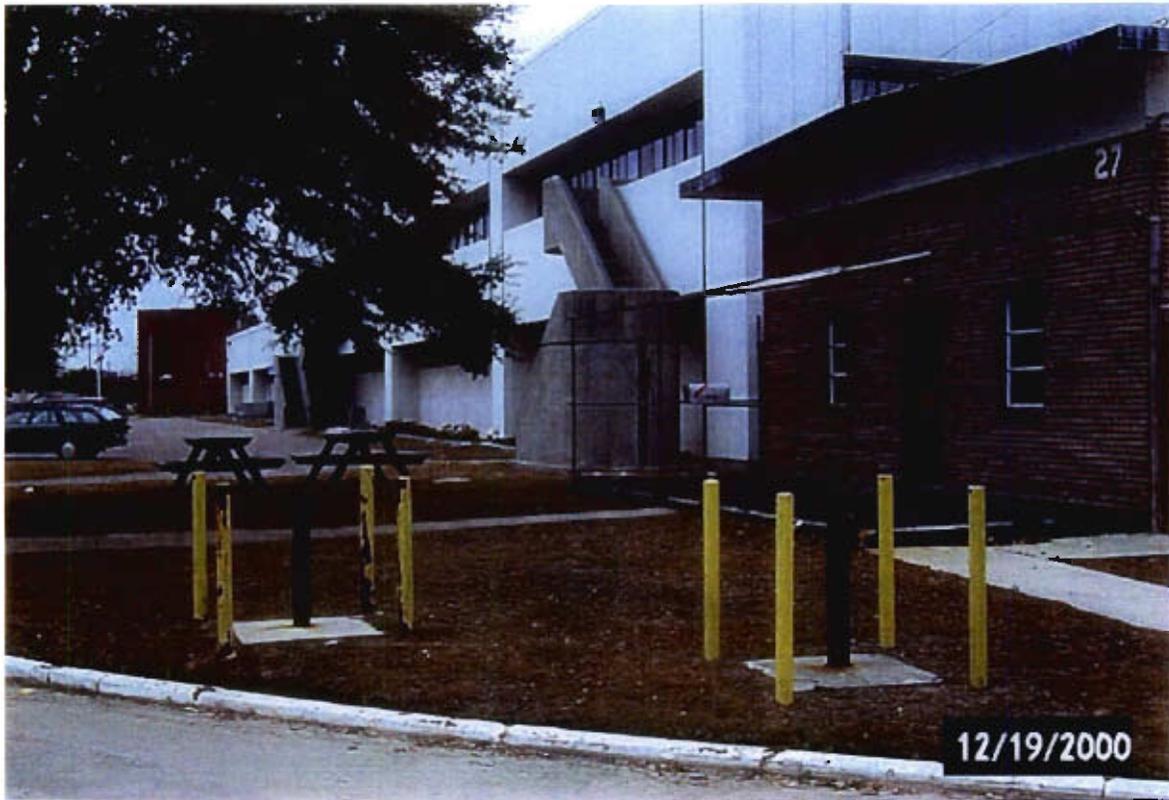
This is a view looking southwest at the corner of Building 681 and NS 27 that shows the proximity of two Zone I grid monitoring well pairs. The OWS and another monitoring well are located just to the right of the picnic tables.

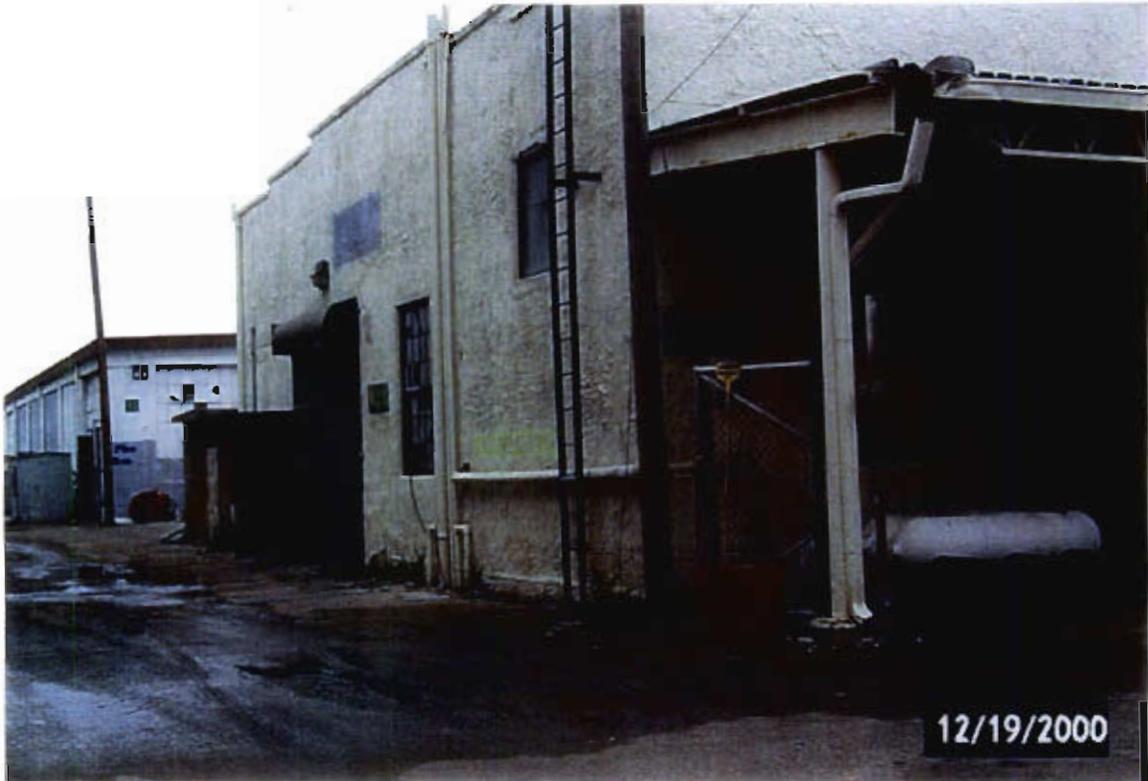
This is a view looking Northeast at Building 1024. A former Oil/Water separator was located just outside of the garage doors on the front of the building.

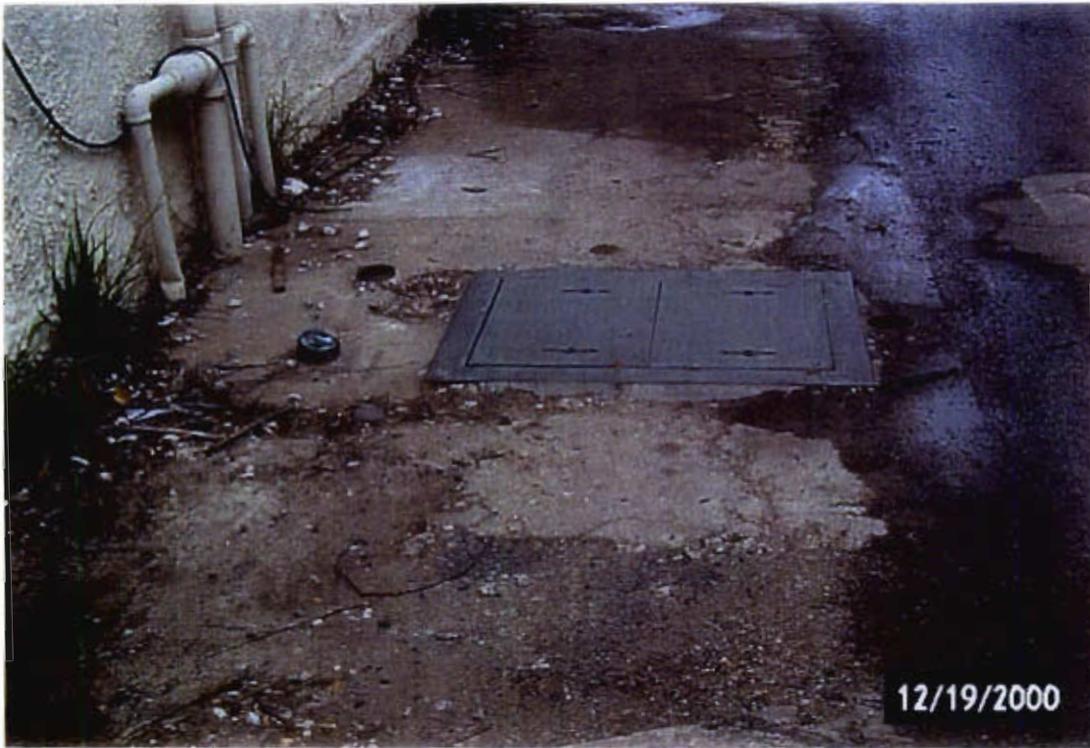
This is a view looking Southwest at the surface penetrations from a UST. It is not certain whether an Oil/Water separator still exists in this area. The penetrations appear to be for fill and vent purposes.

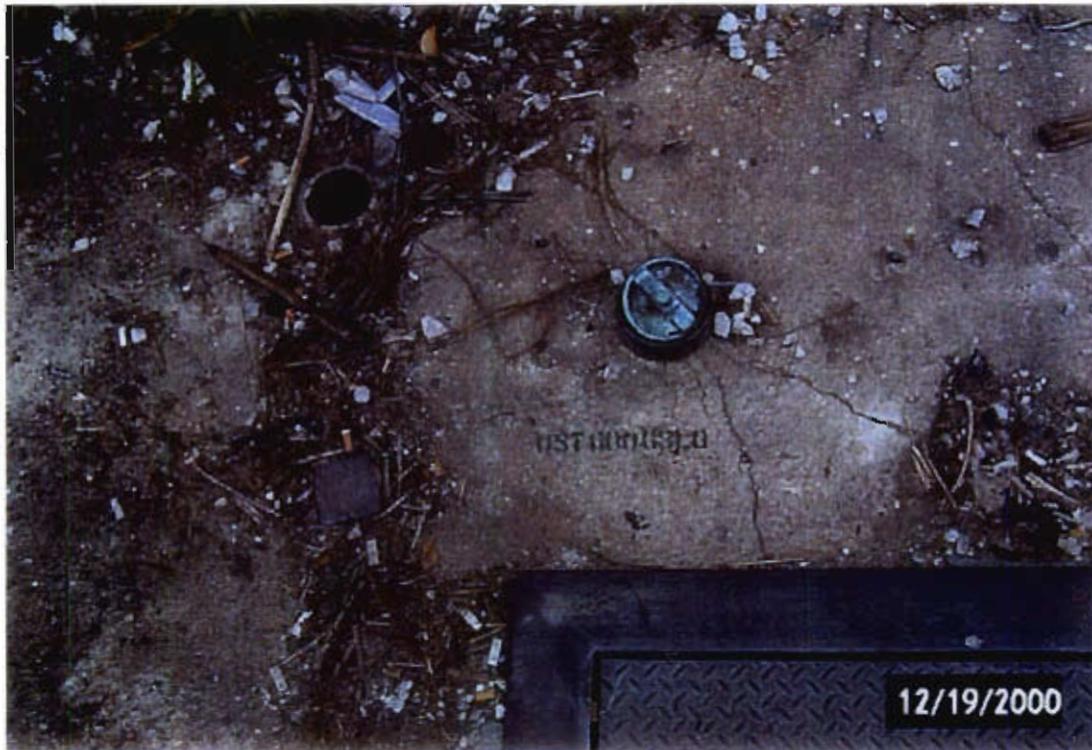
This is a view looking directly downward on the UST penetrations.

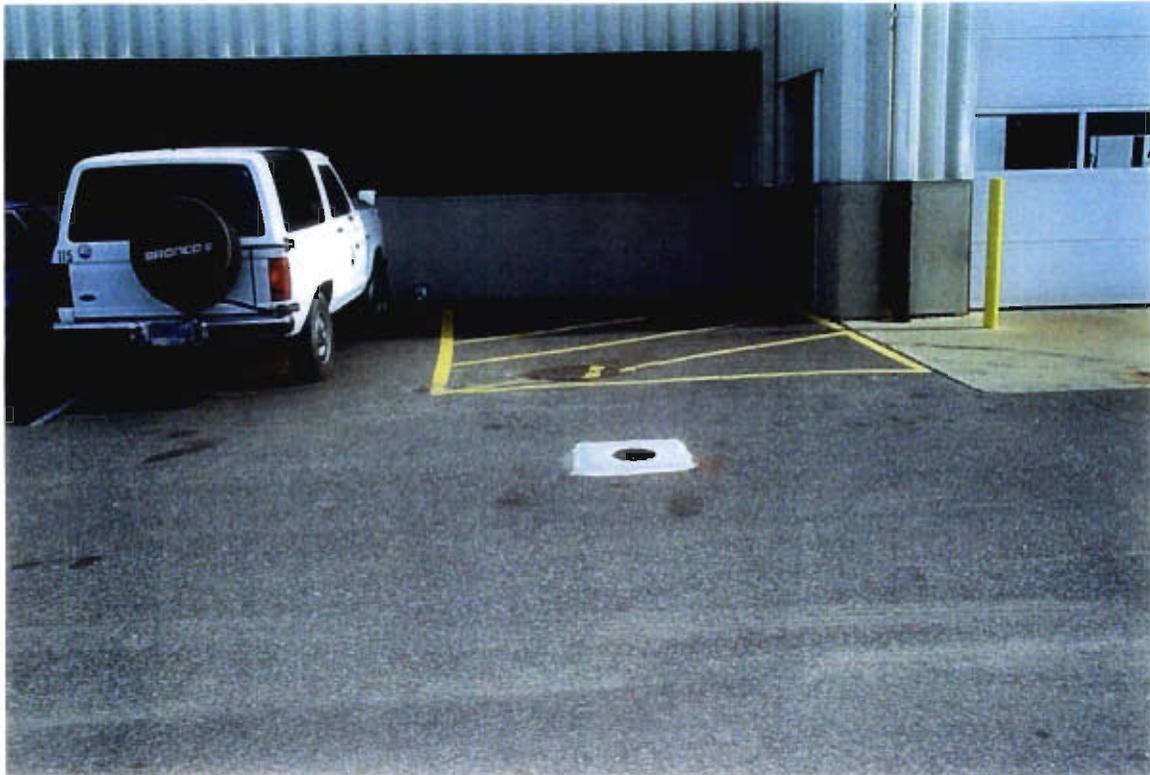
Looking toward the northeast, on the west side of Facility 242. Note the monitoring well in the foreground.

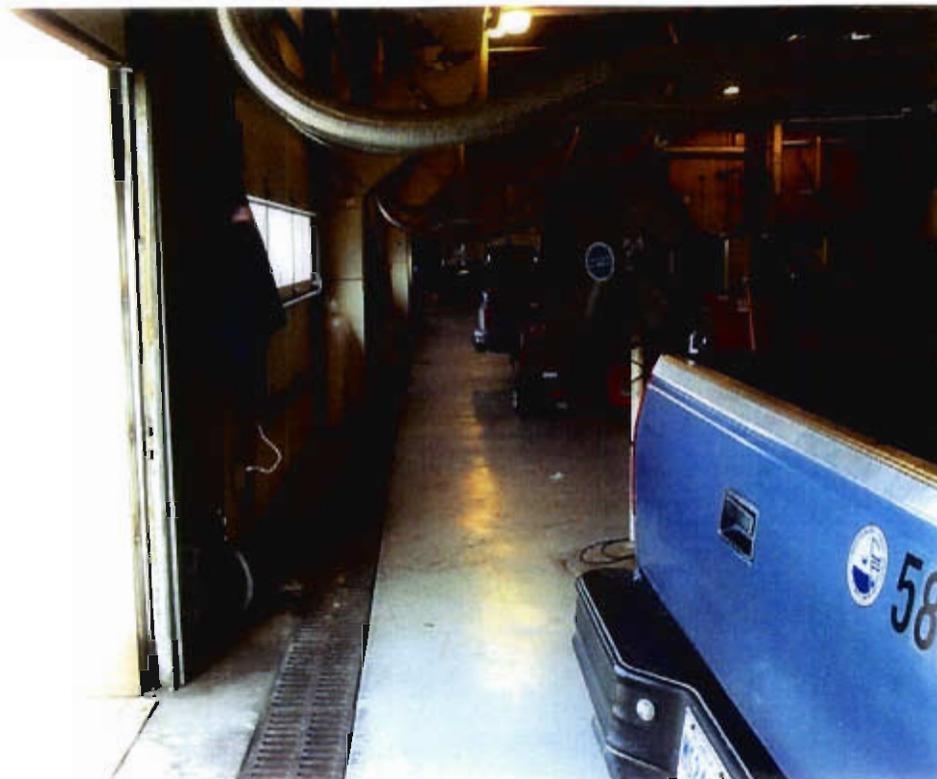
Looking northwest, inside of Facility 242 at the floor drains along the edge of the floor.

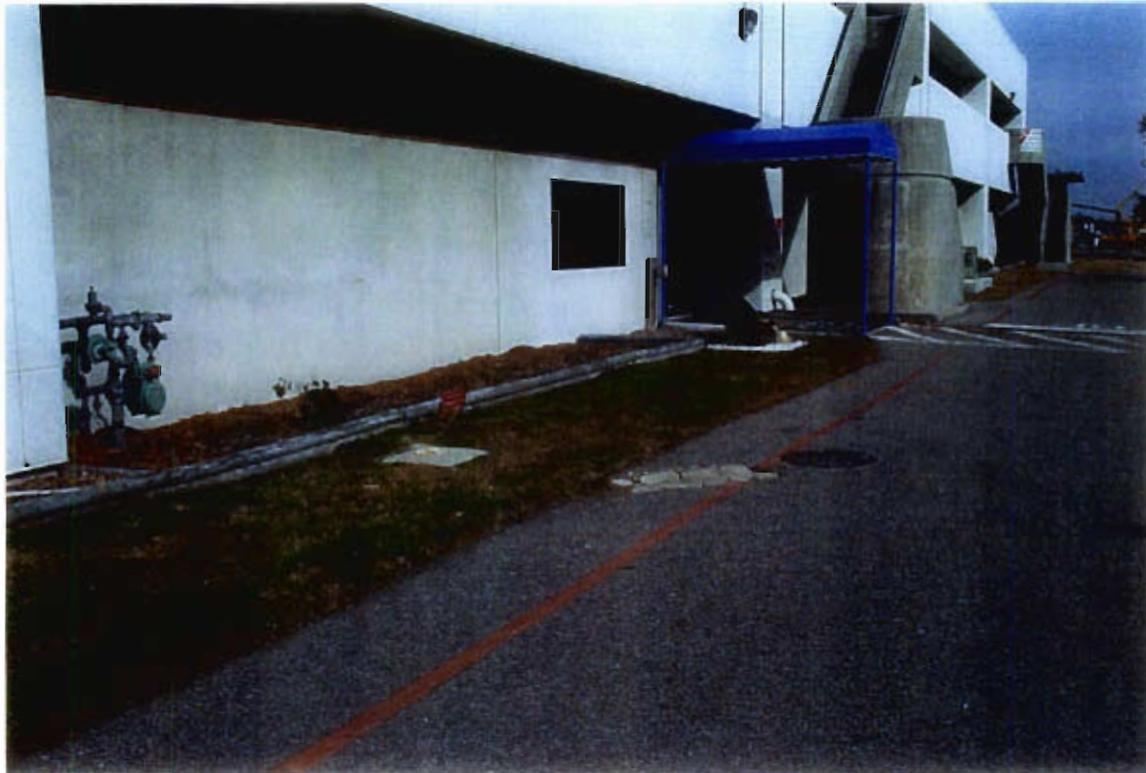
Looking toward the northeast on the east side of Building 681. The red sign identifies the location of the oil water separator.

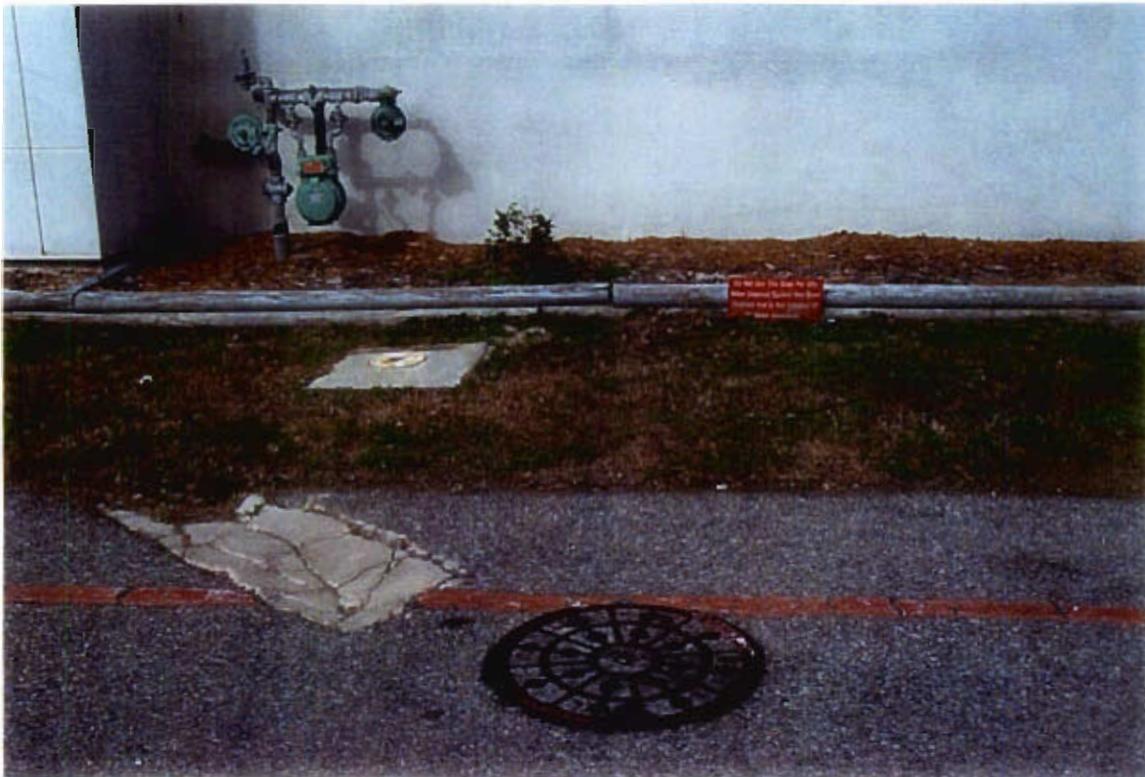
Looking to the west, on the east side of Building 681. The red sign identifies the location of the oil water separator. A monitoring well (white cover) is close to the oil water separator

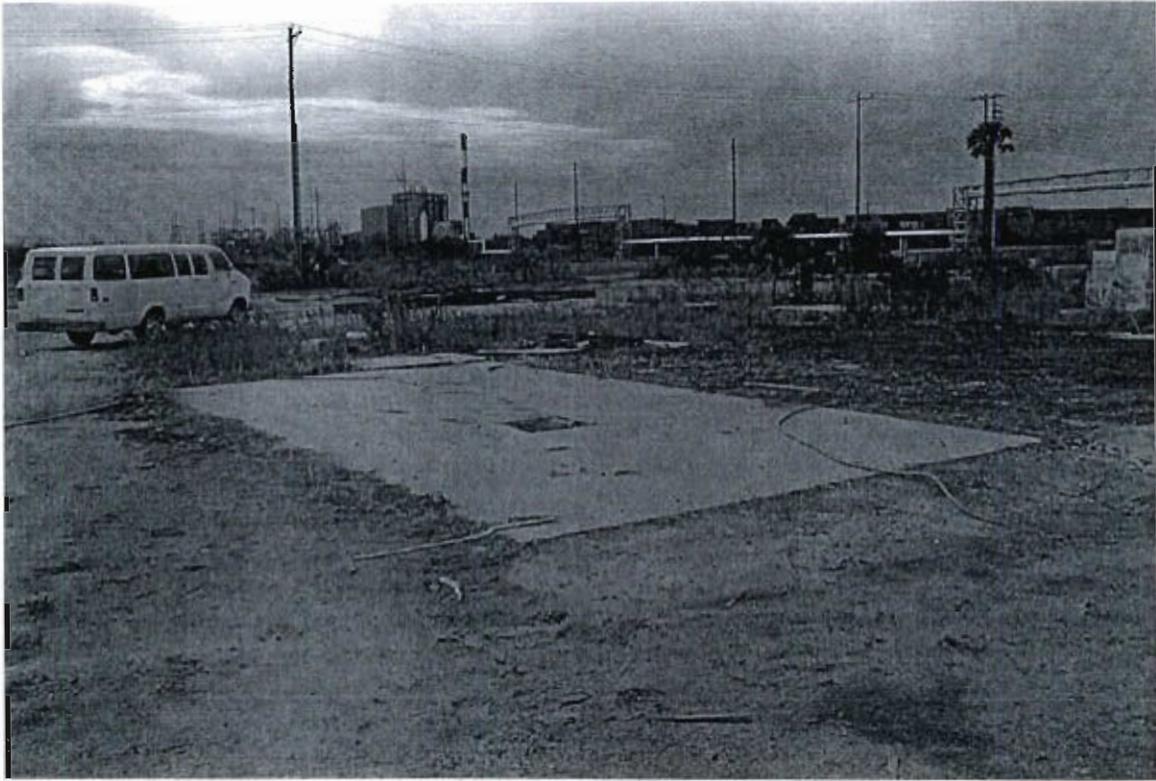
Remaining slab from the wash pad behind Building X12, looking toward Hobson Avenue.

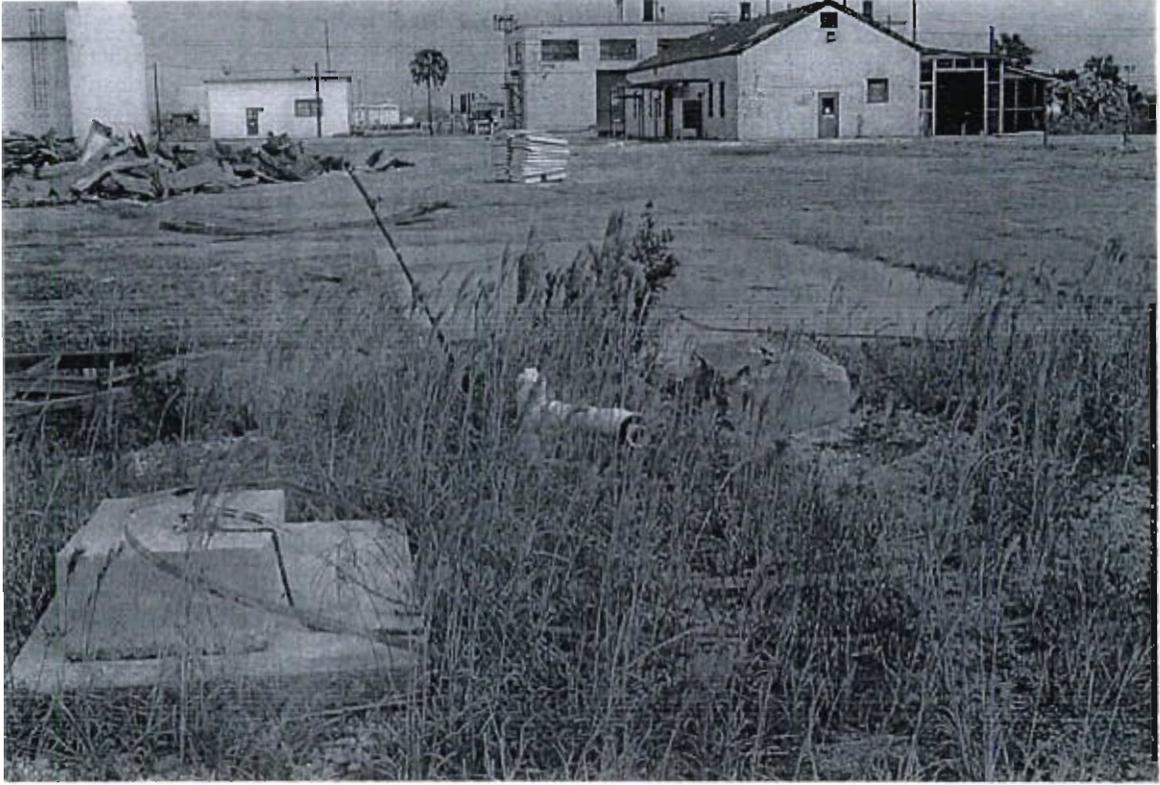
Pipe and other surface debris around the wash pad, behind Building X12, looking toward Hobson Avenue.
