RESOURCE CONSERVATION AND RECOVERY ACT FACILITY INVESTIGATION REPORT
ADDENDUM AREA OF CONCERN 537 (AOC 537) ZONE E CNC CHARLESTON SC
8/29/2002
CH2M HILL

RFI REPORT ADDENDUM

Area of Concern 537, Zone E

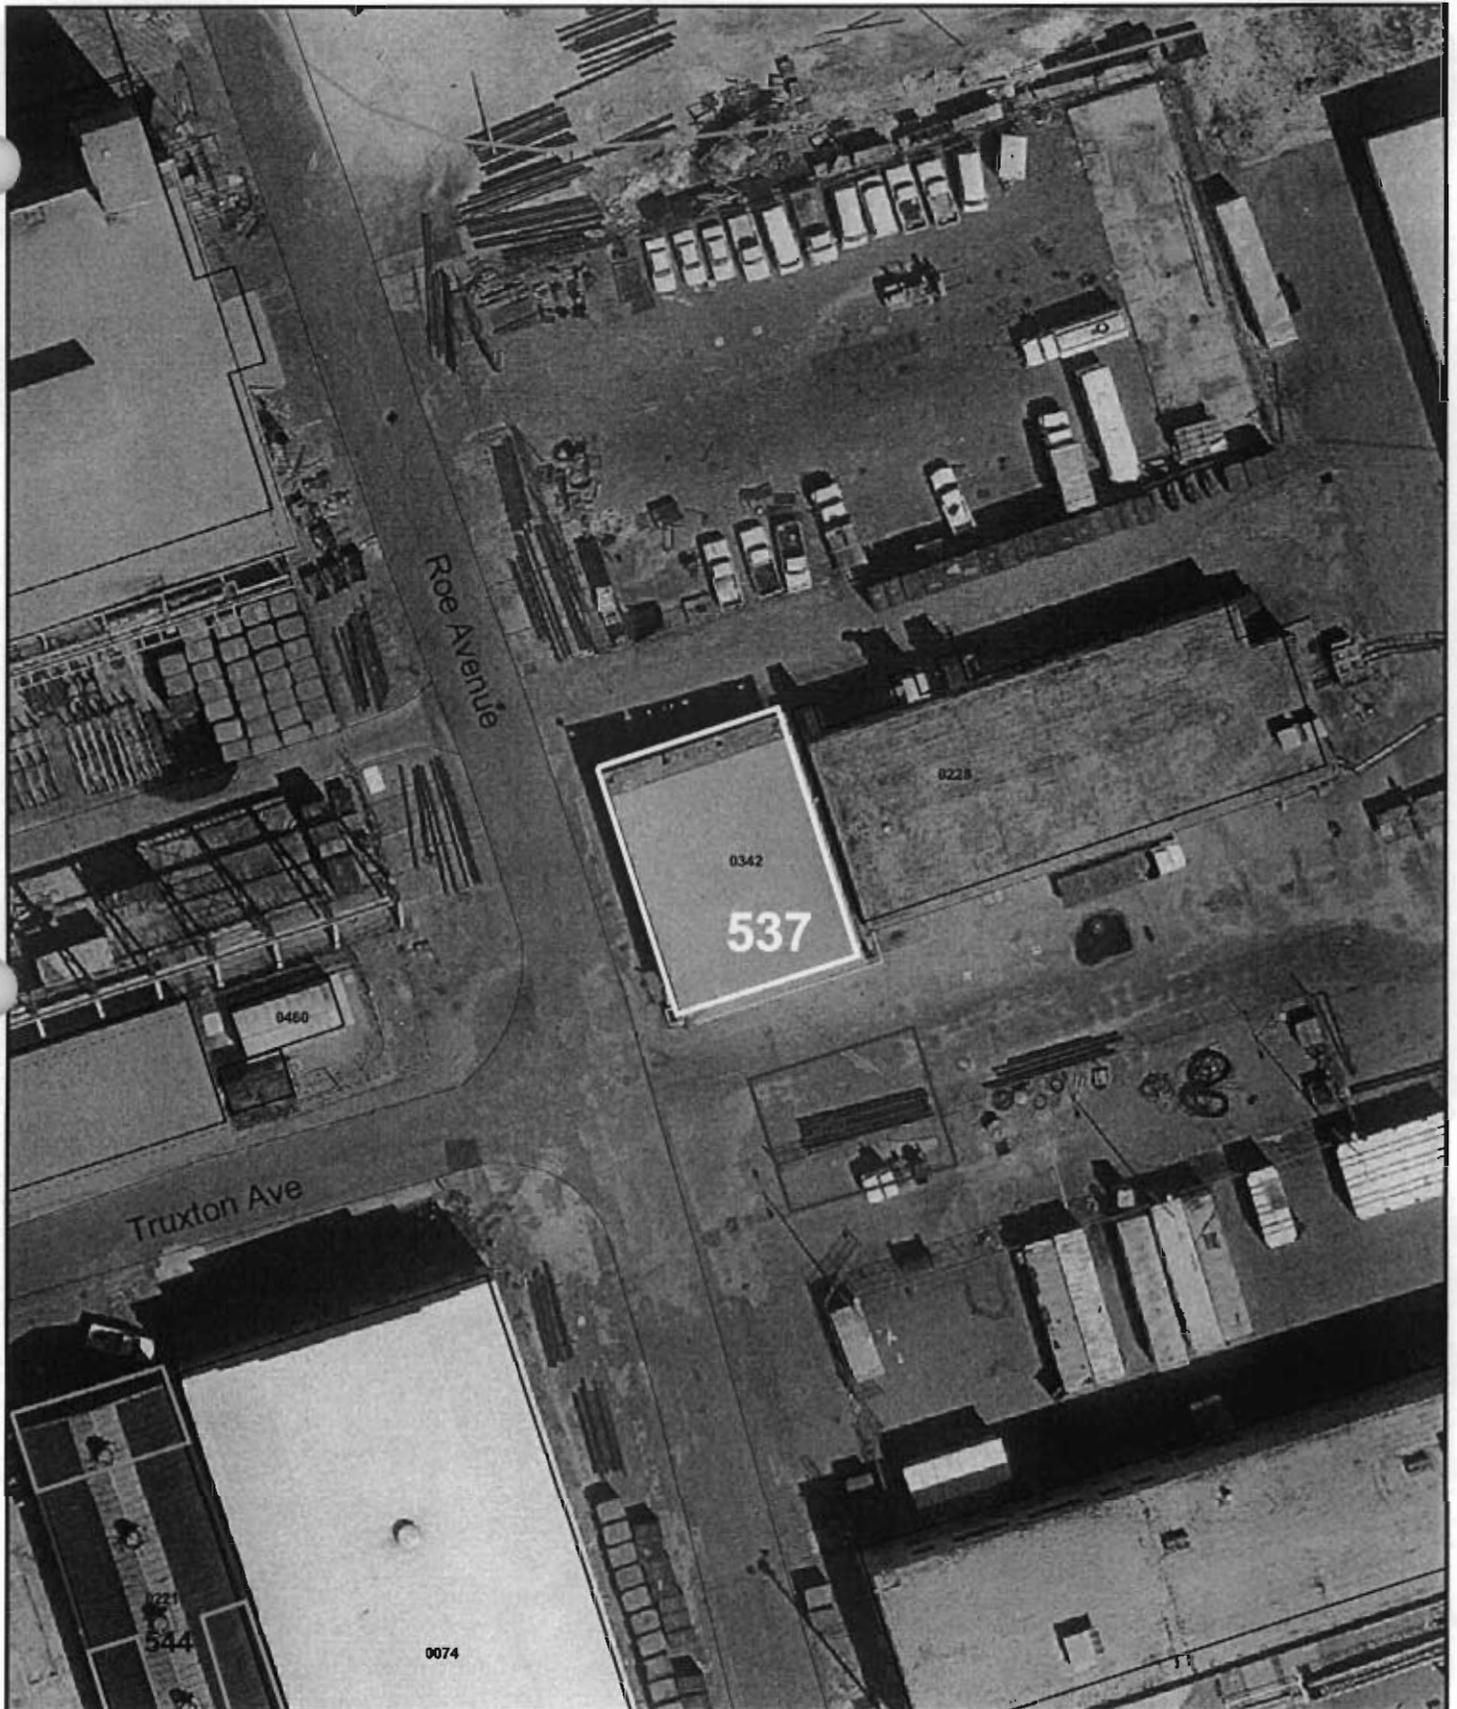
Figure 1-2
 Site Map
 AOC 537, Zone E
 Charleston Naval Complex

AOC 537 consists of an electrical substation at Building 342, a 2,728 square-foot (ft²) single story concrete block building on a slab floor. The building houses an electrical transformer substation, an electrical parts storage area, and an insulation shop. The equipment previously used at the site is unknown, although circuit breakers, dry transformers, and high-voltage switches were present at the substation during the recent site visit. Waste materials identified in the RCRA Facility Assessment (RFA) as associated with this unit include dielectric fluid, insulation, and an oily substance on the insulation shop floor observed during the RFA. According to the RFA for AOC 537, the results of tests conducted in 1987 indicated that the dielectric fluid contained less than 50 micrograms per kilogram ($\mu\text{g}/\text{kg}$) of polychlorinated biphenyls (PCBs). Based on the results of the RFA, a Confirmatory Sampling Investigation (CSI) was recommended. The CSI sampling event for AOC 537 was conducted in April 2002.

2 AOC 537 consists of an electrical substation at Building 342 (see Figure 1-2). The building
3 houses an electrical transformer substation, an electrical parts storage area, and an
4 insulation shop. The equipment previously used at the site is unknown, although circuit
5 breakers, dry transformers, and high-voltage switches were present at the substation during
6 the recent site visit.

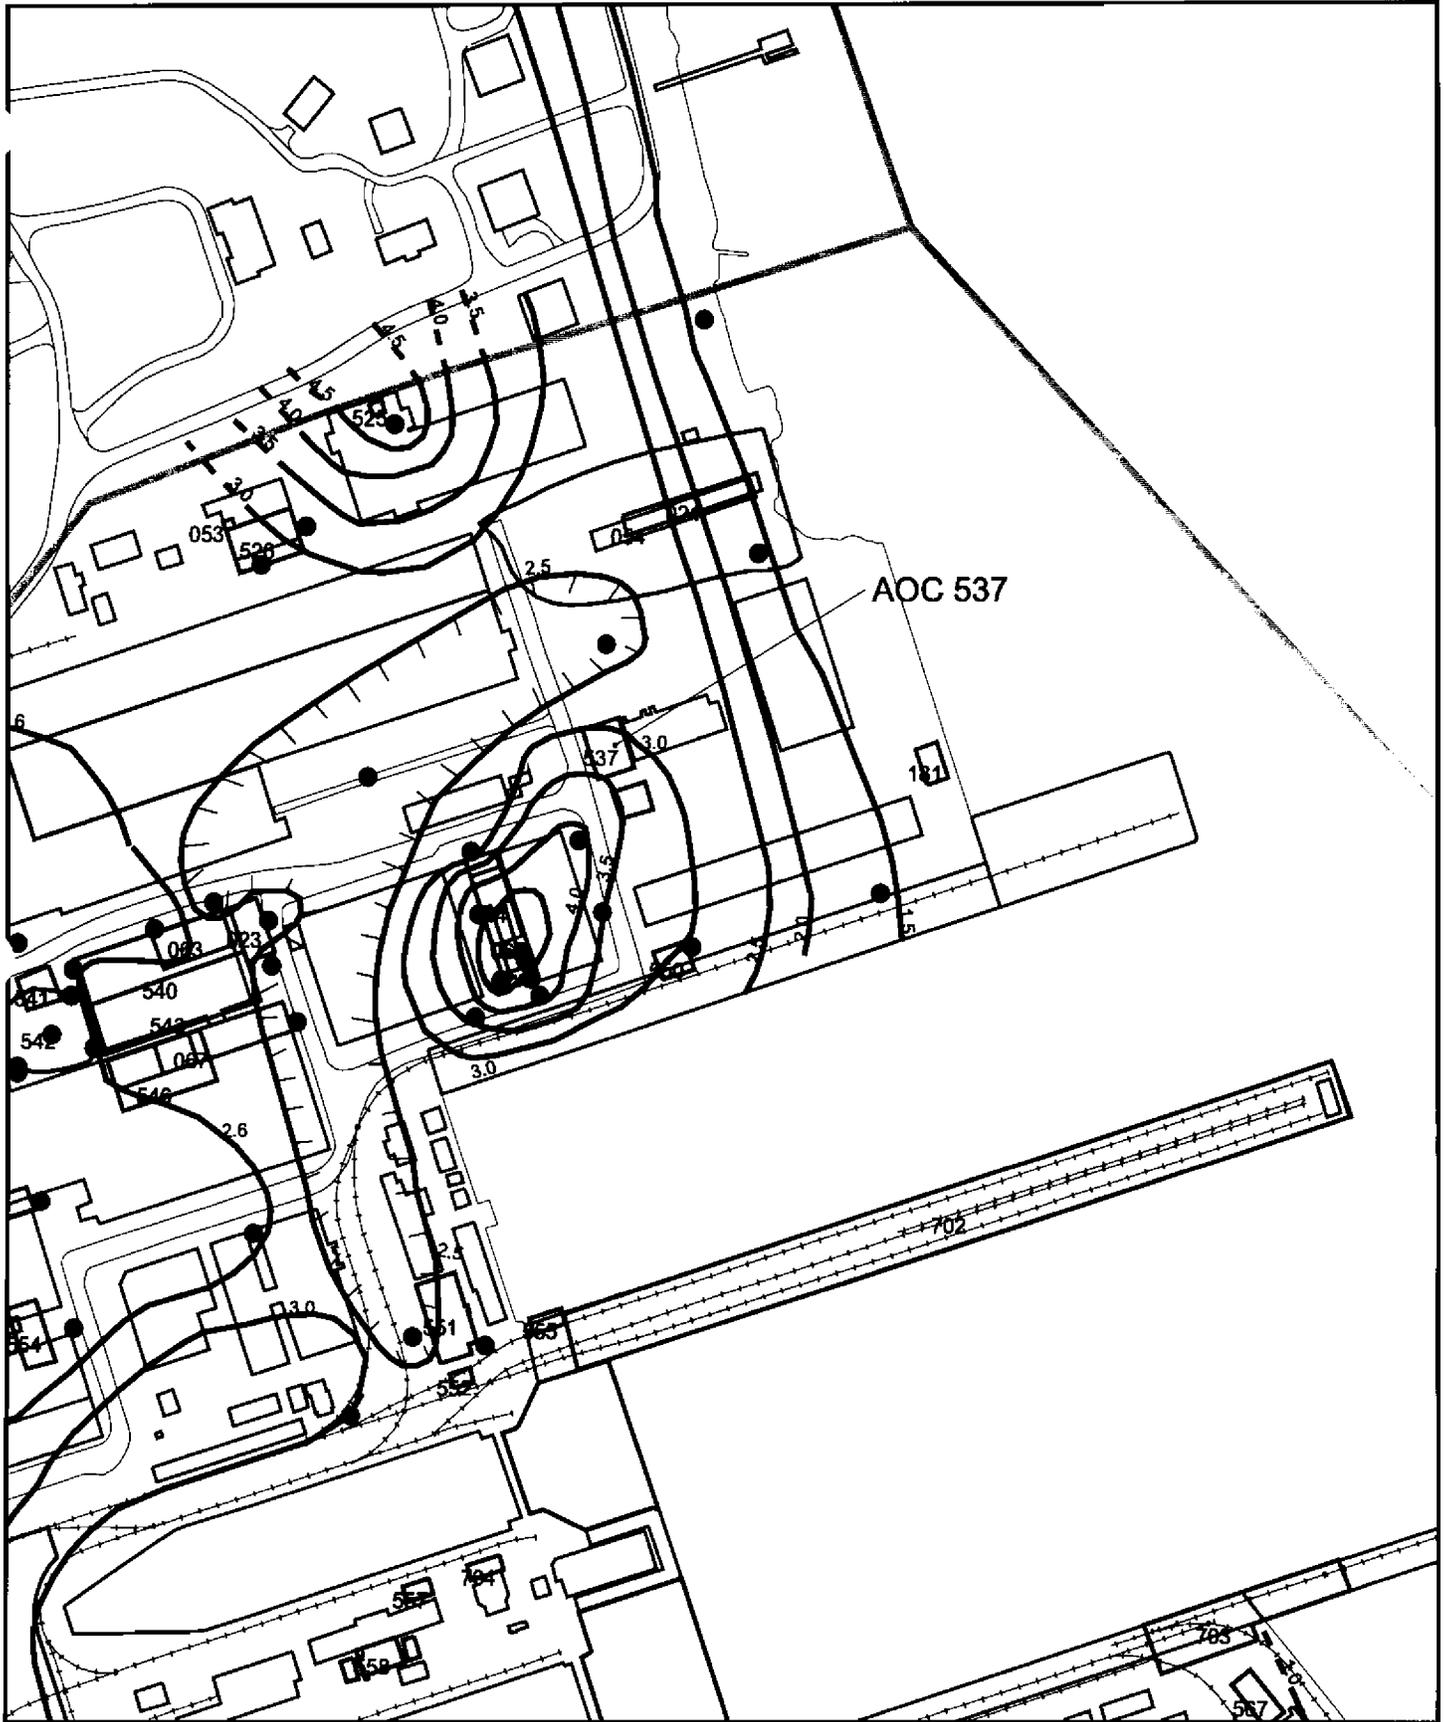
Figure 2-1
 Shallow Groundwater Contours
 AOC 537, Zone E
 Charleston Naval Complex

13 A recent shallow groundwater contour map has been developed for Zone E, using
14 contemporaneous water level elevation data collected in April 2002 (see Figure 2-1). Based
15 on the data, groundwater in the vicinity of AOC 537 appears to ultimately flow generally
16 north or east toward the Cooper River; however, there are be some strongly localized effects
17 due to the presence of the concrete quay walls in the vicinity of Pier C, which is located to
18 the south and east. The man-made structures control the local groundwater flow patterns in
19 this area. Depth to groundwater in the vicinity of AOC 537 is estimated to be approximately
20 3½ feet below land surface (ft bls).

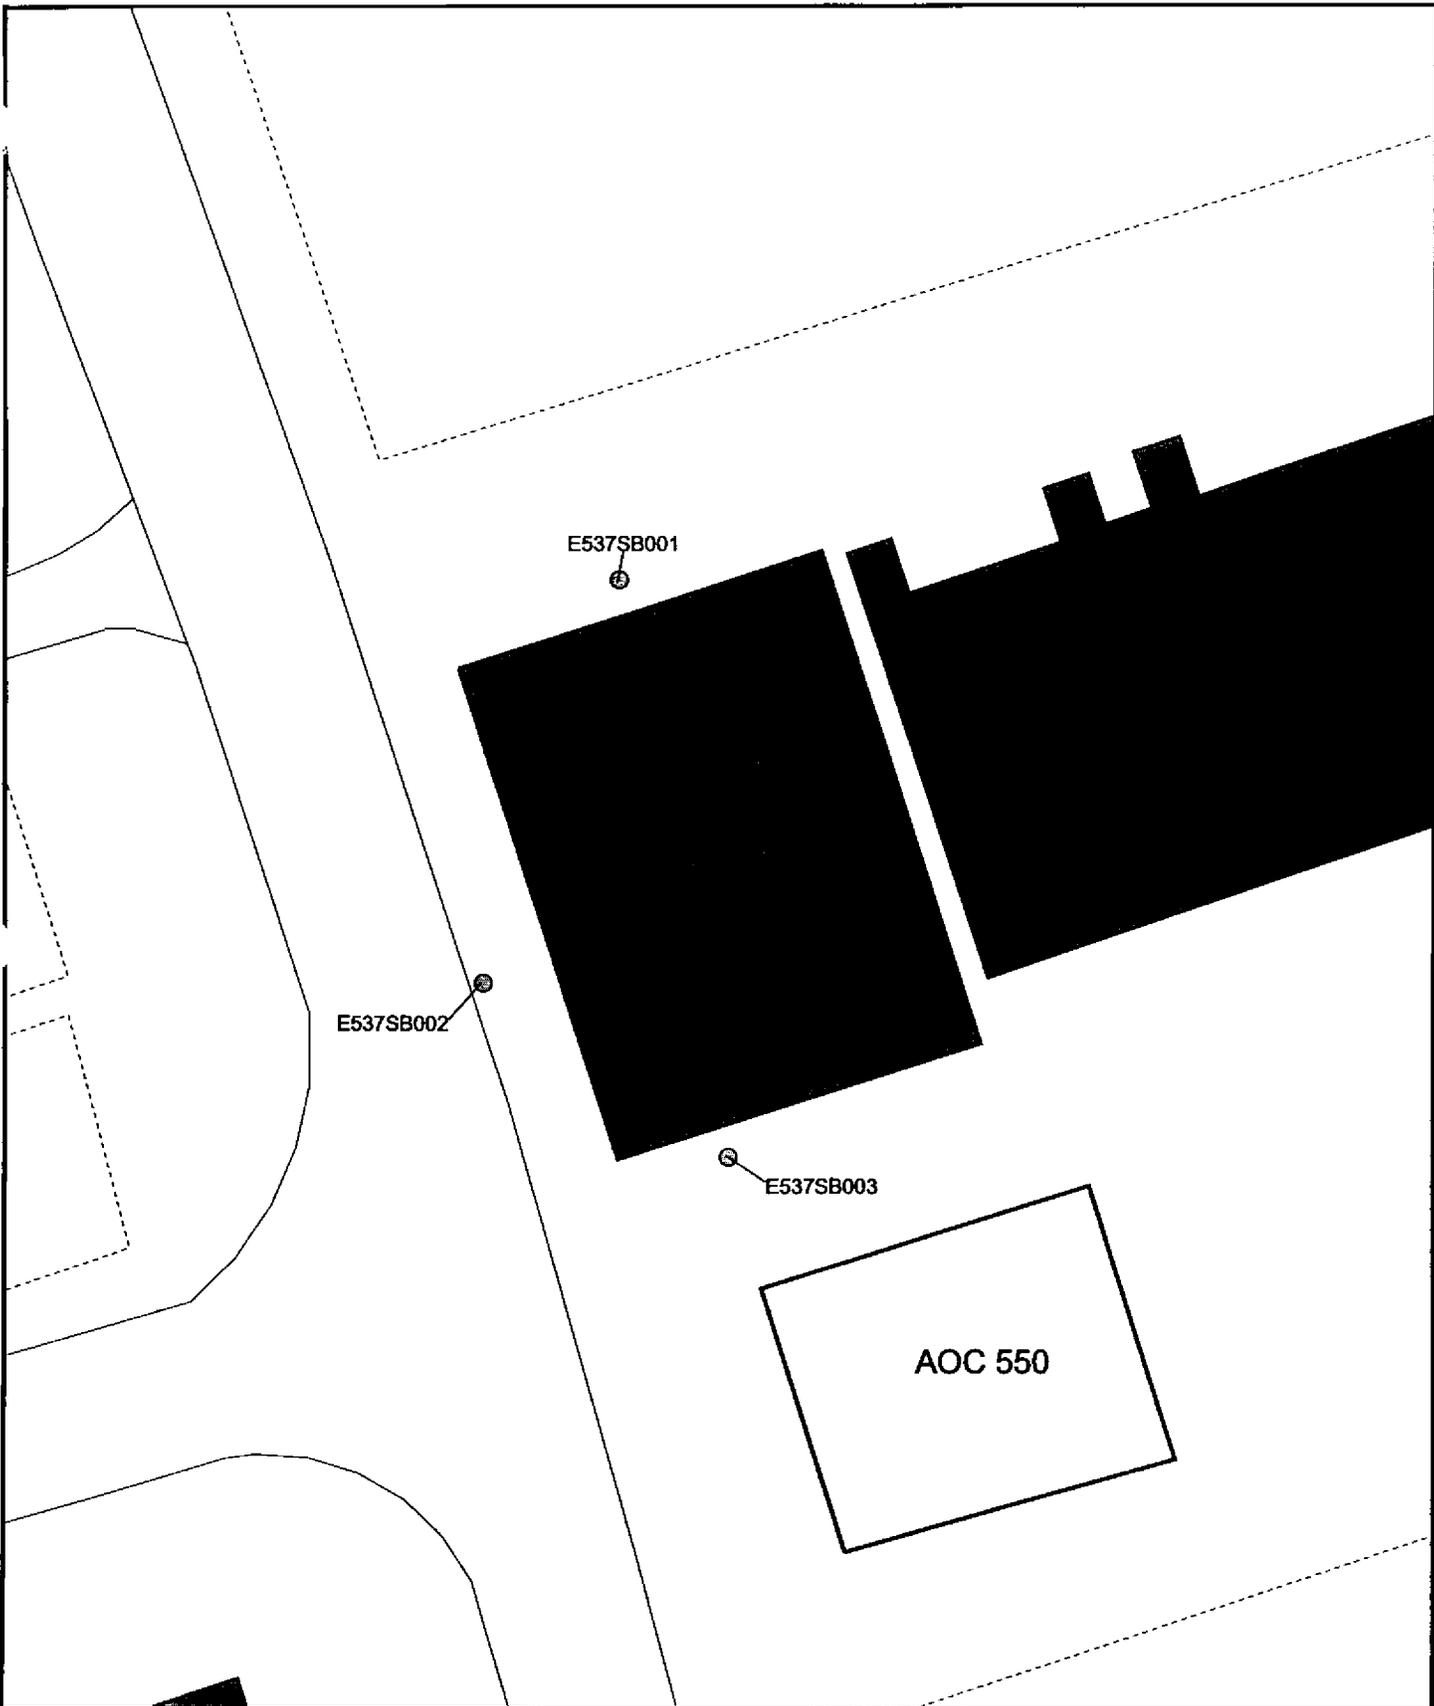
Figure 3-1
 Soil Sample Locations
 AOC 537, Zone E
 Charleston Naval Complex

In April 2002, CH2M-Jones mobilized the field team at AOC 537. The team was scheduled to collect surface and subsurface soil samples at three locations: E537SB001, E537SB002, E537SB003 (see Figure 3-1). A coring subcontractor, Penhall Drilling Co., was also present onsite to core through asphalt and an approximately 3.5-foot thick sublayer of run of crusher (ROC). After the coring was completed and the holes established, a hand auger was used to attempt to collect soil samples. However, buried obstructions were encountered at the bottom of the borehole at each location. In no instance was the field team able to penetrate the obstruction or to collect soil samples from the borings.

1 In response, CH2M-Jones tasked a drilling subcontractor, Columbia Technologies, to
2 attempt to conduct direct-push technology(DPT) sampling. The Columbia driller attempted
3 to punch through the subsurface obstructions utilizing a cone tip. After some hammering,
4 the cone tip was able to break through a 0.5-foot layer of asphalt (3 to 3.5 ft bls), but
5 immediately encountered hard quartz-like material that was believed to be concrete at 3.5 ft
6 bls. The material that was encountered below the buried asphalt prevented further
7 penetration, despite attempts made at one sample location (E537SB001). Appendix A
8 contains a technical memorandum that describes the attempts made to conduct the field
9 investigation at AOC 537. Appendix B contains photo documentation of field conditions at
10 AOC 537.

20 No surface or subsurface soil samples could be collected at AOC 537 due to the presence of
21 buried thick pavement and subsurface obstructions. In addition, visual observation of
22 conditions at this site did not reveal any evidence that a release had occurred. For these
23 reasons, CH2M-Jones determined that sample collection was not practical at this site.

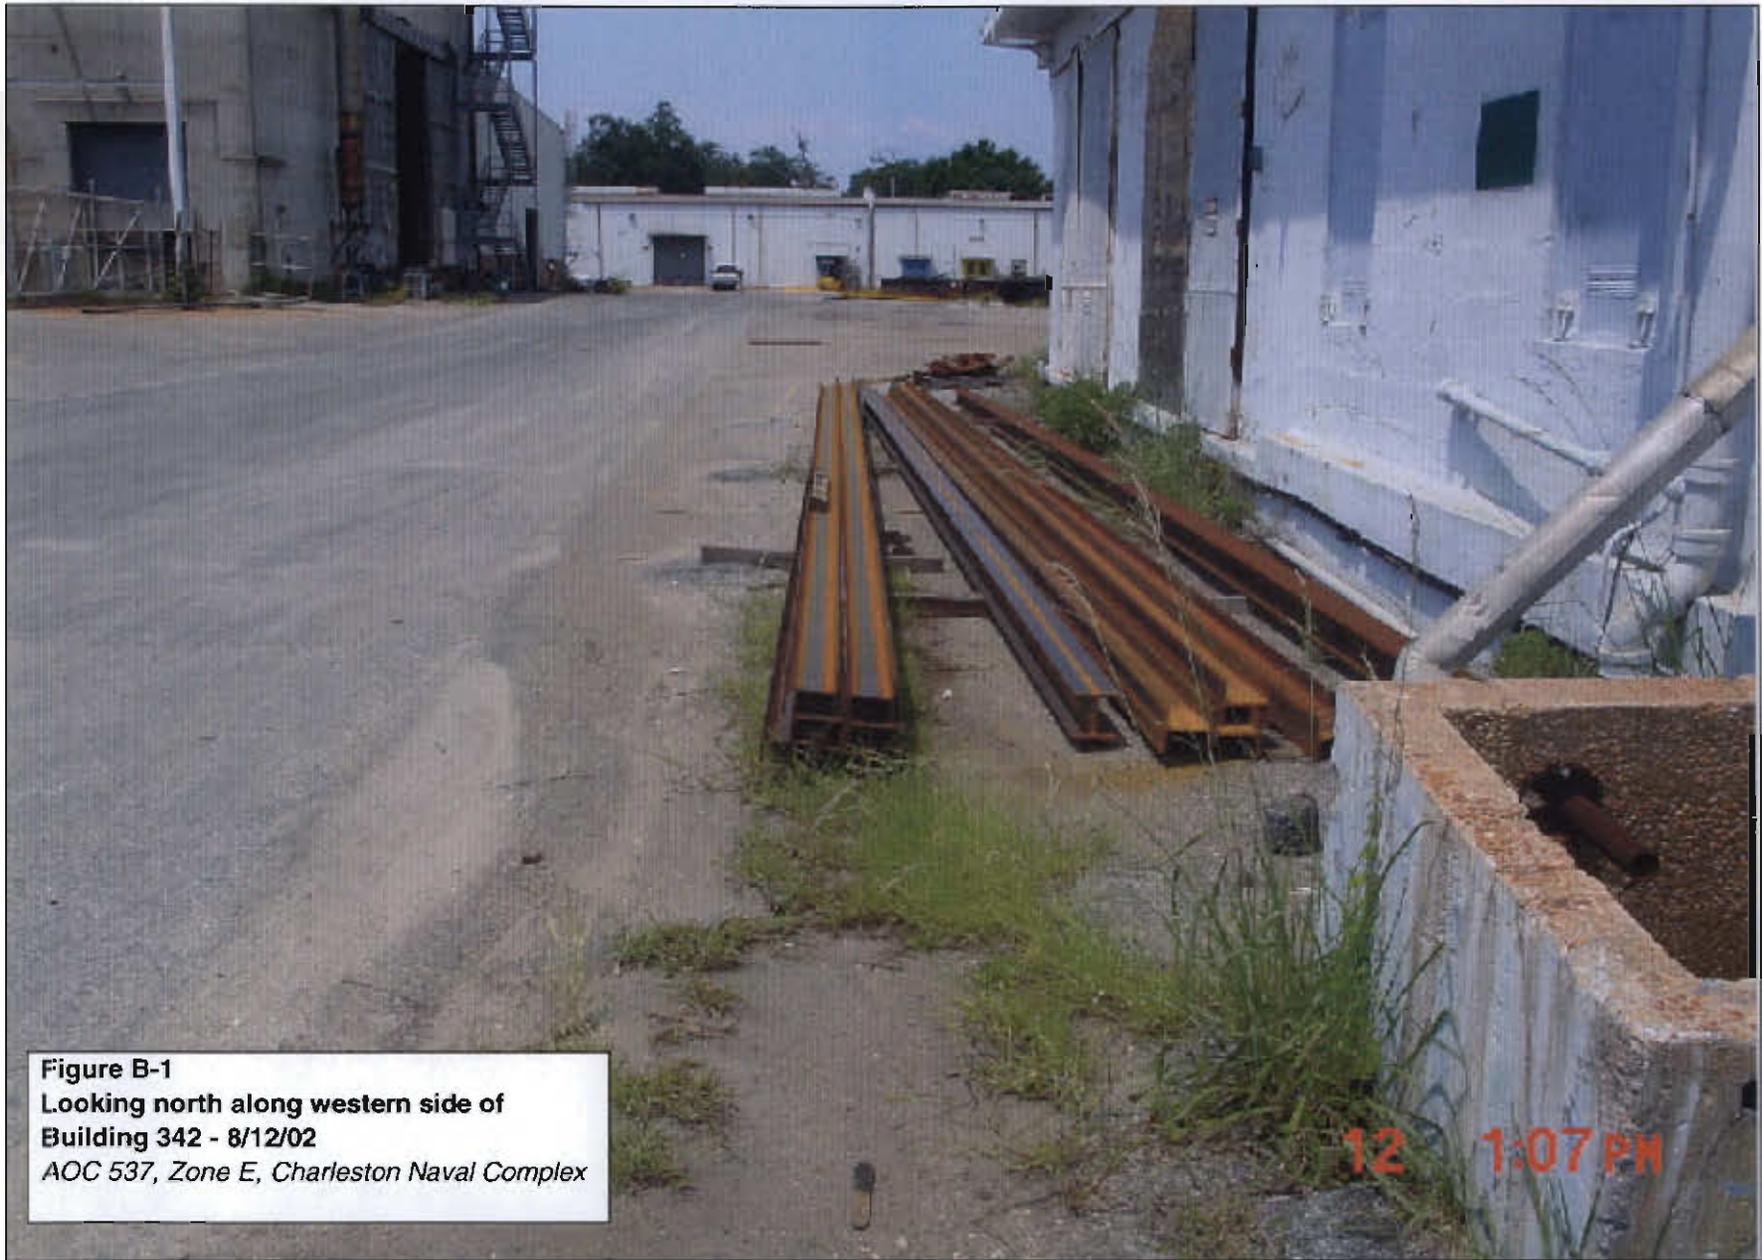
Figure B-1
Looking north along western side of
Building 342 - 8/12/02
AOC 537, Zone E, Charleston Naval Complex

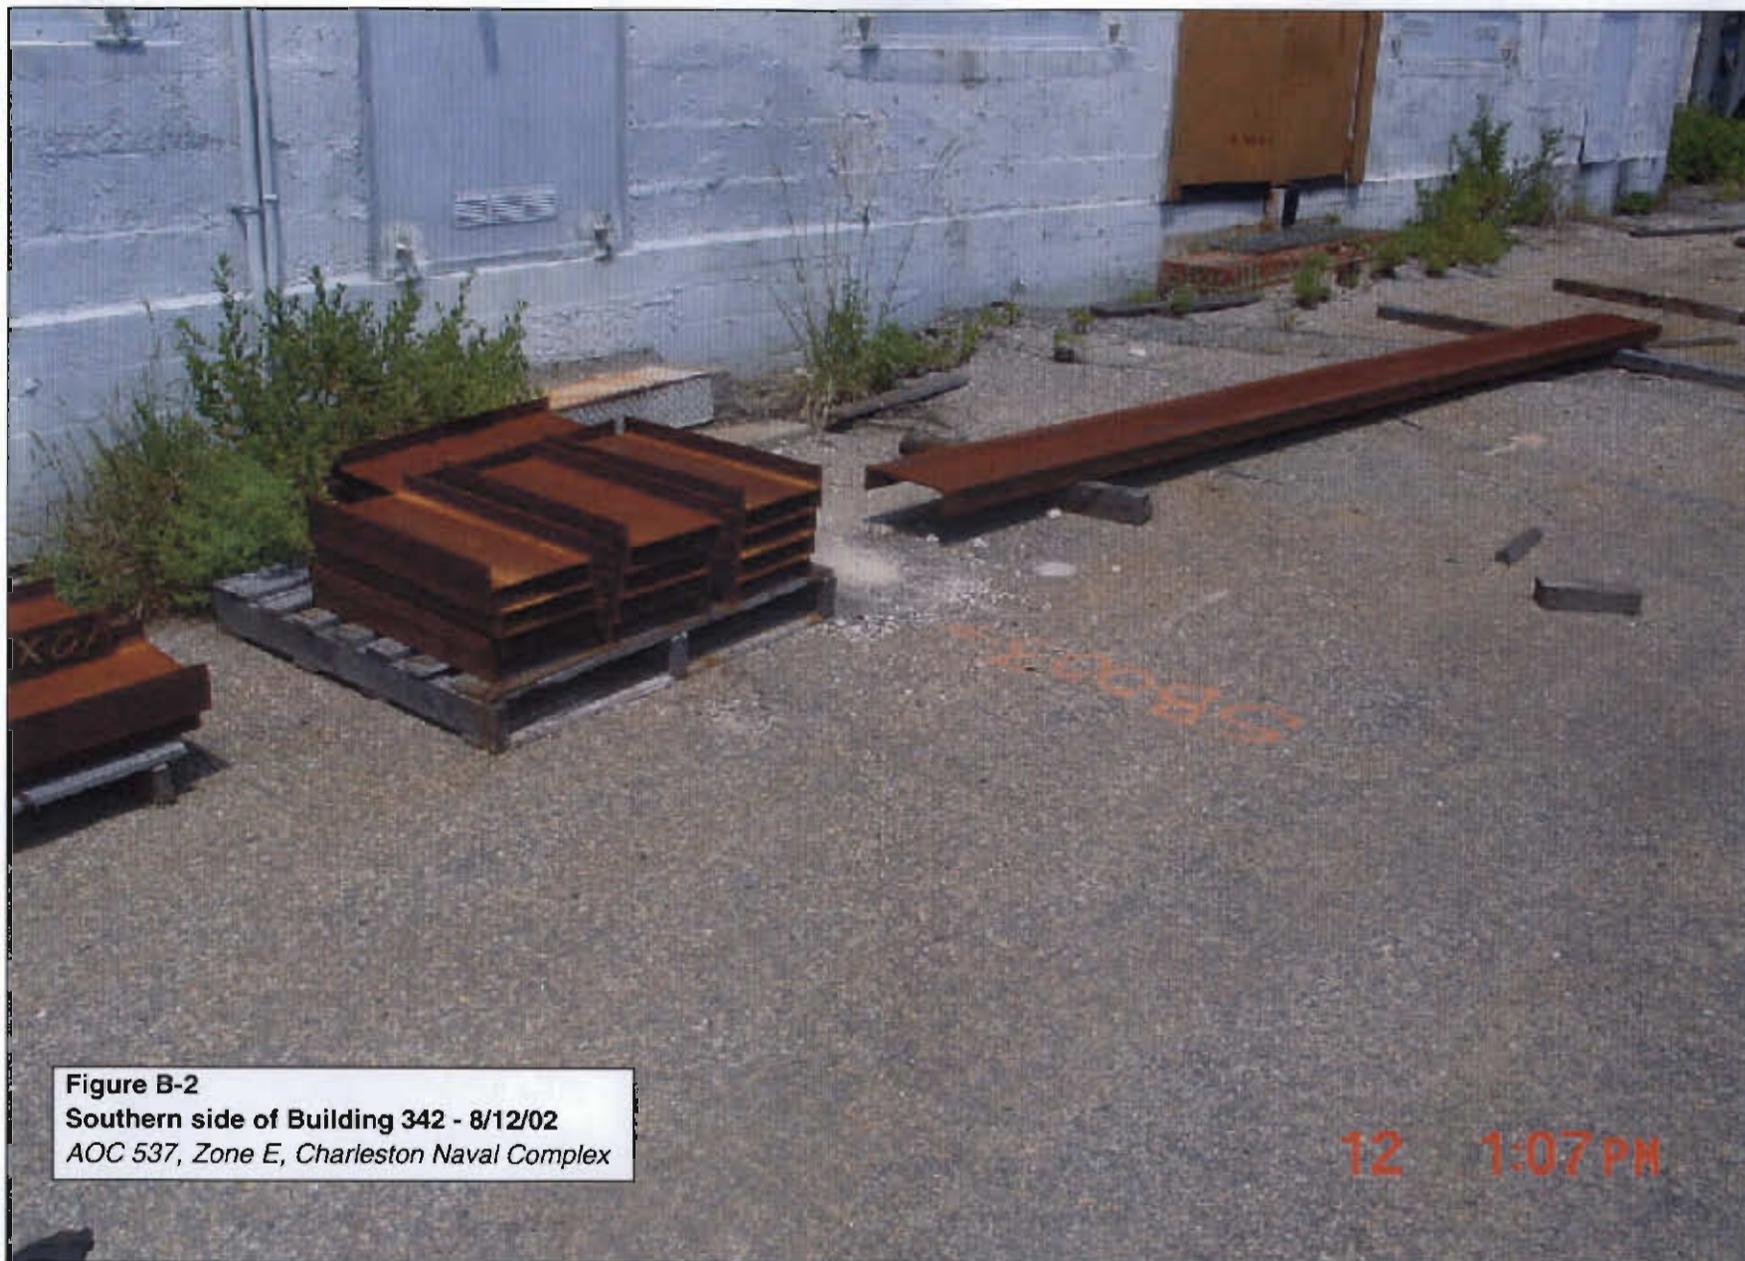
Figure B-2
Southern side of Building 342 - 8/12/02
AOC 537, Zone E, Charleston Naval Complex

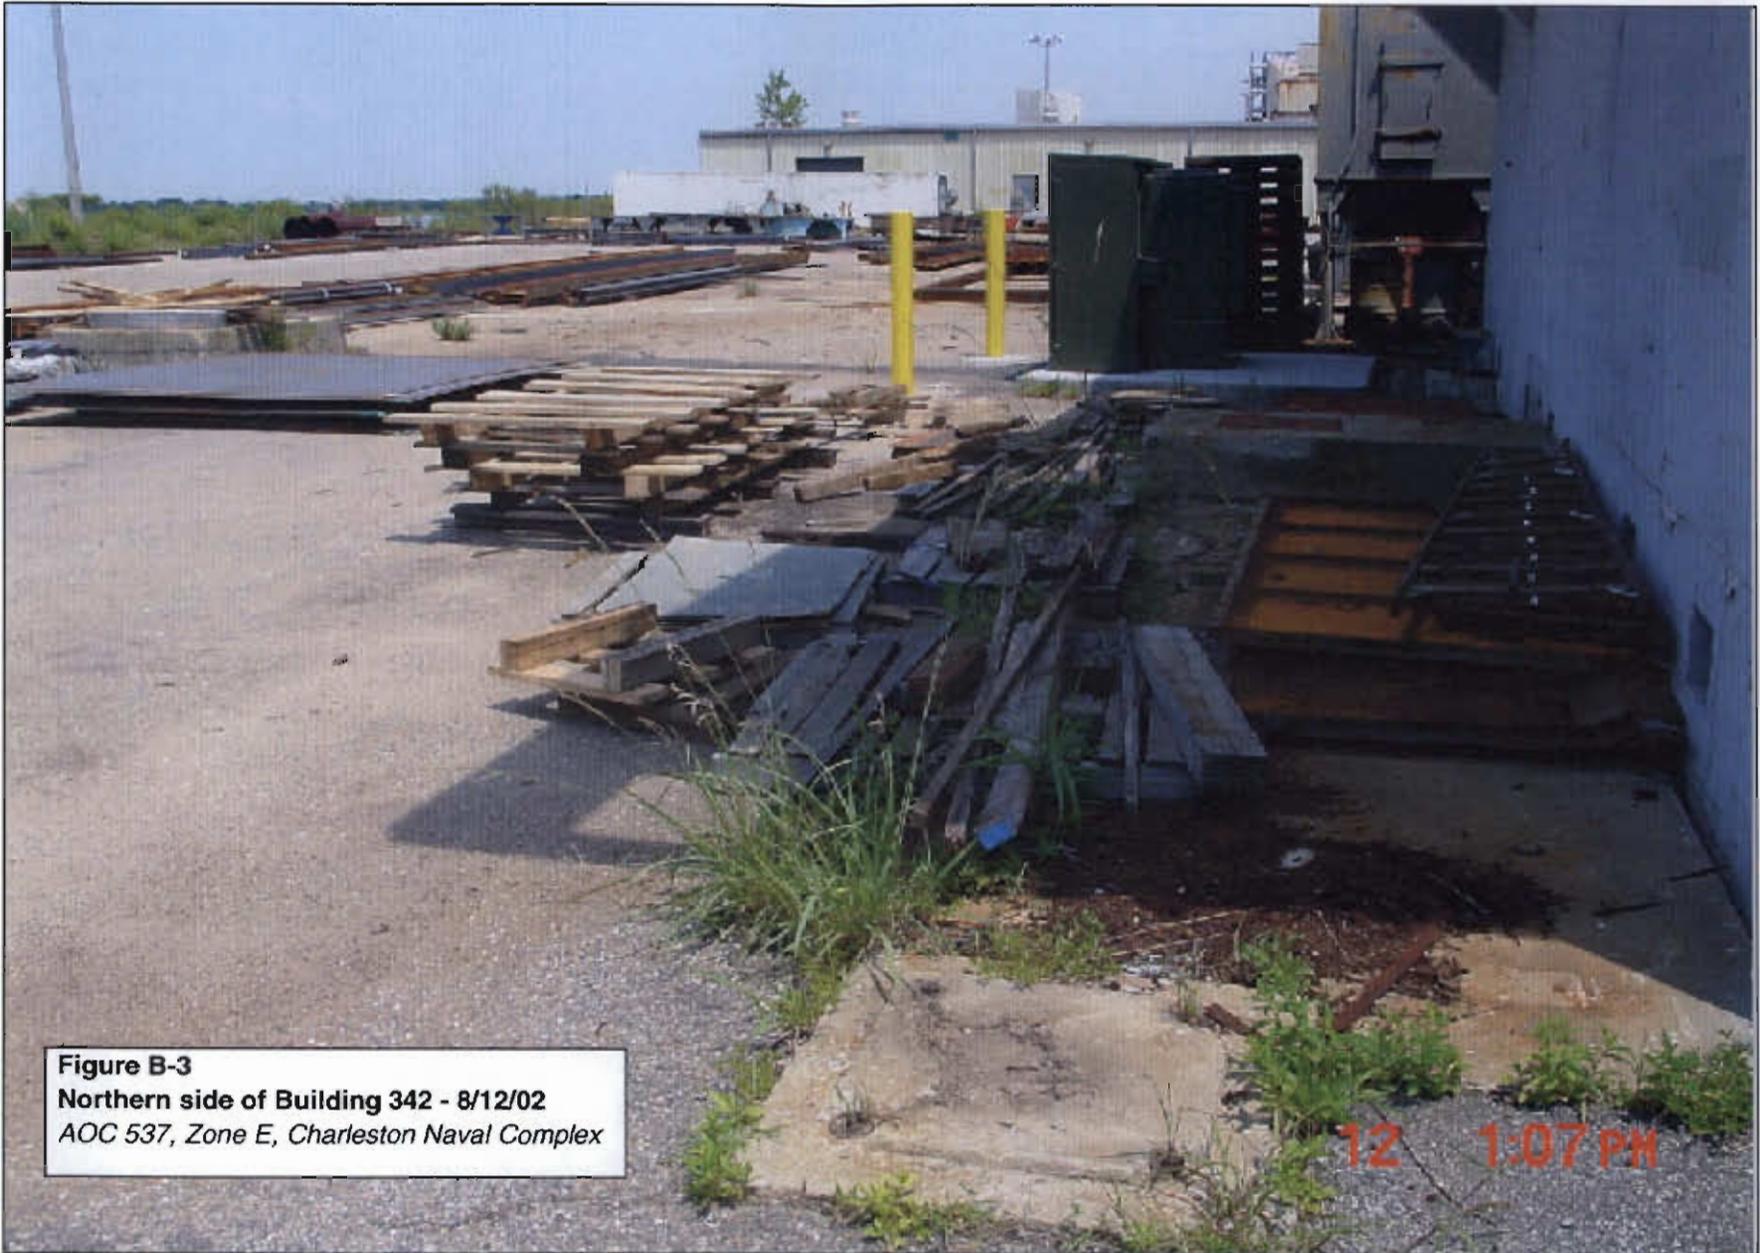
Figure B-3
Northern side of Building 342 - 8/12/02
AOC 537, Zone E, Charleston Naval Complex
