NAVAL NUCLEAR PROPULSION PROGRAM (NNPP) RADIOLOGICAL FINAL REPORT FOR  
DECOMMISSIONING VOLUME II SECTION J SUBSECTION 2.1 THRU SUBSECTION 3.22  
CNC CHARLESTON SC  
4/1/1996  
RADIOLOGICAL ENGINEERING DIVISION

NAVAL NUCLEAR PROPULSION PROGRAM (NNPP)  
RADIOLOGICAL FINAL REPORT  
FOR THE DECOMMISSIONING OF  
CHARLESTON NAVAL SHIPYARD

(VOLUME II)  
SECTION J

SUBSECTION 2.1  
THRU  
SUBSECTION 3.22

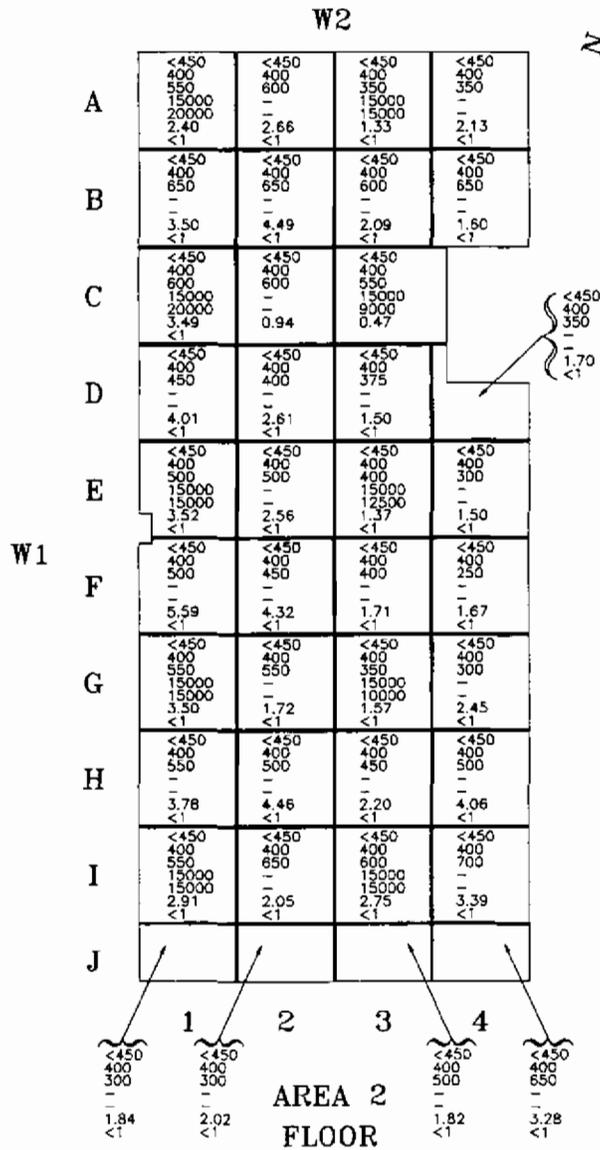
e. Localized Grid Maps

**Sample Data**  
 <450 – IM-247/PD Results [ $\mu\text{Ci}/20\text{cm}^2$ ]  
 200 – IM-253/PD (HV-1 PHA) [bkg.]  
 300 – IM-253/PD (HV-1 PHA) [cpm]  
 7000 – IM-253/PD (HV-2 GROSS) [bkg.]  
 7300 – IM-253/PD (HV-2 GROSS) [cpm]  
 1.82 – MCA Gross Gamma Eq. Co-60 [ $\mu\text{Ci/g}$ ]  
 <1 – MCA Specific Co-60 Results [ $\mu\text{Ci/g}$ ]

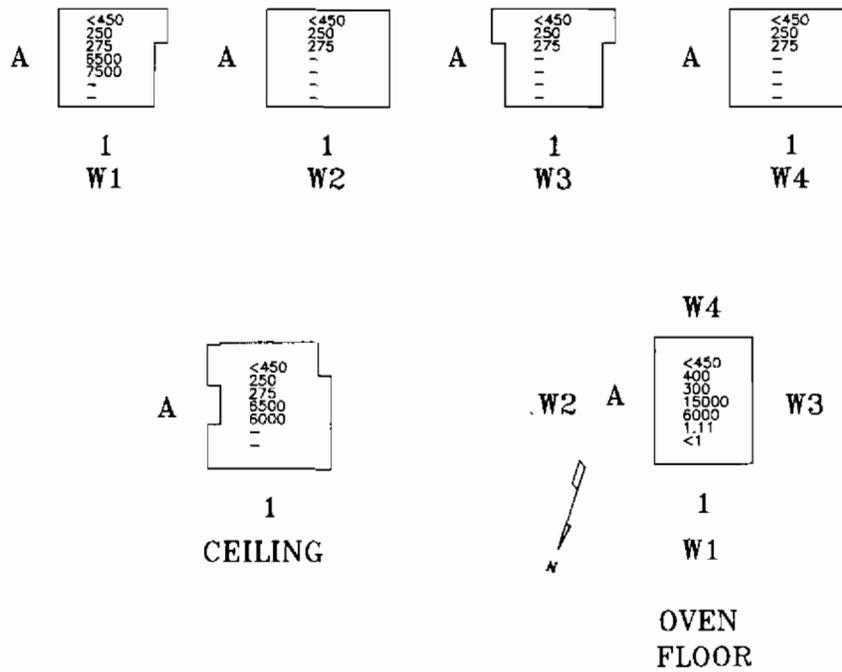
e. Localized Grid Maps

**Sample Data**  
 <450 -- IM-247/PD Results ( $\mu\text{Ci}/20\text{cm}^2$ )  
 200 -- IM-253/PD (HV-1 PHA) [bkg.]  
 300 -- IM-253/PD (HV-1 PHA) [cpm]  
 7000 -- IM-253/PD (HV-2 GROSS) [bkg.]  
 7300 -- IM-253/PD (HV-2 GROSS) [cpm]  
 1.82 -- MCA Gross Gamma Eq. Co-60 [ $\mu\text{Ci/g}$ ]  
 <1 -- MCA Specific Co-60 Results [ $\mu\text{Ci/g}$ ]

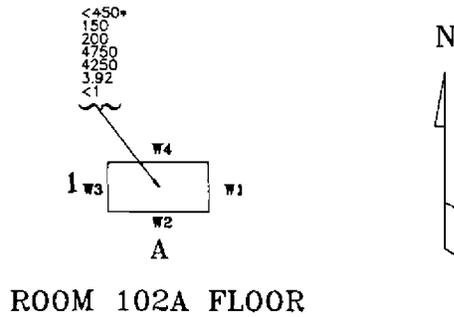
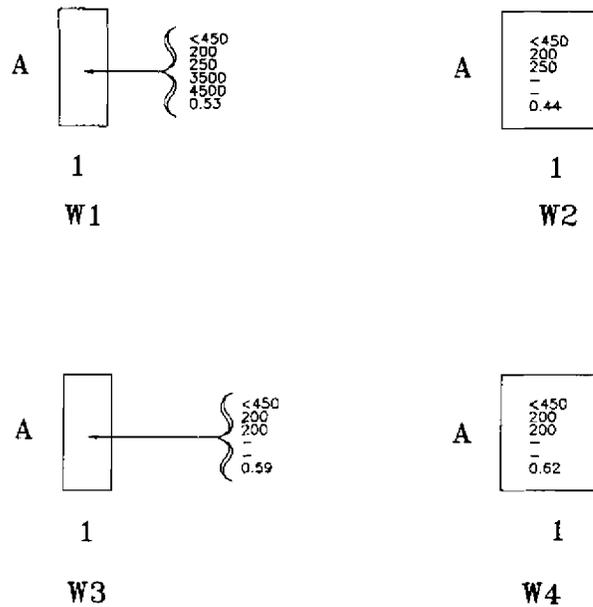
e. Localized Grid Maps

\*Denotes grids which were surveyed with an AN/PDR-56 for Alpha radioactivity and no detectable activity was found.

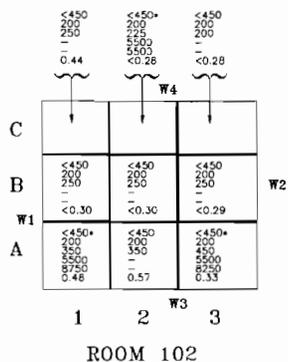
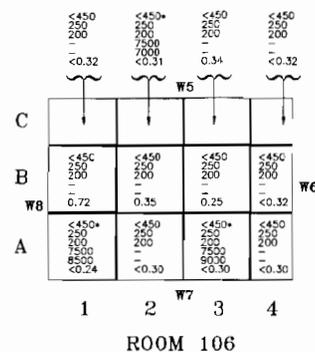
e. Localized Grid Maps

**Notes**  
 1 - Sample taken from Room 102 grid W4-A2 consisted of paint and has a limit of 3 pCi/g.  
 2 - \*Denotes grids which were surveyed with an AN/PDR-56 for Alpha radioactivity and no detectable activity was found.

**Sample Data**  
 <450 - IM-247/PD Results [ $\mu\text{Ci}/20\text{cm}^2$ ]  
 200 - IM-253PD (HV-1 PMA) [Bq.]  
 300 - IM-253PD (HV-1 PMA) [cpm]  
 7000 - IM-253PD (HV-2 GROSS) [Bq.]  
 7300 - IM-253PD (HV-2 GROSS) [cpm]  
 1.82 - MCA Gross Gamma Eq. Co-60 [pCi/g]  
 <1 - MCA Specific Co-60 Results [pCi/g]

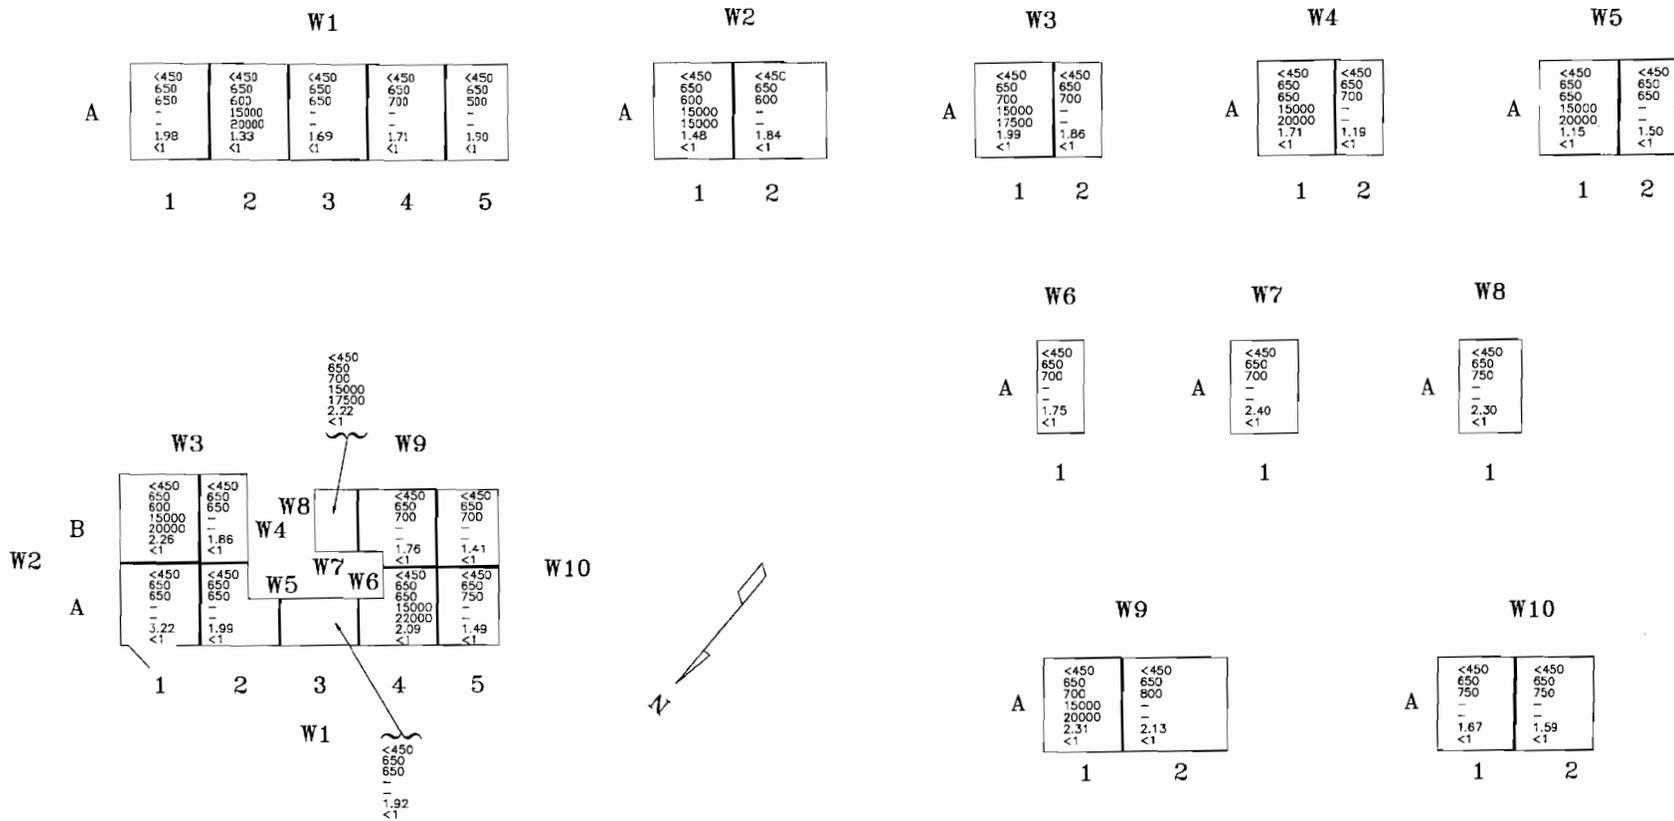
e. Localized Grid Maps

**Sample Data**  
 <450 - IM-247/PD Results (µCi/20cm²)  
 200 - IM-253/PD (HV-1 FHA) [Bq/L]  
 300 - IM-253/PD (HV-1 FHA) [cpm]  
 7000 - IM-253/PD (HV-2 GROSS) [cpm]  
 7300 - IM-253/PD (HV-2 GROSS) [cpm]  
 1.82 - MCA Gross Gamma E<sub>γ</sub> Co-60 [pCi/g]  
 <1 - MCA Specific Co-60 Results [pCi/g]
