COMPLETION REPORT FOR INTERIM MEASURE FOR AREA OF CONCERN 696 (AOC696)
WITH TRANSMITTAL CNC CHARLESTON SC
1/27/1998
U S NAVY

COMPLETION REPORT

INTERIM MEASURE FOR
AOC 696
NAVAL BASE CHARLESTON
CHARLESTON, SC

January 27, 1998

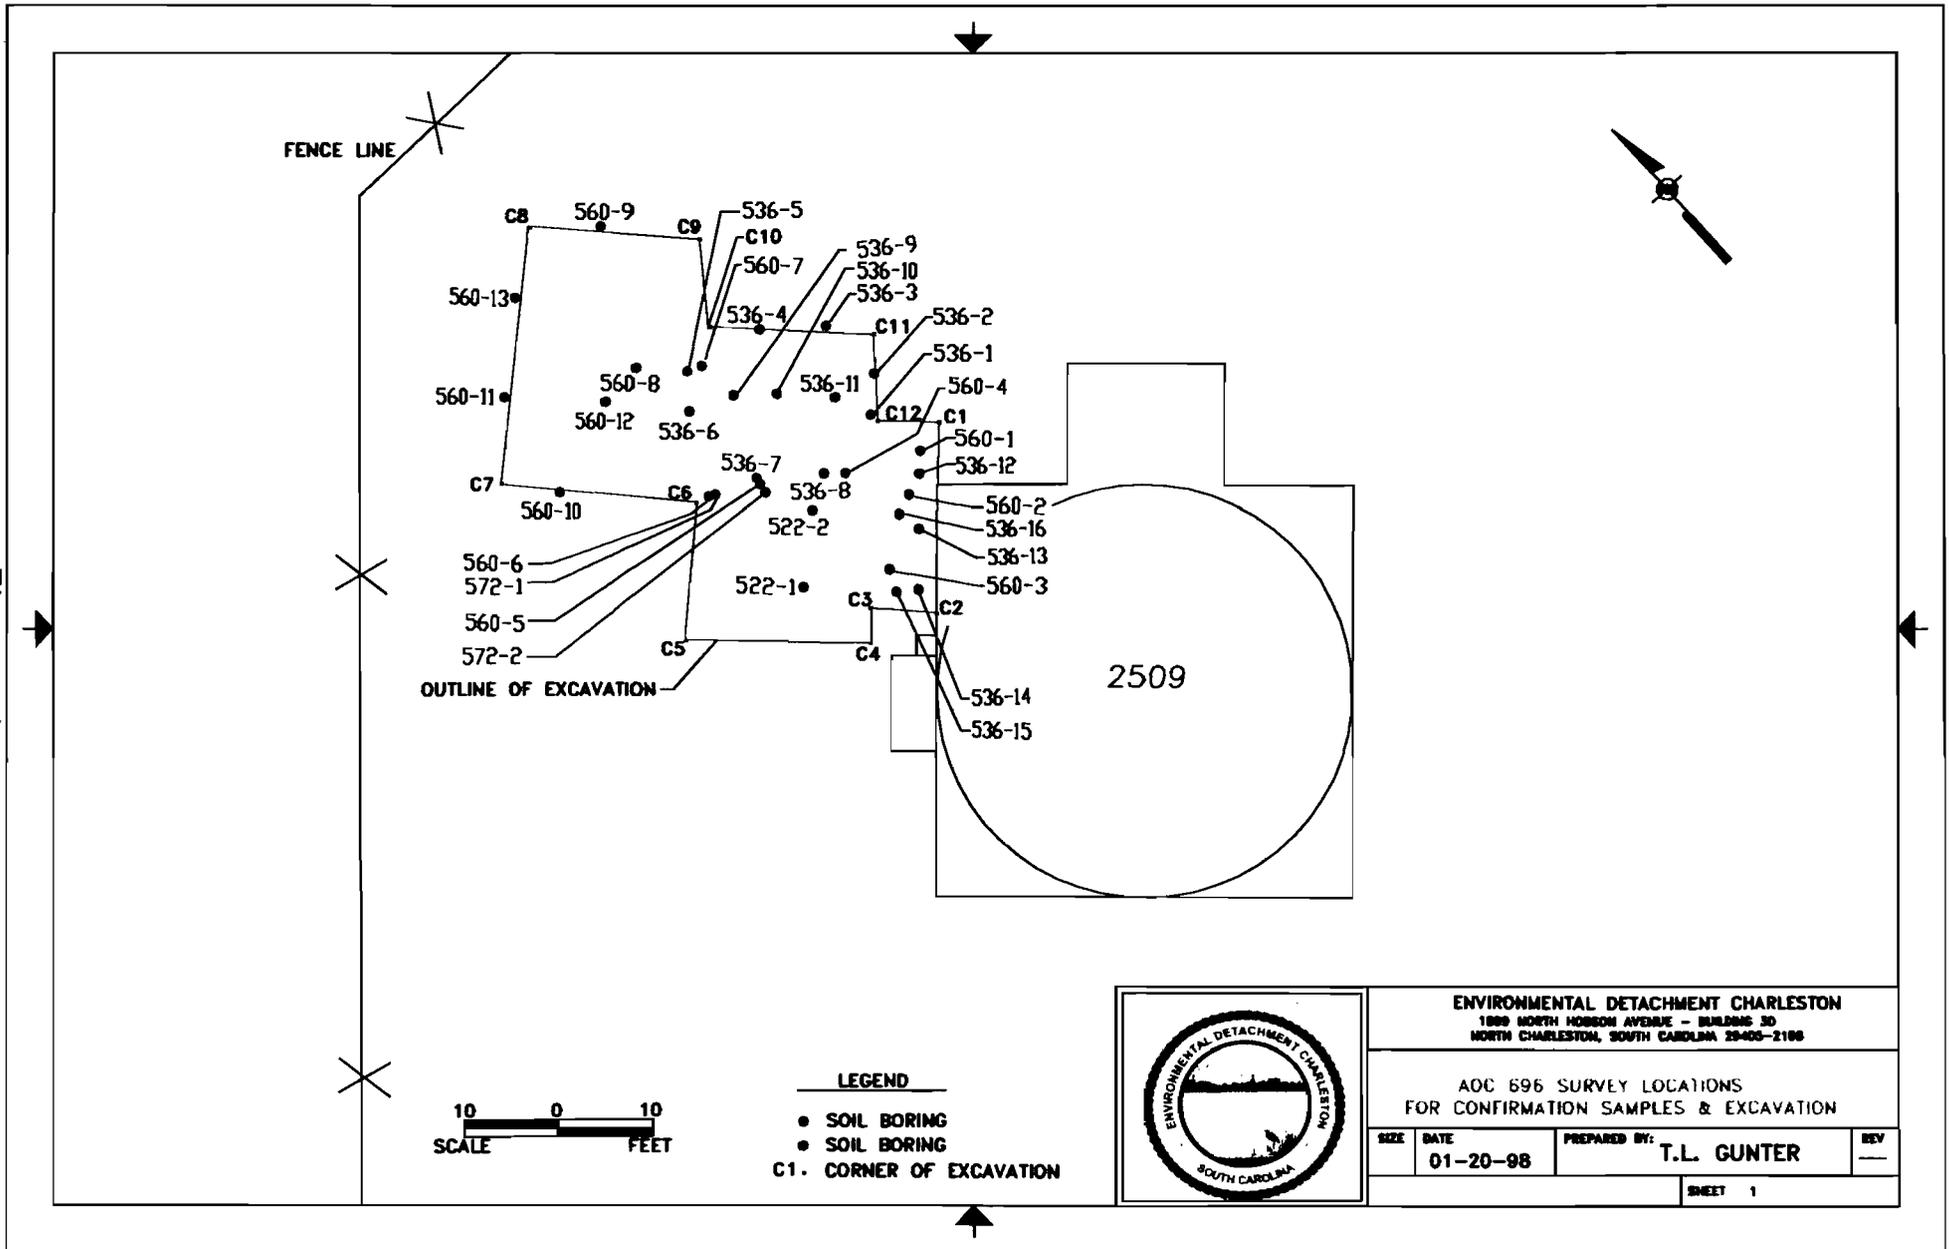
(SPORT0536-1 through SPORT0536-11) were collected from the PCB contaminated area as shown in Figure 1 in Appendix B. Samples were also collected from the side walls and center of the excavated area. See Table 4-2 for results in Appendix B. Elevated levels of Arsenic and PCBs were reported from the first round confirmation sampling. After excavating these areas, another round of confirmation sampling was performed on 30 October 1997. Elevated levels of PCB's of 1.1 and 3.1 ppm respectively were reported. After excavating these areas confirmation samples were collected from each area on 18 November 1997 with the results below clean levels directed for this site.

**Survey Data
(See Figure 1)**

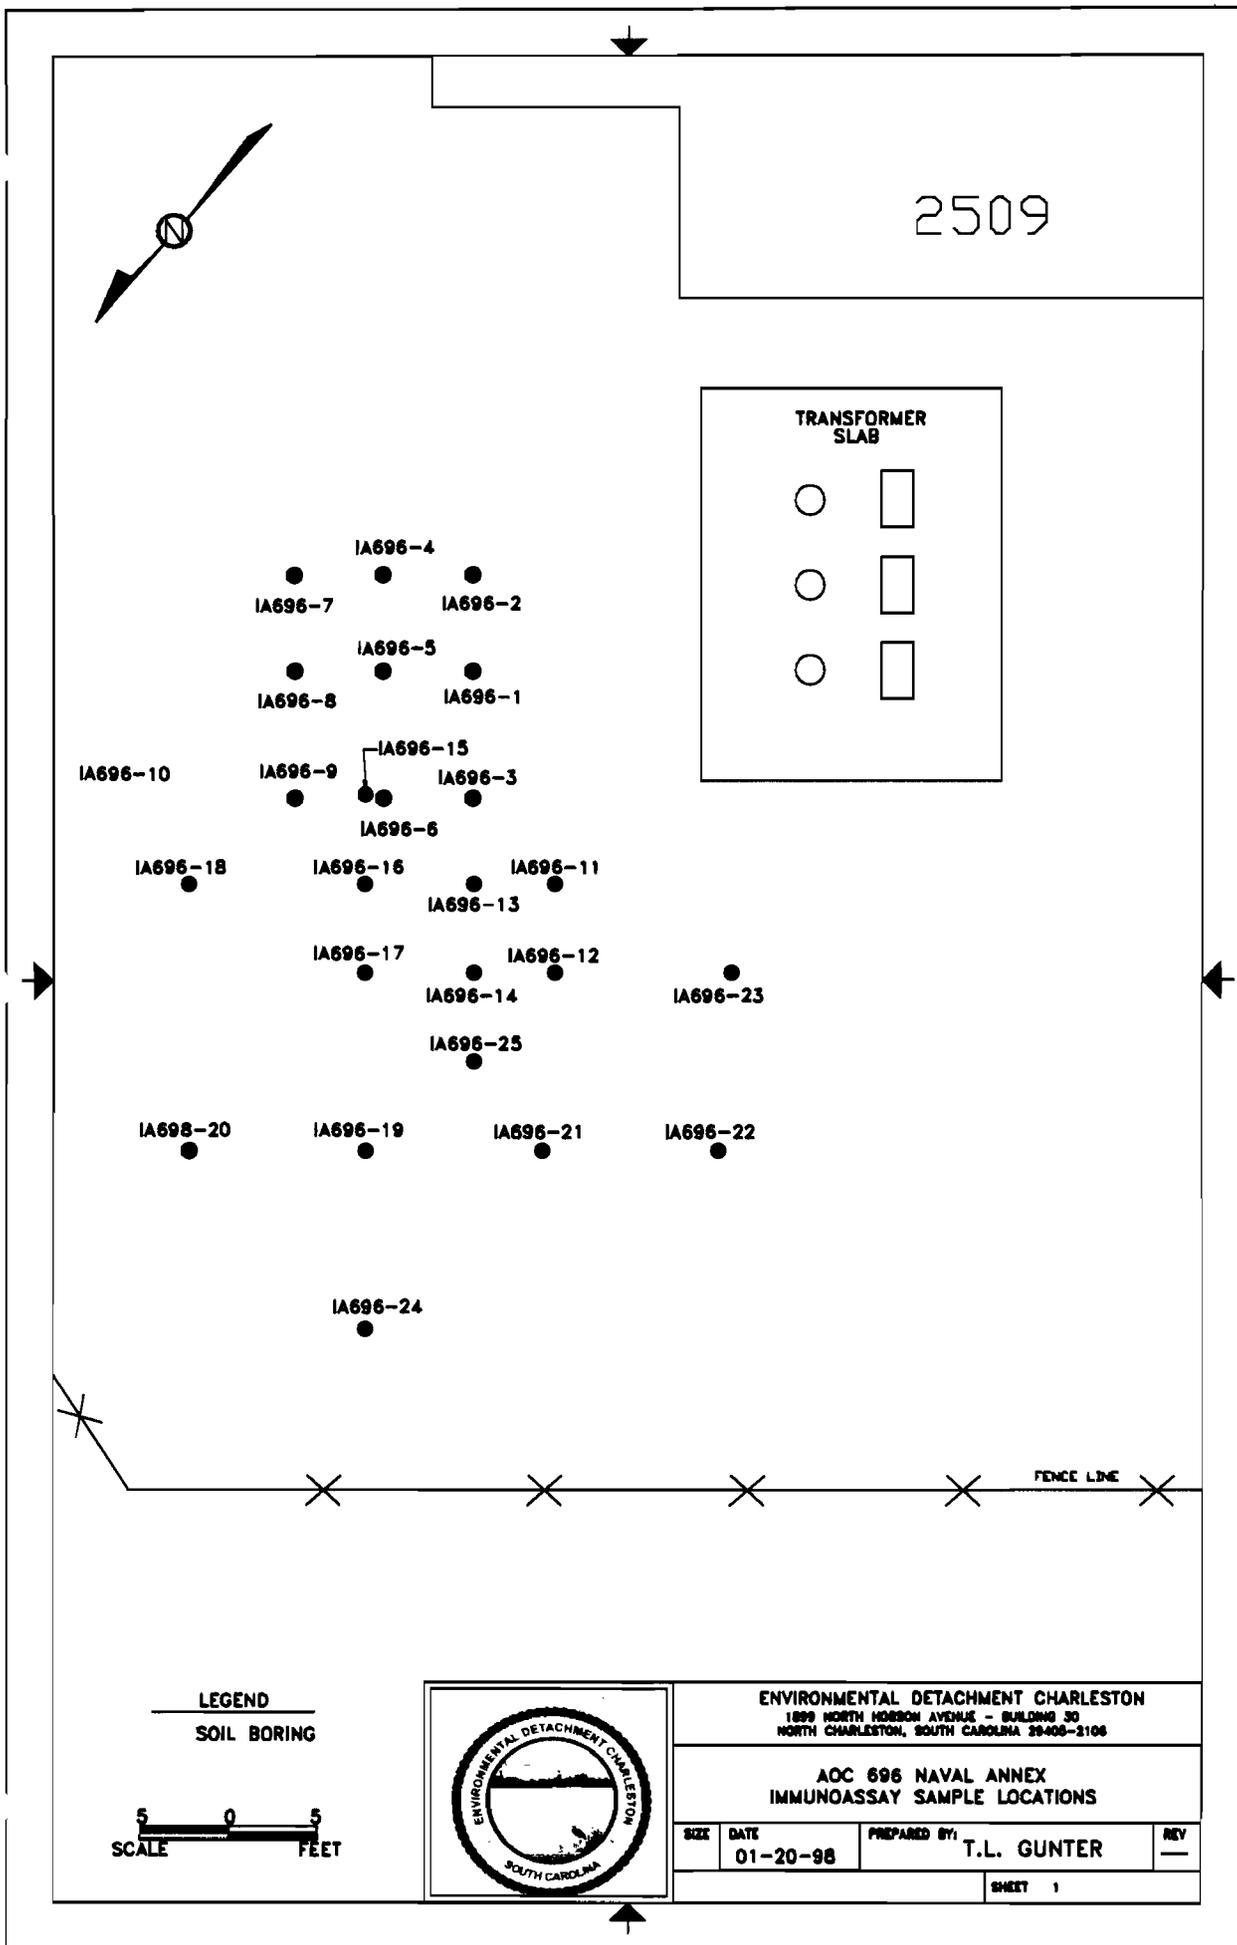
4.1.1 Soil Screening. On 18 September 1997, three soil samples were collected and analyzed using the ENSYS Inc. PCB (Rapid Immunoassay Screen) RIS[®] TEST for On-Site Testing of PCB's in Soil as the screening method. The immunoassay limit for PCB detection in soil for this screening method is a minimum detection of 1 ppm and a maximum detection of 5 ppm. These samples (IA-1, IA-2 and IA-3) were the initial site delineation for PCB contamination before removal activities. Results indicated levels greater than 1 ppm but less than 5 ppm PCBs. These results prompted more investigative sampling which seven samples were collected on 23 September 1997 (IA-4 through IA-10) and analyzed using the same screening method. Based on these results (see Table 4-1 in Appendix B), the initial excavations were conducted. See Figure 2 of Appendix B for locations. Due to the confirmation sampling results from the initial excavations, more investigative sampling was required northeast and west of the excavation for PCBs. On 17 and 23 October 1997, a total of 14 samples (IA12 through IA25) were collected to delineate extent of PCB contamination northwest of the initial excavation. Based on results of the immunoassay testing performed on these samples, the extended excavation area was determined. See Table 4-1 in Appendix B for results and Figure 2 in Appendix B for locations.

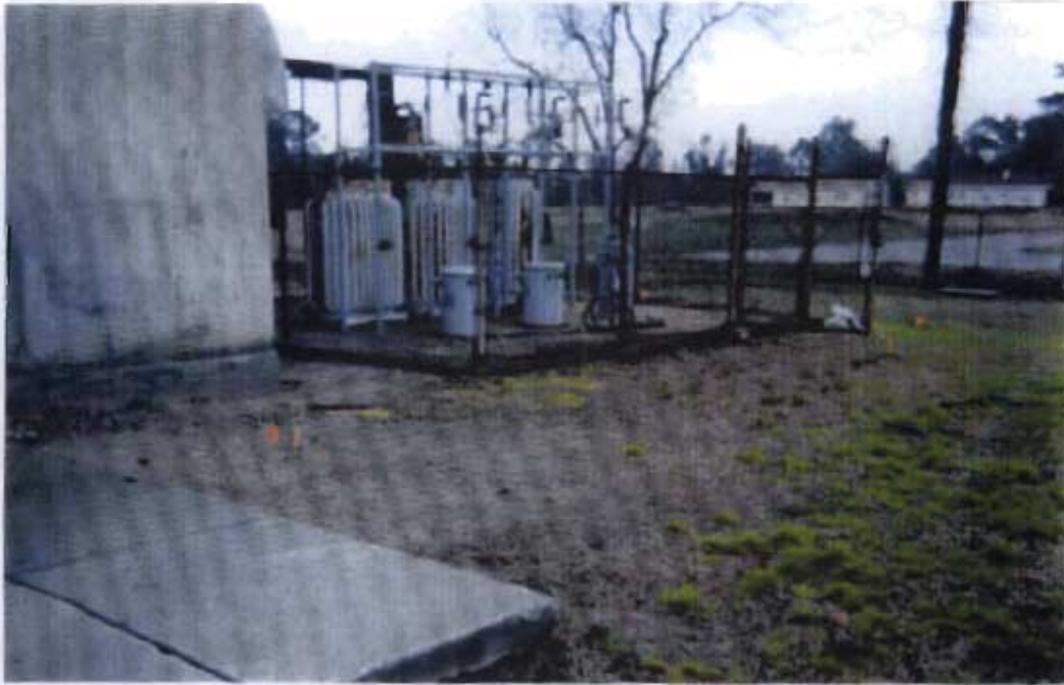
Transformer station facing west.

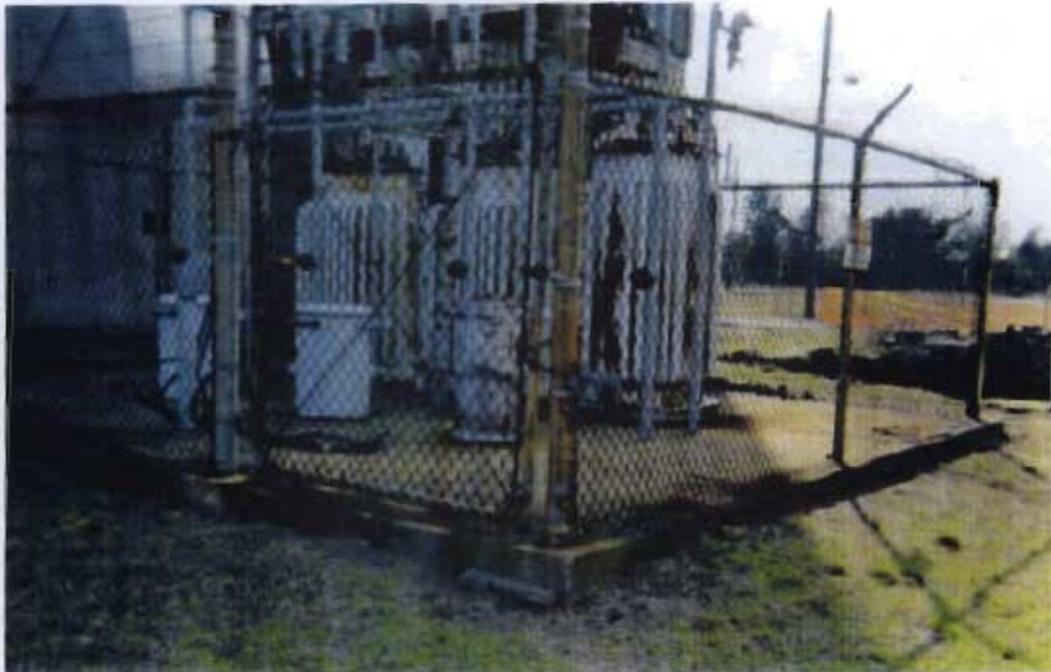
Transformer station facing south. Three 500 lb transformers are visible in foreground, the three 4500 lb transformers are in the background.

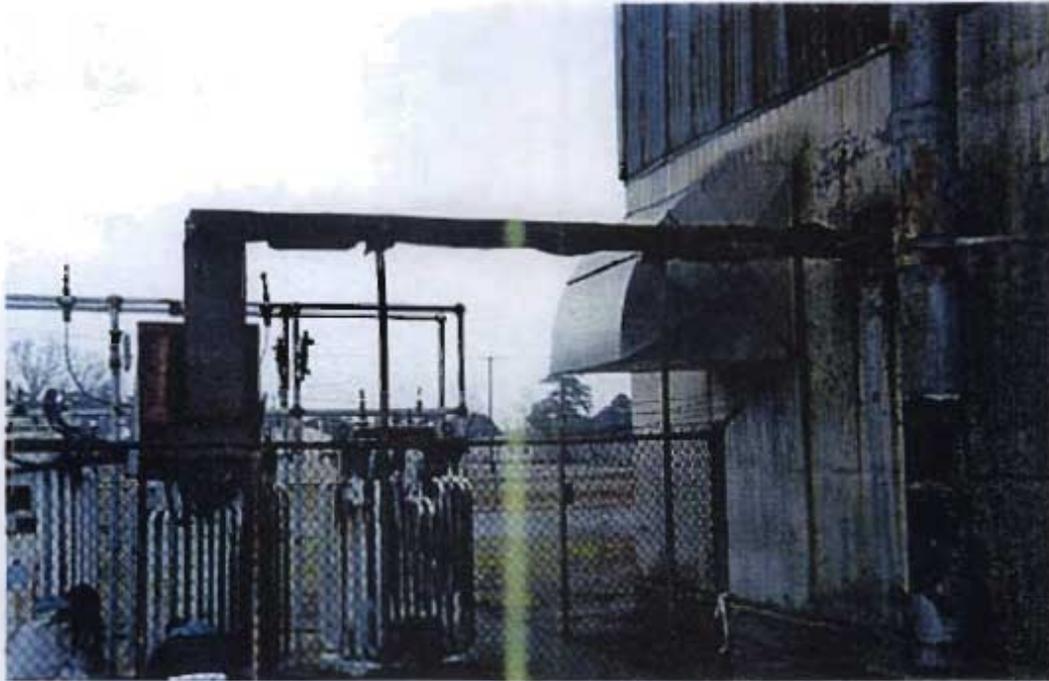
Transformer Station Demolition. Utilities were secured by South Carolina Electric and Gas (SCE&G) before demolition. Fire damage was visible on two of the three 4500 lb. transformers as well as all the associated electrical cables and busbar. Concrete samples were collected in stained areas in the vicinity of the concrete slab and analyzed for PCB content. Results indicated no PCB contamination on the surface of the concrete slab. The concrete slab was removed with earth moving equipment and placed into construction debris containers. An approximate 6 inch depth of crushed rock was discovered underneath the concrete slab. This was removed and disposed accordingly.

**Transformers damaged by fire, building 2509 is to the right.
Facing northwest.**

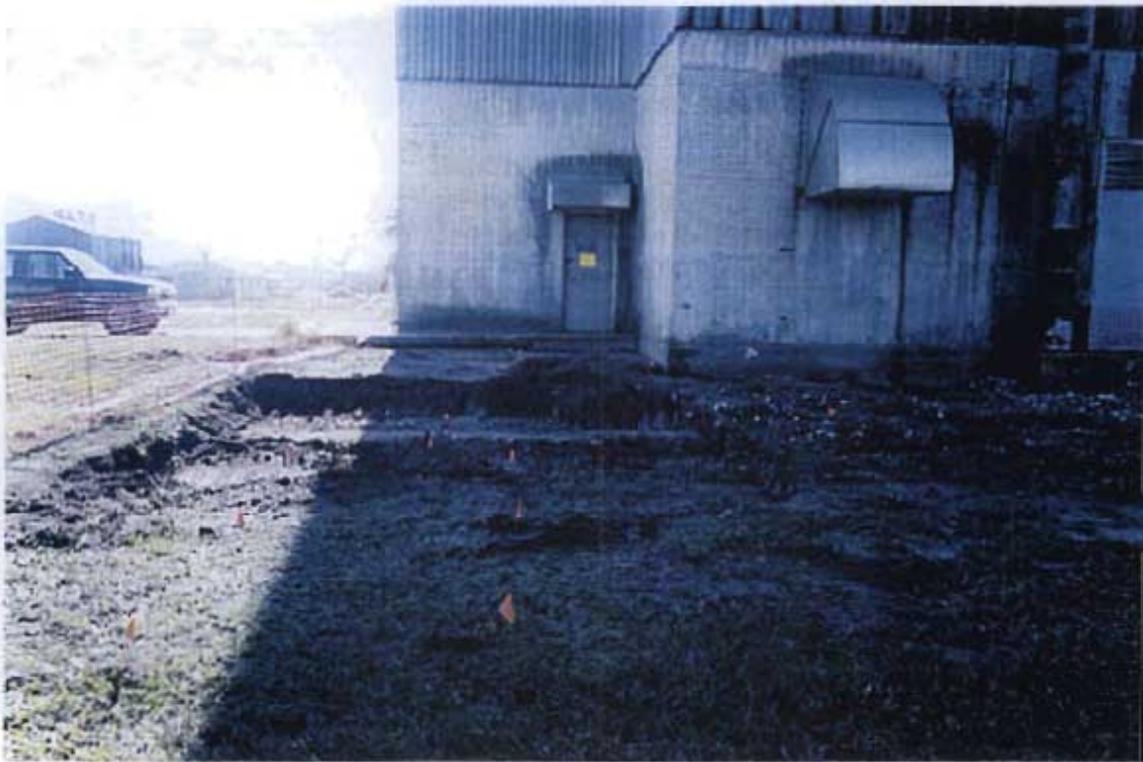
Area excavated on 02 October 1997, building 2509 in background.

2.2.2 Excavation. Soil removal was executed on 02 October 1997 and completed the same day. Soil removal from the two impacted areas were conducted under the specifications of the IM Work Plan (See Figure 1 of Appendix D). The impacted soil was removed with earth moving equipment and placed directly into haul trucks for transportation to the approved Subtitle D landfill. The depth of excavation was approximately 1 foot BLS for each area. Groundwater was not encountered during removal. Confirmation sampling indicated concentrations of arsenic and PCBs above the recommended clean levels (beryllium was within the clean levels) outlined in the IM Work Plan for each area excavated. Therefore, delineation of each area was required to determine further soil removal volumes beyond the original scope of this IM. Immunoassay kits for PCBs were used to delineate the extent of contamination northwest of the excavation as shown in Figure 2 of Appendix B. The area impacted by arsenic and beryllium was not delineated, however, past investigative data was used to estimate volumes for excavation. On 30 October 1997, approximately 29 cubic yards of soil still containing elevated levels of arsenic and PCBs were removed and disposed accordingly. Confirmation samples to be analyzed for arsenic and PCBs were collected the same day and processed by a certified laboratory. Two samples reported elevated levels of PCBs. The soil in these areas were removed and confirmation samples collected later reported no PCB contamination. See Figure 1 in Appendix D for excavated areas.

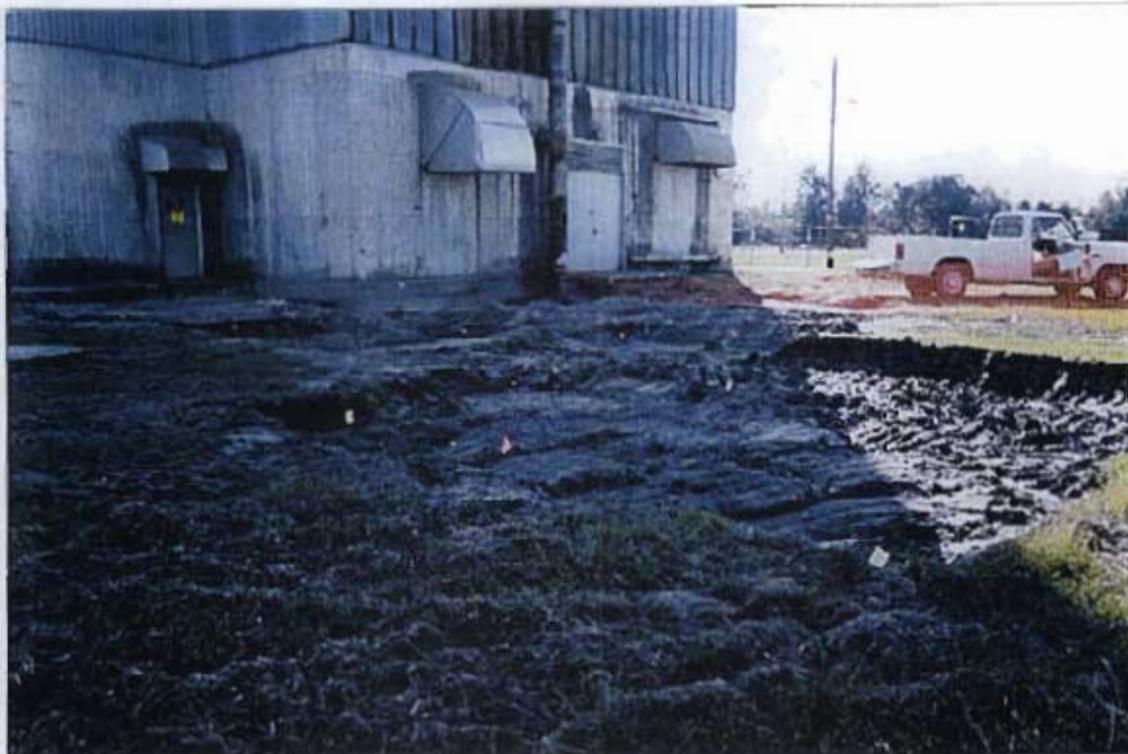
Area excavated on 30 October 1997, facing south.

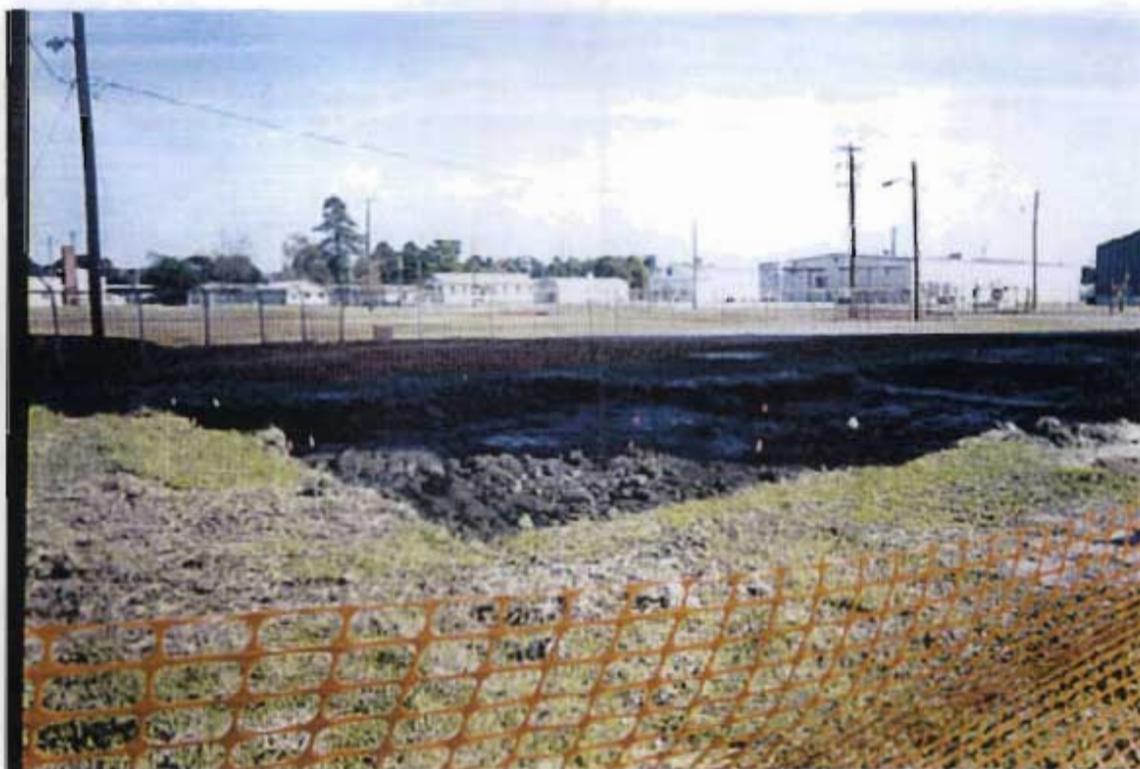
Area excavated on 30 October 1997, facing east.

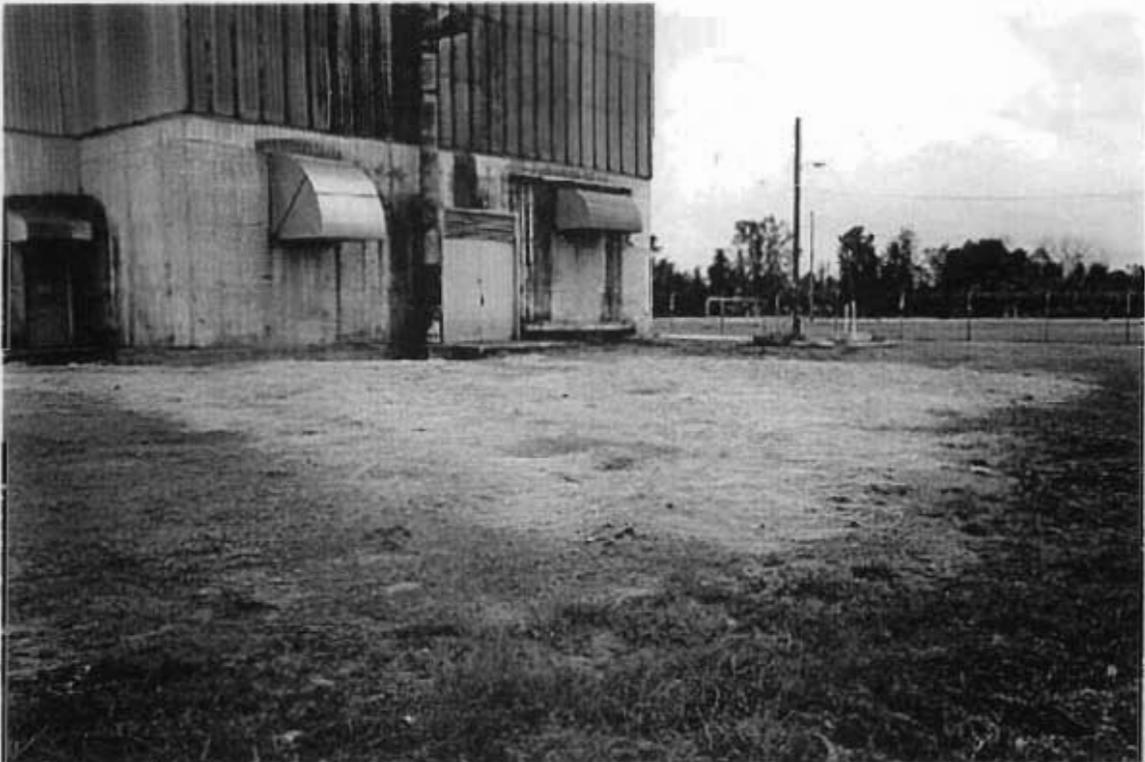
Site conditions upon completion of excavation activities, building 2509 in background.

3.1 SITE CONDITIONS FOLLOWING COMPLETION OF WORK. Following completion of all site work on 26 November 1997, the DET had accomplished removal of PCB, arsenic, and beryllium contaminated soil and demolition/removal of the transformer station. The excavated areas and the former transformer station area were back filled, graded to existing conditions and seeded with grass.
