COMPLETION REPORT INTERIM MEASURE FOR SOLID WASTE MANAGEMENT UNIT 42
(SWMU42) FORMER ASPHALT PLANT TANKS WITH TRANSMITTAL CNC CHARLESTON

**INTERIM MEASURE FOR
SWMU 42 FORMER ASPHALT PLANT TANKS
NAVAL BASE CHARLESTON
CHARLESTON, SC**

July 17, 1997

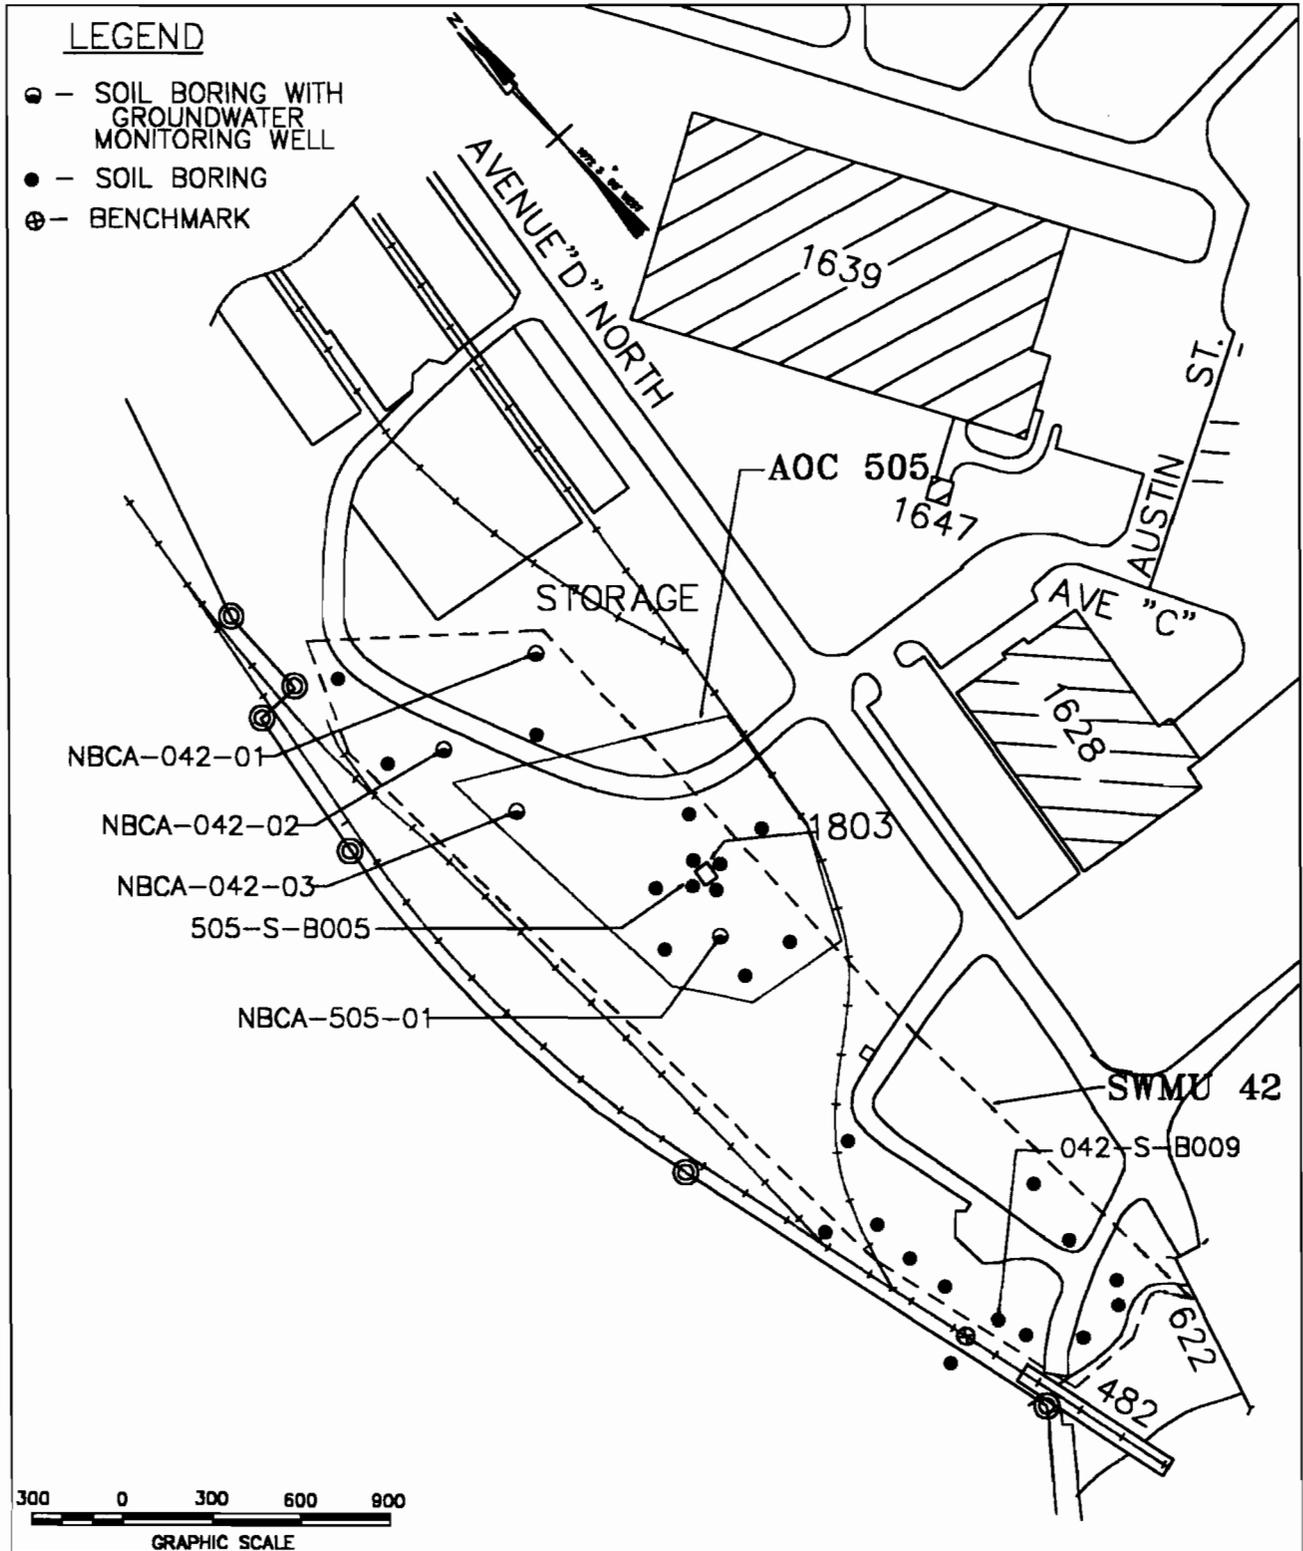
FIGURE A-1
SWMU 42 SITE MAP

1.3 SOLID WASTE MANAGEMENT UNIT 42. SWMU 42 is located in Zone "A", north of Noisette Creek. Figure A-1 of Appendix A illustrates the site. This SWMU consists of a former asphalt plant, associated tanks and storage area. The unit operated from 1947 until 1962 and has since been demolished. Since the unit was taken out of service in the late 1960s into the early 1970s, little information was obtain about dimensions, design features, operating practices, or waste disposal methods. The site currently contains Building 1803, a Golf Course

2.1 ACTIONS REQUIRED BY INTERIM MEASURE WORK PLAN. Removal was performed on an estimated 5.4 cubic yards of lead contaminated soil. This contaminated soil had lead levels greater than 400 ppm. Required action included excavation from the following areas. Excavation locations are shown on Figure A-1.

- Soil boring 505-S-B005 was excavated to an area approximately 6' x 6' and 2 foot in depth.
- Soil boring 042-S-B009 was excavated to an area approximately 6' x 6' and 2 foot in depth.

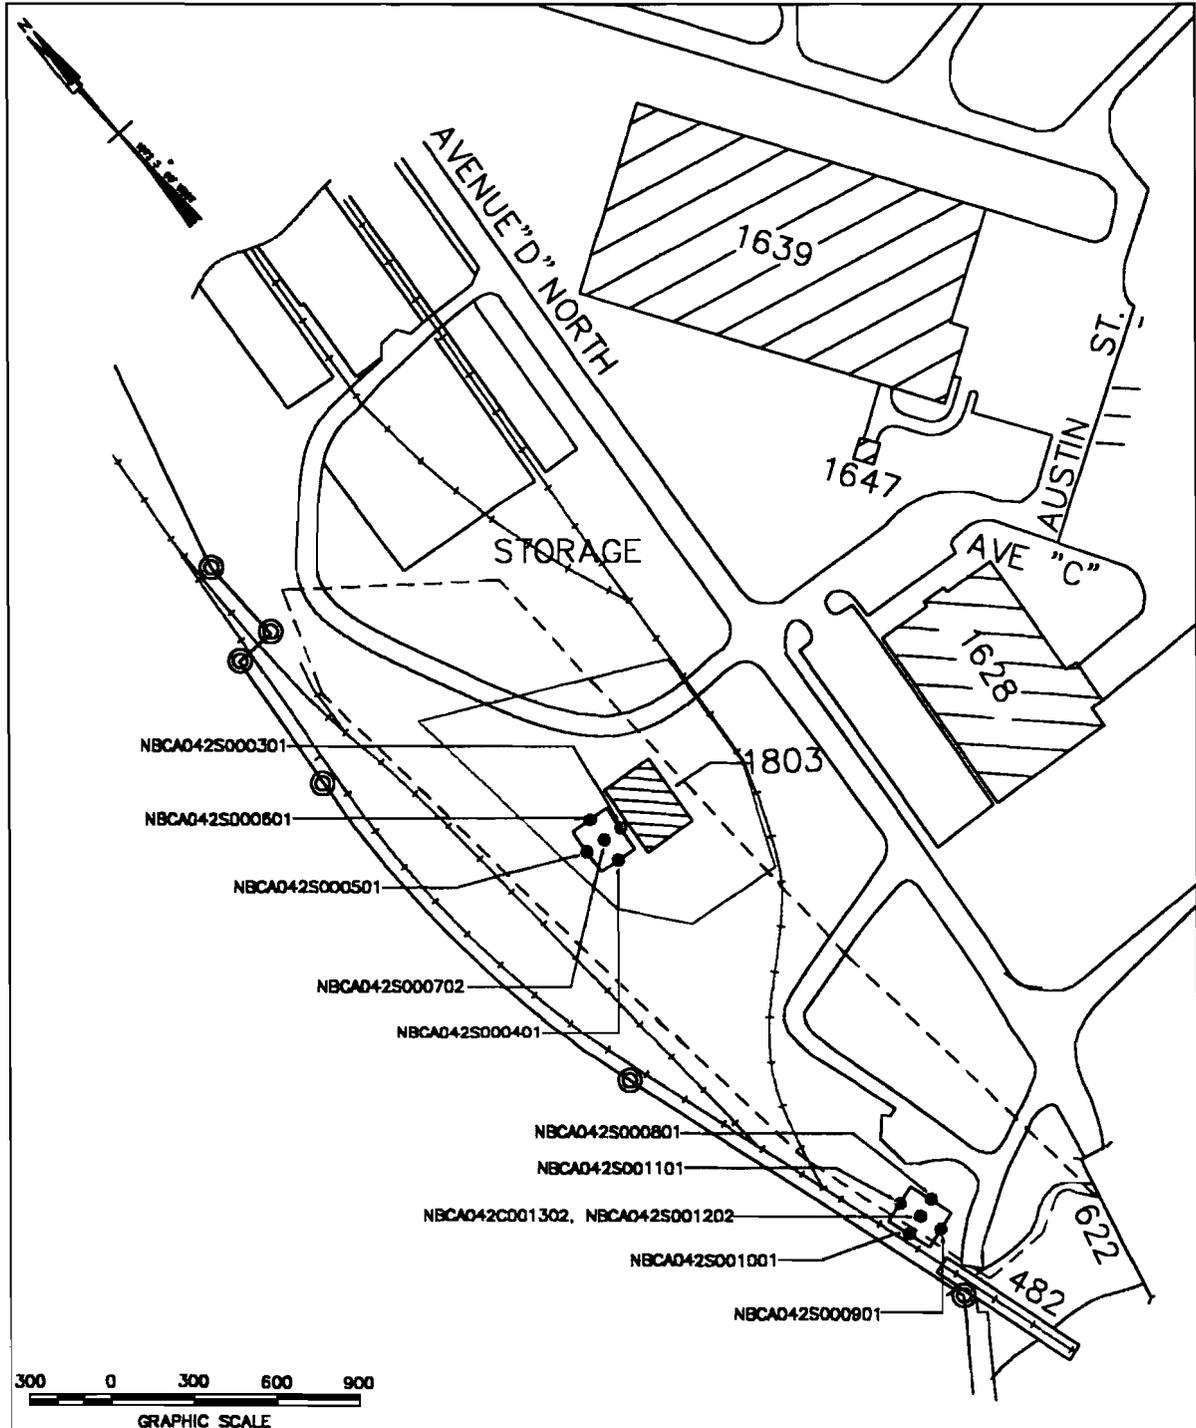
FIGURE B-1

4.1.2 Confirmatory Sampling. Following excavation, confirmatory samples (grab) were taken. These samples were collected at the bottom and sidewalls of each excavated area. These samples were analyzed for Lead. A copy of the analytical results of all confirmatory samples is included in Appendix B. Table B-1 of Appendix B summarizes the results and sample coordinates. Figure B-1 of Appendix B illustrates the sampling locations. There were no detections of Lead above 400 ppm.

SWMU 42 CONFIRMATORY SAMPLING GRID MAP

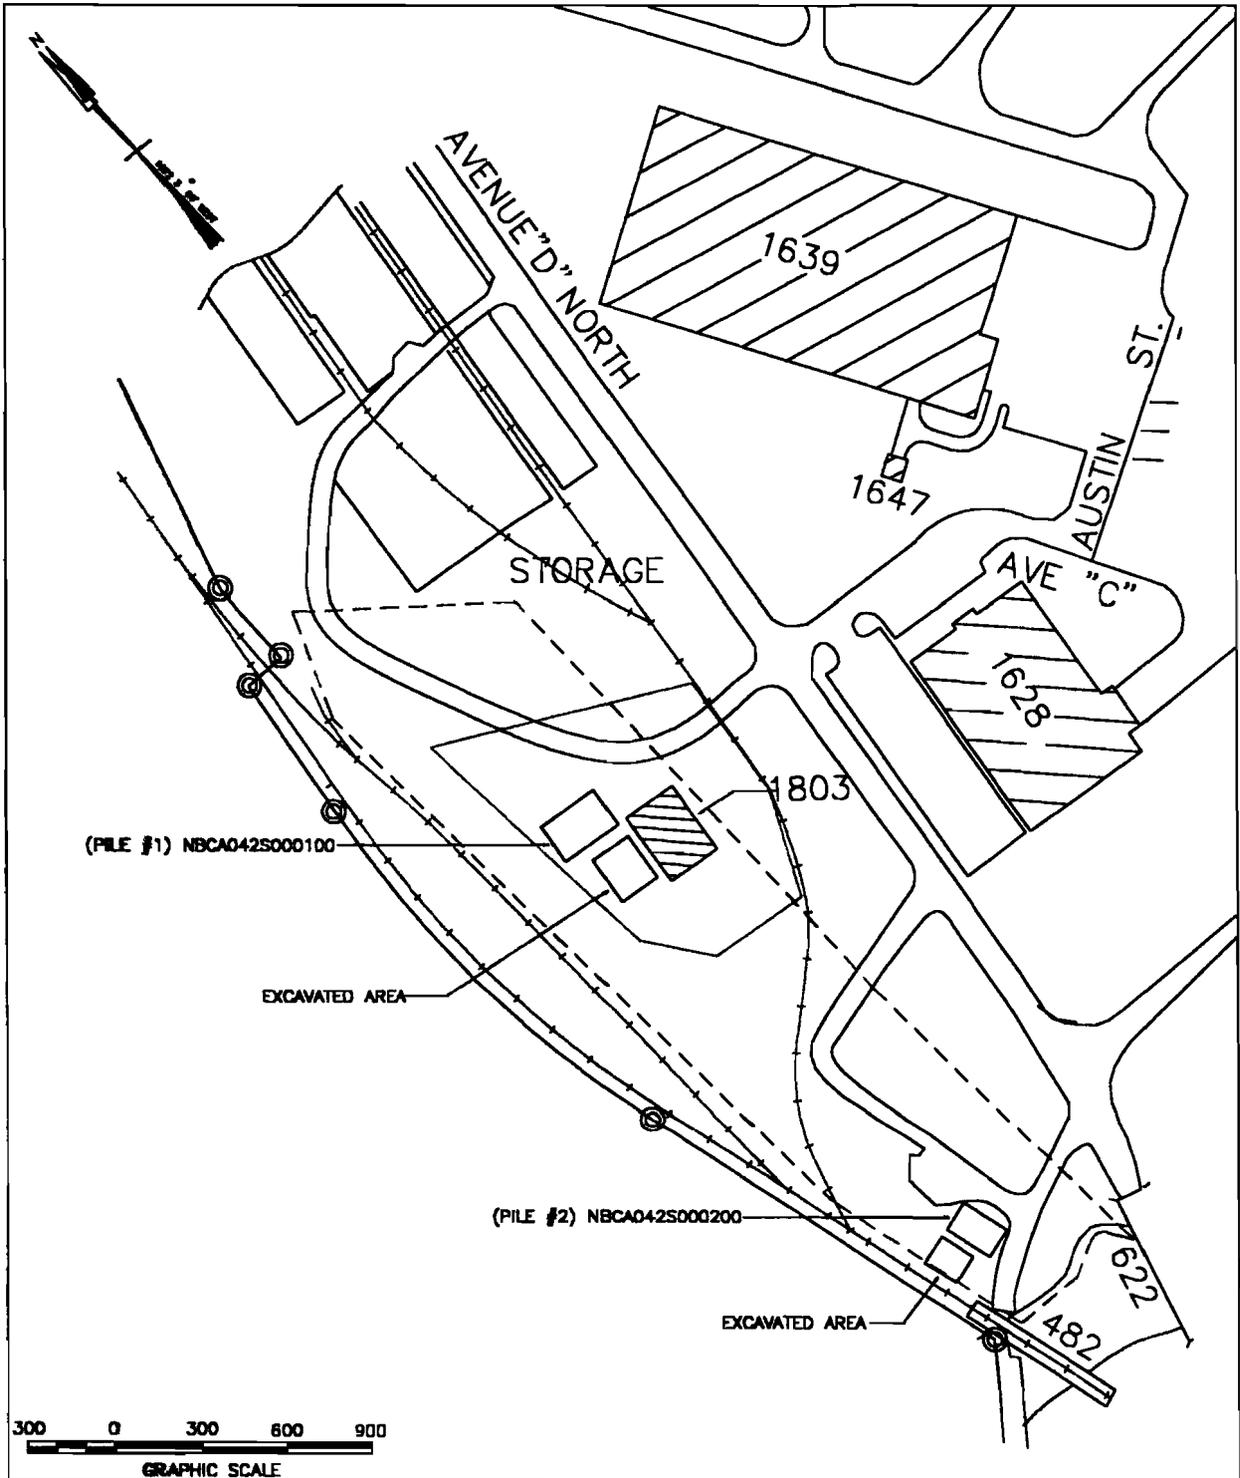
FIGURE B-2

4.1.3 Waste Characterization Sampling. One composite sample was collected from each stockpile of excavated soil and submitted for laboratory analysis for waste characterization. A Toxicity Characteristic Leaching Procedure (TCLP) was done on the waste soil and determined to be non-hazardous. A copy of the analytical results of all waste characterization samples is included in Appendix B. Table B-2 of Appendix B summarizes these samples. Figure B-2 of Appendix B illustrates the arrangement of all stockpiled soil excavated from the site with its corresponding sample identification number.

SWMU 42 EXCAVATED SOIL STOCKPILE MAP

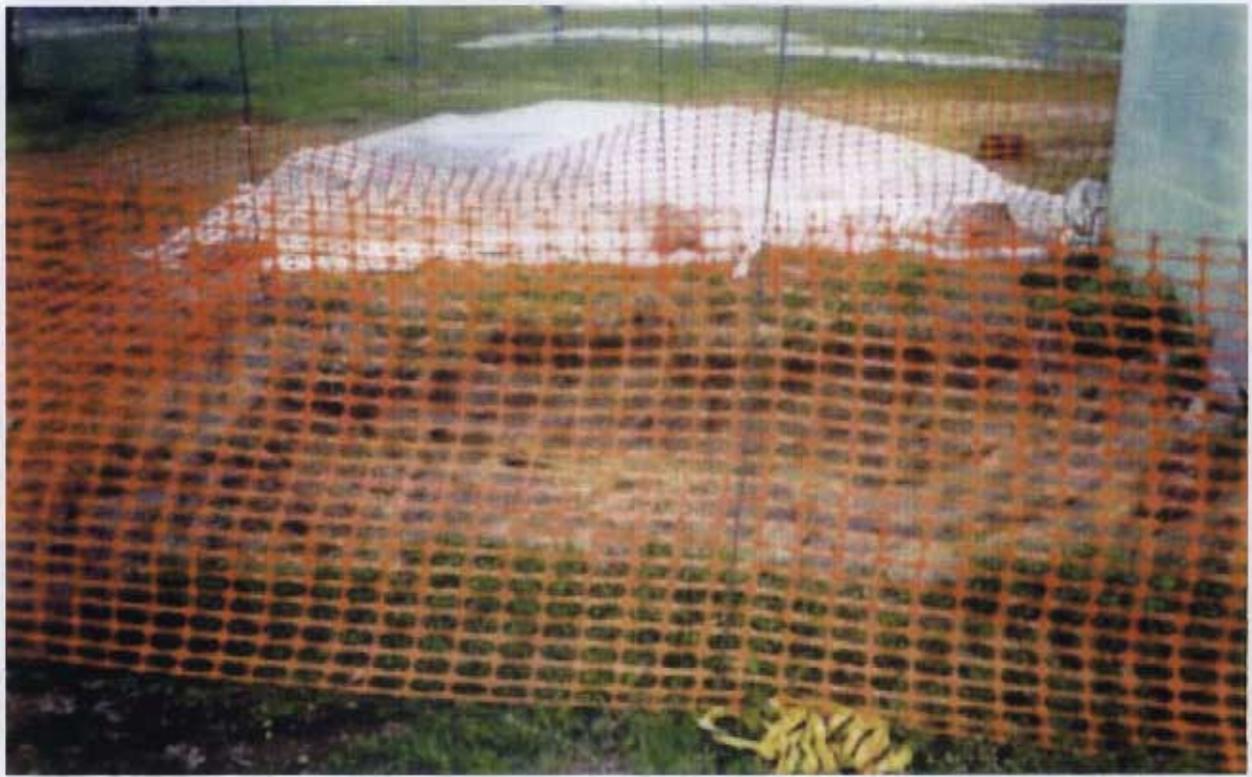
Photo D-1 Excavation viewed from south end of site 1.

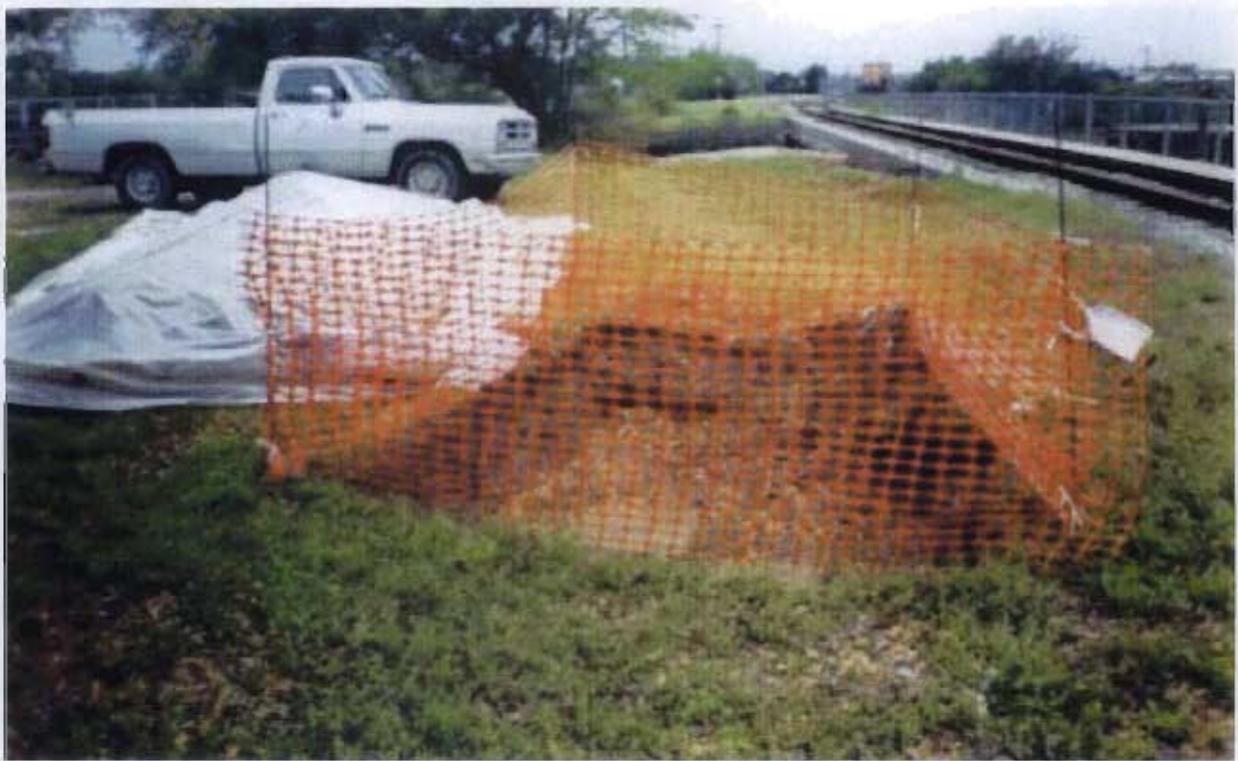
Photo D-2 Excavation viewed from north end of site 2.

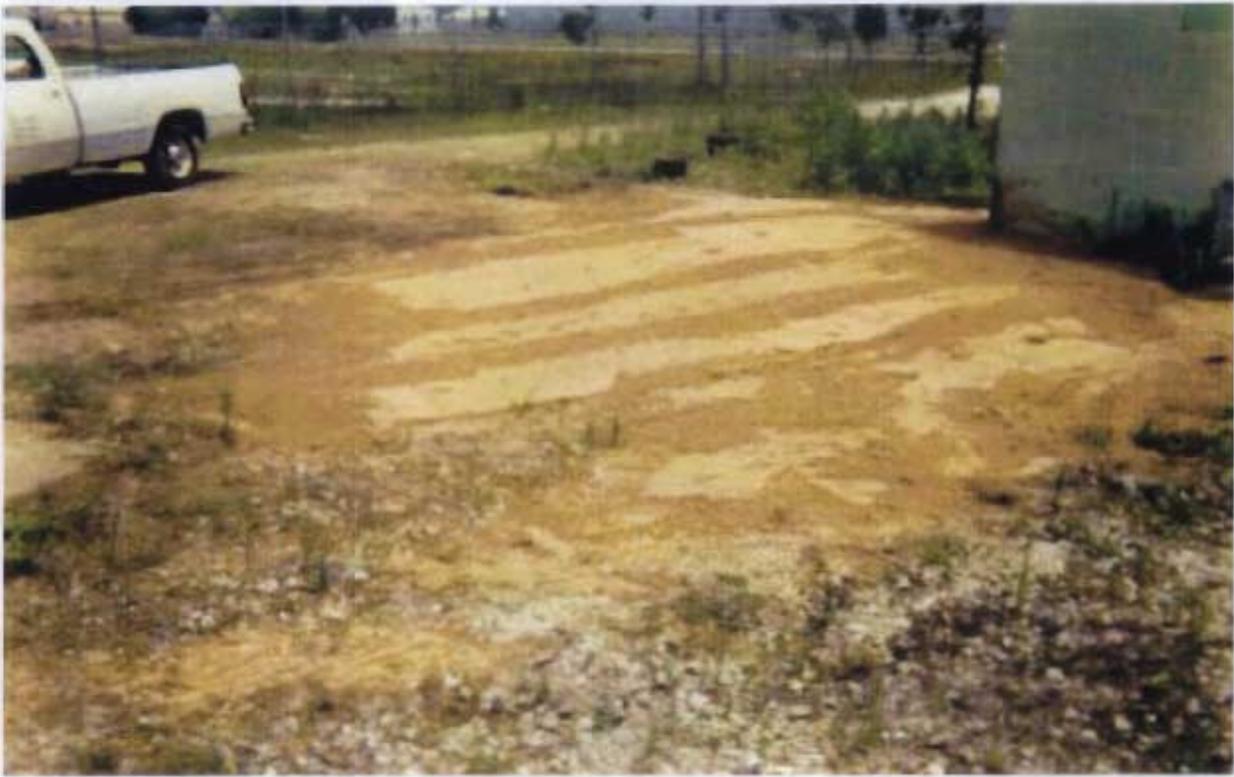
Photo D-3 Work plan complete, waste soil and security fence removed , excavation filled in and viewed from south end of site 1.

3.1 SITE CONDITIONS FOLLOWING COMPLETION OF WORK. Following completion of all site work on 21 May 1997, the excavated areas were backfilled with clean soil. All excavated waste was characterized as non-hazardous and transported to a Sub Title "D" land fill. Photos D-1 and D-2 of Appendix D reflect conditions at the site during removal of contaminated soil. Photos D-3 and D-4 reflect conditions at the site after completion of IM.

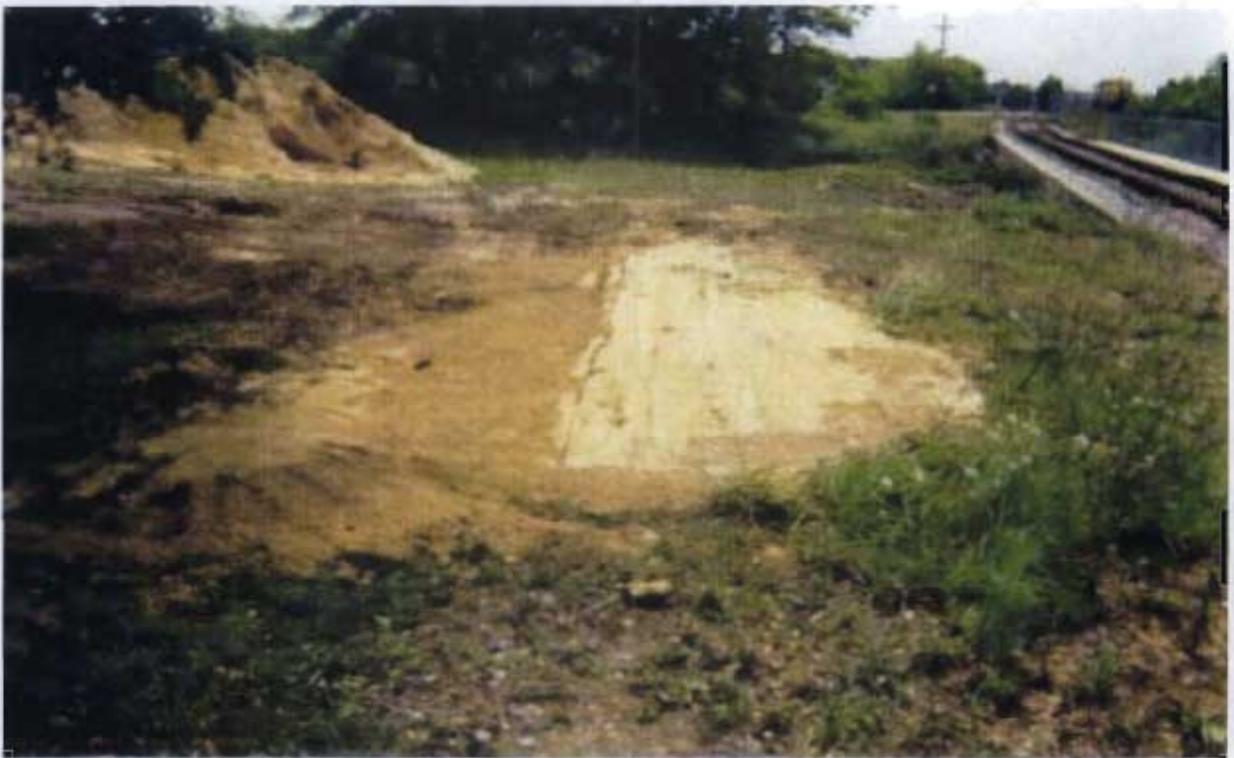
Photo D-4 Work plan complete, waste soil and security fence removed, excavation filled in and viewed from north end of site 2.
