COMPLETION REPORT INTERIM MEASURE FOR SOLID WASTE MANAGEMENT UNIT 2  
(SWMU 2) VOLUME 1 OF 3 WITH TRANSMITTAL CNC CHARLESTON SC  
11/22/1999  
NAVFAC SOUTHERN

INTERIM MEASURE FOR  
SWMU 2  
NAVAL BASE CHARLESTON  
CHARLESTON, SC

**COMPLETION REPORT**  
**Interim Measure for**  
**SWMU 2**  
**Naval Base Charleston**  
**Charleston, SC**

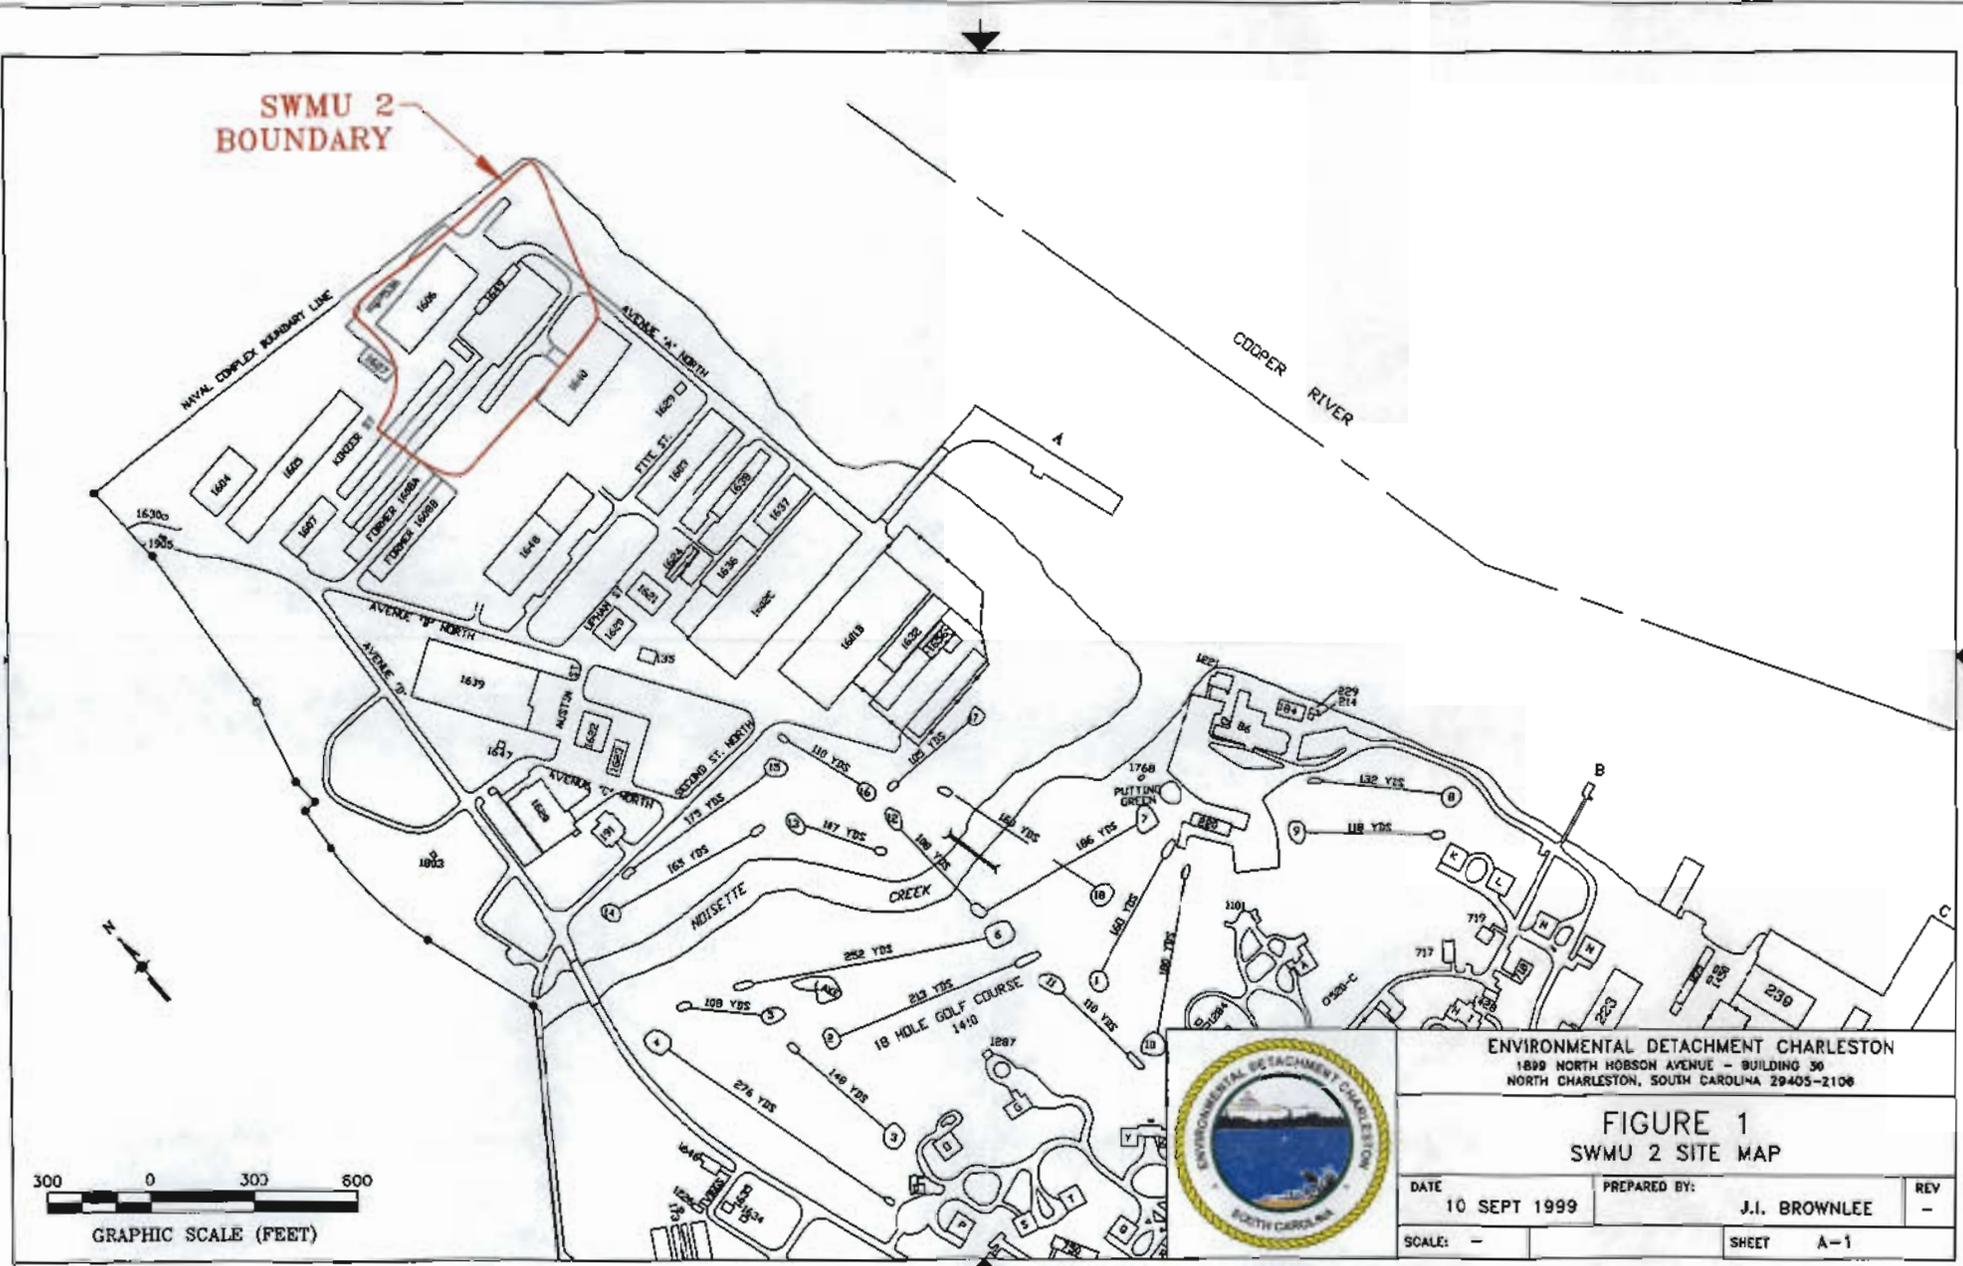
**FIGURE 1  
SWMU 2 SITE MAP**

**1.3 HISTORY.** SWMU 2 is the site of the former Defense Reutilization and Marketing Office (DRMO) storage area and salvage yard located in Zone A of the Charleston Naval Complex. A site map (Figure 1) showing the SWMU 2 area is included in Appendix A. The approximately 6-acre area was used to store recovered lead from lead-acid submarine batteries from the mid-1960s until

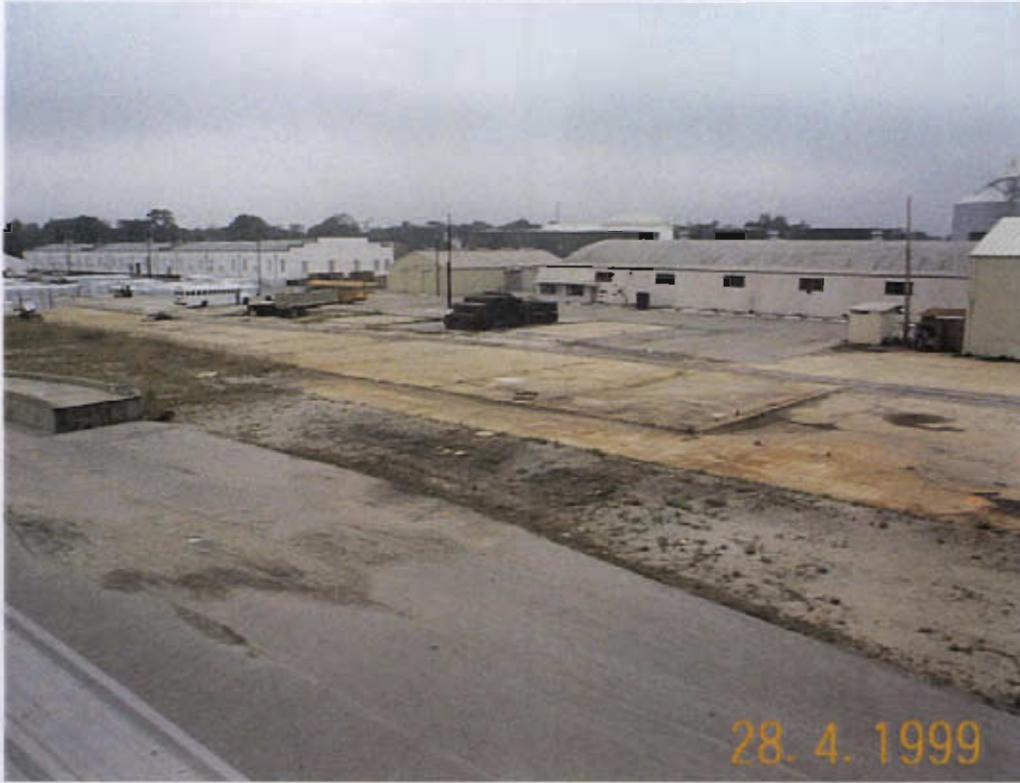
SWMU 2 Area Before Interim Measure. View from Atop Building 1640

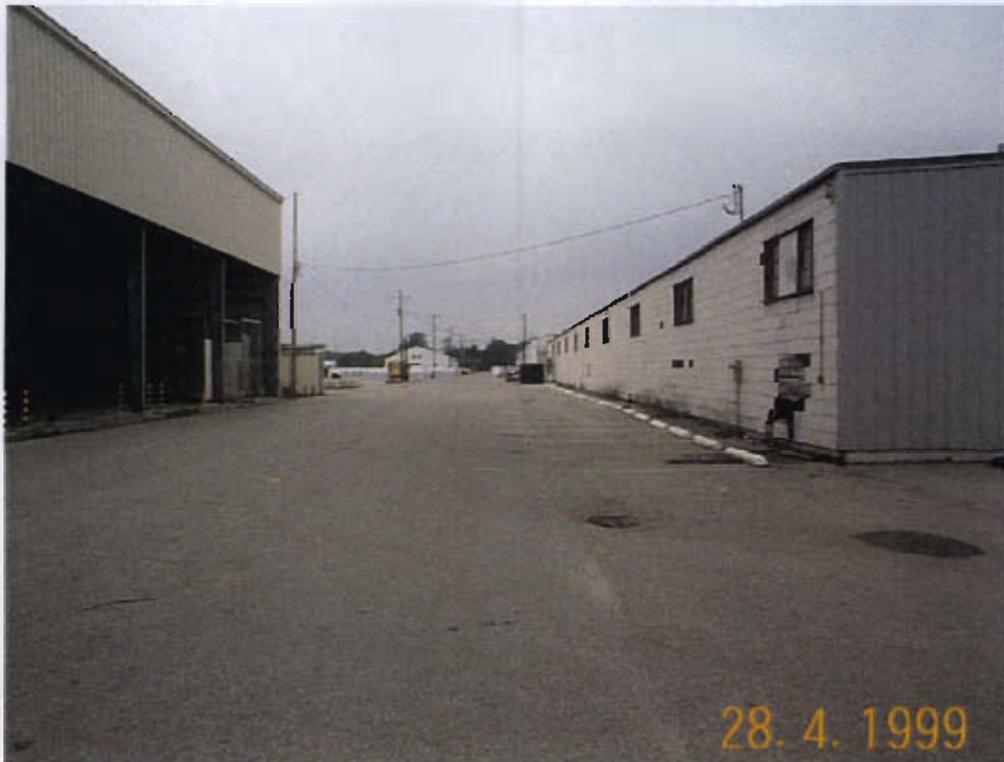
East End View of 6<sup>th</sup> Street North before Interim Measures

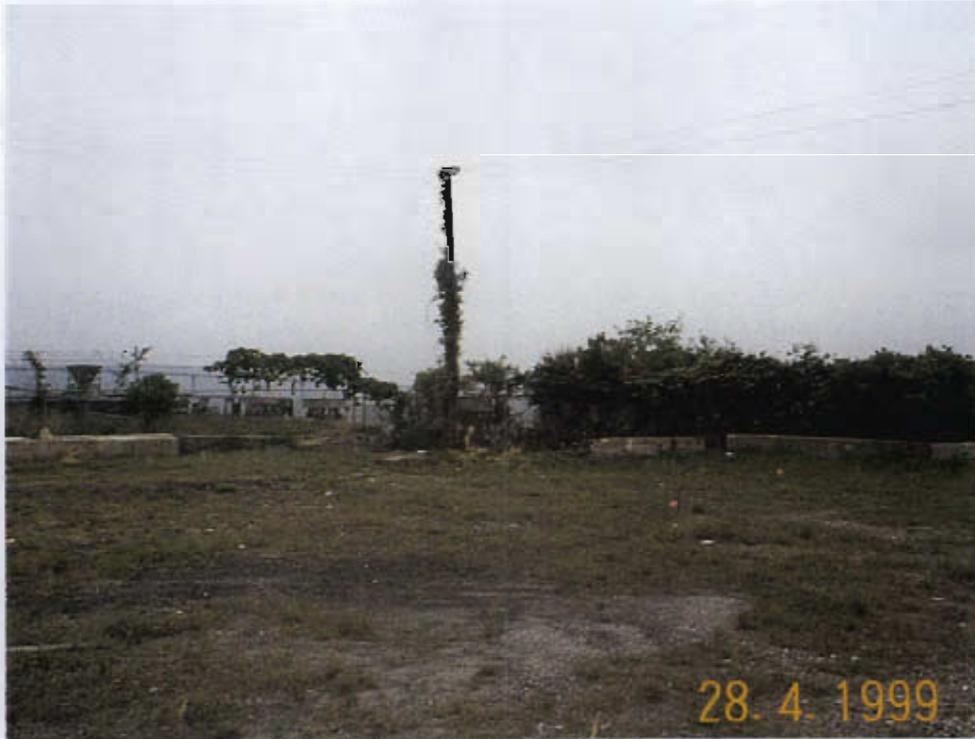
View of Zone 1 before Interim Measures

**2.2.4 Excavation.** Impacted soil removal began with the excavation of the three isolated areas located northeast and south of Building 1606 (Zones 1 and 3) and the area adjacent to Avenue A North (Zone 2). Soil was excavated to a depth of approximately 28 inches from land surface in each area. Groundwater was not encountered during the excavation of soil.

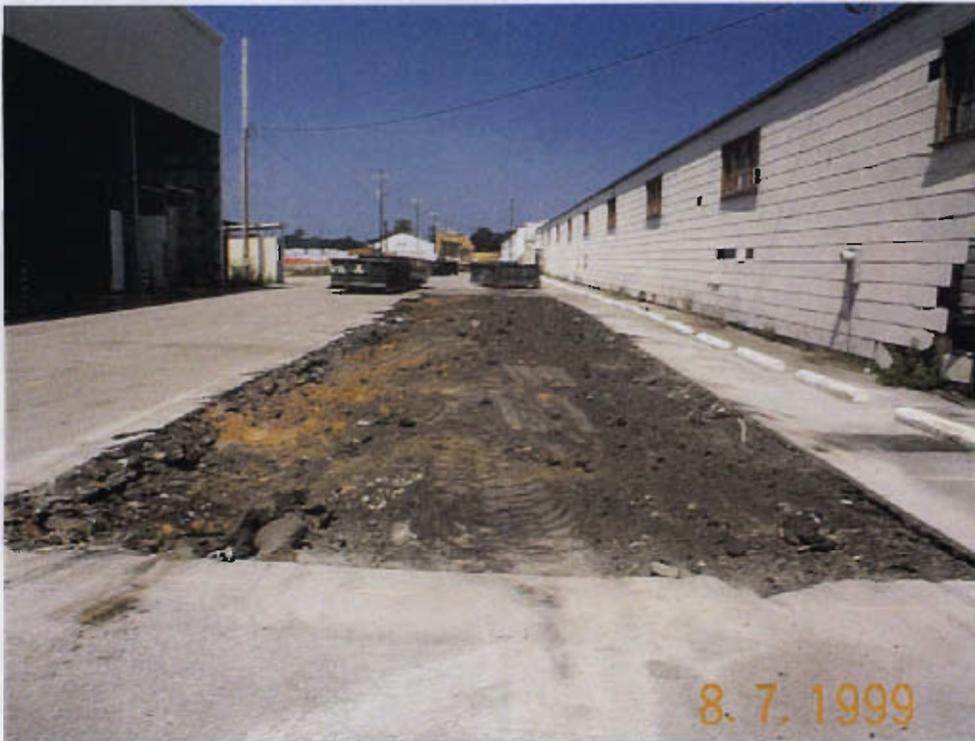
East End View of 6<sup>th</sup> St. North-Asphalt Removed

**2.2.3 Concrete/Asphalt Removal.** Concrete and asphalt covered approximately 80% of the area requiring soil removal. The project commenced on 02 July 1999 with the process of removing concrete and asphalt in the areas delineated for soil removal. Concrete and asphalt characterized as non-hazardous was placed inside containers, which were transported to Chambers Landfill. A section of concrete slab, characterized as hazardous, was left in place until soil removal operations were to begin.

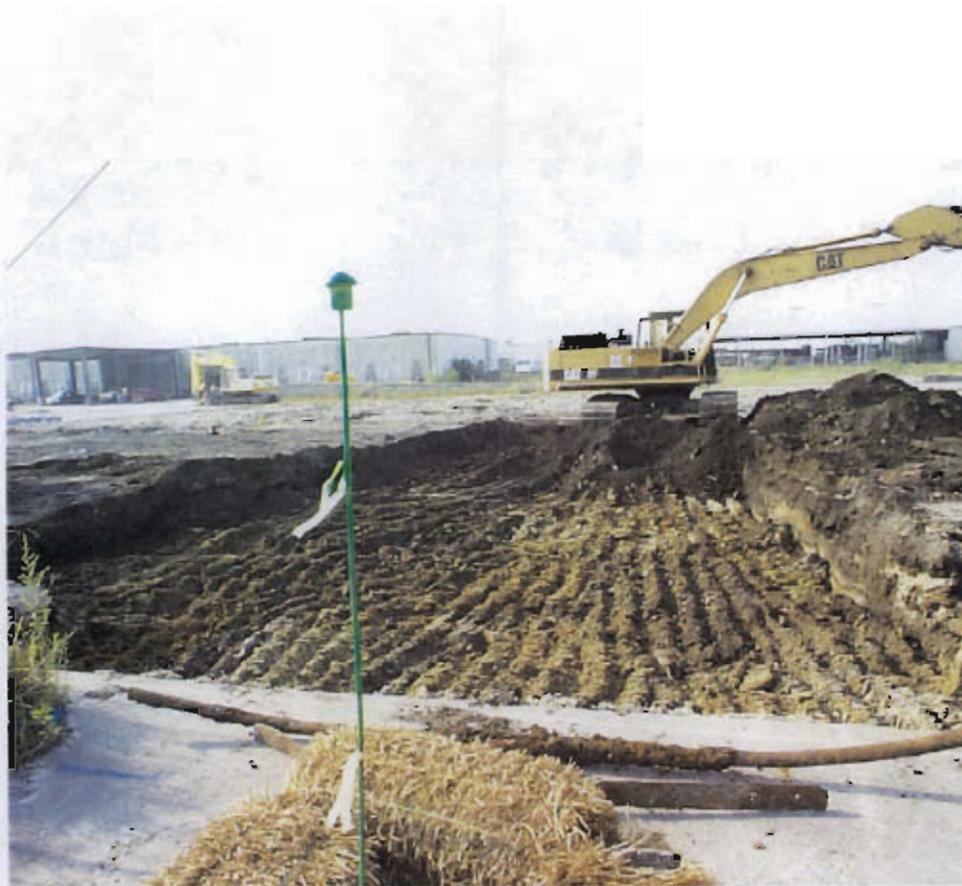
Excavating soil-View Looking South

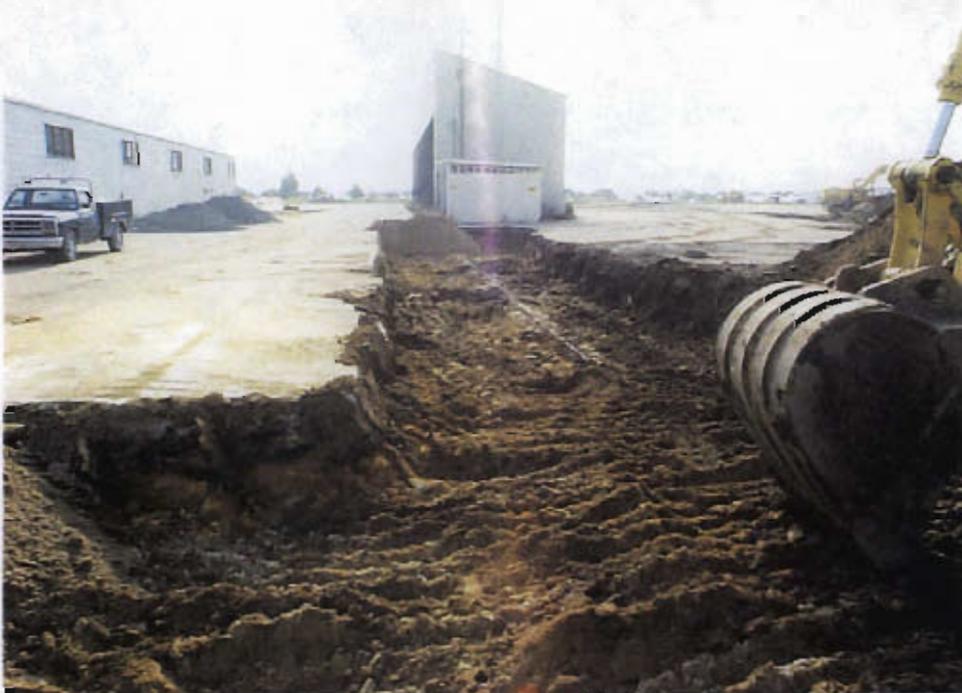
Excavating Soil-View Looking East

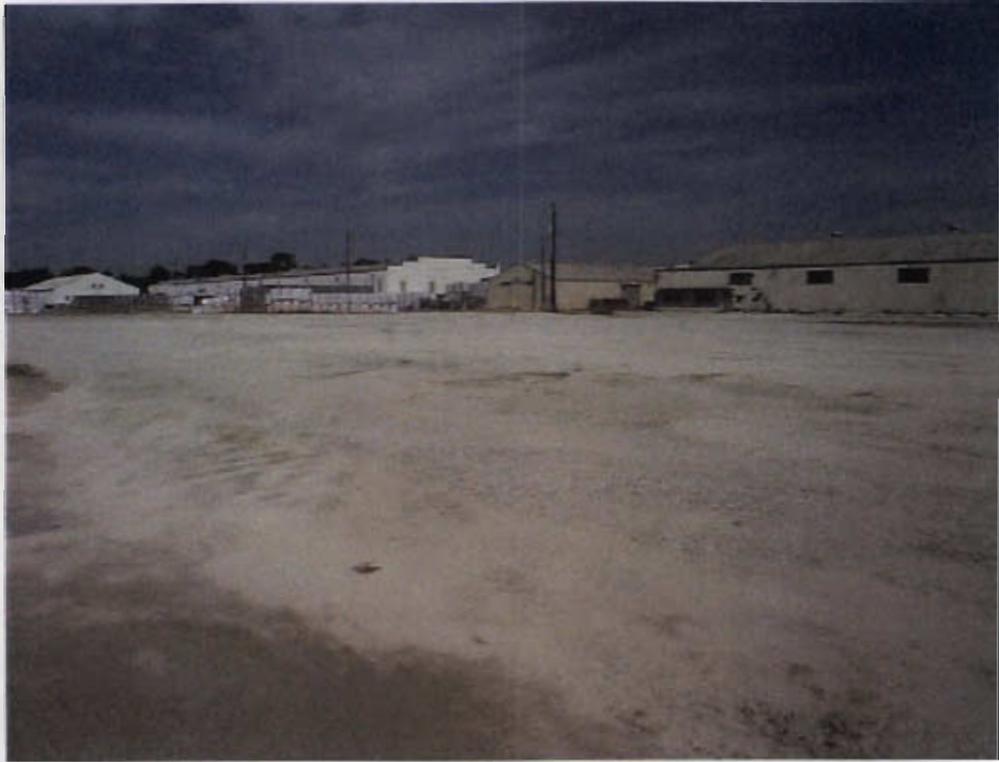
SWMU 2 After Completion of Interim Measures

**3.1 SITE CONDITIONS FOLLOWING COMPLETION OF WORK.** Following completion of all site work, the DET had accomplished the removal of 8,320.44 tons of contaminated soil and concrete and approximately 1,366 tons of non-hazardous debris. Test results of the remaining soil confirmed that the conditions following the excavation met the objectives of paragraph 1.4 of this report. Site restoration included back-filling the excavations and grading the site to existing conditions with run-of-crush (ROC).
