ASBESTOS CONTAINING MATERIAL RE-INSPECTION BUILDING 33 VOLUME 5 CNC  
CHARLESTON SC  
2/15/2000  
BAT ASSOCIATES, INC.

**Asbestos-Containing Material Re-inspection  
For Building 33  
Charleston Naval Shipyard  
Charleston, South Carolina**

February 15, 2000

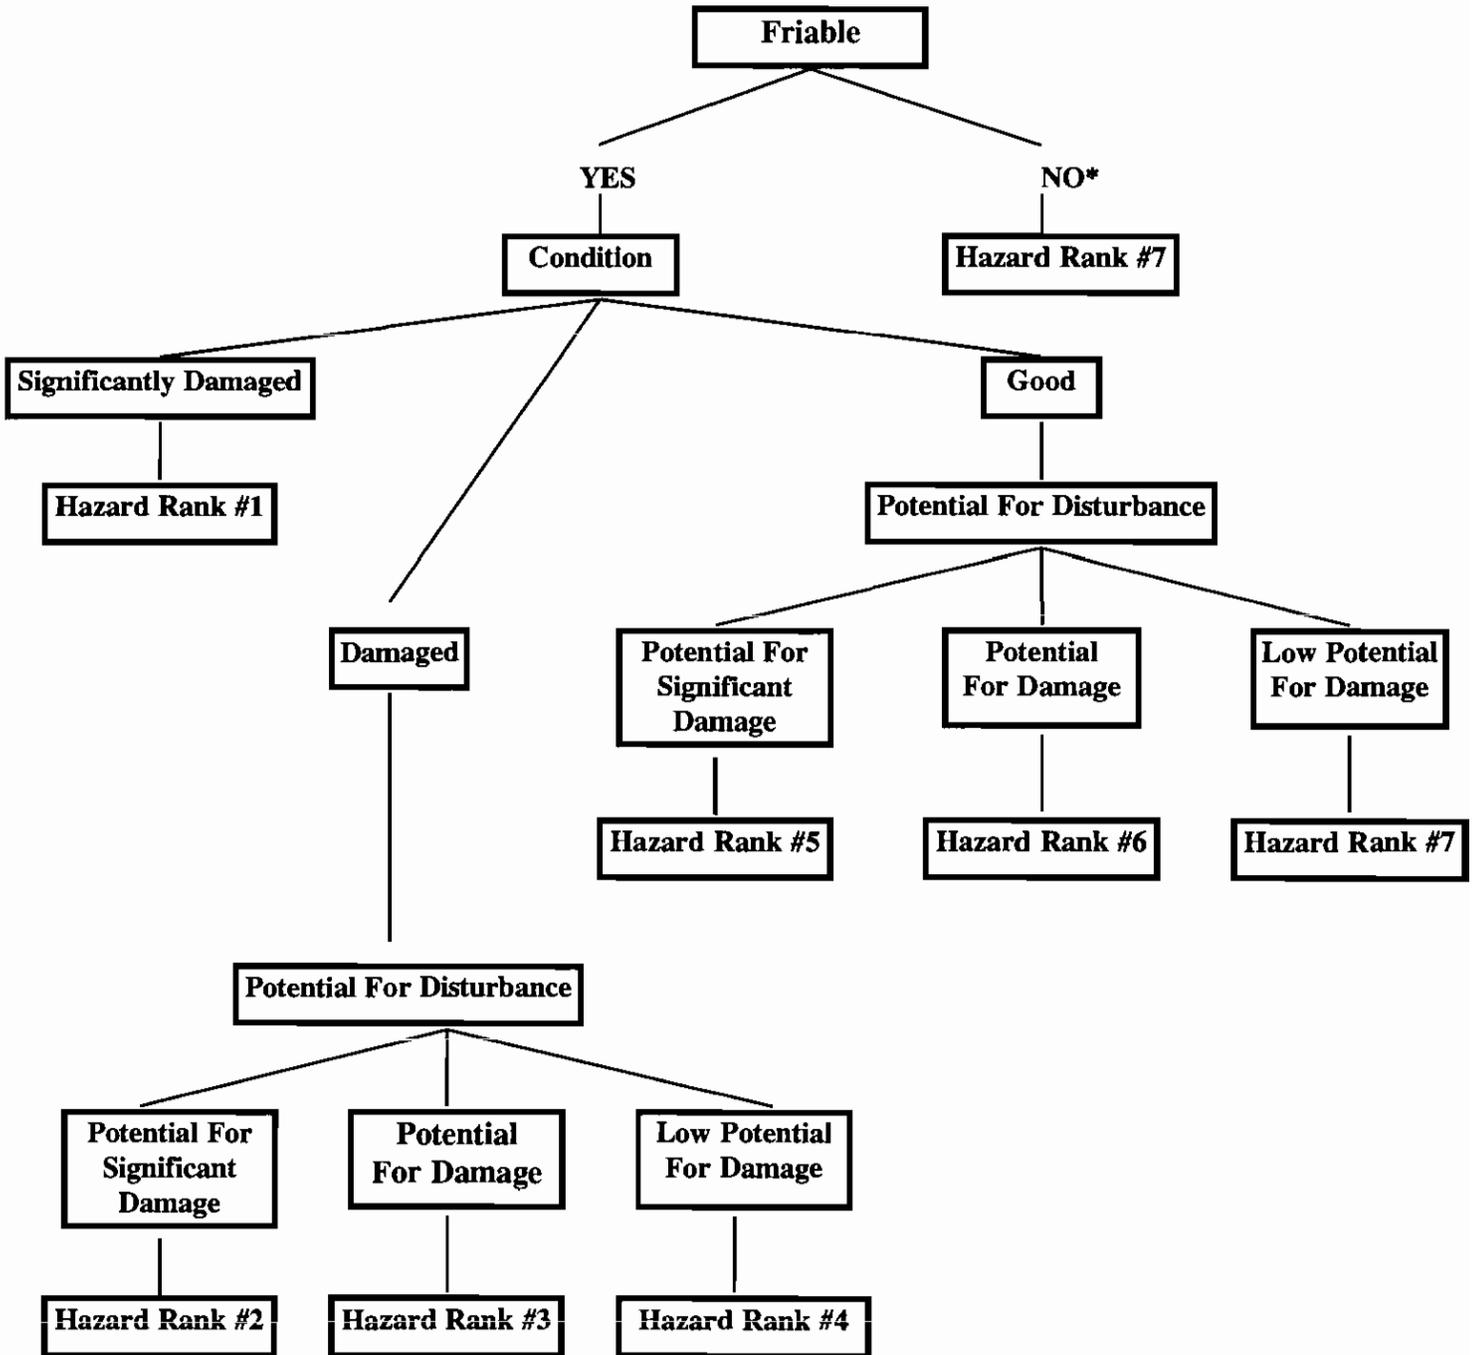
**Figure 1.0 Decision Tree Diagram For Hazard Assessment**

Hazard rank #1 are materials of highest concern, and hazard rank #7 are the materials least likely to release asbestos fibers to the work area.

\*Miscellaneous materials that are considered non-friable were placed in the Hazard Rank #8 category, which is in good condition with a low potential for damage.

BAT adopted for this re-inspection one of the four general classes of hazard assessment models considered during the AHERA rule-making process. This method for hazard assessment is a modified decision tree as detailed in the USEPA, *Guidance for Assessing and Managing Exposure to Asbestos in Buildings*, or the *Pink Book*. Based on the physical assessment responses documented in the field, the BAT Management Planner proceeded through the decision tree process depicted in Figure 1.0 on the following page.

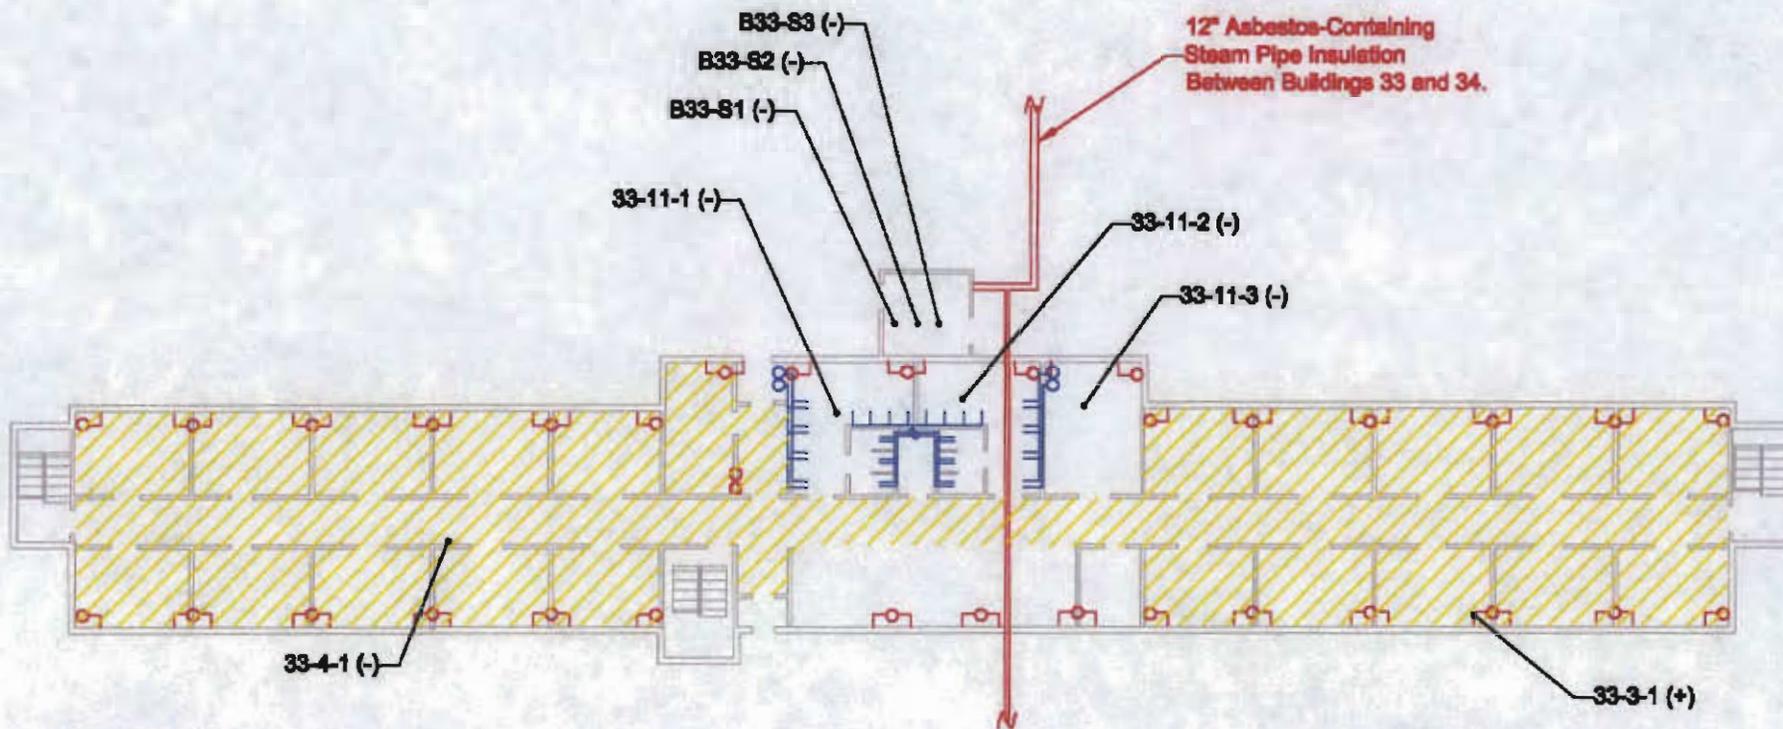
- - Sample Location
- (-) - Non-Asbestos-Containing Sample Location
- (+) - Asbestos-Containing Sample Location
- Asbestos-Containing Floor Tile and Mastic
- Asbestos-Containing Pipe Fitting Insulation on Riser and Branches to Radiator
- Asbestos-Containing Pipe Fitting Insulation on Domestic Water (Inaccessible in Walls)

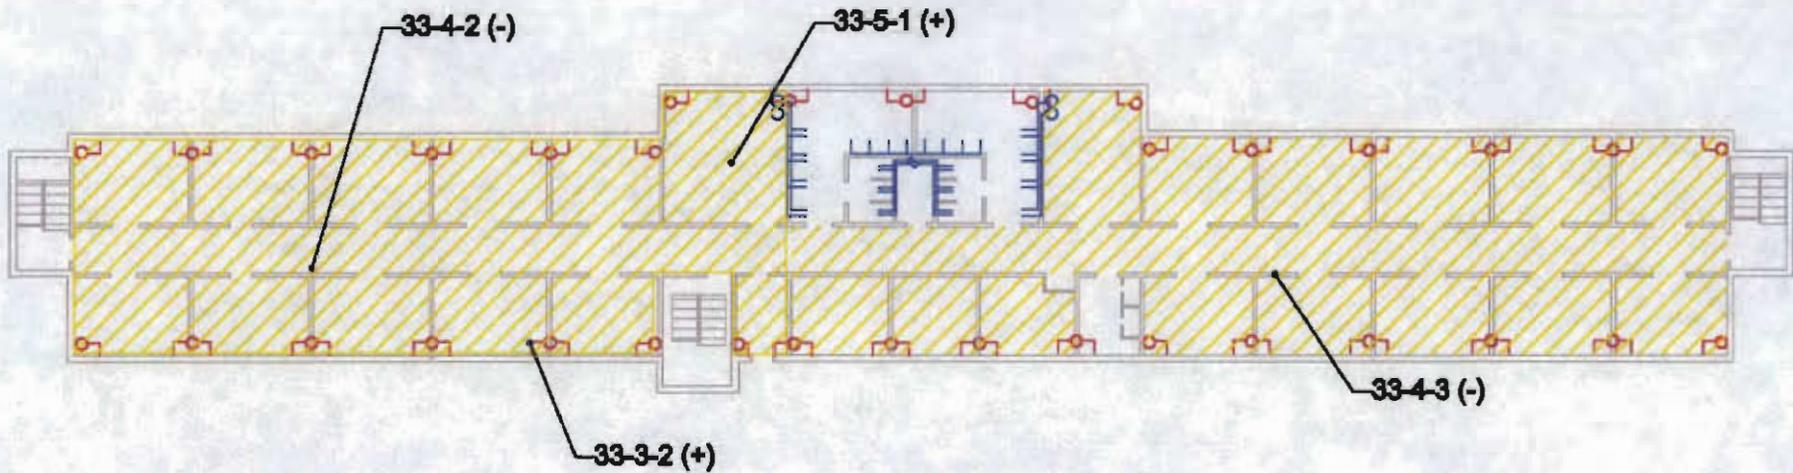
- - Sample Location
- (-) - Non-Asbestos-Containing Sample Location
- (+) - Asbestos-Containing Sample Location
-

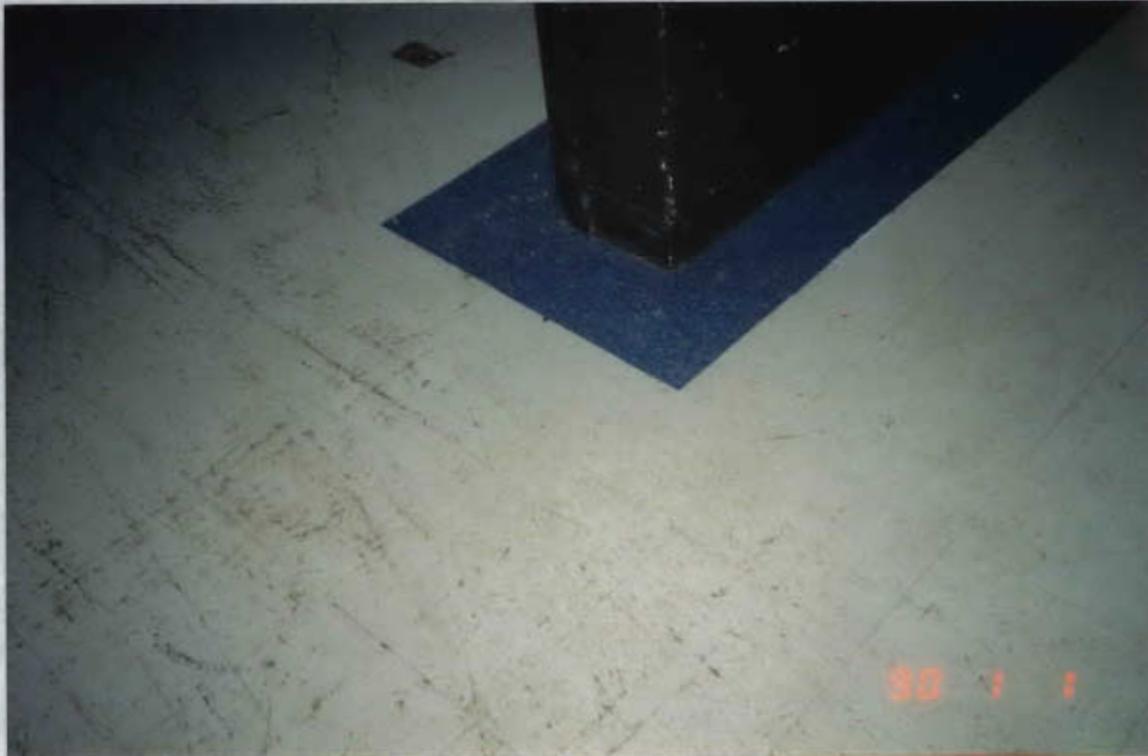
**Floor Tile, 12" x 12" brown with light and dark specks w/ black mastic, HA # 5**

**MATERIAL IS LOCATED UNDER HA # 8 AND 9**

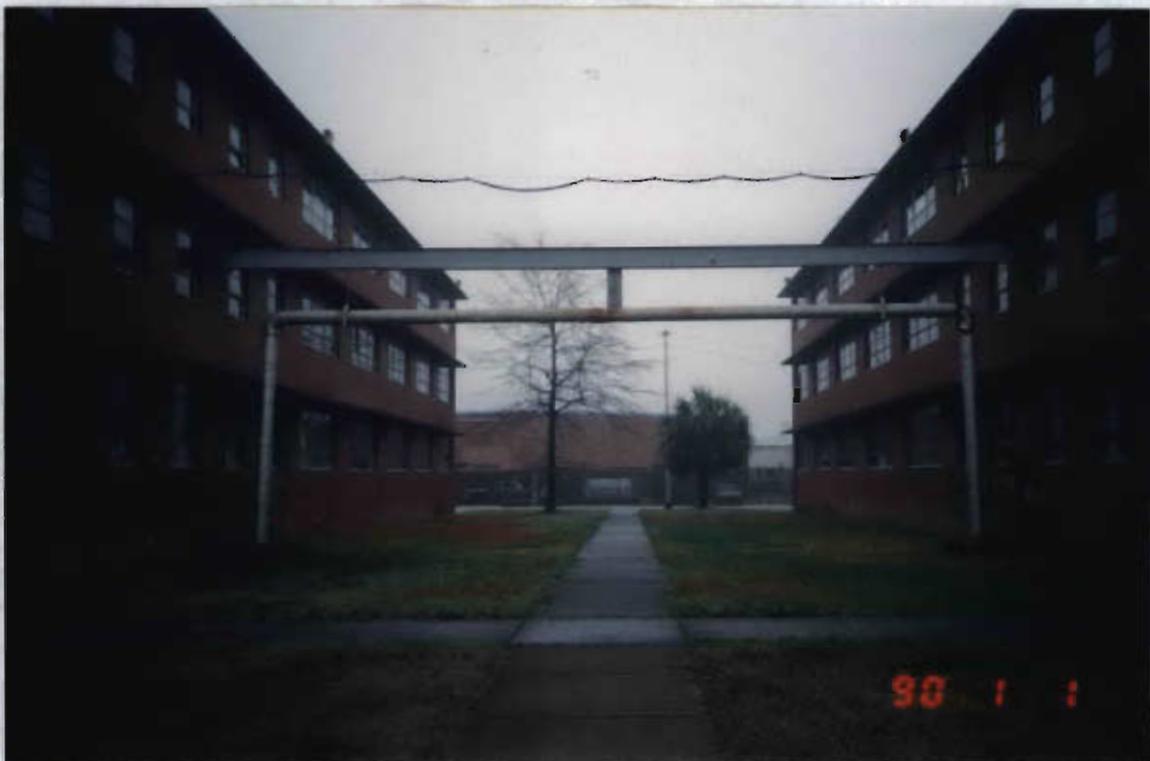
**Floor Tile, 9" x 9" red w/ black mastic, HA # 10**

**Pipe Insulation, 12" with metal wrap, HA # 17**

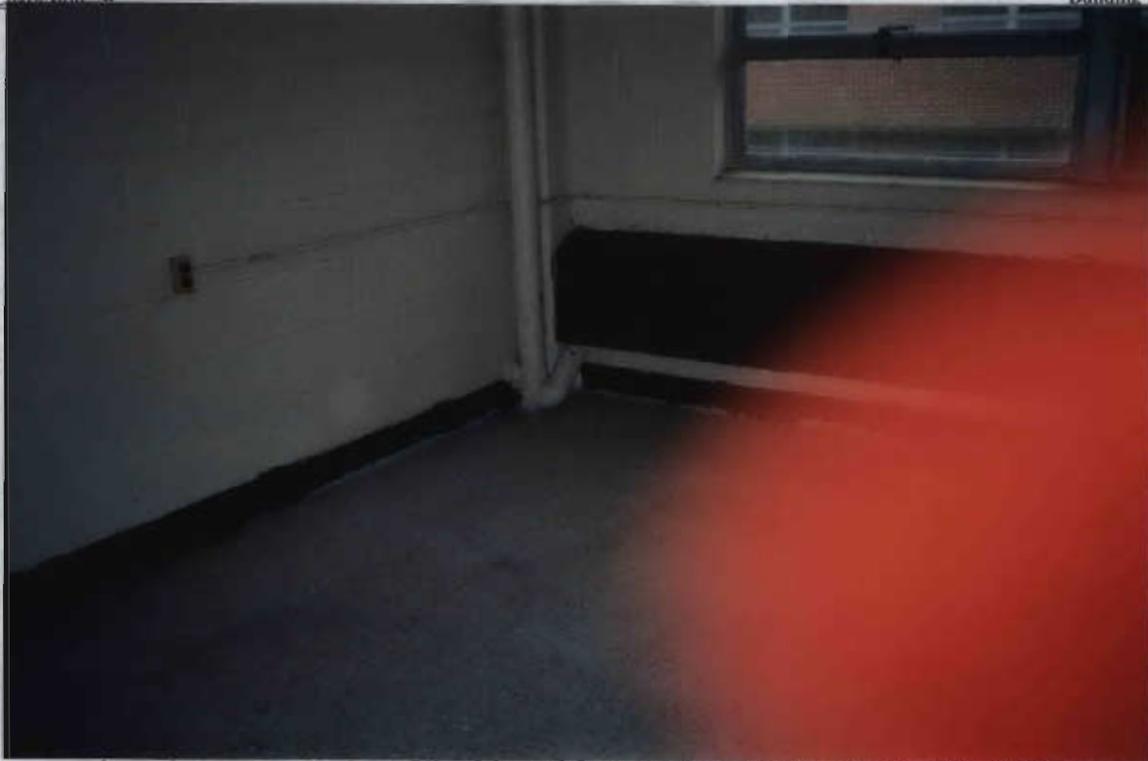
**Pipe Fitting Insulation, 3" white with canvas wrap on steam, HA # 13**

**INACCESSIBLE IN WALLS**

**MATERIAL IS LOCATED UNDER HA # 3 AND 5**

**Floor Tile, 9" x 9" black w/ black mastic, HA # 1**

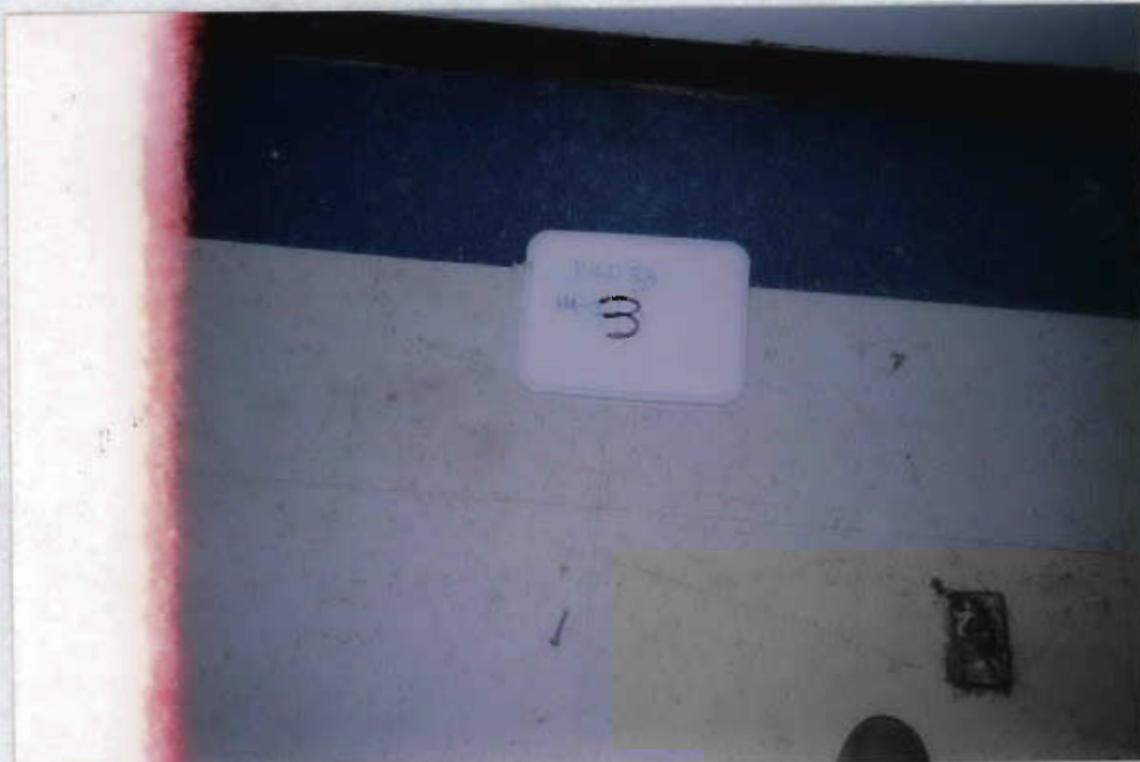
**Floor Tile, 12" x 12" gray with off-white and brown streaks w/ black mastic, HA # 3**

**Floor Tile, 12" x 12" black w/ black mastic, HA # 7**

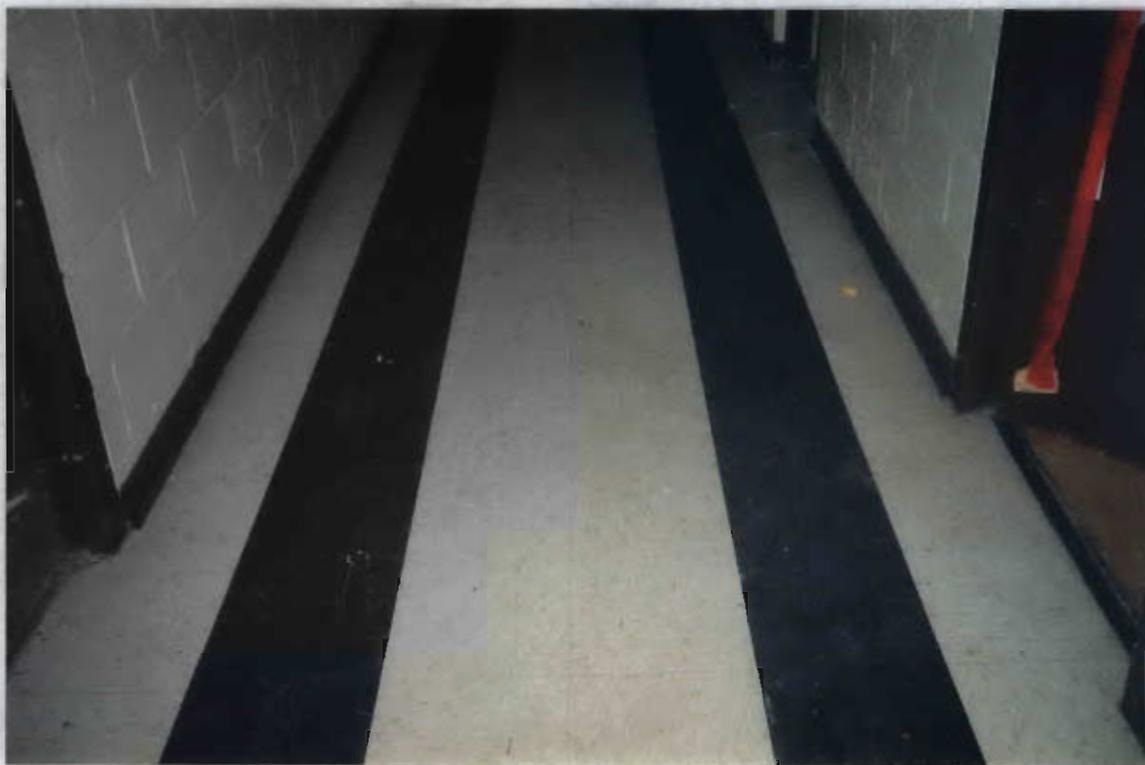
**Floor Tile, 12" x 12" off-white with olive streaks w/ black mastic, HA # 8**
