ASBESTOS CONTAINING MATERIAL RE-INSPECTION BUILDING 76 VOLUME 11 CNC  
CHARLESTON SC  
2/15/2000  
BAT ASSOCIATES, INC.

**Asbestos-Containing Material Re-inspection  
For Building 76  
Charleston Naval Shipyard  
Charleston, South Carolina**

**Contract No. N2467-96-D-0998  
Delivery Order No. 0013**

**February 15, 2000**

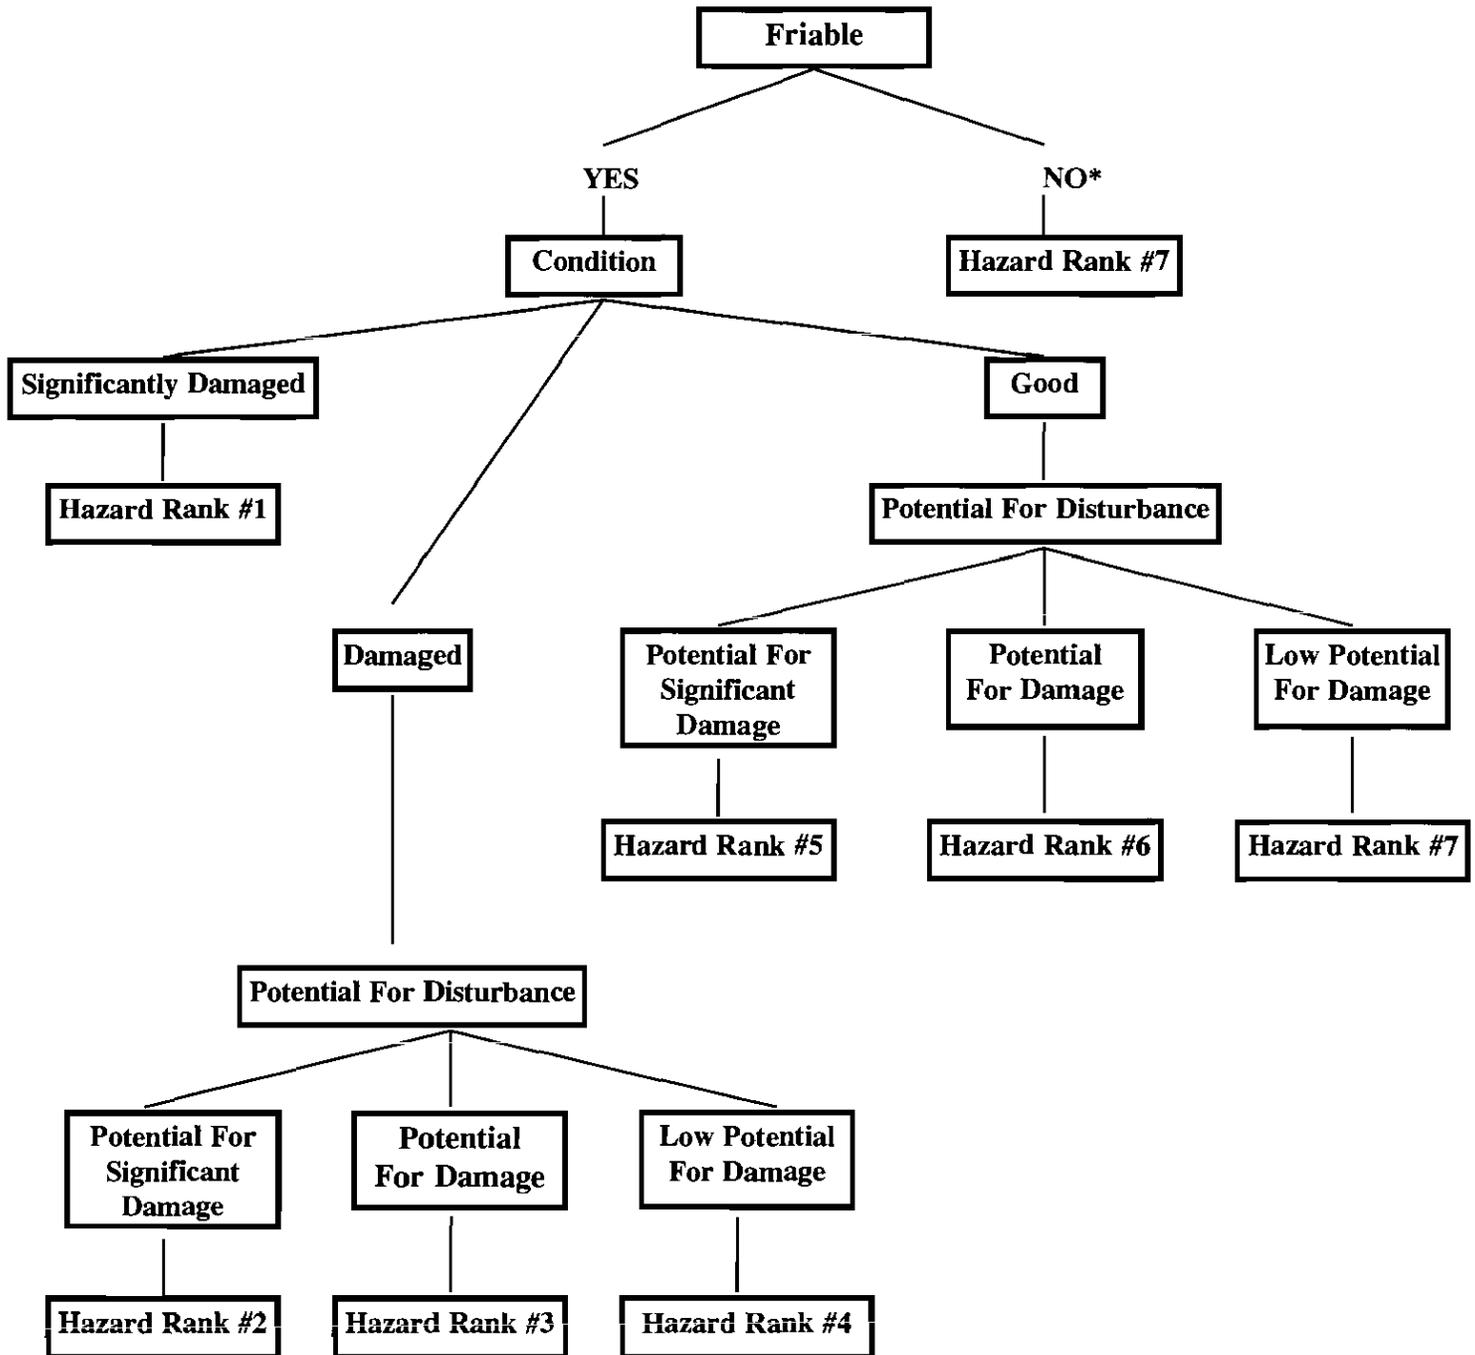
**Figure 1.0 Decision Tree Diagram For Hazard Assessment**

Hazard rank #1 are materials of highest concern, and hazard rank #7 are the materials least likely to release asbestos fibers to the work area.

\*Miscellaneous materials that are considered non-friable were placed in the Hazard Rank #8 category, which is in good condition with a low potential for damage.

BAT adopted for this re-inspection one of the four general classes of hazard assessment models considered during the AHERA rule-making process. This method for hazard assessment is a modified decision tree as detailed in the USEPA, *Guidance for Assessing and Managing Exposure to Asbestos in Buildings*, or the *Pink Book*. Based on the physical assessment responses documented in the field, the BAT Management Planner proceeded through the decision tree process depicted in Figure 1.0 on the following page.

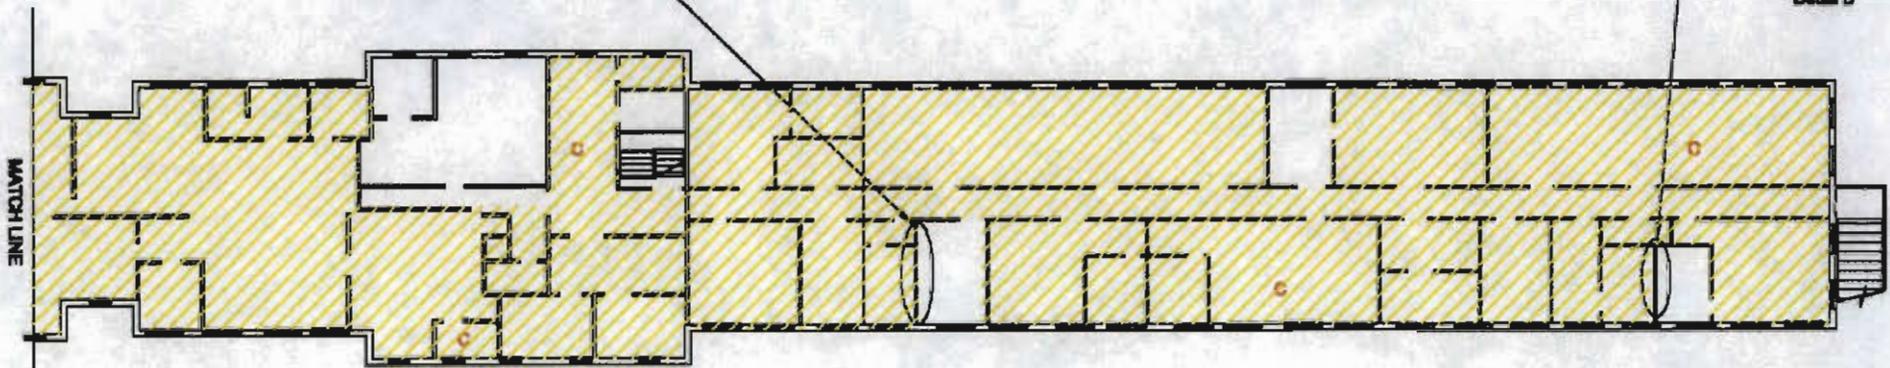
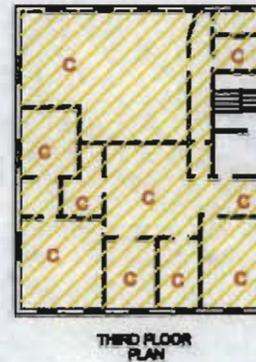
**NOTE: Roof Flashing and Roofing Tar on Parapet Wall Are Asbestos-Containing.**

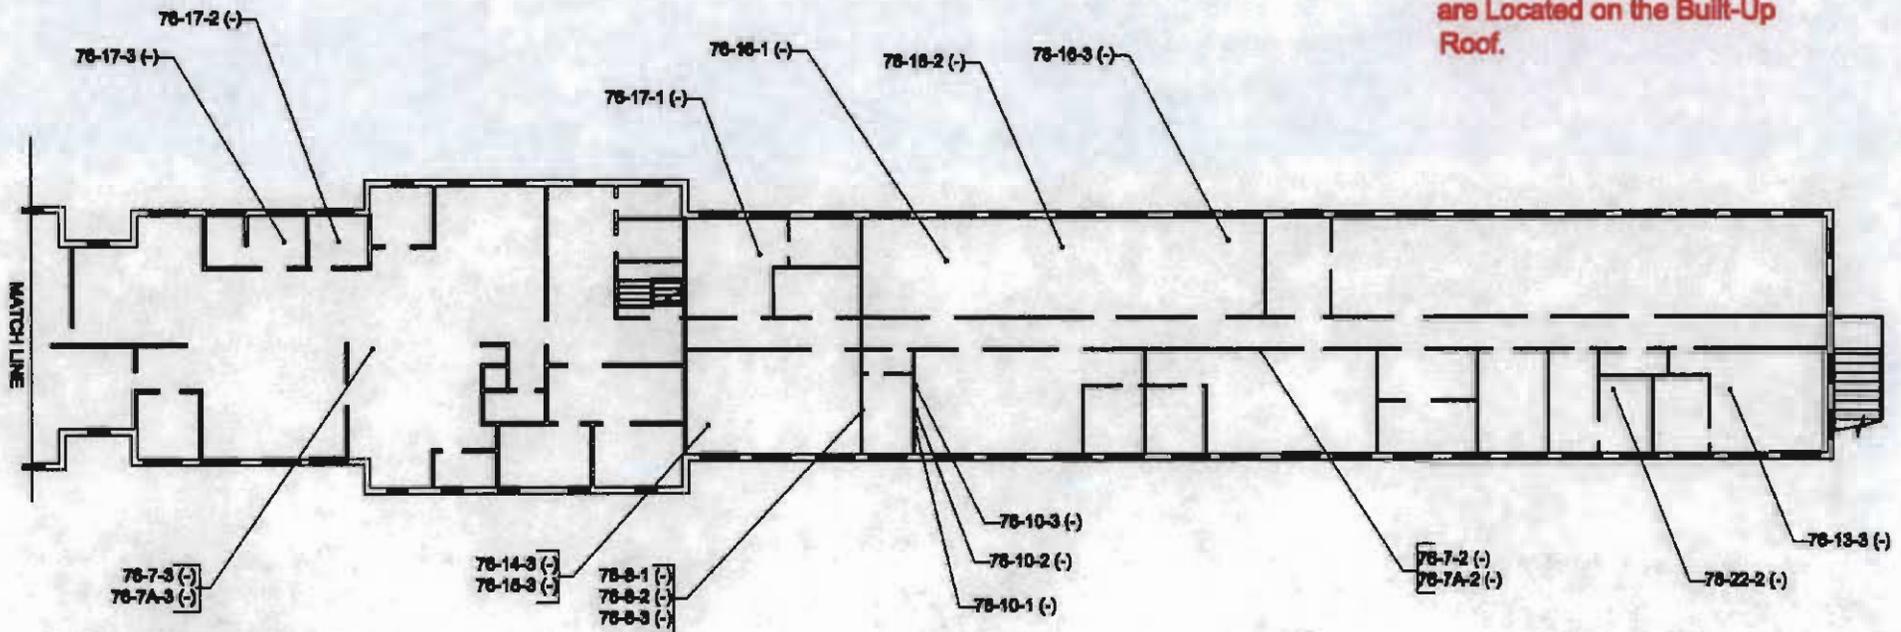
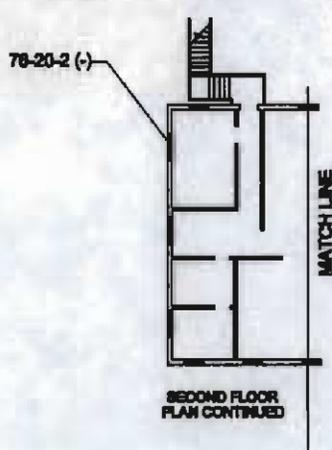
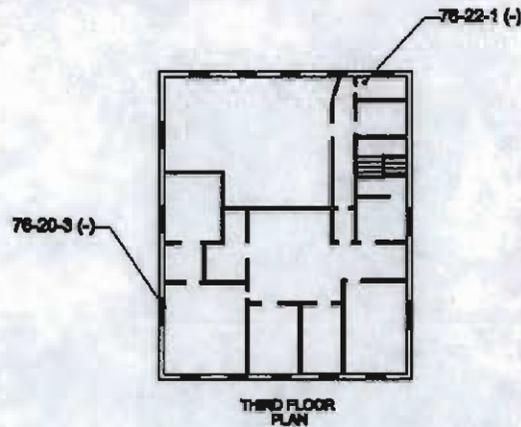
**NOTE:** Samples 76-25-1 (+), 76-25-2 (+), and 76-25-3 (+) are Located on the Flashing on the Roof.

**NOTE:** Sample 76-26-1 (+) is Located on the Tar on the Roof Parapet Wall.

**NOTE:** Samples 76-27-1 (-), 76-27-2 (-), and 76-27-3 (-) are Located on the Built-Up Roof.
