ABOVE GROUND STORAGE TANK (AST) ASSESSMENT REPORT BUILDING M-82 CNC
CHARLESTON SC
07/20/1999
ENVIRONMENTAL DETACHMENT CHARLESTON

Aboveground Storage Tank (AST) Assessment Report

Site I.D. #:	M82, Unregulated		
Facility Name:	Charleston Naval Base Complex, Building M-82		
Street Address:	Truxtun Avenue		
City:	North Charleston, 29405-2413	County:	Charleston

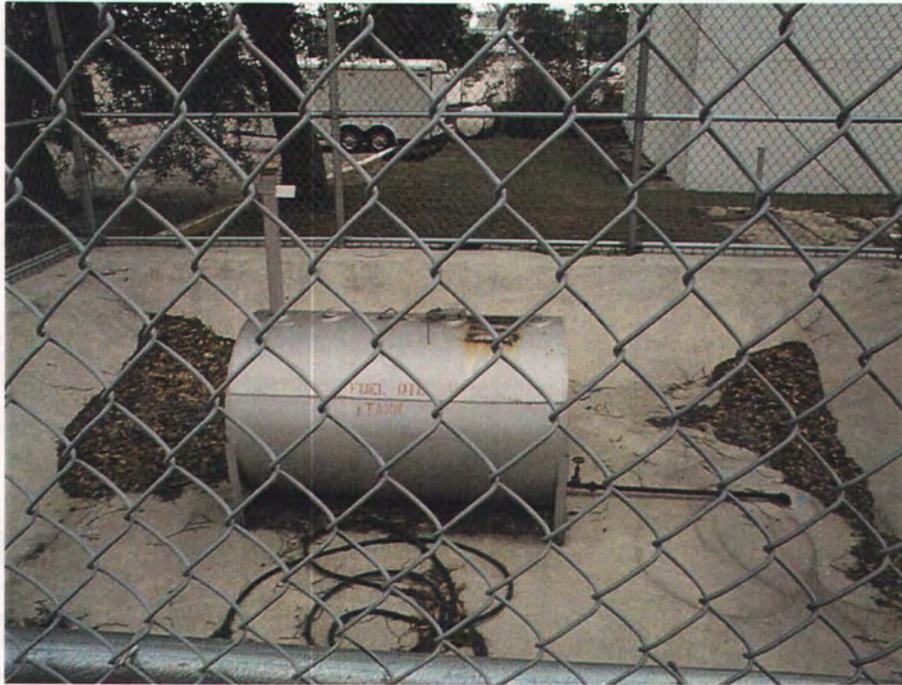
Surface rust observed in one area of deteriorated paint. No pitting or holes were observed.

Photo A: AST M82 in the berm

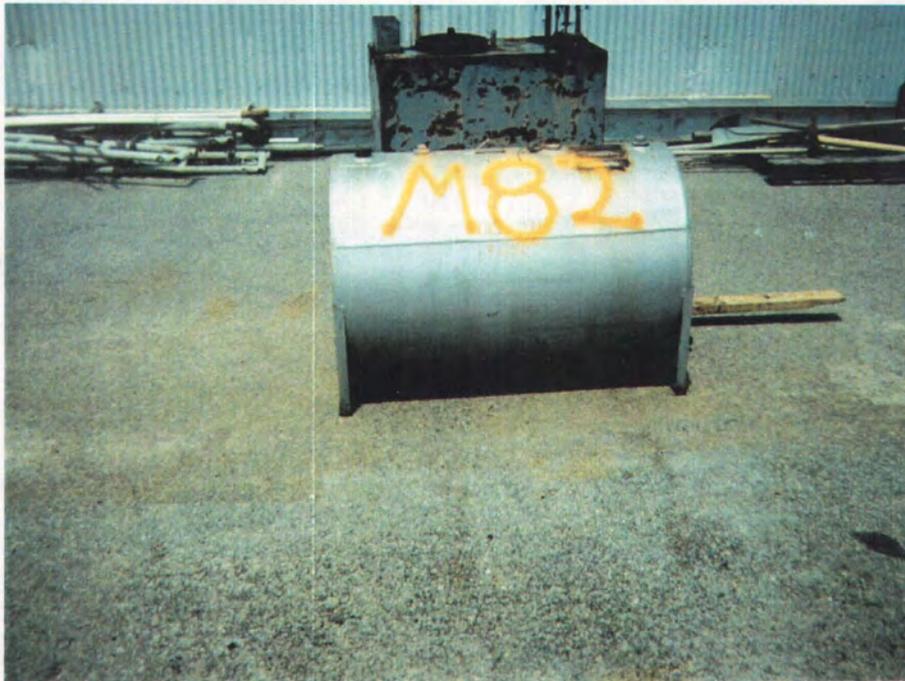
Photo B: AST M82 cleaned

AST M82 was removed, drained, cut open at both ends, and cleaned with a steam cleaner. It was then cut up for recycling as scrap metal. (See Attachment III.)

The tank was cut open on both ends, cleaned with a steam cleaner, cut into sections, and disposed of as recyclable scrap metal.
