NO FURTHER ACTION (NFA) UNDERGROUND STORAGE TANK (UST) ASSESMENT
REPORT DATED 29 JULY 1998 FOR QUARTERS M8 HOUSING CNC CHARLESTON SC
09/02/1998
SOUTH CAROLINA DEPARTMENT OF HEALTH AND ENVIRONMENTAL CONTROL

Re: **Underground Storage Tank Assessment Report dated 29 July 1998**
Quarters "M8" Housing (Site Identification # 15405-General File)
Charleston Naval Complex/Charleston Naval Base
Charleston, SC
Charleston County

South Carolina Department of Health and Environmental Control (S.C.D.H.E.C.)
Underground Storage Tank (UST) Assessment Report

Site I.D. #:	Unregulated		
Facility Name:	Charleston Naval Base Complex, Quarters M8		
Street Address:	801 Commissary Street		
City:	North Charleston, 29405-2413	County:	Charleston

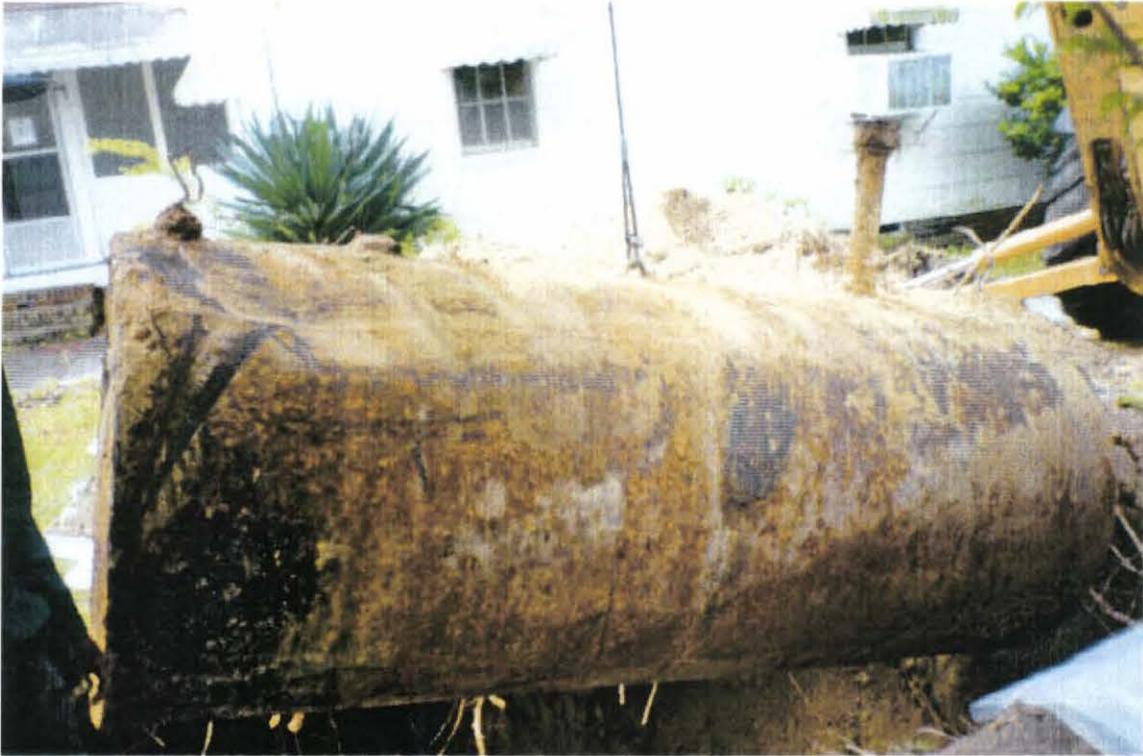
UST Quarters M8 had a thin coating of corrosion throughout its exterior, with heavier strips of rust where the hold-down bands encircled the tank. No holes were found in the tank.

Photo 1: UST Quarters M8 being hoisted from the excavation.

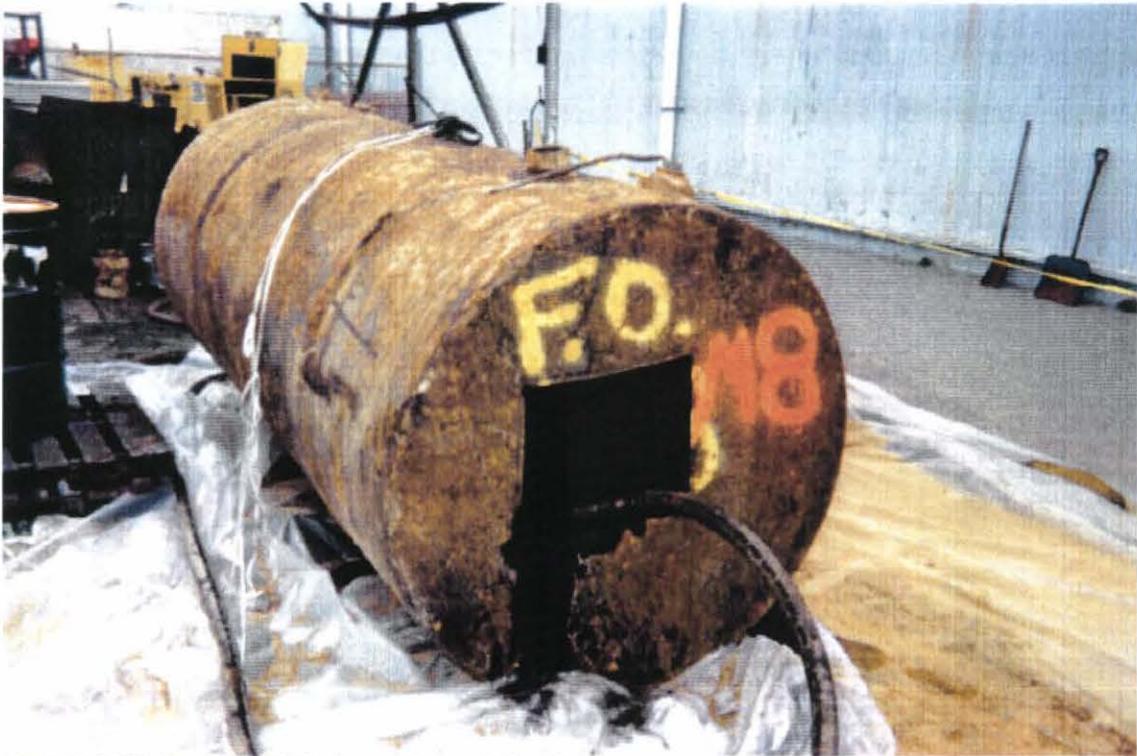
UST Quarters M8 was removed, drained, cut open at both ends, and cleaned with a steam cleaner. It was then cut up for recycling as scrap metal. (See Attachment III.)

Photo 2: UST Quarters M8 during cutting and cleaning.
