NO FURTHER ACTION (NFA) UNDERGROUND STORAGE TANK (UST) ASSESSMENT  
REPORT DATED 2 APRIL 1998 FOR BUILDING 643 (UST 643A) CNC CHARLESTON SC  
05/29/1998  
SOUTH CAROLINA DEPARTMENT OF HEALTH AND ENVIRONMENTAL CONTROL

Re: Underground Storage Tank Assessment Report dated April 2, 1998  
Building 643 (UST 643A) (Site Identification # 15405-General File)  
Charleston Naval Complex/Charleston Naval Base  
Charleston, SC  
Charleston County

South Carolina Department of Health and Environmental Control (S.C.D.H.E.C.)  
Underground Storage Tank (UST) Assessment Report

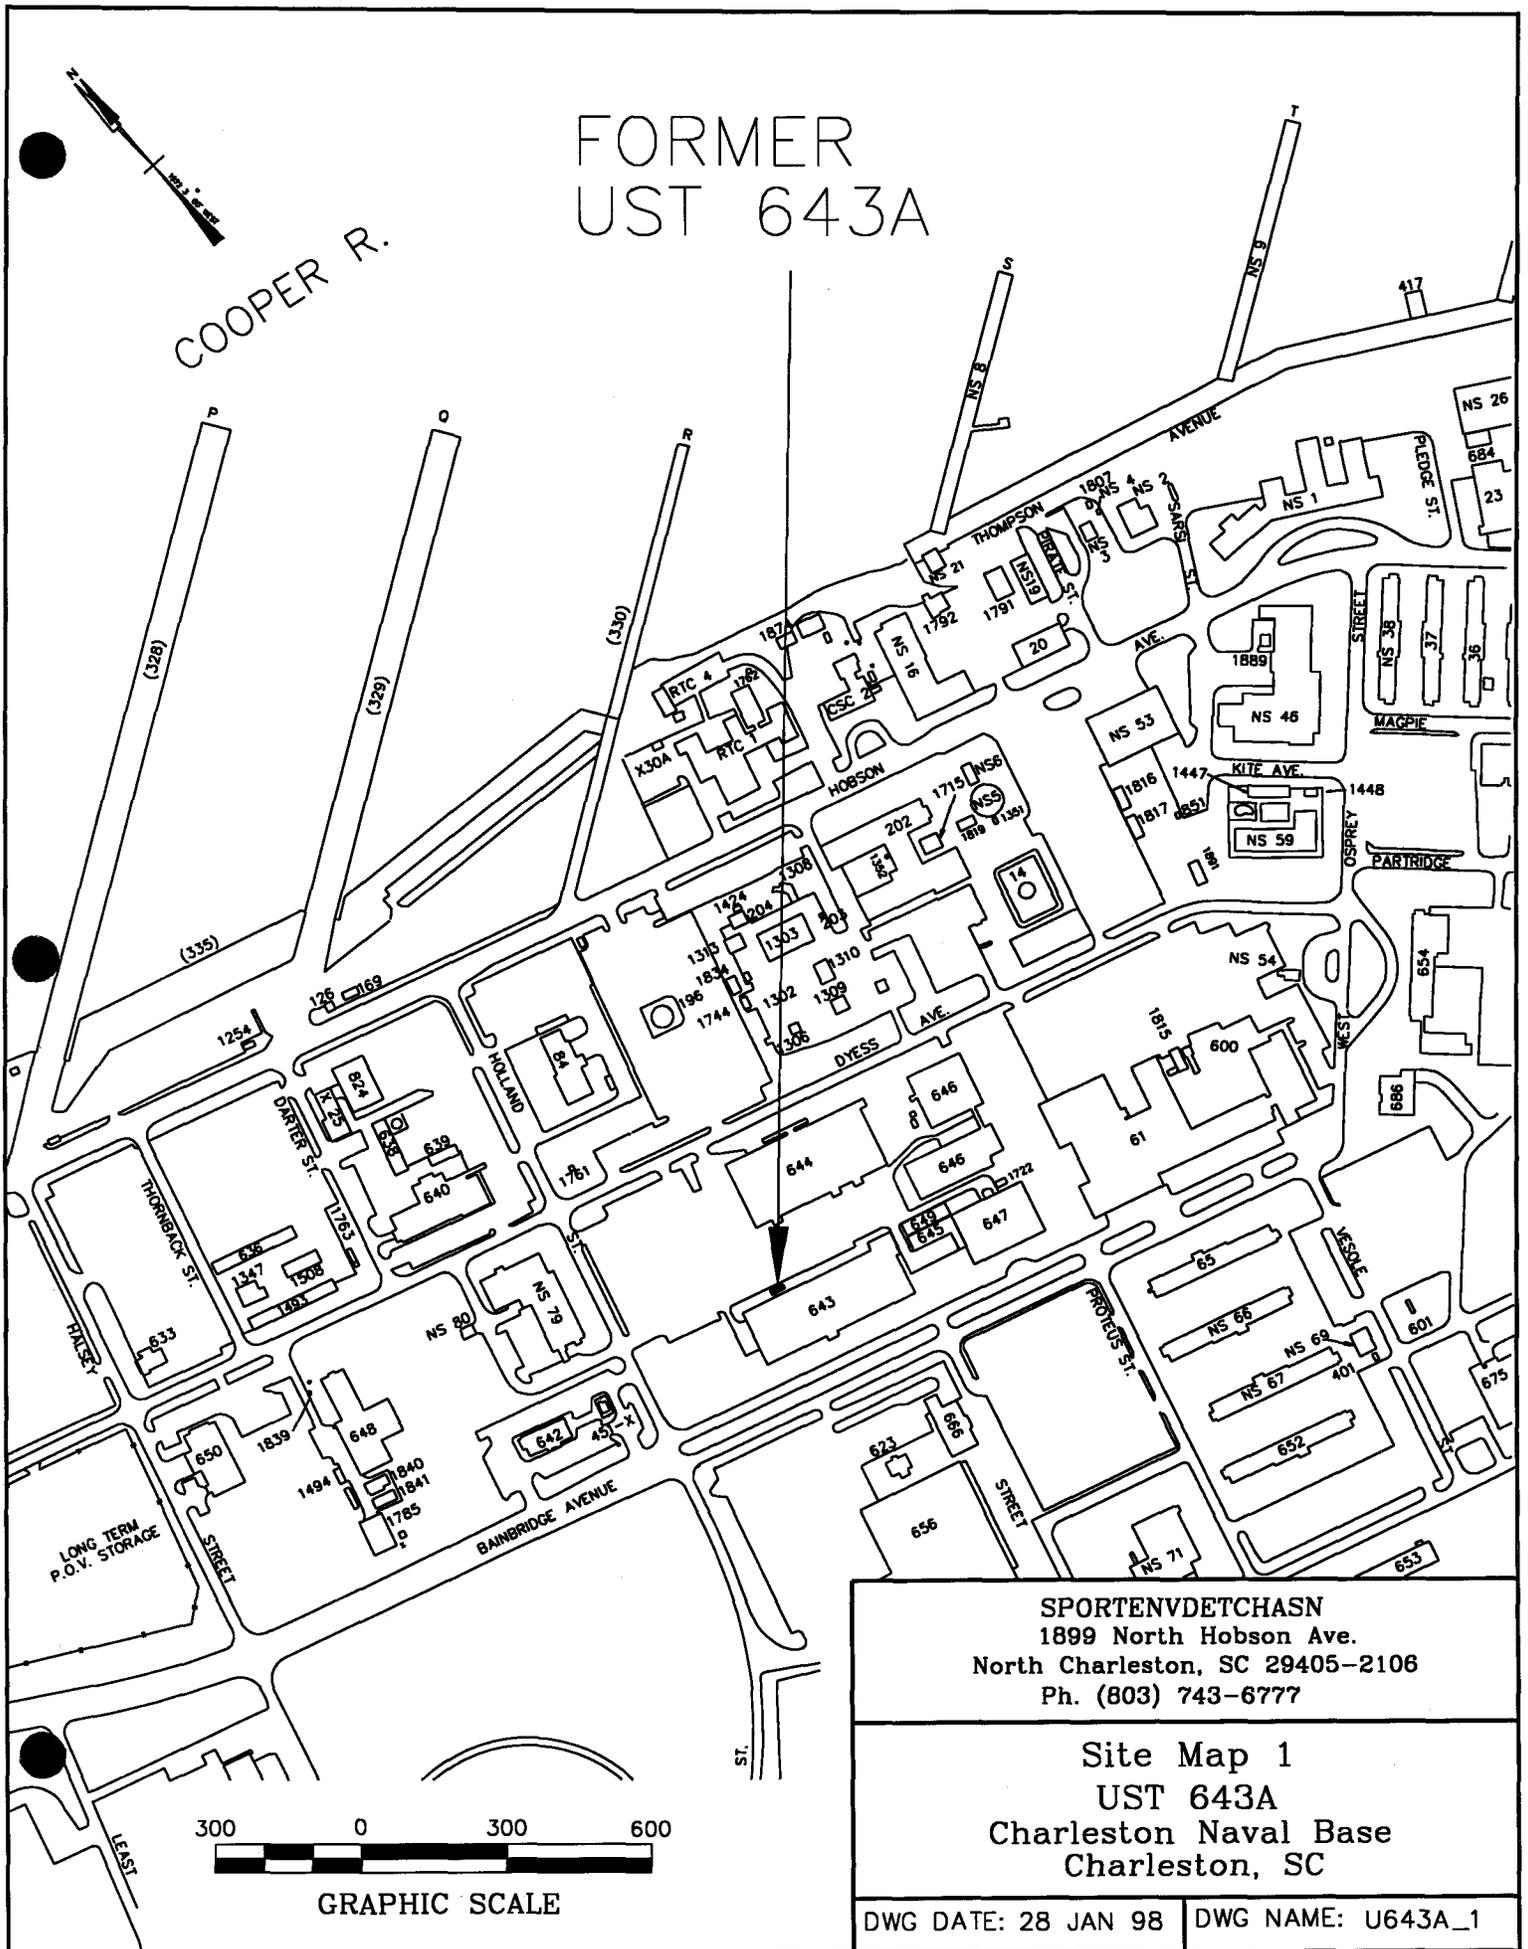
BLDG 643

FORMER UST 643A

STORM DRAIN

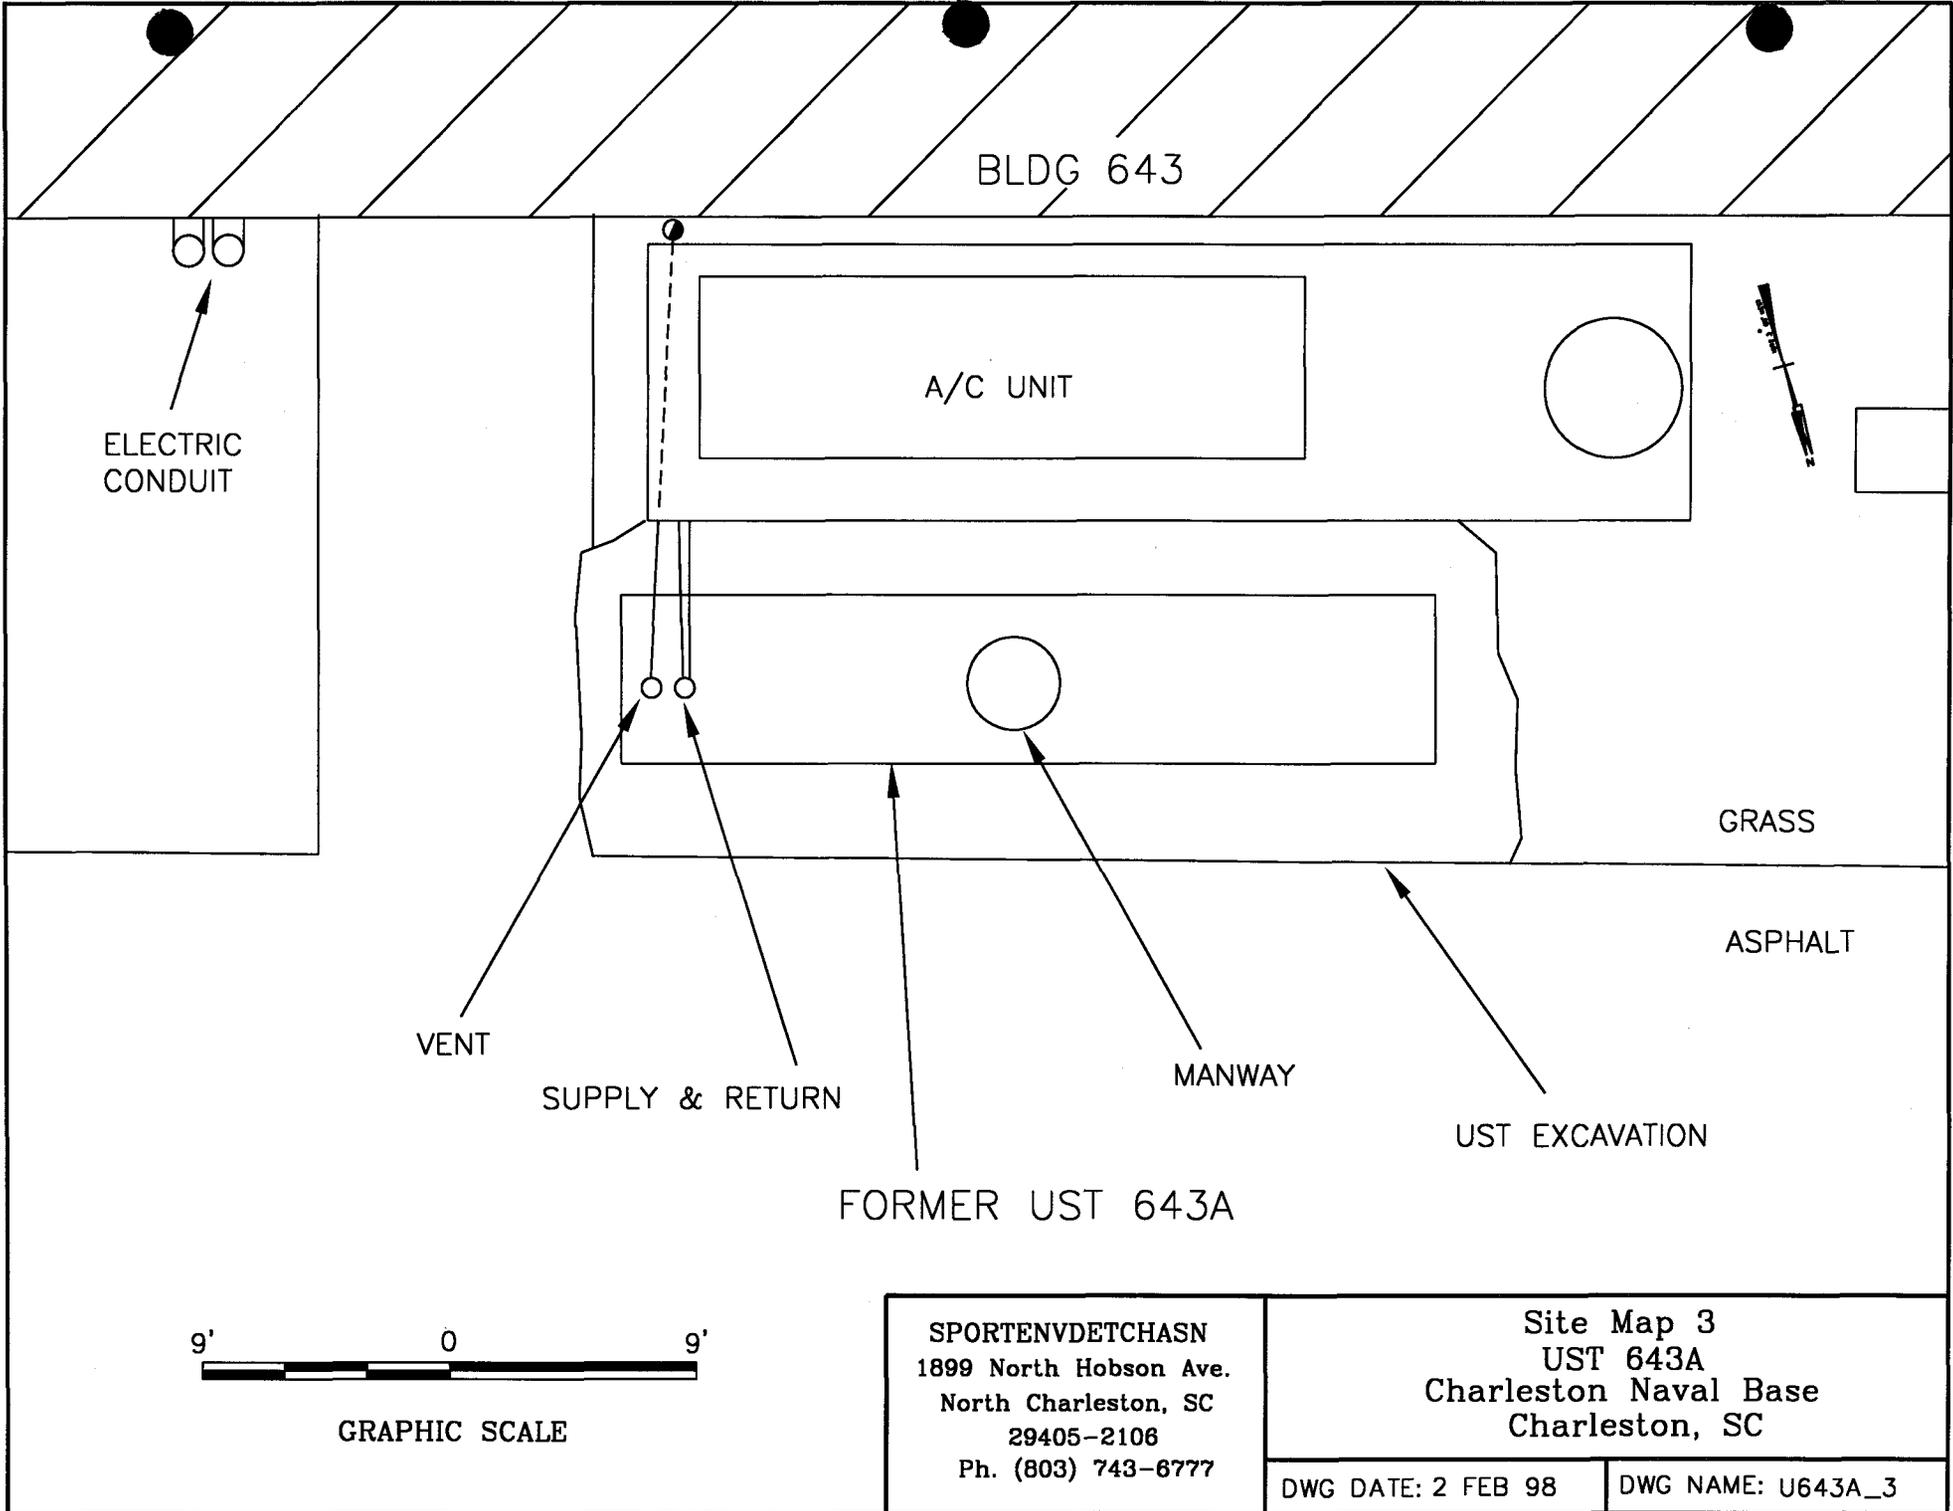
Site Map 2  
UST 643A  
Charleston Naval Base  
Charleston, SC

VENT

SUPPLY & RETURN

MANWAY

UST EXCAVATION

FORMER UST 643A

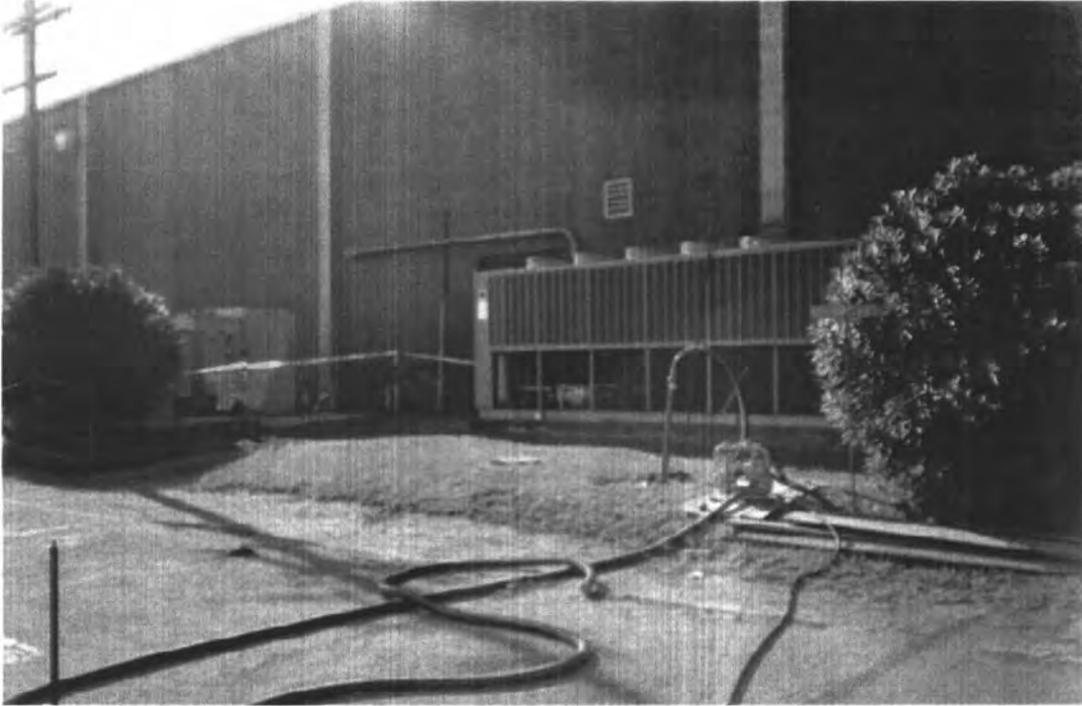
Photo 1: UST 643A site prior to tank removal.

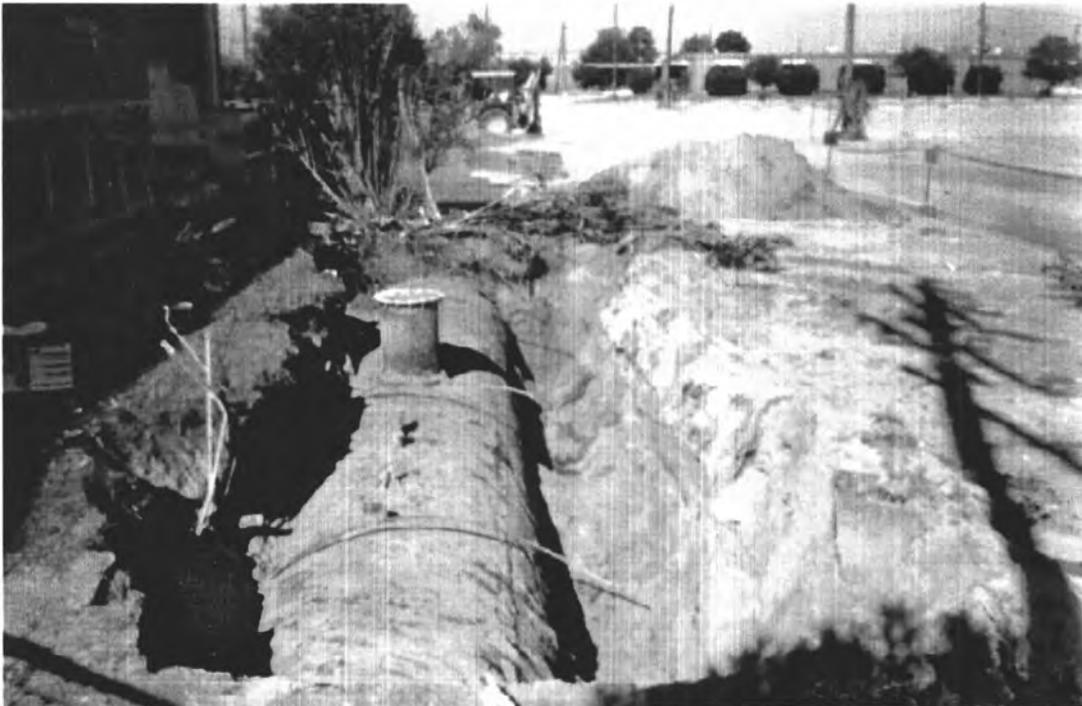
No corrosion, pitting, or holes were found. UST 643A was covered with a protective coating of black pitch.

Photo 2: UST 643A exposed.

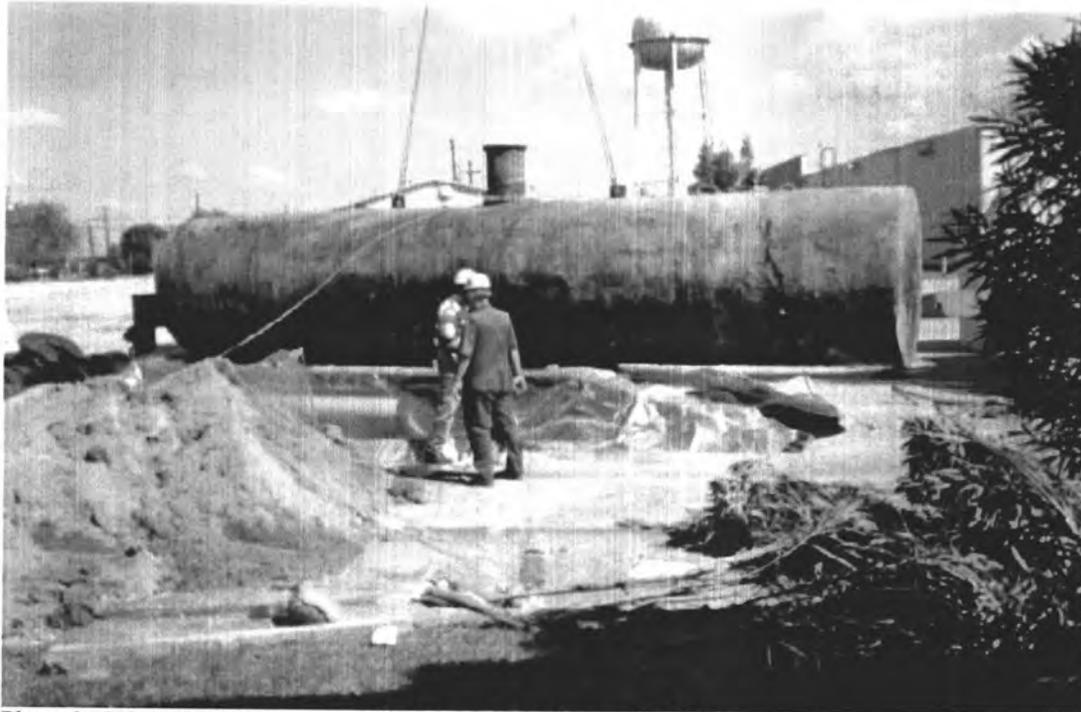
Photo 3: UST 643 being prepared for transport to the cutting pad.

UST 643A was removed, drained, cut open at both ends, and cleaned with a steam cleaner. It was then cut up for recycling as scrap metal. (See Attachment III.)
