UNDERGROUND STORAGE TANK (UST) ASSESSMENT REPORT DATED 2 APRIL 1998
FOR BUILDING 647 WITH SOUTH CAROLINA DEPARTMENT OF HEALTH AND
ENVIRONMENTAL CONTROL REVIEW LETTER CNC CHARLESTON SC
05/29/1998
NAVFAC SOUTHERN

Re: Underground Storage Tank Assessment Report dated April 2, 1998
Building 647 (Site Identification # 15405-General File)
Charleston Naval Complex/Charleston Naval Base
Charleston, SC
Charleston County

South Carolina Department of Health and Environmental Control (S.C.D.H.E.C.)
Underground Storage Tank (UST) Assessment Report

Site Map 1
UST 647
Charleston Naval Base
Charleston, SC

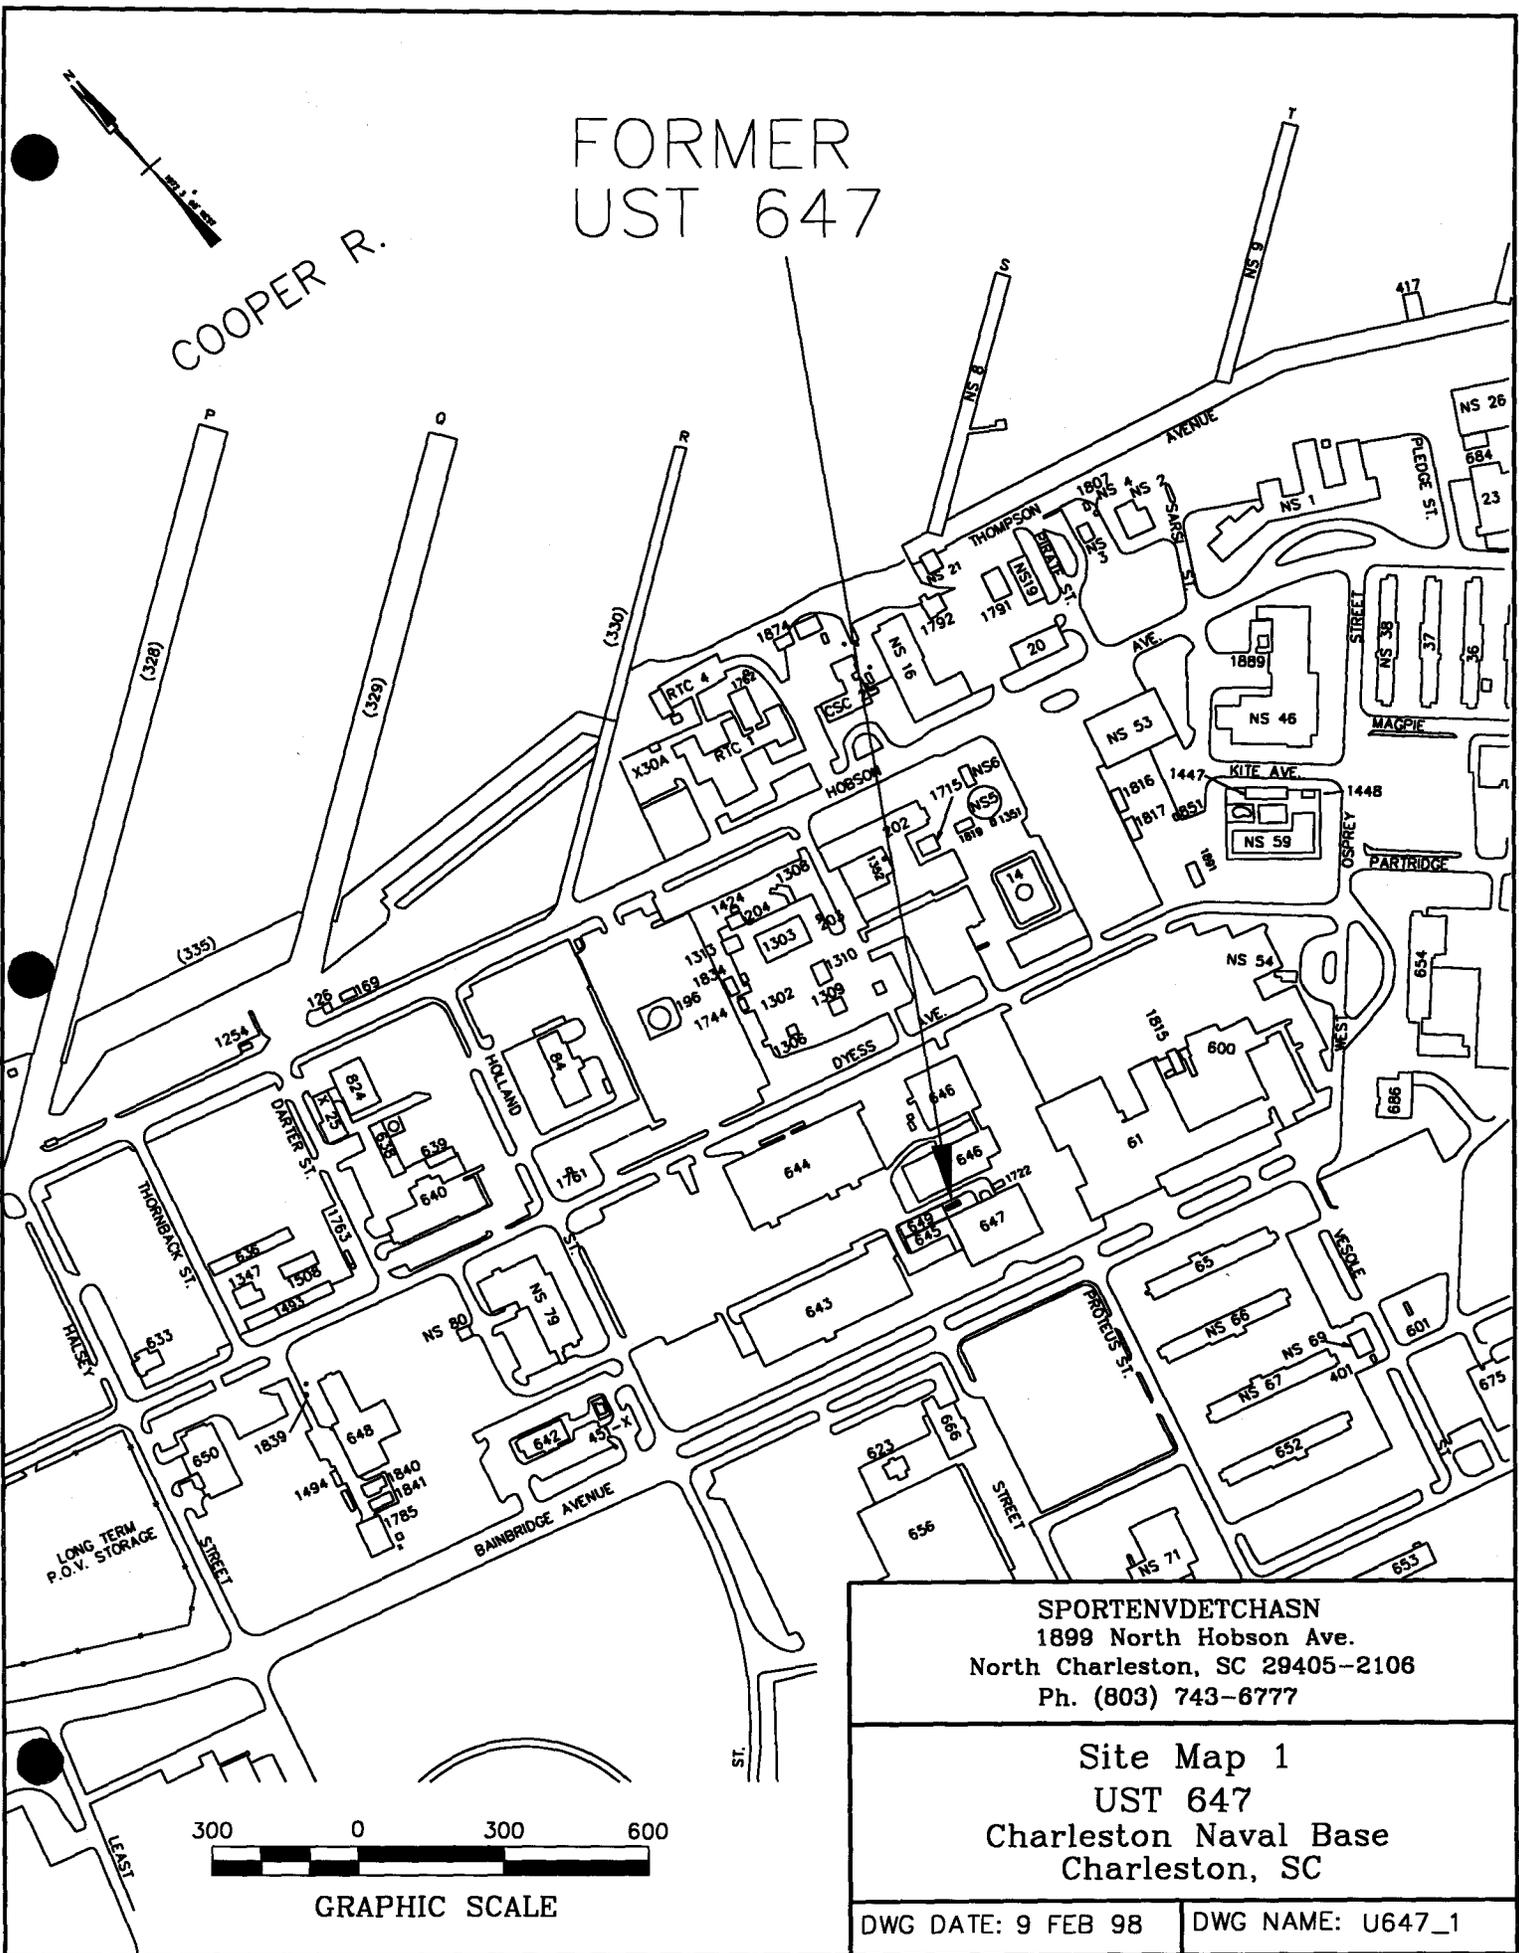
FORMER UST 647

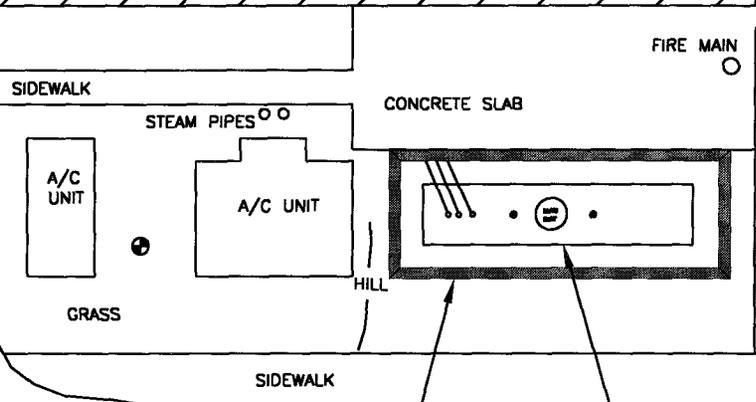
Site Map 2
 UST 647
 Charleston Naval Base
 Charleston, SC

CUT AND CAPPED
RETURN
SUPPLY
TANK LEVEL INDICATOR

CINDERBLOCK VAULT,
EARTH FILLED

SOIL SAMPLE SPORT 0580-2
(DARK BROWN, SANDY, NO ODOR)

SOIL SAMPLE SPORT 0580-3
(DARK BROWN, SANDY, NO ODOR)

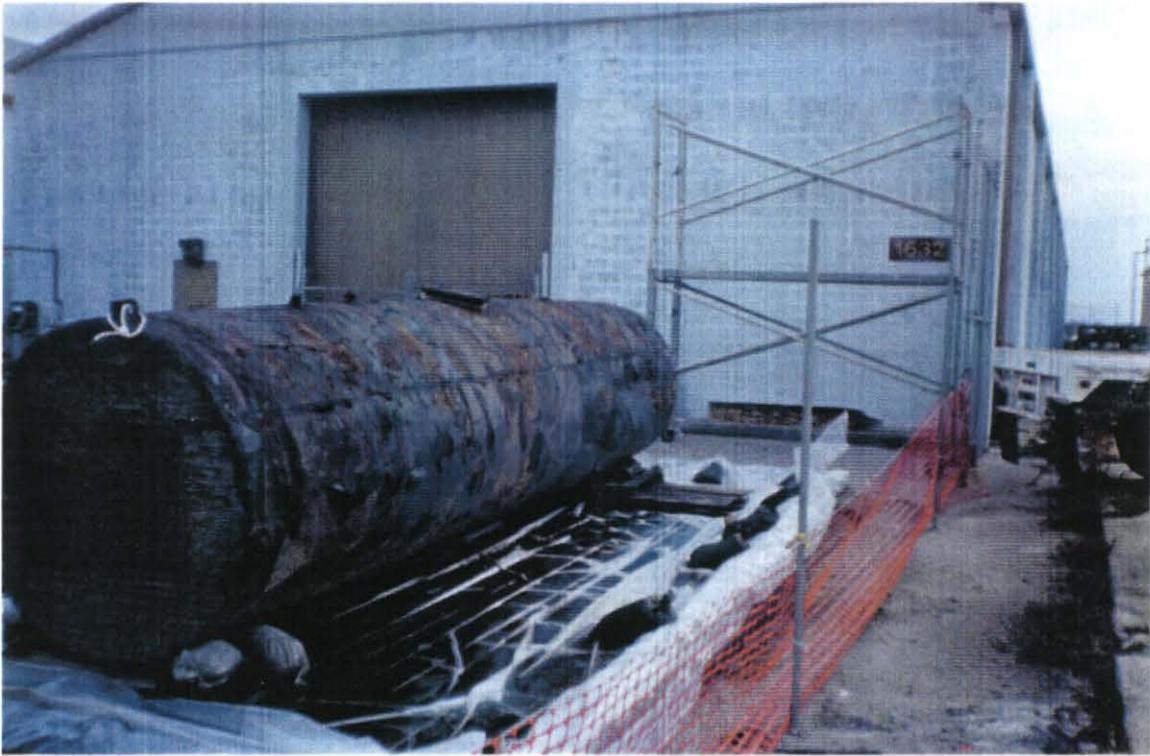
UST 647 was in good condition. The tank was coated with a thick layer of pitch. It had no holes, corrosion, or pitting.

Photo 1: UST 647 in the cutting pad berm. The ends have been cut open for cleaning.

UST 647 was removed, drained, cut open at both ends, and cleaned with a steam cleaner. It was then cut up for recycling as scrap metal. (See Attachment III.)

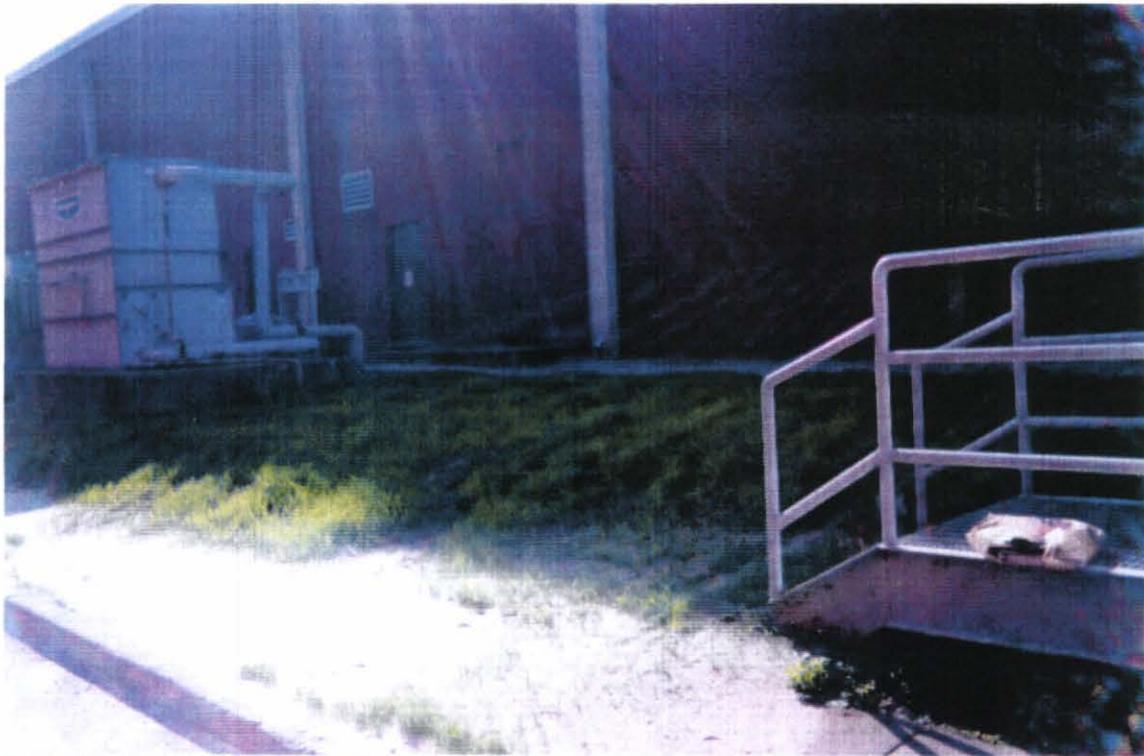
Photo 2: Site of UST 647 removal.
