SITE CHARACTERIZATION RAPID REFUEL PIT NO. 1

Roosevelt Roads Naval Station
Ceiba, Puerto Rico

Contract Number N62470-93-4021

June 1995

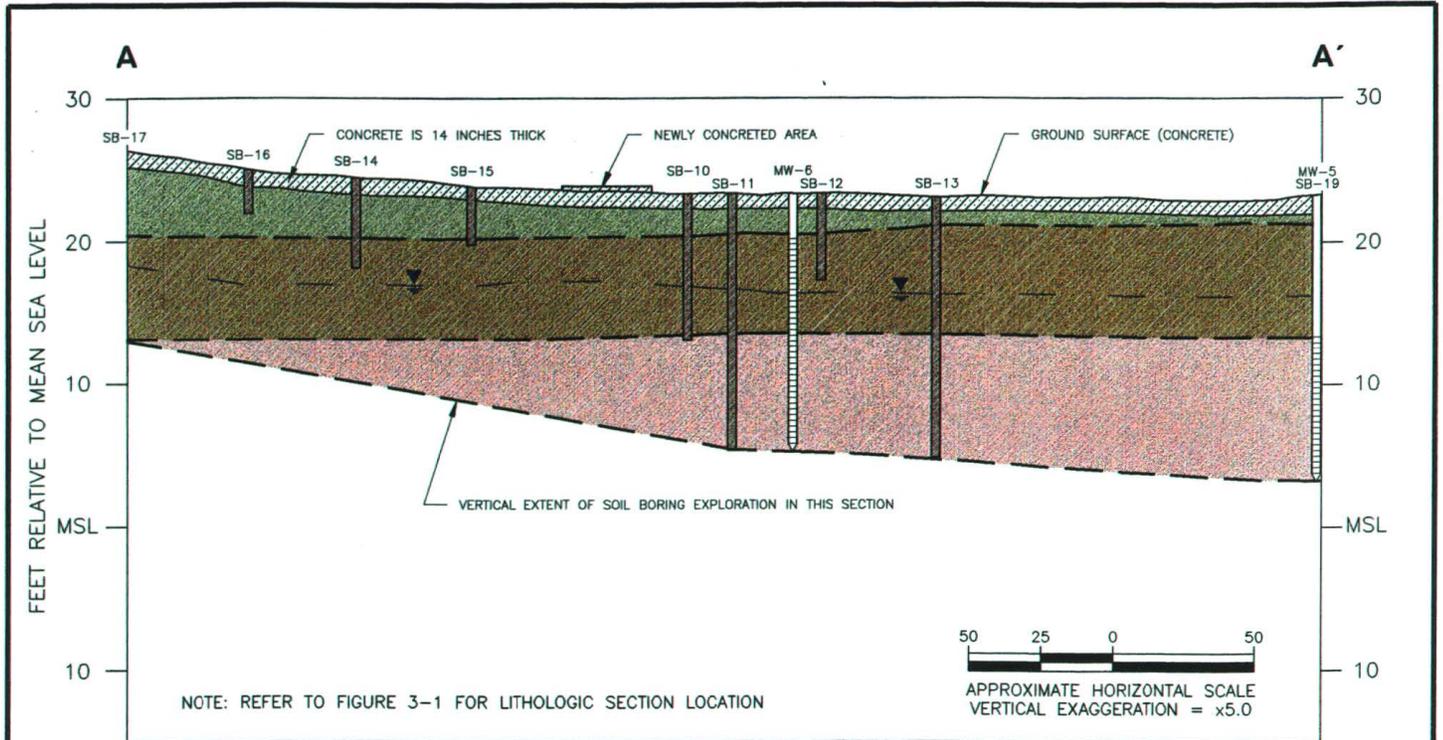
Correlation of these various lithotypes, observed in the field, to those documented in Puerto Rican geologic literature by M'Gonigle (1979) and others suggests that subsurface samples collected from below the 14-inch thick concrete slab to a depth of 26 feet BLS represent detrital deposits of Quaternary age. Within the study area, these deposits are predominantly clays with incorporated pebble-to-gravel sized detritus as follows:

1. From 14 inches BLS to 4 feet BLS is dark, greenish gray clay with pebble-to-gravel sized fill.
2. From 4 feet BLS to 8 feet BLS is dark brown to dark yellowish-brown clay with occasional pebble-sized fill.
3. From 8 feet BLS to 26 feet BLS is dark red or brown, gray, white, and yellow mottled red clays, with occasional black pebble-sized fill.

The wide variance in clay color is attributed to the varying extent of oxidation of the iron minerals contained in the sediments, which were derived from weathered volcanic rock. The colors described were determined in the field by chart comparison with Munsell color standards. Apart from color and texture differences, no significant lithologic changes were apparent that may suggest preference or impedance to groundwater flow, such as fault planes or volcanic intrusions, or that would also affect the indicated groundwater flow patterns and hence contaminant transport.

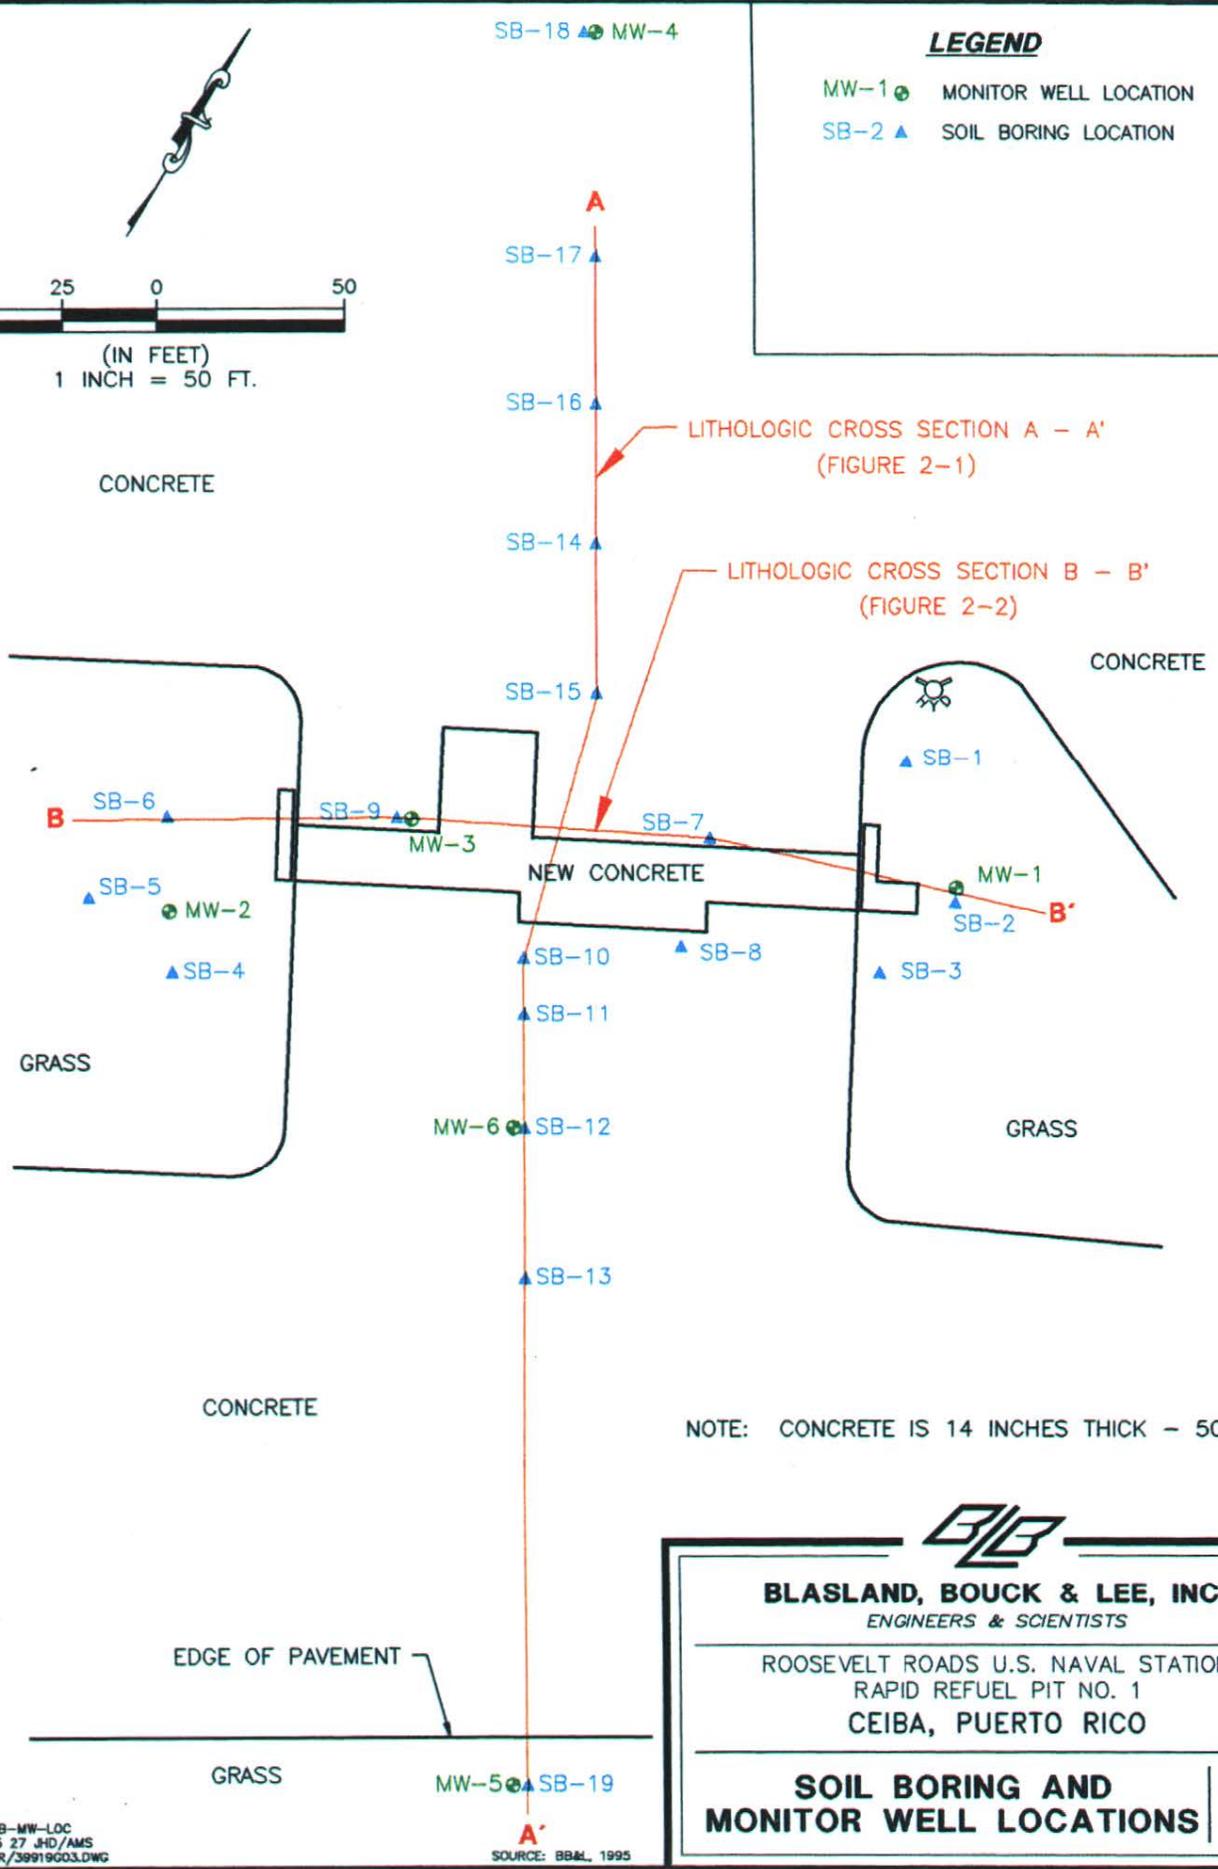
Nineteen soil borings (RRP No. 1-SB1 through RRP No. 1-SB19) were installed (**Figure 3-1**) to determine and delineate the extent of soil and groundwater contamination. Soil borings were advanced to the water table using a 2-foot long, stainless-steel, split-spoon sampler inside a hollow-stem auger. Standard penetration test procedures, in accordance with ASTM D-1586, were followed during collection of soil samples. Soil samples were collected continuously at 2-foot intervals to the water table. Rock and soil types were described in accordance with the Unified Soil Classification System (USCS). Soil boring lithologic logs are presented in **Appendix A**.

- MW-1 ● MONITOR WELL LOCATION
- SB-2 ▲ SOIL BORING LOCATION

NOTE: CONCRETE IS 14 INCHES THICK - 5000 PSI

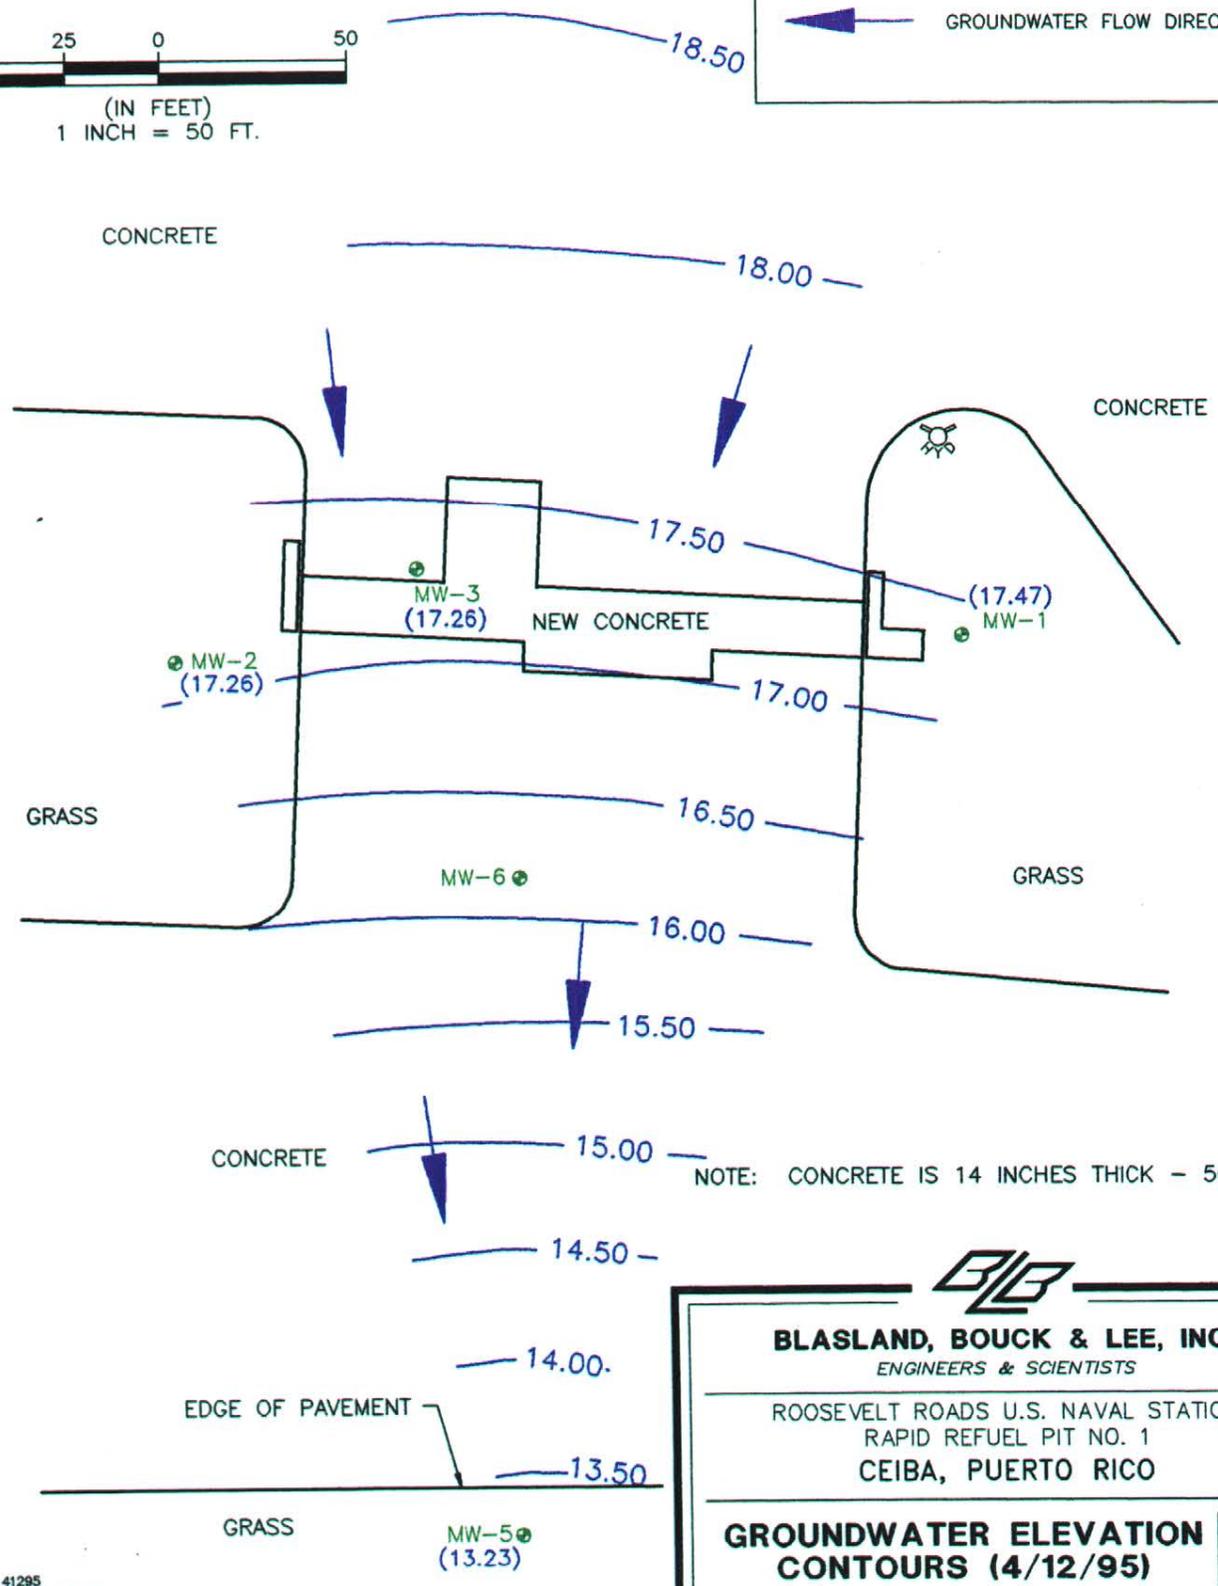
- MW-1 ● MONITOR WELL LOCATION
- (18.98) GROUNDWATER ELEVATION (FT. ABOVE MEAN SEA LEVEL)
- 18.00 — GROUNDWATER ELEVATION CONTOUR LINE (FT. ABOVE MEAN SEA LEVEL)
- ▲ GROUNDWATER FLOW DIRECTION

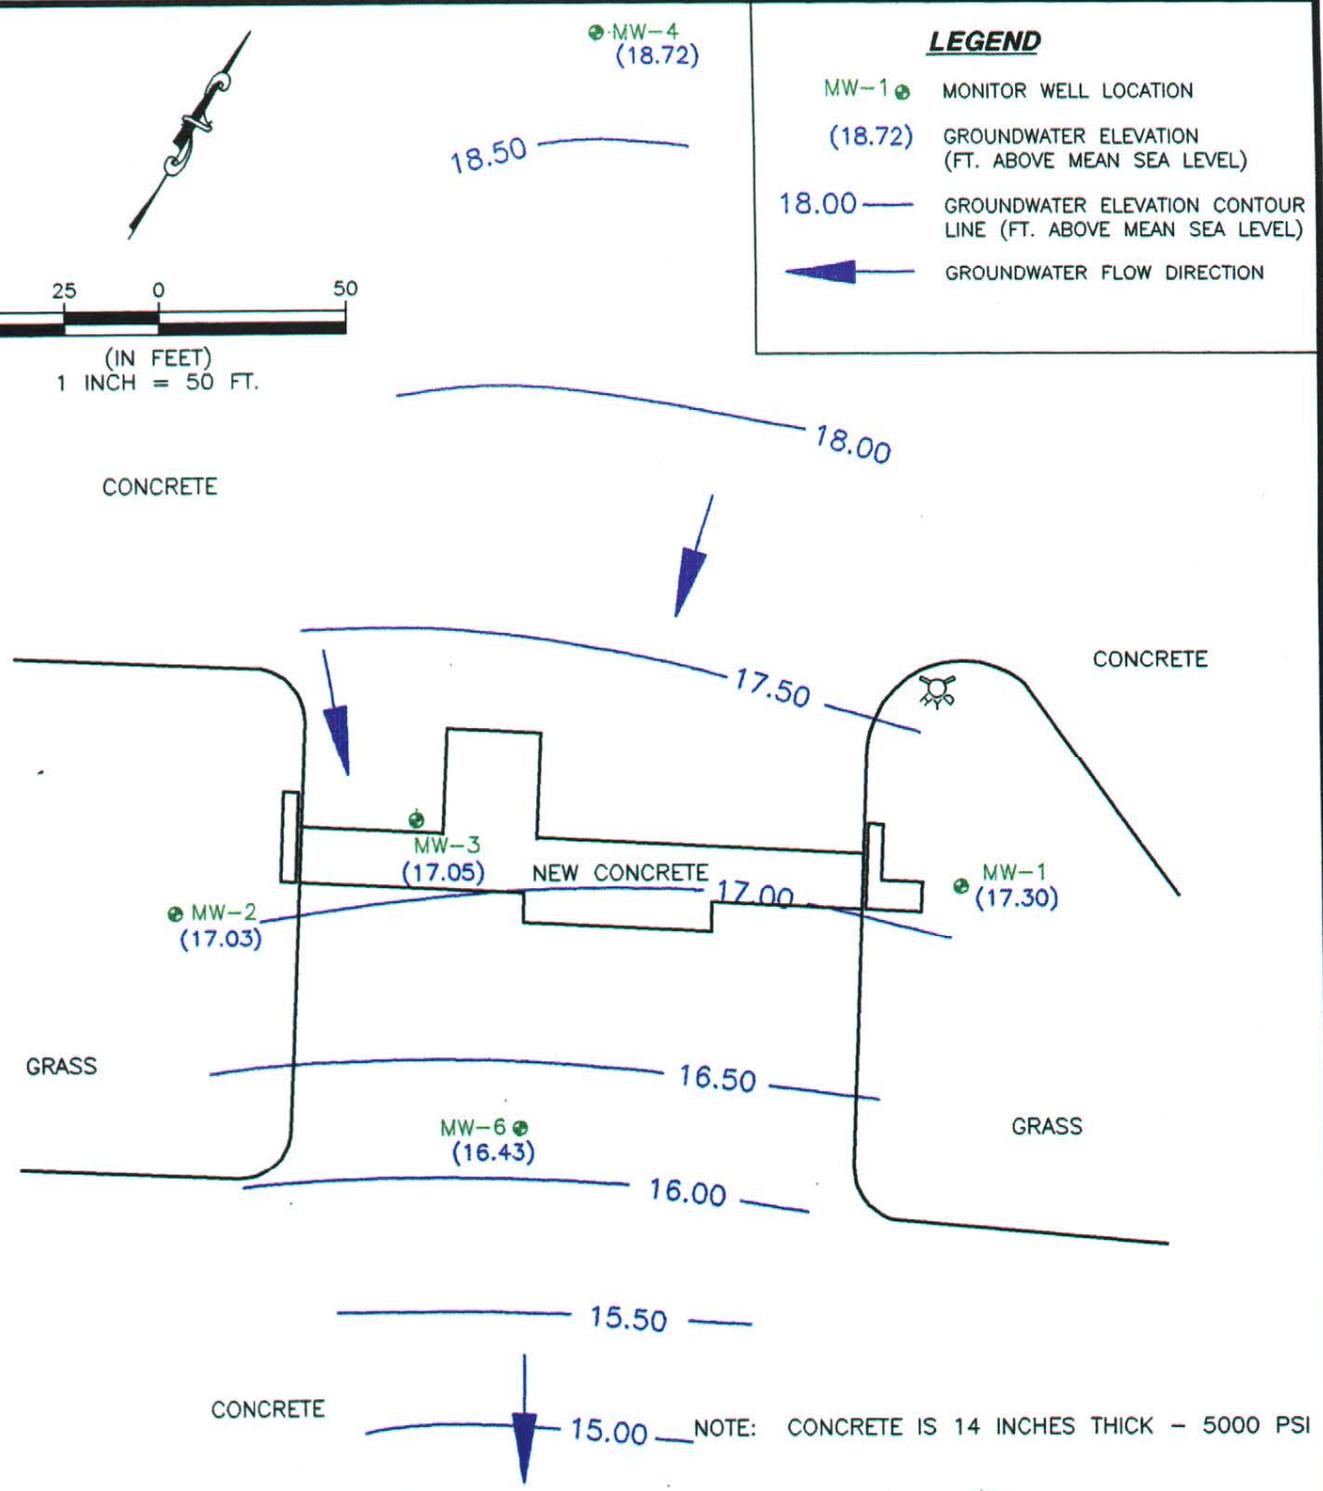
- MW-1 ● MONITOR WELL LOCATION
- (18.72) GROUNDWATER ELEVATION (FT. ABOVE MEAN SEA LEVEL)
- 18.00 — GROUNDWATER ELEVATION CONTOUR LINE (FT. ABOVE MEAN SEA LEVEL)
- ▲ GROUNDWATER FLOW DIRECTION

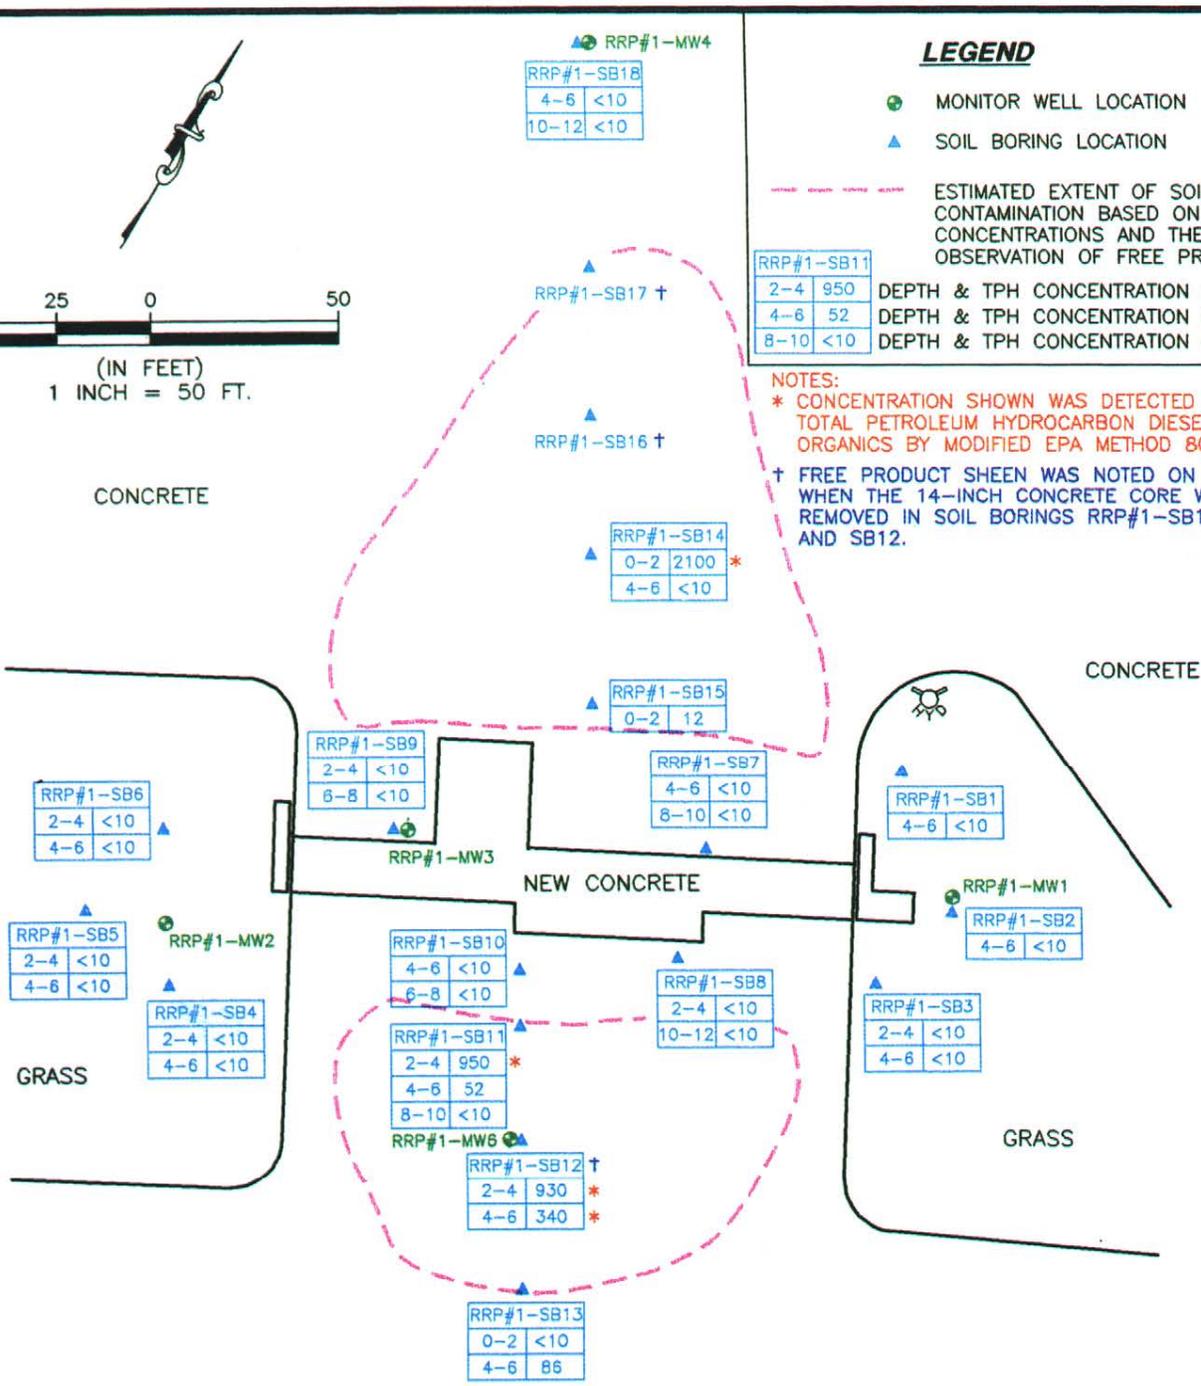
FIGURE
4-1

performed on these soil borings. The soil borings containing a free product sheen on the water introduced during coring were RRP#1-SB12A, RRP#1-SB12, RRP#1-SB16, and RRP#1-SB17. At boring RRP#1-SB12, free product was observed dripping from the split spoon at the 4 to 6-foot depth interval during soil boring advancement. Boring RRP#1-SB12 was converted to a monitoring well to measure and monitor the extent and thickness of free product, if present at the site.

- MONITOR WELL LOCATION
- ▲ SOIL BORING LOCATION
- ESTIMATED EXTENT OF SOIL CONTAMINATION BASED ON TPH CONCENTRATIONS AND THE FIELD OBSERVATION OF FREE PRODUCT

RRP#1-SB11	2-4	950	DEPTH & TPH CONCENTRATION (mg/Kg)
	4-6	52	DEPTH & TPH CONCENTRATION (mg/Kg)
	8-10	<10	DEPTH & TPH CONCENTRATION (mg/Kg)

NOTES:
 * CONCENTRATION SHOWN WAS DETECTED IN THE TOTAL PETROLEUM HYDROCARBON DIESEL RANGE ORGANICS BY MODIFIED EPA METHOD 8015 DRO.
 † FREE PRODUCT SHEEN WAS NOTED ON THE SOIL WHEN THE 14-INCH CONCRETE CORE WAS REMOVED IN SOIL BORINGS RRP#1-SB17, SB16 AND SB12.

Based on the information contained in this report, soil excavation is not feasible or recommended because of the fueling operations and air traffic in the area. *In-situ* remediation methods are not recommend either, due to the low permeability conditions presented by the clays underlying the site. Natural biodegradation processes are expected to reduce the levels of petroleum

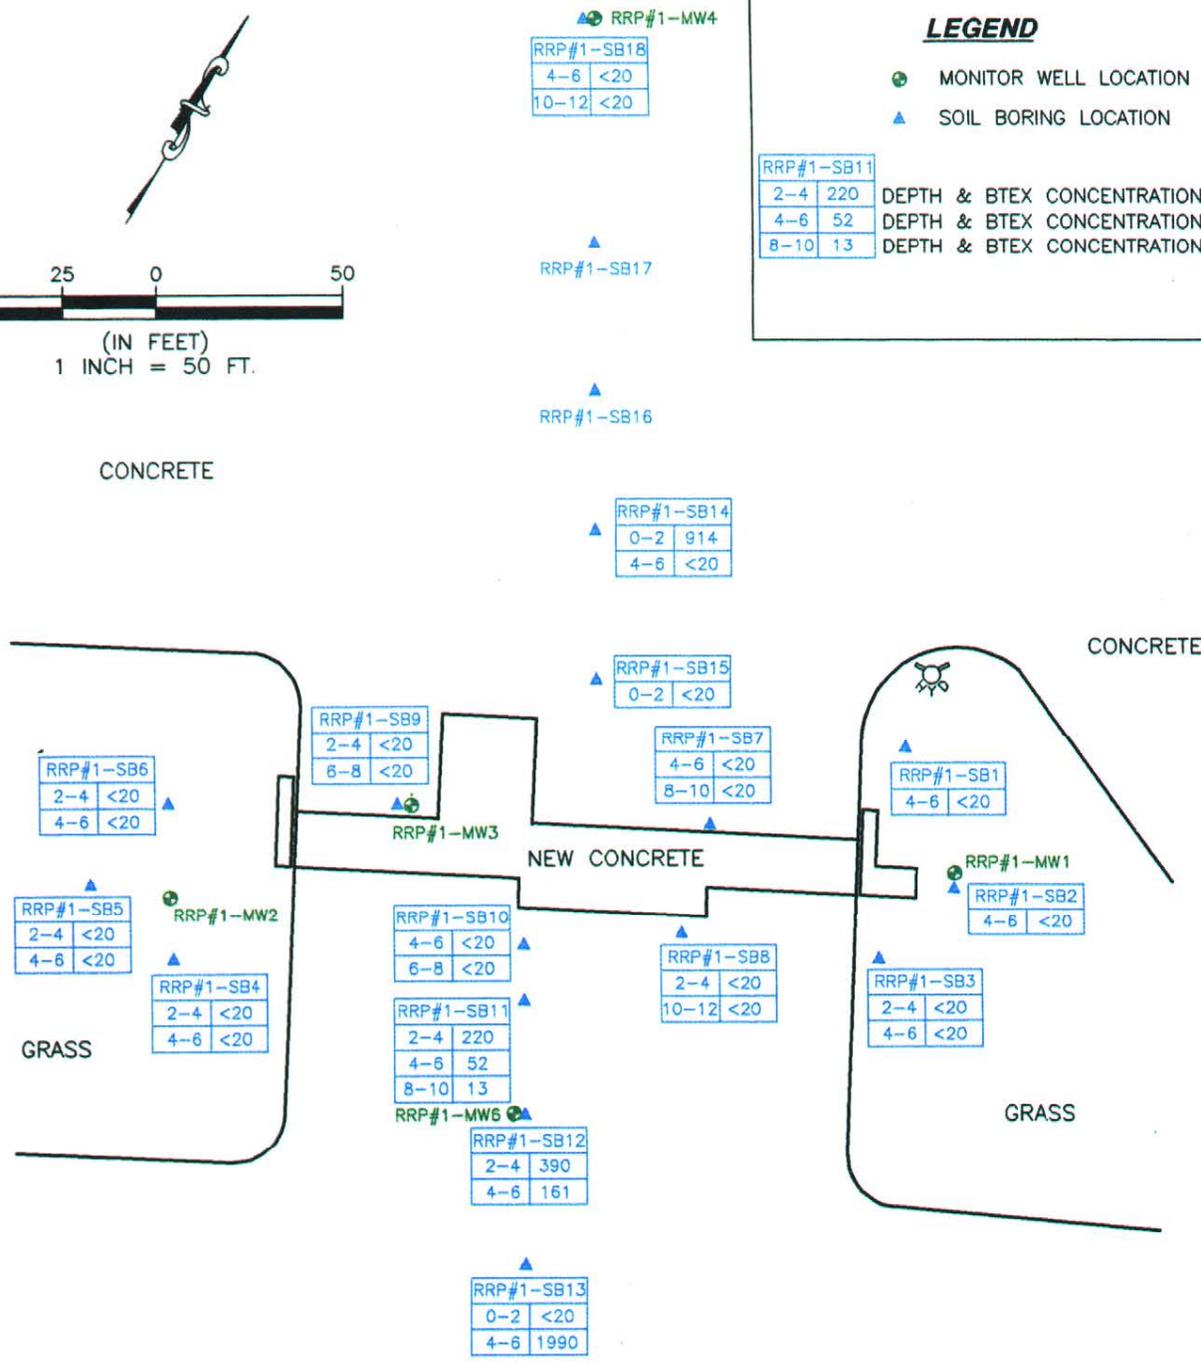
- MONITOR WELL LOCATION
- ▲ SOIL BORING LOCATION

RRP#1-SB11	
2-4	220
4-6	52
8-10	13

DEPTH & BTEX CONCENTRATION (ug/Kg)
 DEPTH & BTEX CONCENTRATION (ug/Kg)
 DEPTH & BTEX CONCENTRATION (ug/Kg)

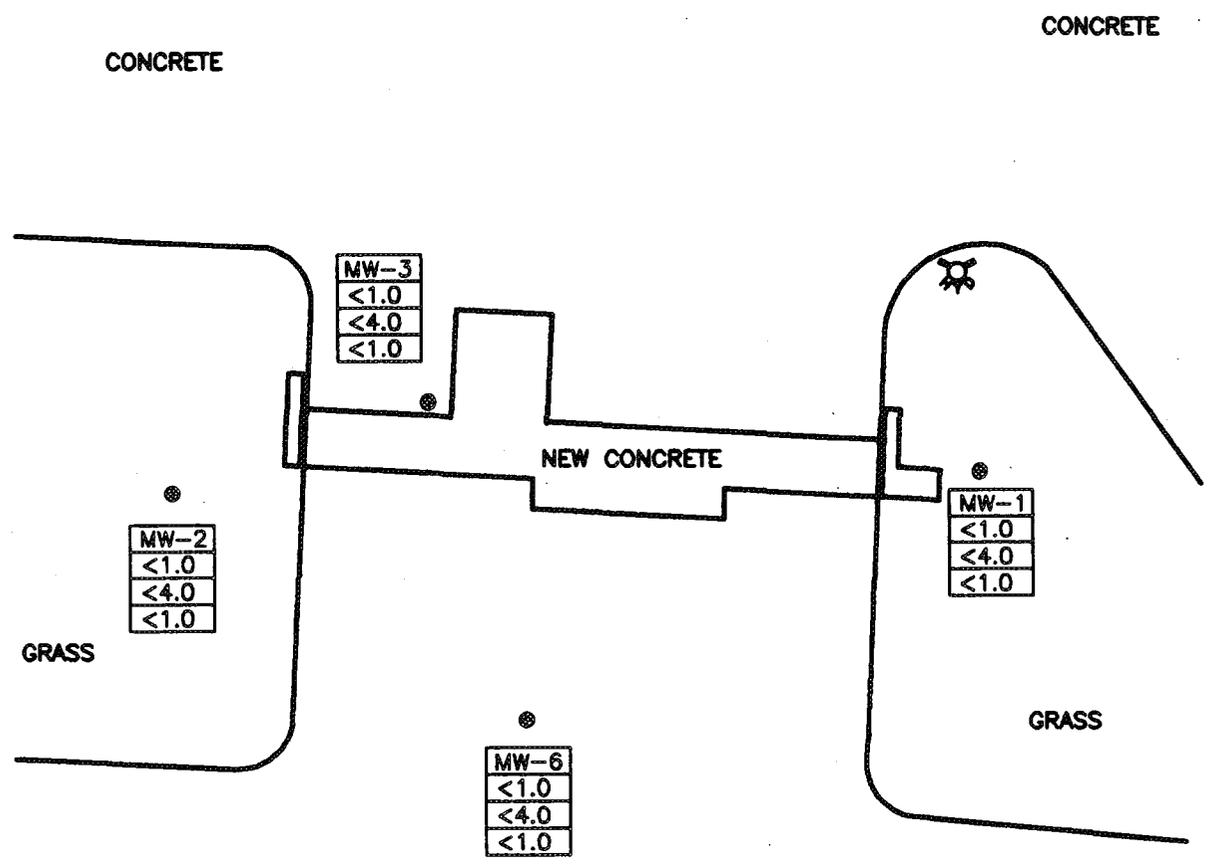
MW-4
<1.0
<4.0
<1.0

MW-2
<1.0
<4.0
<1.0

BENZENE CONCENTRATION (ug/L)
 TOTAL BTEX CONCENTRATION (ug/L)
 TPH CONCENTRATION (mg/L)

the groundwater samples collected from the monitoring wells sampled at the site. A free product sheen was observed on the water introduced during the concrete coring of four soil borings at the site; however, no free product was detected in any of the six monitoring wells later installed at the site.

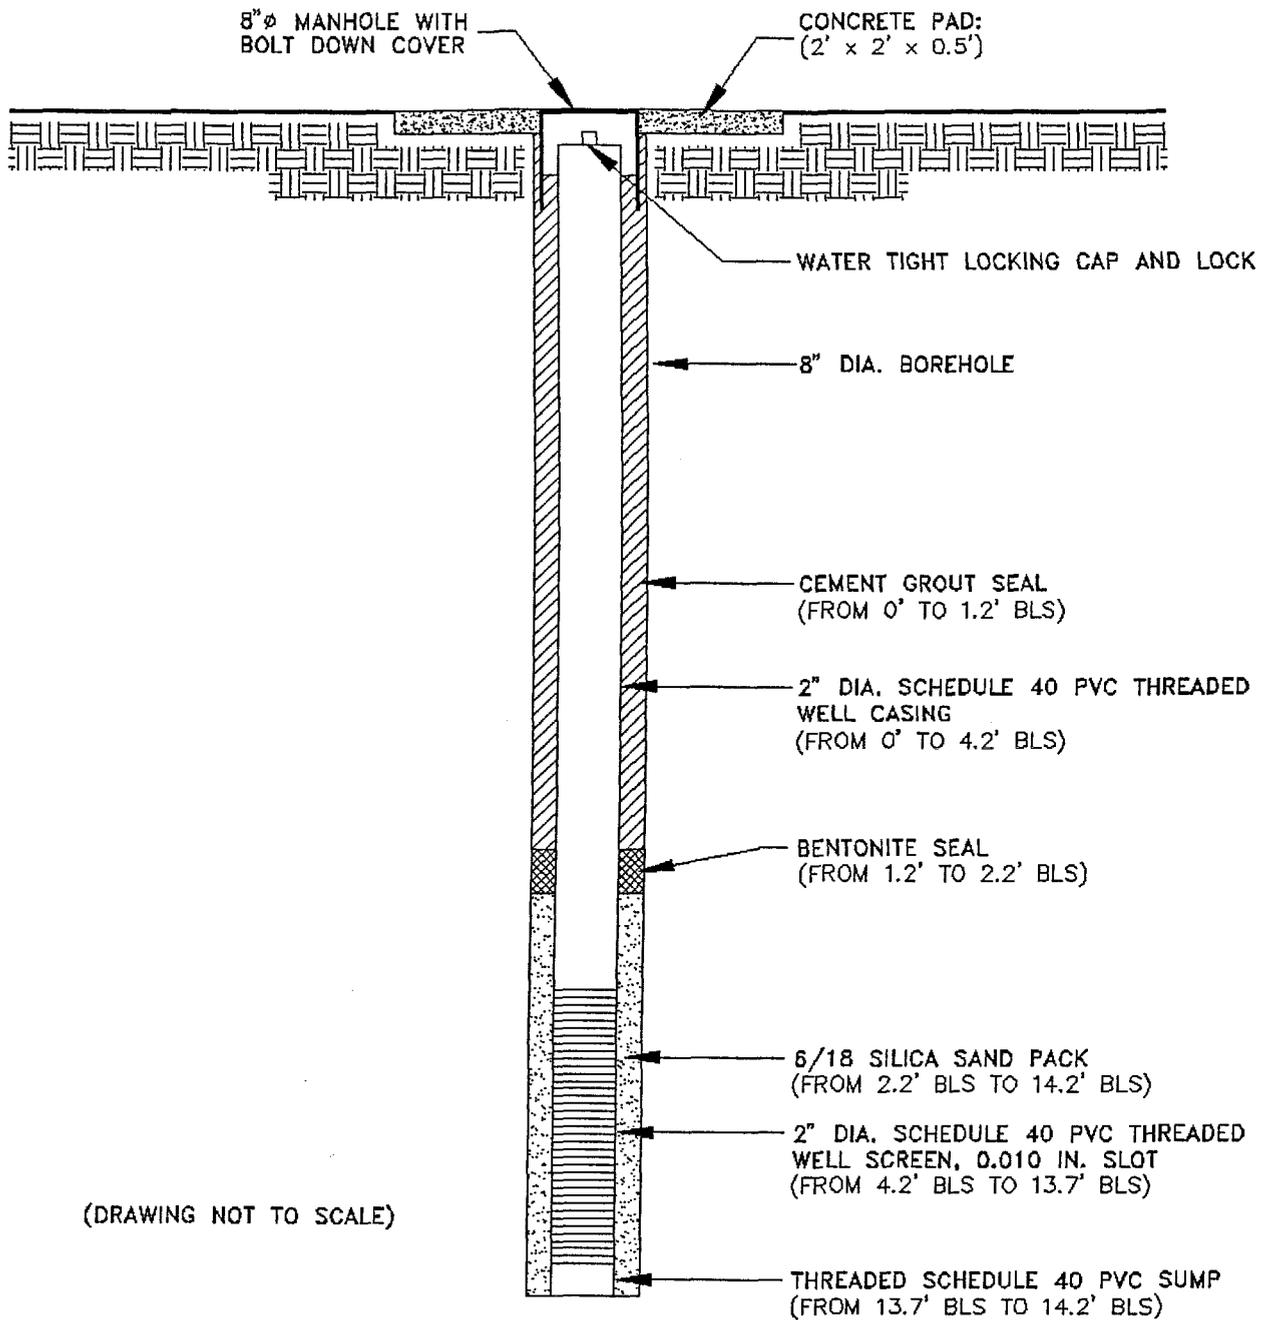
PROJECT NO.: 399.19
WELL NO.: MW-1
BY: M. BAUER
DATE: 3/20/95
CASING ELEVATION: 24.111 FEET
DEPTH TO WATER UPON COMPLETION: 6.12 FEET
UNIT MONITORED: SURFICIAL AQUIFER

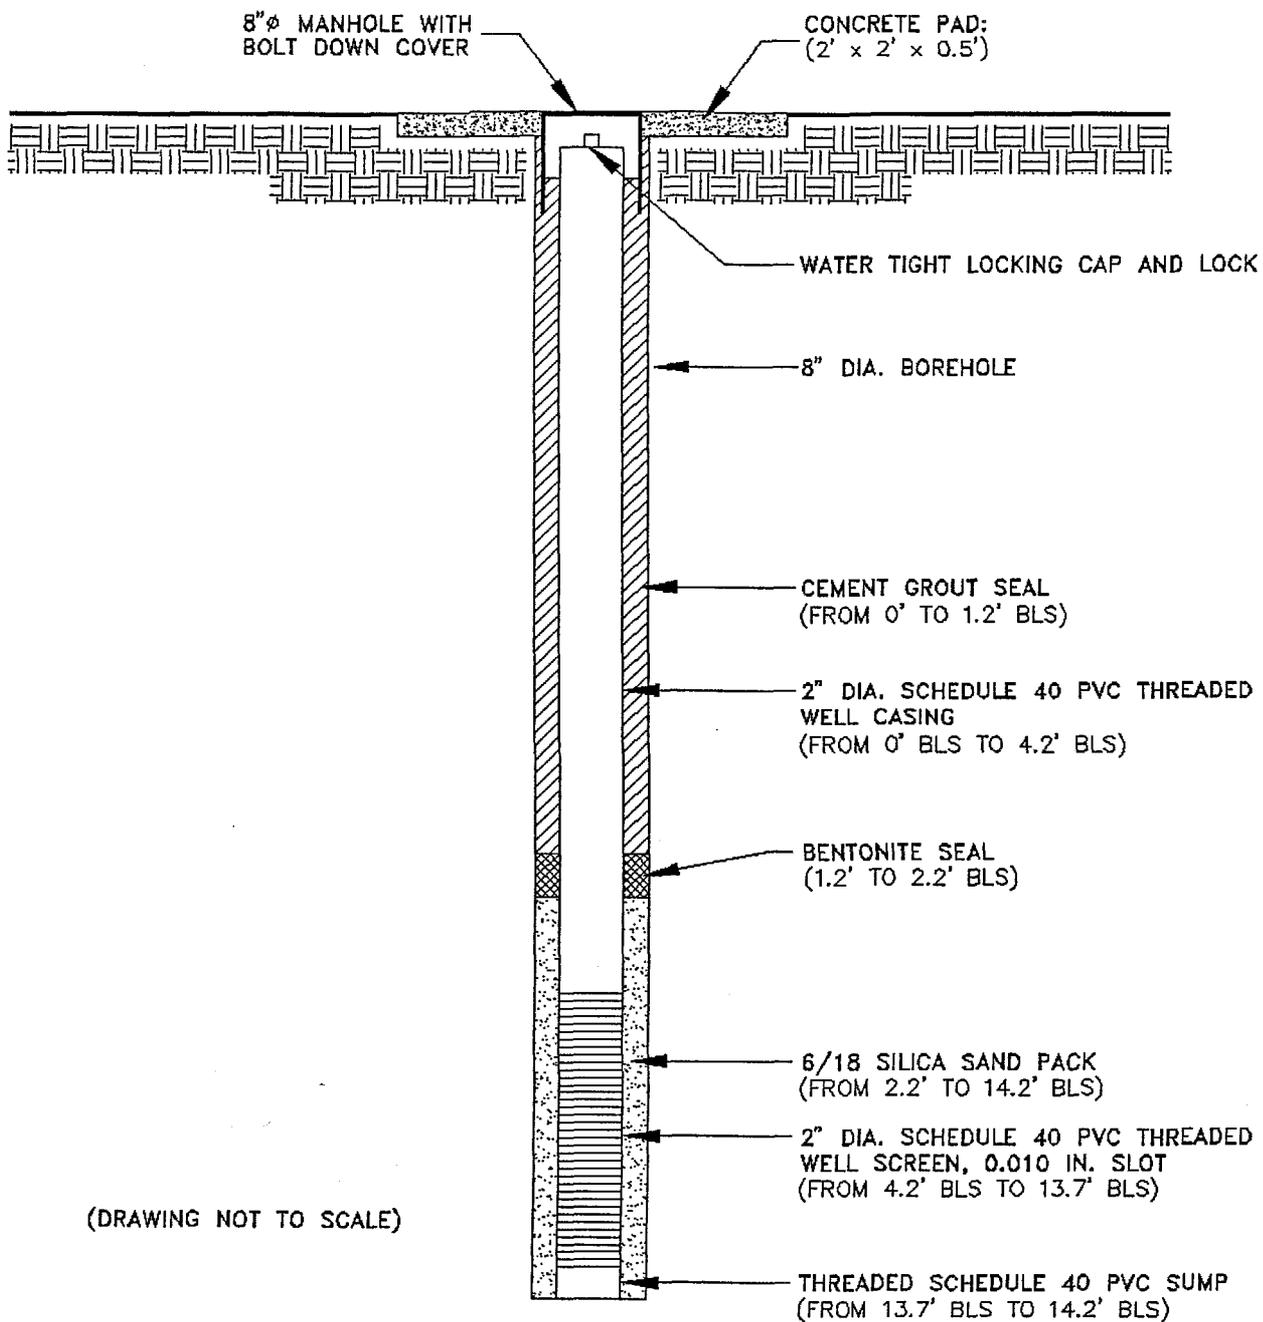
PROJECT NO.: 399.19
WELL NO.: MW-2
BY: M. BAUER
DATE: 3/20/95
CASING ELEVATION: 23.195 FEET
DEPTH TO WATER UPON COMPLETION: 6.13 FEET
UNIT MONITORED: SURFICIAL AQUIFER

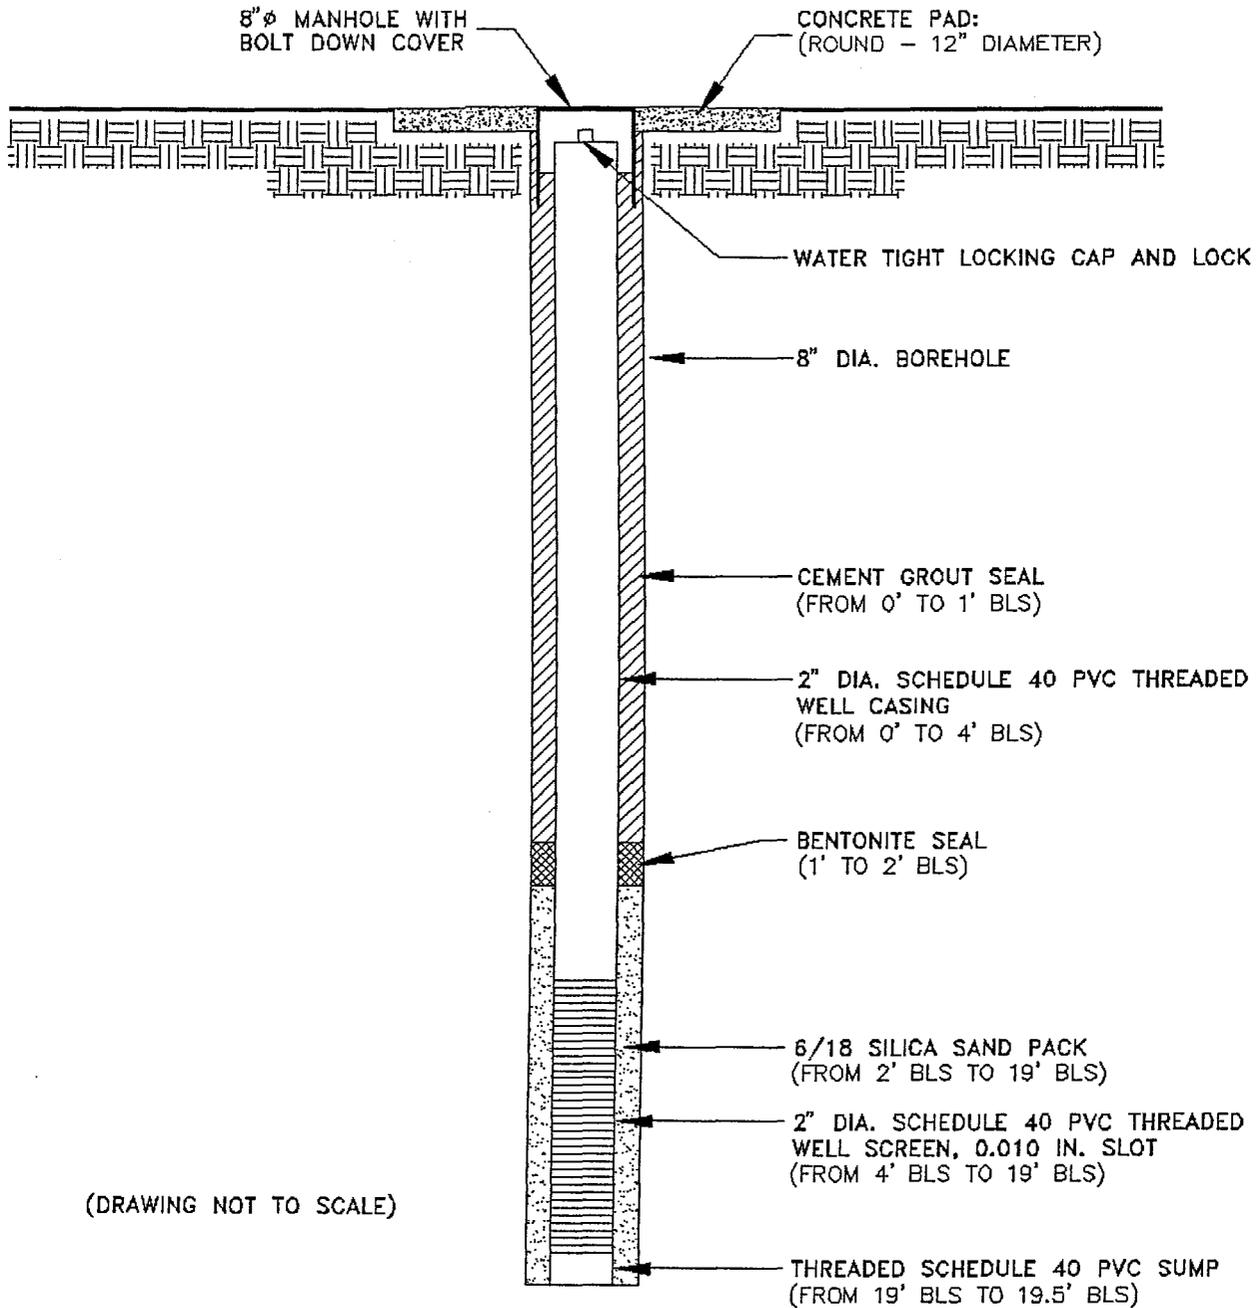
PROJECT NO.: 399.19
WELL NO.: MW-3
BY: M. BAUER
DATE: 3/22/95
CASING ELEVATION: 23.963 FEET
DEPTH TO WATER UPON COMPLETION: 14.00 FEET
UNIT MONITORED: SURFICIAL AQUIFER

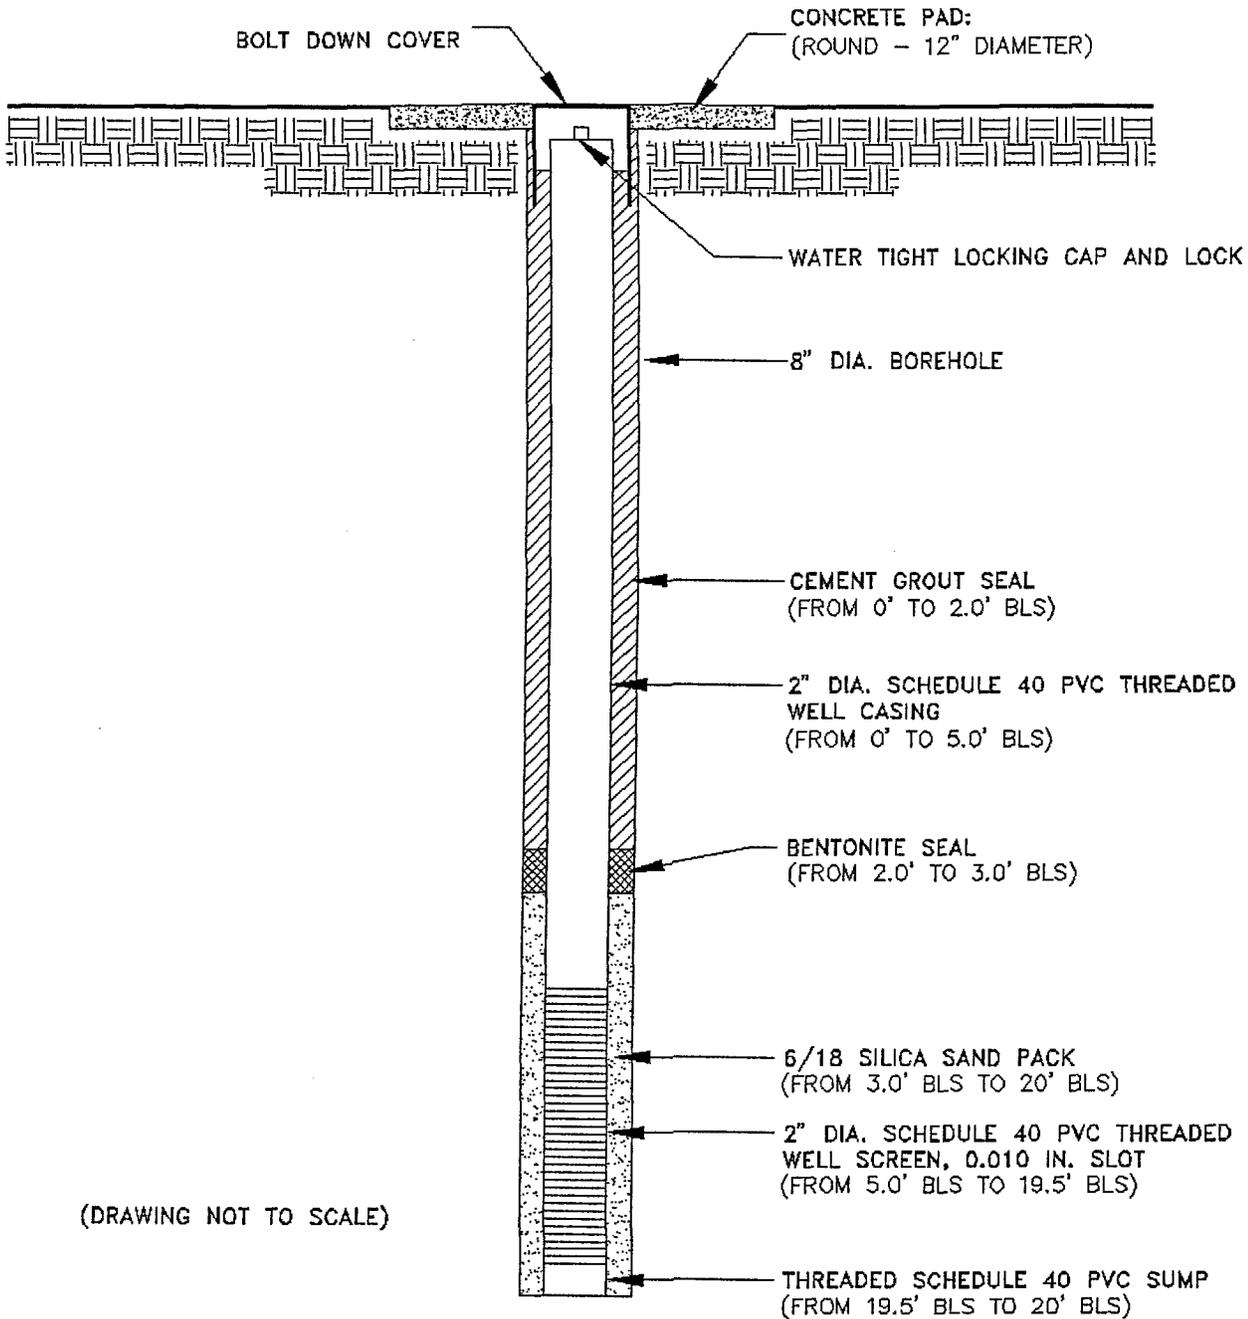
PROJECT NO.: 399.19
WELL NO.: MW-4
BY: J. Skidmore
DATE: 4/11/95
CASING ELEVATION: 27.391 FEET
DEPTH TO WATER UPON COMPLETION: 14.00 FEET
UNIT MONITORED: SURFICIAL AQUIFER

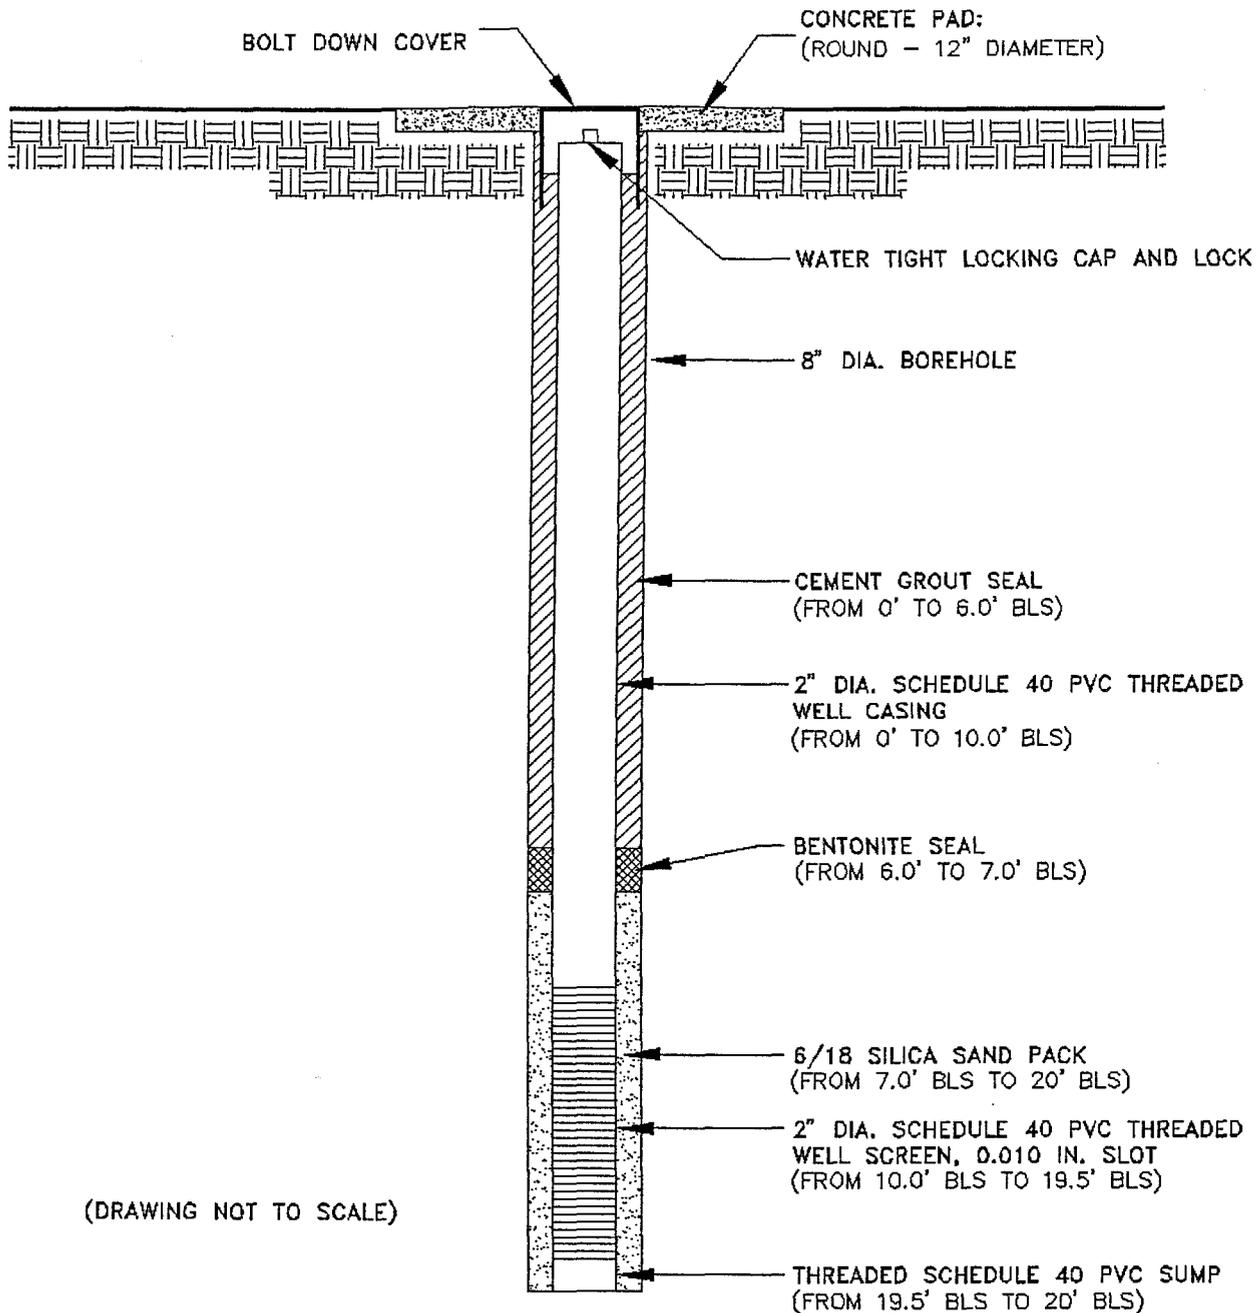
PROJECT NO.: 399.19
WELL NO.: MW-5
BY: J. SKIDMORE
DATE: 4/11/95
CASING ELEVATION: 23.251 FEET
DEPTH TO WATER UPON COMPLETION: 14.00 FEET
UNIT MONITORED: SURFICIAL AQUIFER

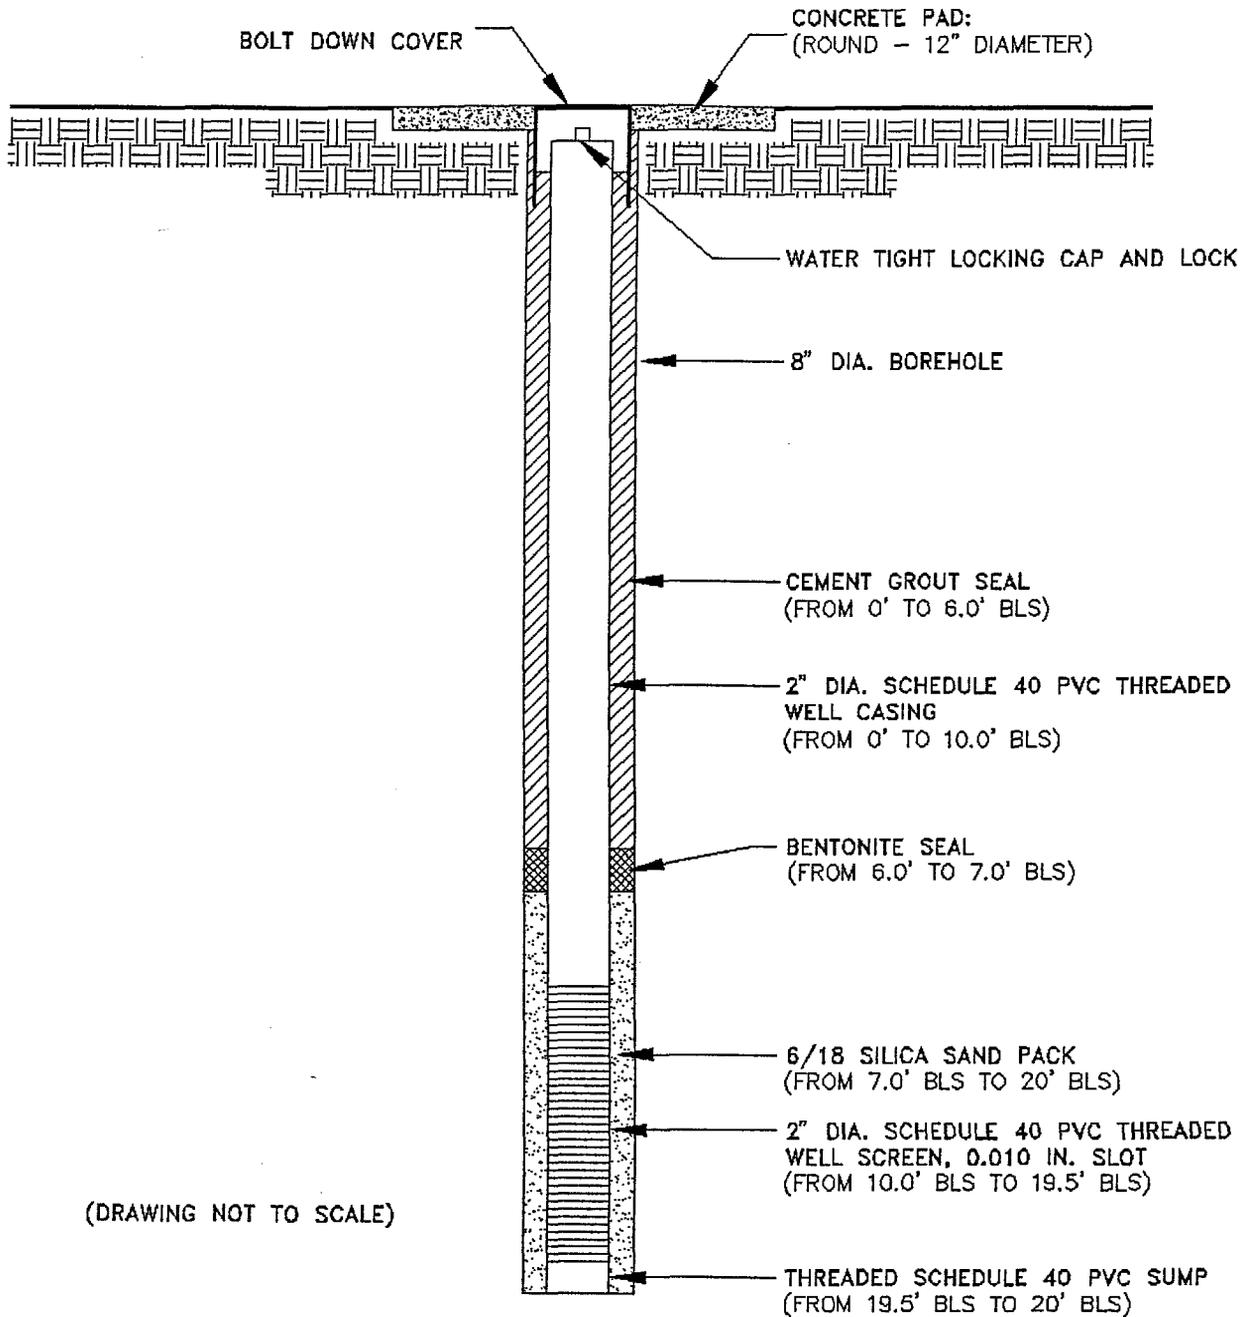
PROJECT NO.: 399.19
WELL NO.: MW-6
BY: J. SKIDMORE
DATE: 4/11/95
CASING ELEVATION: 23.251 FEET
DEPTH TO WATER UPON COMPLETION: 14.00 FEET
UNIT MONITORED: SURFICIAL AQUIFER

DRILLER: SOIL TECH, INC.
DRILLING METHOD: HOLLOW STEM AUGER
TOTAL DEPTH: 20 FEET
SAMPLE TYPE: SPLIT SPOON
SAMPLE INTERVAL: CONTINUOUS
